# MONK'S BARN, MARINE DRIVE, LLANDUDNO

## ARCHAEOLOGICAL ASSESSMENT

Report No. 407

**ARCHAEOLOGICAL ASSESSMENT  
(G1676)**

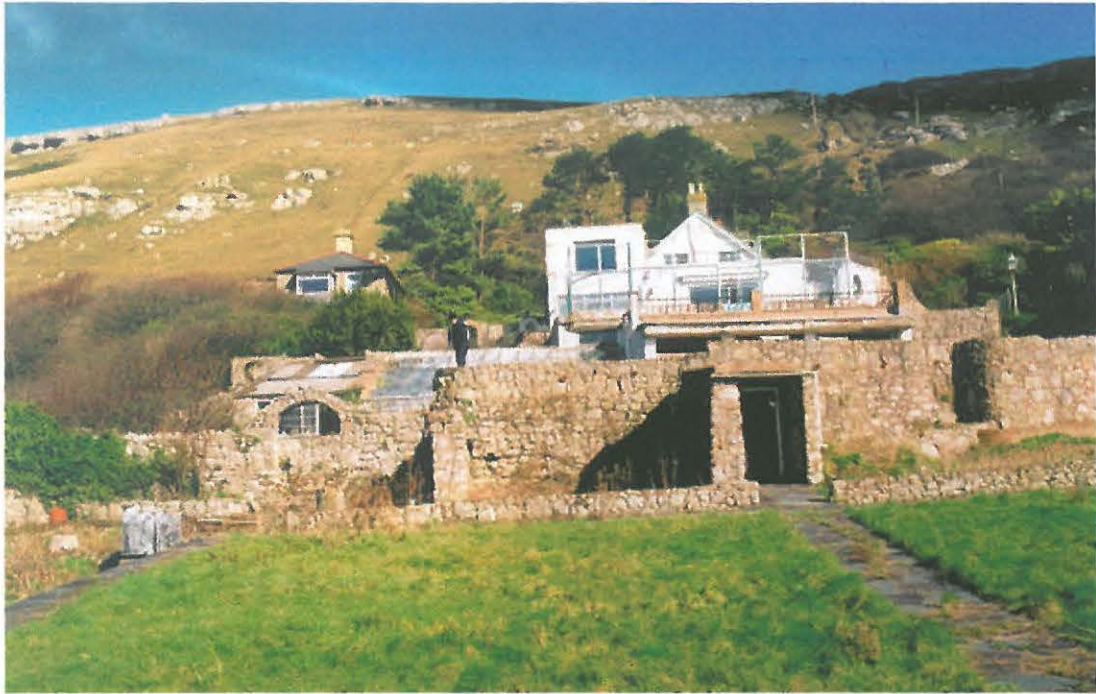
Plate 4: Monk's Barn from south-west

Monk's Barn is an individual house built in a mixture of styles. The rectangular core of the house, which presumably retains the plan of the earlier farmhouse, was re-roofed with overhanging eaves, and given a *cottage ornée* feel. The south-western end of the house is built in a modernist style (**plates 4 and 5**). It has numerous idiosyncratic features of external decoration, and internal decoration in grand style with large dramatic doorways and fireplaces (**plates 6-8**) seemingly quite out of keeping with the size of the house.

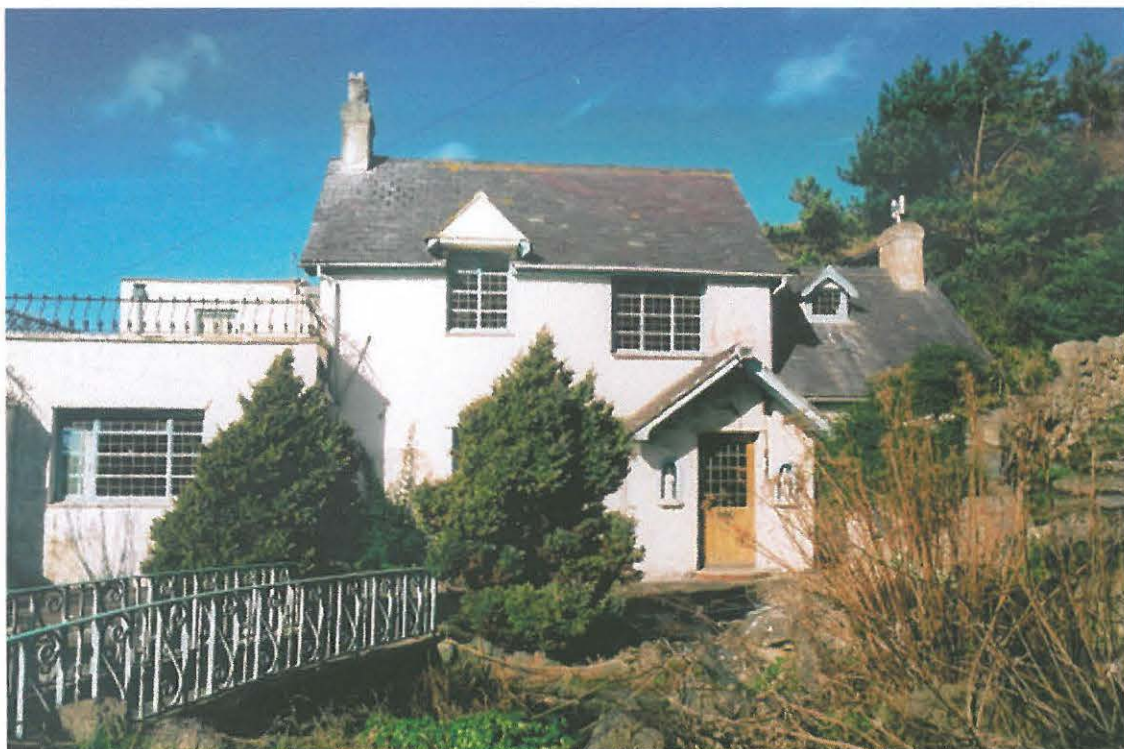
Plate 5: Front of Monk's Barn, from south-east

##### **Site 1 House (Plate 5)**

*Category: C, Impact: Considerable.*

The core of the house is a simple, pitched roofed farmhouse, almost certainly that shown on the 1840 tithe map, although much altered. Later structures of largely concrete construction, surround the earlier building.

*Recommendation for further assessment: None.*

*Recommendation for mitigatory measures: Basic recording of interior and exterior, followed by watching brief during the demolition and the excavation of foundations for the new house.*
