# A487 FISHGUARD TO BANGOR TRUNK ROAD IMPROVEMENT AT FFRIDD GATE, MACHYNLLETH

## ARCHAEOLOGICAL ASSESSMENT

Report No. 434

Project No. G1726

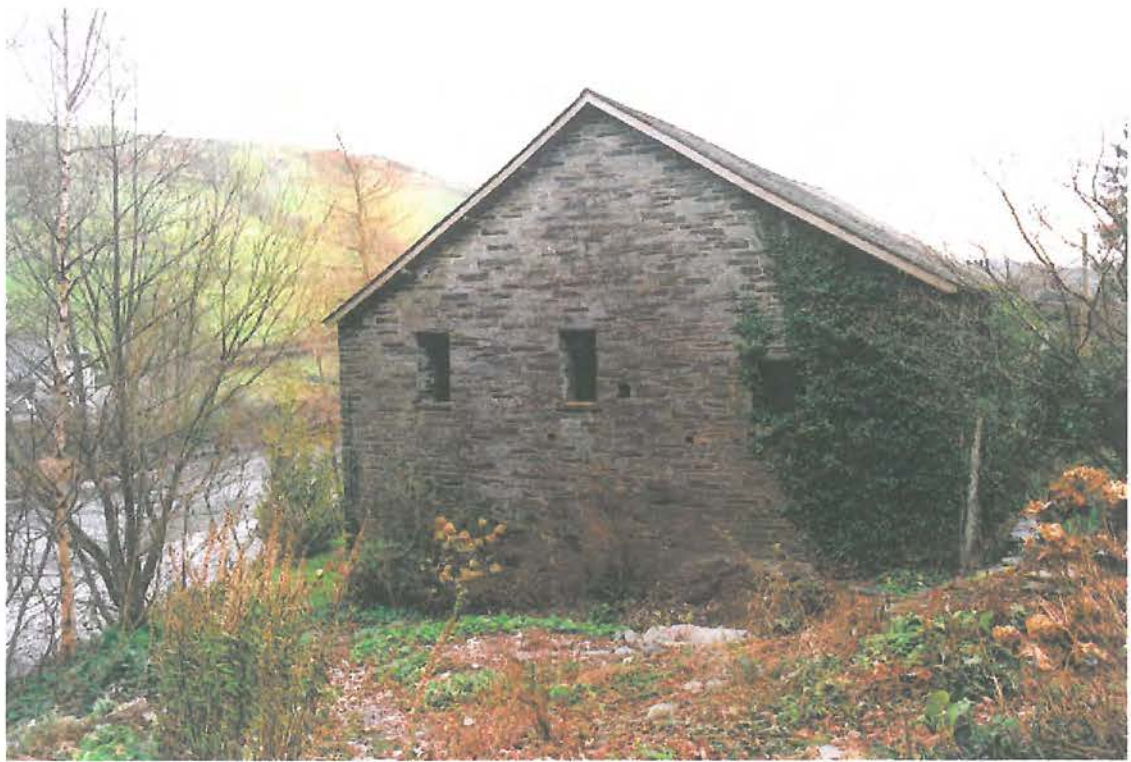
Plate 1: Felin y Ffridd, feature 1

The mill building is still in very good condition (**plate 1**). The interior has not been renovated, and though the machinery has gone, other fixtures remain. It is still just possible to trace the outline of the leat, although it has been entirely in-filled, and incorporated in a garden. The house south of the mill has been recently renovated and the survival of original features is unknown. This building is shown on the 1844 tithe map. The condition of the smaller buildings in the complex was not inspected.

*Recommendations for mitigatory measures: Avoid*

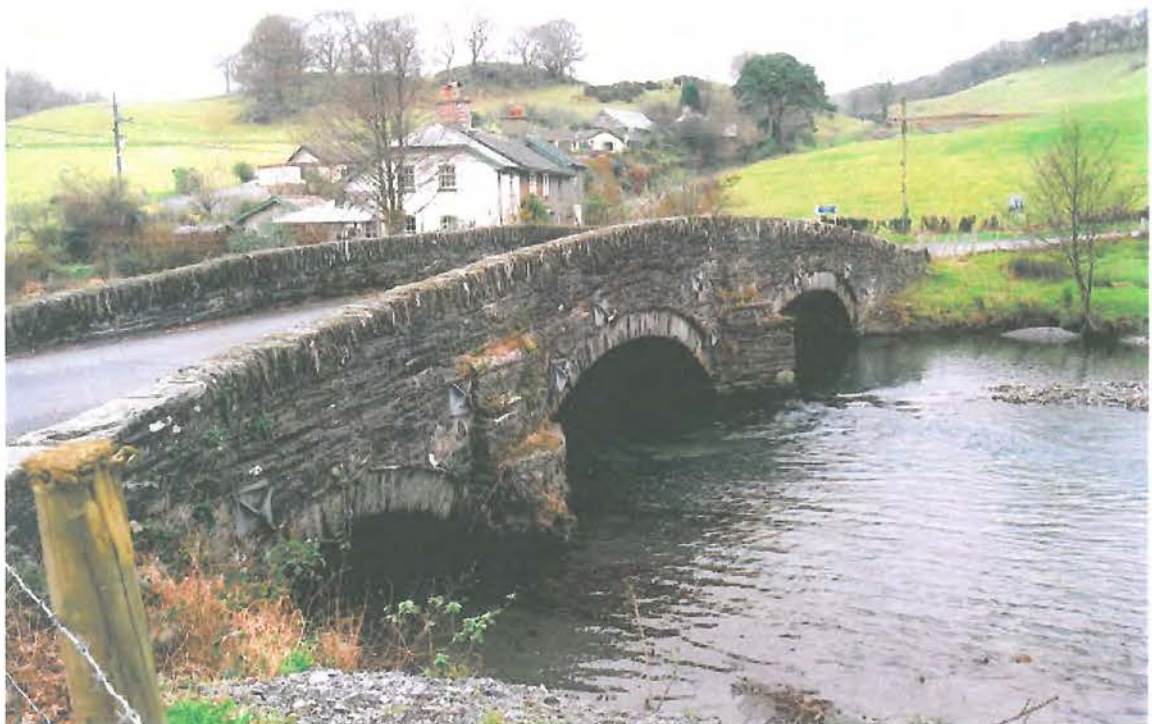
Plate 2: Pont Felin y Ffridd, feature 3

The bridge carries the B4404 over the Afon Dulas. It has three arches and has been widened on its upstream side, so it is now double its original width (**plate 2**). The Cadw listing information dates the bridge as 18<sup>th</sup> century, and notes in the Merioneth Quarter Session Rolls mentioning Pontarddulas in 1756 and 1788 probably refer to this bridge (William-Jones 1965, 148; Hough 1996). It was on the 17<sup>th</sup> century road from St David's to Holyhead (Jervoise 1936, 58).

*Recommendations for mitigatory measures: Avoid*

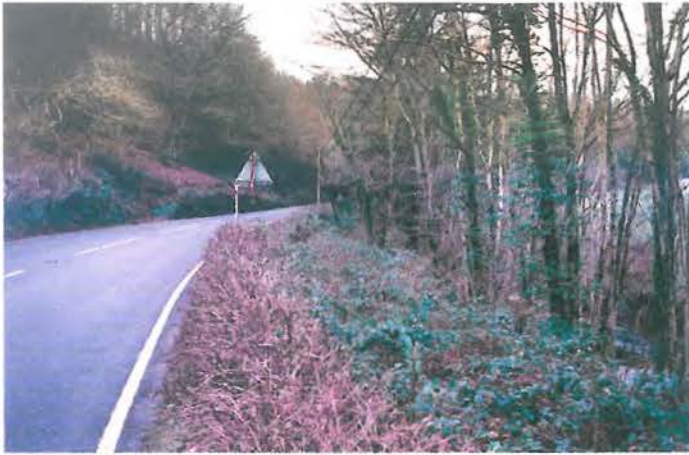
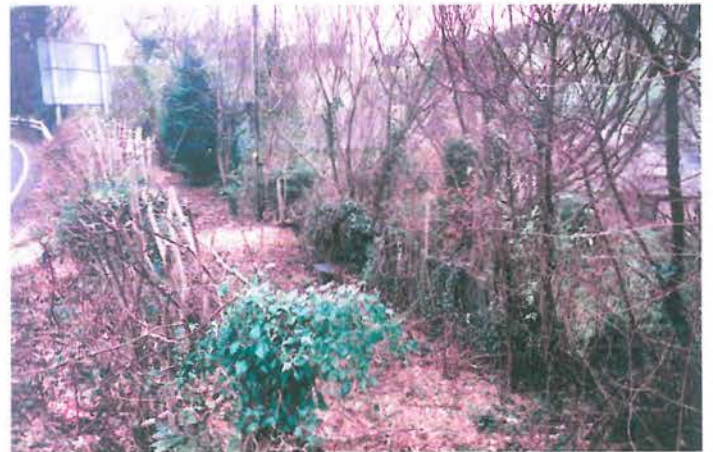
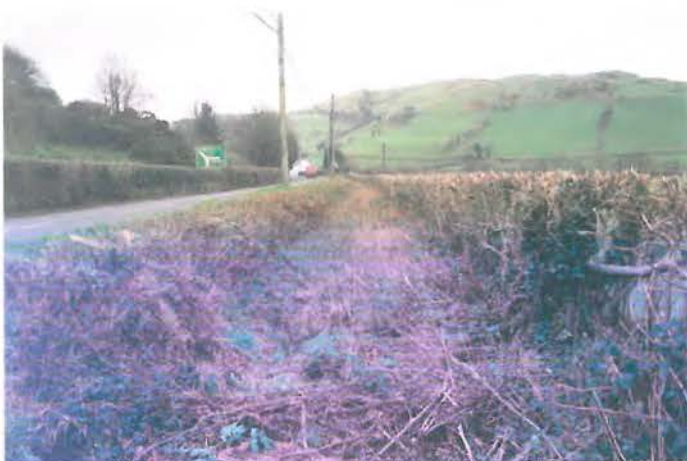
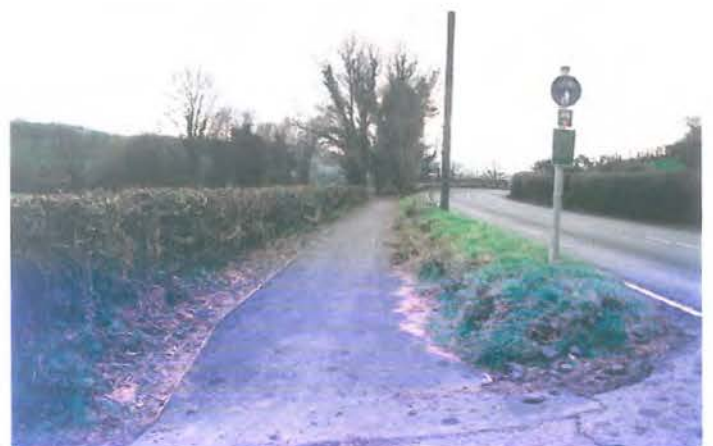
The bed of the line still survives along the whole length of the survey area. For most of its length it is overgrown with brambles (**plates 3a, b, c**), but parts of it have been adapted for various uses. Where the line passes east of Turnpike Cottage it has been made into a driveway. On the other side of the road it has also been converted into a drive for Haulfryn, with a new gate and section of slate walling. On

the east and south side of Haulfryn the line has been incorporated into the garden. In the southern part of the study area the line has been made into a cycle path leading to the new cycle bridge over the Dyfi (plate 3d). Along much of the eastern side of the line the original slate fencing still survives.

Plate 3a: Railway line at north end of study area

Plate 3b: Railway line north of Turnpike Cottage

Plate 3c: Line south of Haulfryn

Plate 3d: Line converted to cycle track  
in southern part of study area

*Recommendations for mitigatory measures: Basic recording and watching brief*

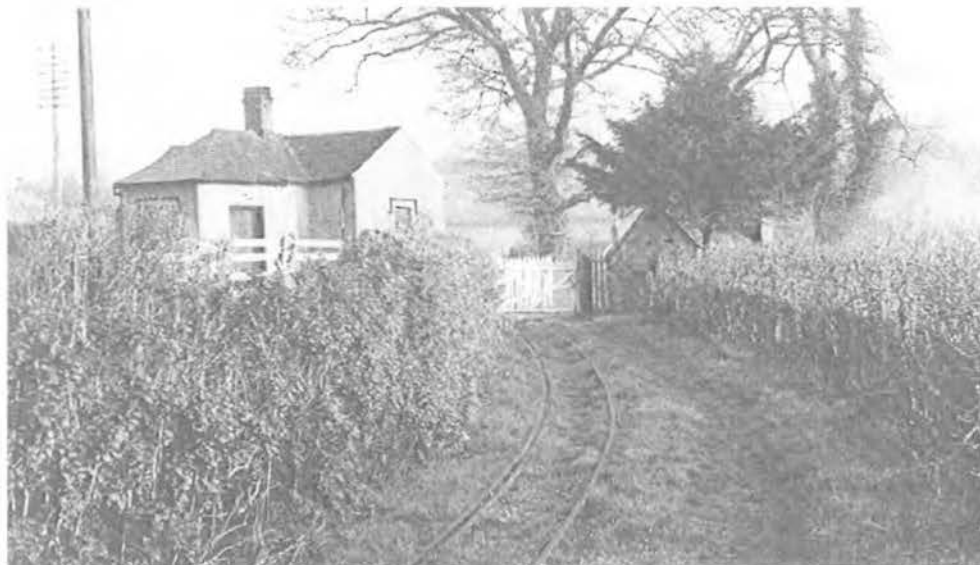
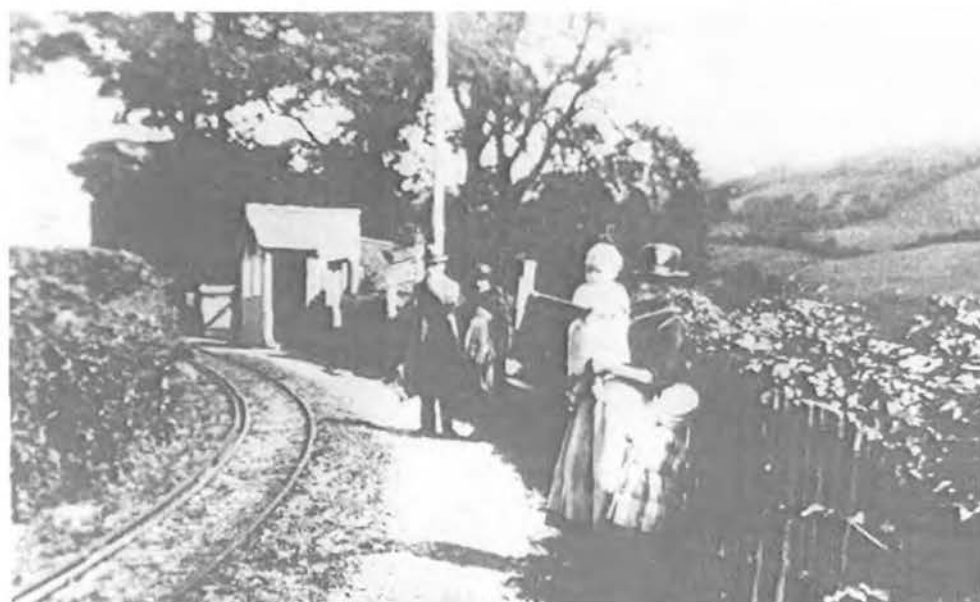
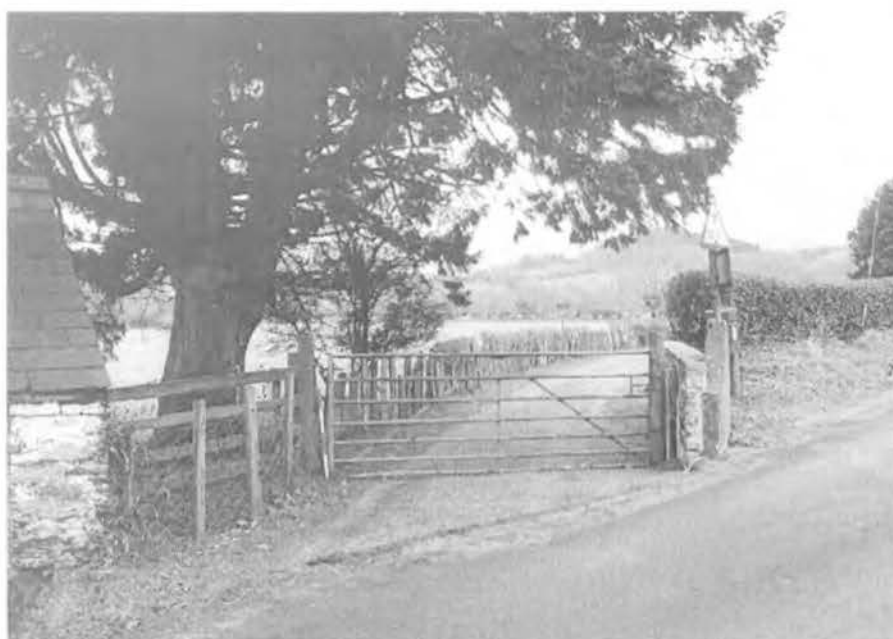
This is the first station north of Machynlleth, and was opened in 1885 to serve the adjoining hamlet and the village of Llanwrin (Corris Railway Society 1988, 34). The station consisted of a platform and a small, sentry box-like shelter (plate 4a, b). Neither these, nor the crossing gates, survive, as the area is now the gateway and drive to Haulfryn (plate 4c). However, the small fir tree shown in a photograph dating probably from the 1940s (plate 4a) is now a large and impressive tree. A small stone building visible in this and an earlier photograph is also still there. This appears to be a shed, and it has been re-roofed relatively recently. It appears on the 1901 25" map (figure 3), but not on the 1844 tithe map. It is likely that the shed predates the station, and was used by the occupants of Turnpike Cottage.

Plate 4a: Ffridd Gate station (LGRP, in Morgan 1991, p46)

Plate 4b: Ffridd Gate station in use (Chris Hawkins Collection, in Morgan 1991, p46)

Plate 4c: The site of the station today, looking from NE.

*Recommendations for mitigatory measures: Avoid*

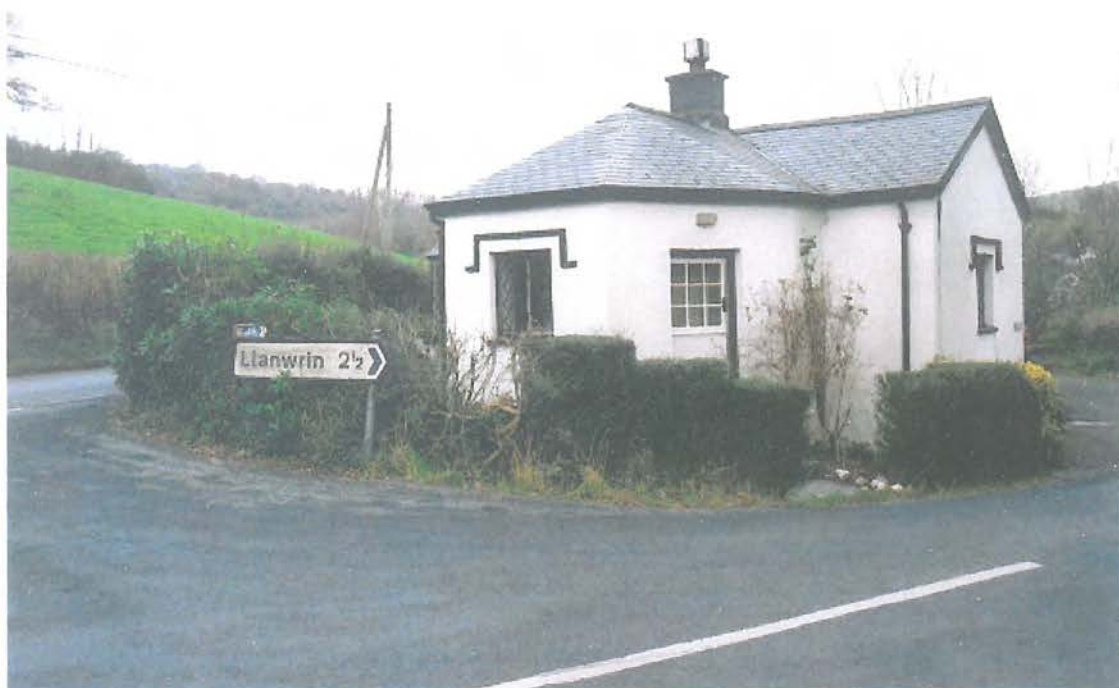
Plate 5: Feature 7, Turnpike Cottage

Single storey, stone built cottage, with slate roof. Retains distinctive T-shaped plan of a toll-house, including bay window overlooking the road, with its original glazing (plate 5). Built in c.1830 to control south end of the turnpike road to Dolgellau. The building appears on the 1844 tithe map, where gates are shown across both roads to either side of the cottage.

*Recommendations for mitigatory measures: Avoid*

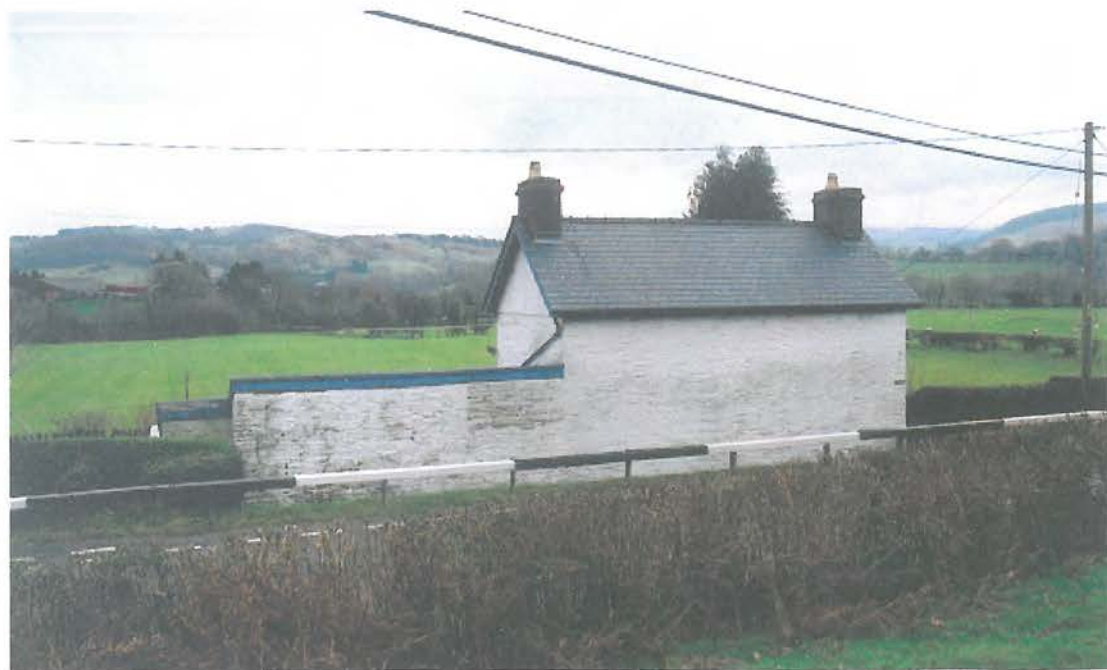
Plate 6: Feature 8, Haulfryn

A stone built cottage with sheds added to its north-eastern end. The house has recently been re-roofed in slate. The most unusual feature about the house is its lack of windows on the western side (plate 6), presumably to avoid seeing and hearing the road from inside the house. Haulfryn is not shown on the 1844 tithe map, nor on the 1850 tramway plan (Z/CD/128), but was built by time the 1901 25" map was surveyed.

*Recommendations for mitigatory measures: Avoid*

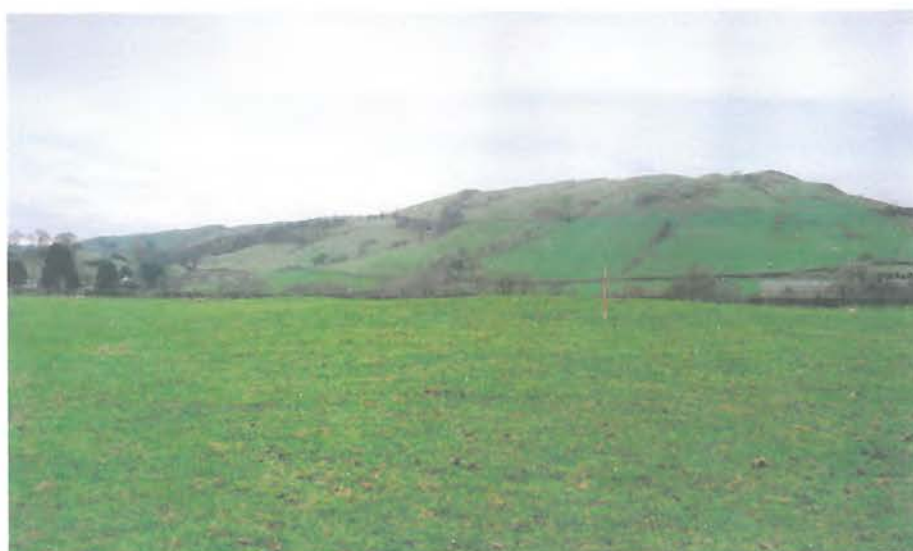
Plate 9: Feature 11, two round barrows

Two circular mounds were noticed in a field to the east of the road. As this is on Mr Evans's land the opportunity was taken to inspect them. The northern mound measures about 20m diameter, and is 0.6m high, while the southern one is about 18m in diameter and c.0.5m high. Both are circular and fairly well defined, with only some slight hollows suggesting disturbance (plate 9). The northern barrow had some disturbance on its southern edge, possibly caused by a previous field boundary or drainage. This is the flood plain of the Afon Dulas, and the fields are quite flat, except for these two mounds. Bronze Age barrows are not usually located in such a low-lying area, but the views from the site are good, particularly to the south down the valley. The regularity of the features and the lack of other mounds and hummocks in the surrounding fields do suggest that these are Bronze Age burial mounds. Only excavation could confirm this.

**Recommendations for mitigatory measures:** *None*

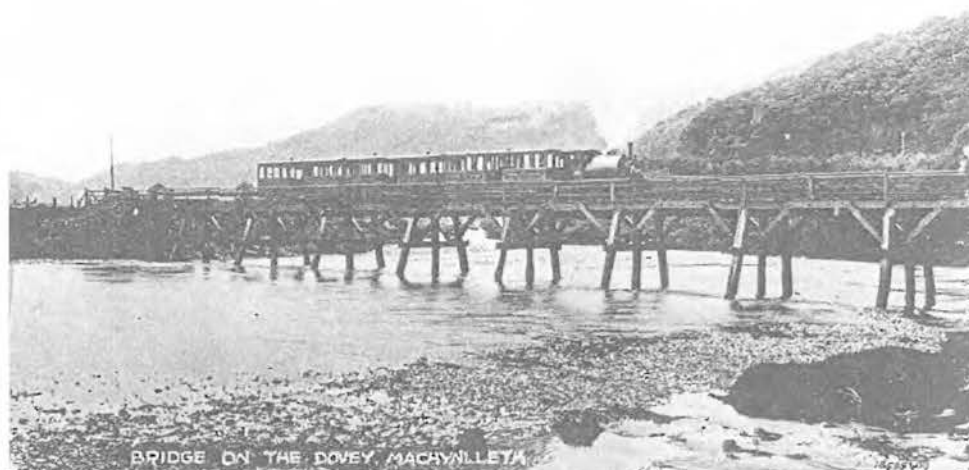
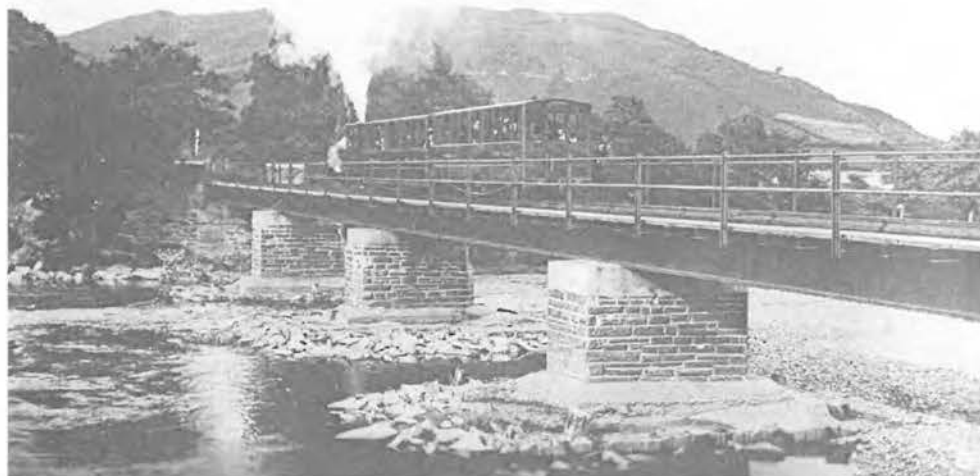
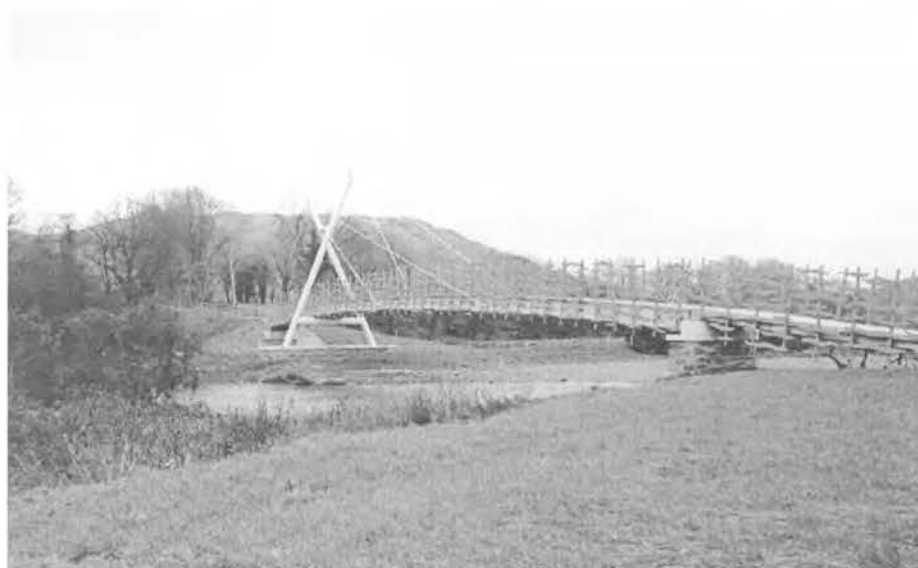
The railway crossed the Dyfi on a viaduct supported on timber trestles (Morgan 1991, 11) (plate 10a). This structure had deteriorated by the start of the 20<sup>th</sup> century, and work on rebuilding the bridge in ironwork started in 1906 (ibid, 9). The new bridge was carried on stone piers, with four steel spans (Boyd 1970, 26) (plate 10b). When the railway was abandoned the viaduct was one of the first sections to be demolished (Boyd 1970, 28). As a millennium project a new cycle bridge was constructed in the place of the viaduct. This new bridge is of a dramatic modern design and was opened on 22<sup>nd</sup> October 2001 (plate 10c). There is now little to see of the railway viaduct, though boulders lying against the south bank of the river presumably originate from it.

Plate 10a: Timber bridge over the Dyfi (Brian Hilton Collection, in Morgan 1991, p9)

Plate 10b: New railway bridge over the Dyfi (Brian Hilton Collection, in Morgan 1991, p42)

Plate 10c: Millennium Project cycle bridge over the Dyfi

*Recommendations for mitigatory measures: None*
