**TOWYN Y CAPEL**  
**Trearddur Bay, Anglesey**

**ARCHAEOLOGICAL RECORDING  
AND CONSOLIDATION**

Report number : 440

### REPORT ON STORM EROSION OCTOBER TO DECEMBER 2001 (G1714)

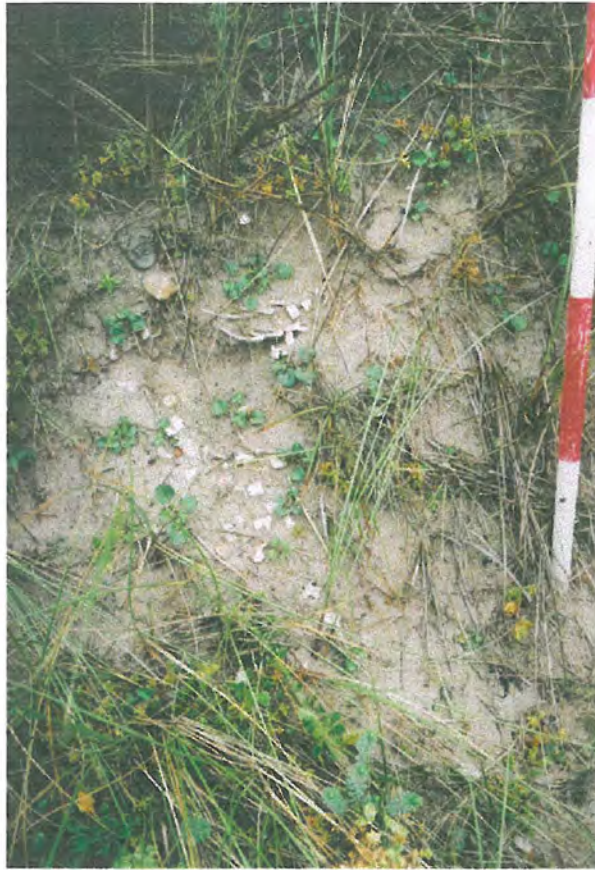
The work was carried out on 4<sup>th</sup> October 2001. It was decided to keep excavation to a minimum, as the area round the skeleton was well grown with marram grass, and therefore relatively stable. Removal of the marram grass would have contributed to even greater erosion. The skeleton was eroding from a steep scarp, and any cutting back would have left a high, exposed section, which would have been difficult to consolidate (plate 1). As a result the exposed bones were cleaned up, and the full skeleton was not excavated. The bones were left *in situ*, enabling the skeleton to be more fully investigated in the future, if necessary.

Plate 1: Bones visible before investigation

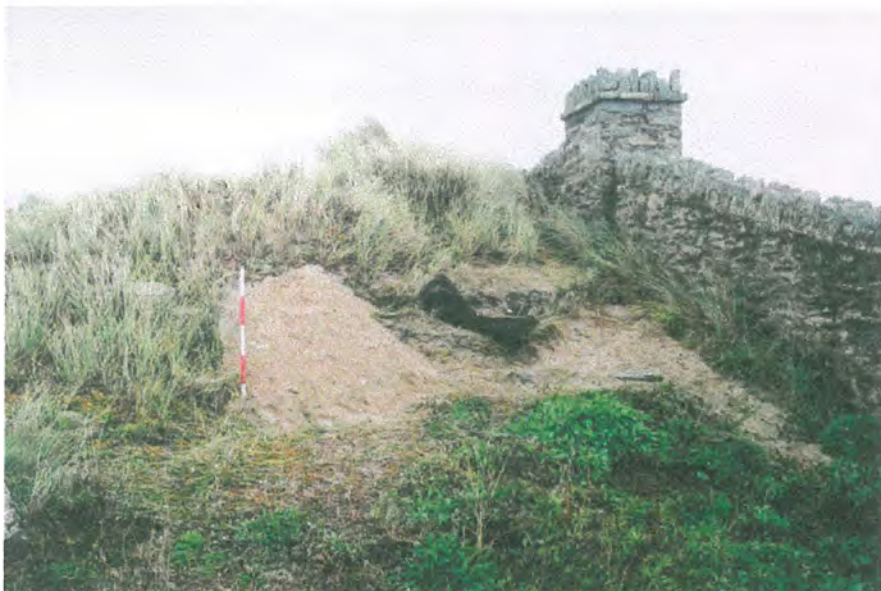
When recording was complete the area was consolidated with sandbags built up against the exposed face. The sandbags were disguised by covering them with beach sand (plate 2).

Plate 2: Area after consolidation

Following the consolidation work the mound has been monitored at regular intervals. The sand which had been placed over the sandbags had, by early November, been washed and blown away, leaving the sandbags exposed. This looked unsightly, but nonetheless, the area of erosion was still protected.

However, storms in December removed some of the lower bags which were replaced. These were followed by significantly greater storms in January 2002, in which high tides backed by a strong westerly wind caused huge waves to wash over the mound. The stone wall (which was already part demolished – see above) was completely destroyed along the sea front. All the sandbags were washed from their location, and the remains of several skeletons were visible eroding from different areas of the mound. An attempt has been made to cover the worst of the areas with sandbags, but this can only be a very temporary solution.

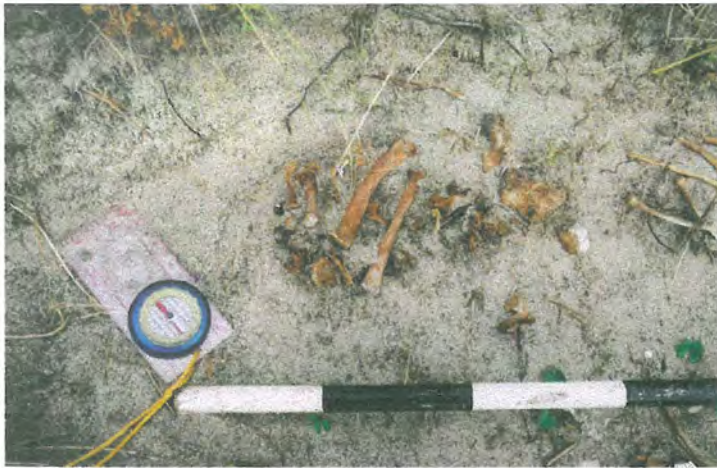
Plate 3a: Detail of foot

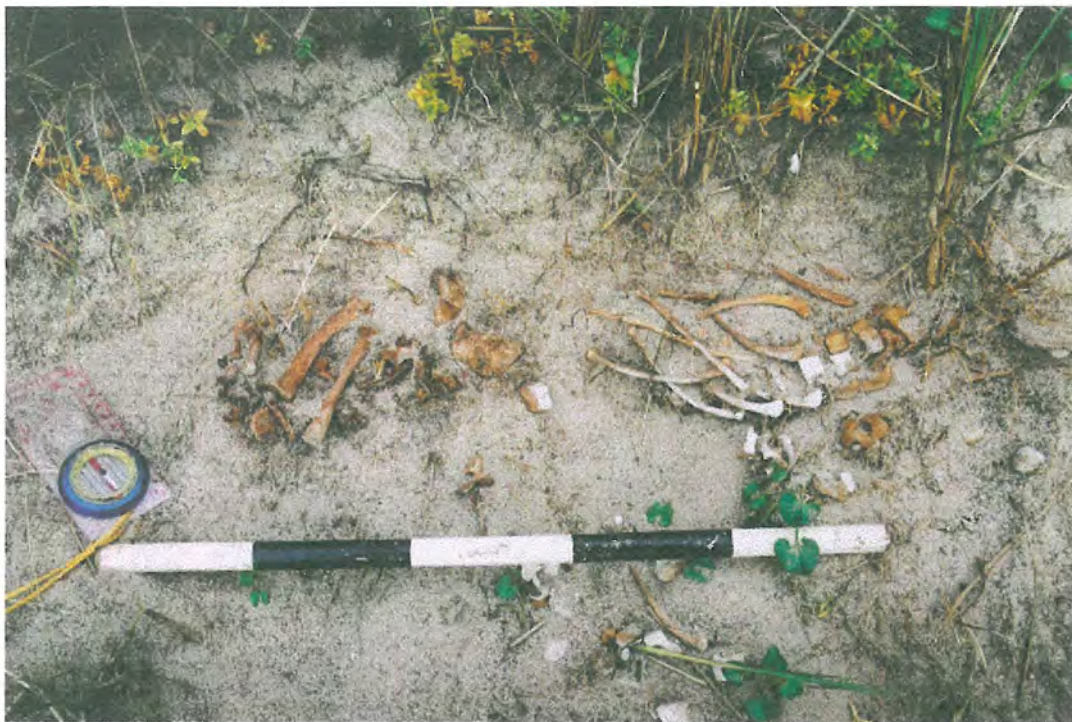
The remains were of a young child, laid on its back, with the legs bent (plate 3). The policy of not exposing the full skeleton made the interpretation of the remains a little unclear in places. The head was not exposed, but the right scapula projected from the mound. The spine and ribs had been exposed by the sand erosion, and many vertebrae from the lower back had slipped out of place down the slope (plate 3b). Elements of the pelvis seemed to be in approximately the correct position, and the feet were articulated (plate 3a). The exact position of the legs was uncertain, as the femurs were not exposed. Two long bones could be seen, one of which was a tibia, but the identification of the other was uncertain. The position of the feet in relation to the torso, and the angle of the tibia, suggests that the legs were bent up towards the body. All visible epiphyses were unfused, making bone identification difficult to a non-specialist, but proving that this was the body of a young child. From the small number of bones recovered, especially the scapula, the age of the child has been estimated at between 5 and 7 years (Pepper 2001).

The body was orientated north-west to south-east, with the head at the south-east. While rather close to a north-south alignment, the orientation is not beyond that possible if it was aligned on the mid summer or mid winter sunrise, and so might be considered an east-west alignment. The head, in early medieval burials, is usually at the western end, so this burial is atypical in this respect. The burials excavated in the evaluation trench (Davidson 1997) were much closer to east-west in orientation, and all had their heads to the west.

Plate 3: Exposed skeleton after cleaning

The loose, eroded bones were collected, as was the projecting scapula, as it was too vulnerable to protect effectively *in situ*. These bones are stored at the Trust. The remaining bones were preserved *in situ* by covering them with an empty sandbag and a layer of sand. If further work is necessary in the area it should be possible to expose the full skeleton.

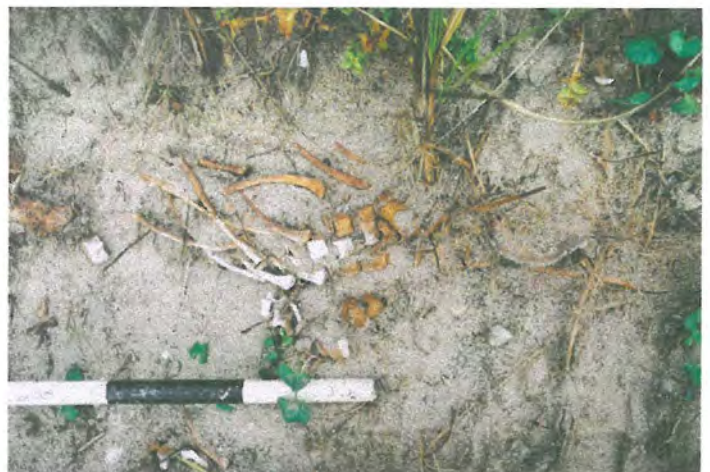
Plate 3b: Detail of torso
