PROPOSED DEVELOPMENT AT BRITANNIA PARK, BANGOR

ARCHAEOLOGICAL MITIGATION WORK

Report No. 446

Project No. G1735

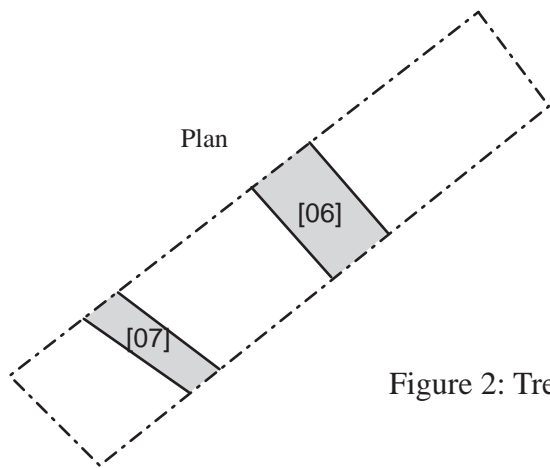
Figure 2: Trench A

This trench was located to investigate two parallel gullies running south-east to north-west, down the hill. On the surface this feature appeared as a shallow ditch, c.4m wide and c.0.5m deep. On either side of the ditch was a slight bank, and to the south-west the traces of another, parallel ditch. Excavation showed that the slight banks were within the topsoil. The ditches were 0.8m wide and up to 0.6m deep, filled with a mixed clay fill. At the south-western end of the trench the JCB dug deep enough to reveal a yellow ceramic pipe in the south-western ditch, so it was assumed that both were land drain trenches and no further excavation was carried out. These are recent features and not part of the earlier field system.

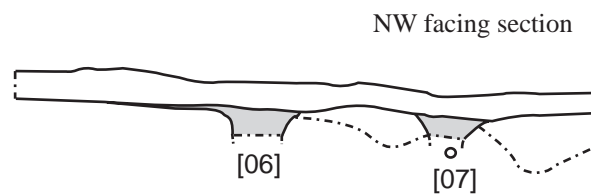
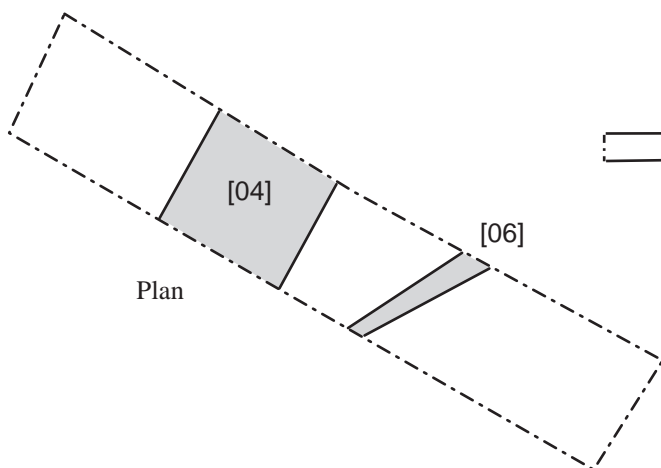
Figure 3: Trench B

The surface feature (feature 10b) under investigation by this trench was a low scarp (c. 0.3m high), running north from Porthwell Covert. It could be followed as a continuous feature up to a north-west-south-east running ditch, after which there was no trace of the scarp.

At the base of the scarp excavation revealed a fairly broad ditch (cut 04) aligned NNE to SSW. This was c. 2m wide and 0.6m deep. It was filled with a homogenous red-brown silty clay, containing occasional stones and some manganese mottling. The ditch cut was higher on the south-eastern side, and fairly slight on the north-western side. Both sides sloped gradually into the rounded base. The ditch fill contained sherds of post-medieval pottery with a red fabric and cream glaze. A variety of post-medieval and modern pottery was recovered from the topsoil over trench B.

It was clear that the scarp visible on the surface was created by the ditch, and not by a built-up of plough soil. This feature fits very closely to a boundary shown on the 1832 map, but not on the 1777 map (figure 11 (b)). It can, therefore, be interpreted with some certainty as a field boundary dating to the late 18th century or early 19th century.

A field drain containing a yellow ceramic pipe was also uncovered, running south-west to north-east across the south-eastern end of this trench.

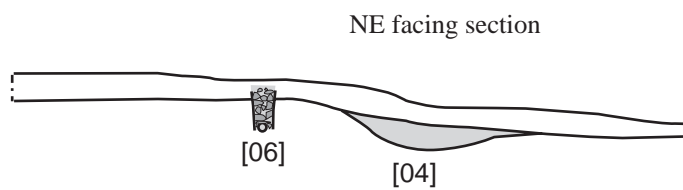
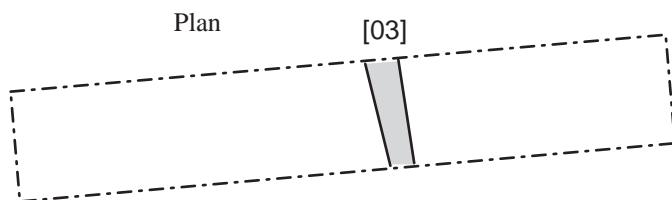
Figure 4: Trench C

This trench was to investigate a shallow ditch, c. 2m wide and 0.1m deep, with a slight bank on the western side. On the surface this did resemble a land drain and the trench revealed a land drain with a yellow ceramic pipe running nearly north-south across the trench.

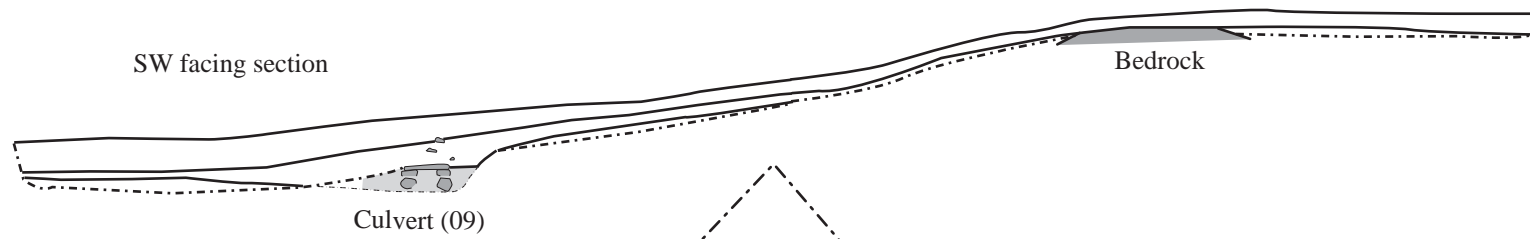
Figure 5: Trench D

Visible on the surface was a fairly substantial scarp, reaching a height of 1.4m, and running south-west to north-east for c. 84m (feature 10d). Towards its south-western end there was a slight terrace, c. 30m in length, in this slope. The trench was positioned to investigate both the main scarp and this terrace. The main scarp proved to be an entirely natural feature in the boulder clay. Comparisons between the location of this feature and field boundaries on the early maps (figure 11(c)) strongly suggest that the

The terrace feature was proved to be caused by a well-built culvert, aligned south-west to north-east (plate 2). It was constructed with small limestone blocks forming the sides and large slate slabs as lintels. The base was not seen, but was likely also to have been formed from slate slabs. The culvert was still functioning and seemed to flow down towards the south-west. No surface trace of this feature could be seen to the north-east or south-west of the terrace. In the field to the west of the development area is a slate trough fed and drained by a similar culvert. This trough is marked on the 1900 edition of the 25" map (Caernarvonshire XI.3), but not on the 1889 edition, dating its construction relatively accurately to the end of the 19th century. It is likely that the culvert in trench D is of a similar date.

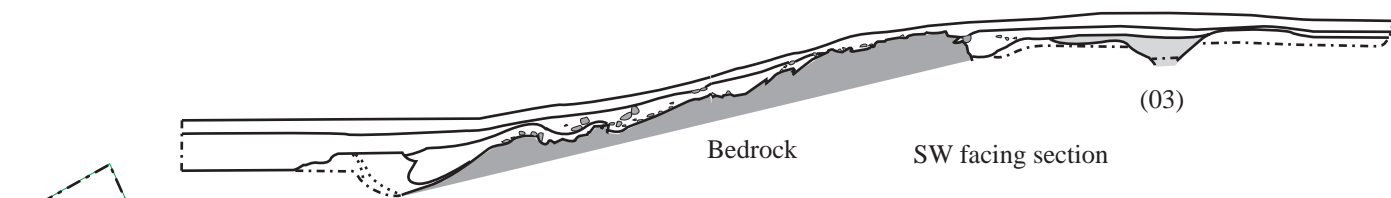
Figure 9: Trench H

Feature 10c is a substantial scarp, up to 1.4m in height, aligned south-west to north-east, with stones visible protruding through the grass. The trench demonstrated that the scarp was of entirely natural origin, and was formed by the limestone bedrock protruding through the glacial boulder clay. At the north-western end the boulder clay had been deposited in a rather convoluted manner against the bedrock. It contained lenses of grey, gleyed clay, but there was nothing to suggest that this was not natural. A linear feature (context 3) crossed the trench at the south-eastern end, but excavation showed this too to be natural, and probably an ice-wedge cast or similar formation.

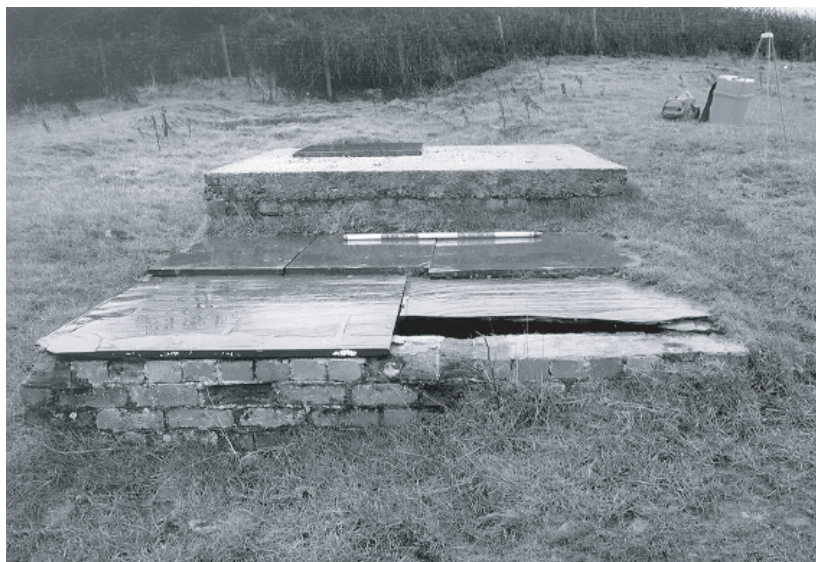
Plate 1: feature 7

This was a rectangular structure measuring 3.8m x 2.4m overall. It was set in a mound, with a linear hollow on its eastern side, probably caused by a pipe trench. The structure had brick sides and was divided into two sections, the south-eastern one set a little higher than the other. The south-eastern section was covered by concrete, with a square access hole in one corner. The north-western section was capped with reused slate slabs. Under the former cover was a tank still containing water, under the latter the tank had filled in with earth.

This feature appeared to be a septic tank, and the linear hollow to the east suggested a soil pipe coming from the direction of the sawmill. It seems unlikely that the sawmill alone would necessitate the

construction of a septic tank, and it is possible that this feature was originally related to the prisoner of war camp, which preceded the sawmill.

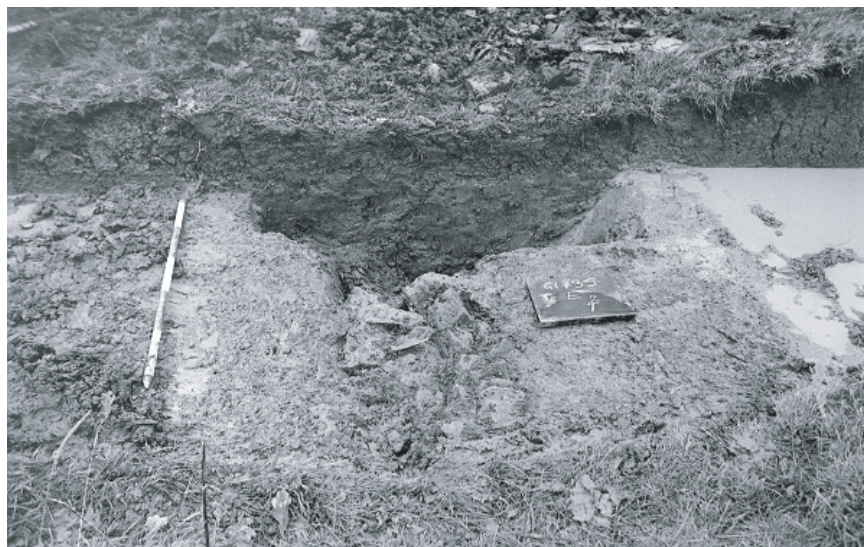
Plate 3: Ditch and land
drain in trench E

Feature 10e is a narrow ditch running from the north-western side of Porthwell Covert to the southern tip of Cow Pasture Covert. The feature is c.3m wide and up to 0.5m deep, with an unusual double curve of its route. The trench revealed that the feature was indeed a ditch (cut 07), measuring 1.6m wide and 0.5m deep (plate 3). It had two fills, the upper one being a mid-brown silty clay, and the lower a grey, gleyed clay containing c.20% stones.

A stone filled land drain was also found in the trench (cut 09), but it terminated with a square end close to the middle of the trench, and did not appear in the south-east facing section.

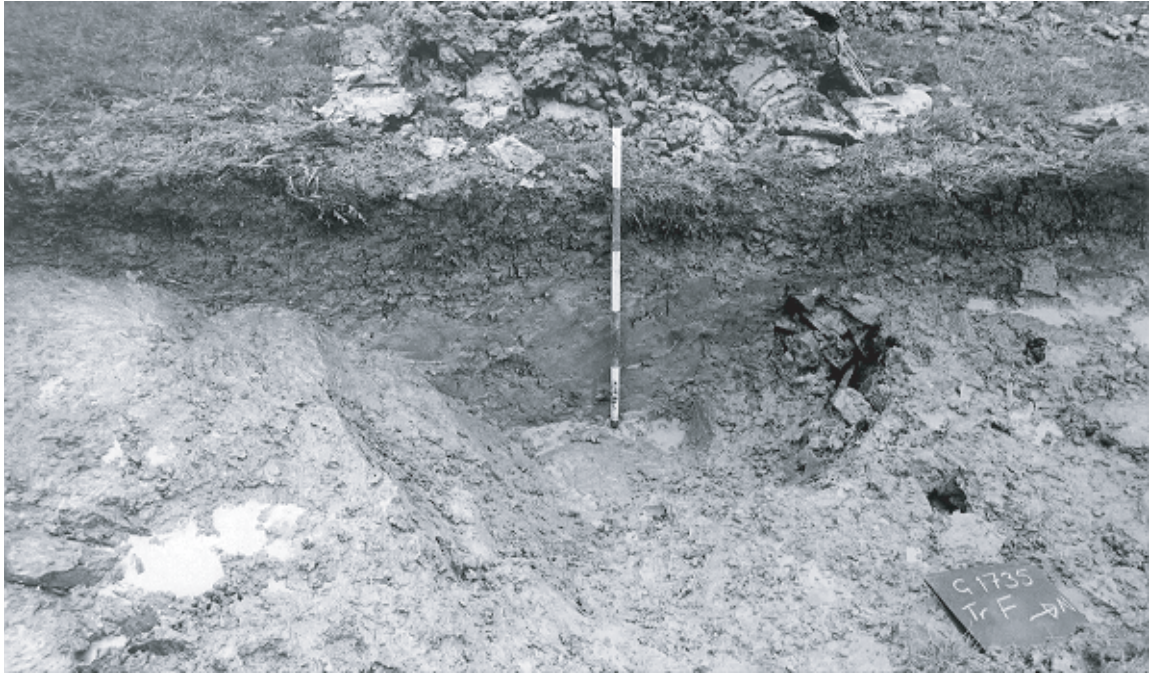
Plate 4: Ditch in trench F

In the south-western corner of the field is a curved scarp (feature 10f), 1m high, with a linear hollow on its southern side. It was initially thought that the hollow was a trackway, but the excavation showed that it was created by a ditch (cut 08), c.2m wide and 0.8m deep (plate 4). The fill of the ditch was a mixed clayey deposit, becoming gleyed towards the base. The ditch terminated with a rounded end within the trench, but a shallower hollow did continue the line of the ditch towards the east. The steep sides of the terminus were particularly conclusive in demonstrating that this feature was not a trackway.

The northern edge of the ditch was cut by a land drain (cut 04), with another immediately to its north (cut 06). 04 was filled with fairly small angular stones and contained a red ceramic drain pipe. This drain was certainly modern, and seems to have cut drain 06, which was filled by larger, more rounded stones. Drain 06 was not excavated, so the type of pipe it contained was not ascertained, but it may have been considerably earlier than 04.

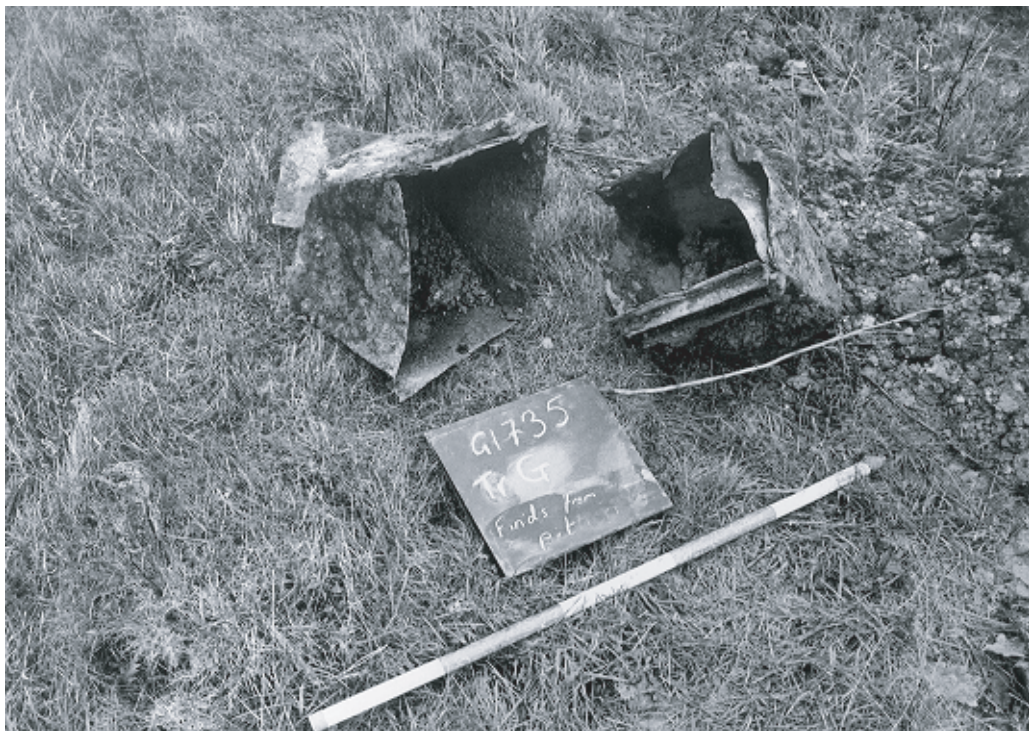
Plate 5: Iron objects from trench G

Trench G was placed to investigate a dump of stones and earth towards the north-eastern end of the field. This was not recorded in the assessment, but the presence of stones and the regular plan of the dump suggested that it may mask the foundations of a structure, so it was considered worthwhile investigating. The trench proved that there were no foundations, and that the dumped material had been deposited around the edges of a large, in-filled pit. The pit contained fills of mixed clay and silt and a deposit of clinker. Several iron objects were found, four of which were recovered from the pit, examples of which were photographed and sketched, but not kept. The objects were all the same and resembled flat-sided buckets, measuring 0.3 x 0.3m and 0.36m high (plate 5). They had flanges on two sides and a central hole on the same two sides, close to the rim. Their function is unknown, but their condition and manufacture demonstrated that they were of a fairly modern date.
