# Holyhead WTW Improvements

## Final Effluent Scheme

Archaeological assessment  
and field evaluation

Report no. 462

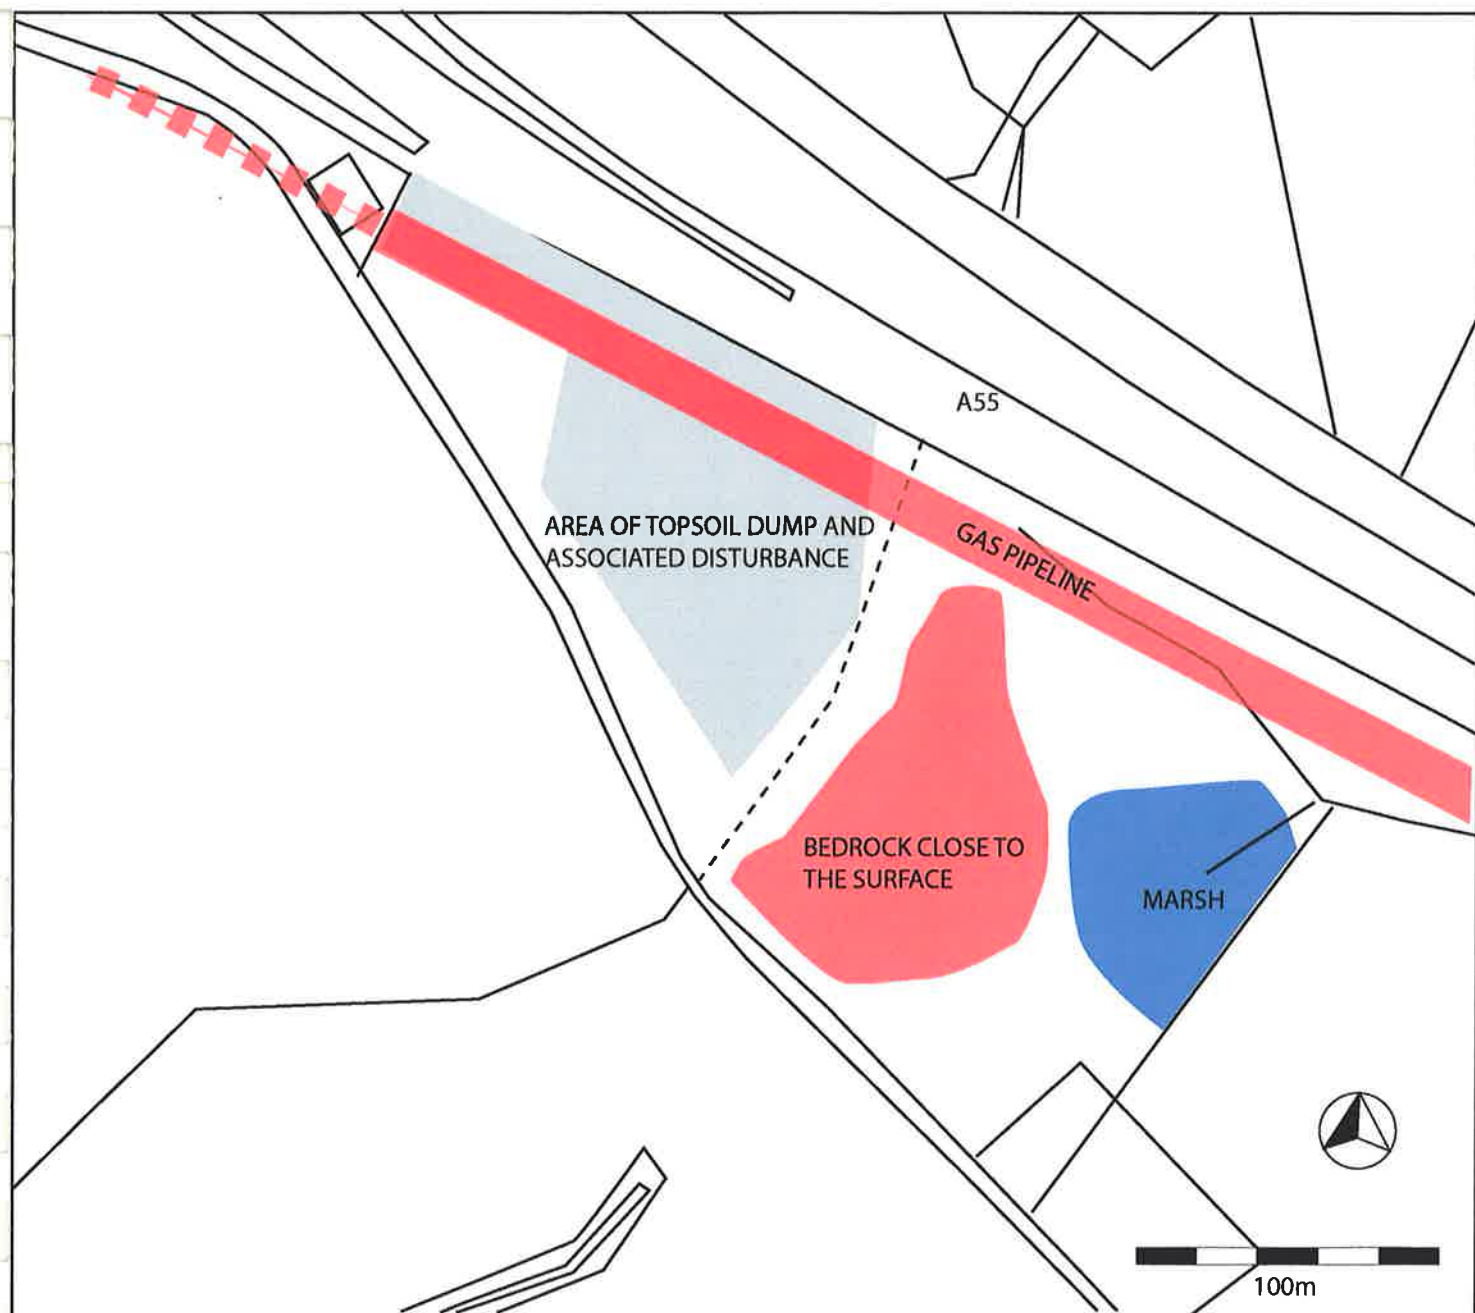
Fig.5 Geophysical survey area A, results of magnetic scanning

The area is usually first examined using a fast assessment technique called magnetic scanning. The operator walks across the field in widely spaced traverses. No readings are recorded but the visual display is observed. This procedure allows large ferric (e.g. pipelines) and bedrock anomalies to be avoided in the main survey and under certain conditions allows areas that appear to be archaeologically promising to be targeted.

The geophysical survey failed to reveal any anomalies that could be interpreted as archaeology. Area A contained three large areas that were unsuitable for survey and no further work was carried out. About half of area B was masked by responses from geology and no anomalies were visible in the remaining portion of the survey.

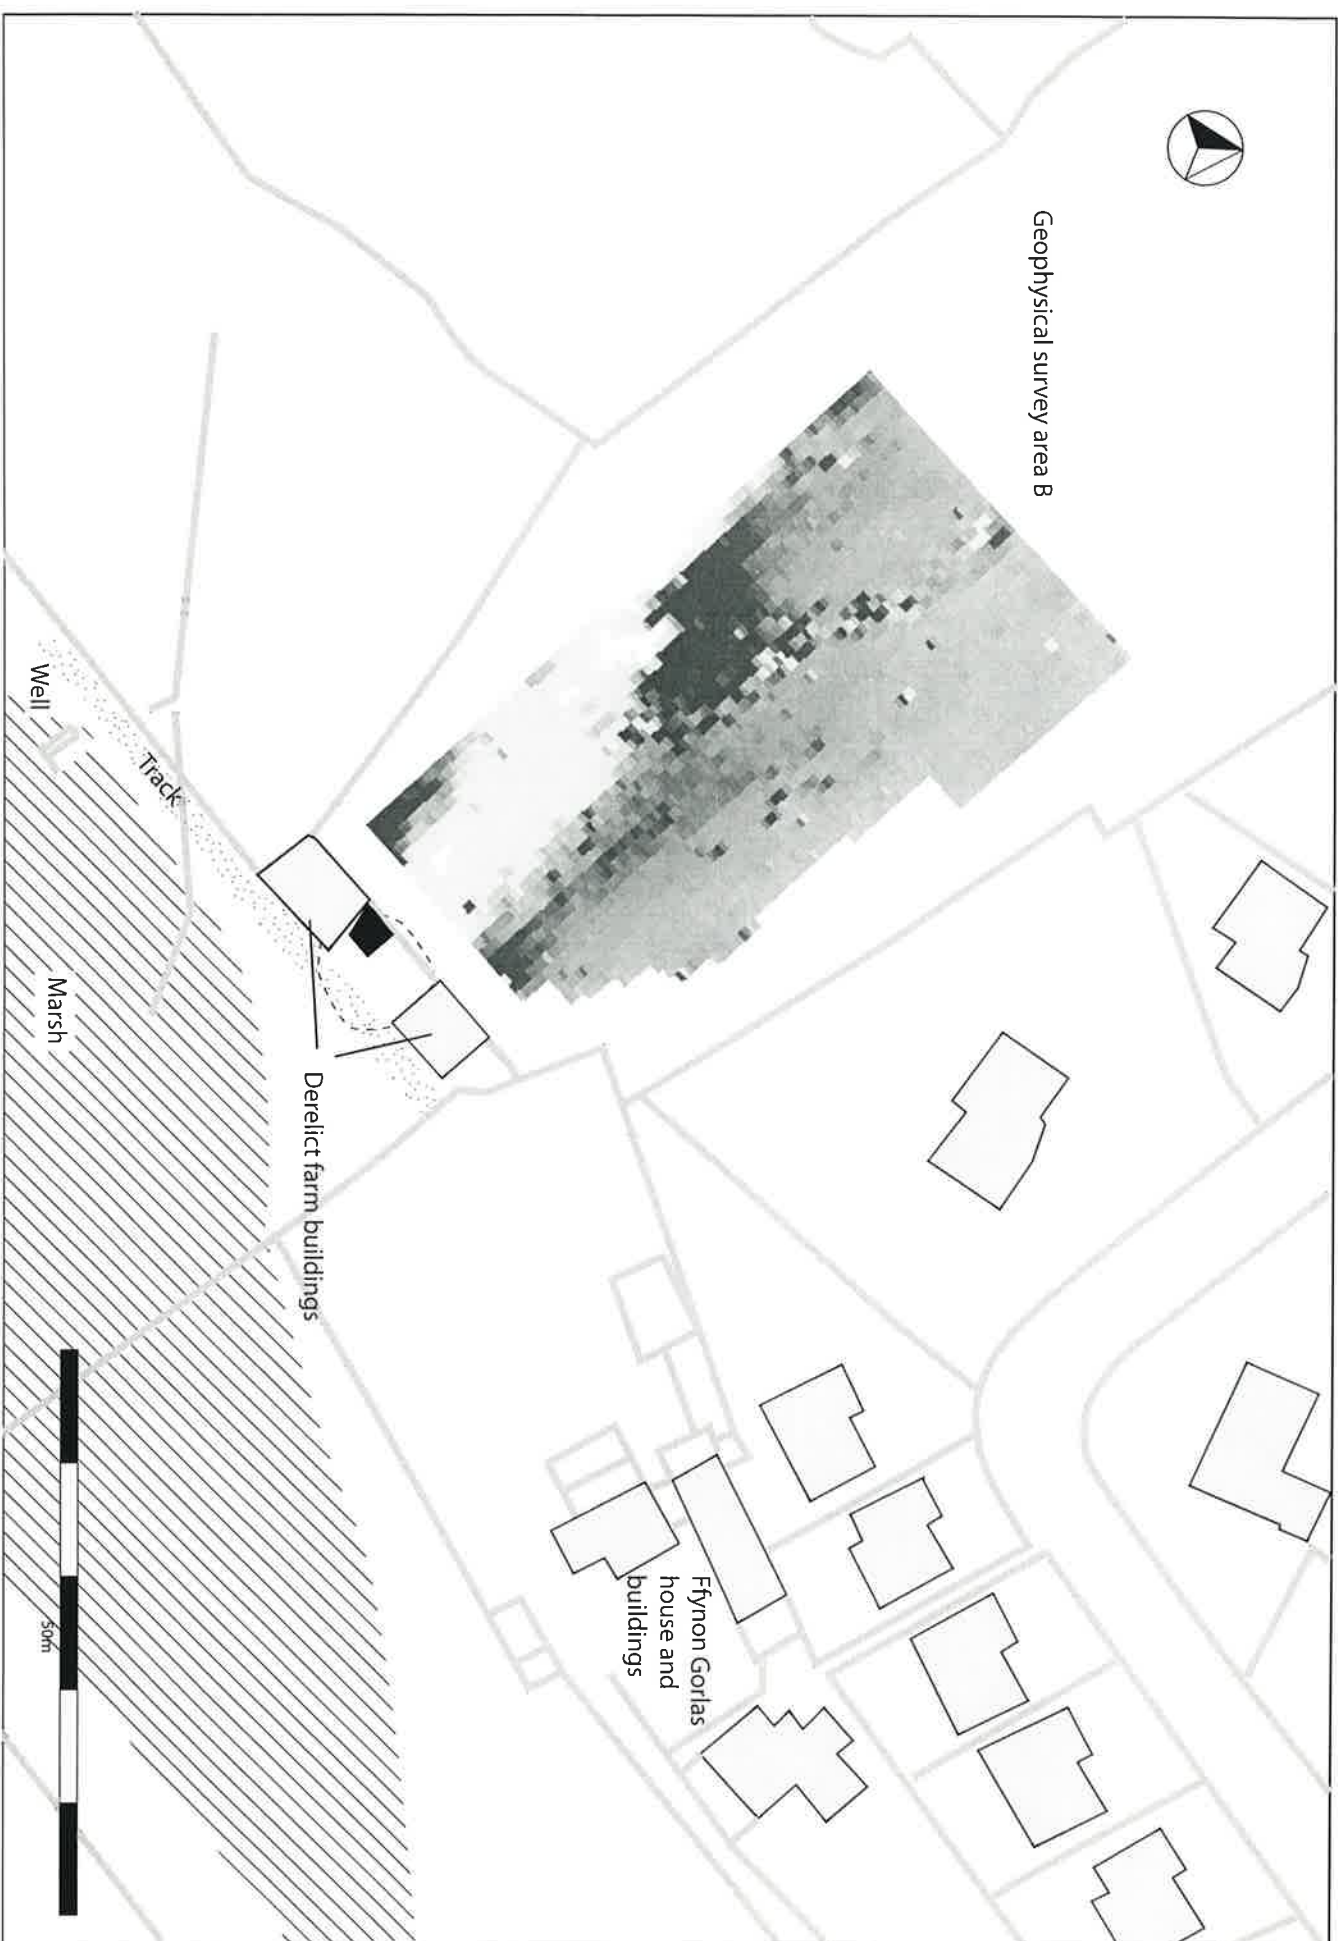
Fig. 6 Geophysical survey area B, grey-scale plot

The data is presented with a minimum of processing. High readings caused by stray pieces of iron, fences, etc are usually modified on the grey scale plot as they have a tendency to compress the rest of the data. The data is however carefully examined before this procedure is carried out as kilns and other burnt features can produce similar readings. Corrections are also made to compensate for instrument drift and other data collection inconsistencies. Any further processing is noted in relation to the individual plot.

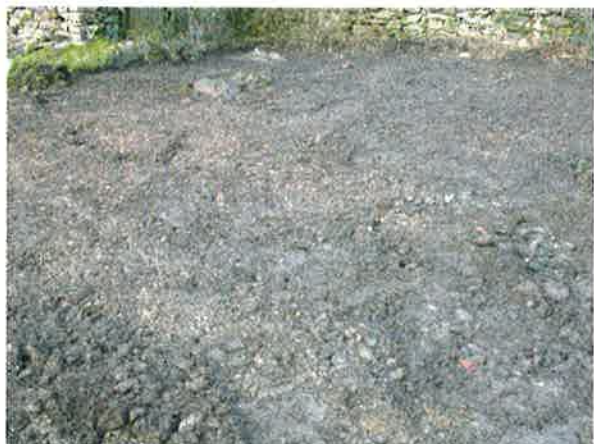
Fig 10a: Fragmented stone after initial cleaning

An area 9m x 6m (see fig 7 and 8) was cleaned by mechanical excavator using a 1.5m wide toothless bucket. This revealed a layer of hard standing, consisting of small broken stone typically less than 100mm in size. Many of the stones were red in colour, as though burnt. They lay in a matrix of black silt, with medium to fine particles, some of it almost clay. No charcoal was immediately apparent, though again the material appeared burnt.

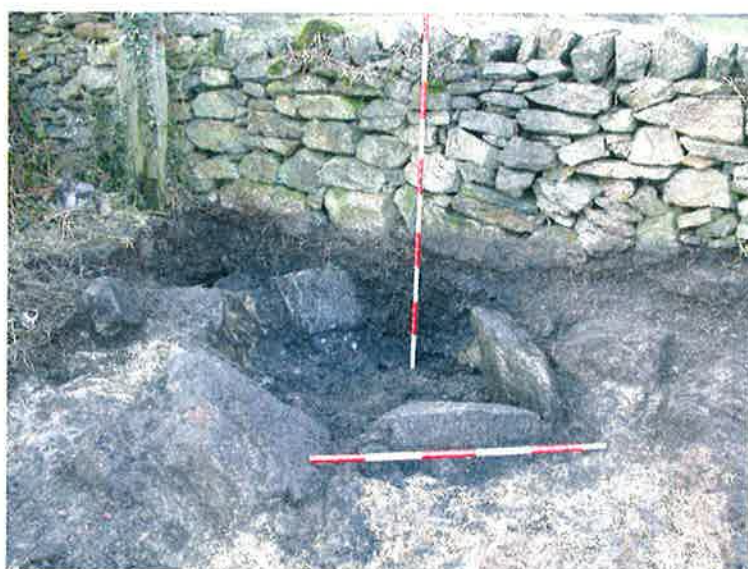
Fig 10b: Stone-lined pit after excavation

The fragmented stone and dark silt are very similar in appearance to those that occur on sites typically called burnt mounds. These vary in detail, but consist of mound of burnt and fractured stone which makes up over 90% of their content, the remaining material being dark clay/silt with charcoal intrusions. A rectangular pit lies adjacent to or under the burnt stone. Although the function of burnt mounds remains unknown, there is little doubt that the remains consist of stone that was heated in a fire, and then used to heat water within the adjacent pit. This could then have been used for cooking, washing, or textile processing. The mound of stone is formed by the disused stone, which can only be used a limited number of times before the fracturing and splitting caused by the sudden change in temperature reduces its effectiveness to conduct heat. The mounds are always adjacent to a water supply, usually a stream or spring. Evidence from other sites shows that burnt mounds were used from the Early Bronze Age to historic times, though the principal period of use was in the later Bronze Age c. 1200 to 800 BC.

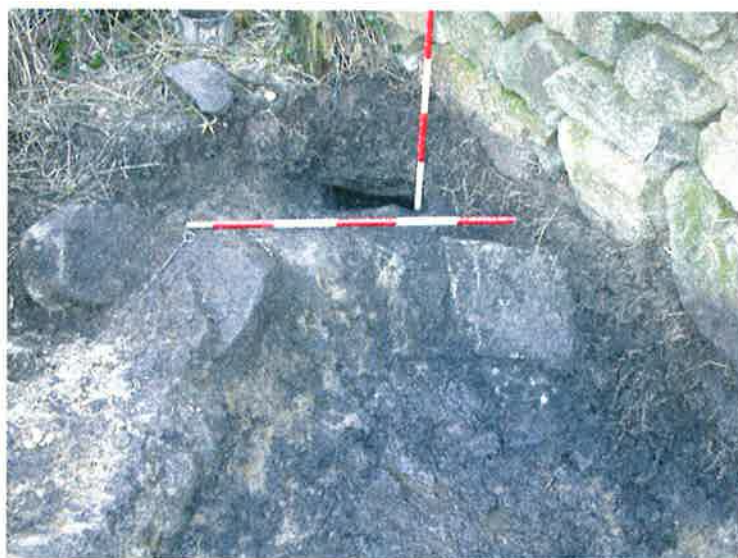
Fig 10c: Drain (?) at west corner of pit

Outside the pit, off the south-west corner, was found an aperture to a narrow hole leading at an angle of approximately 45 degrees into the ground. It appeared to have been purposefully dug, and had a stone lintel supporting the roof. The aperture measured approximately 350mm across, and 80mm deep. It was separated from the adjacent pit by a bank of clay.

The drain is also difficult to interpret. It may be directly associated with the pit though no parallels are known to exist with other burnt mounds. Alternatively, the farmer says a major land drain, dug in the late 19<sup>th</sup> or early 20<sup>th</sup> century, runs across the ridge and north through the fields. It may be that the excavated feature links into the field drain, and was dug in the early 20<sup>th</sup> century to drain the area alongside the sheds, where cattle were kept. However, the aperture was full of the fragmented stone and black silt, and was overlain by it, thus arguing for a date contemporary with the pit.
