FAIRBOURNE WASTE WATER TREATMENT SCHEME

ARCHAEOLOGICAL ASSESSMENT

1. THE PIPELINE EASEMENT

Report No. 469

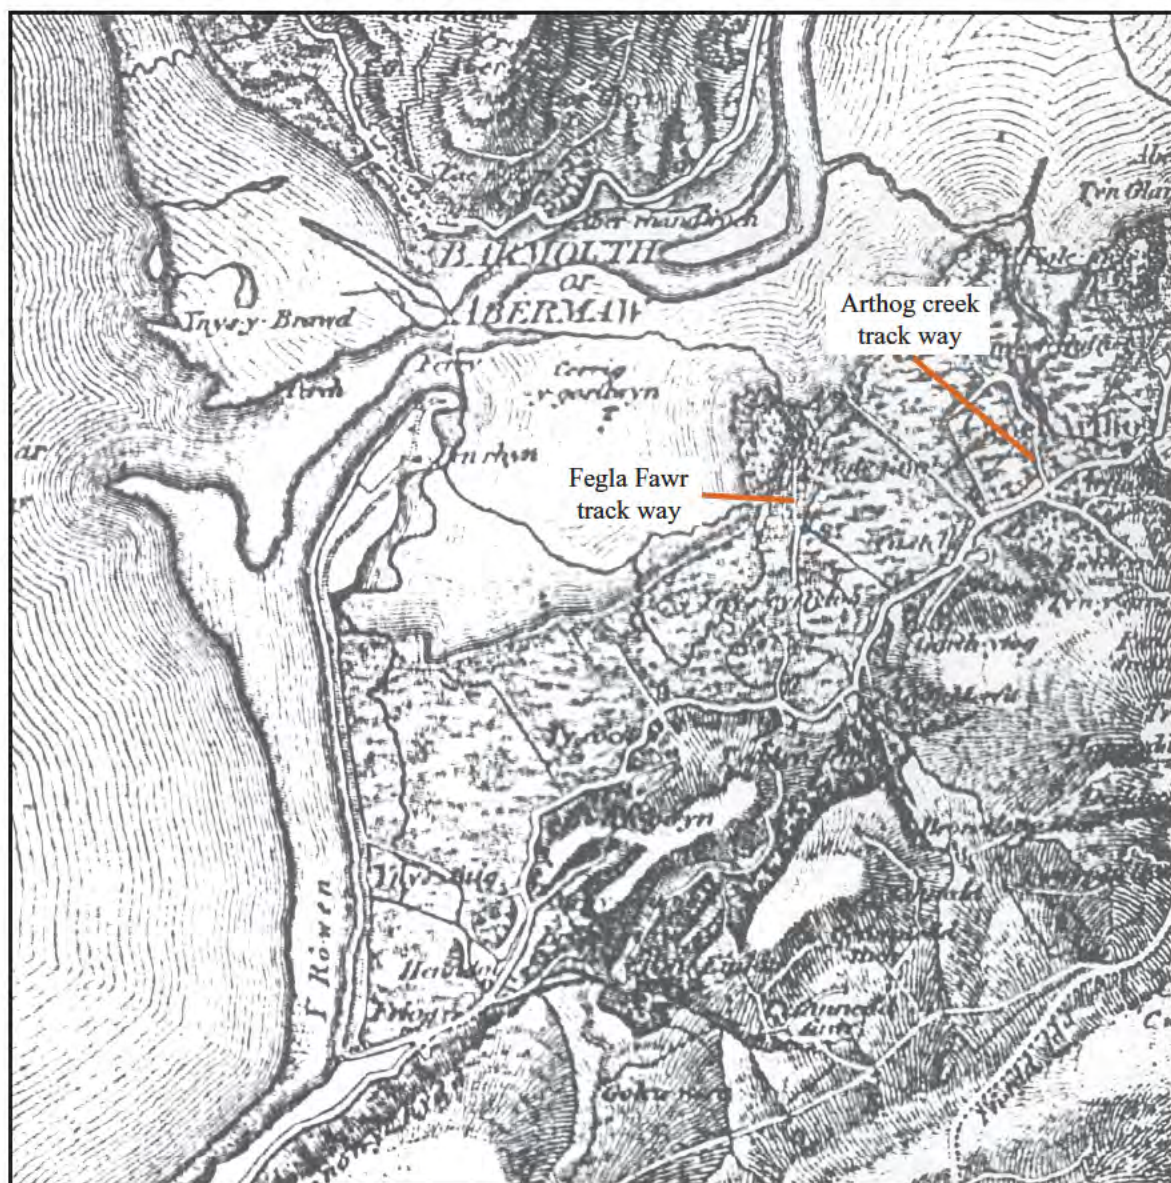
Fairbourne Waste Water Treatment Scheme:
 Fig. 2 OS One-inch to a mile, First edition, c. 1838

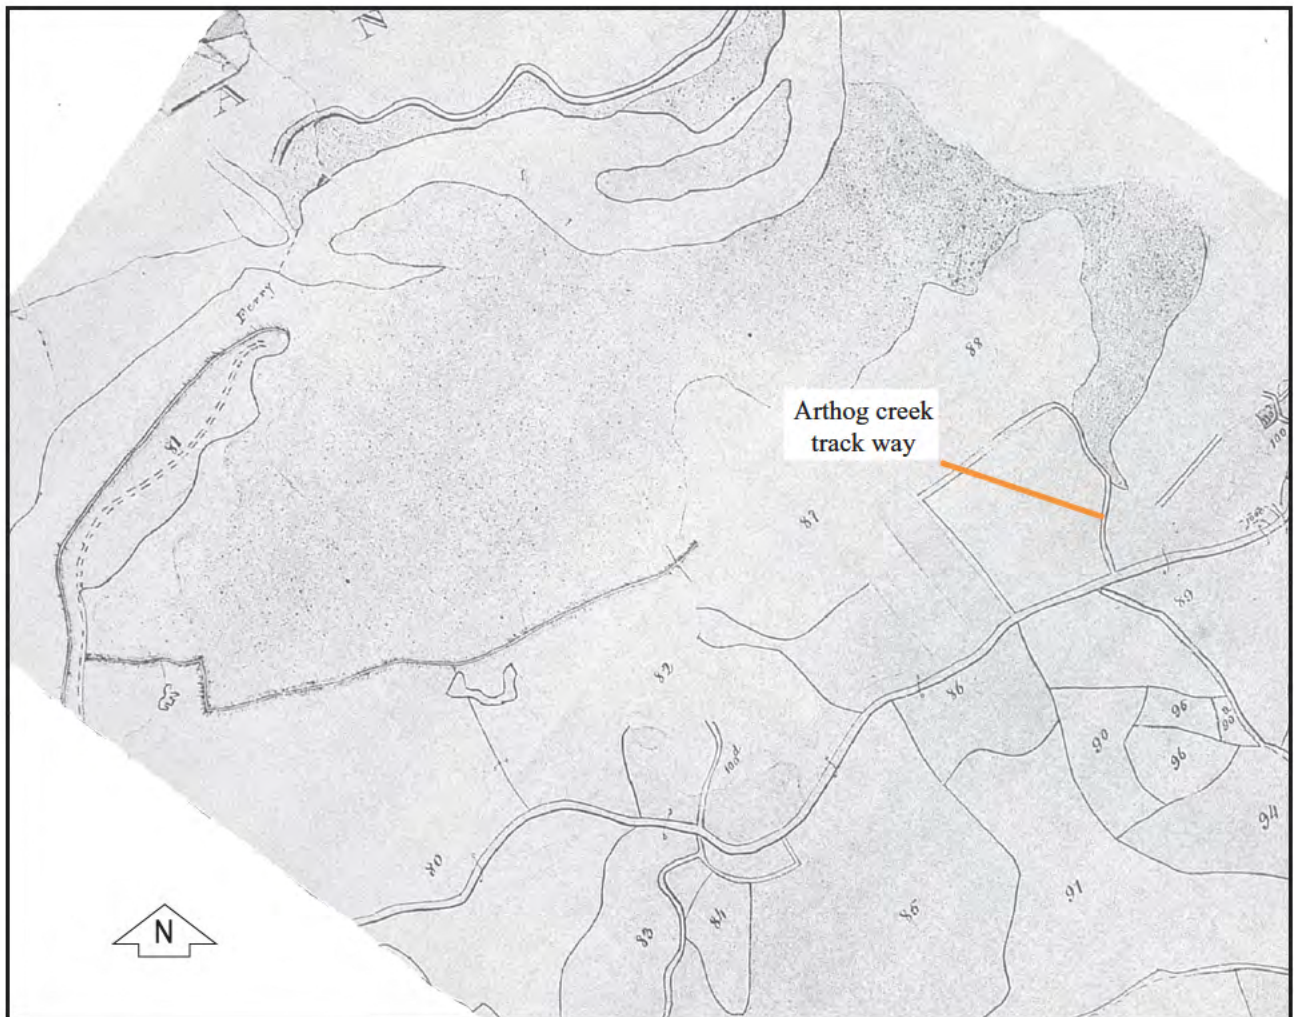
Fairbourne Waste Water Treatment Scheme:
Fig. 3 Llangelynnin tithe map, 1840, c. 2 inches = 1 mile

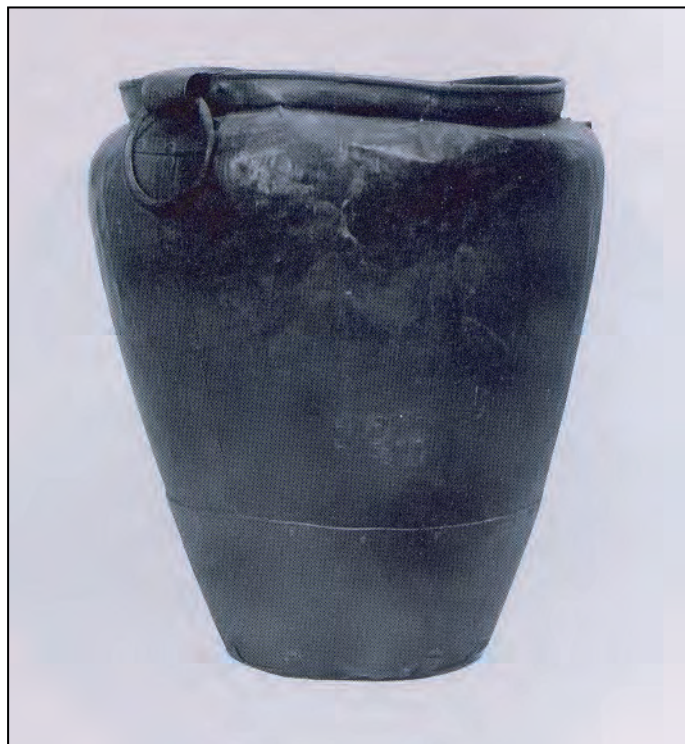
Fairbourne Waste Water Treatment Scheme:
Fig. 4 The Late Bronze Age bronze urn from Arthog.
National Museum of Wales (Savory 1980, Plate IV a).

The Late Bronze Age bronze urn from Arthog
(National Museum of Wales)

In contrast, the lowlands present a total different landscape, with no prehistoric features and only one prehistoric find, that of the bronze urn, mentioned above, to show that there was any early activity there (Fig. 1a). The lack of evidence suggests that these peat areas were still inaccessible marshland, probably with little value except for wildfowling. It was only with a surge in land enclosure and improvement in the 18th and 19th century, and drainage that the marshes were made usable. Up to that time there were only small areas of settlement clinging to the foot of the hill land along the coast road. The parish church was at Llangelynin,

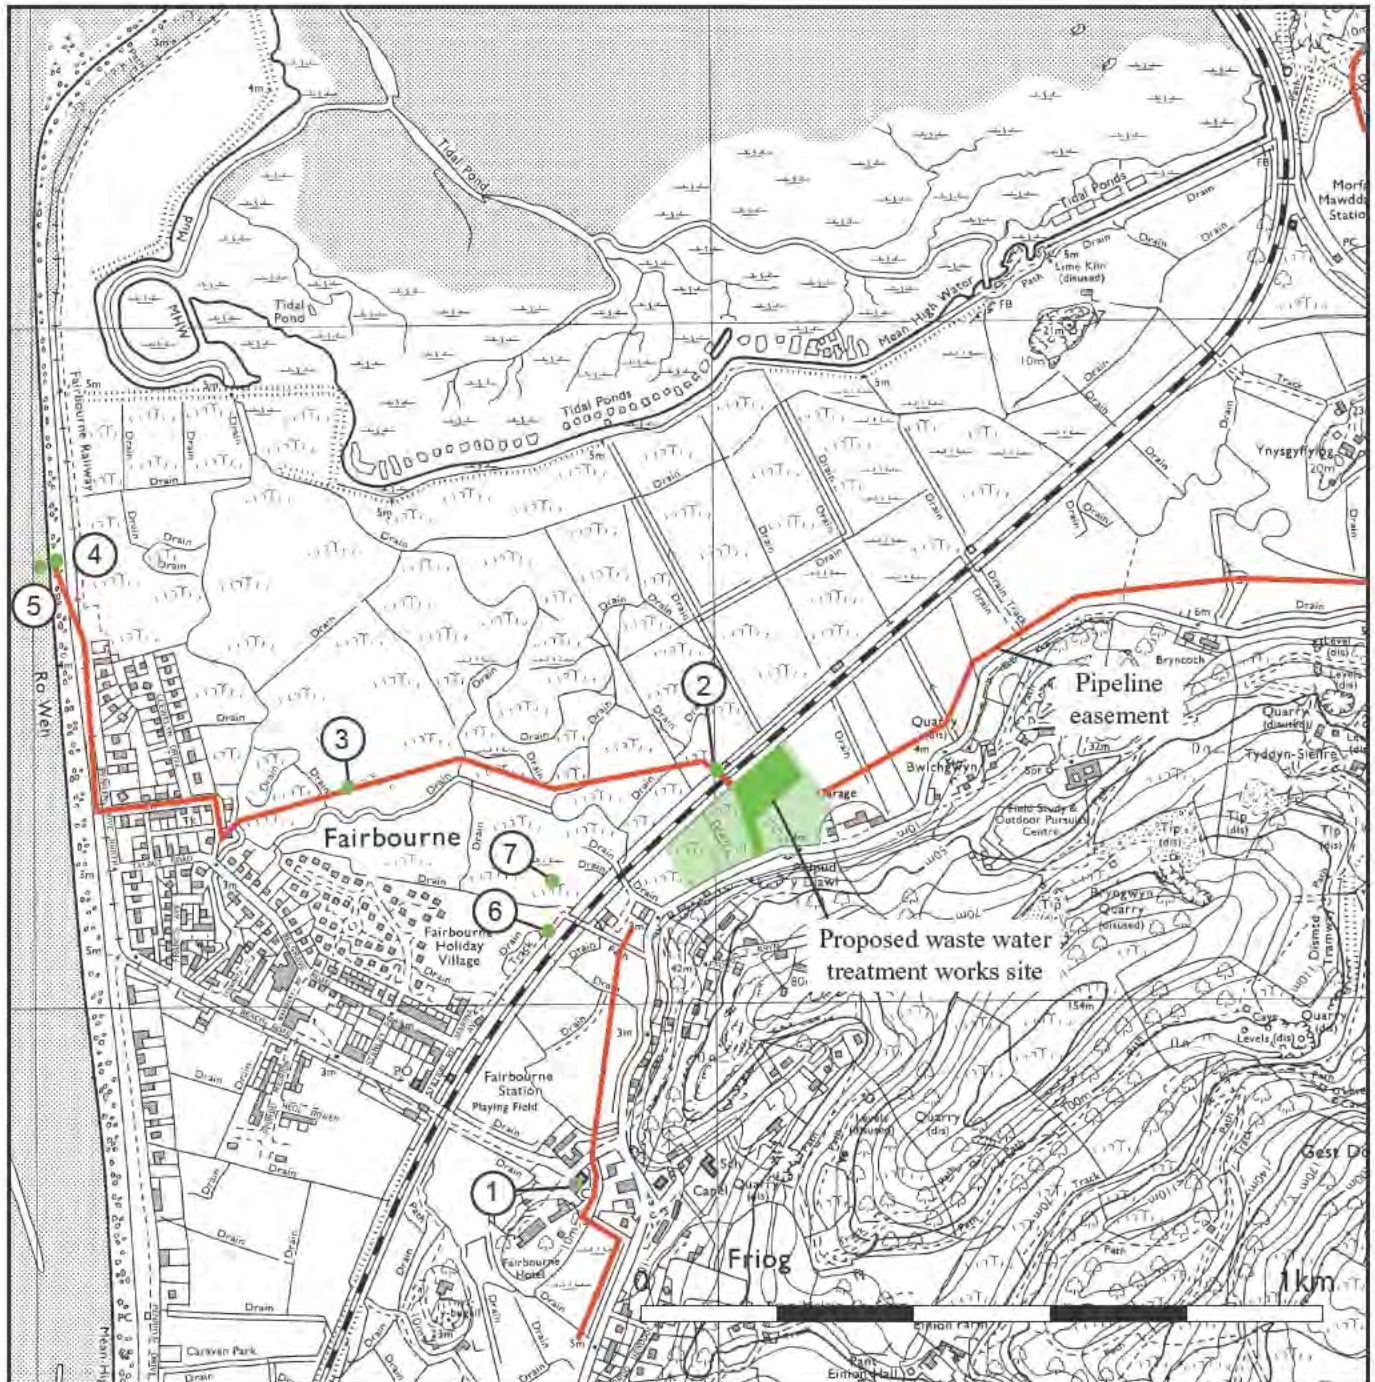
Fairbourne Waste Water Treatment Scheme:

Fig. 7 Pipeline West and the proposed Treatment Works site: Archaeological features 1-7.

4.3 The Archaeological Survey (Figs 7 and 8)

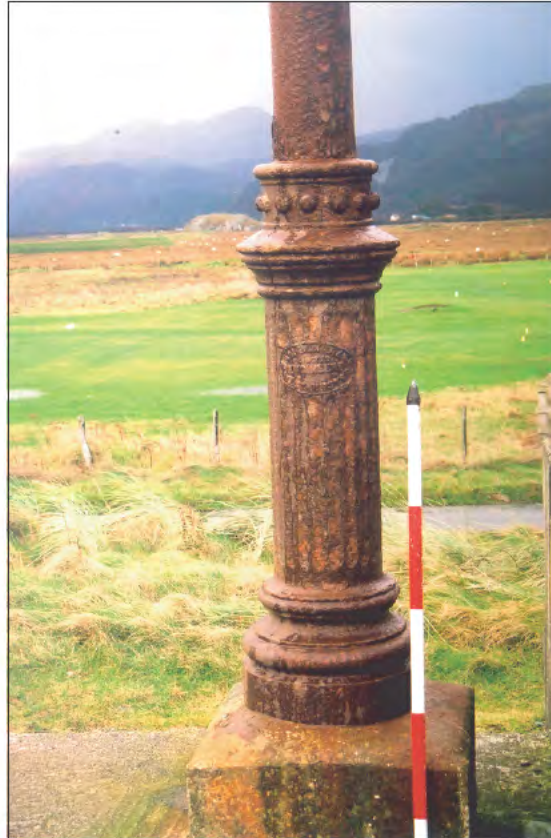
A cast-iron outfall vent pipe on the access chamber in the sea-wall, immediately north of Fairbourne. The pipe is a decorative casting but the pipe itself is partly rusted through because the base seems to have been kept painted, but not the pipe itself. The casting inscription on the base reads 'Ham Baker & Co. Limited Engineers Westminster'

A Victorian feature of local historical interest but in poor condition.

Fairbourne Waste Water Treatment Scheme:
Fig. 9 Outfall vent pipe, Feature 4. Scale with 20cm divisions

Recommendations for mitigatory measures: Avoidance

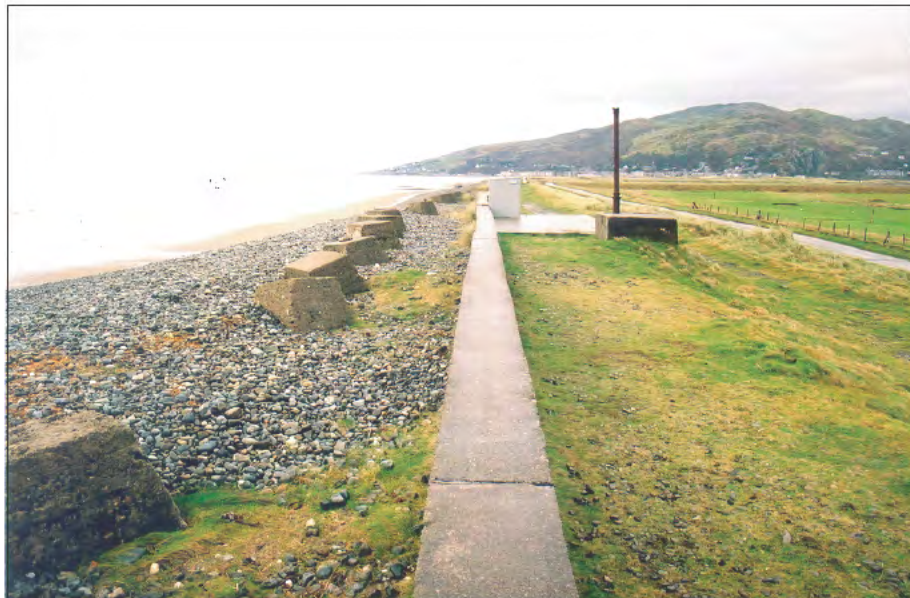
A long line of large, square concrete blocks line the seaward side of the sea-wall at Fairbourne, remains of World War II anti-tank landing defences. They are well preserved and now quite a rare example of such defences. They must have been made *in situ*. Efforts to remove them, as an eyesore to the tourist trade after the end of the war had to be abandoned because of their size and weight. However, by the existing sewage outfall one or two are missing or subsided into the beach, possibly as a result of relaying the outfall. Even if a new outfall were to be built it may be possible to insert it without disturbing any blocks.

Fairbourne Waste Water Treatment Scheme:
Fig. 10 Outfall vent pipe, Feature 4 and Anti-tank defences, Feature 5

Recommendations for mitigatory measures: Avoidance

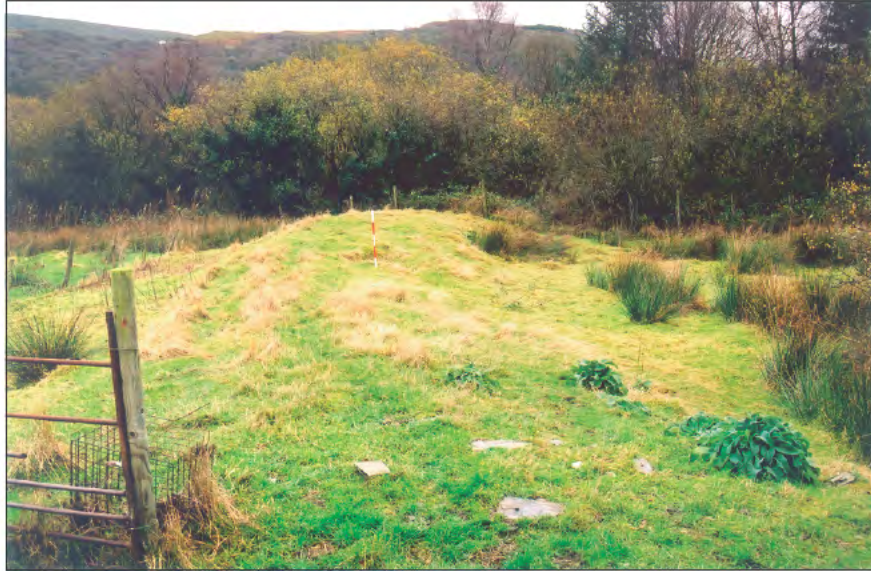
This is the track bed of a tramway built by McDougall (of self-raising flour fame) as part of his venture to create a holiday village here, eventually named Fairbourne. The tramway was built in 1890 to take bricks from a specially built brick and tile works and other materials offloaded from the Cambrian Railway to build the first houses of Fairbourne. It was then used for passenger traffic until at least 1903 before being sold in 1911 and replaced by the Fairbourne Miniature Railway. This length specifically served the brick works (Feature 7) and was abandoned after the construction of Fairbourne, the tramway then running just from Fairbourne Station to Penrhyn Point (for ferries to Barmouth).

Fairbourne Waste Water Treatment Scheme:
 Fig. 11 Solomon Andrews' tram way track bed, Feature 12,
 north of the Mawddach Junction gated crossing. 1m scale

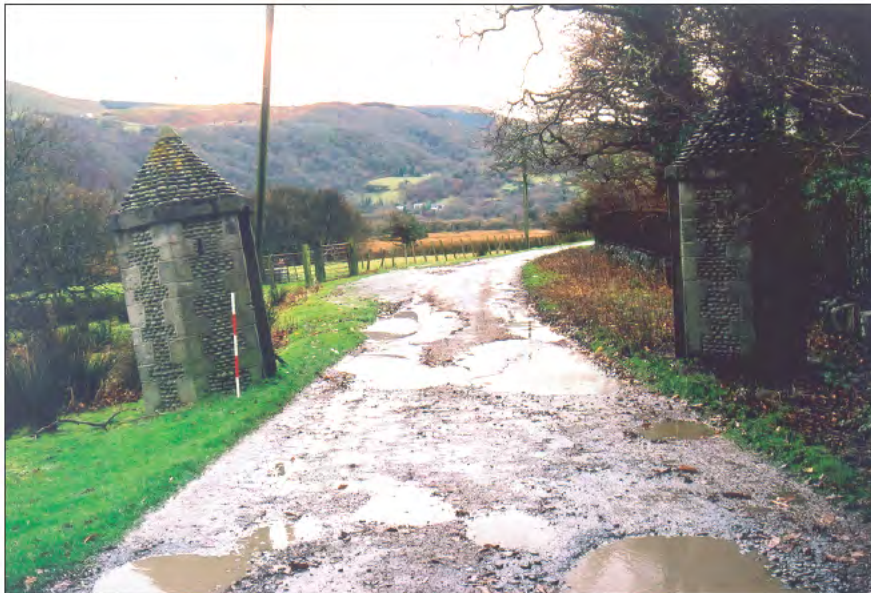
These are a rare, unusual and complete survival, in good condition, possibly unique. They may be regarded as of national value when incorporated in the Defence of Britain project. They should not be affected as they lie to either side of the pipeline route but care needs to be taken to avoid accidental damage by earthmoving machinery. They already have a few grooves from passing vehicles.

Fairbourne Waste Water Treatment Scheme:
 Fig. 12 Sentry boxes , Feature 13, east of Fegla Fawr. 1m scale

Recommendations for mitigatory measures: Avoidance and Watching brief

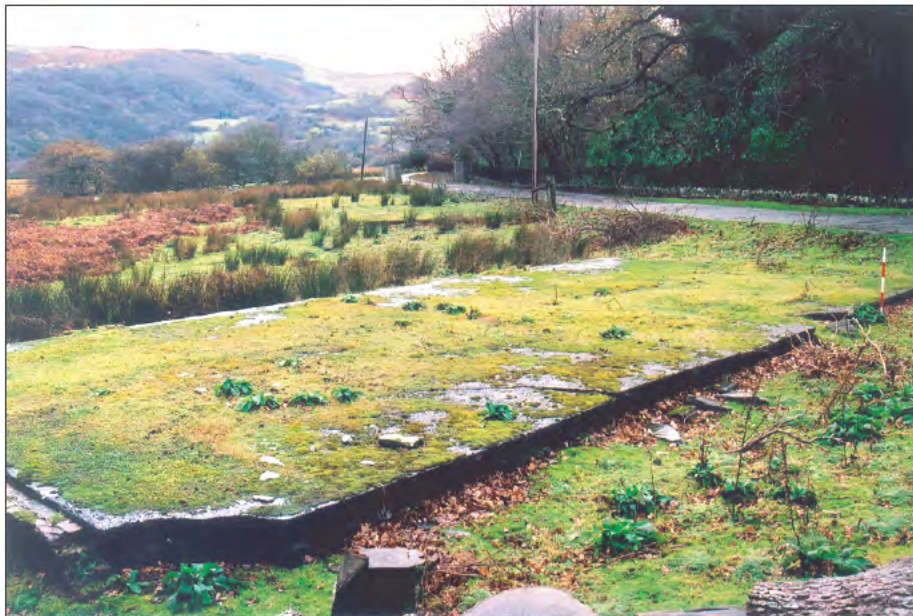
Situated to the east and north-east of Fegla Fawr are numerous rectangular concrete foundation platforms and attendant features including the sentry boxes (Feature 13), oil tank stands, footpaths, walls and drains. The extensive features were not fully investigated although a sketch plan of the whole lay-out is printed in O'Connor (2000). This was a Royal Marines' training camp, codenamed 'Iceland', built in 1941, later used for more general training of gunners and engineers, used very briefly after the war and then demolished (O'Connor 2000).

Fairbourne Waste Water Treatment Scheme:
Fig. 14 Concrete hut base, Royal Marine camp 'Iceland', Feature 14
and Sentry boxes, Feature 13 in background, east of Fegla Fawr. 1m scale

Recommendations for mitigatory measures: Avoidance

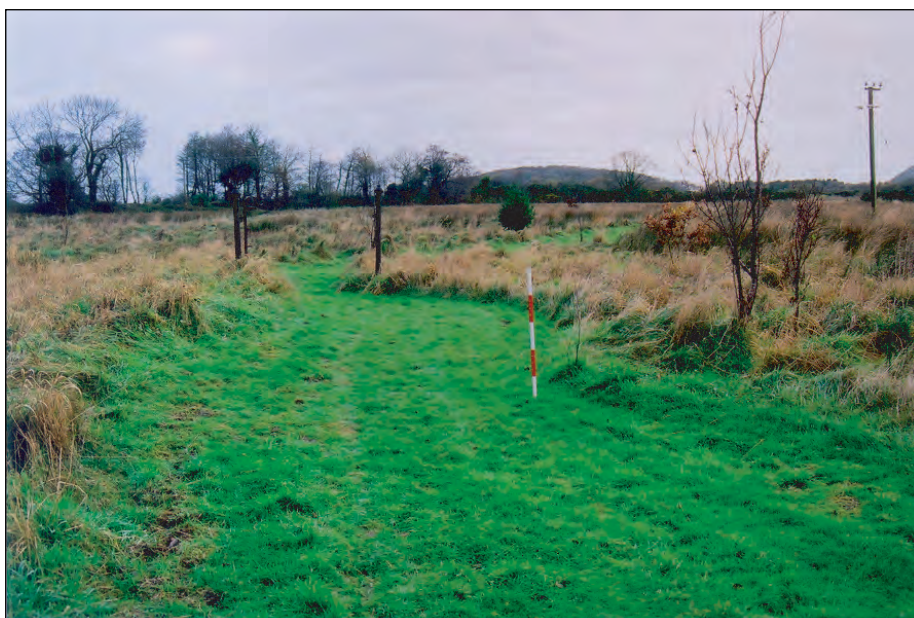
Fairbourne Waste Water Treatment Scheme:
Fig. 15 Cast iron gate posts, Feature 20
and possible location of the Arthog Bronze Age urn find, Feature 21. 1m scale

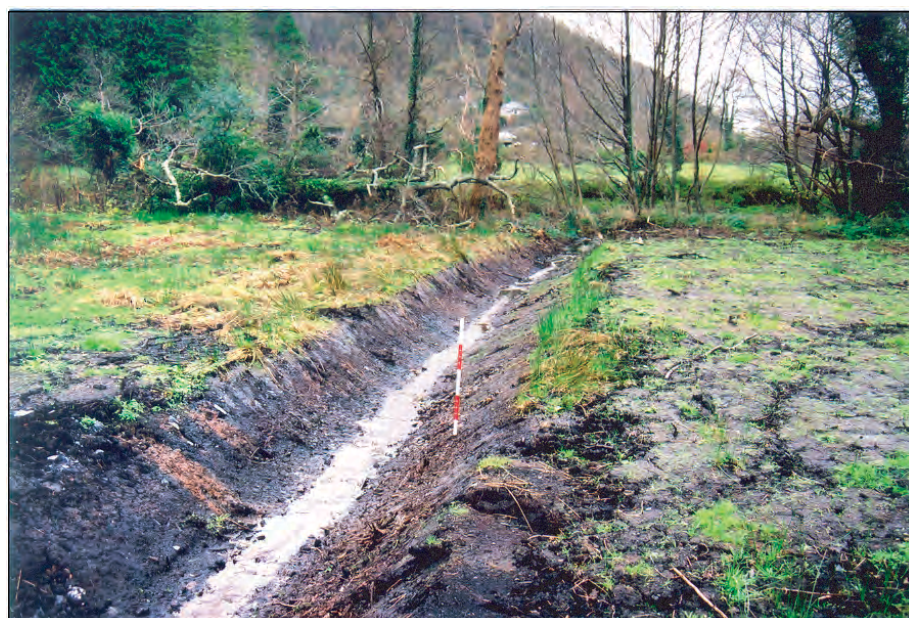
The context of such a rare and valuable find needs to be observed. The context itself is of interest and there could be other associated finds. Timber remains are a possibility. There is clearly a good depth of peat here. A freshly machine-dug ditch was observed in the adjoining field to the north-east, with over a metre of peat, at the base of which were (natural) woody remains.

Any cutting of the peat here is very sensitive and needs to be monitored although similar peat beds are probably to be found over the whole part of the pipeline easement from Arthog to Friog, where it runs through the level Morfa and prehistoric finds are a possibility at any point. Excavation by machine needs to be done in a controlled manner accompanied by an archaeological watching brief. Water logging may make it difficult to produce a detailed record but such a record will need to be produced if any artefacts are found. If this happens than environmental sampling, and possibly a specialist visit will be needed. As a minimum, radiocarbon dating of the peat is desirable, to test its association with the previous bronze urn find.

Fairbourne Waste Water Treatment Scheme:
Fig. 16 Exposed peat beds in a recent drainage ditch, close to the find spot of the Arthog
Bronze Age urn find, Feature 21. 1m scale

Recommendations for mitigatory measures: Prior machine excavation of the pipe-line trench under archaeological supervision, together with basic or detailed recording, as required. Sampling and dating of deposits.
