Watching brief at Henllys Hall, Beaumaris

Report No. 488

June 2003

**Henllys Hall, Beaumaris
Watching brief**

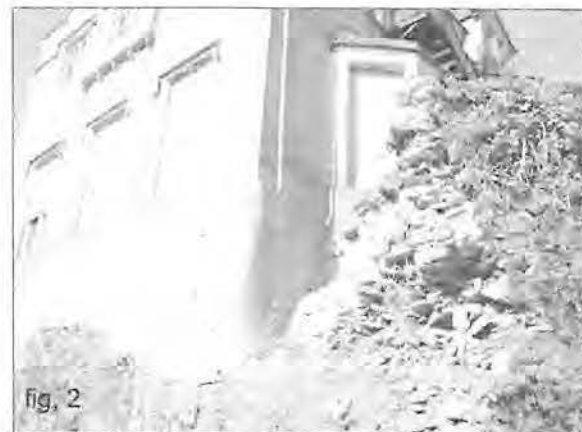
Excavations had commenced onto the surface of the rock between block R and block J leaving exposed sections on the south-western and north-western faces of the area. It was clear from these exposures that the excavations for the foundations of the south-eastern face of the 19th century Henllys Hall had been carried onto the bedrock to a level some depth below the modern ground surface in this area. A stone wall with rubble core and randomly coursed, pointed, external and internal faces revetted a level terrace on the north-east and south-east sides of the hall (fig. 2).

This terrace showed every indication of being made-up ground of re-deposited material. The bedrock itself could be seen to slope steeply from the eastern wall of the hall. The modern ground surface to the south, however, retained a relatively level profile eastward over a distance of some 13 m. This was due to the presence of a second, now buried, retaining wall on the line of projection of the access road to the hall from the lodge to the south (fig. 4). No significant archaeological features were identified. However, it is noteworthy that the summit of the boss of rock may originally have been more restricted and, perhaps, more visually striking than the more recent landscaped topography suggests.

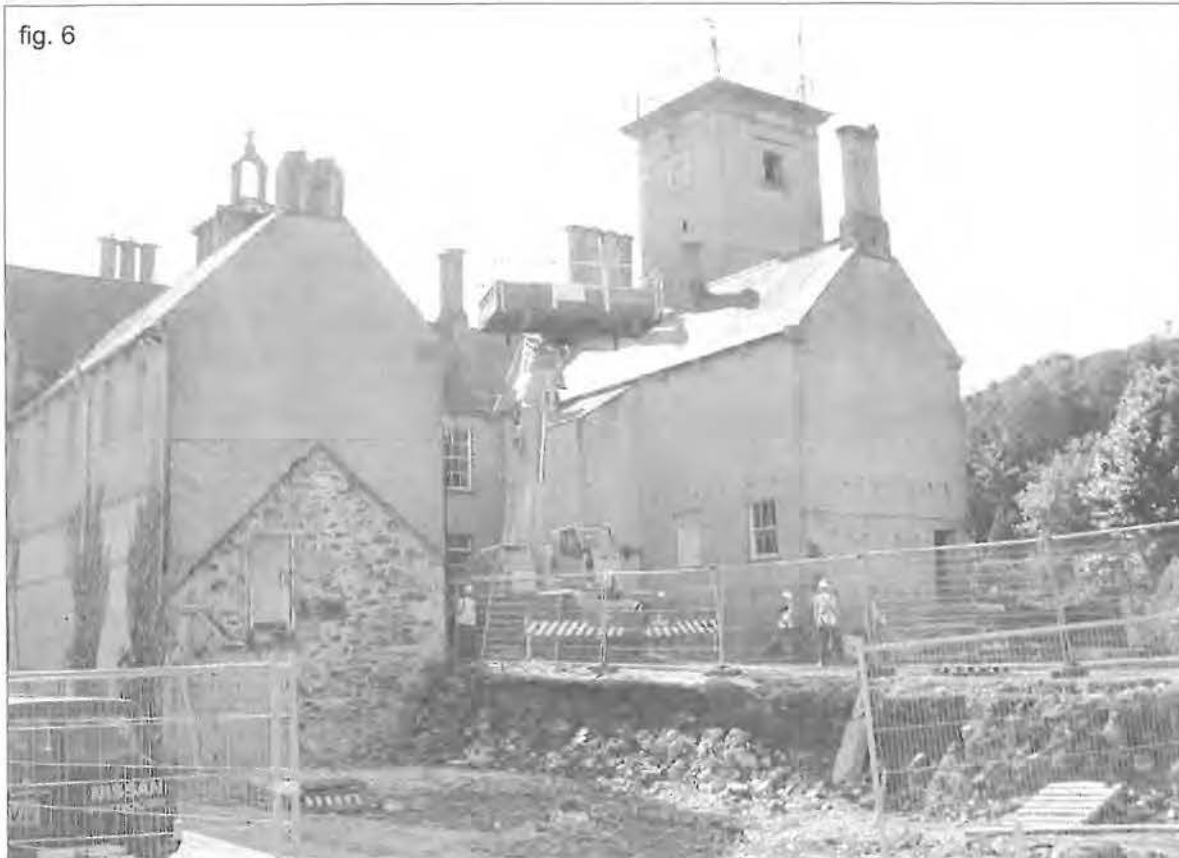
fig. 6

In the area of block M (Section A fig. 6)

The modern ground level at block M was lower than that immediately to the south. The ground surface here had been terraced into the gentle natural slope which fell from south to north. The removal of the pre-existing building at Block M revealed a soil profile as an exposure in the northern face of the upper terrace. The principal components were (to a depth of 1.5m) from the top:

1. Hard standing for yard on upper (southern terrace)
2. Dirty brown soil
3. Orange grey shaley layer with the appearance of having been re-deposited.
4. An orange clayey soil.

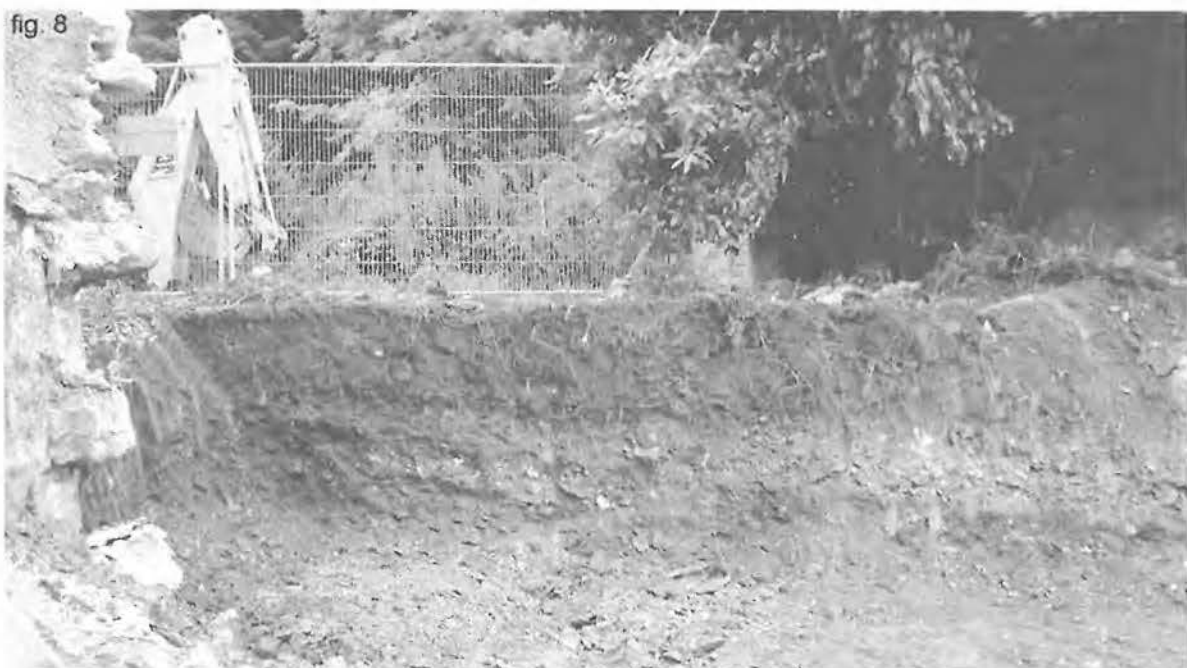
In the area of block K (Section F, Fig. 8; fig. 9) Excavations were undertaken around the perimeter of an area of approximately 11.5m north-south and 12.0m west-east. The terraced surface to the west of the south-west wing of the

hall is on the same level as that in the area of block L. However, this surface had been terraced into the higher ground immediately to the south when the present hall was built in the 1850s.
