**PROPOSED NEW VISITOR CENTRE, COED Y BRENIN**  
**ARCHAEOLOGICAL ASSESSMENT (G1797)**

GAT Report No. 503

**PROPOSED NEW VISITOR CENTRE, COED Y BRENIN**

**ARCHAEOLOGICAL ASSESSMENT**

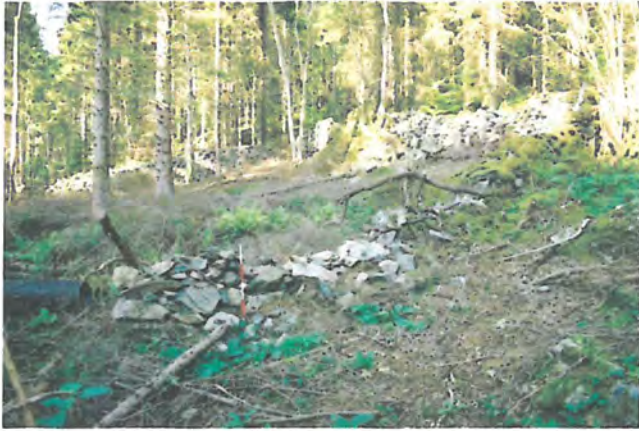
Fig. 5 Sheep/cattle fold, Feature 1. From S, 1m scale

#### 1. Sheep/cattle fold SH72152730 (Fig. 5)

*Category: C Impact: Likely*

A rectangular walled enclosure. Ruined. Walls up to 1.8m high and 0.8m wide. Post-medieval. Not marked on 1841 Tithe map so probably more recent.

*Recommendation for mitigatory measures: Avoidance or basic recording.*

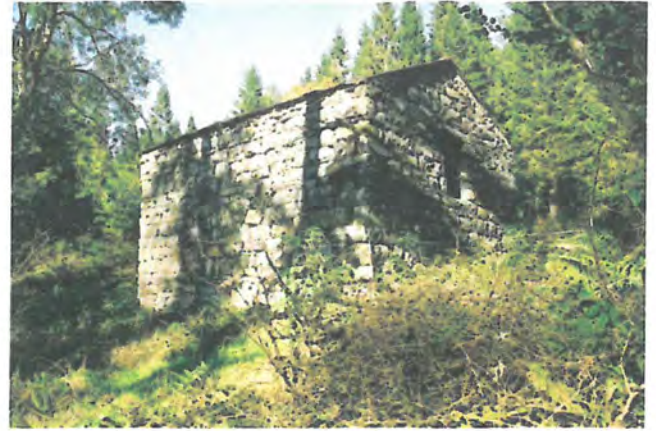
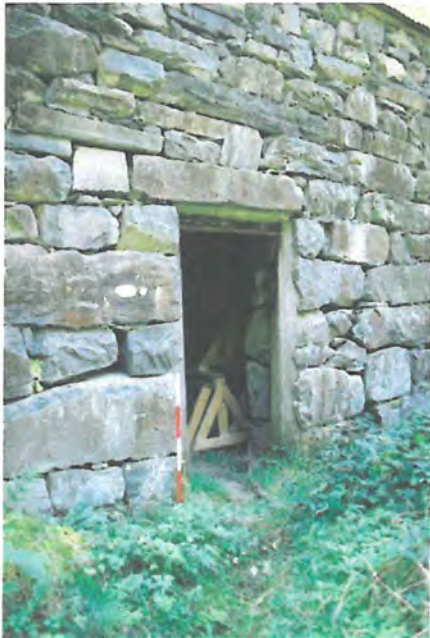
### **3. Hay barn/Cattle shed SH72162723 (Figs 6-7)**

*Category: B Impact: Slight*

A rectangular two-storey standing building, c. 7m by 6m with a single door at the east, uphill side. Built on a terrace deeply cut into the hillside. Very strongly built, the walls restored and re-roofed in tin with new timbers. Originally the upper floor was a hay loft, the lower has animal feed racks. There is a single window to the upper floor at the south and a single door in the centre of the east side. Now used as a store and will probably continue to be used as part of the new visitor complex. It provides a useful and attractive visible historic landscape feature and should be retained, preferably eventually re-roofed in traditional style.

Fig. 6 Hay barn/Cattle shed, Feature 3. From SW, 1m scale

Fig. 7 Hay barn/cattle shed, Feature 3.  
Detail of door. From SE, 1m scale

*Recommendation for mitigatory measures: Avoidance or detailed recording.*

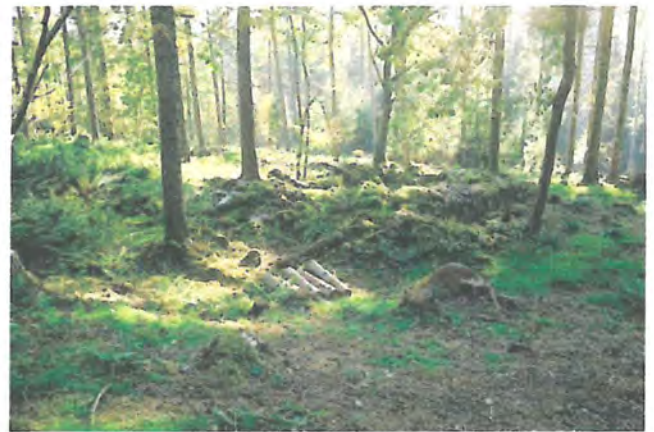
Fig. 8 Cattle shed, Feature 7. From NE, 1m scale

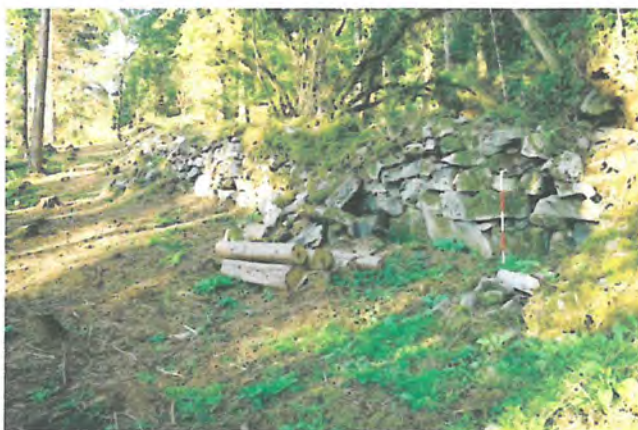
Fig. 9 Farmstead main enclosure wall, Feature 9.  
From SW, 1m scale

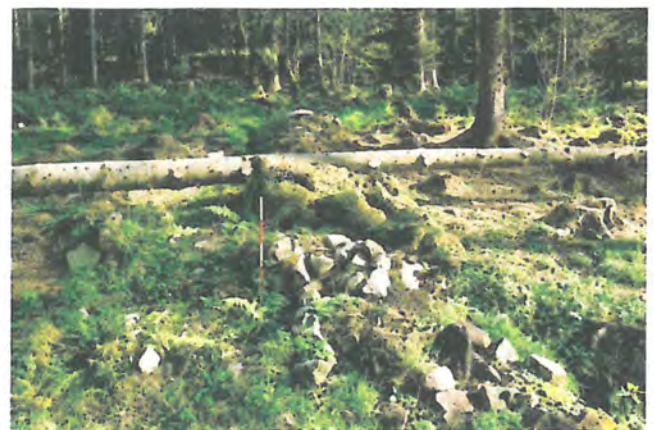
number of ruinous field walls (Fig. 10), gateways and tracks. The farmyard itself has been obliterated by the forestry road construction. The fields and associated features have been damaged by forestry operations but in parts are still intact and the overall outline of them is still traceable. A watching brief during clearance of the ground might identify features not visible on the surface, such as remains of burnt mounds, charcoal burning or iron-working.

Fig. 10 Example of damaged farm wall at south-west  
edge of area. From SW, 1m scale

*Recommendation for mitigatory measures: Watching brief.*
