A494 WAL GYNNAL TY MAWR, RHYDYMAIN IMPROVEMENTS

ARCHAEOLOGICAL ASSESSMENT

G1804

Report number : 504

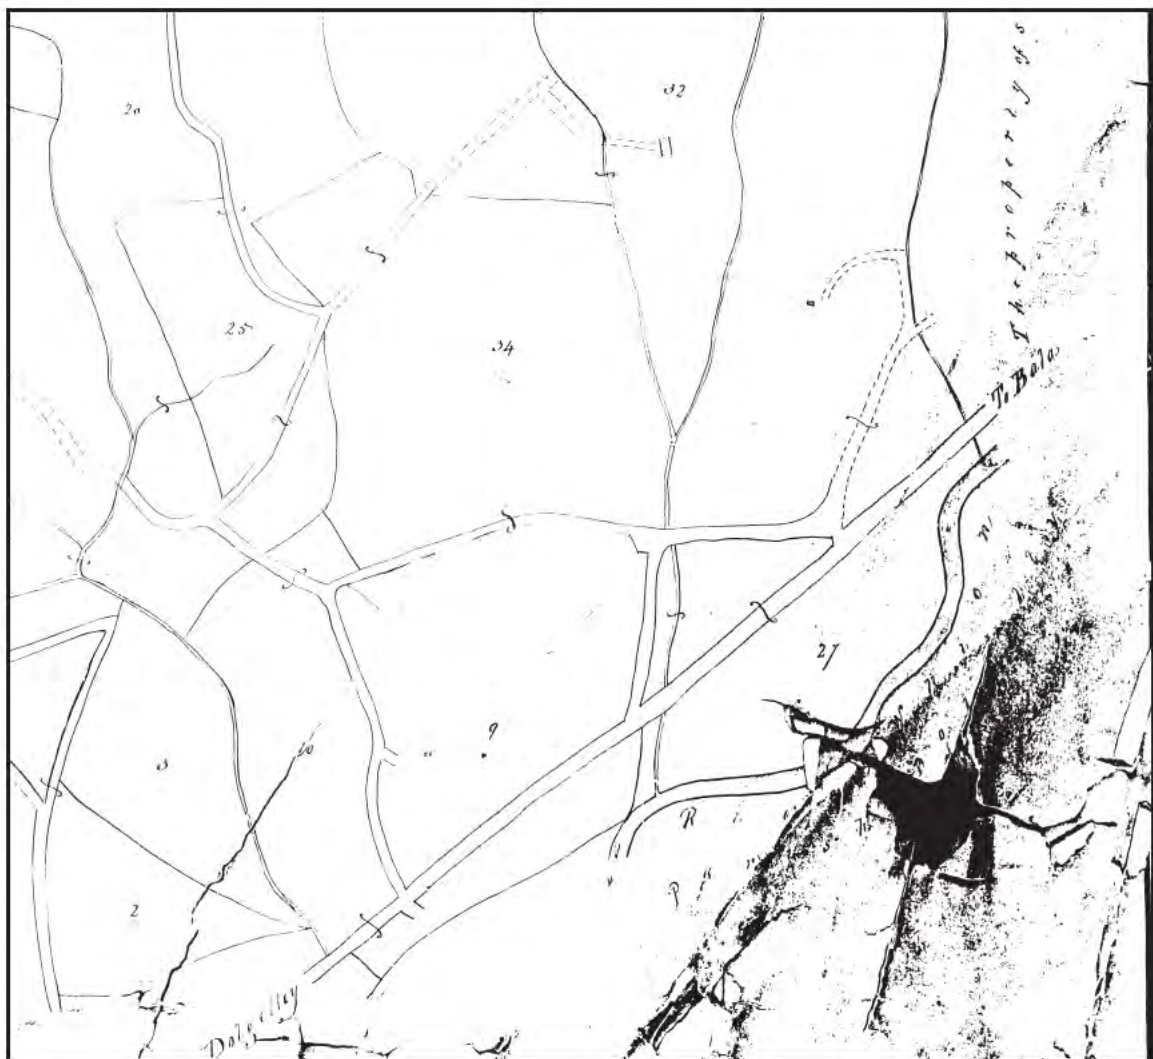
Fig. 4 Tithe Map for Dolgellau Parish 1846

The tithe map of the area, dated 1846, records that the whole of the study area and most of the surrounding lands were the property of Sir R.W. Vaughan (of Nannau). The maps are unusually sketchy and show few details. Unfortunately the Nannau estate maps were not included in the papers obtained by UWB archives and are not available for public consultation.

The late 18th century turnpike formerly ran along the line of the present minor road between Rhydymain and Wenallt. This was superseded by the time the tithe map of 1846 (Fig. 4) was compiled. The road continued to be used as an access to the farms of Ty-Mawr, Pen-y-rhiw and Wenallt. It is now a minor road with a tarmacadam surface.
