FAIRBOURNE WASTE WATER TREATMENT SCHEME

ARCHAEOLOGICAL WATCHING BRIEF

THE PIPELINE EASEMENT AND TREATMENT WORKS SITE

Report No. 506

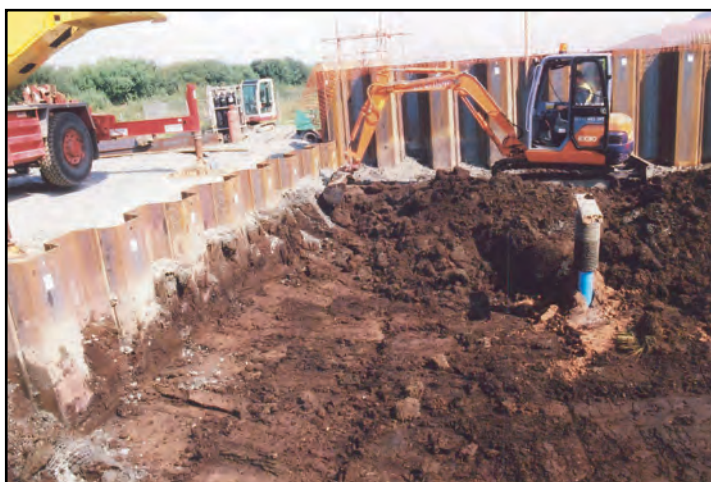
The Treatment Works tank construction,
showing estuarine clay revealed beneath the peat and ancient forest horizon

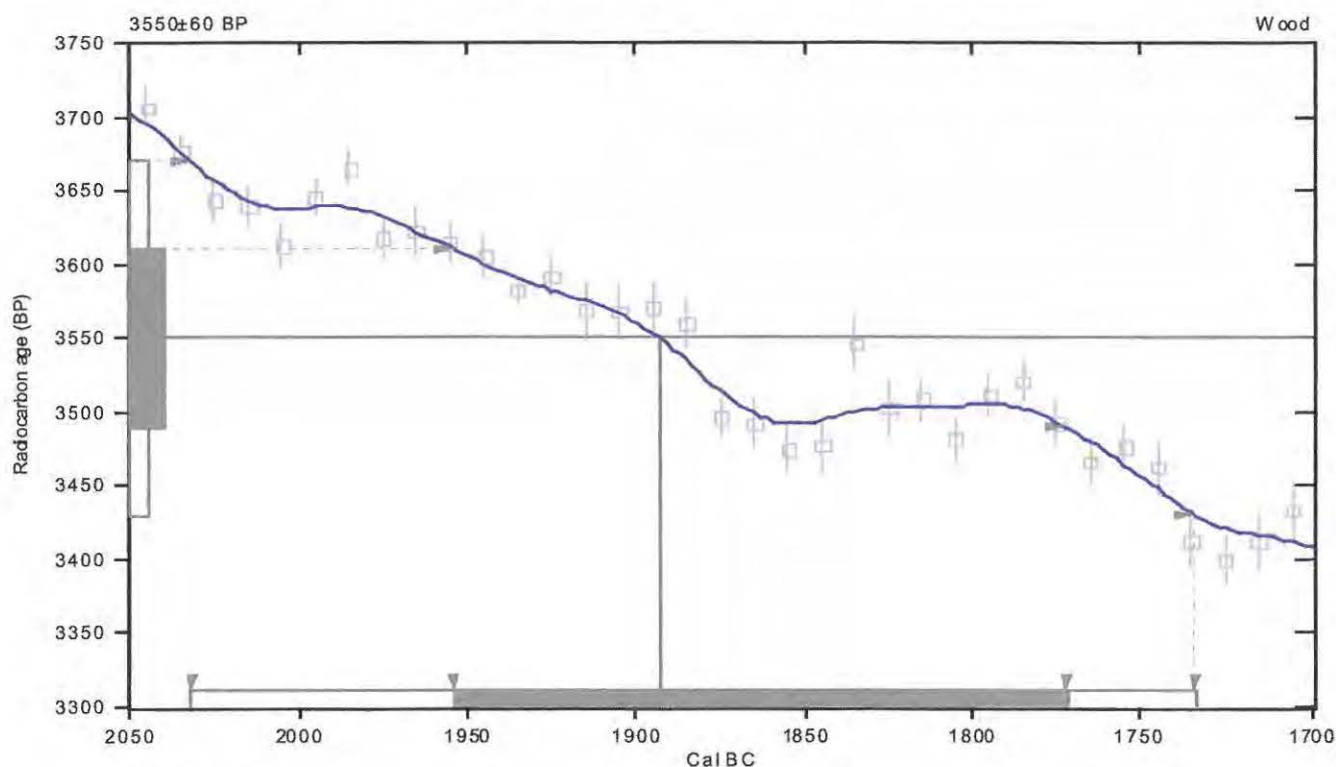
Laboratory number: **Beta-193839**

Conventional radiocarbon age¹: **3550±60 BP**

2 Sigma calibrated result: Cal BC 2030 to 1730 (Cal BP 3980 to 3680)
(95% probability)

Intercept of radiocarbon age
with calibration curve: Cal BC 1890 (Cal BP 3840)

1 Sigma calibrated result: Cal BC 1950 to 1770 (Cal BP 3900 to 3720)
(68% probability)

Sample 1 was taken from the outermost rings of a fallen tree trunk of oak that *in situ* in the peat at 1m below present ground level, lifted during excavation of the peat for the holding tank of the waste water treatment works site (Area A). This produced a determination of 3550 \pm 60 BP (Beta 193839), 2030-1730 Cal BC at 95% probability.

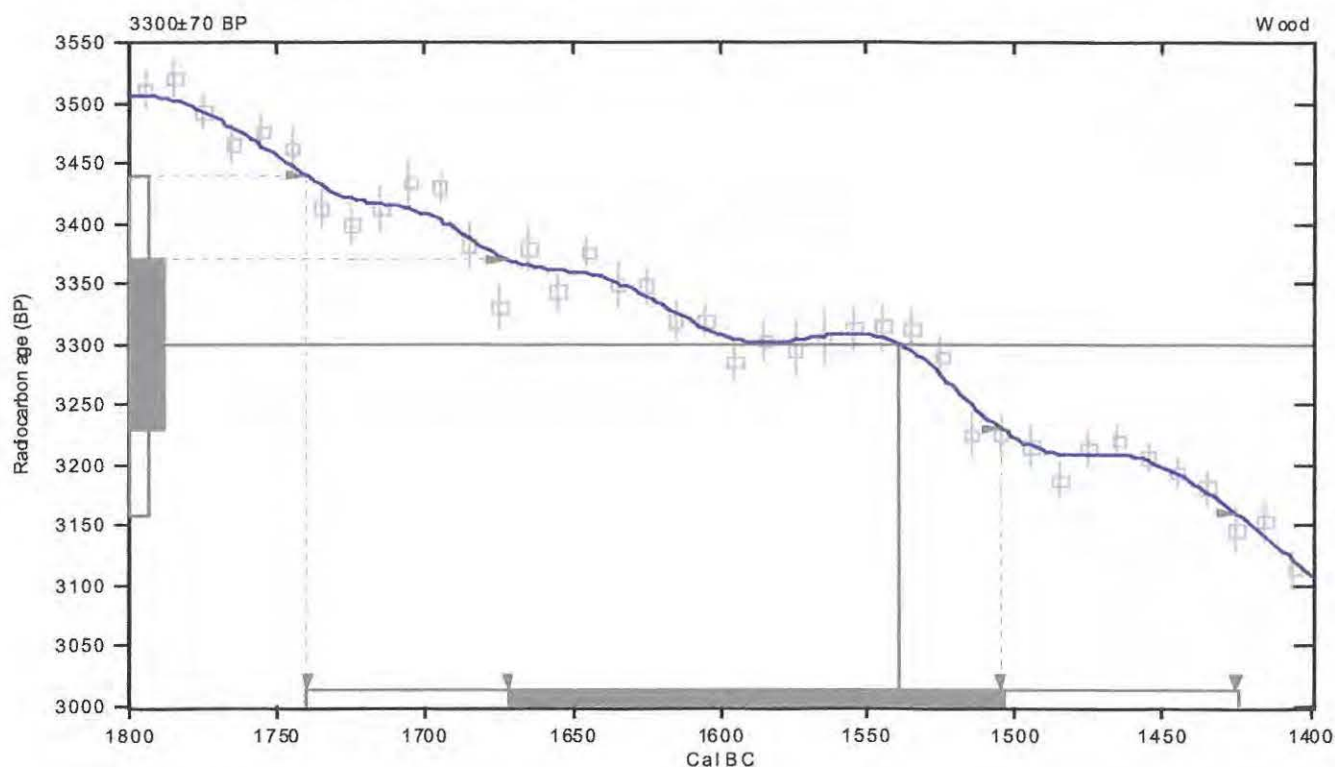
Laboratory number: **Beta-193840**

Conventional radiocarbon age¹: **3300±70 BP**

2 Sigma calibrated result: Cal BC 1740 to 1420 (Cal BP 3690 to 3380)
(95% probability)

Intercept of radiocarbon age
with calibration curve: **Cal BC 1540 (Cal BP 3490)**

1 Sigma calibrated result: Cal BC 1670 to 1500 (Cal BP 3620 to 3460)
(68% probability)

Sample 2 was a piece of small branch wood of birch, one of several pieces from peaty soil near the base of the pipe trench at a depth of about 1m below present ground level at the east end of the pipe-line, just north of Bont Arthog (Area F). This produced a determination of 3300 \pm 70 BP (Beta 193840), 1740-1420 Cal BC 95% probability.

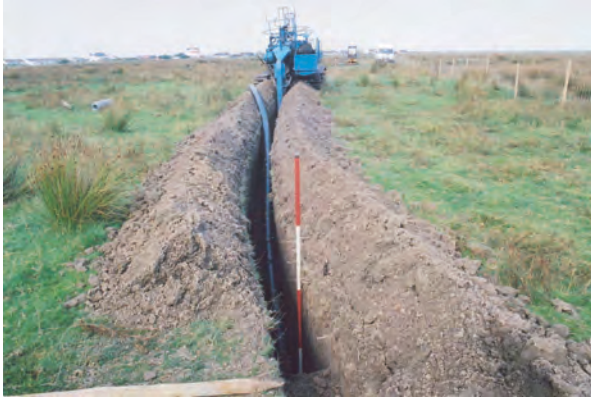
The pipe trenching was underway in the field on the Fairbourne side of the railway line close to the treatment works site. Work happened to have stopped while awaiting a delivery of pipe and a length of trench was open for observation. The pipe was laid in a very narrow trench, c. 0.3m wide and c. 1.25m deep. The subsoil levels

were visible because there the long spell of dry weather meant that there was no ground water. It was possible that could have been present but it was suggested in the assessment report that this area might be just of clay on the evidence that clay pits had been dug close by for the McDougall brick works during the construction of Fairbourne in the 1890's. In the exposed area here at least the deposits below the topsoil were all grey-brown silty clay to the depth of the trench as shown most obviously in the material excavated from the trench (Fig. 4).

Fairbourne Waste Water Treatment Scheme,
Archaeological Watching Brief:
Fig. 4 Area A Pipe trench, from the east. 1m scale

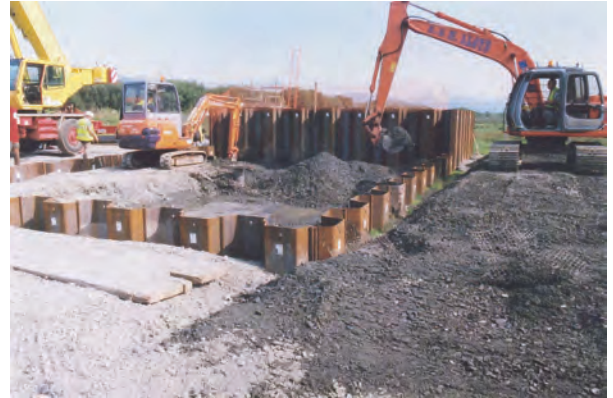
The watching brief was designed to cover the deep excavation for the wastewater holding tank at c. SH62051330. The excavation was to take place within a rectangular area of steel piling that had already been driven into place (Fig. 5). Excavation was delayed because of standing water on the surface and at a high level in the pipe of a test boring which was thought to show that the ground was totally waterlogged and so could not be dug until a pump arrived and this had not been pre-ordered. However, a start at excavation showed that the surface water had simply collected on top of the ground compressed by machine trampling. The bore-hole water was high because of ground pressure. The excavated soil was found to be dry and no ground water was encountered.

Fairbourne Waste Water Treatment Scheme,
Archaeological Watching Brief:
Fig. 5 Area B Treatment Works tank construction.
General view, from the south-west

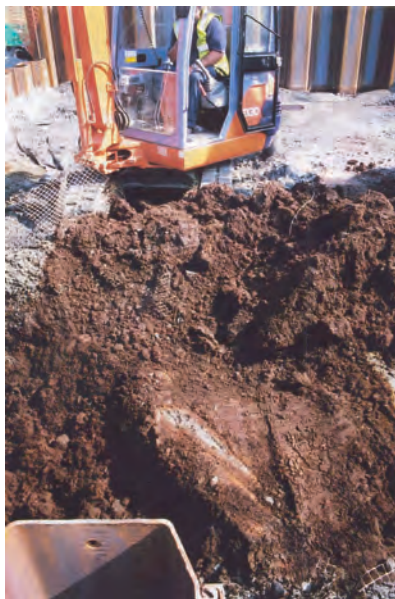
All the excavated soil was of peat, which was fibrous and had no visible stratigraphic breaks. The lowest level was better preserved and contained tree remains which appear to have grown on a peaty surface that had formed immediately on top of the grey clay with many roots penetrating into the clay. Peat had then continued to accumulate, burying the tree remains. The tree remains included the boles and part of the trunks of two trees that were still *in situ* but which had fallen or blown over. Both seem to have fallen in the same direction, towards the north-east, possibly blown over by a south-westerly wind. The largest trunk was about 4m long and 0.5m dia. (Fig. 6). The tree was removed by machine and put to one side. A section of the tree was later cut by the contractors for possible use by Nigel Nayling in developing a dendrochronological curve for Wales. Neither trunk had any attached branches. The smaller trunk was about 1.5m long, above the bole. There were also two large, less well preserved trunkless boles that appeared to be more ancient, as if decayed before being buried by the peat accumulation. There were also occasional short lengths of anciently broken branches in the peat but no obvious twiggy or brashy material.

Fairbourne Waste Water Treatment Scheme,
Archaeological Watching Brief:
Fig. 6 Area B Treatment Works tank construction.
Ancient tree trunk as first exposed

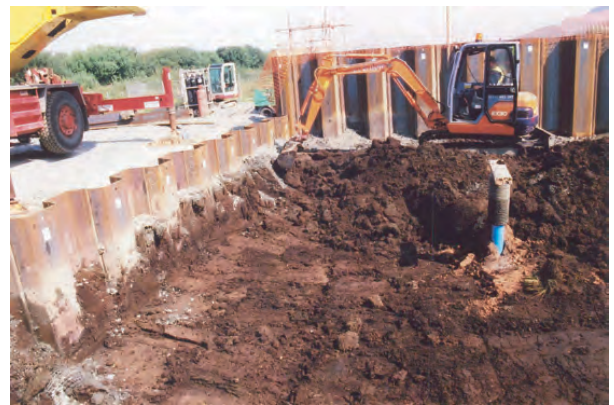
The peat continued to a depth of 1m below the present ground surface at which level grey estuarine clay was encountered (Fig. 7). This happened to be the level at which excavation was halted because of the need to reinforce the rim of the piling before deeper excavation continued. The peat had been expected to be deeper here because a trial hole further to the east (i.e. inland) had shown over 2m depth of peat. It is suggested therefore that the peat was deeper there because of the presence of a palaeo-channel or lagoon.

Fairbourne Waste Water Treatment Scheme,
Archaeological Watching Brief:
Fig. 7 Area B Treatment Works tank construction.
Showing clay revealed beneath peat

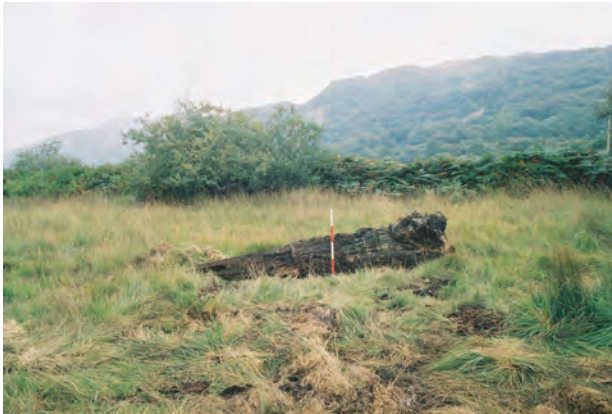
Another large tree had been encountered by the contractors as an obstruction during excavation of the pipeline trench alongside the Fegla Fawr (Mawddach Crescent) trackway. The tree had been lifted out and left on the surface (Fig. 8). It was a trunk and bole about 4m long and 0.75m diameter. However, although larger than the tree found in Area B it was in poorer condition and its stratigraphic position had not been verified so no sample was taken.

Fairbourne Waste Water Treatment Scheme,
Archaeological Watching Brief:
Fig. 8 Area C Ancient tree from pipe trench
by the Fegla Fawr trackway. 1m scale

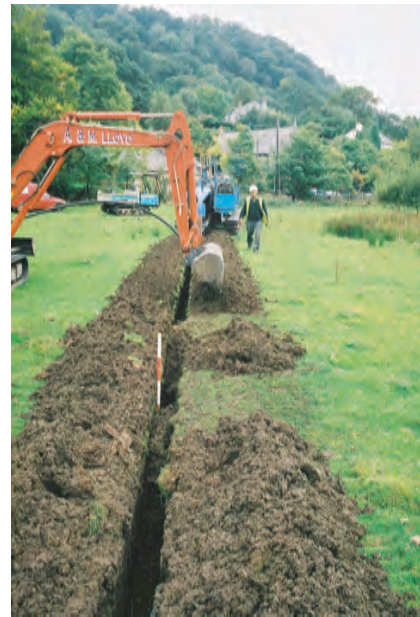
Most of the subsoil was peaty silt with a layer of preserved roots or brashy material in a peatier layer towards the base of the cutting. This was similar to the section previously seen in a freshly cut ditch on the east side of the Afon Arthog during the initial assessment. Only one larger branch was seen and no trunks or boles. Close to the Afon Arthog an area of cobbles and silt was encountered possibly an earlier stream channel or recently dumped material because the Afon Arthog was canalised at this point during the 19th century, running in a straight line between Pont Arthog and the creek with a high artificial flood bank alongside it.

Several stone-built culverts were crossed by the pipe trench. They were very shallow, their cover stones actually slightly above the field surface, presumably due to shrinkage of the peat. There were also several round-sectioned clay pipe drains at deeper depths.

Fairbourne Waste Water Treatment Scheme,
Archaeological Watching Brief:
Fig. 9 Area E Pipe trench west of the Afon Arthog,
from the east. 1m scale

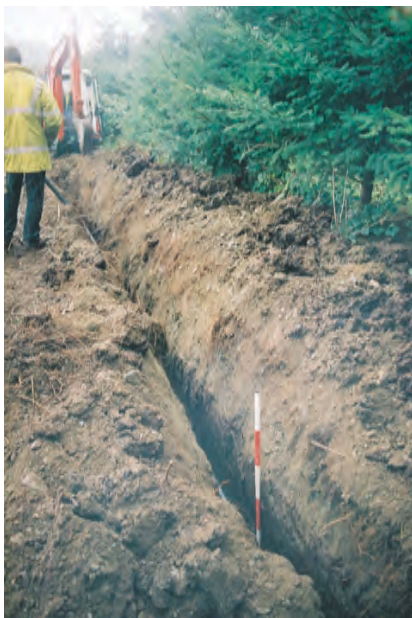
The trench was to be dug by mini-excavator here because of the lack of access for the trenching machine. The trench was dug to the same depth (0.30m wide and 1.10m deep) making the subsoil difficult to observe. The pipe was put into the trench immediately it was dug and backfilled shortly after.

For 35m east of the Afon Arthog the ground surface sloped up towards the river bank. This proved to be because of a thick spread of cobbles and gravel. These thinned out at about 35m east of the river and changed to clayey silt over woody peat (Fig. 10). This continued to about 41m east of the east corner of the walled garden where the peat thinned out and changed to silty clay with an organic top horizon. In three places the peat dipped into channels or hollows. Samples of wood (probably birch to judge by the preserved bark) were taken at 0.60m depth at 30m east of the east corner of the walled garden and at 1m depth at 35m west of the ditch at the east side of Mr Skulford's property.

Fairbourne Waste Water Treatment Scheme,
Archaeological Watching Brief:
Fig. 10 Area F Pipe trench east of the Afon Arthog,
from the west. 1m scale

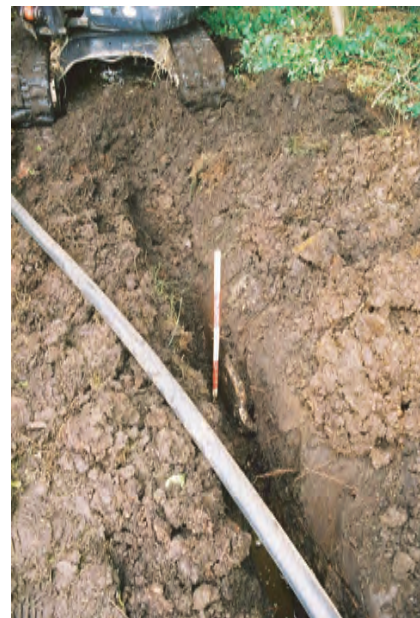
A complete, well-preserved cattle skeleton was discovered at 0.80m depth at about 10m west of the ditch at the east side of the property (Fig. 11). The skull of the cattle was horned with the horn sheaths and cores still preserved and there was also smelly organic fluid associated with the body. It appeared to have been laid in a shallow cut or possibly ditch or hollow in the top of the peat. It was therefore not of archaeological interest and probably a fairly modern diseased burial. According to Mr Skulford, this must be at least pre-1950 AD as no cattle have been kept there in recent years.

Fairbourne Waste Water Treatment Scheme,
Archaeological Watching Brief:
Fig. 11 Area F Cattle skeleton revealed in pipe trench,
east of the Afon Arthog, from the west. 1m scale
