# REGENT HOUSE, 17, CHURCH STREET, BEAUMARIS

## ARCHAEOLOGICAL ASSESSMENT AND EVALUATION EXCAVATION

GAT Project No. G1807

Report No. 508

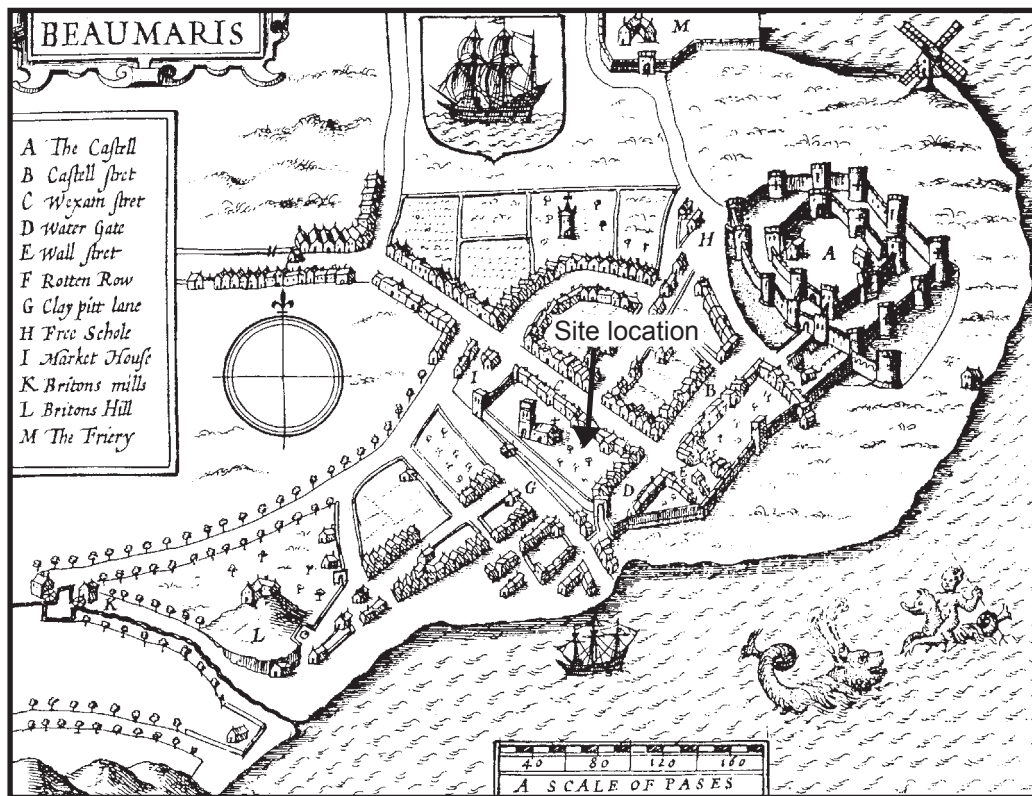
Regent House, Beaumaris Fig. 2 Speed's map of Beaumaris, 1610

The original layout of the town must have been truncated to some extent by the new defences, perhaps extending as far as Steeple Lane on the west side. This may well account for the large area of open space that still existed in 1829, to the south-west of the church, an area beyond the bounds of the burgrave plots fronting Castle Street and Church Street. Speed's map (1610) shows the whole of this area at the west of the town, within the town walls as open ground around the church (Fig. 2). The town wall forms the west and north sides of this area while along the east and south are continuous rows of houses. The east side is labelled as all Wexam Street with no Church Street although this could be just an error. The street now known as Steeple Lane, which probably ran along the edge of the town ditch was then called Clay Pitt Lane, probably referring to the ditch or to use of it for digging clay for brick-making and there may have been a brick works nearby. The area south of the church on Speed's map is of interest because within it was the area covered by the present development. The map shows it with several small trees so it was probably disused or possibly orchards in

contrast to the spaces behind the two blocks of houses between Rotten Row and Castle Street, which are clearly shown as having cultivated garden plots. Although Speed shows a continuous row of houses at the east side of the church along what is now Church Street a Baron Hill Estate map of 1829 shows that by then at least there was only one building left there (Fig. 3). This was undoubtedly because of attempts to make the approach to the church more grand, with the help of the Bulkeley family who probably donated the land for this landscaping scheme. Where burgage plots were taken up and used continuously the backs of the plots may have been simply used as gardens but even so, in a town situation various rubbish pits might be expected which might preserve good collections of pottery for instance. Behind particular commercial premises however, there might be other evidence deriving from trade and crafts such as metal-working or leather-working and these would be looked for in the archaeological trial excavation.

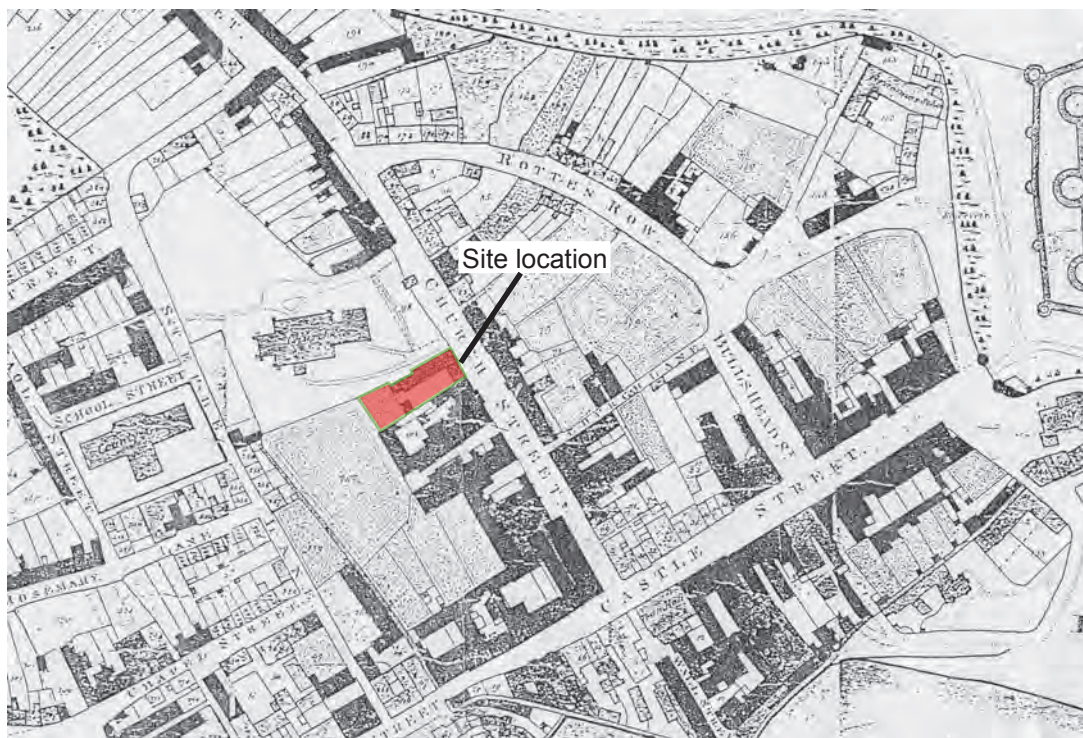
Regent House, Beaumaris Fig. 3 Part of the Baron Hill Estate Map 1829 (UWB 6496)

606). This conveyance was perhaps needed before a new house could be built to replace The Old Plas (see below). The 'void ground' was that which formed the gardens of Hen Blas and was still in use as gardens at the time of the 1829 map (Figs 3 and 4)

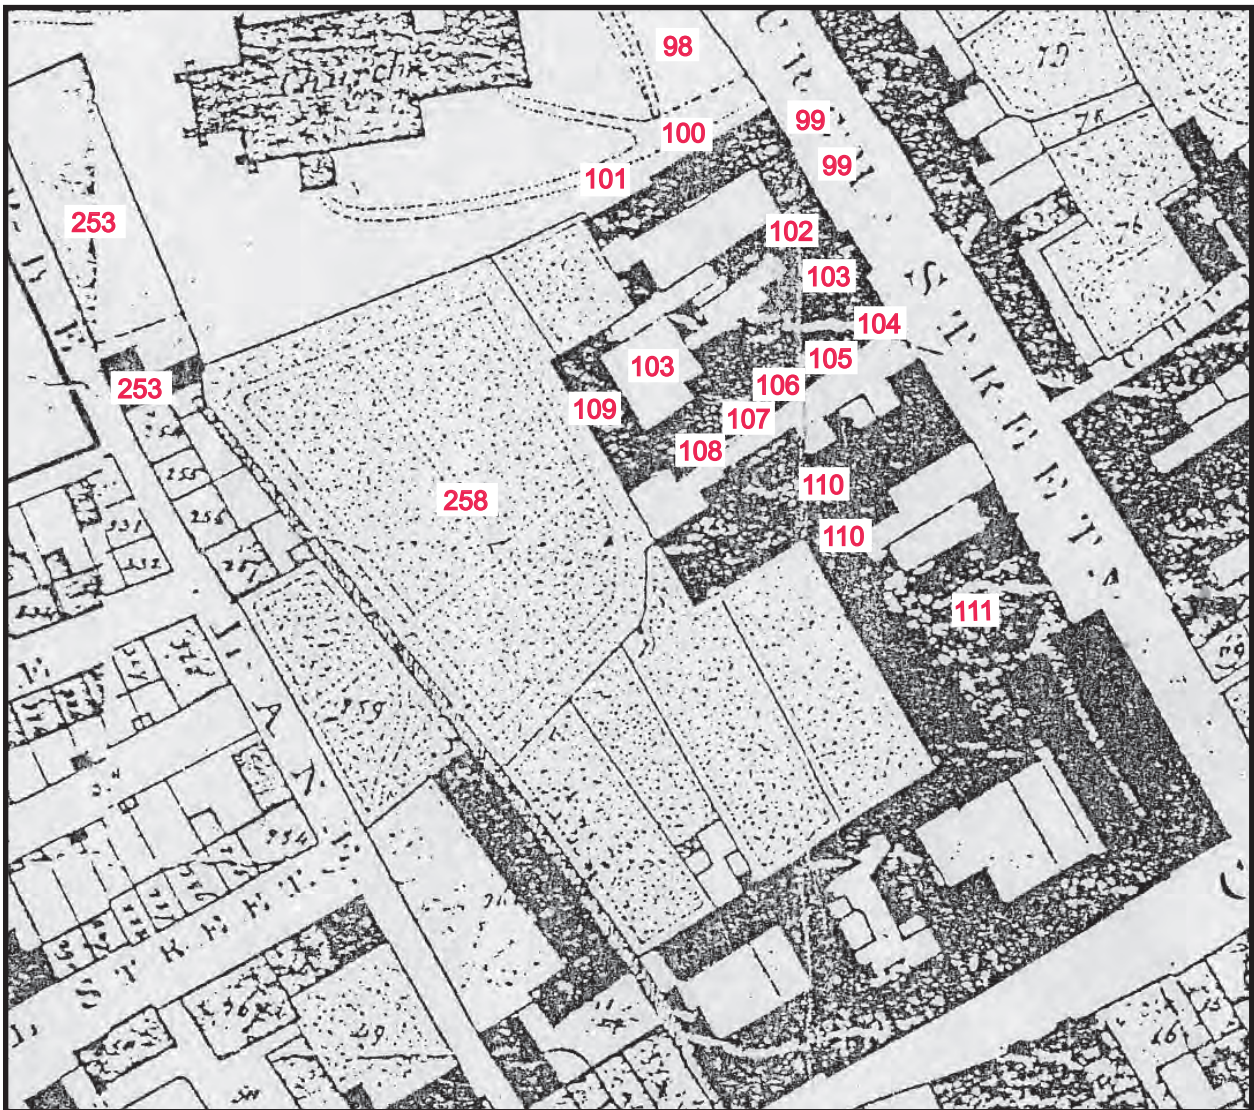
Regent House, Beaumaris Fig. 4 Baron Hill Estate map 1829 (UWB BH 6496).  
 Enlargement of area of relating to Church Street showing property numbers  
 identified in Baron Hill Schedule (UWB BH 8211) and referred to in text

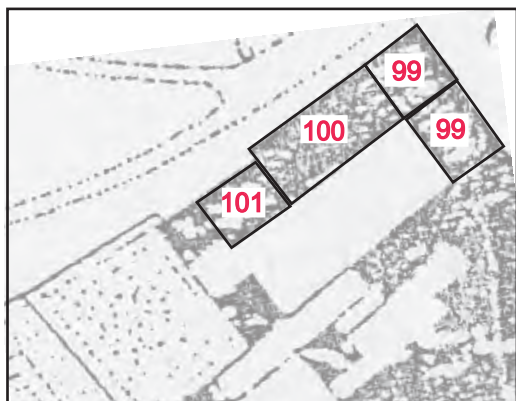
Fig. 5a No. 17 Church Street in 1829  
(Baron Hill UWB BH 6496)  
Re-oriented to OS north  
and structural divisions emphasised

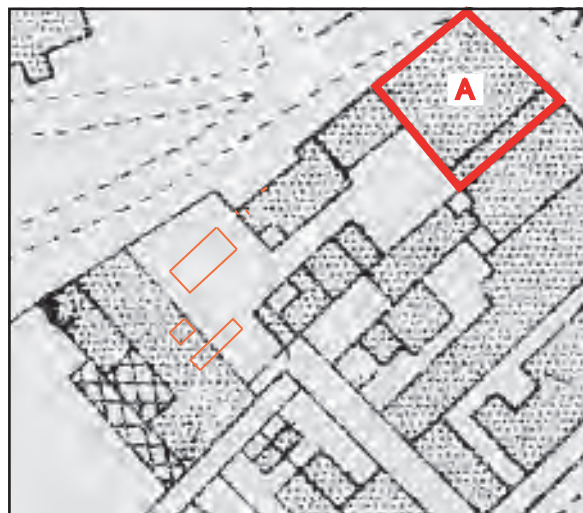
Fig. 5b No. 17 Church Street in 1919 and position  
of trenches excavated Nov. 2003  
Based on Ordnance Survey 1:2500 map, 1919

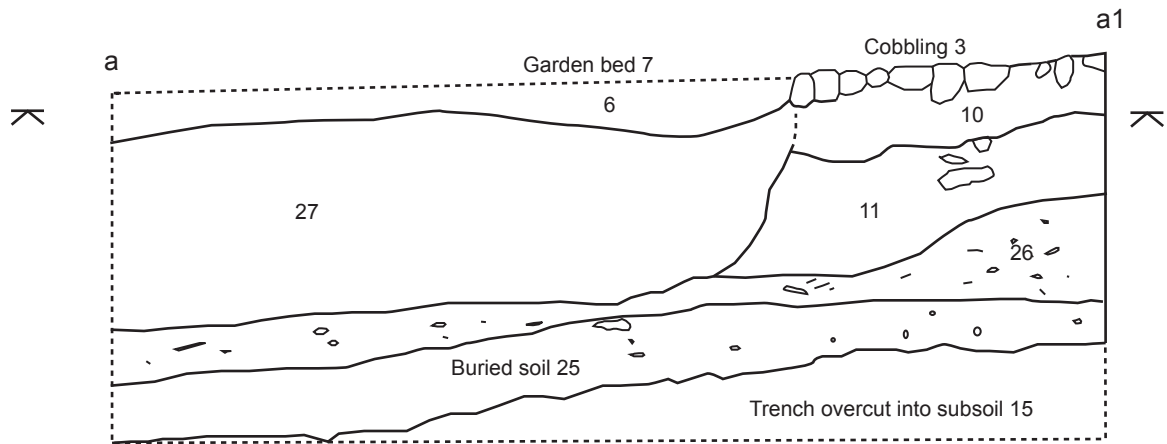
# TRENCH A West-East SECTION

Regent House, Beaumaris Fig. 7 Sections of Trenches A and B

**Trench A** (Fig. 7) was 4m long and 2.8m wide, lying parallel to and about 2m from the face of the churchyard wall. The most recent feature was a garden bed. This had been cut through a neatly cobbled yard surface. This yard surface was edged by large flattish, sub-rectangular stone slabs, about 100mm deep. Very little of the area beyond the edging slabs was exposed but what was contained many pieces of various ironwork (not farriery) presumably belonging to the former smithy in the north-west corner of the plot. The yard surface probably formed part of a regular pattern of paths around a garden area related to the 19<sup>th</sup> century occupation of Regent House. The cobbles were laid upon a humic, rubbish-rich soil layer (Context 10) with many pieces of 18<sup>th</sup> century and early 19<sup>th</sup> century pottery, glass bottle fragments and occasional animal bone and oyster shell. The deeper layers were only excavated by hand in the eastern metre of the trench. There Context 10 lay upon a more clayey and more compact, yellow-brown soil (Context 11) which contained mainly 18<sup>th</sup> century pottery with occasional 19<sup>th</sup> century pieces. This was not humic and seemed to be a make-up layer, not an old topsoil layer. This lay upon another even more compact yellow-brown layer (Context 12), the surface of which was marked by a good number of pieces of broken roof slate, as if forming a trampled surface. This contained only 18<sup>th</sup> century pottery and seems likely to represent the construction phase for Regent House. Below was a more compact still cleaner silty layer the surface of which contained occasional slate fragments, charcoal and pebbles. This was taken to be the subsoil surface, at a depth of c. 0.75m below the ground surface. Further excavation by machine showed that the subsoil surface sloped down gently from the north (i.e. from the church wall) to the south, that is following the expected natural slope of the ground surface in contrast to the relatively level modern surface of the yard. At the north side of the trench a relatively stone-free humic soil about 150mm deep, was revealed below the previously identified layer 12 but there was no artefactual dating evidence. However, it is best interpreted as a garden soil that predated the construction of Regent House. Its position immediately above the subsoil at the base of the terrace beneath the churchyard wall may also mean that it predated the construction of the house before Regent House and so belong to the original construction of the terrace, which has been suggested to be as part of the later 16<sup>th</sup> century gardens of the Plas (see Desktop Assessment above).

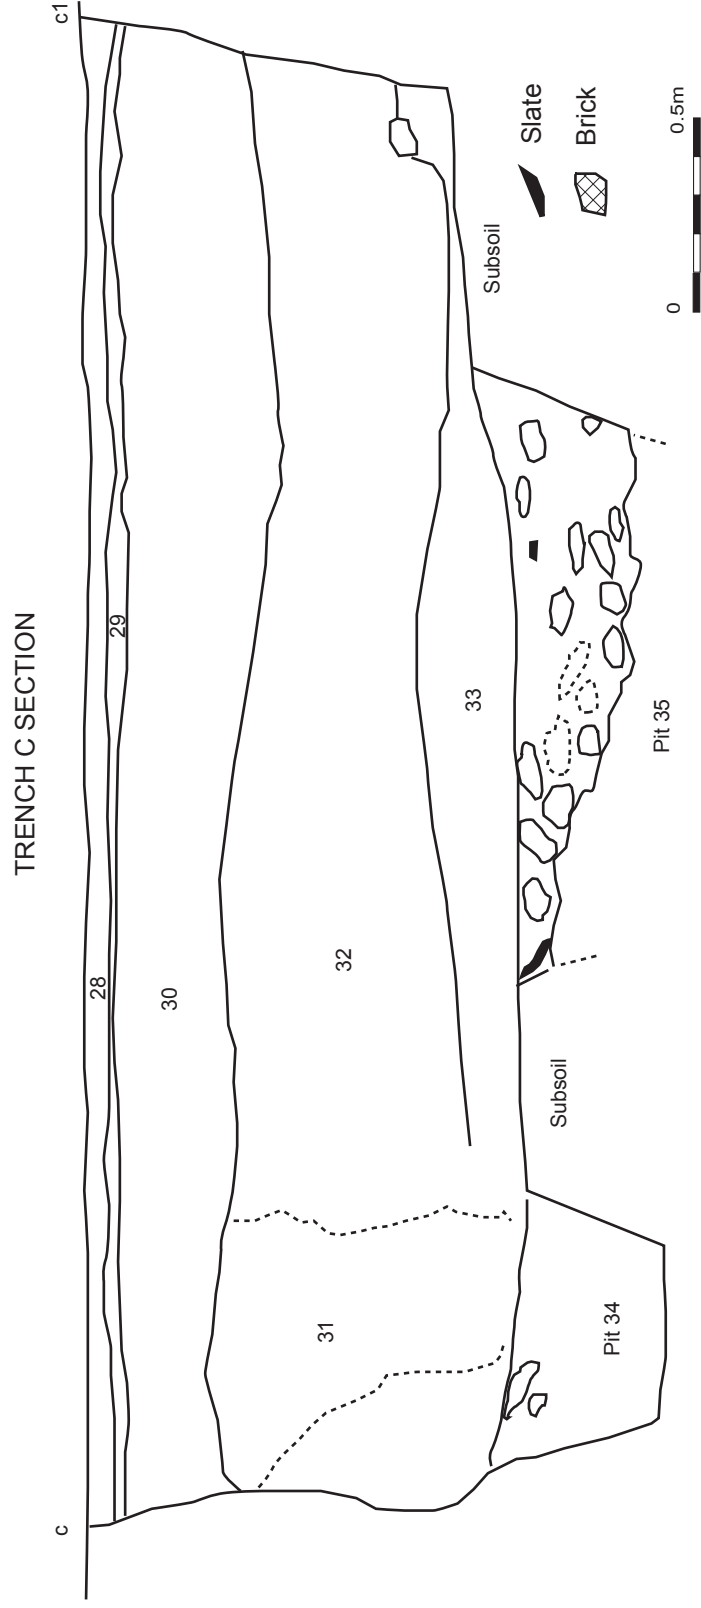
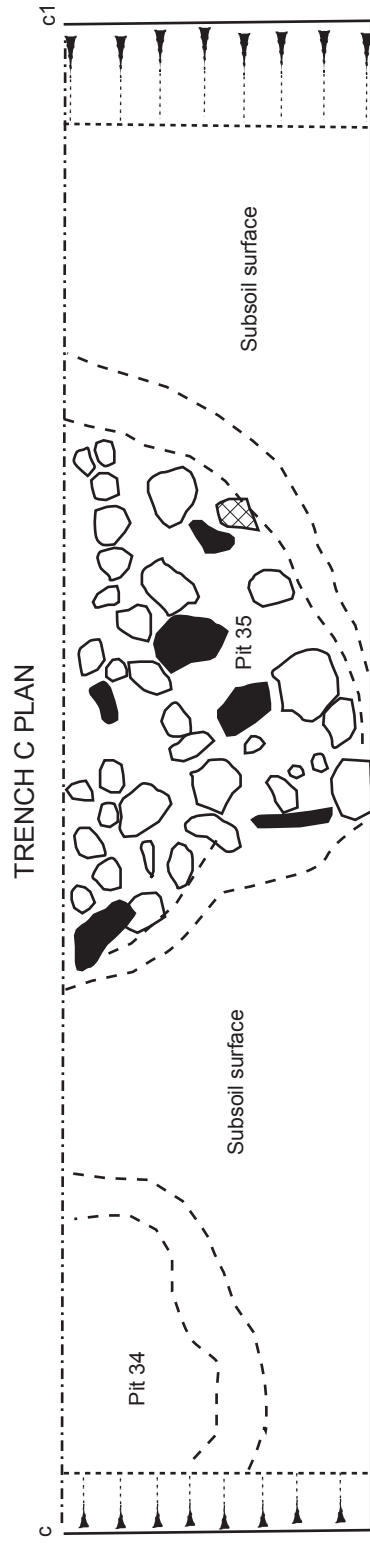
Regent House, Beaumaris Fig. 8 Section and plan of base of Trench C

**Trench C** (Fig. 7) was 0.9m wide and 3.7m long. The layers identified as of post-medieval date were machined out down to the yellow-brown clayey silt identified as sub-soil. Three layers were identified, equivalent to layers 10, 11 and 12 in Trench A and 17, 18 and 19 in Trench B. Two features were revealed in the surface of the subsoil, both only partially exposed in the narrow trench. Both were irregular curvilinear edged pits. That at the west (Pit 35) was possibly 1.66m dia. if it was circular. It was only exposed to about 0.40m below the surface of the subsoil, 1.30m below the ground surface but was continuing down at that depth. It was full of larger rubble than that in Pit 20 in trench B and contained stone cobbles, slate and bricks. Possibly it was a soak-away rather than a builder's rubble dump. It was covered by the layer equivalent to layer 19 in Trench B and so pre-dated Pit 20. The brick fragments show it was no earlier than c. 1600 and probably to be associated with the 18<sup>th</sup> century phase of 17, Church Street. The other pit (Pit 34) in Trench C was only exposed in one corner, possibly about 1m dia. if symmetrical. It was exposed to a depth of 0.40m, at 1.50m below the present ground surface, but may have continued further. Its fill was quite different to that of Pit 35, being a soft grey and orange clayey silt containing oyster and winkle shells and animal bones. No dating evidence was found but it too appeared to be sealed by the layer equivalent to Layer 19 in Trench B. Its fill suggests it was a rubbish pit.
