# St Celynnin's Church Llangelynnin

GAT Project No. 1730

Report No 518

St Celynnin's Church  
Llangelynnin  
Archaeological Recording

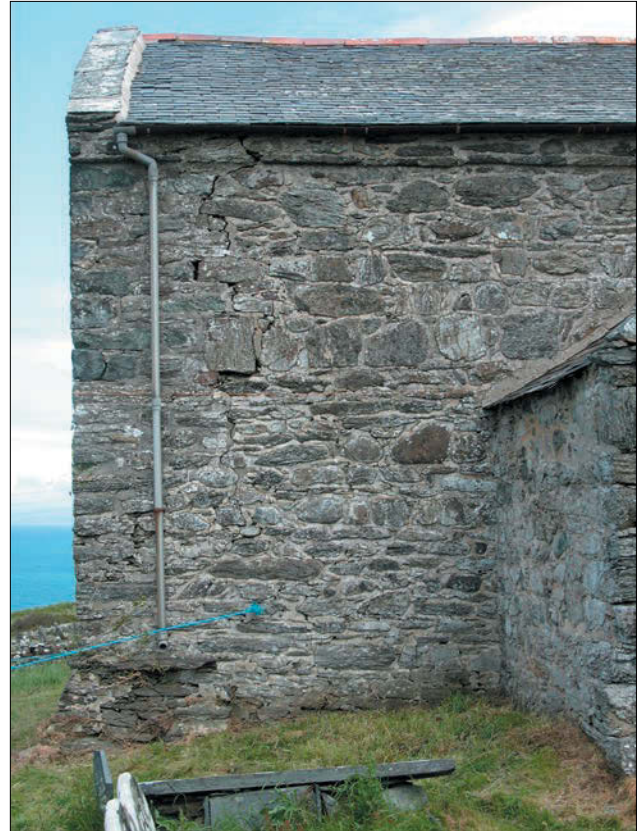
The interior walls are plastered and lime washed. Outside, the masonry is visible although heavily pointed in places. A serious vertical crack is visible in the south wall at between 1.00m and 1.4m from the west wall, corresponding to the thickness of the west wall which appeared to be in danger of becoming detached from the main building. A similar crack in a corresponding position of the north side has been previously treated with heavy pointing.

*south-west corner showing structural cracks*

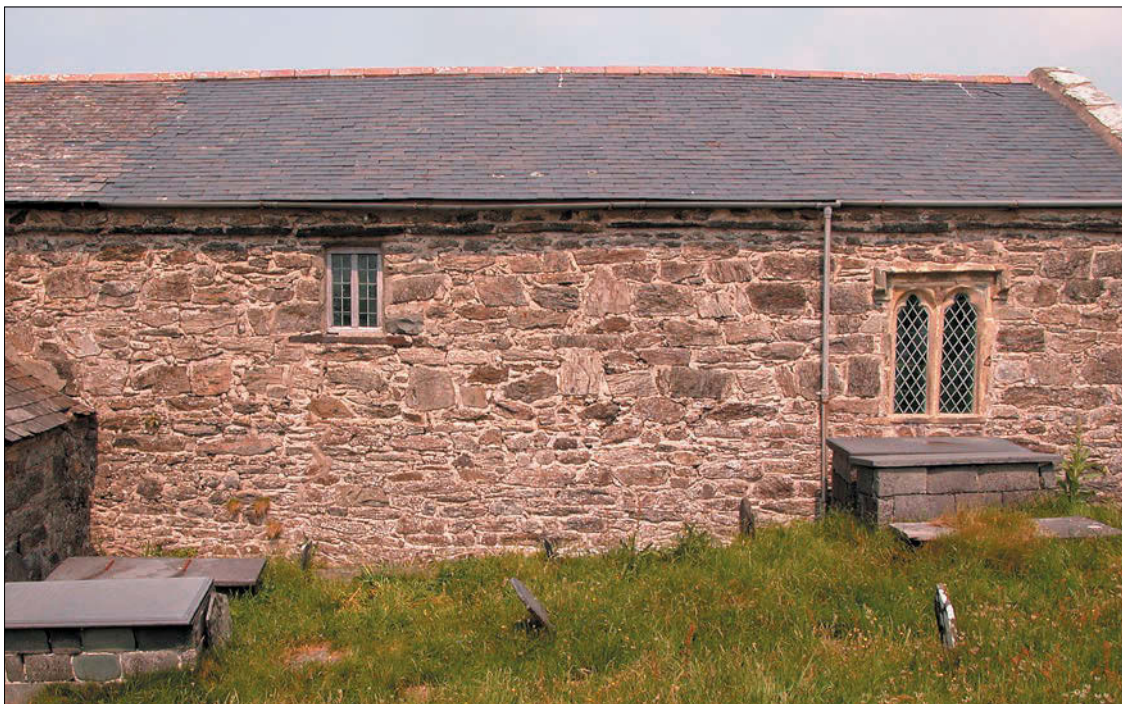
A clear distinction is visible in the character of the external masonry on all four faces. In the south wall a horizon marks this distinction at a height of c.1.00m above the present external ground surface at the east end and at a height of c.3.00m at the west end. The stonework changes from generally small, sometimes rounded, predominantly elongated stone below this line to an admixture of predominantly larger, more square quarried stone. The horizon between the two builds is practically level. The upper build is carried to a height of a further 1.90m above the lower build at the east end and 1.70m at the west end. At this point a string course

*south wall showing masonry phases*

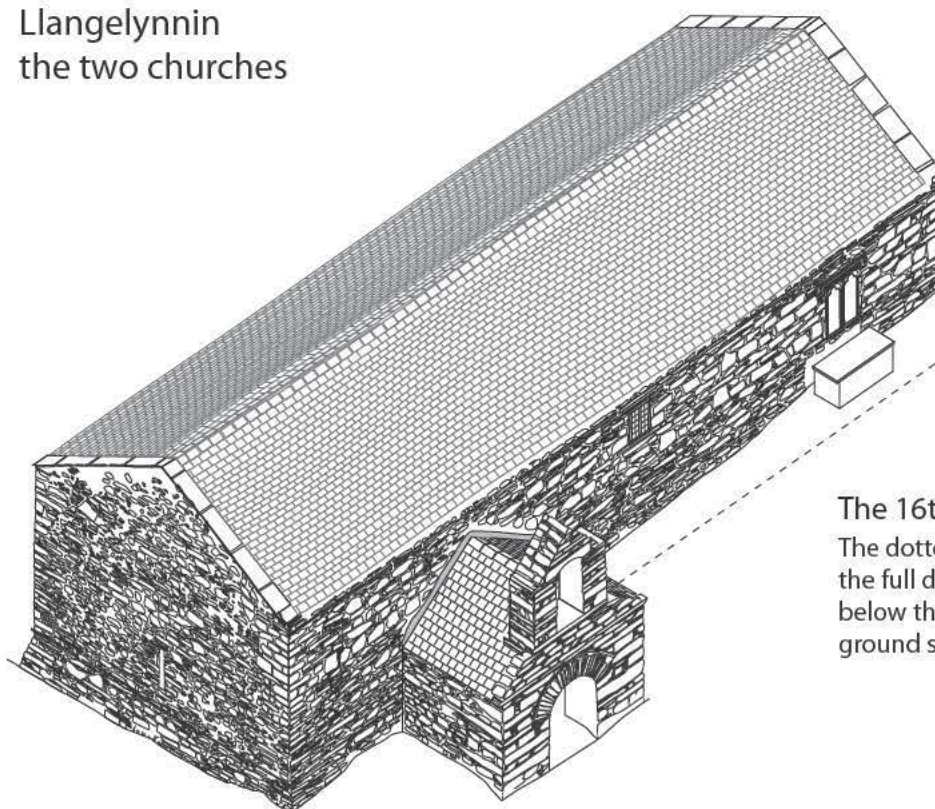
**The 16th century church**  
The dotted line represents  
the full depth of the wall  
below the present  
ground surface

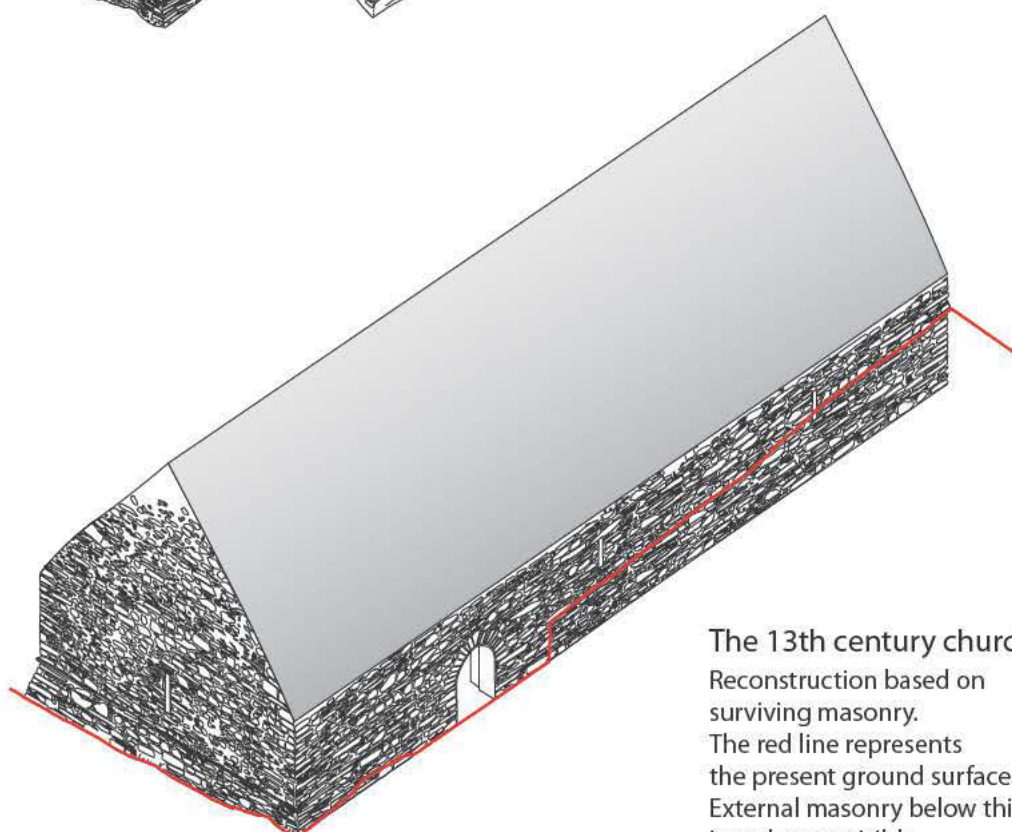
**The 13th century church**  
Reconstruction based on  
surviving masonry.  
The red line represents  
the present ground surface.  
External masonry below this line  
is no longer visible

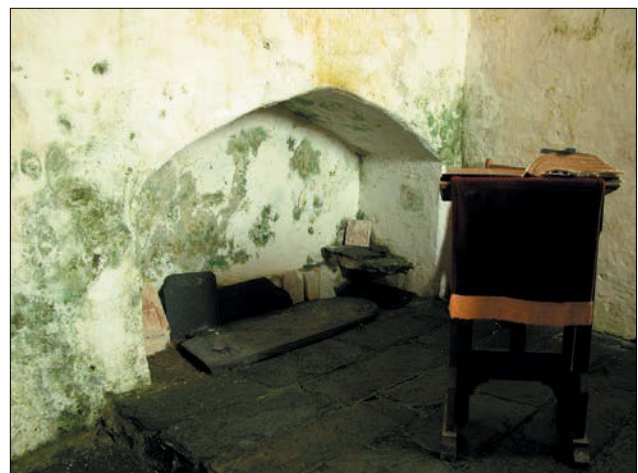
*Northern sepulchral recess before conservation*

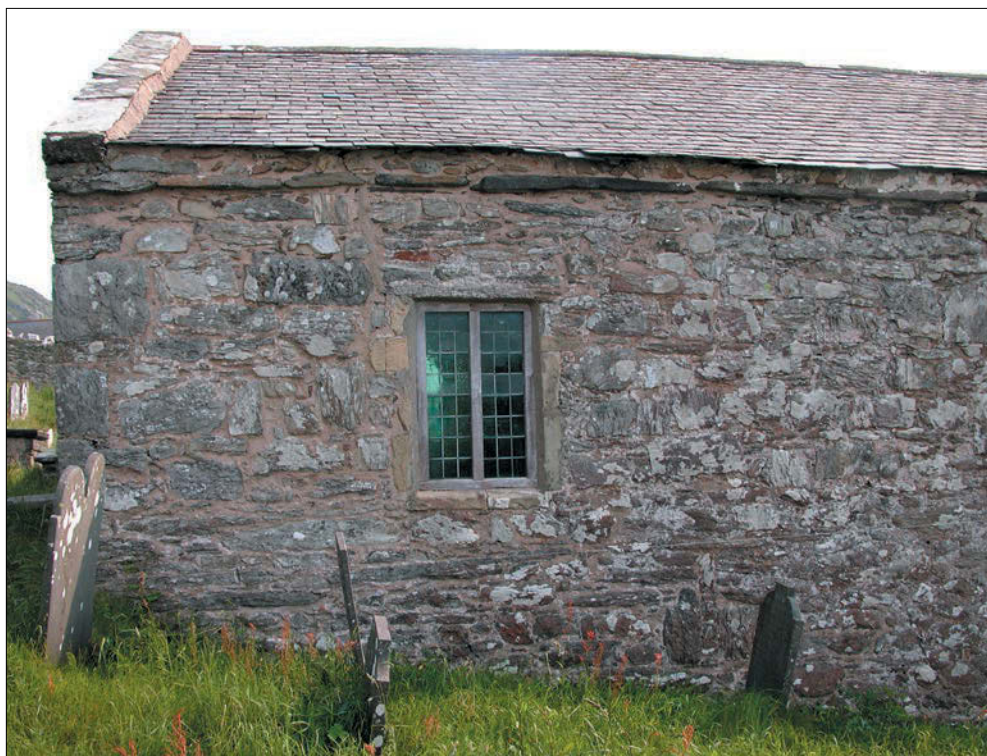
In the north wall of the chancel, beneath the second truss is a small rectangular niche 900mm across, 360mm deep. On the exterior this shows as a blocked narrow slit window in the masonry of the phase 1 wall, comparable to the western window but smaller. On the interior wall the original side splay is visible but the height has been truncated, top and bottom to serve as a cupboard.

*North wall at west end showing re-framed and set chancel window and, immediately to the left of the right hand gravestone, the blocked, early slit window*

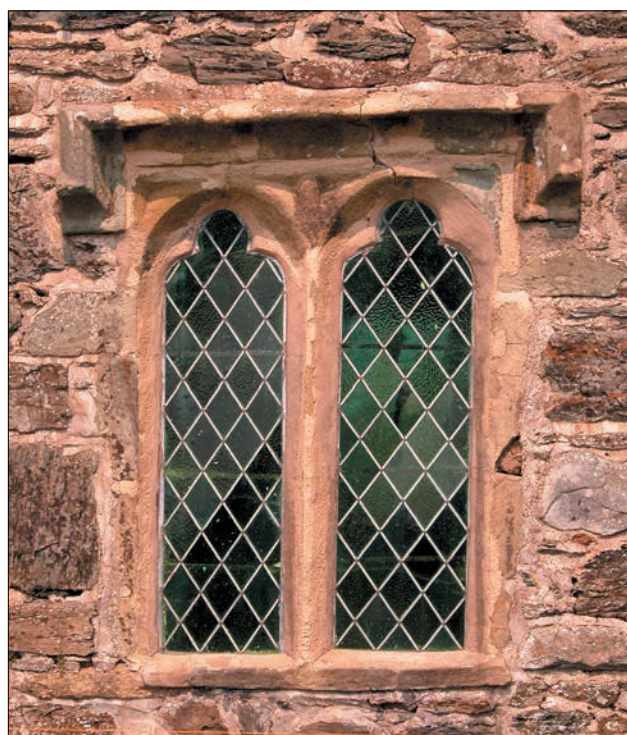
The window in the south wall of the chancel is the most elaborate of the surviving windows. Like its counterpart in the north wall it is set at the interface of the early and later masonry. On the outside wall the window shows as two trefoiled lights within a rectangular frame surmounted by a moulded label with truncated out-turned stops. The stone is dressed sandstone. Both this window and its northern partner are splayed internally.

*South chancel window, 16th century*

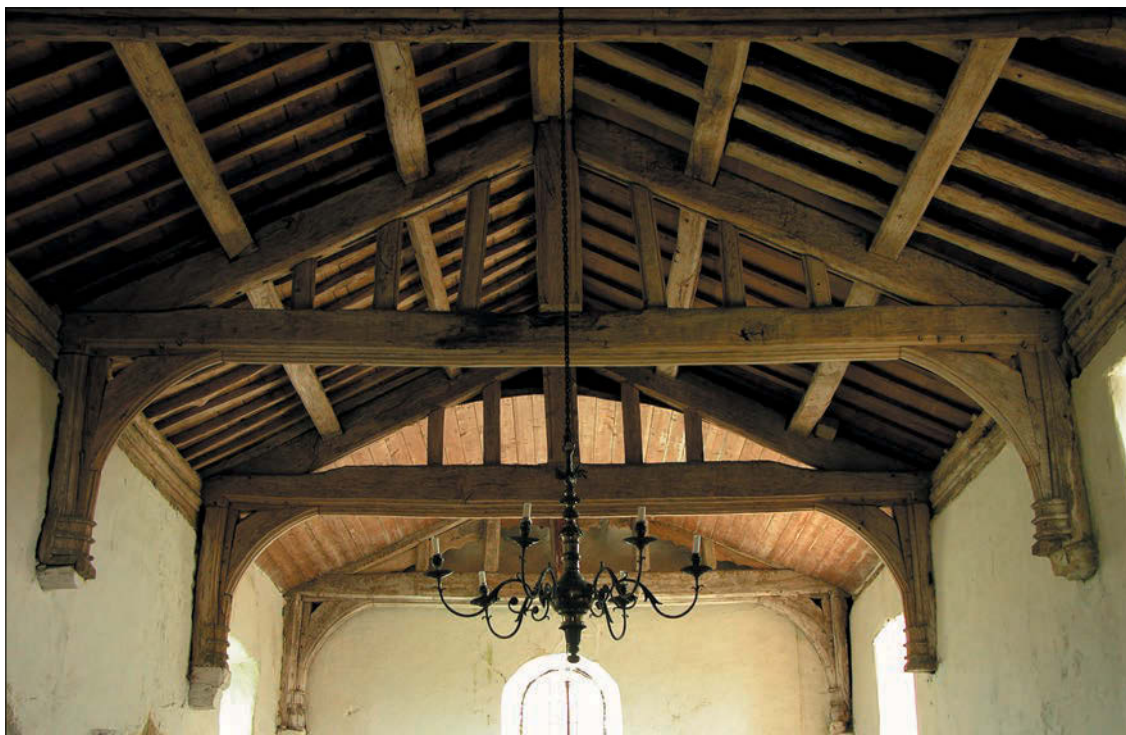
The trusses are all of king-post construction with tie-beams supported by arch-braces springing from stone corbels set in the wall. The purlins rest on recessed

*The first three bays of the roof, looking east*

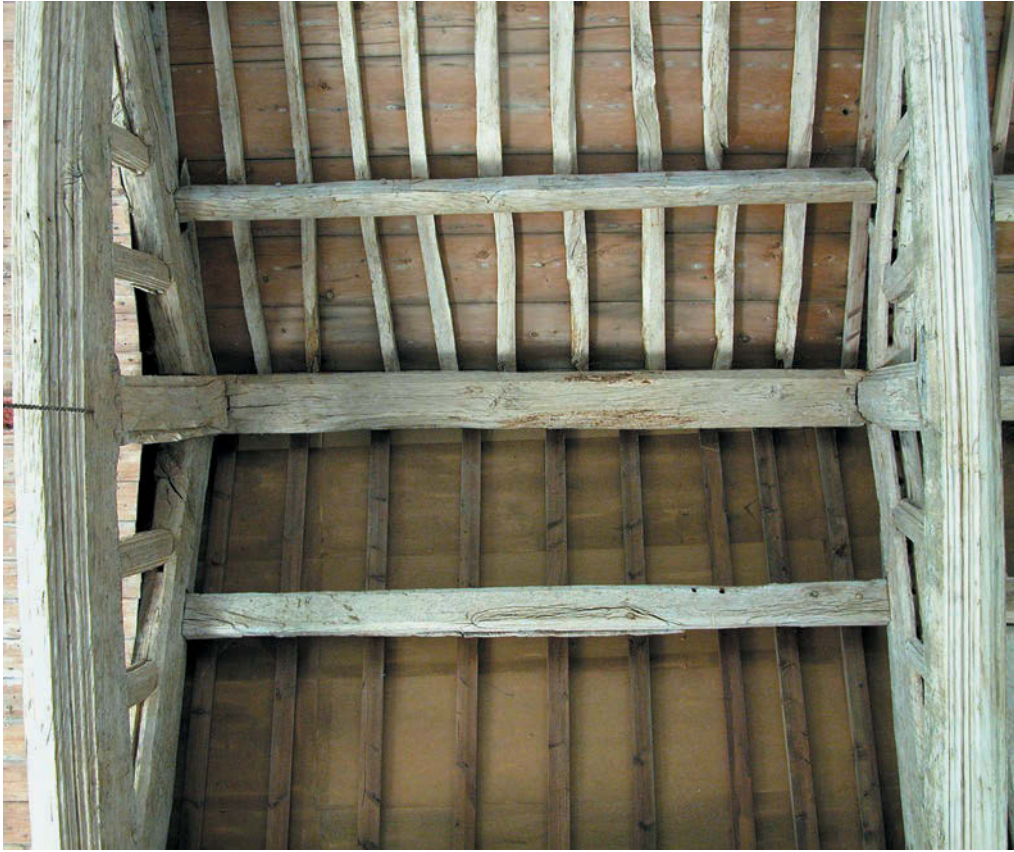
Diagrammatic reconstruction of roof truss and decorative wall plate moulding.

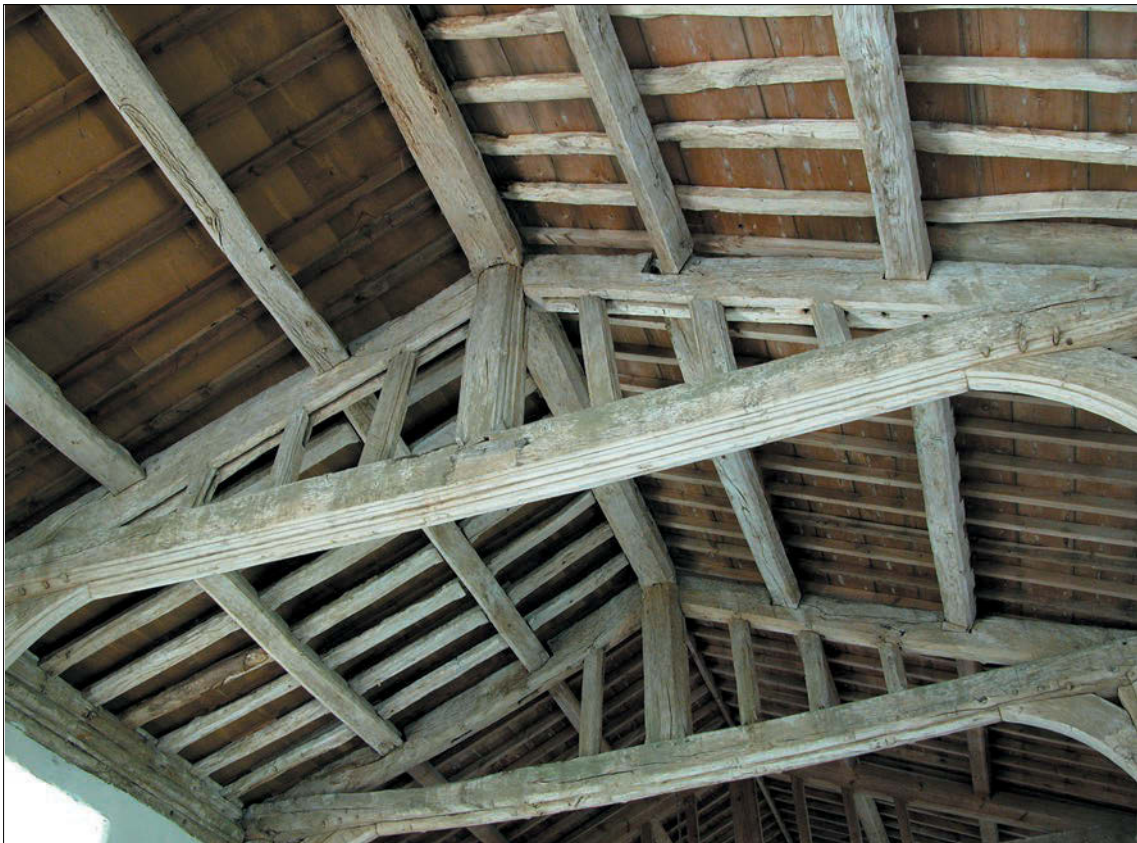
*Details of the roof structure, second bay, above; second and third bay, below*

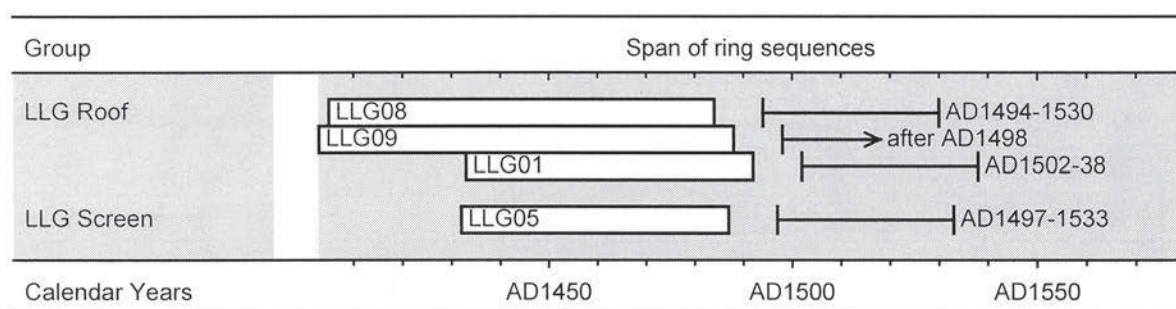
*Figure 1 Bar diagram showing the chronological positions of the dated timbers. Estimated felling ranges for individual timbers are based on most recent British sapwood estimates (Tyers. 1998)*
