Pont Bodfel, Llannor

GAT Project No. 1773

Report No 521

Pont Bodfel,
Llannor
Archaeological Recording

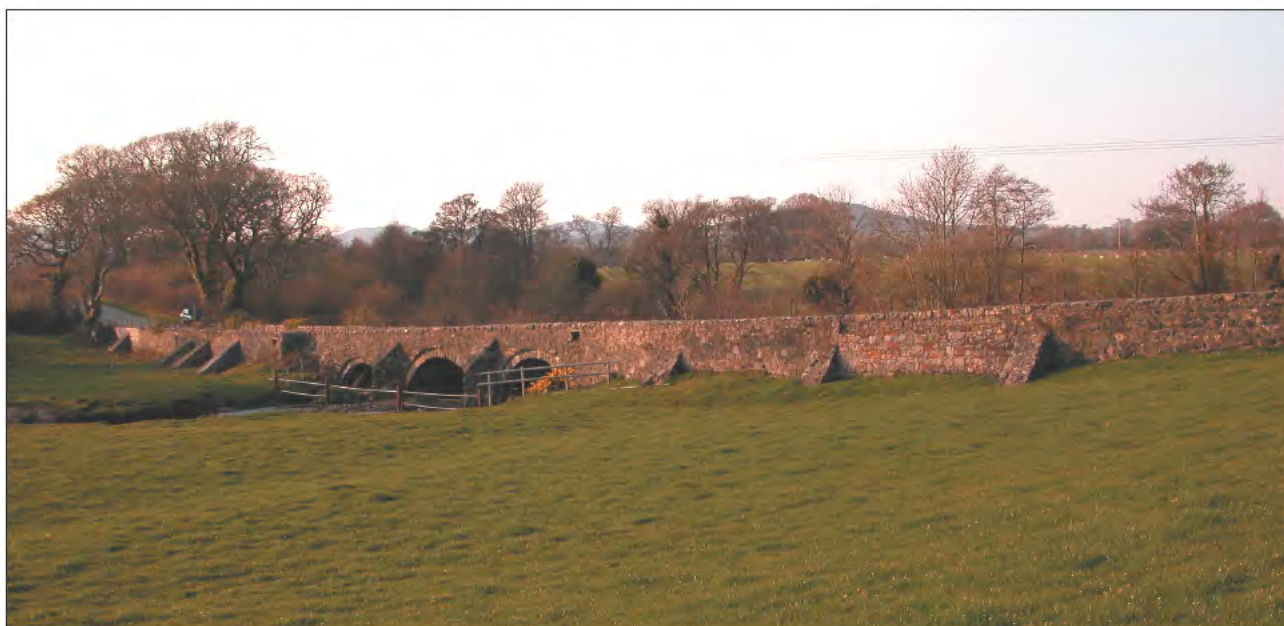
Fig. 3. Pont Bodfel, south side showing bridge, causeways, buttresses and modern repair

There have been several repairs to the bridge over 200 years of use. The most notable are the provision of supporting buttresses to the causeways on both the north and south faces and at each end of the bridge. The walls have been rendered and and repointed on a number of occasions and there have been heavy repairs and rebuilding of the masonry in places too. This is particularly evident at the junction of the causeway and bridge at its eastern end on both the north and south sides. Certain of the drain holes have been repaired and provided with new lintels.

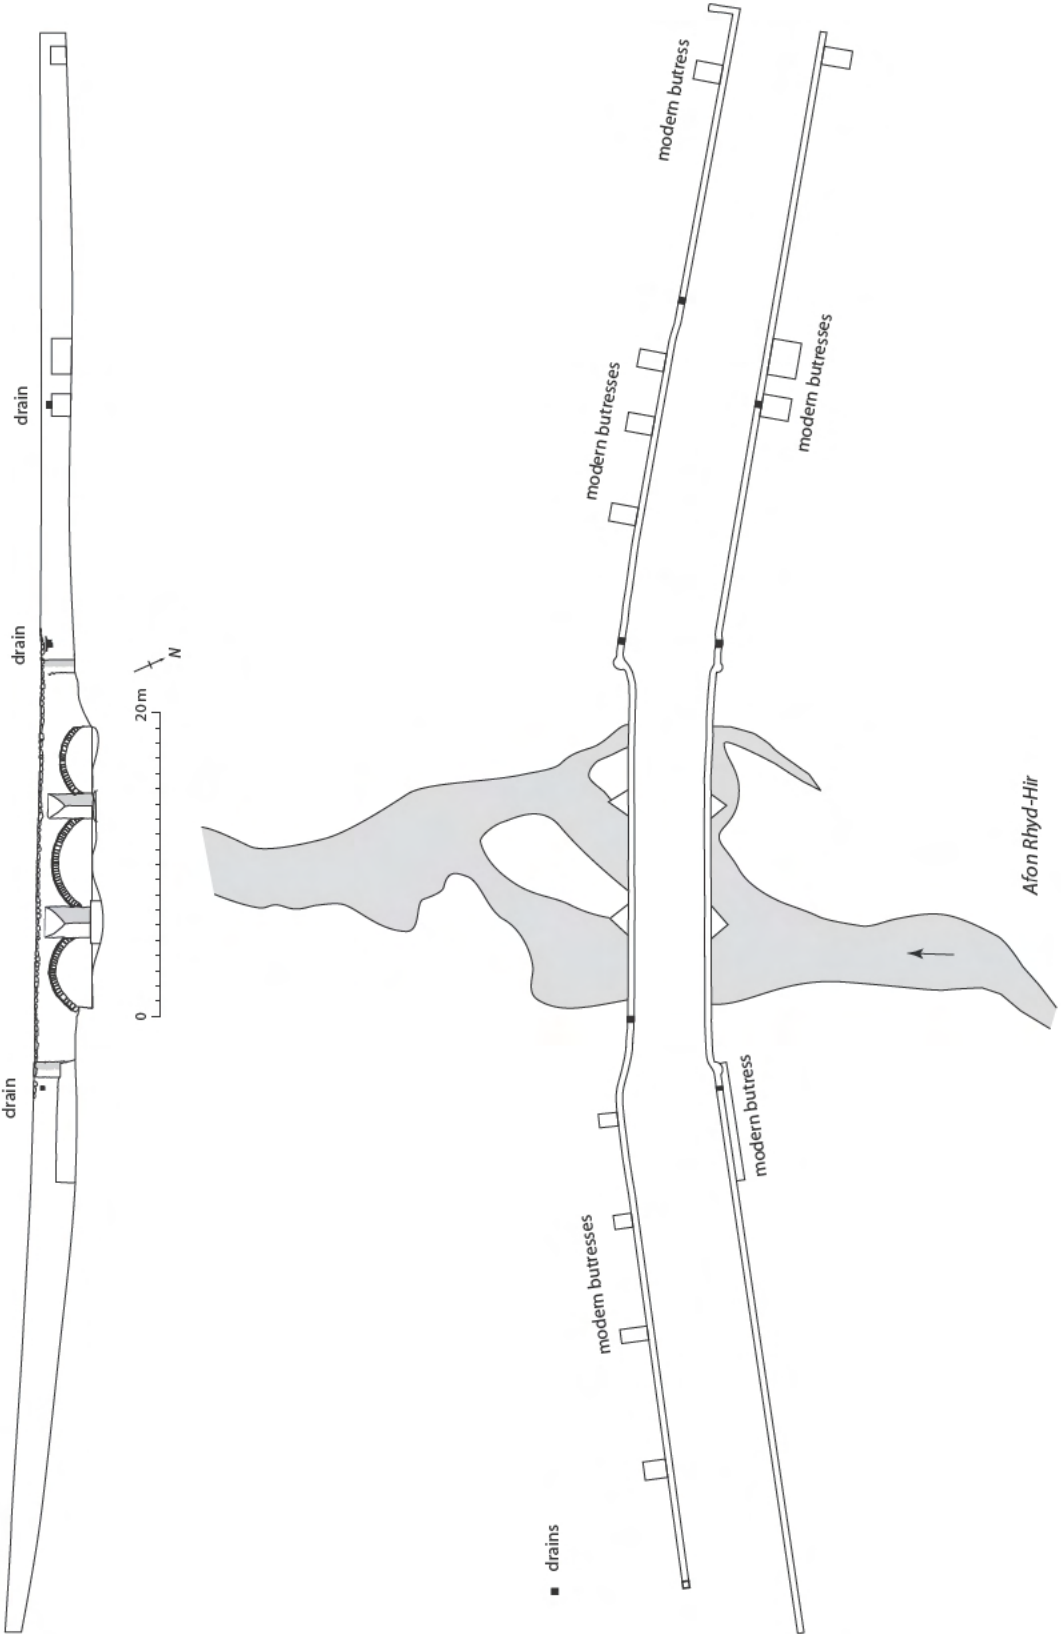
Pont Bodfel General plan and elevation of bridge and causeway

The overall dimensions of the bridge as built conform reasonably closely to the design. Some small variations were noted as follows:

The span of the three arches, from east to west, were intended to measure 14 feet, 20 feet and 14 feet. As built, the dimensions are 15 feet, 19 feet and 14 feet. The two piers were designed at equal widths of 6 foot. As built, the eastern pier, excluding plinth, is 8 foot 6 inches and the western pier is 6 foot 2 inches.

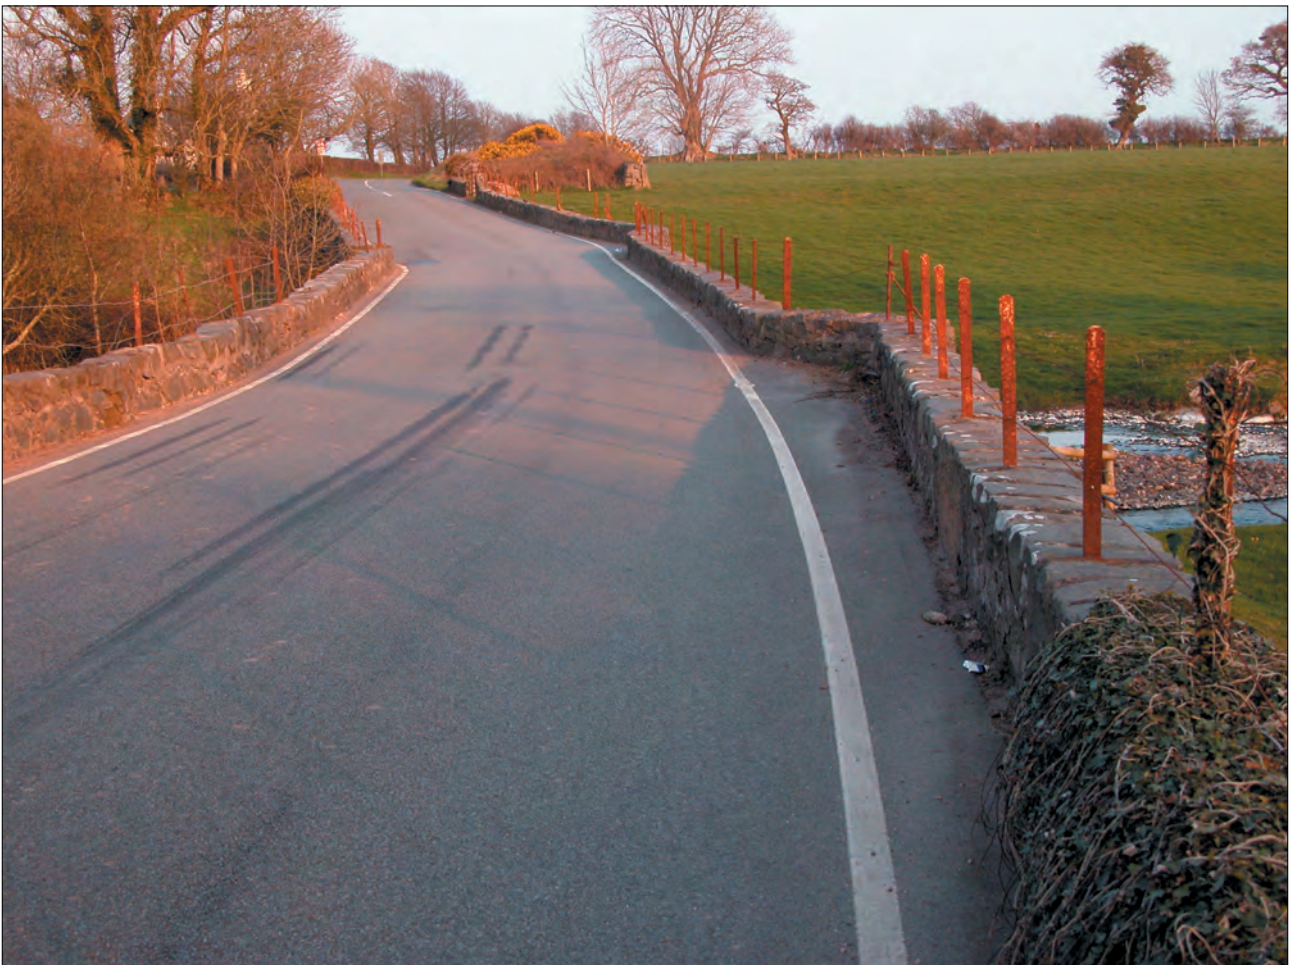
Fig. 5. A497 carriageway looking east, showing road narrowing at bridge and skid marks on carriageway

The carriage way has evidently been built up over several years. It is now a tarmac surface with a consequent reduction in the relative height of the guard walls or parapet. The carriageway on the south side is consistently higher relative to the parapet wall than is the case on

the south side. On the bridge itself the south wall now rises little more than 15 inches to 18 inches above the level of road, a circumstance which may be compared with the intended height of 3 feet. On the north side the height is 17 inches to 20 inches. Off the bridge the parapets stand 20 inches to 24 inches above the carriageway.

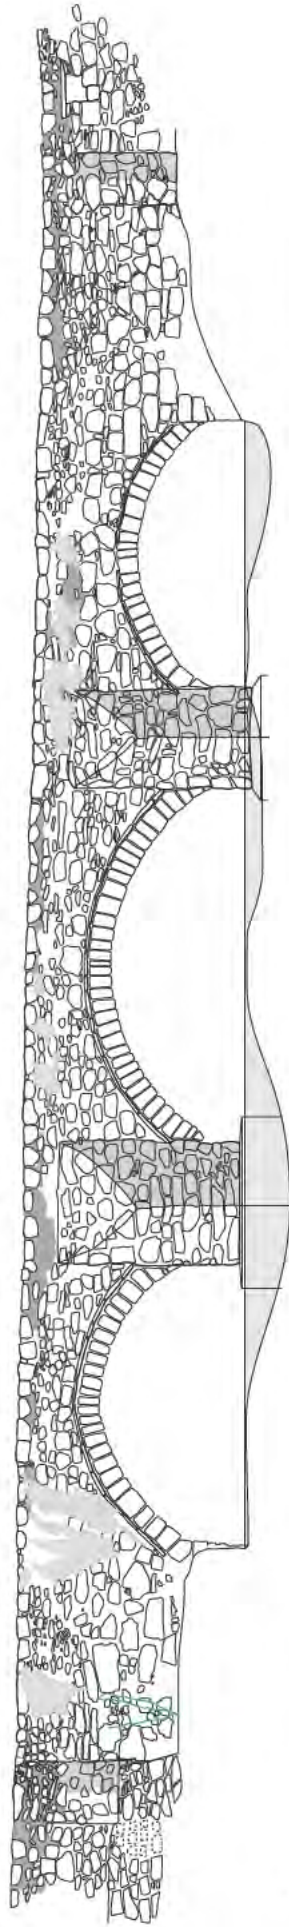
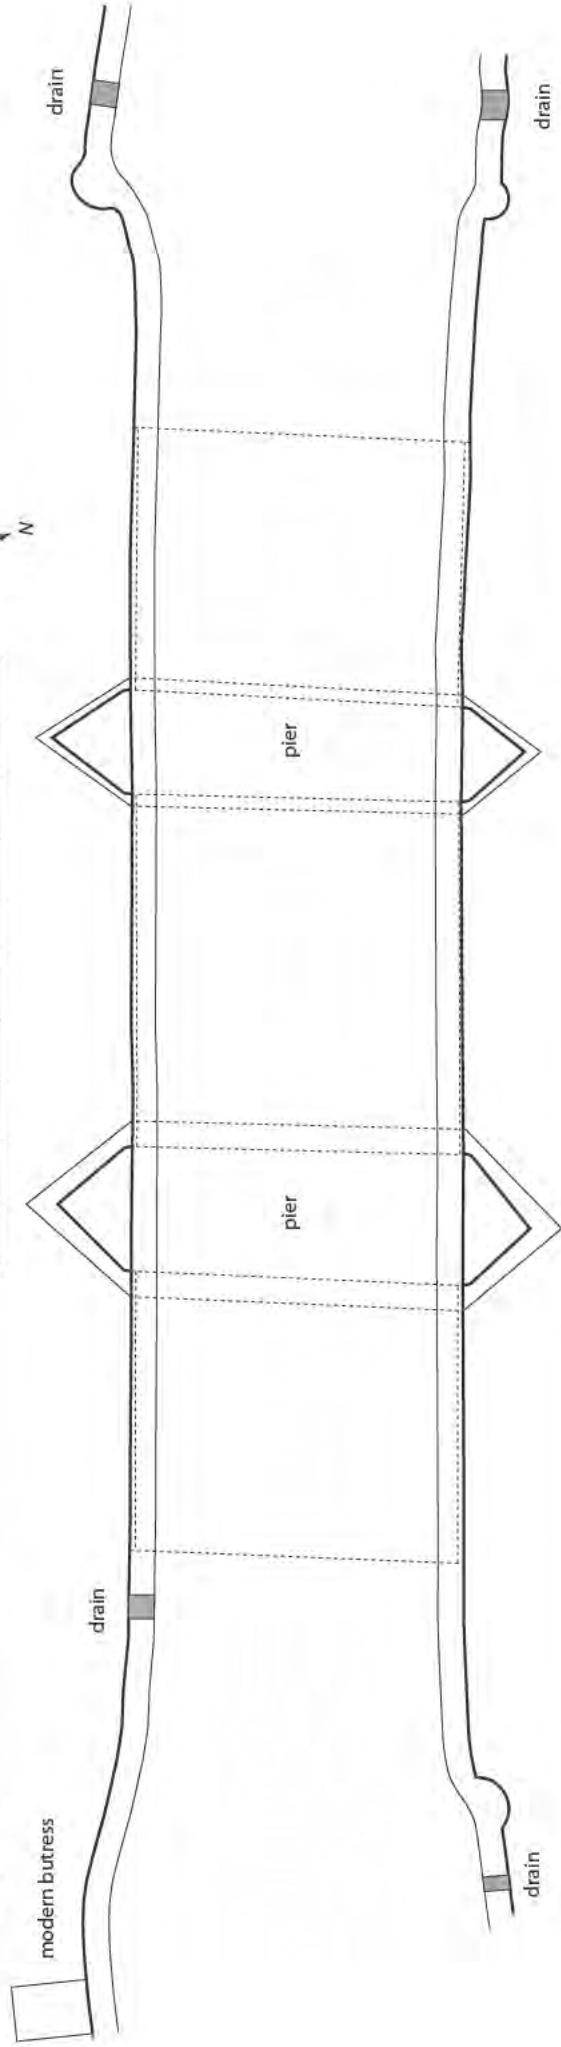
Pont Bodfel Plan and elevation

- vegetation obscuring masonry
- recent repair and repointing

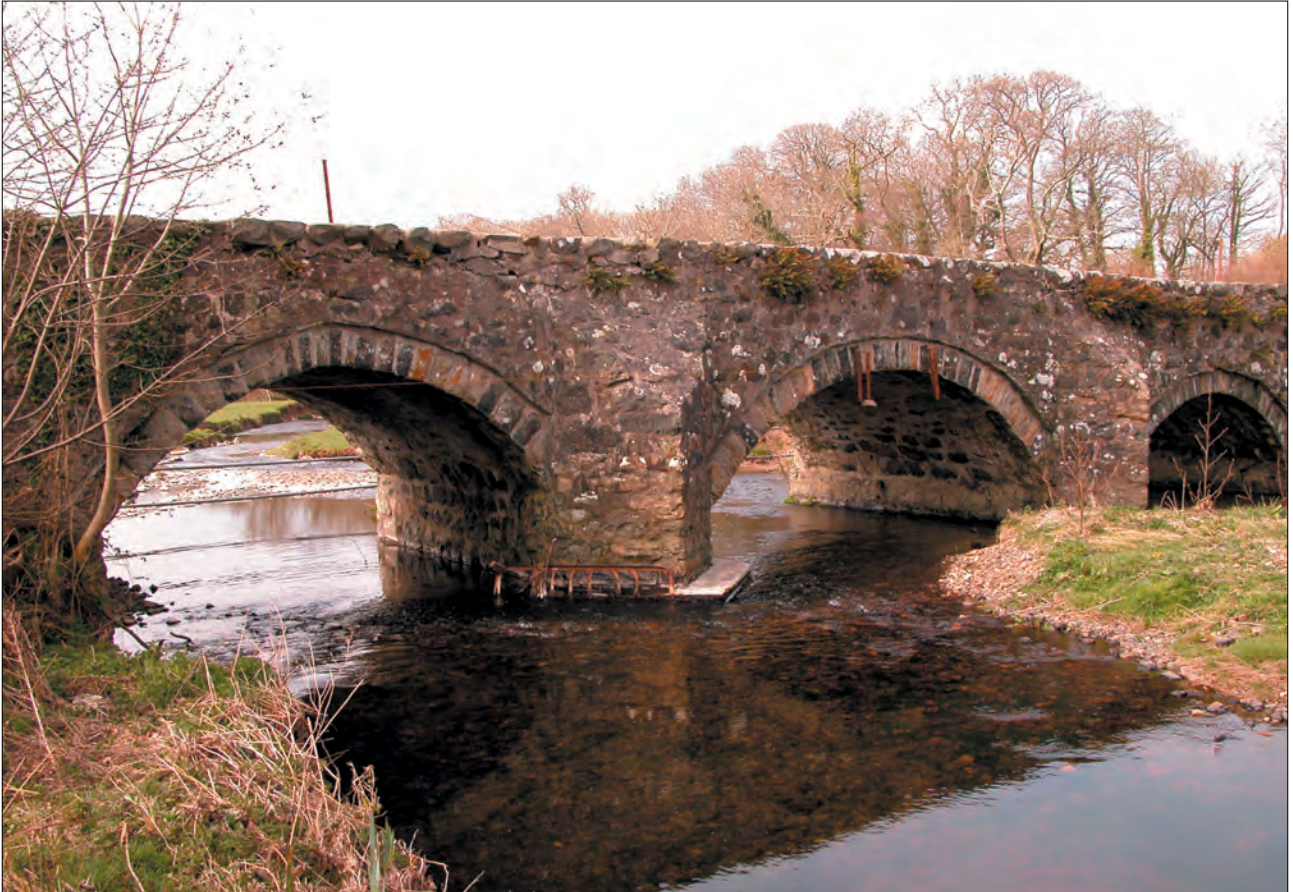
Fig. 7. Pont Bodfel, north side from east

The junction of the bridge and causeways, and the narrowing of the road at this point, was marked by a slight out-turn of the parapet walls, terminating in half-drum buttresses. This feature at the south-east corner is now lost. The upper parts of the two on the north side have seen repair.

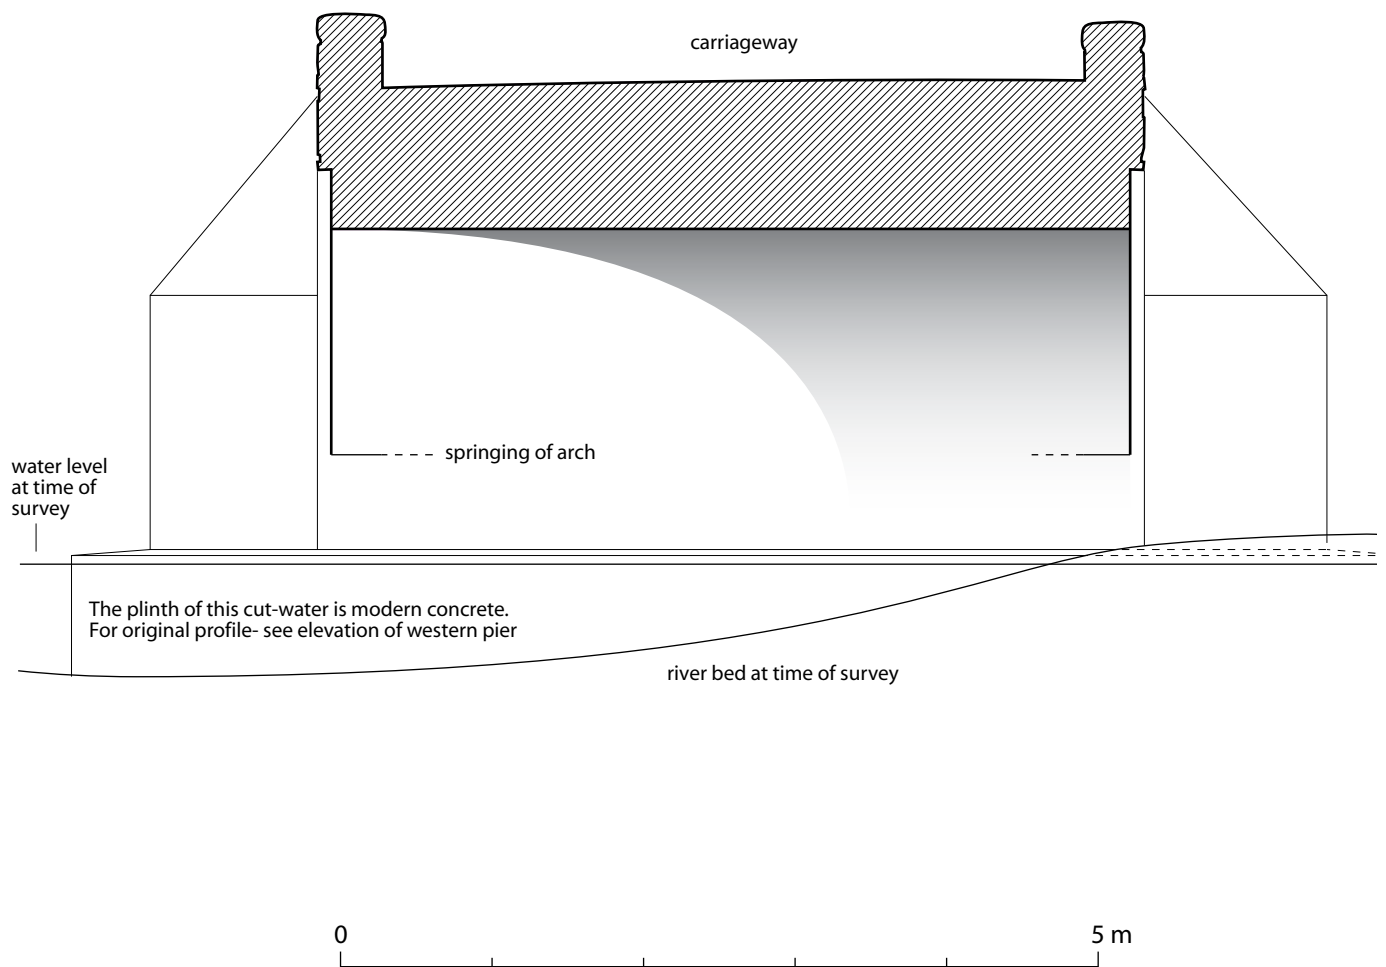
is 3.6m below the parapet and 3.08m below the level of the carriageway. At the time of the survey the river level was 3.12m below the carriageway.

Cross-section across Pont Bodfel at the central arch with adjacent eastern buttresses projected

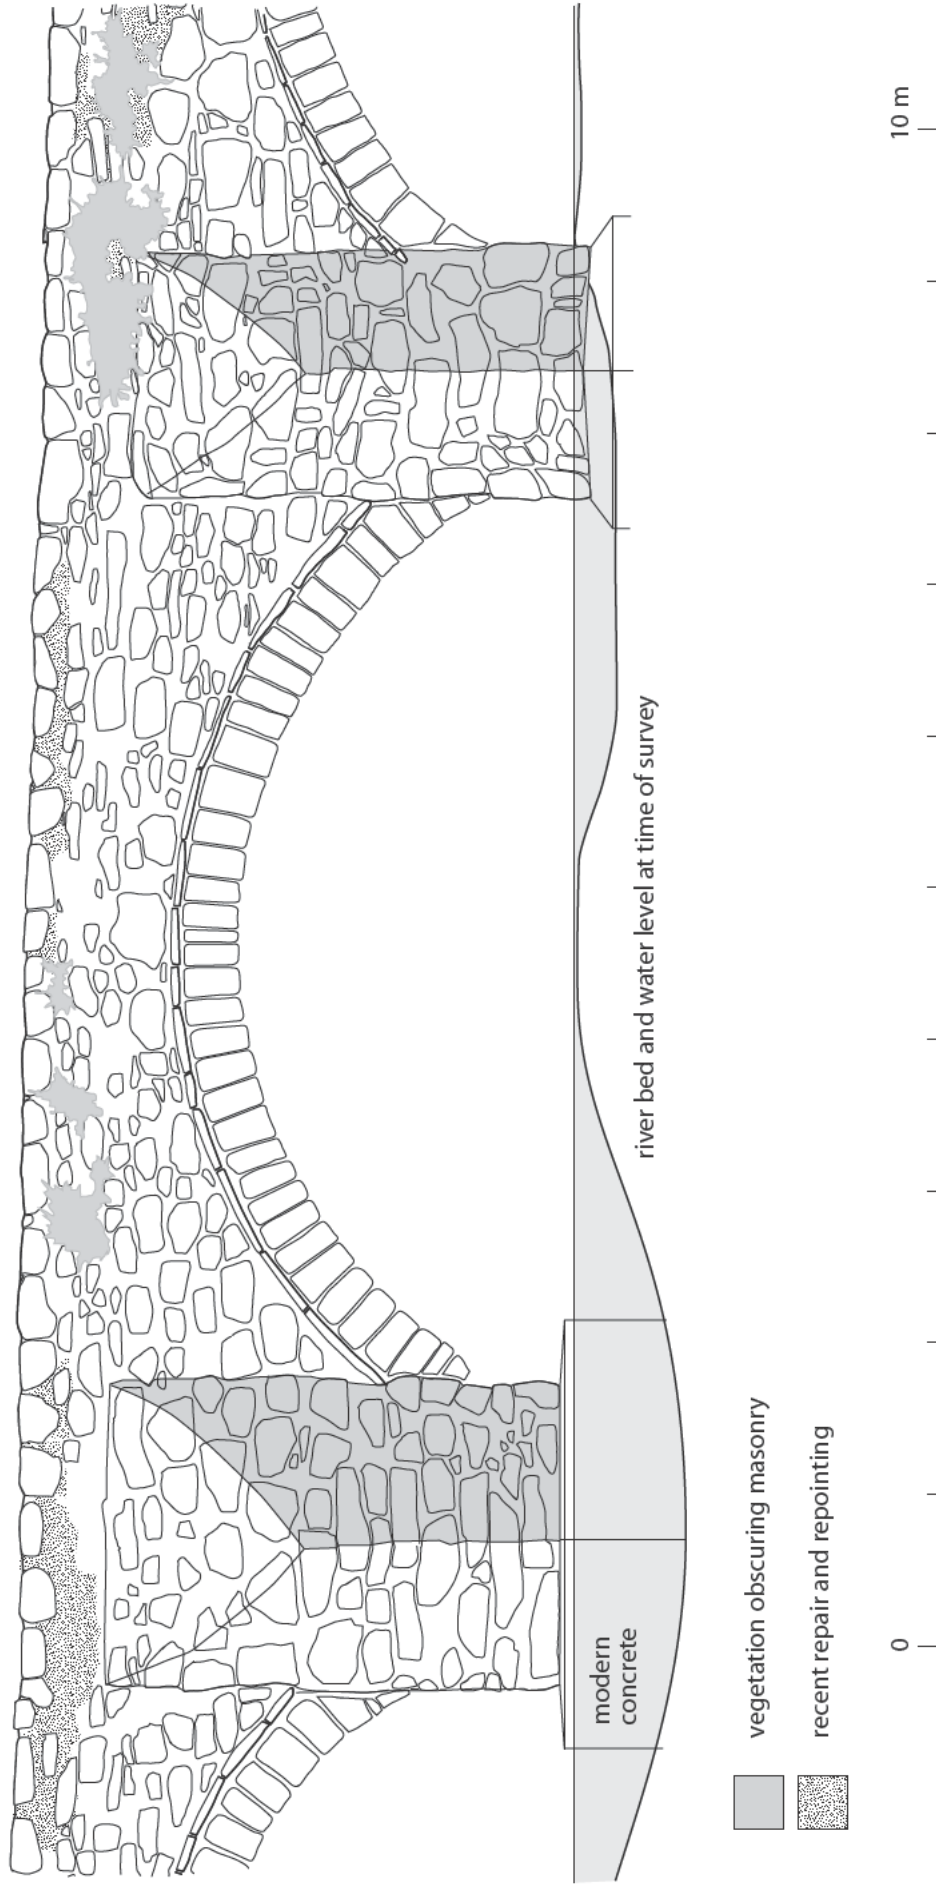
Detail of central arch (north face) and adjacent piers
