Afon Wen Waste Water Treatment Works

Chwillog

Archaeological Assessment

Report No. 551

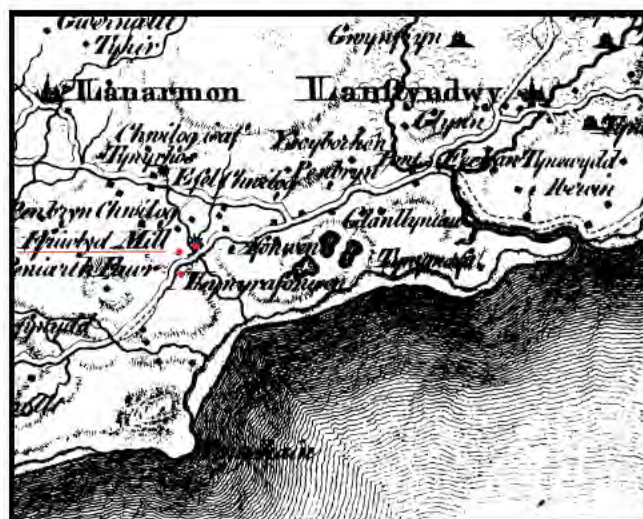
Figure 2: Part of John Evans' 1795 map of North Wales
(Tyddyn Berth, Tyddyn Mawr and Melin Ffridd-lwyd in red)

There have been relatively few changes to the area since the 18th century and some of the early buildings survive along with the general layout of the fields and roads. The present A497 is approximately along the line of a route which would have been important since at least the 12th century and was turnpiked in 1803 by the Portinllaen Turnpike Trust (Bassett and Davies 1977, 78, 164-166). John Evans' 1795 map of North Wales (figure 2)

shows the main road here along its present route, but does not show the lane up to Tyddyn Mawr, probably because it was too minor. The lane is shown on the tithe map in 1839 (figure 3). Minor improvements have taken place on the roads; between 1839 and 1889 the A497 seems to have been straightened, possibly when Afon Wen Terrace was built in the mid 19th century. In more recent times the southern end of the lane to Tyddyn Mawr has been altered so that it meets the main road at a right angle.

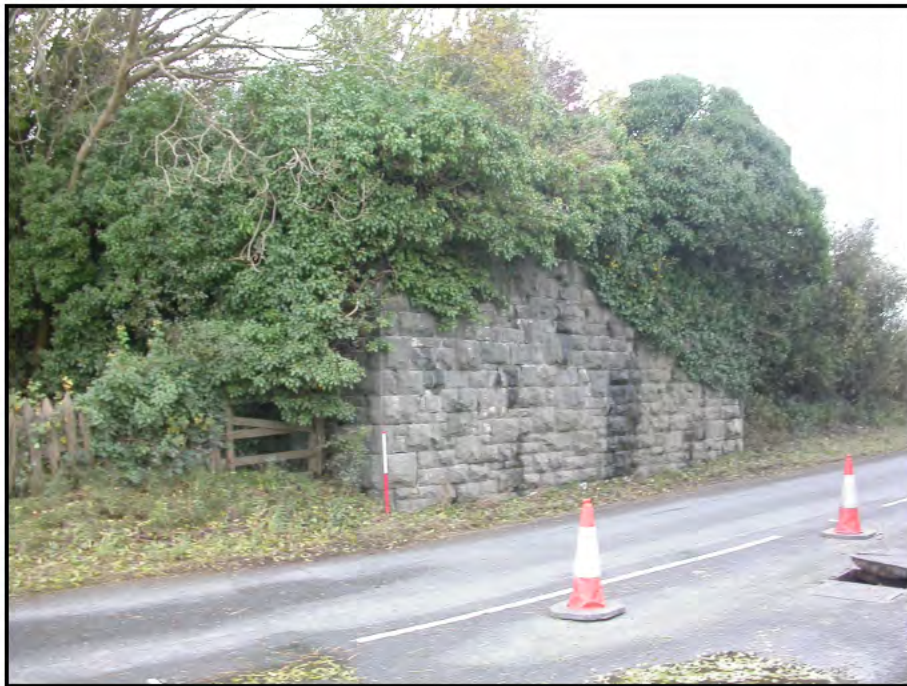
Plate 1: Remains of railway bridge over A497, from north-east

Embankment for Caernarvonshire Railway Line, opened 1867, track removed 1968 (plate 1).

Recommendations for further assessment: None
Recommendations for mitigatory measures: None.

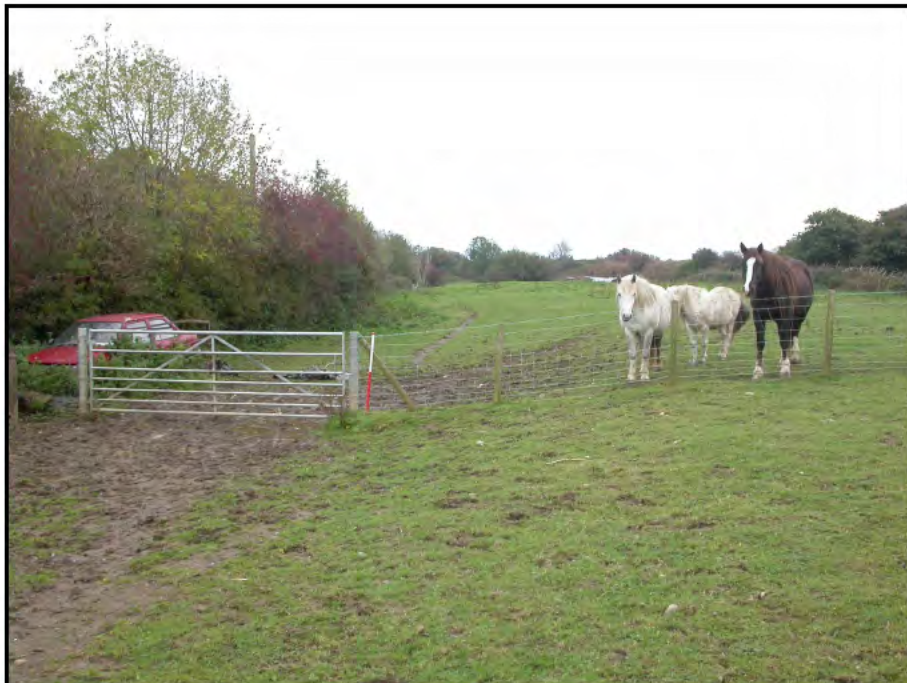
Plate 2: Feature 3 looking south, also showing general character of the study area

A broad scarp was seen curving down the eastern side of the study area until it turned sharply west at its southern end forming a well defined scarp c.1m high (feature 3, plate 2). This seems to represent the boundary between fields 983 and 980 on the tithe map, with the southern scarp being the south-eastern boundary of field 981 (figure 3). If the tithe map can be taken as accurate there was a sharp bend in the river at this point, which was straightened out when the railway embankment was built. A ditch marked the original route of the river and this is shown on the OS maps and is still visible today (feature 6). To the south of this was a small area of uneven ground (feature 4), which had probably never been ploughed. It was initially assumed that the unevenness may be outlying earthworks related to those on the other side of the railway (PRN 5733). However, if the course of the river had been straightened the unevenness almost certainly related to that process.

A fairly well defined, rather sinuous scarp running roughly north-south down the eastern side of the study area (plate 2). This probably represents a field boundary and build-up of soil from ploughing dating from at least the 18th century and possibly earlier.

Recommendations for mitigatory measures: Watching brief during development works with possibility for hand digging and sampling if this proves to be worthwhile.
