NEFYN WASTE WATER TREATMENT SCHEME

ARCHAEOLOGICAL MITIGATION: WATCHING BRIEF REPORT

Gwynedd Archaeological Trust
Project No. G1760

Report No. 556

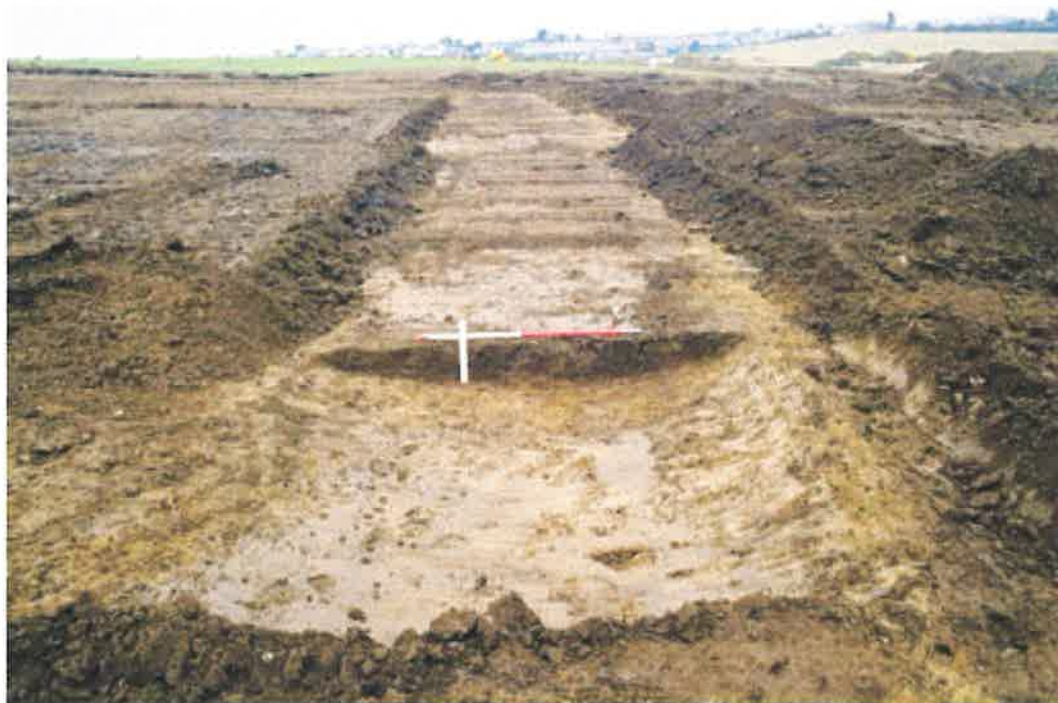
The ditch is best interpreted as a field drainage ditch of a field predating the existing field layout, which has been shown to have been the same since at least 1839. It seems to mark out an area of better quality land higher up the slope from the stream to the south-east and which therefore would have been more suitable for arable crops. With this identification in mind other slight linear ridges seen in the field to the north-east, oriented up and down slope can also be seen as remnants of this earlier phase of agriculture.

Fig. 6 The waste water treatment works area: Cross section of Ditch 6. From west. Horizontal scale with 0.5m divisions.

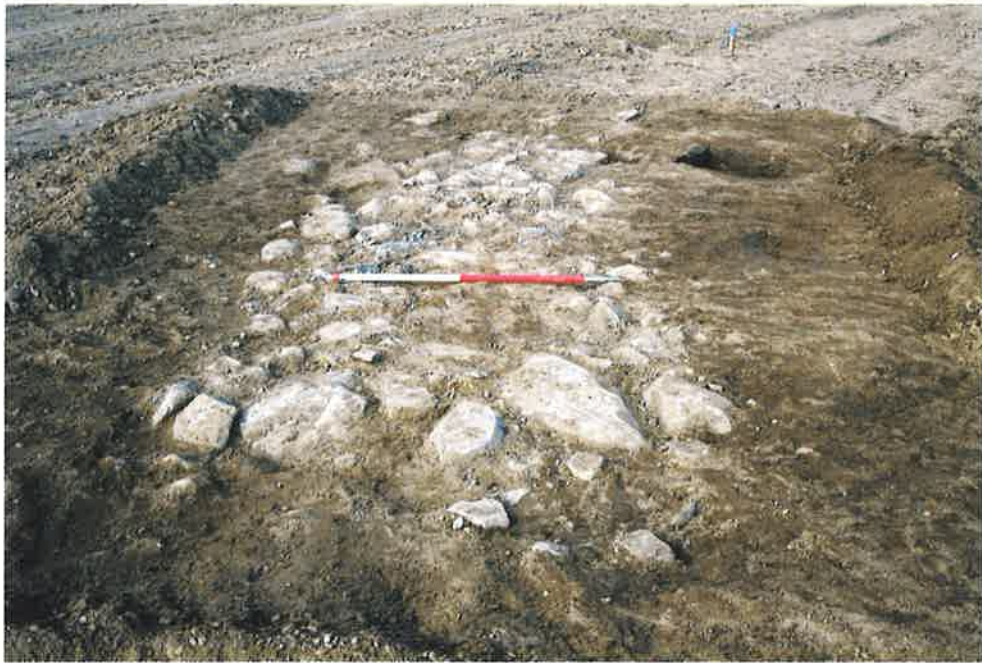
Fig. 8 The waste water treatment works area: Floor 1, from the south-east. Scale with 50cm divisions

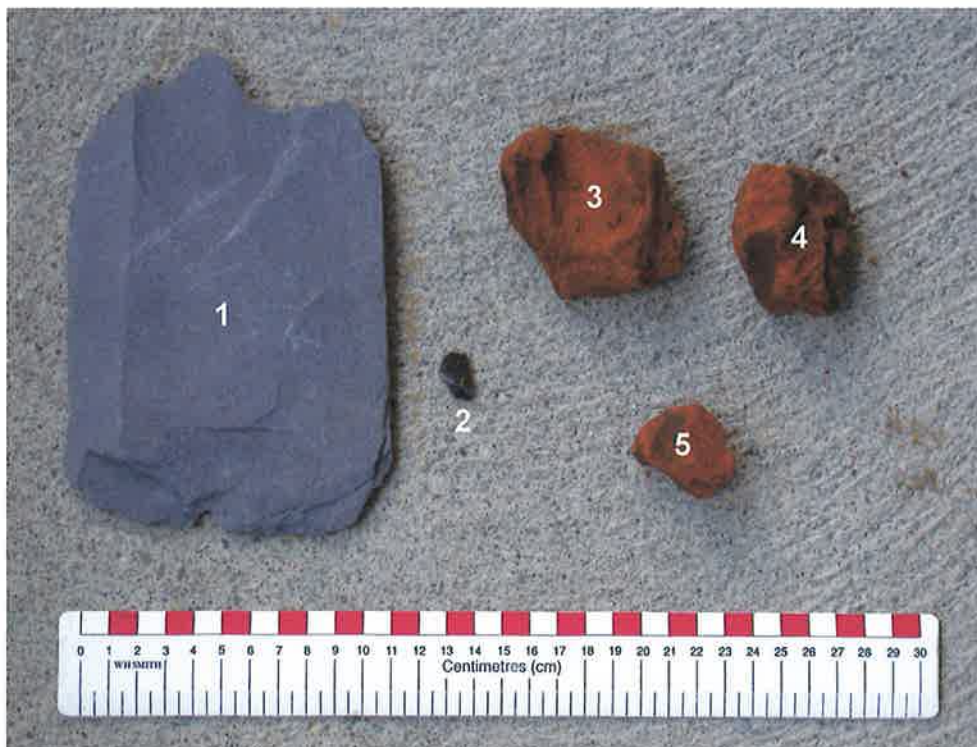
fabric and a dark brown glaze, internally and externally. This type of pottery, probably made at Buckley in Cheshire, can be dated to the 17th or 18th century (Edwards in Smith 2002).

Fig. 9 The waste water treatment works area: Finds from Ditch 6 and Floor 1.
Ditch 6: 1 Roofing slate fragment. 2 Brown-glazed pottery fragment
Floor 1: 3 - 5 Fired clay oven? fragments

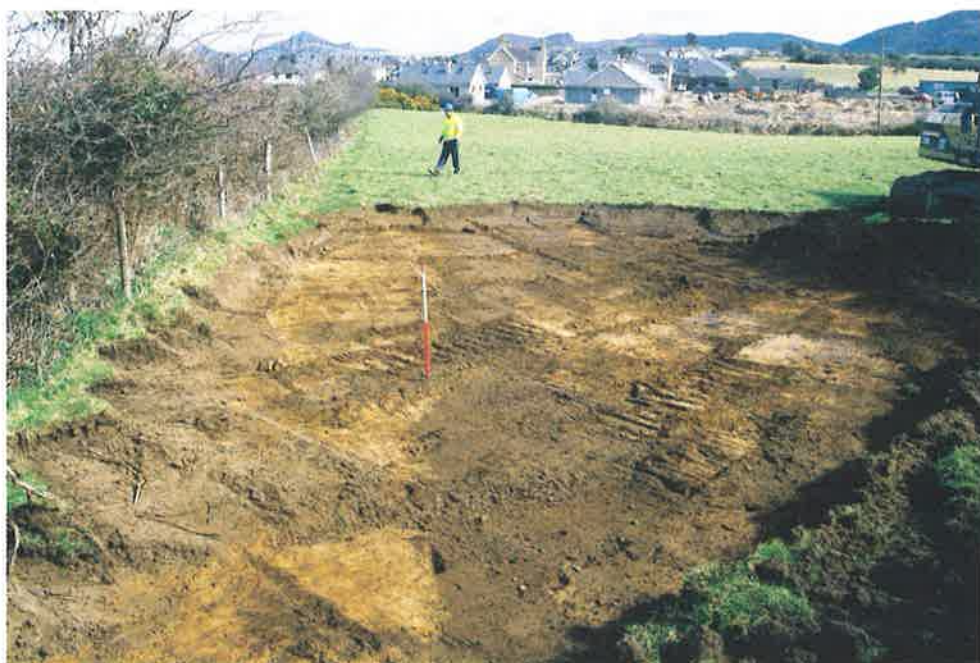
Stripping of the topsoil close to the modern road, to provide the entrance to the new access road revealed a number of linear features (Fig. 9). Parallel to the existing boundary was clear linear feature 0.70m wide, which proved to be only some 0.05-0.10m deep and was interpreted as a plough feature, possibly alongside a former trackway about 2.5m wide along the field-edge or possibly just a plough headland (Fig. 10). There was no direct dating evidence and the feature could belong with the modern phase of agriculture or with the earlier phase represented by Floor 1 and Ditch 6 (above).

Fig. 11 The western access road: Linear ploughing feature 9, from the south-west. Scale with 50cm divisions

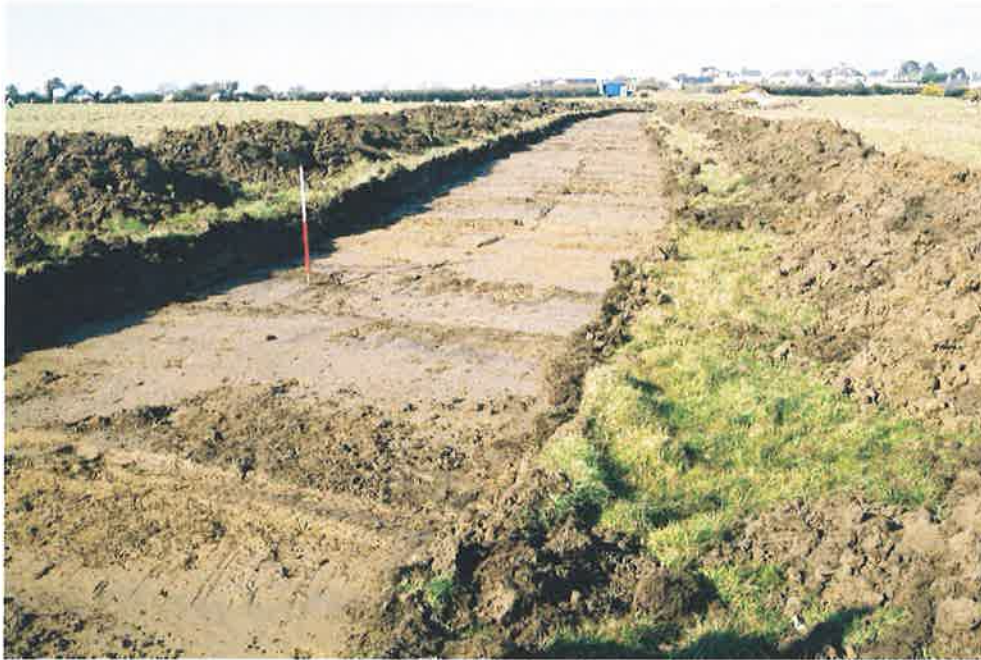
Further to the south, downslope, the access track crossed more marshy ground with a clay subsoil and here it crossed two narrow stone-filled field drains (Fig. 11). Stone-filled drains in most places probably pre-date clay pipe drains and so could well belong with the 17th - 18th century agricultural phase identified above.

Fig. 12 The western access road: General view from the north-east in the clay sub-soil area showing the stone-lined drains. Scale with 50cm divisions.

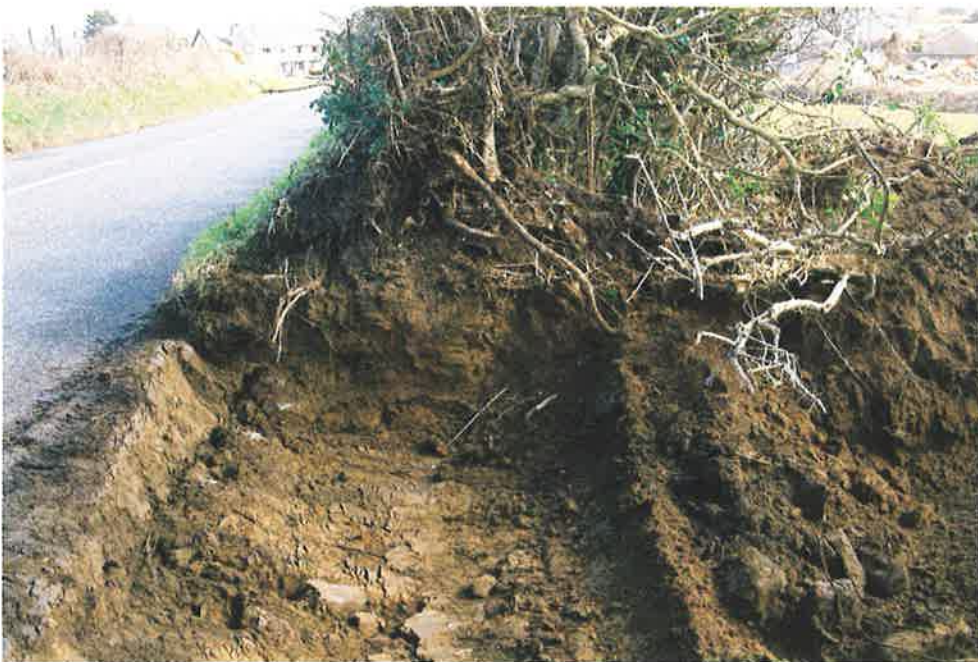
The existing roadside hedge-bank (clawdd) was cut through by machine and this was observed because although rebuilt in modern times might have retained traces of an earlier bank within it. The bank was of sandy loam faced on the road-side with sub-rounded cobbles. The modern road surface was some 0.5m higher than the subsoil surface on the field side of the bank. The road level had been built up by over the years by re-surfacing and this was demonstrated by the fact that the bank facing stones continued some way beneath the level of the road. Lower down, at the edge of the road, was a layer of larger sub-angular stones, c. 0.30m maximum dimension, possibly the foundation for the existing road, or of an earlier phase of it (Fig. 12).

Fig. 13 The western access road: The roadside hedge bank showing the stone facing and the stone foundations of the bank or possibly of an earlier road, on the base of the trench. From the west.

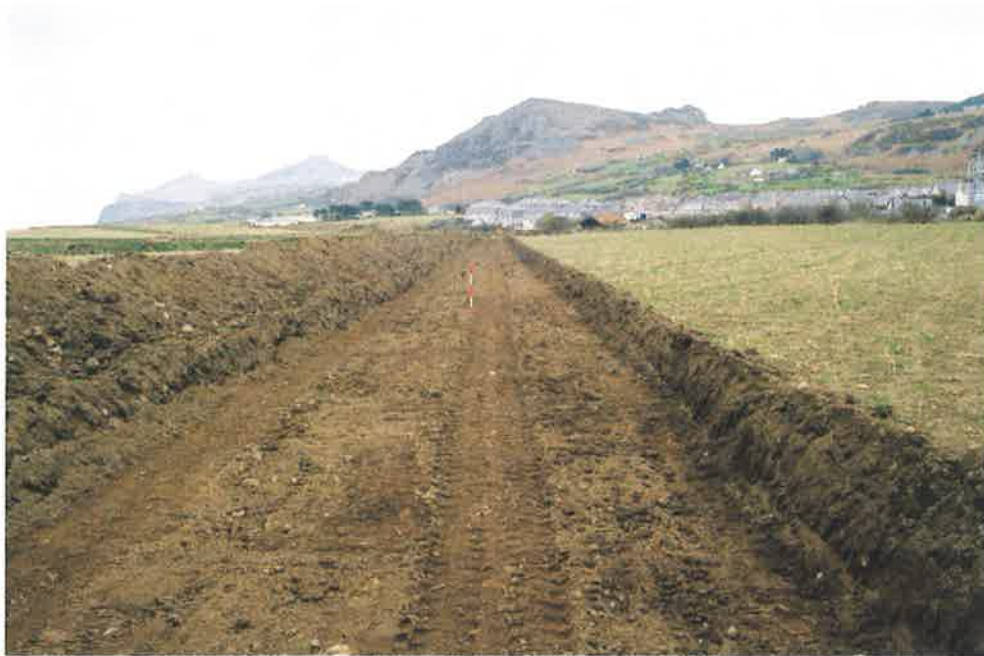
This road was required to provide access to a small pumping station at the east end of the pipeline. Its route took it across fields that were identified as the remains of medieval strip fields (Features 11 and 13) and through field banks (Features 12 and 15) that might retain traces of medieval boundaries. The topsoil here was extremely fine and deep sandy loam. Stripping of the trackway did not expose the subsoil and revealed no features belonging to the medieval strip fields (Fig. 13). The trial excavations carried out in 2003 indicated that this area, used for arable at the present day, had been deep ploughed removing any traces of medieval agricultural features.

Fig. 14 The eastern access road: The easement cutting across the area of the former medieval strip field, Feature 11, showing the deep topsoil and absence of exposed subsoil. From the south-west. Scale with 50cm divisions.

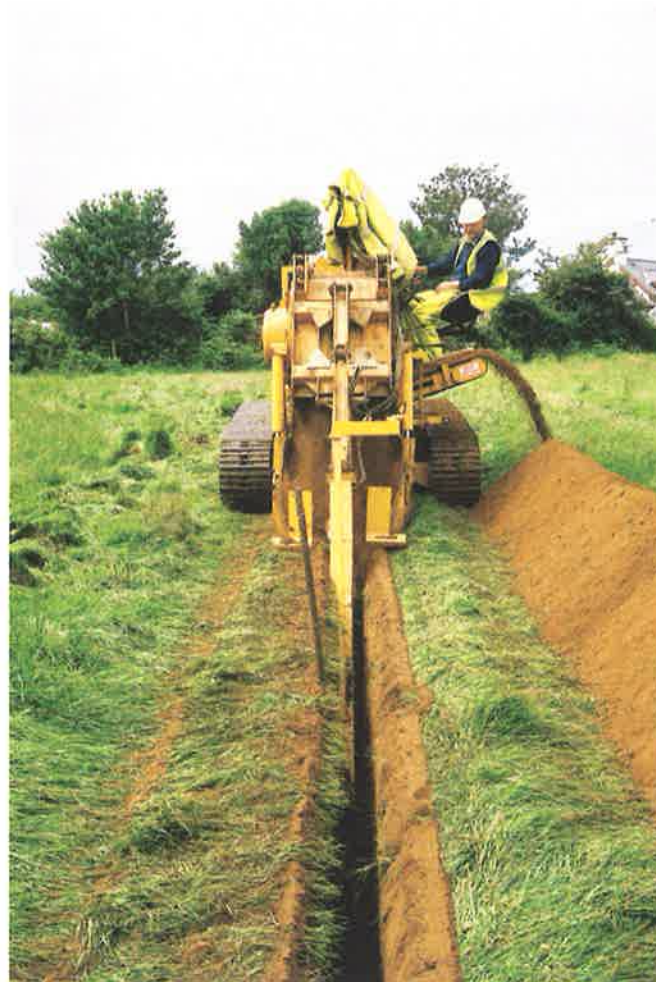
There were a number of features along the pipeline route for which an intensive watching brief had been recommended. In addition a partial watching brief, that is occasional visits, was recommended for the whole route. The pipe was laid using a pipe-laying machine. This cut a narrow vertical trench approximately 0.20m wide and 1.0m deep. The pipe was then fed in behind the machine in short lengths of about 10m and immediately backfilled. This meant that very little of the soil or subsoil was exposed or disturbed and there was very little possibility of identifying features or even soil changes in such a narrow trench. The machine cut the trench with an arm with cutter blades, similar to a large chainsaw. This mixed the soil as it worked, throwing the soil to the surface and therefore reducing the likelihood of observing changes in soil type or of the context of any artefacts (Fig. 14).

Fig. 15 The pipeline excavation: Mr Griffith's trench cutting machine at work, showing the narrow trench and mechanical soil mixing

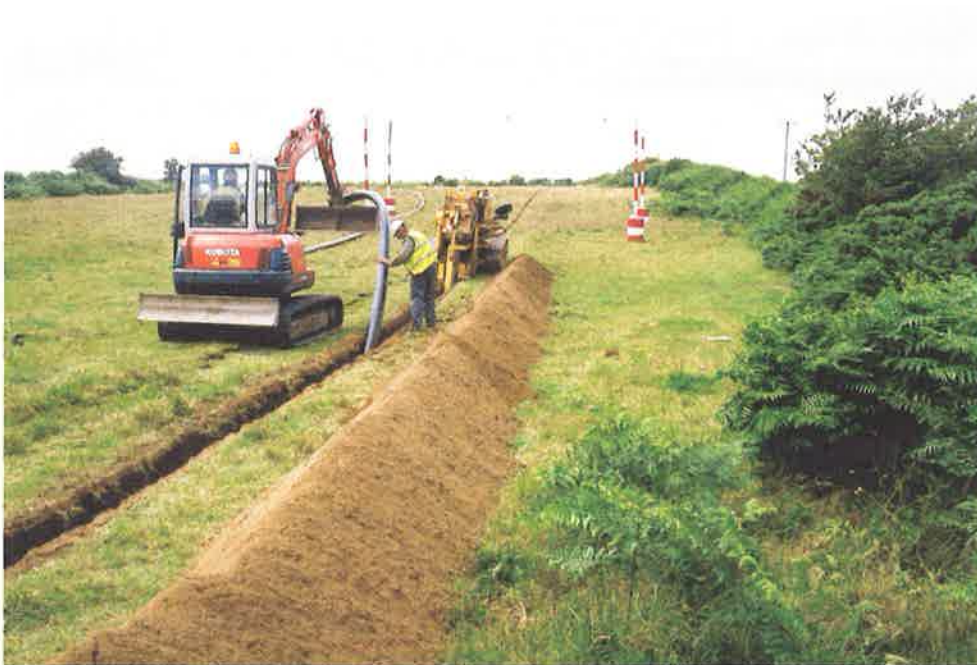
The area of relict medieval fields had a very deep sandy soil similar to the fields to the north of Nefyn. Like those fields this area had probably also been ploughed deeply in modern times for arable crops. The pipeline here followed mainly longitudinally along the same line that would have been taken by the medieval strip fields. There was therefore less likelihood of identifying relics of individual strip fields or headlands. The trial excavation within one area of strip fields indicated that any remnants of the medieval fields survived only as changes within the topsoil horizon and similarly here, no subsoil features were present (Fig. 16).

Fig. 17 The pipeline excavation: Trenching through the area of the former medieval strip fields, Feature 20. From the east.
