A497 Improvement Abererch to Llanystumdwy

Assessment of Potential for Post-excavation Analysis

GAT Project No. 1692

Report No. 573

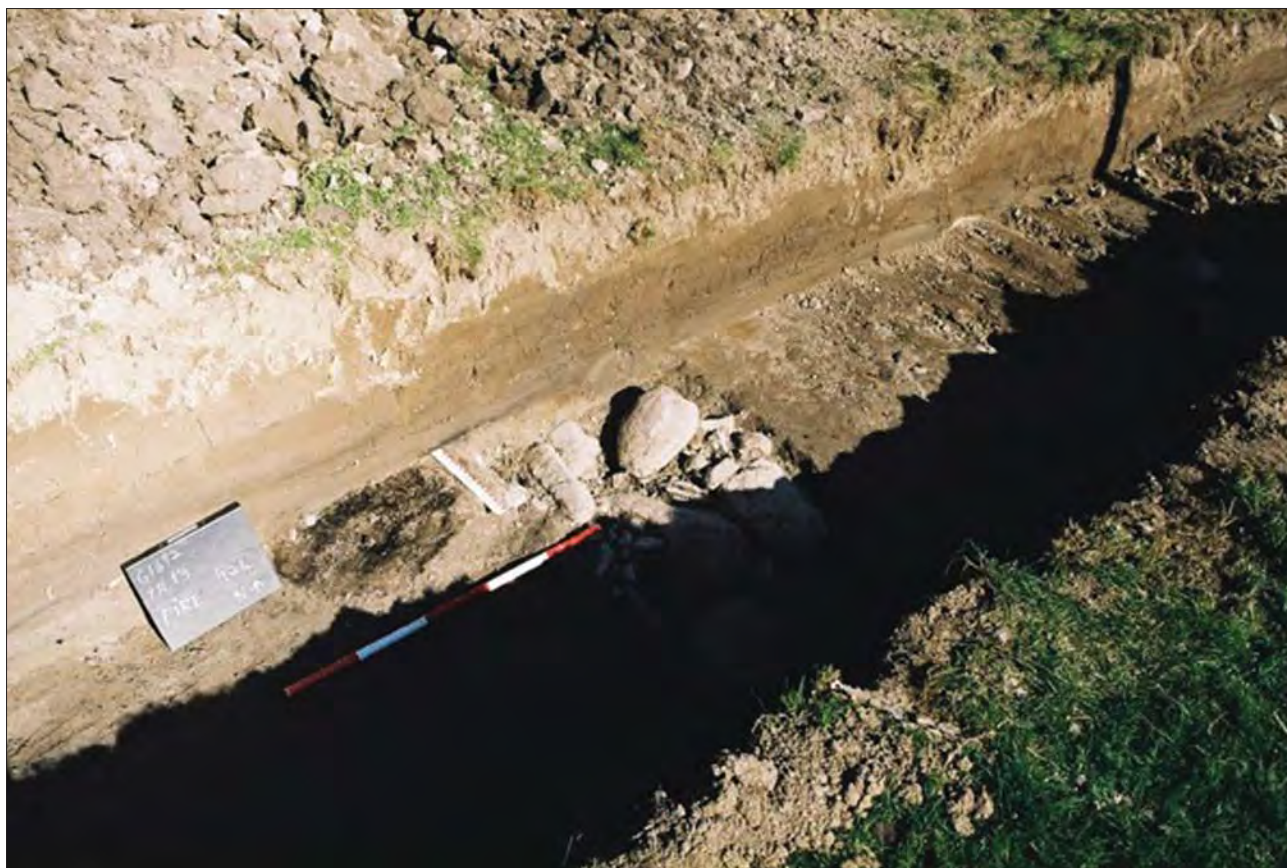
Plate 1. Trench 13, Context (124). Facing north. G1692/05/11

Trench 13 were located east of Trench 12 (Figure 2). The topsoil lay over clean, mid-grey natural silt, which, at a depth of 0.78m, was removed to expose a stone-rich horizon. In this surface, three areas of burning were noted: a small area of charcoal (context 124) and two areas of burnt, fractured stone (contexts 134 and 136, respectively). Samples were taken from context 124 for palaeoenvironmental processing and radiocarbon dating (samples 1 and 2). A flint flake was recovered from the spoil heap.

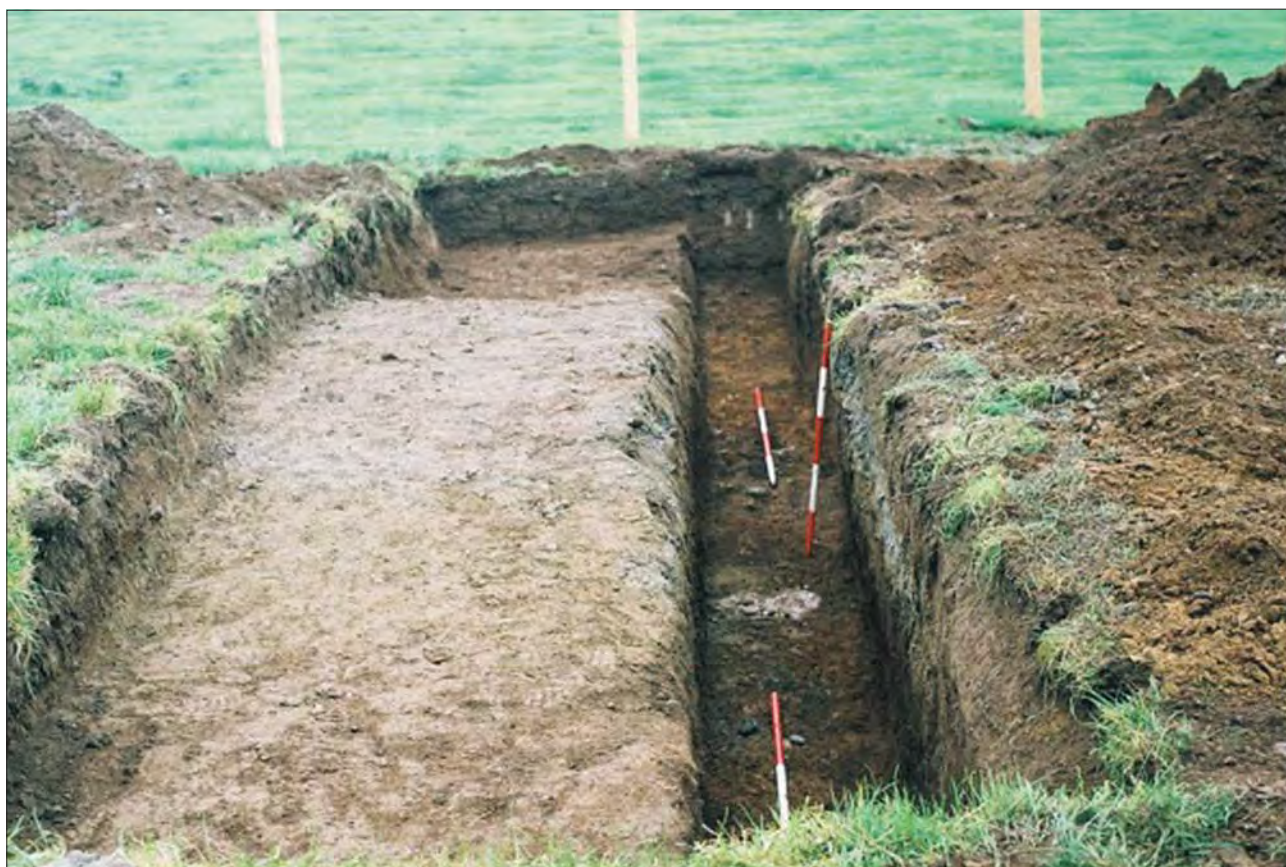
Plate 2. Trench 35. Toll road. Facing south. G1692/15/22

Trench 35 was located on the eastern side of the trackway leading to Glan Morfa Farm and was inserted to accommodate a positive/negative linear anomaly. This signal was revealed as a distinct cambered roadway, 4.2m wide, built from a succession of sand and gravel layers compacted into a concreted mass, 0.45m deep (context 173) [Figure 12]. The road was cut into a thick deposit of subsoil (context 171). Below this subsoil was a natural layer of Morrainic Drift Geology (context 172), which contained discreet patches of burning. Environmental samples were taken for macrobotanical and dating purposes.

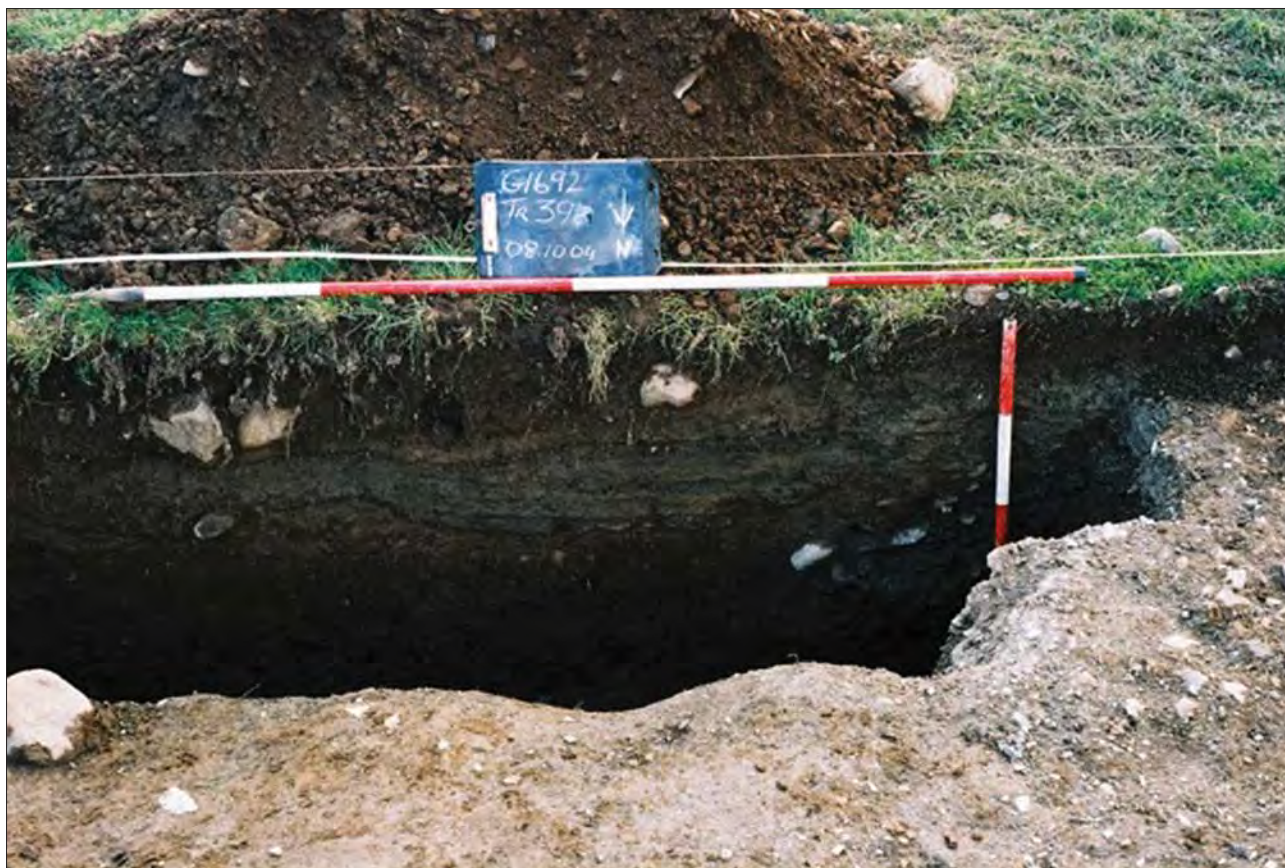
Plate 3. Trench 39. Section through toll road. Facing south. G1692/19/22

This trench contained extensive evidence for the 18th Century toll road including evidence for structural repair.

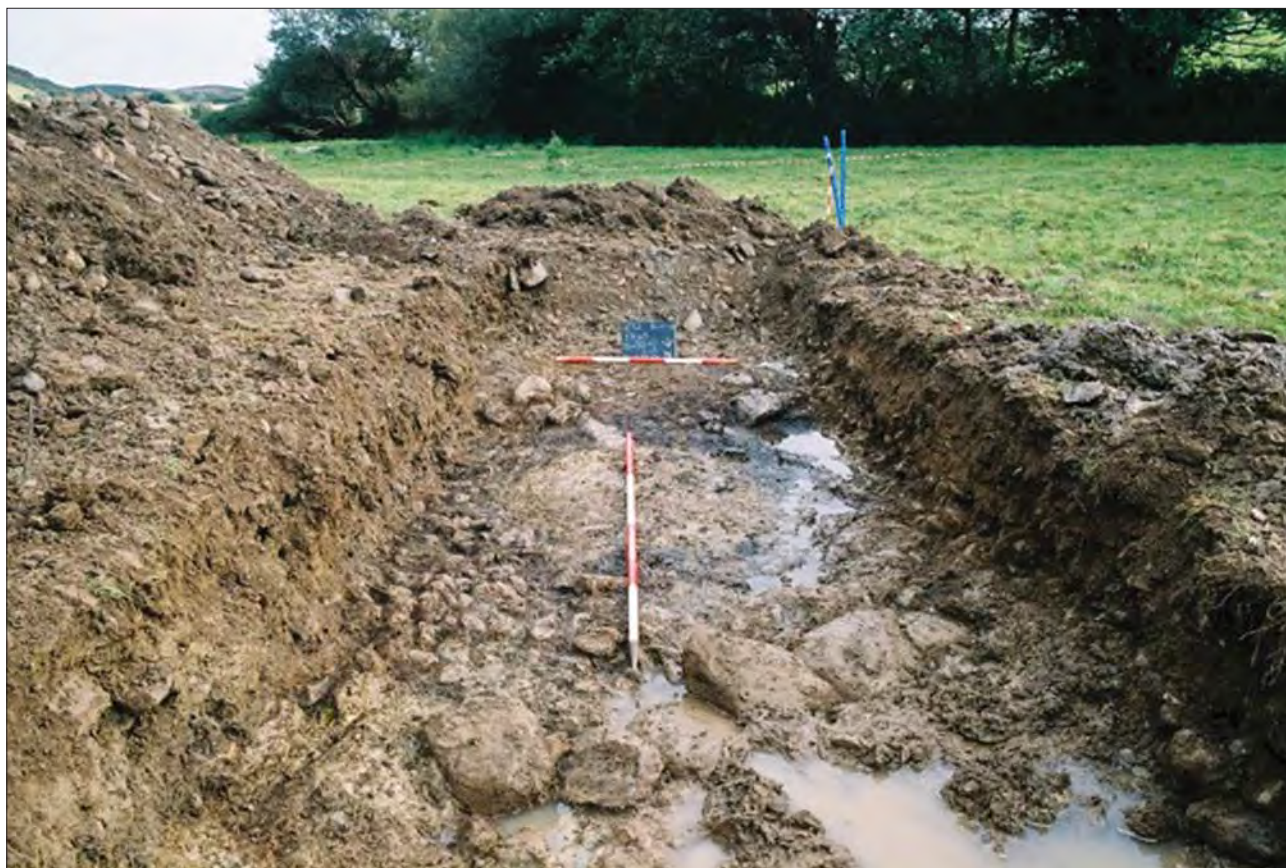
Plate 4. Trench 40. Facing south. G1692/23/13

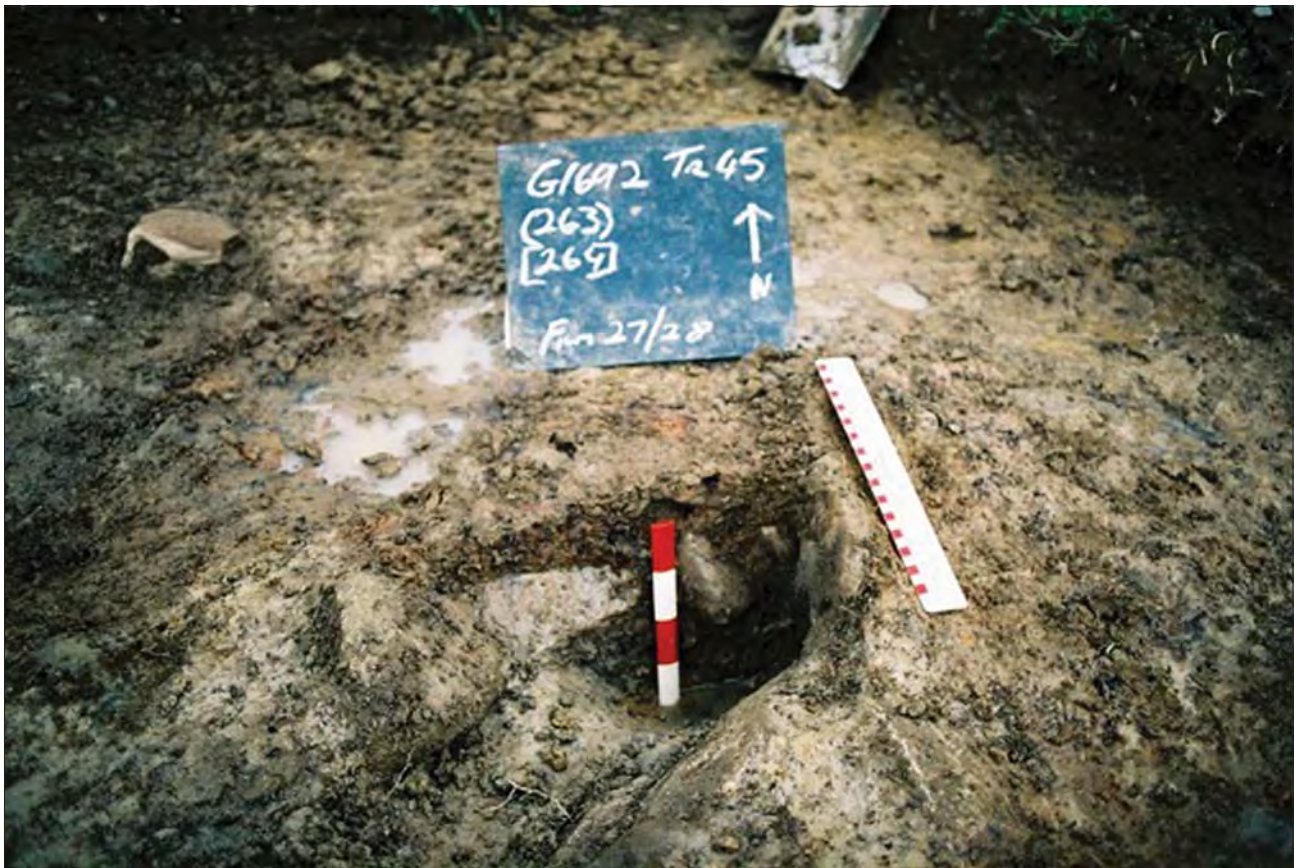
Plate 5. Trench 45. Contexts (263) and (264). Facing north. G1692/27/29

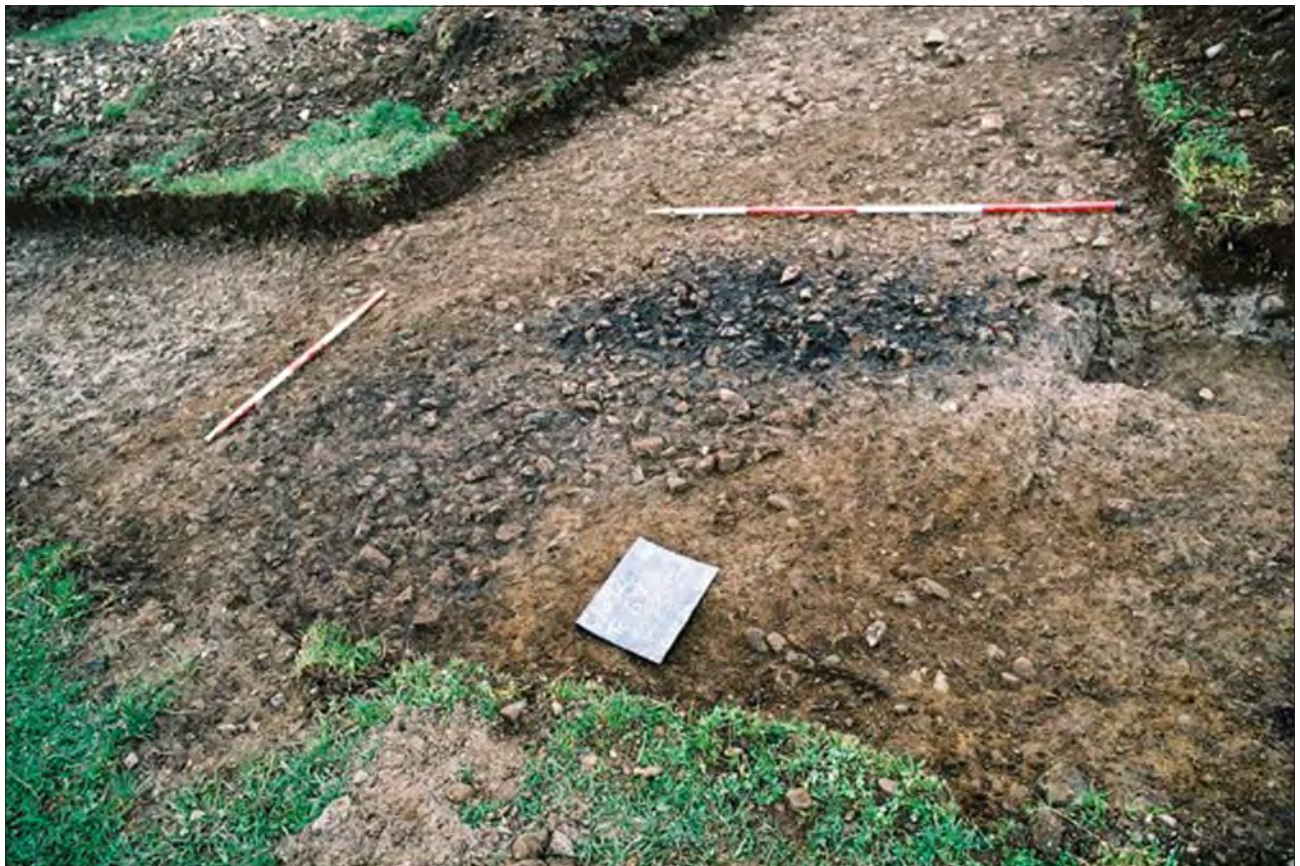
Plate 6. Trench 67. General view of burnt stone. G1692/29/32

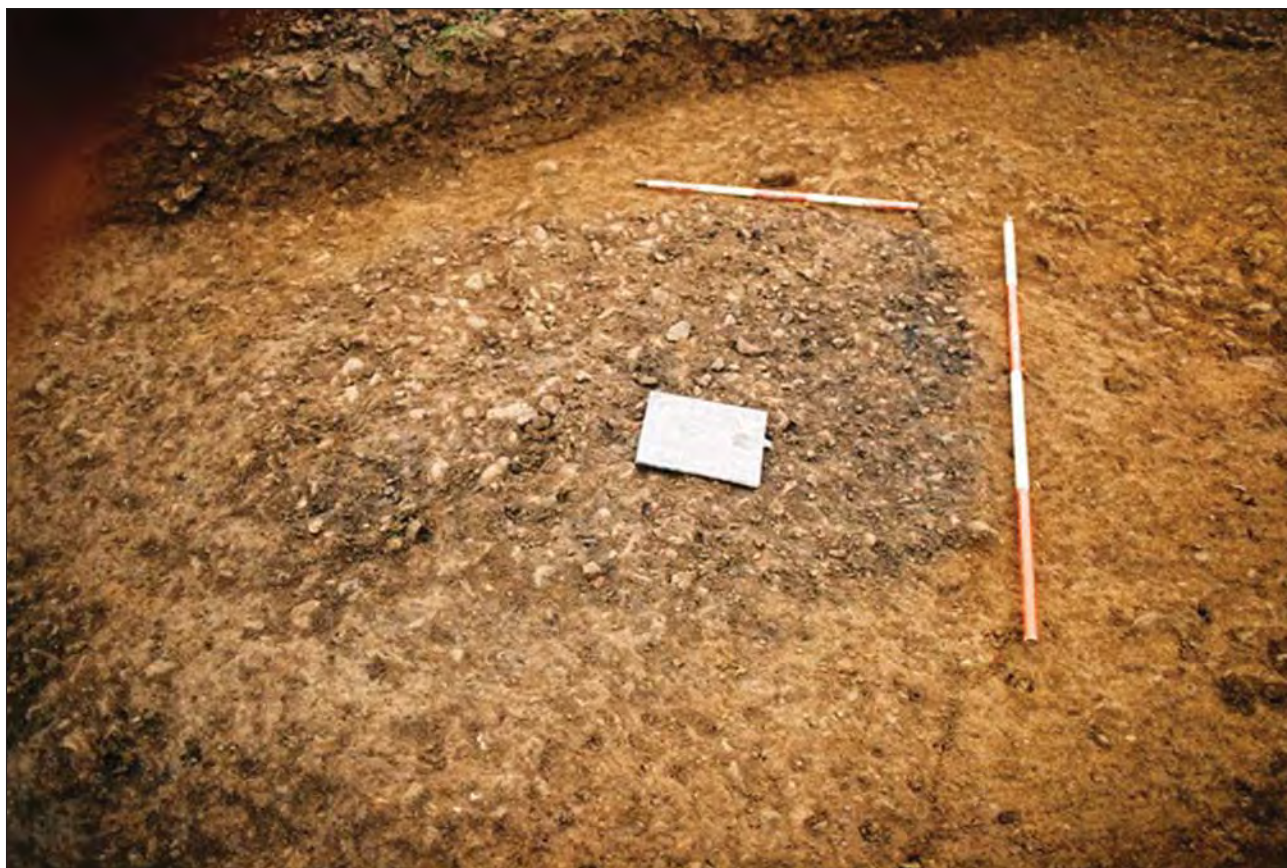
Plate 7. Trench 80. General view of context (341) and (342). Facing east. G1692/27/29

This trench was located towards the eastern end of the road scheme in a field belonging to Glanllynau Farm. Trench 80 was opened in response to an apparent pit alignment identified on the geophysics survey. The majority of the alignment was outside the road scheme. The trench was located at the base of an east-west slope, with the ground rising more gently to the west. The field was presently used for arable farming and had good drainage. A large pit was identified in the trench, c.2m across (context 342). It was filled with a brown/black silt rich in sub-rounded heat fractured stones (context 341). There were no signs of extraneous burning around the pit, suggesting the pit may have been dug to as a refuse for the stones. The pit was cut into a stone-rich layer of grey silt (context 355). On the eastern side of the pit the grey silt was charcoal-flecked, but not on the western side; suggesting the eastern side was the main focus for associated activity. The trench was subsequently extended eastwards, c.6m and the grey layer was investigated further. The grey layer sealed a layer of concentrated sub-rounded stones (context 389), also cut by the pit. The stones were most likely an artefact of ploughing, but ploughing that predated the pit. A poorly defined gully ran along the northern end of the trench, cutting context (389) of the gully also contained a fill of heat fractured stone. A more detailed investigation of the pit proved there was also a stake-hole cut into the side of the pit. The stake-hole may have been used concurrently with the pit and the gully.

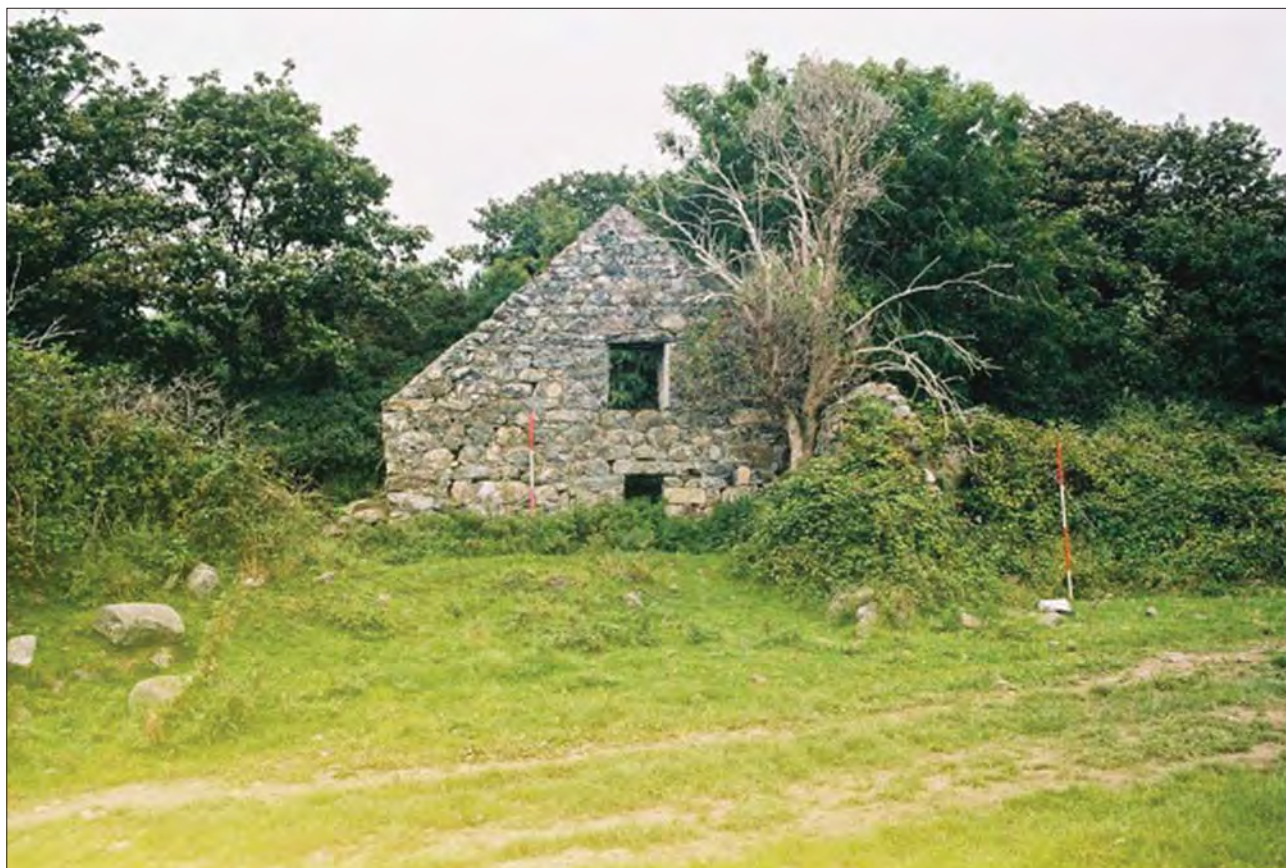
Plate 8. Feature 15. South facing elevation. G1692/03/13
