GAT Project No. 1798
Report No 583
2003 rev. May 2005

The Walled Garden,
Henllys Hall,
Llanfaes,
Ynys Mon

Prepared for John Moore and Partners

A watching brief in the area of the Walled Garden, Henllys Hall, Llanfaes.

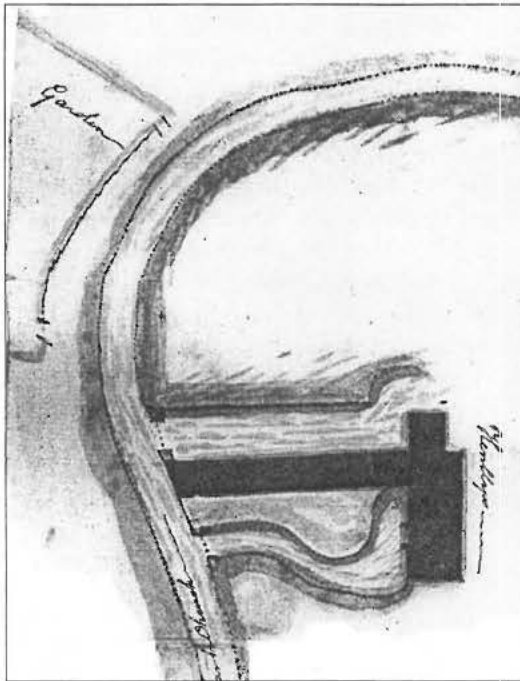
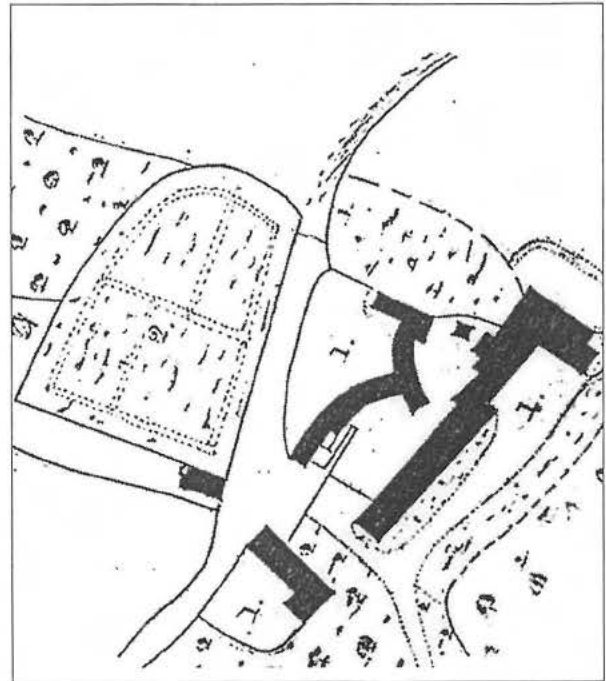
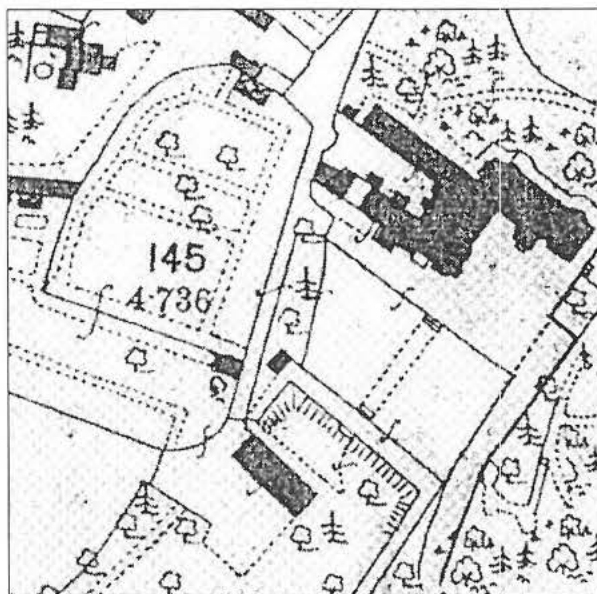
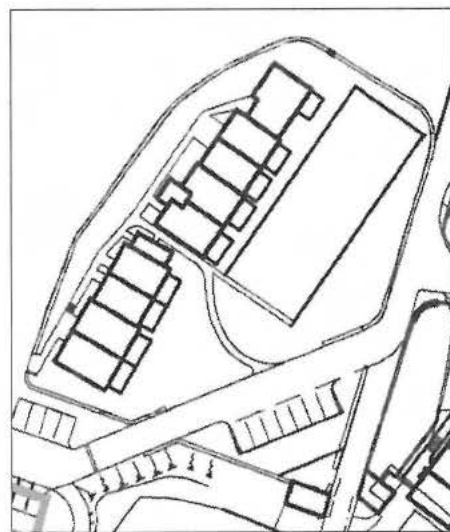
Fig 2. The walled garden from 1786 to 2004

1786

1830

1889

2004

The garden is first recorded on a survey undertaken in 1786 in preparation for the construction of a new road from Henllys Lane to St. Catherine's church. Henllys Hall is shown, as is the 'Old Road' which, at that time passed through Henllys, between the hall and the walled garden, en-route to the church via a northerly route. Little detail of the garden is visible, although two gates or entrances are shown at the north and south ends, respectively, of the wall flanking the road. Forty years later a more detailed survey of Henllys Demesne (UWB Henllys MS 1191) shows the garden clearly. It is subrectangular in plan with curving north and east walls. A path is shown running around the inside of the wall. The garden is bisected in an east-west direction by another path and two additional paths run north and south from this. A small building is shown abutting the outside of the eastern end of the southern wall. The area is

next portrayed in detail on the 1889 first edition 1:2500 OS map. A new building is shown on the outside of the north-eastern apex of the wall along with what appears to be a glasshouse in a corresponding position on the inside of the wall but offset slightly to the east. The paths have been modified and now run to three entrances; one in the southern corner, one in the western corner and one in the north east wall, to the west of the glasshouse and running into the building on the outside of the wall. Two east-west paths are shown along with deciduous trees. The layout is unchanged on the 1900 1:2500 map although the trees are not shown. The 1919 map shows no details of the interior apart from the glasshouse outline. Discussion with a local gardener suggests later use as a vegetable garden and the presence of peach houses on the north-western wall.

Before redevelopment, the garden had retained its subrectangular plan, with dimensions of 68m x 54m, as shown on the 1830 map. The wall is of lime mortared, local, undressed stone and stands to a height of around 3.5m. The top of the wall is built to an inverted V-shape in section. The building shown at the south of the garden on the 1830 map still stands. The building incorporates the garden wall and may be contemporary with it. A change in the masonry style beneath the eaves suggests that the roof line has been lifted. The building is currently of two stories with a door in the west wall along with a window and door facing into the garden. A small fireplace and chimney can be seen in the eastern gable. The two buildings at the north of the garden had been lost before redevelopment. An increase in the height of the wall presumably marked the position of the building to the outside and brick foundations marked the site of the glass house. The site of the peach houses was marked by mortar marks on the west wall and the remains of wire espaliers. All three entrances shown on the 1889 map were still visible. The two southern entrances had been widened in recent years by demolition of lengths of the wall but enough of the masonry surrounds have survived to

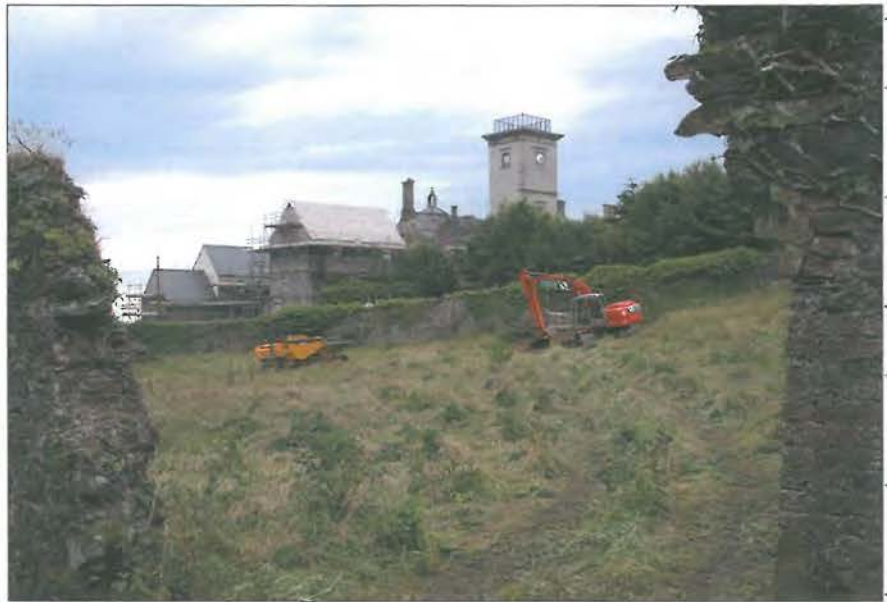
Fig 3. The walled garden at commencement of topsoil strip, July 2003

west corner and the new gap in the eastern side to a width of c.10m at its western end, narrowing to c.5.5m where it approached the original south-western entrance. A field drain was exposed at about 1.20m from the eastern wall and parallel with it. Orange clay and stones were exposed at either end of the access track close to the garden wall with more gravel close to the south-eastern gate. Good brown topsoil was exposed along the rest of its length. The track was surfaced with hardcore.

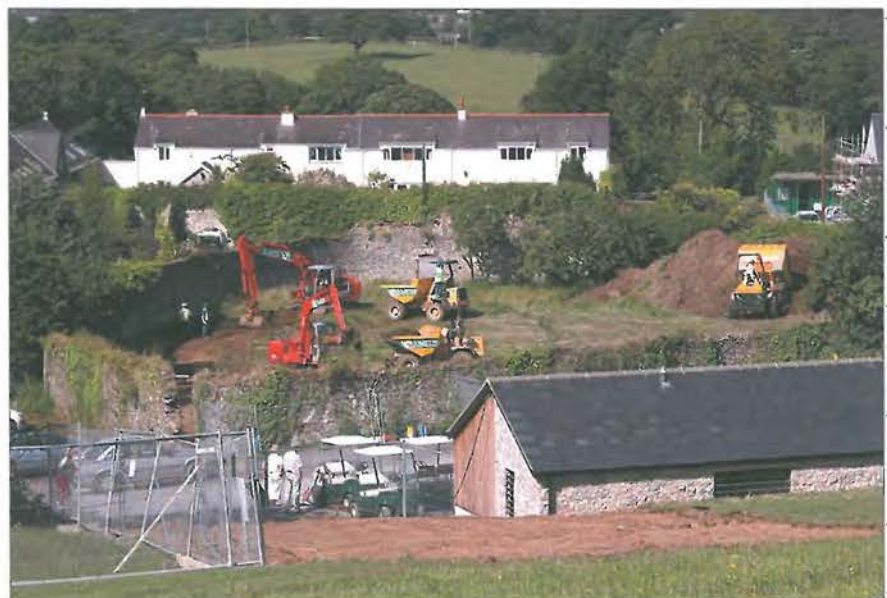
Fig 4. Earthmoving in progress, July 2003

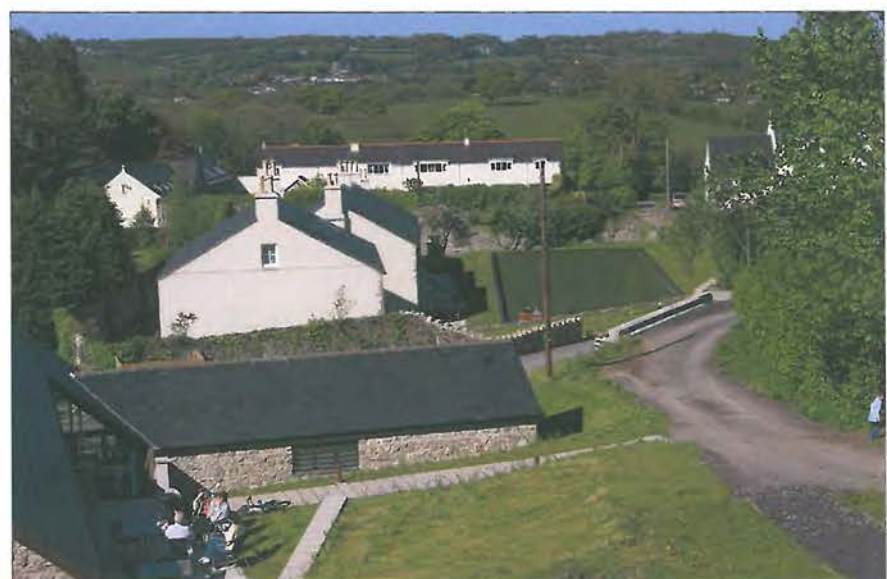
Fig 5. The completed development from the south, May 2005

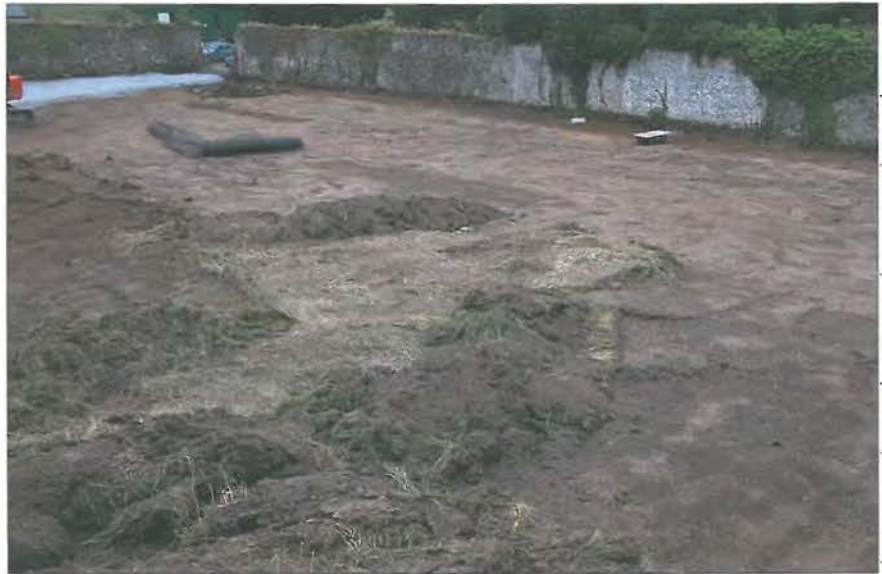
Fig 6. The walled garden, July 2003, archaeological trial trench and former garden path revealed after stripping

Soil stripping continued north of the track over the entire western part of the walled garden to a depth of around 300mm. The greatest depth of soil removed was in the northern part of the garden, at about 600mm. A garden path, characterised by the presence of orange-brown gritty soil, was identified c.2.5m from the western wall. Trenches 1 and 2 of the archaeological evaluation of May 2003 were identified as were several lengths of 3½ inch square lead and round sectioned ceramic water conduits. A concentration of lime mortar and brick was observed close to the northern entrance where a glass house is marked on the 1889 OS 1:2500 map.

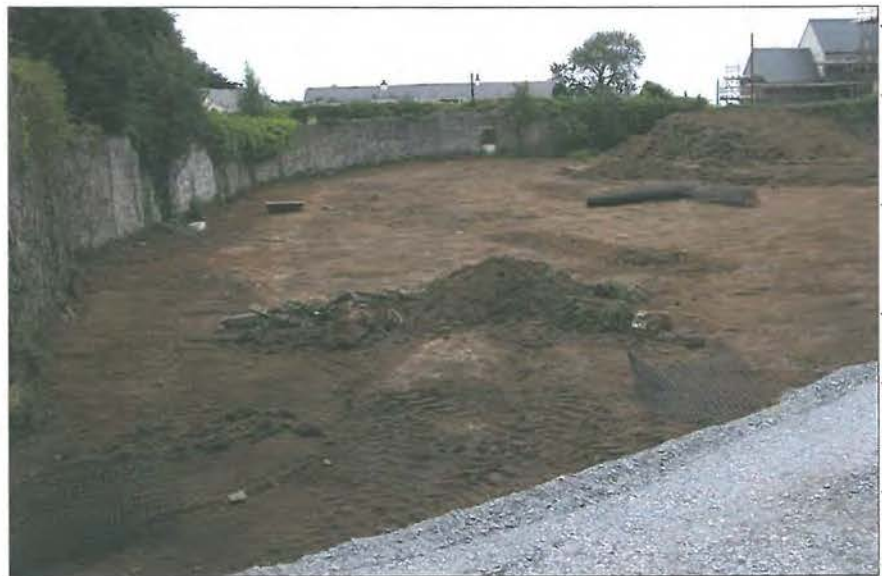
Fig 7. Stripped surface with access track, July 2003

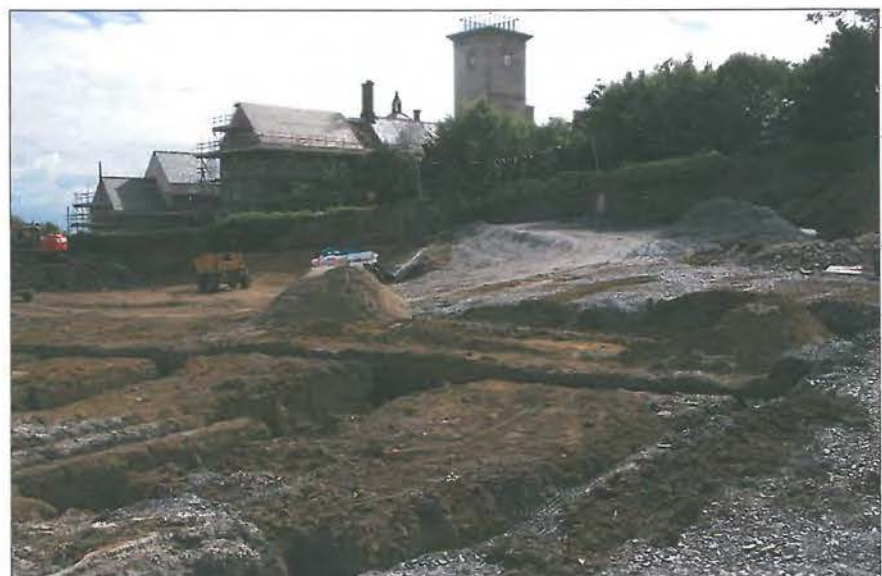
Fig 8. The walled garden, July 2003, foundation trenches being dug

Foundation trenches were machine dug to a depth of c.1m up to 1.5m in total, below the pre-existing turf line in the western part of the garden. A large gap was knocked through the southern wall to facilitate the movement of machinery. The exposed sections of the foundation trenches were observed but no features of archaeological significance were identified.

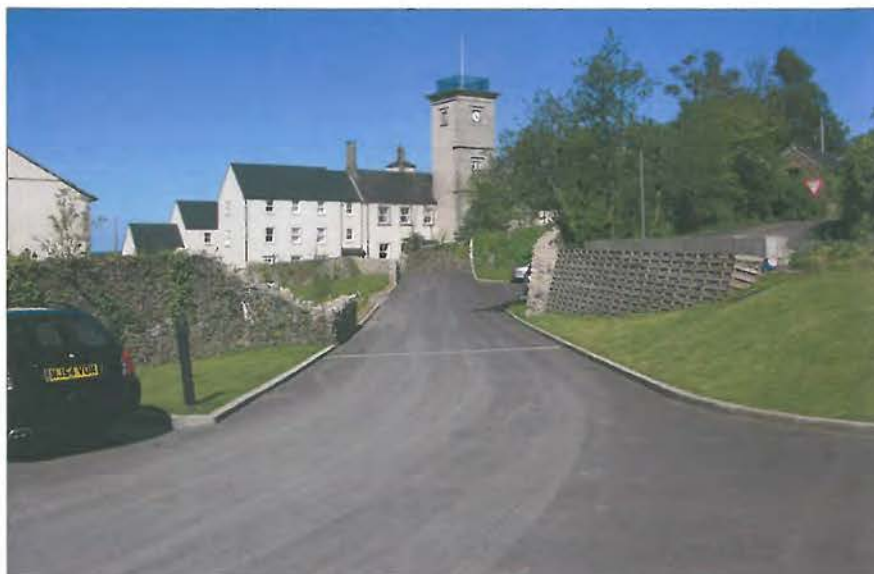
Fig 9. Similar viewpoint to figs 3 and 7 after completion of construction work

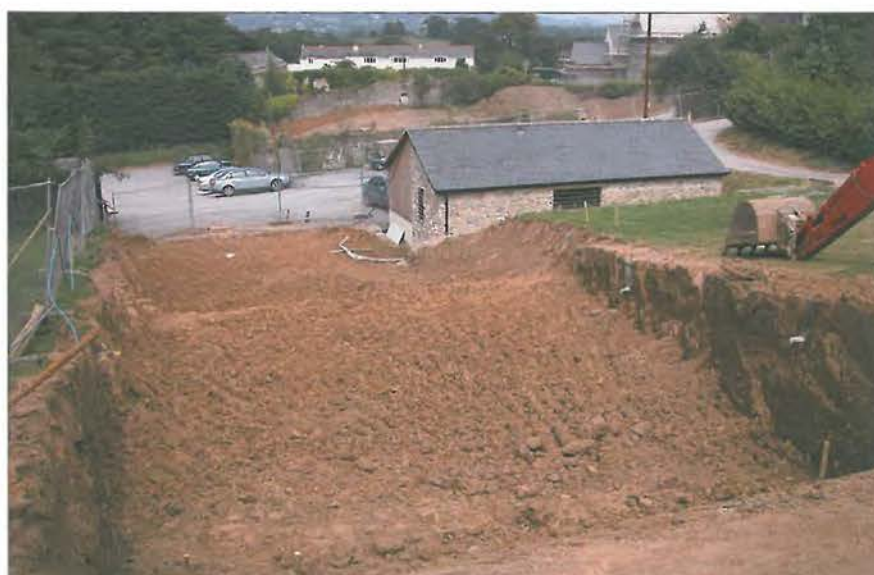
Fig 10. The clubhouse extension excavation, July 2003

An extension to the golf course clubhouse involved substantial earthmoving into the hillside sloping up behind and to the south of the walled garden. The excavation was observed. Nothing of archaeological significance was identified or recorded.

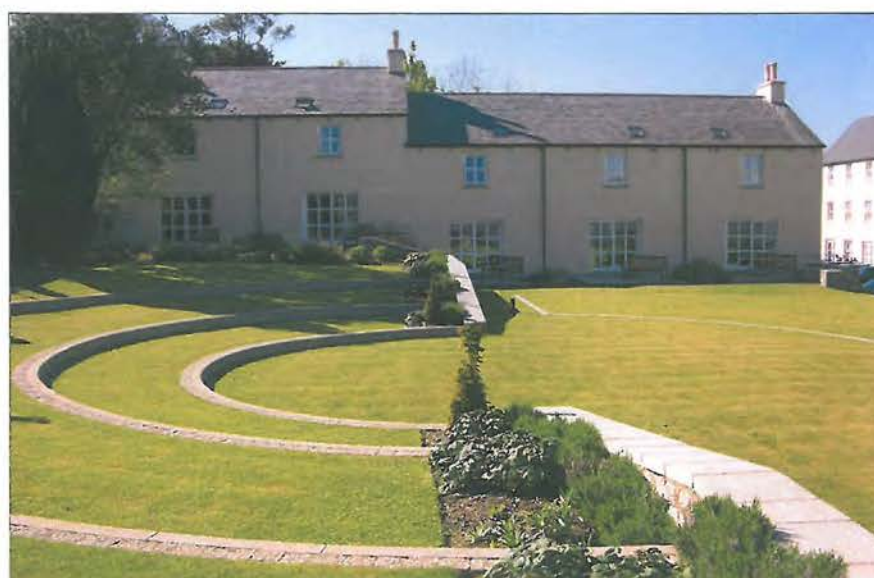
Fig. 11 The completed works at Block U and the walled garden

An exposed north-south section on the western periphery of the former formal terraced garden in the area south of the main hall and now occupied by Block U was observed and recorded. This section revealed an exposure of rock, cut back and cut into to a depth of between 700mm and 1050mm. The rock was revetted on the northern side by a stone wall and was, presumably, similarly revetted on the eastern side as indicated on the OS 1:2500 map of 1889. Behind this wall, to the west there lay, over the

rock, a deposit of shaley rubble up against the wall and, to the south of this, a deposit of orange brown soil to a depth of between 650mm and 970mm. Between the rock and the orange brown soil there extended a thin spread of lime mortar. To the south of the formal garden an exposed section of the terrace above, on which a tennis court once stood revealed a similar exposure of cut-back rock.

It would seem that the formal garden had been terraced to some depth into the local rock. The mortar spread might be explained as resulting from the demolition of the early nineteenth-century structures in this area (referred to in Report No.488) as was the case in the exposures adjacent to block K. The demolition horizon overlay the rock, the formal garden itself was terraced into the rock as part of the re-design of the central area of the demesne around 1852. This work may well have removed much, if not all of the evidence of the eighteenth and early nineteenth century structures in this area.
