BETHEL TO FELINHELI RISING MAIN

WATCHING BRIEF

GAT Project No. G1840

Report No. 588

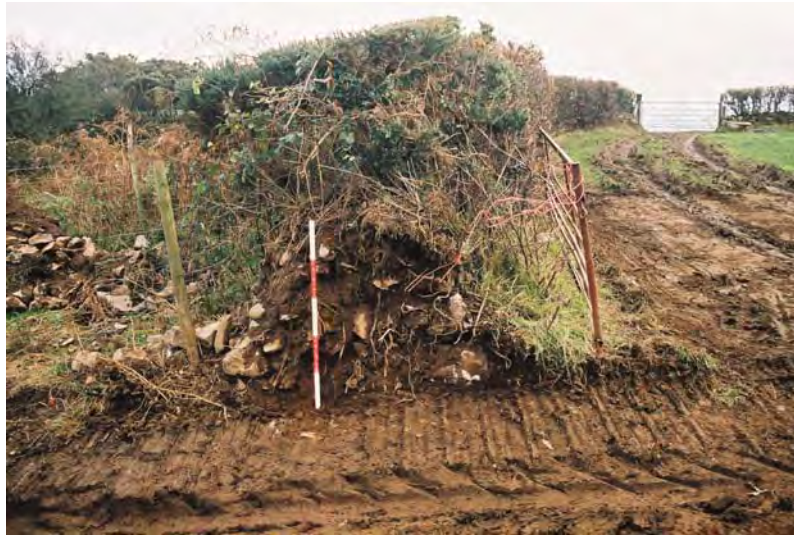
Feature 8. Clawdd land boundary cross-section north of Carreg Goch

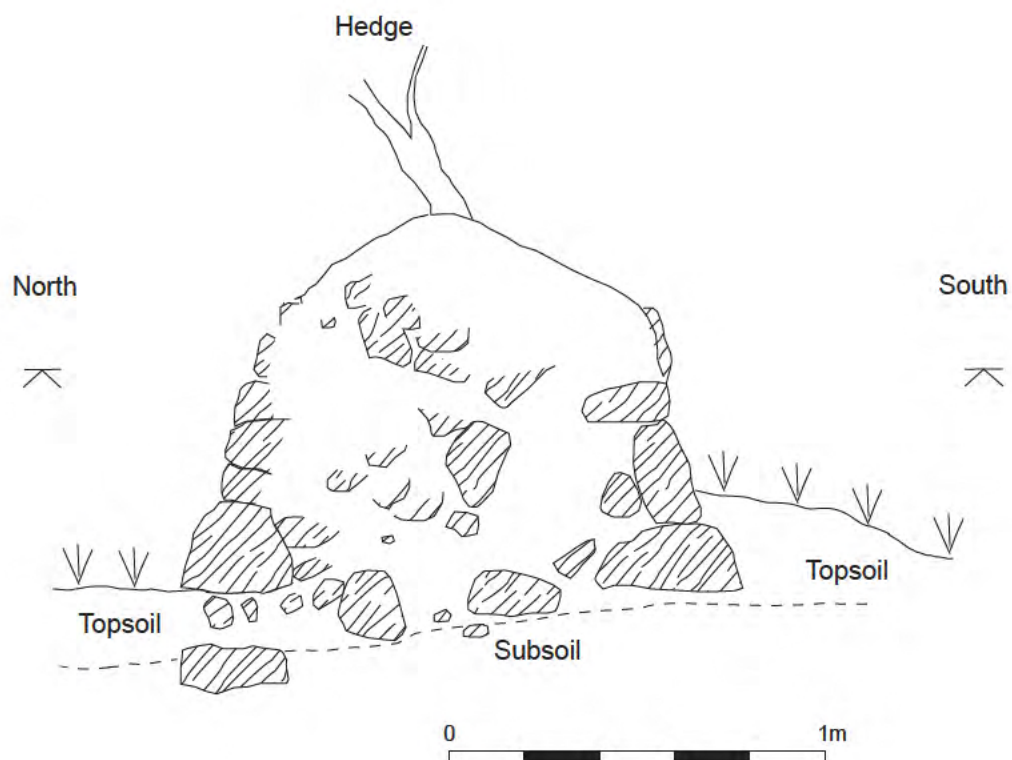
Bethel-Felinheli Rising Main Watching Brief Fig. 3 Section through clawdd/ hedge bank Feature 8

25th November 2004: Visited site to record the exposed section of Feature 8. It appeared certainly of a single build and of relatively recent construction. It consisted of a bank of stony orange-brown loam and loose small stones with slightly inclined facing of roughly laid larger stones. There were no foundation stones and the bank was built directly on the orange-brown silty loam subsoil. There was no evidence of flanking drainage or quarry ditches (Figs 3-4). Although this irregular boundary between the two farms may have origins with some antiquity the impression was that it had been re-built within the last century or two.

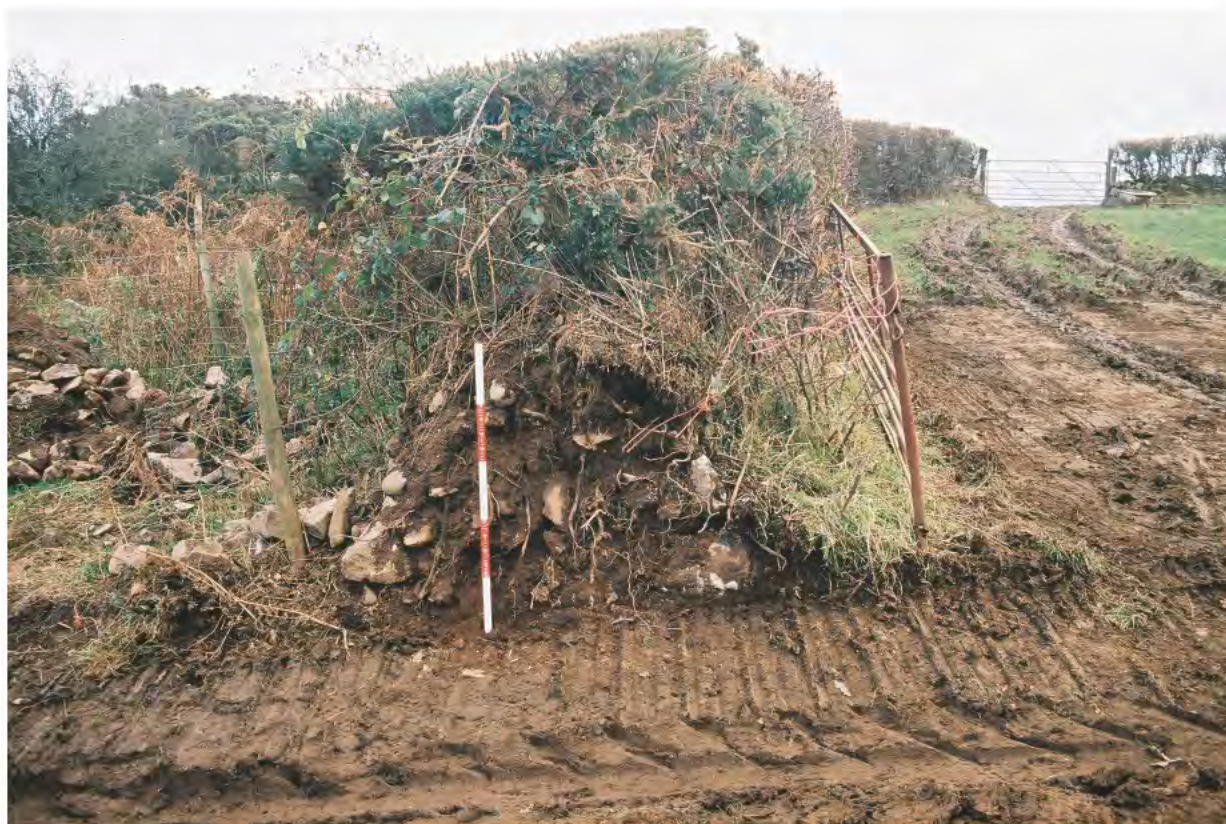
Bethel-Felinheli Rising Main Watching Brief Fig. 4 Section through clawdd/ hedge bank Feature 8.
25th November 2004. From the north-west. 1m scale

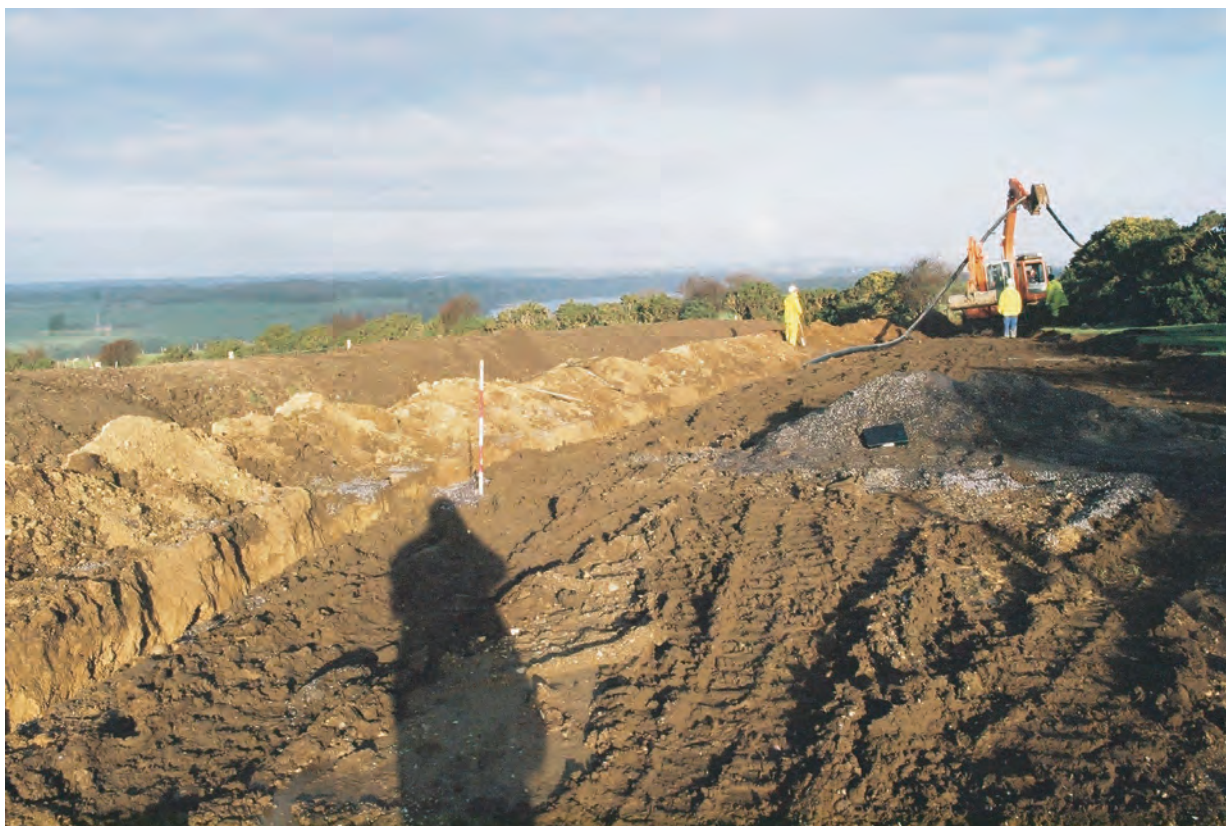
Bethel-Felinheli Rising Main Watching Brief Fig. 5 General trench section 10th December 2004. From the south. 1m scale

10th, 16th, 21st December 2004: Brief visits to check on progress and to walk over the stripped easement. The route across Bodandreg Farm missed the lynchet, Feature 10 and the pipe was mole-trenched under the field boundaries, features 9 and 11 so they were not affected and no recording was needed. Beyond Feature 11 the subsoil on the route became stonier and the work was carried out by Hughes Bros. using a large 360⁰ excavator. The work in December and January was hampered by very wet weather which meant that ground conditions and visibility of exposures were poor (Fig. 5).

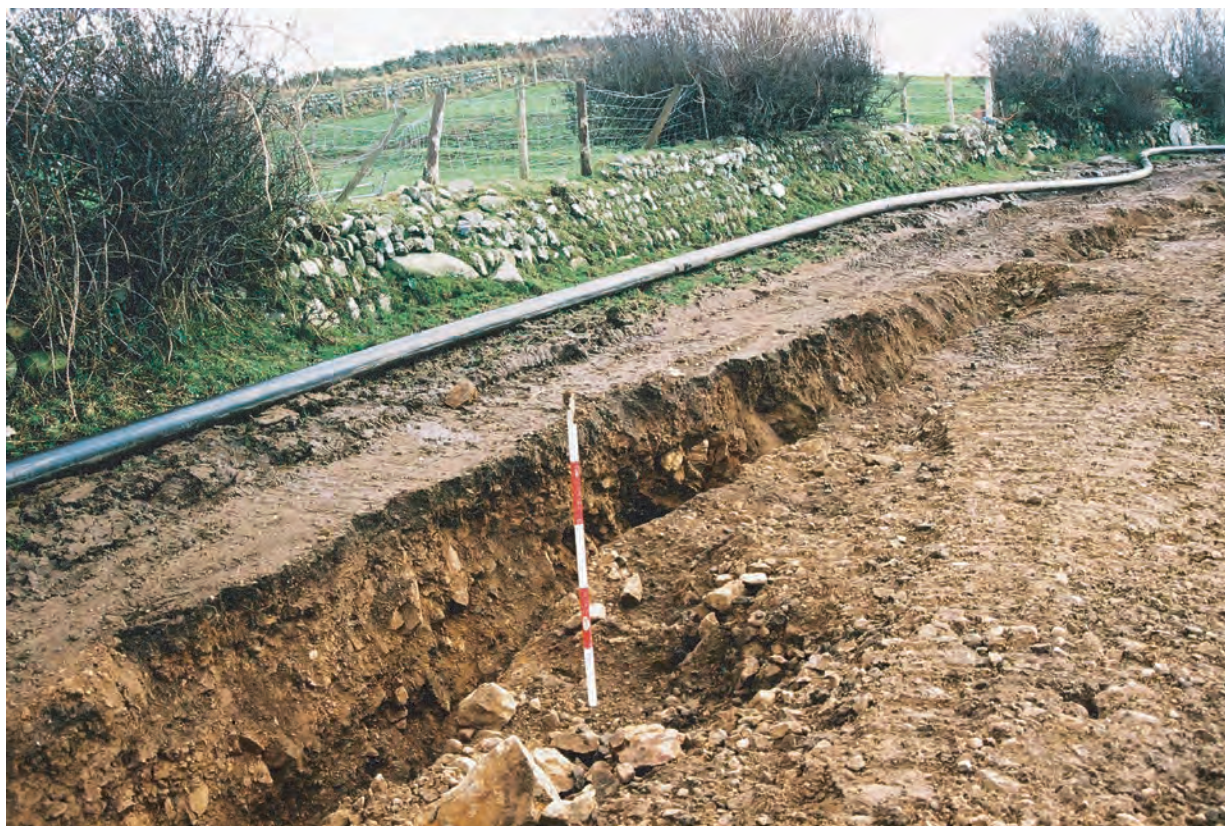
Bethel-Felinheli Rising Main Watching Brief Fig. 6 General trench section 11th January 2005. From the north. 1m scale

10th January 2005: The trench had been cut between and across two field banks at the west side of Bush Farm. Both banks consist of earth with stone facing and no evidence of any antiquity in the form of silted-in ditches, for instance. The westernmost bank had shallow, 'scoop' bordering quarry ditches. At the west end of this area the pipe trench cut through yellow-buff silty till (Fig. 6), from the second field bank through rock. The clarity of the subsoil meant that any archaeological features would be easy to identify.

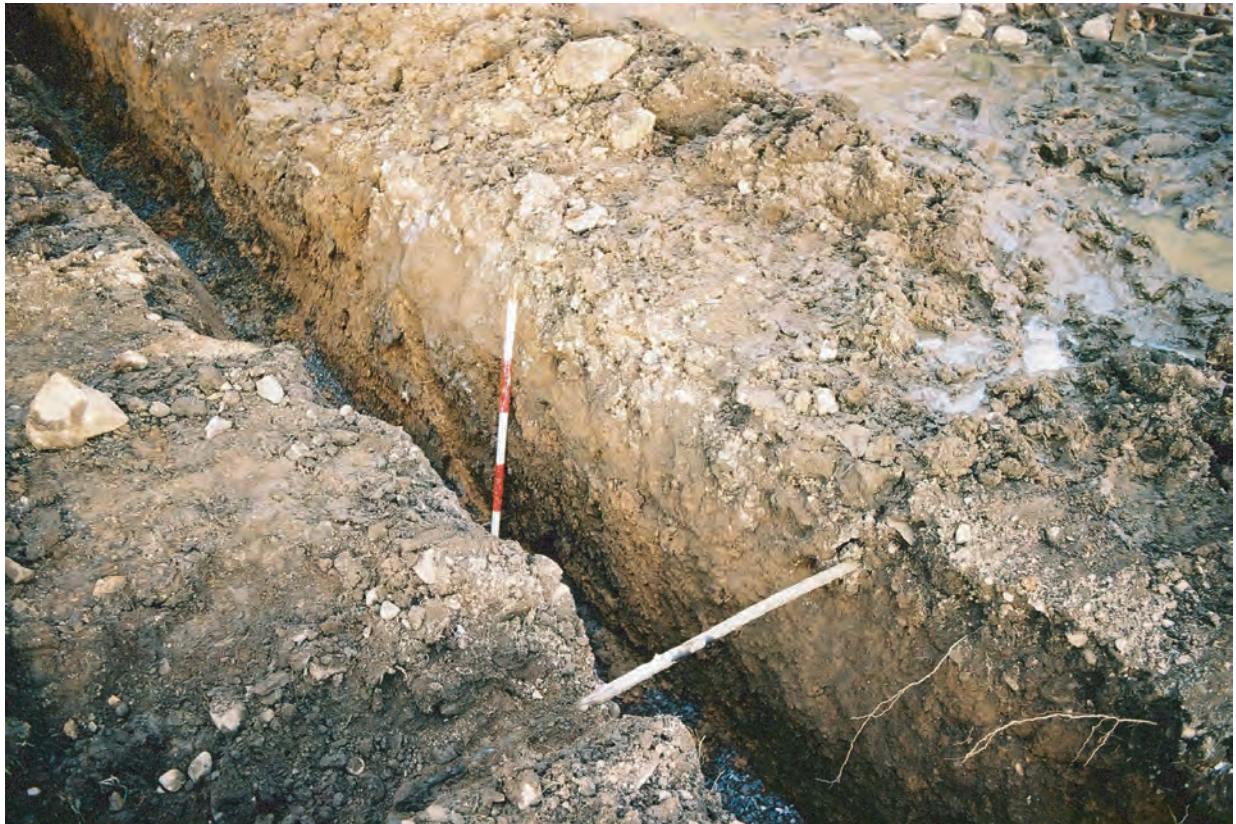
Bethel-Felinheli Rising Main Watching Brief Fig. 7 Ditch?Hollow-way Feature 17 section.
13th January 2005. From the west. 1m scale

13th January 2005: Two features were found cut by the pipe trench. The first was a partly decayed and therefore relatively recent sheep burial. The second was much larger feature (Feature 17), appearing in both sides of the trench and therefore possibly linear, about 4m wide and 1.40m deep with medium sloping sides, filled with dark loamy soil. It was somewhat deeper than the cut of the pipe trench, which averaged about 1.20m deep, so had to be excavated into the base of the trench to locate the base of the feature. It was not possible to take a good photographic record because the trench was so narrow (Fig. 7). The feature was measured to nearby boundaries and a measured sketch section recorded. There was no dating evidence but the feature lined up with a nearby gateway through which a public right of way runs (Fig. 8). The public right of way must have once been a well-used route because it is visible as a terraced track on the steeper slope west of Bush Farm. This suggests that the feature discovered is a worn hollow-way, perhaps because the track was a pack-horse route, not just a footpath. The hollow-way would have been filled in to improve the field once the modern road system the levelled in. The feature is surprisingly deep for its width, as a hollow-way, but could be accounted for as a pack-horse way and no other explanation seems likely.

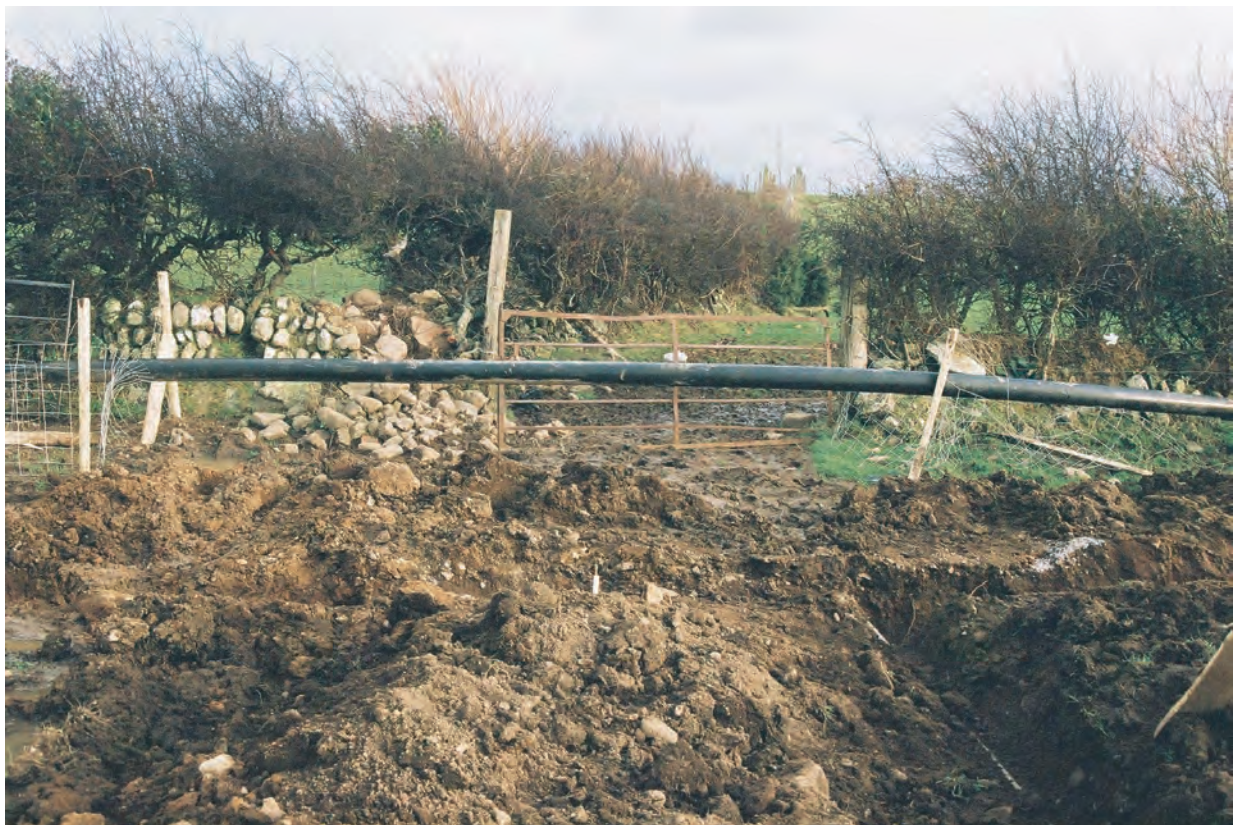
Bethel-Felinheli Rising Main Watching Brief Fig. 8 Ditch/Hollow-way Feature 17 position in relation to adjoining field boundary.
(White tip of scale showing in pipe trench at north edge of feature. 13th January 2005. From the north-west. 1m scale

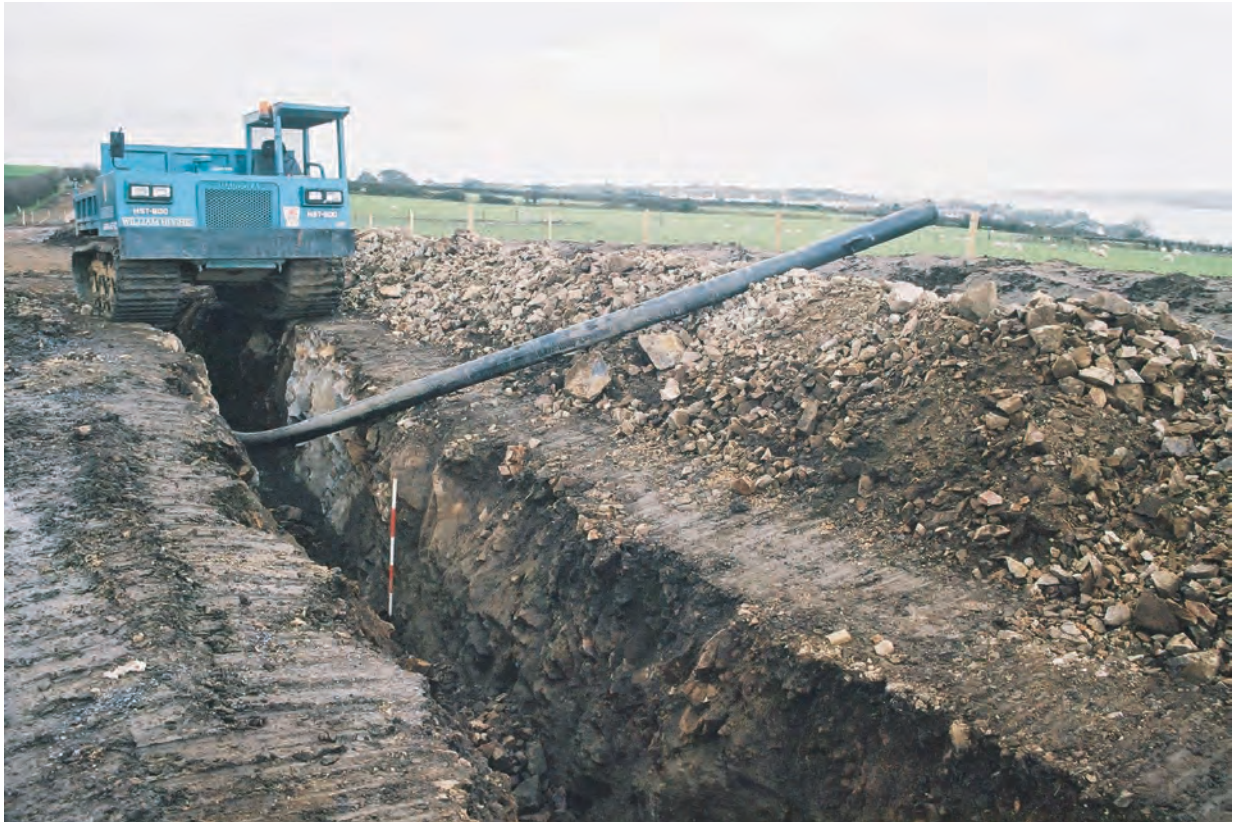
Bethel-Felinheli Rising Main Watching Brief Fig. 9 General trench section in rock-cut area immediately south of Bush Farm house. 17th January 2005. From the north-east. 1m scale

17th January 2005: The final field south-west of Bush Farm was observed because a crop mark of a possible Iron Age/Romano-British roundhouse had been recorded as part of the assessment about 60m to the west of the pipe-trench route. There was therefore some potential for other features in the same field, however pipe-trench cut through bed-rock here with a shallow topsoil on quite a steep slope and there were no features present (Fig. 9).

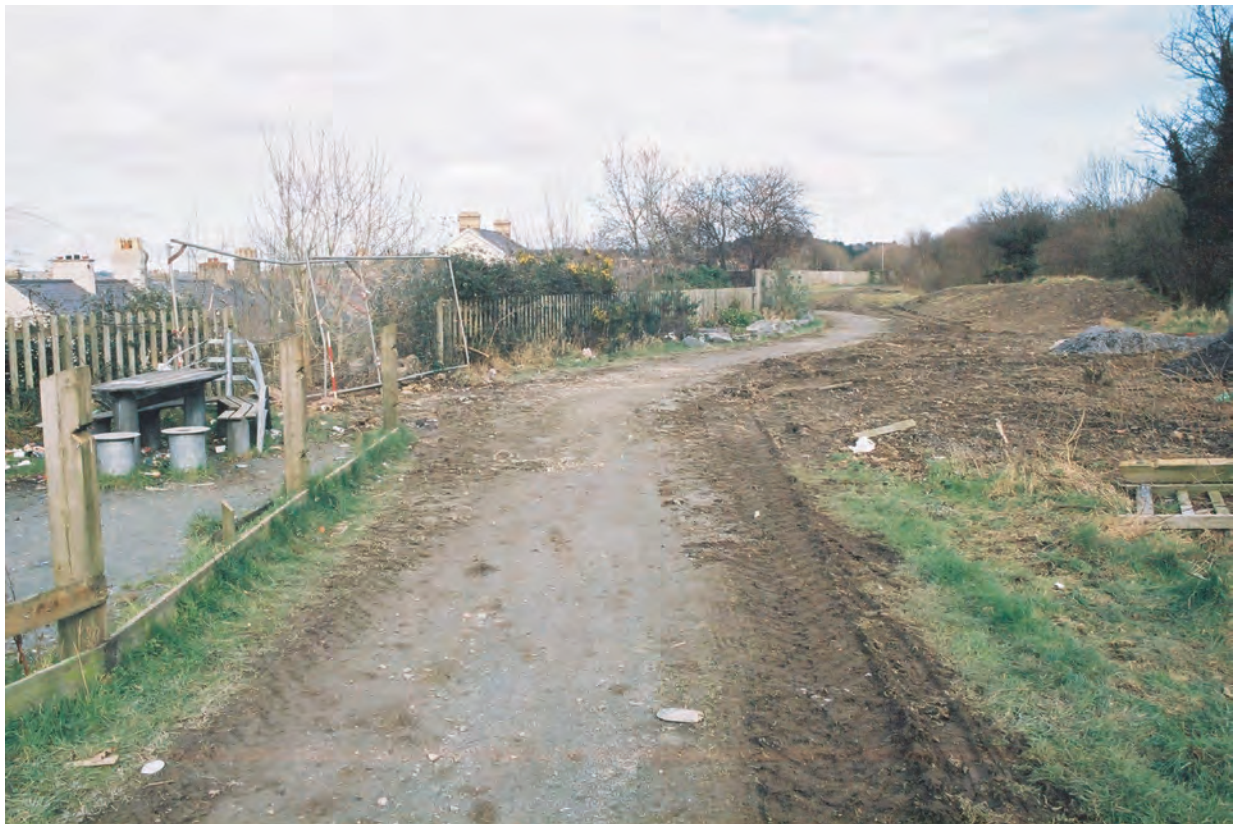
Bethel-Felinheli Rising Main Watching Brief Fig. 10 Completed pipe trench across former railway line, Feature 15, Lon Las Menai, Y Felinheli. 21st February 2005. From the south. 1m scale

21st February 2005: North of Bush Farm house the pipeline crossed the road and then followed a gravelled track as far as Pen-Rallt before turning down a very steep slope. The features in this part of the route were all identified as Post-medieval in date and not requiring mitigation. A short visit was made to observe the completed works at Y Felinheli. The trench through the redundant railway line had been backfilled but the fences had still to be reinstated (Fig. 10).
