Harlech to Llanbedr and Llanbedr to Llandanwg Rising Mains

Archaeological watching brief
2005

GAT Project No. 1795

Report No. 594

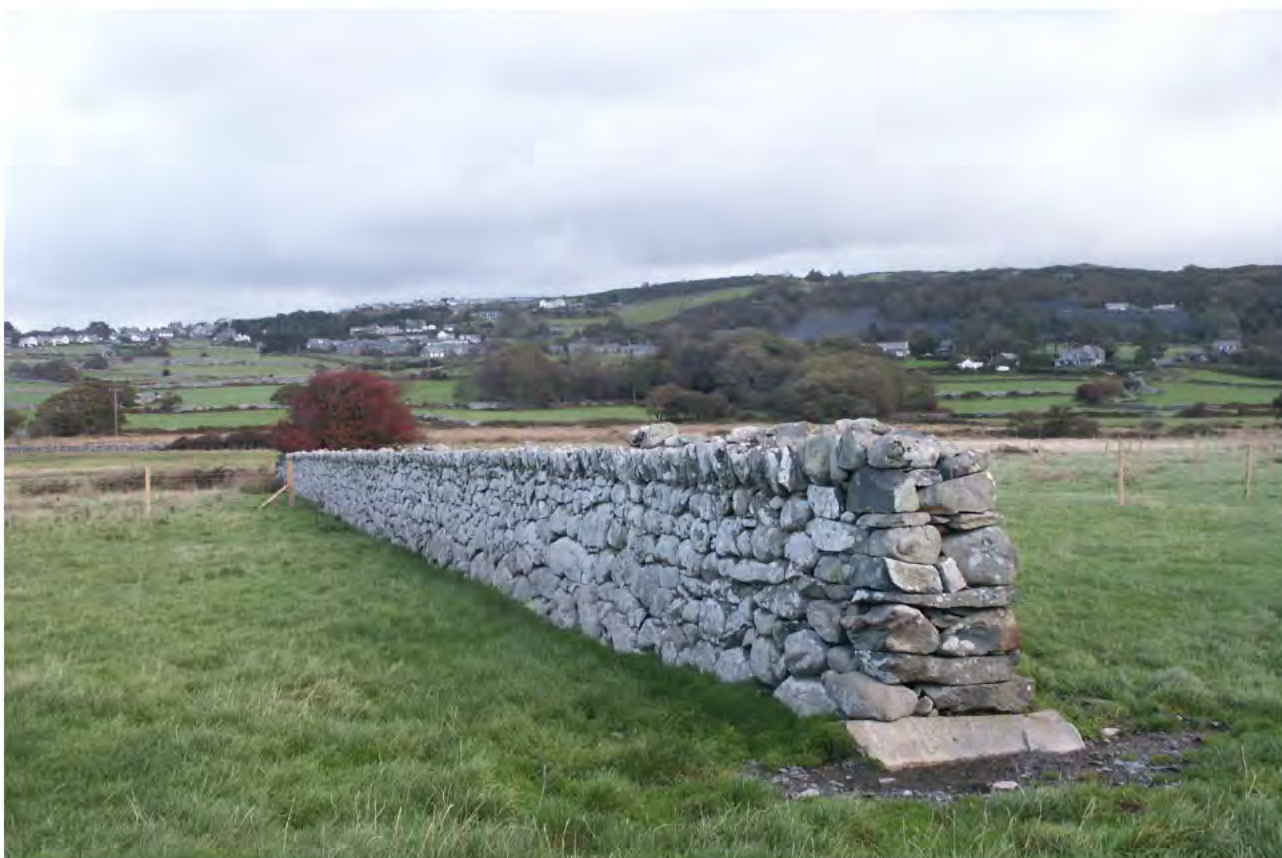
Plate 2. Feature 5. Wall

Feature 5: Post medieval wall (SH57462977). Dry-stone field wall, probably nineteenth century (Plate 3).

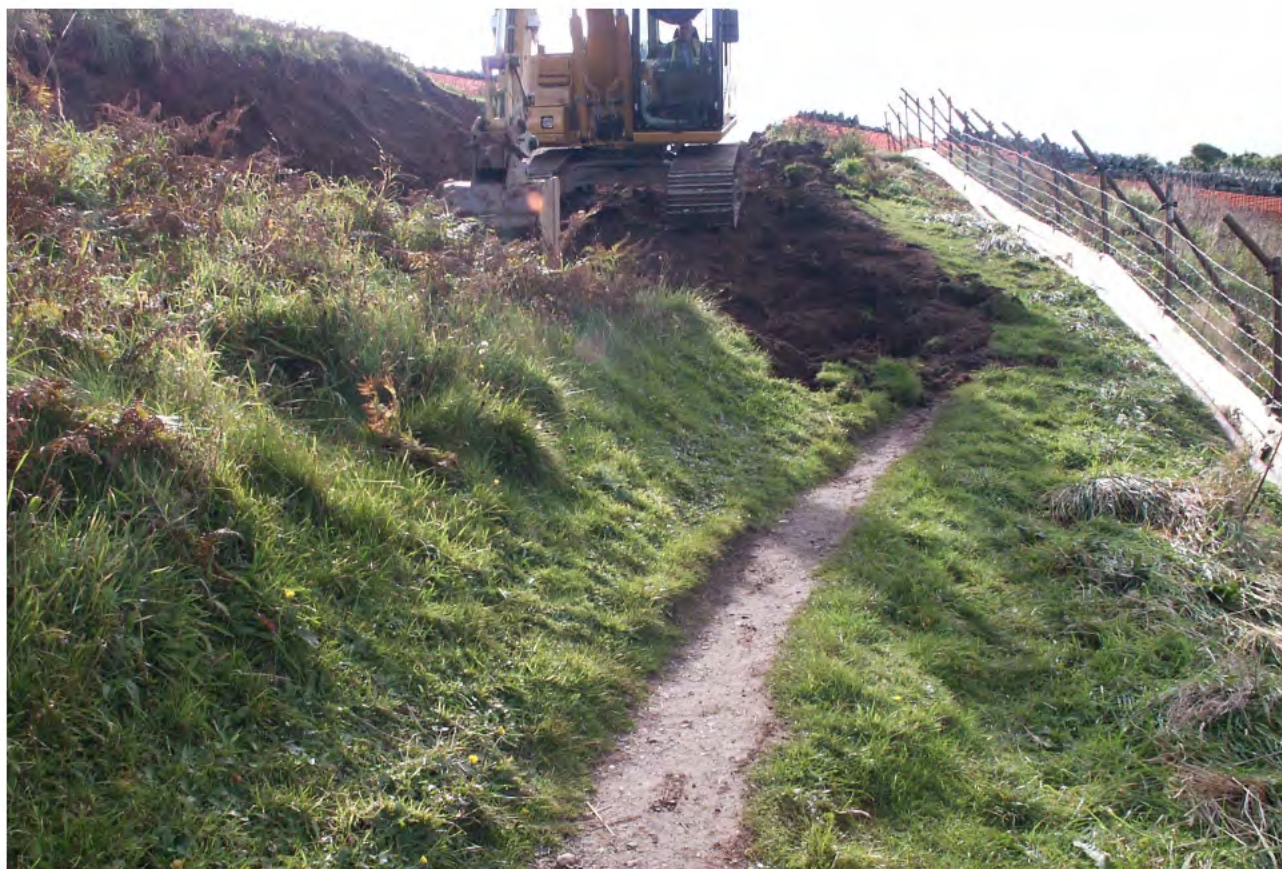
Plate 3. Feature 6. Path

The path from the beach zigzags up the very steep gradient of Harlech Cliff. The path is probably Victorian and may be contemporary with the railway.

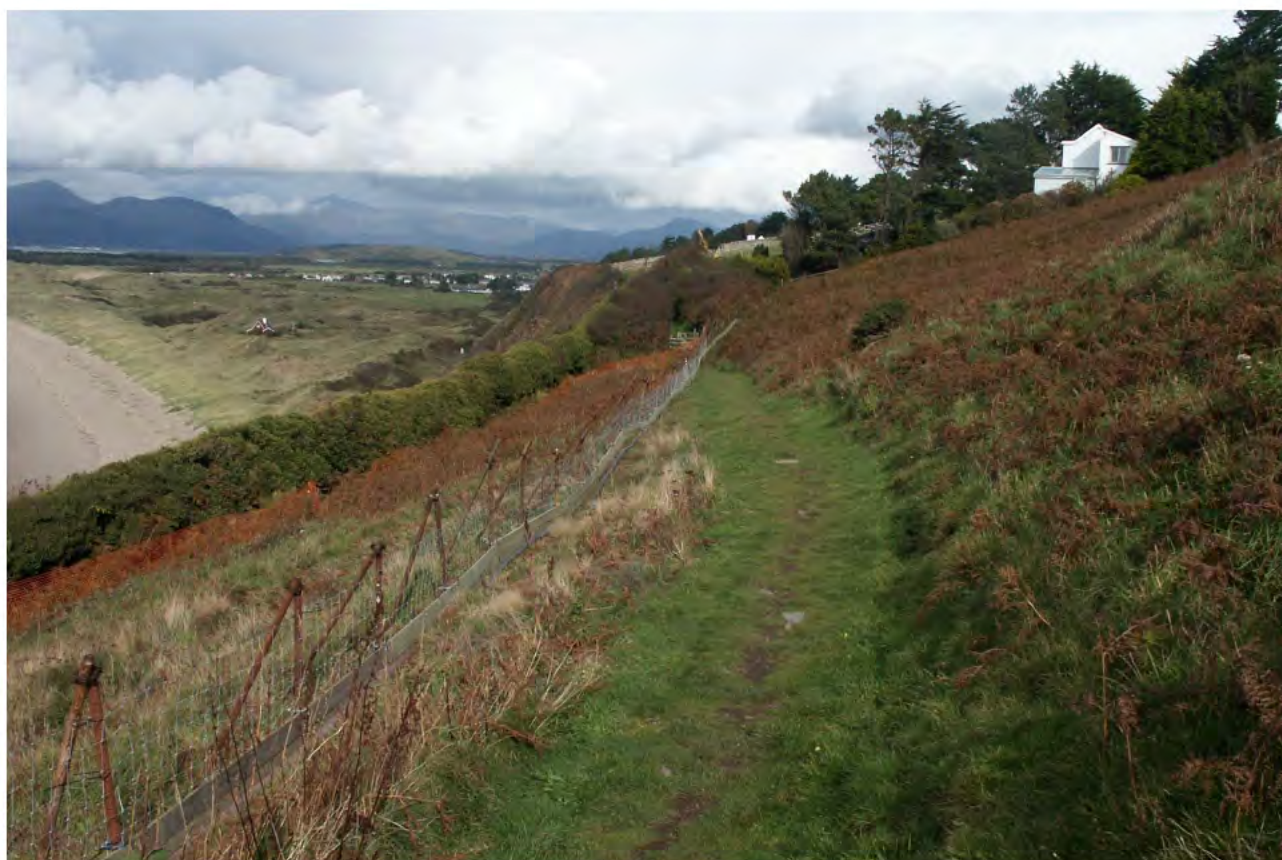
Plate 4. Feature 8. Track.

A largely turfed over, roughly cobbled track runs through the field along the top of the cliff. This could pre-date the current road that is shown on the 1839 tithe map. A footpath is marked here on the 1901 OS map.

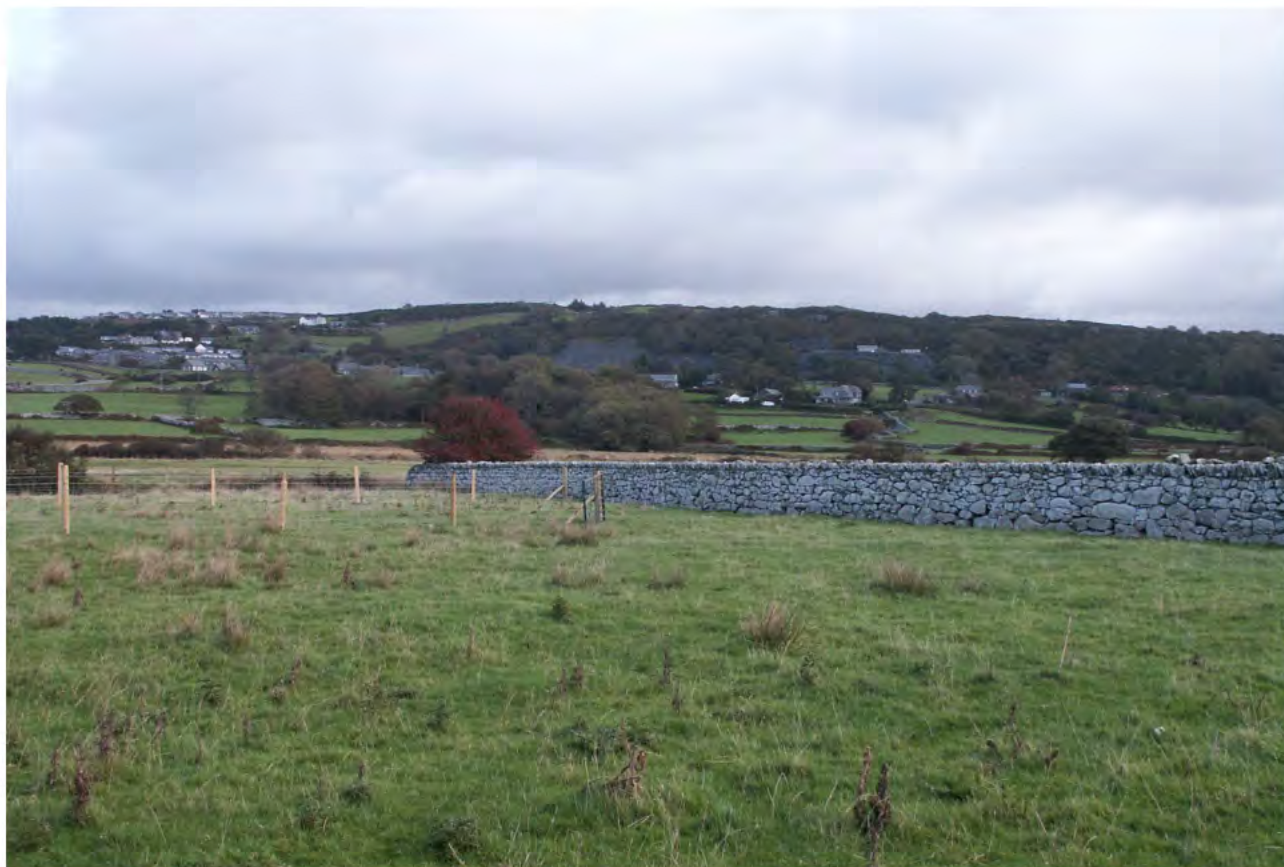
Plate 5. Feature 10. Wall

Dry-stone field wall, probably nineteenth century.

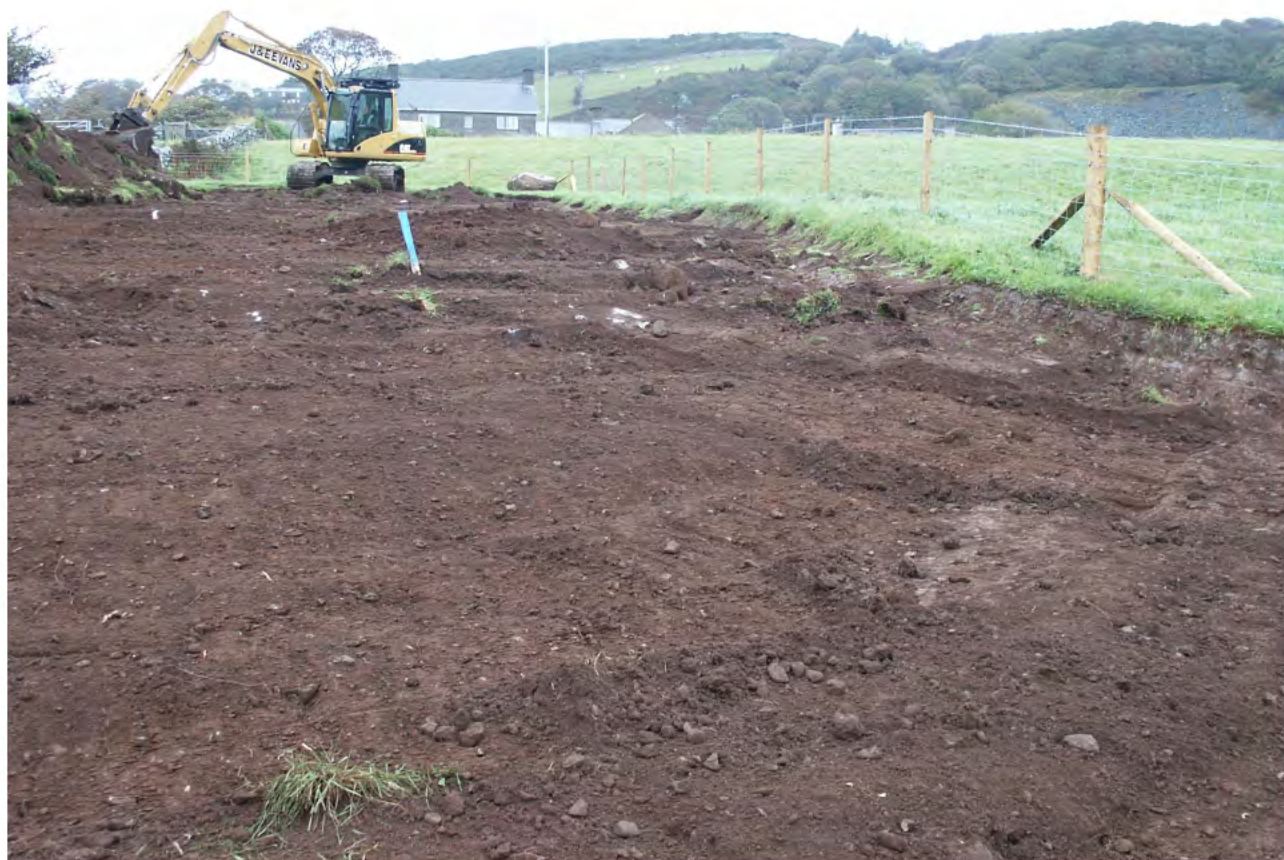
Plate 6. Feature 15. Lynchets

Romano/British or Medieval suspected ploughed out enclosure or boundary (SH57642895). An arc of a possible curvilinear boundary or ploughed down lynchet was visible as break of slope in improved pasture to the south of Llanfair. This could have been an element of an early field system around Llanfair, perhaps an outlying part of the fields around the hut group to the northwest.

The pipeline crossed, at an angle, a curvilinear boundary which was thought to be a ploughed down lynchet or an element of an early field system (Figure 2). This feature proved to be substantial when the topsoil was removed, with topsoil varying in thickness from 0.10m at the top and bottom of the slope to 0.35m at the crest of the slope (lynchet A), before it began to descend into either a stone revetment or a deposit of field clearance stone reinforcing the edge of the slope and protecting it from erosion (Figure 3). A second, less pronounced band of smaller stone was visible partway down the slope, also holding behind it thicker topsoil (lynchet B; Figure 3). This evidence reinforced the suggestion that it was part of an earlier field system, separate to the extensive nineteenth century stone-

built boundary system, as the lynchet was on a different alignment and appeared to be cut by a later field wall, suggesting that there is little continuity between the two systems.

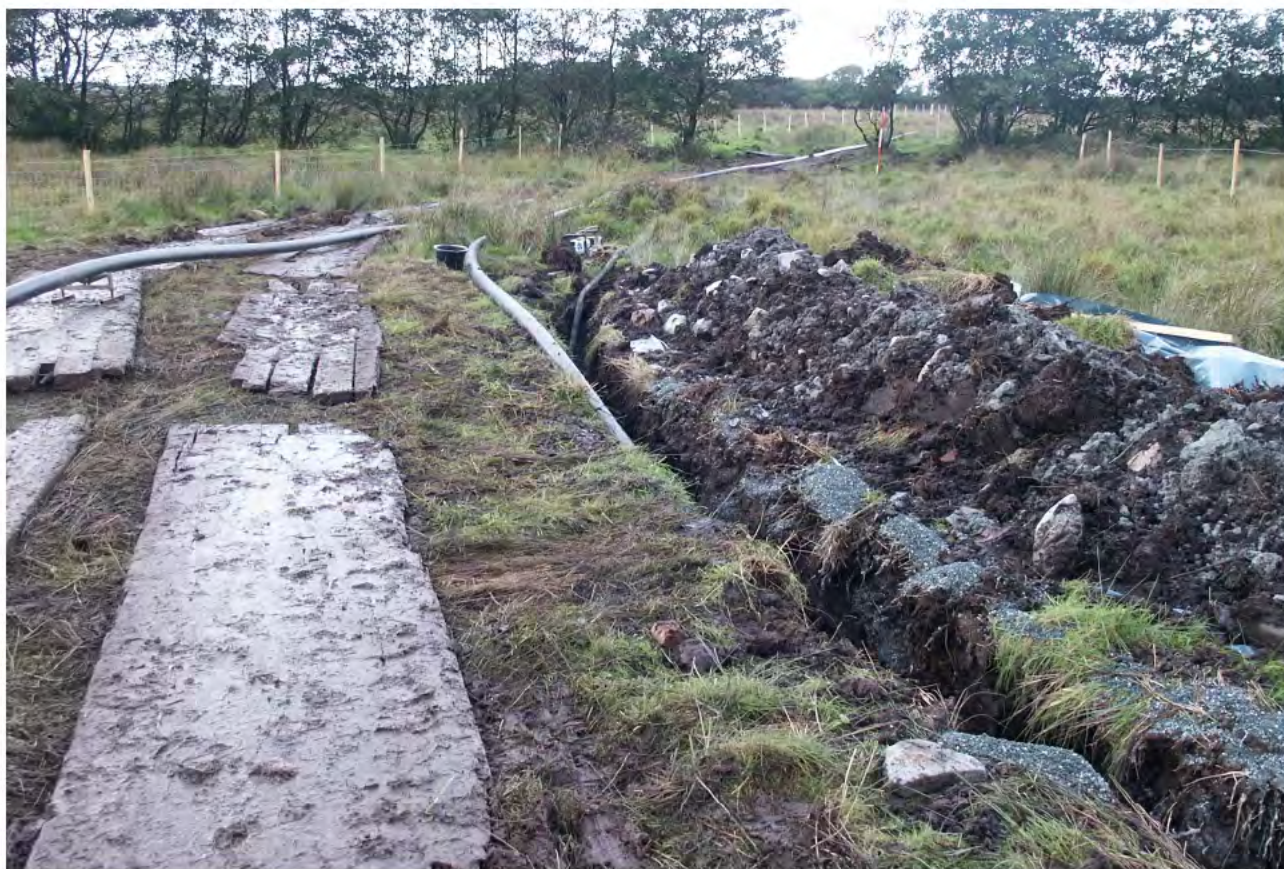
Plate 9. Feature 16. Marsh

Marshland near Afon Artro (SH57602835). A semi-improved coastal marshland to the south-west of Llandanwg and to the north of the Afon Artro that probably originated as coastal mudflats and was hoped to contain environmental evidence for coastal change in the area.

The marshland was crossed by the pipeline revealing deposits of sediment rich soils over grey clay, both topsoil and subsoil being heavily studded with glacial erratics. There was no visible evidence of coastal change.

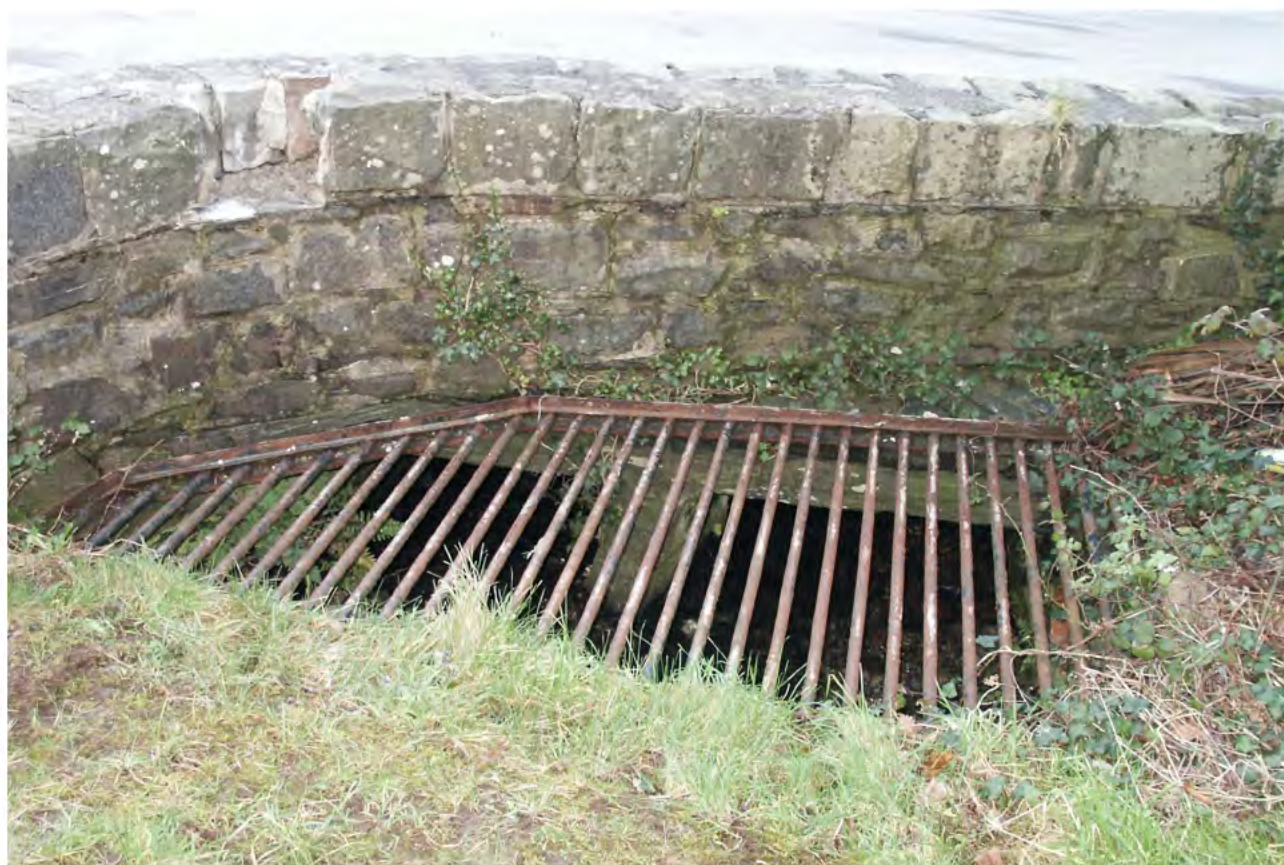
Plate 10. Clapper Bridge

Two small stone clapper bridges were noticed, one under the road junction into the treatment works and one under the next junction to the south. The bridges predated the culverting of the stream and were partly overlain by two modern road junctions. Neither were directly affected by the pipeline. An earlier road surface was identified below the present road, visible intermittently in stretches of the trench between the Watergate and Coleg Harlech. This may relate to a slightly different road line or, more likely, to a method of resurfacing that did not remove the earlier surface.
