Afon Adda Flood Alleviation Scheme

Bangor

Archaeological Watching Brief

GAT Project No. 1876

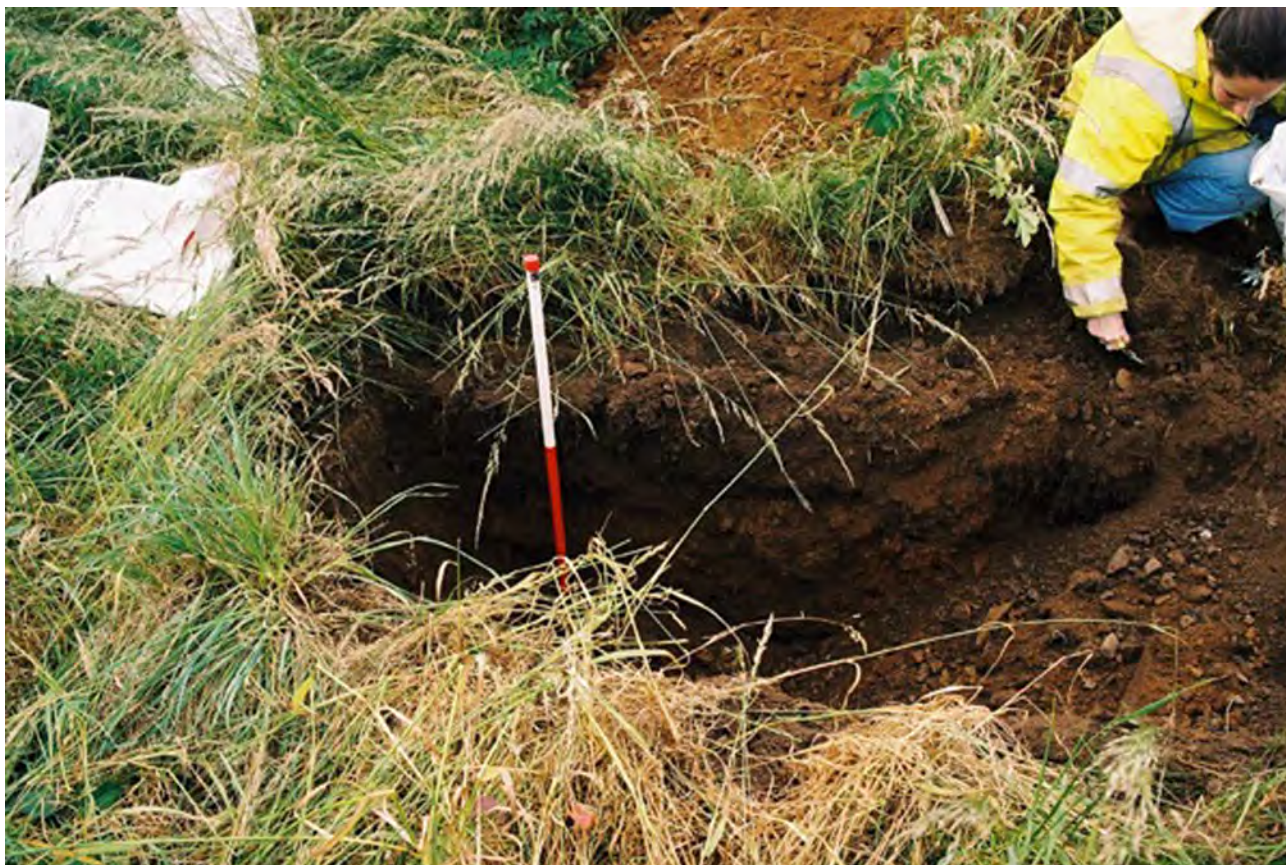
Plate 1. Test Pit 101

Size: 1.20m x 0.60m x 1.70m (l x w x d)

The topsoil was extant to a depth of 0.30m and comprised a dark-grey brown humic topsoil; a yellow-brown glacial silt, 0.80m deep, followed this. Bedrock was identified at 1.10m.

The test pit was archaeologically sterile

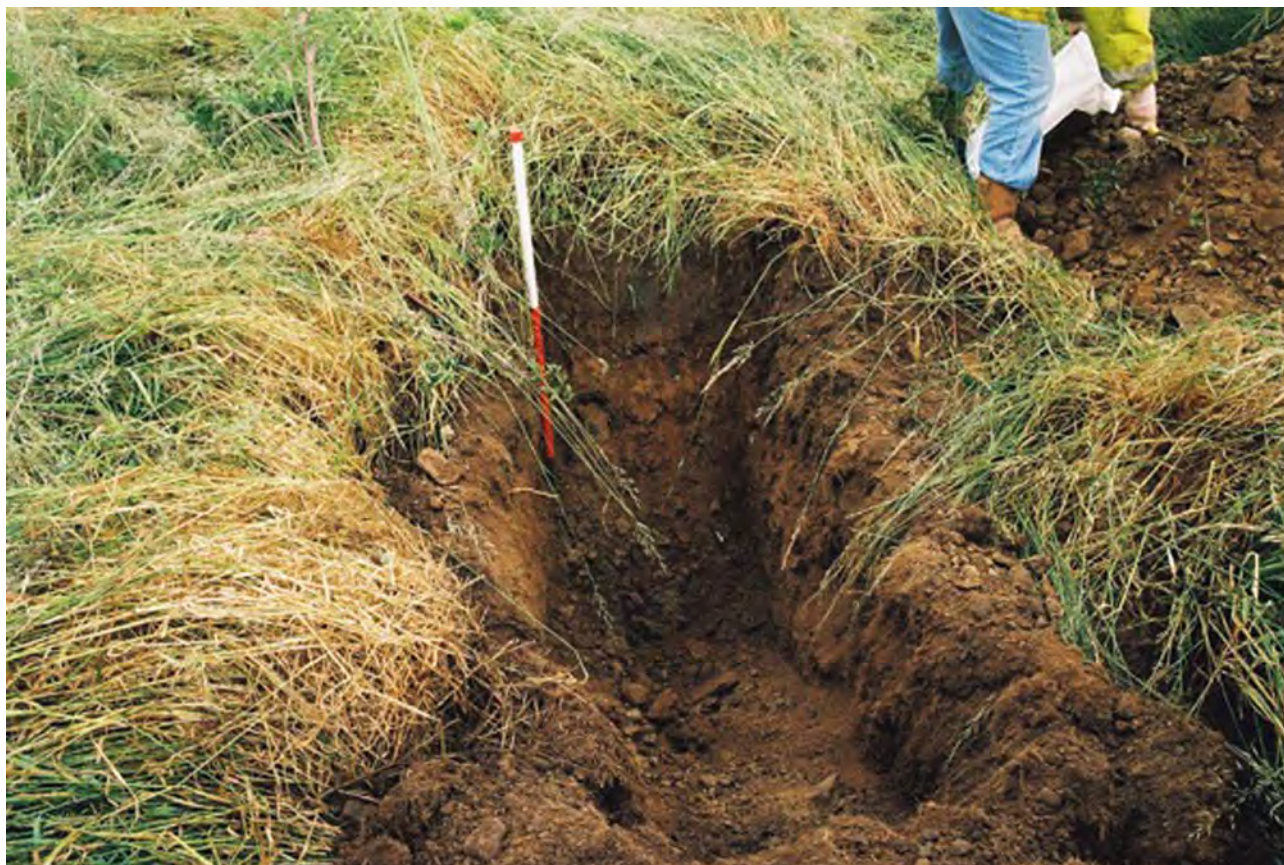
Plate 2. Test Pit 102

Size: 1.20m x 0.60m x 2.00m (l x w x d)

The topsoil was extant to a depth of 0.30m and comprised grey humic topsoil; this was followed by gravel-rich glacial silt, 1.70m deep. Bedrock was identified at 2.00m.

The test pit was archaeologically sterile

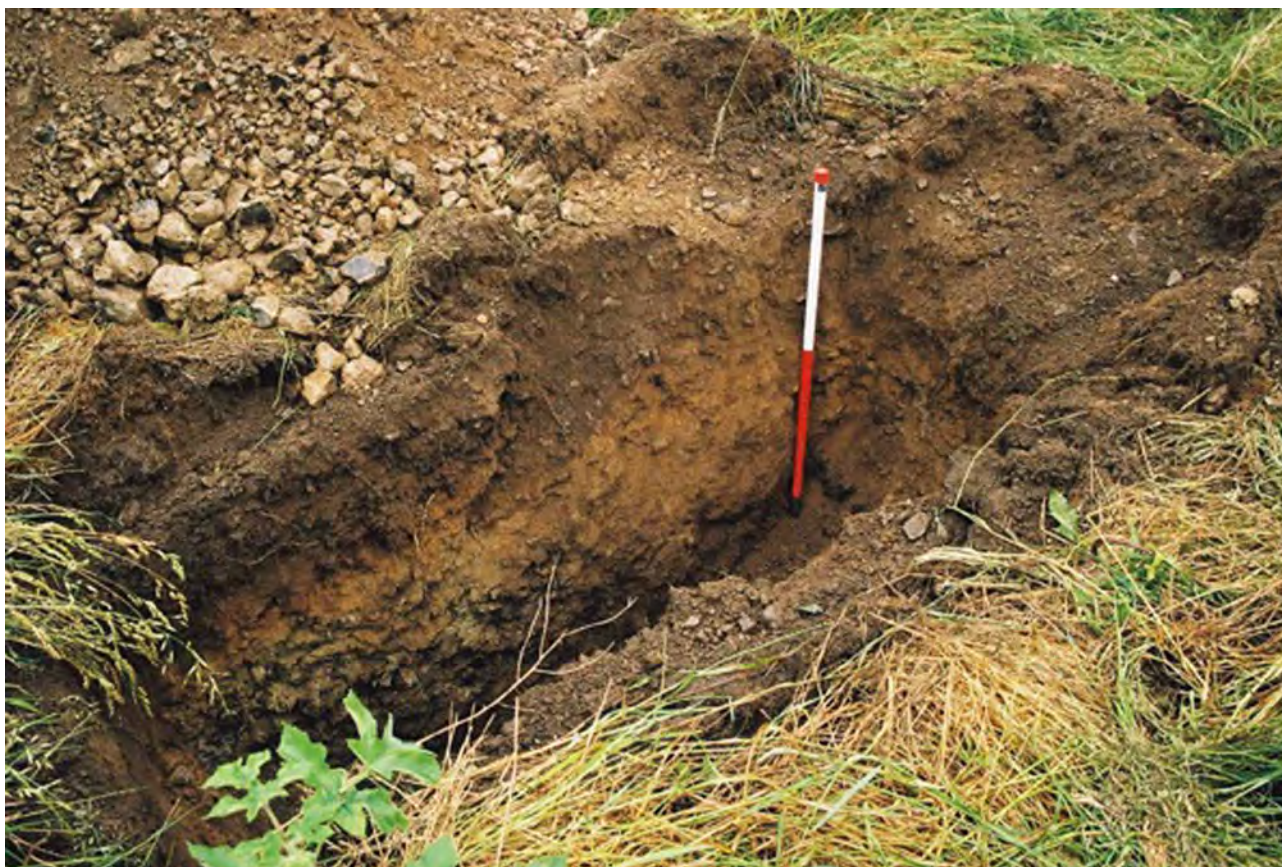
Plate 3. Test Pit 103

Size: 1.20m x 0.60m x 4.00m (l x w x d)

The topsoil was extant to a depth of 0.30m and comprised grey humic topsoil, followed by yellow-brown glacial silt, 0.50m deep; this was followed by gravel-rich glacial silt, 3.20m deep. Bedrock was identified at 4.00m.

The test pit was archaeologically sterile

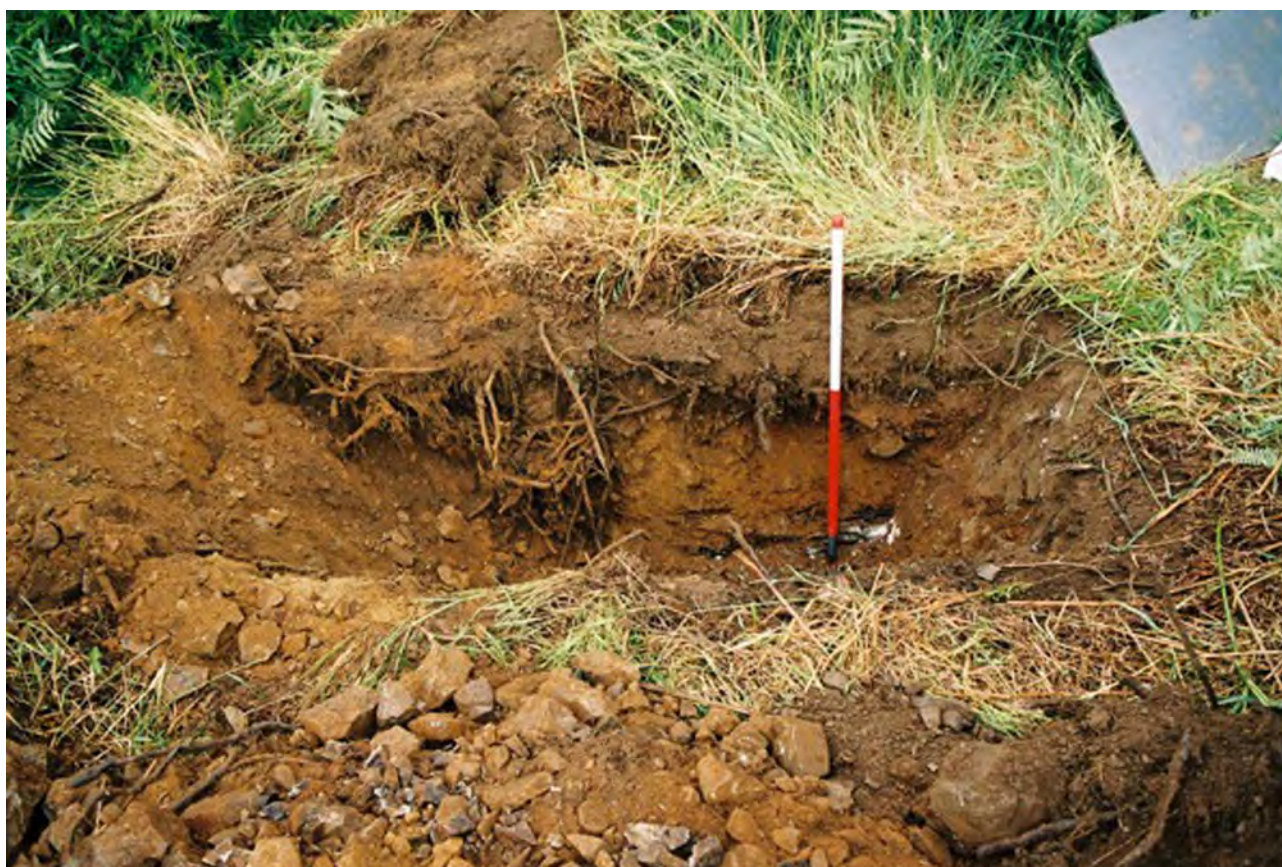
Plate 4. Test Pit 104

Size: 1.20m x 0.60m x 0.60m (l x w x d)

The topsoil was extant to a depth of 0.25m and comprised a grey-brown silty topsoil; this was followed by orange-brown glacial silt, 0.35m deep. Bedrock was identified at 0.60m.

The test pit was archaeologically sterile

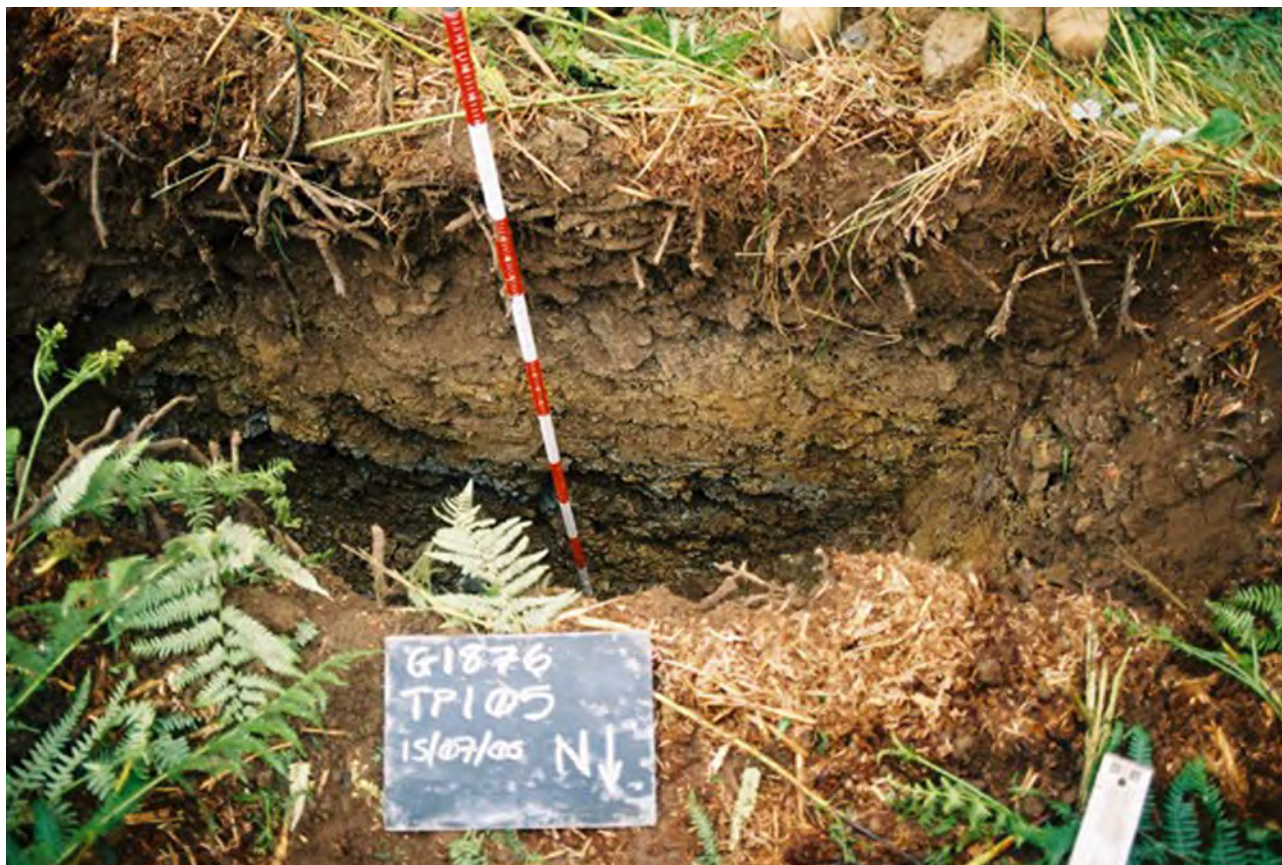
Plate 5. Test Pit 105

Size: 1.20m x 0.60m x 1.30m (l x w x d)

The topsoil was extant to a depth of 0.30m and comprised a mid-brown silty topsoil; a grey-brown silty subsoil, 0.20m deep, followed this; this was followed by grey-brown glacial clay, 1.30m deep. Bedrock was identified at 1.30m.

The test pit was archaeologically sterile

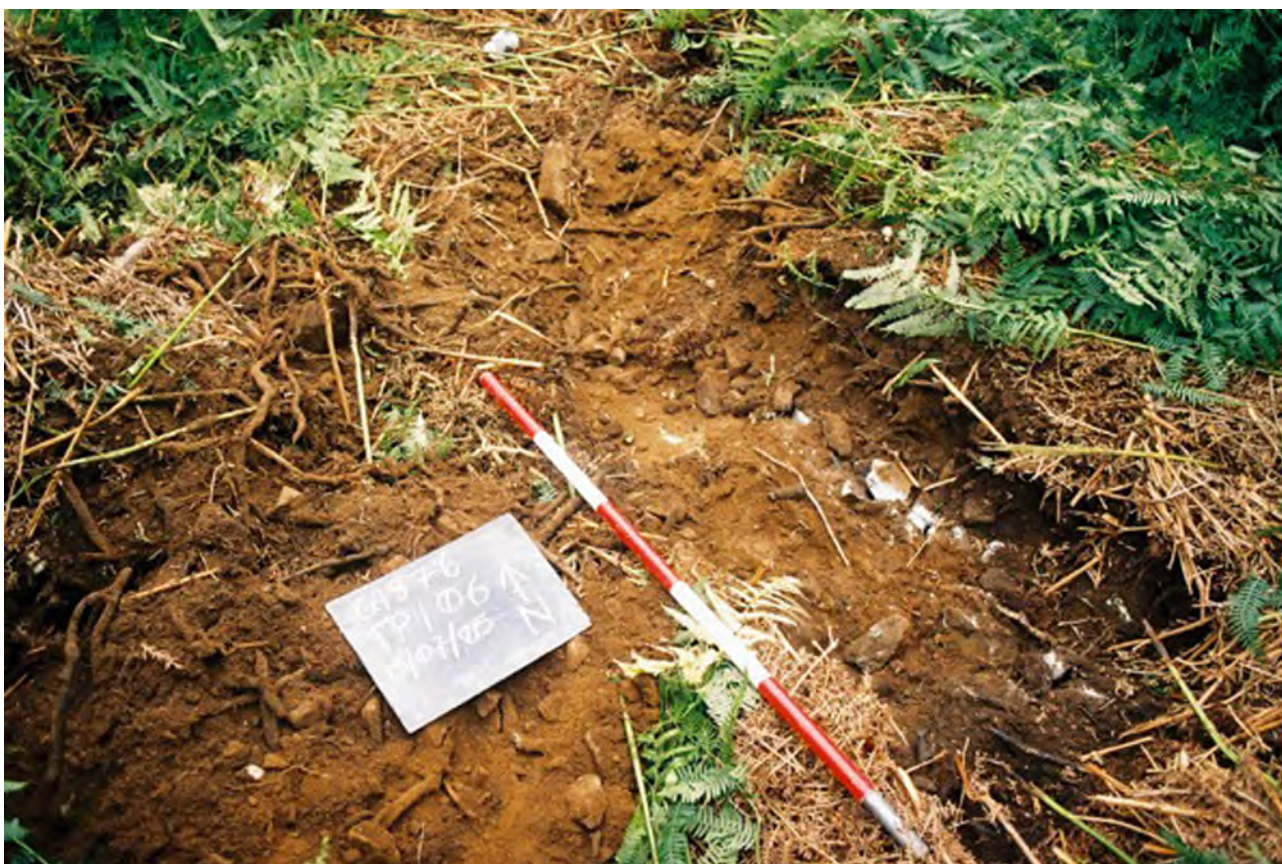
Plate 6. Test Pit 106

Size: 1.20m x 0.60m x 0.50m (l x w x d)

The topsoil was extant to a depth of 0.20m and comprised mid-brown silty topsoil; this was followed by stone-rich grey-brown silty subsoil, 0.30m deep. Bedrock was identified at 0.50m.

The test pit was archaeologically sterile

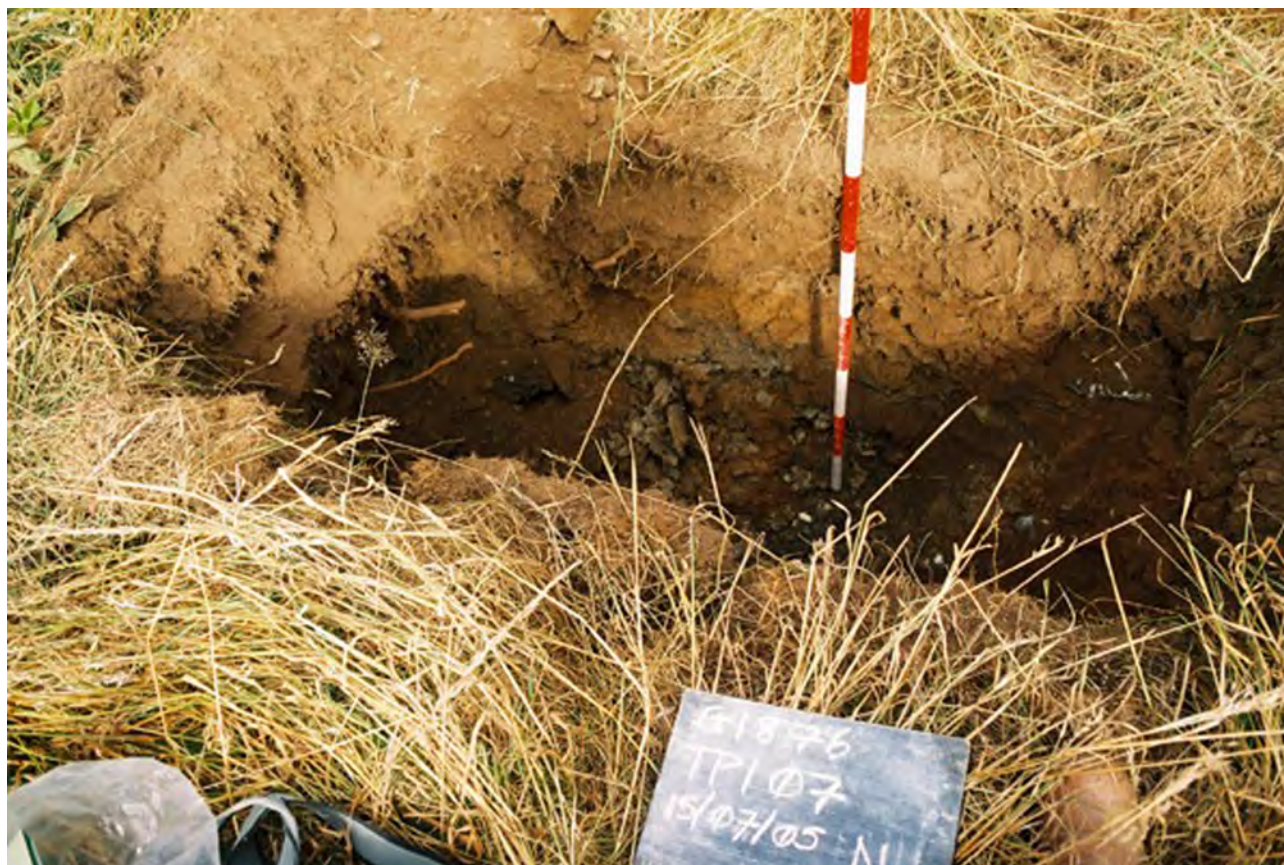
Plate 7. Test Pit 107

Size: 1.20m x 0.60m x 1.30m (l x w x d)

The topsoil was extant to a depth of 0.50m and comprised mid-brown silty topsoil; a glacial silt deposit, 0.80m deep, followed this. Bedrock was identified at x 1.30m.

The test pit was archaeologically sterile except for several sherds of modern glazed pottery indicative of farming activity.

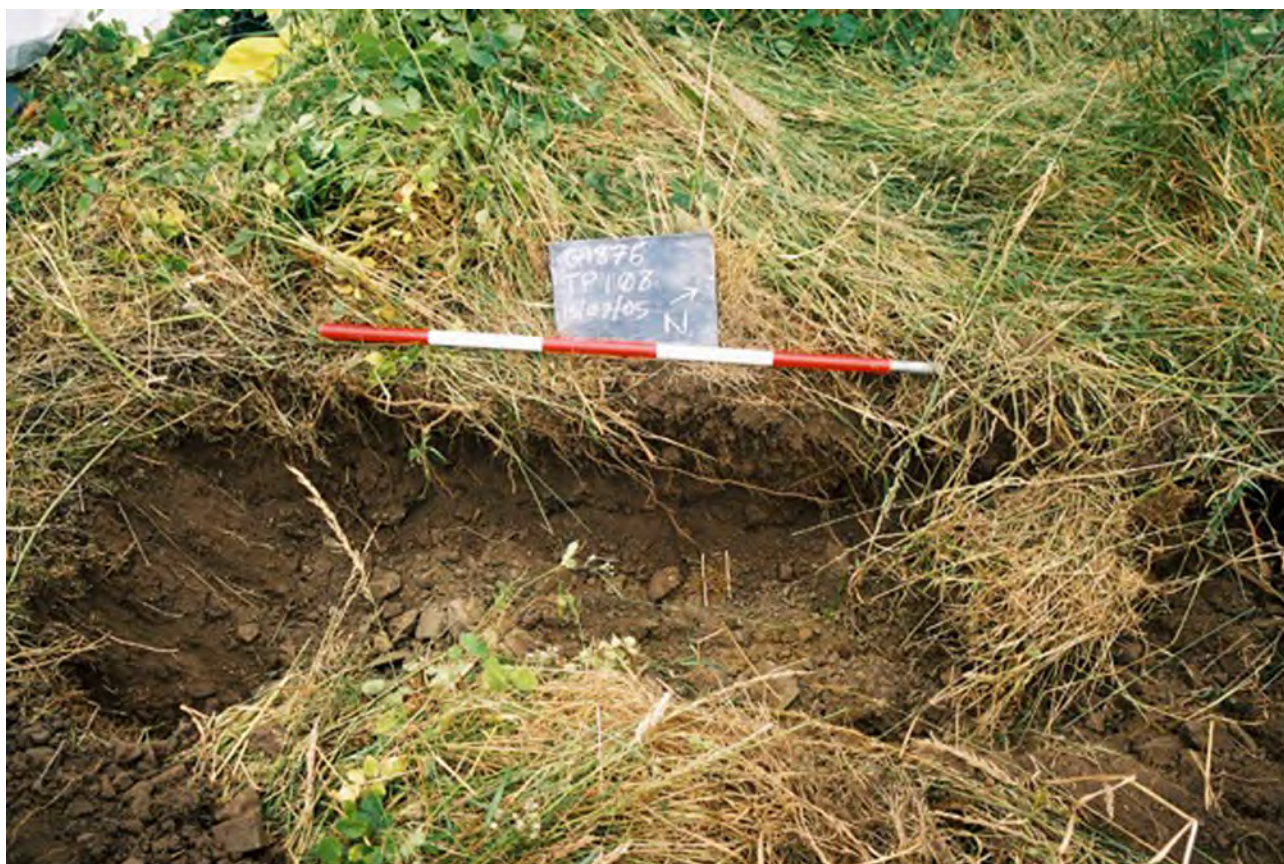
Plate 8. Test Pit 108

Size: 1.20m x 0.60m x 3.40m (l x w x d)

The topsoil was extant to a depth of 0.40m and comprised mid-brown silty topsoil; this was followed by yellow-grey glacial silt, 0.50m deep; this was followed by glacial clay 2.50m deep. Bedrock was identified at 3.40m.

The test pit was archaeologically sterile except for several sherds of modern glazed pottery indicative of farming activity.

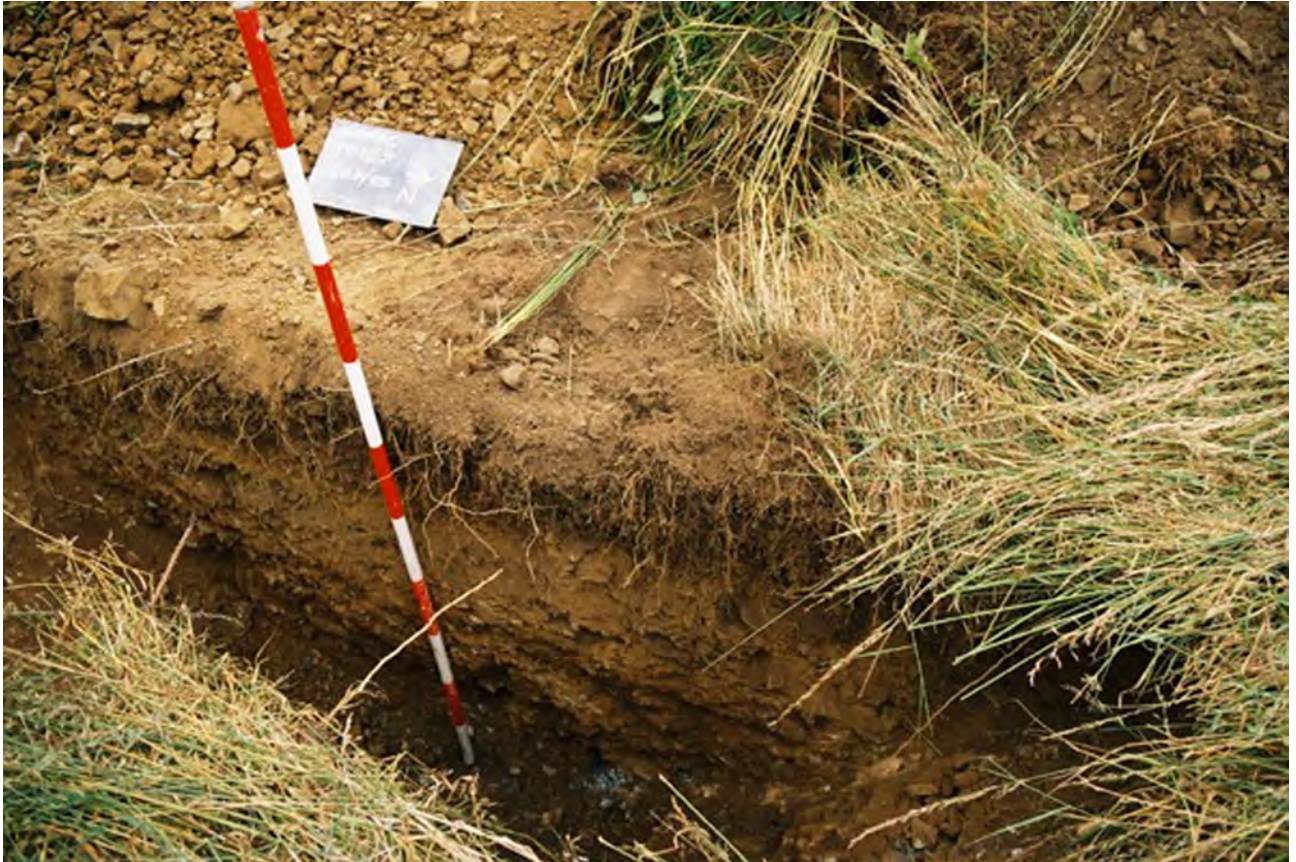
Plate 9. Test Pit 109

Size: 1.20m x 0.60m x 1.80m (l x w x d)

The topsoil was extant to a depth of 0.30m and comprised bioturbated mid-brown silty topsoil; this was followed by stone-rich glacial silt, 0.40m deep; this was followed by glacial clay 1.10m deep. Bedrock was identified at 3.40m.

The test pit was archaeologically sterile except for several sherds of modern glazed pottery indicative of farming activity.

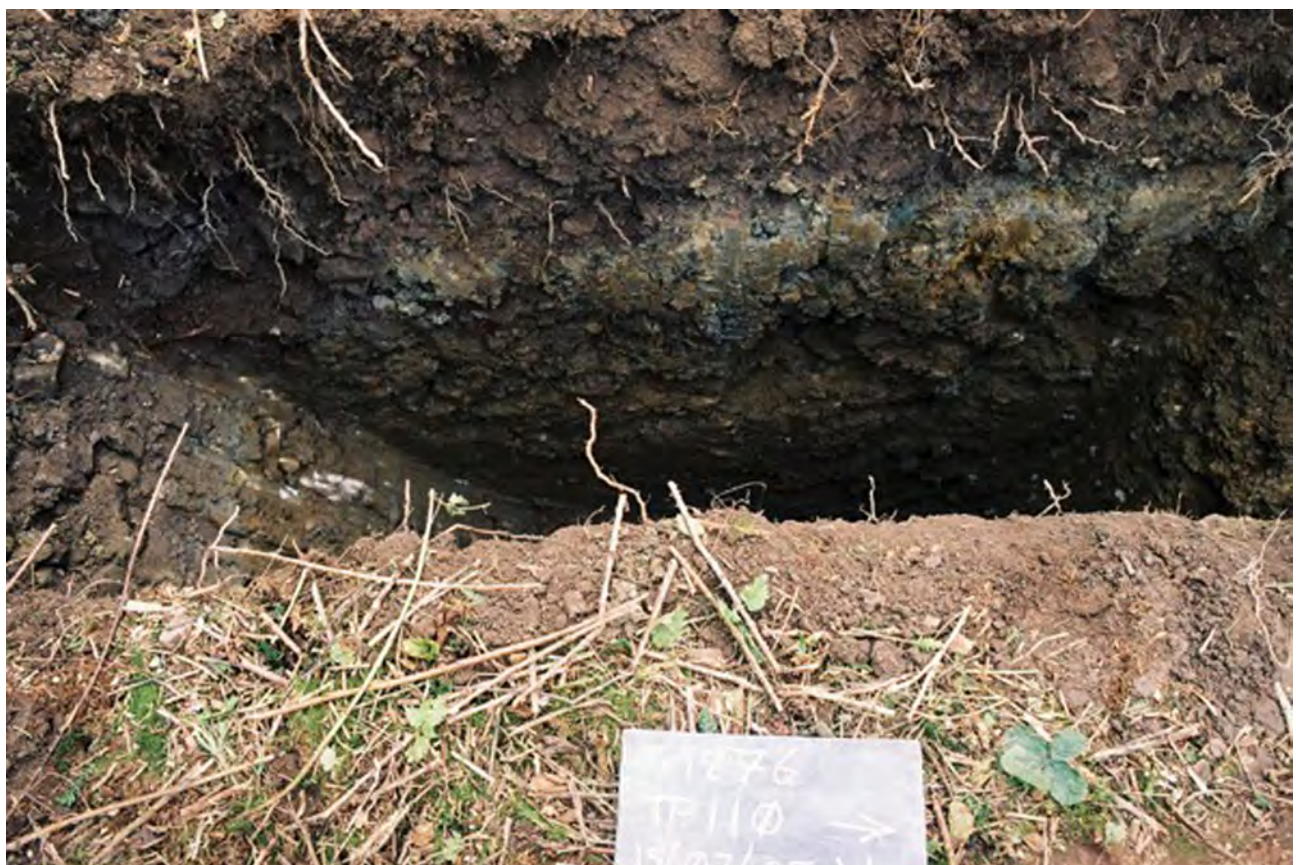
Plate 10. Test Pit 110

Size: 1.20m x 0.60m x 2.20m (l x w x d)

The topsoil was extant to a depth of 0.50m and comprised mid-brown silty topsoil; this was followed by stone-rich glacial silt, 0.40m deep; this was followed by glacial clay 1.70m deep. Cutting the glacial clay was a linear ditch with a U-shaped profile filled with small sub-angular stones and dark humic matter. Bedrock was identified at 2.20m.

The linear feature was identified as a drainage ditch. A fragment of roofing slate was recovered from the fill, suggesting that the feature was post-medieval in date, associated with the farm. Whilst the field did not appear to suffer from poor drainage, the ditch was located at the base of a shallow north to south slope, running in an east to west direction, suggesting it was located to accommodate the water running down the slope.

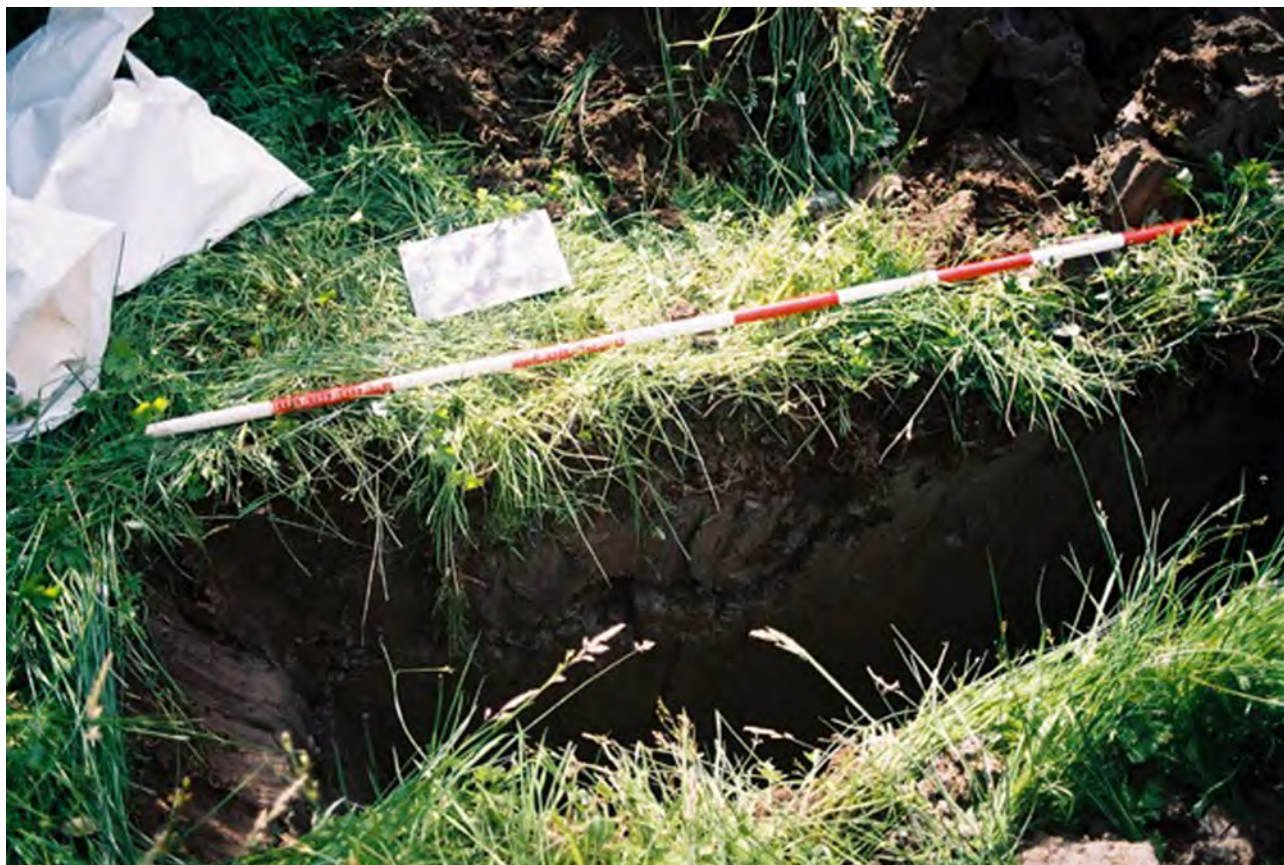
Plate 11. Test Pit 111

Size: 1.20m x 0.60m x 3.50m (l x w x d)

The topsoil was extant to a depth of 0.25m and comprised mid-brown silty topsoil; this was followed by glacial clay, 3.15m deep; this was followed by glacial clay 1.10m deep. Bedrock was identified at 3.40m.

The test pit was archaeologically sterile. This was the only test pit within the Carreg Hwfa farmland. The field appeared to have been used for little more than pasture and was generally flat in profile, with no obvious scarps, ditches or boundaries.

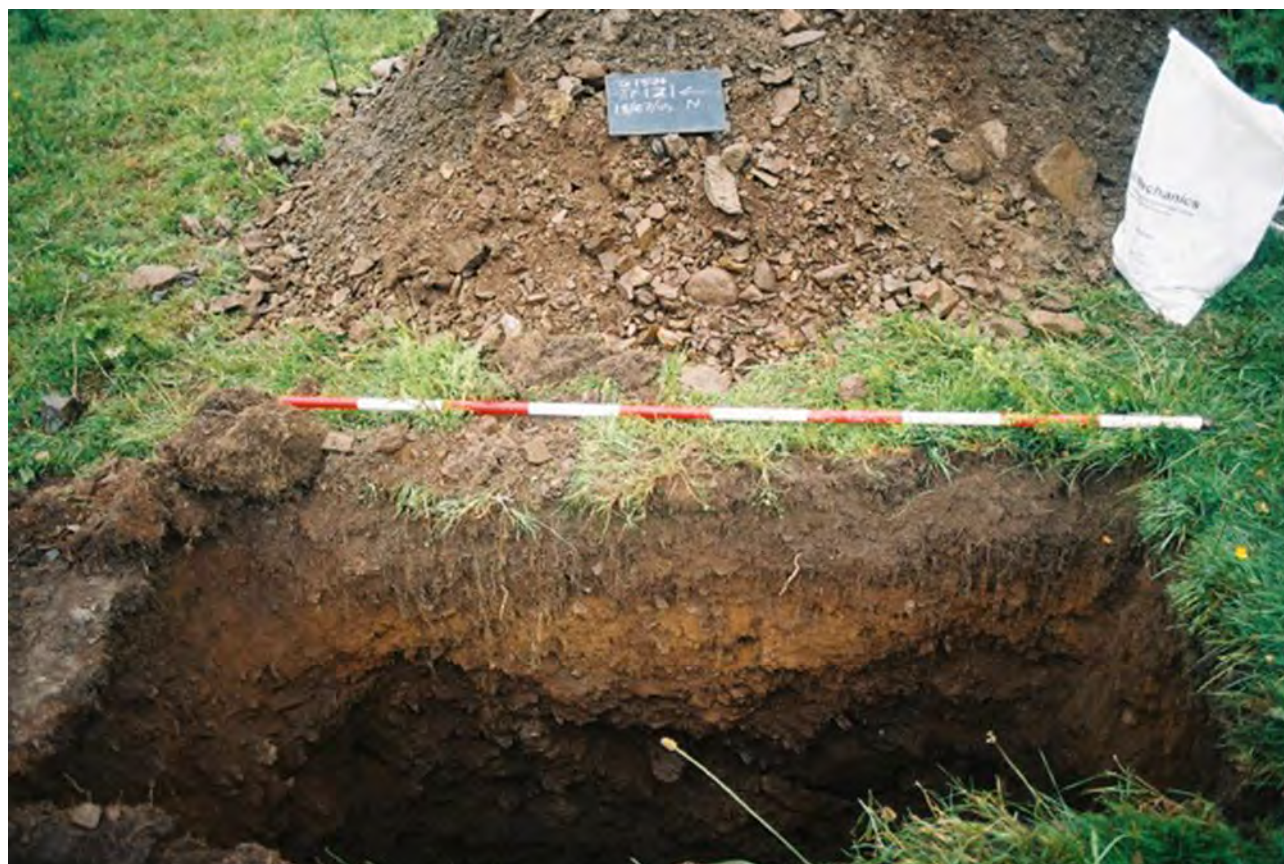
Plate 12. Test Pit 121

Size: 1.20m x 0.60m x 2.00m (l x w x d)

The test pit was located at the base of a steep south to north slope, close to a narrow, culverted stream and sinkhole. The ground had generally good drainage. There was no visual evidence for unusual scarps, ditches or anything else suggestive of archaeology. It was assumed, however, that the pit would contain extensive colluvial deposits that could mask any potential features. The topsoil was extant to a depth of 0.30m, followed by a 0.50m thick deposit of colluvium; below this was a series of glacial sands extant for the remaining 2.40m. Bedrock was identified at 3.00m.

The test pit was archaeologically sterile save for two fragments of modern glass in the topsoil.

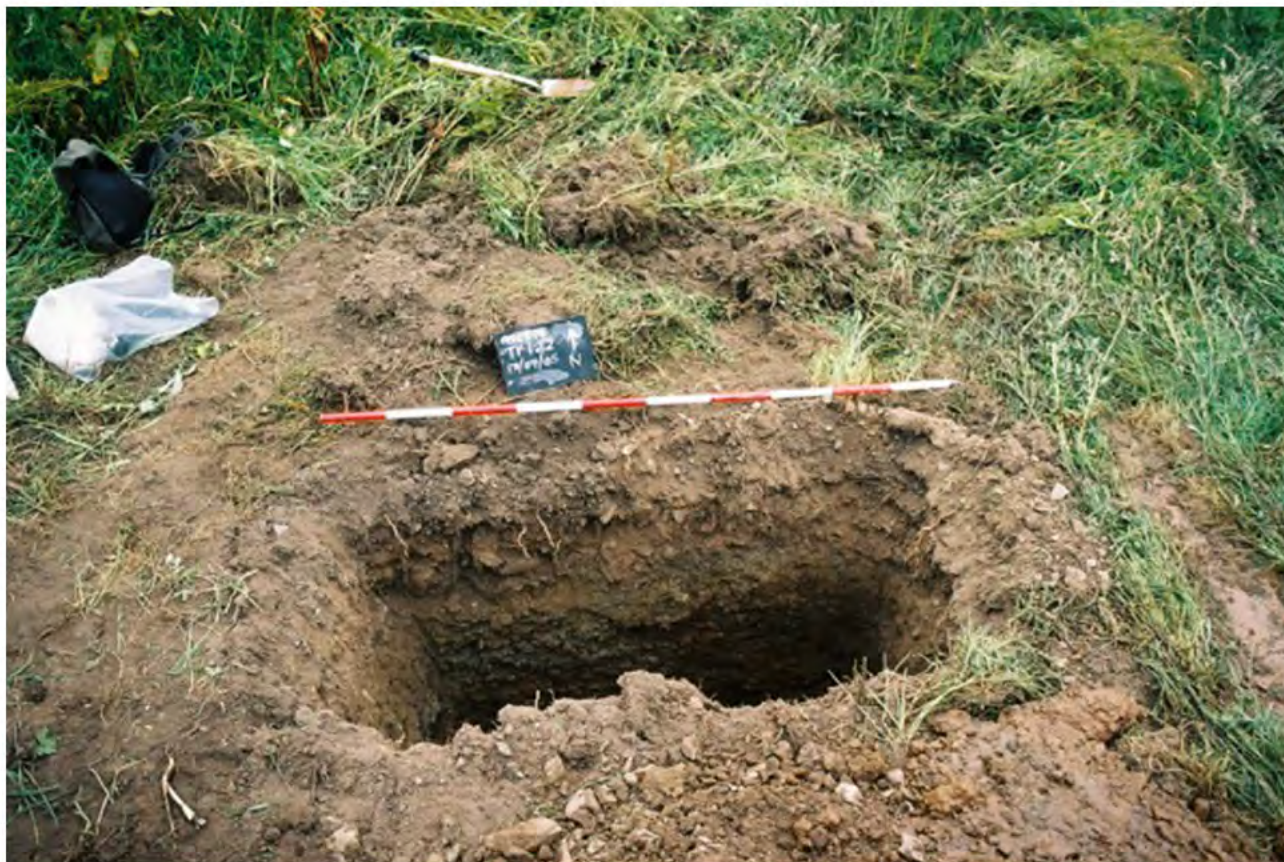
Plate 13. Test Pit 122

Size: 1.20m x 0.60m x 3.00m (l x w x d)

This test pit was located c.10.0m west of Test Pit 121 in an area with good drainage. The area was heavily overgrown with weeds making a preliminary inspection difficult. The topsoil was extant to a

depth of 0.50m and contained fragments of shale and sub-rounded stone. Below the topsoil was a 0.30m thick deposit of yellow-grey topsoil that appeared to contain iron panning, indicative of waterlogging. Below this deposit was a 2.00m thick deposit of glacial silts. The bedrock was identified immediately below this at a mean depth of 2.80m.

The test pit was archaeologically sterile save for several sherds of modern glazed pottery.

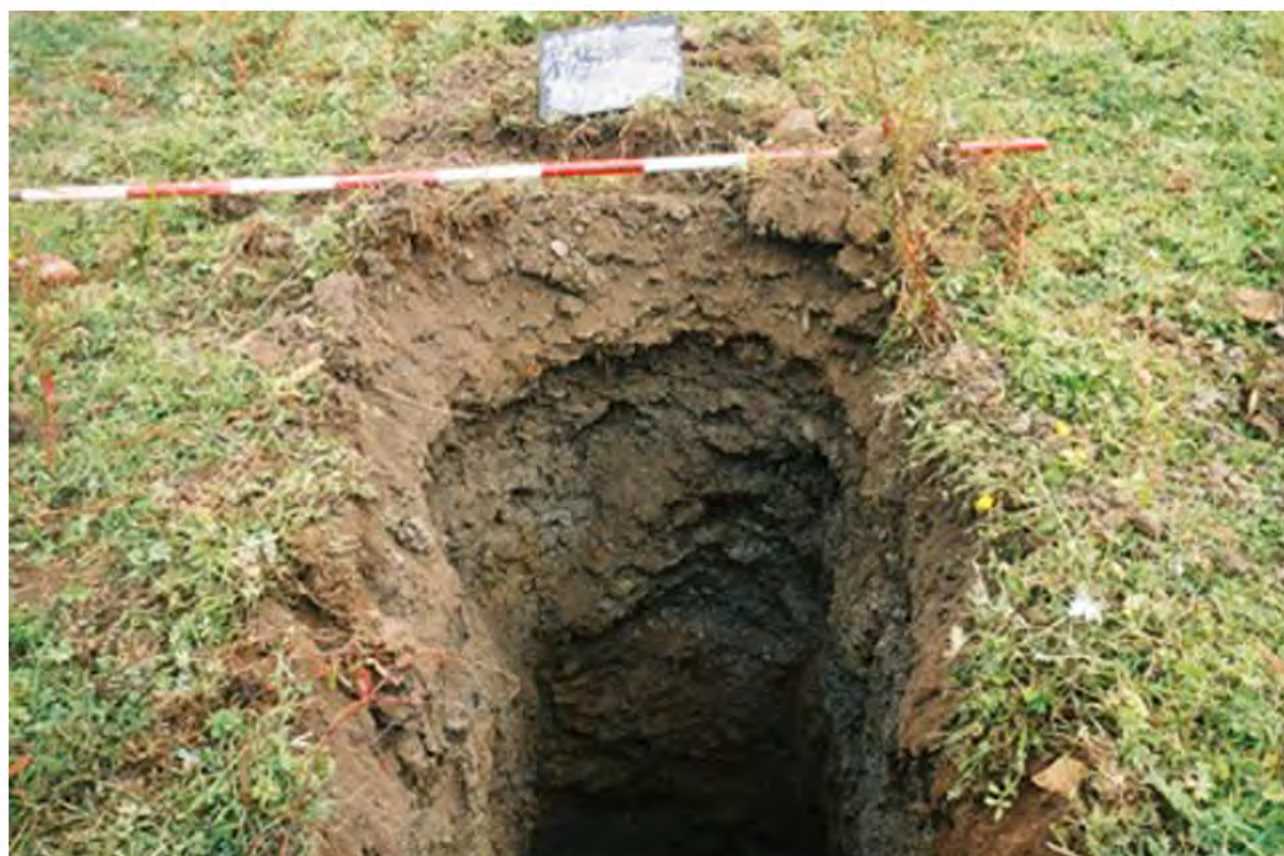
Plate 14. Test Pit 123

Size: 1.20m x 0.60m x 3.70m (l x w x d)

This test pit was located c.10.0m to the southwest of Test Pit 121 and c.5.0m to the southeast of Test Pit 122. The topsoil was shallow, only 0.20m in depth, with inclusions of shale fragments. The subsoil below this was similar to that in Test Pit 122, in containing evidence of iron panning and waterlogging. The subsoil was extant to a depth of 0.30m. Below the subsoil was a 3.20m thick deposit of glacial silts. The bedrock was identified at a depth of 3.70m

The test pit was archaeologically sterile save for several sherds of modern glazed pottery.

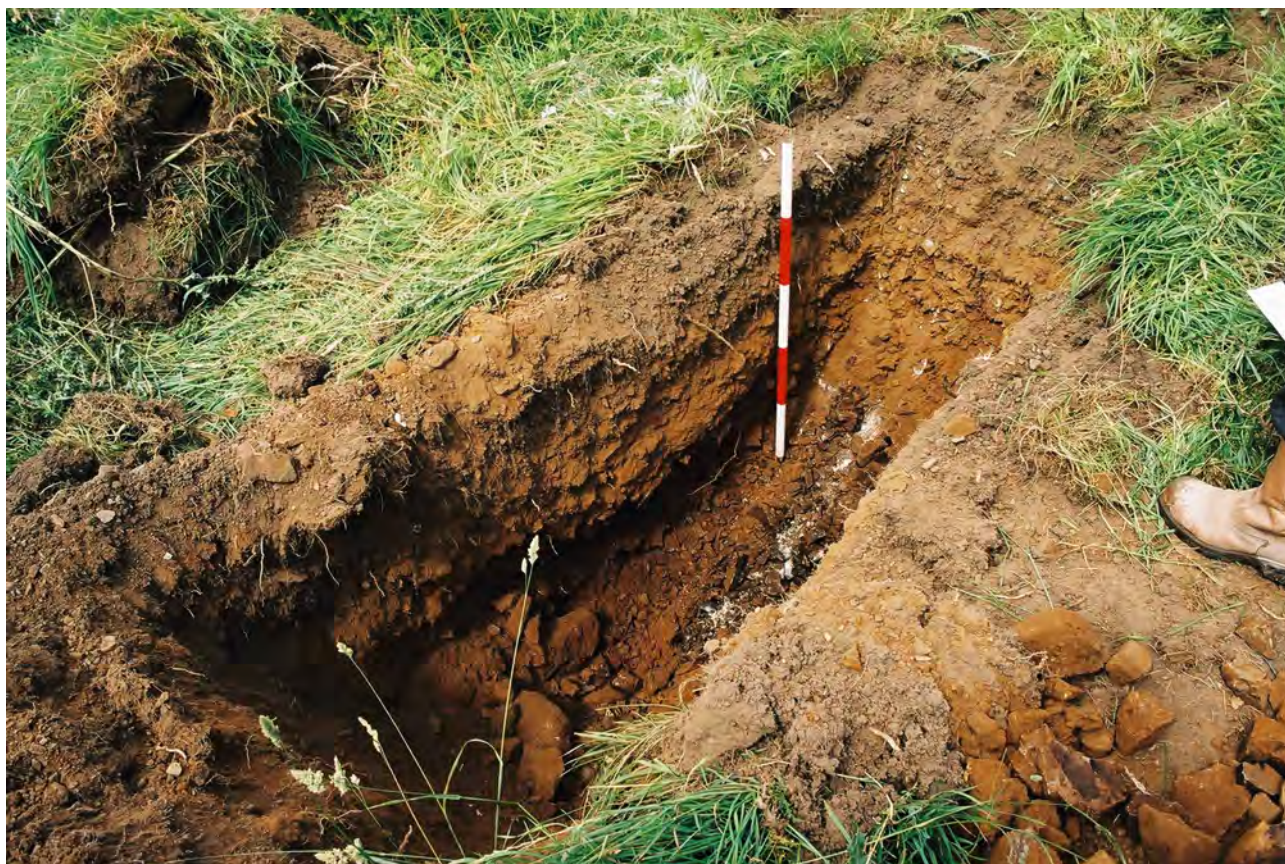
Plate 15. Test Pit 124

Size: 1.20m x 0.60m x 2.00m (l x w x d)

The topsoil in this test pit was similar to that identified in Test Pit 123. Below the topsoil was a 0.45m thick deposit of orange-brown subsoil with frequent inclusions of shale fragments. Below the subsoil was a 0.75m thick deposit of fragmented bedrock mixed with a silty-loam. Bedrock was identified at a depth of 2.45m

The test pit was archaeologically sterile save for a sherd of nineteenth century glazed pottery.

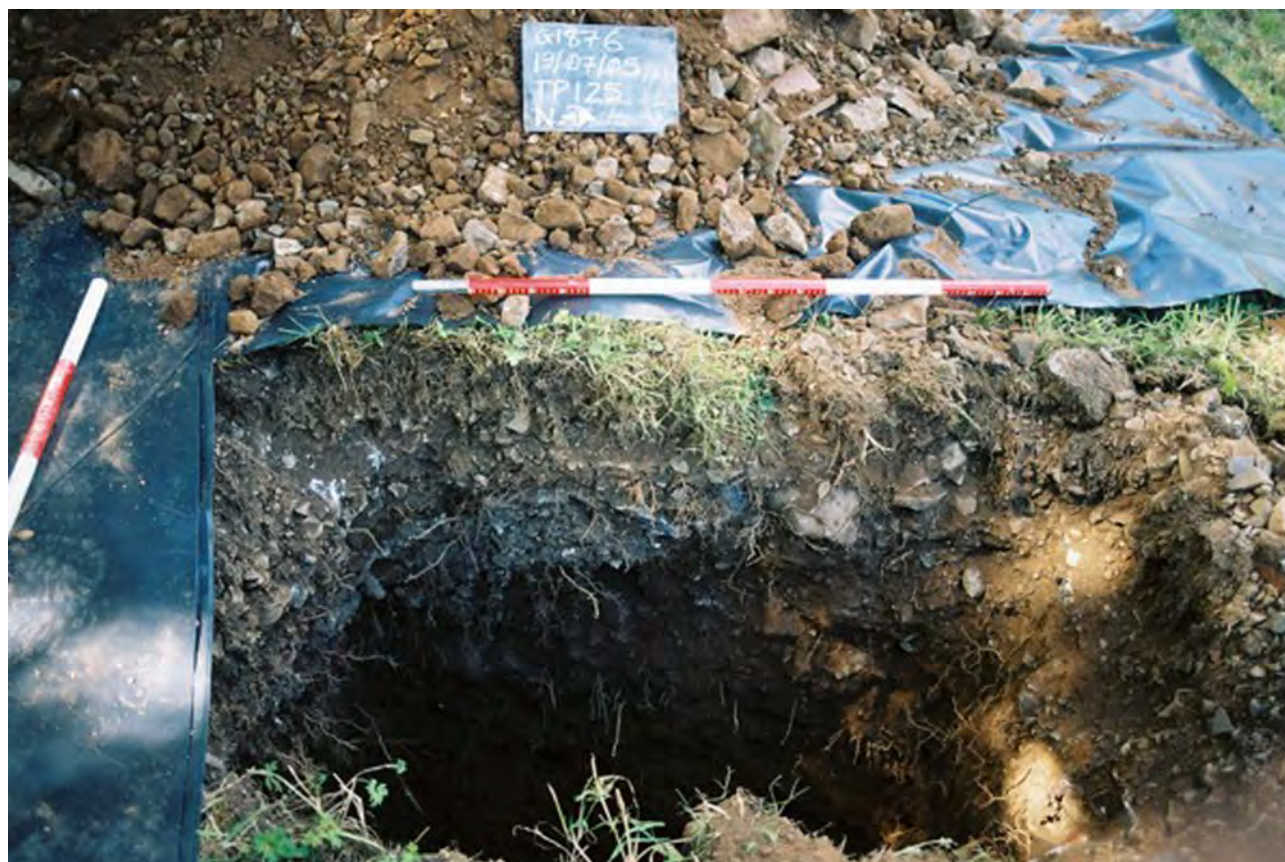
Plate 16. Test Pit 125

Size: 1.20m x 0.60m x 2.30m (l x w x d)

This test pit was located to the west of the Hendrewen field in the grounds of a private house. The house was not extant on any maps but the owner said it had been constructed in 1990. To the immediate south of the test pit was a pronounced bund that was deposited when the house was built. The test pit was located halfway up a relatively steep southeast to northwest facing slope. The test pit contained extensive deposits of brick fragments, mortar and slate, extant to a maximum depth of 0.50m, which had been tipped from the north. The material was twentieth century in origin, as suggested by the inclusion of frogged brick. There was also a large slab of grano-concrete in the northeastern corner of the test pit. The bucket of the backhoe could not remove the concrete as it continued past the limits of the pit. This suggested that the demolition deposit continued for some distance down the slope. Below the demolition layers was a deposit of mid-brown loam, c.0.8m thick at its deepest point, which was followed by a 1.30m thick deposit of glacial silts. The bedrock was identified at 2.30m.

It was not possible within the parameters of the test pit to determine whether the demolition material was associated directly with the building of the house, but it was apparent that the material was deposited to reduce the angle of the slope slightly (it was assumed, also, that the mid-brown loam below the demolition material was the original topsoil level). It was not thought that the material was from an earlier structure on the property, however, as there was no documentary evidence to support this.

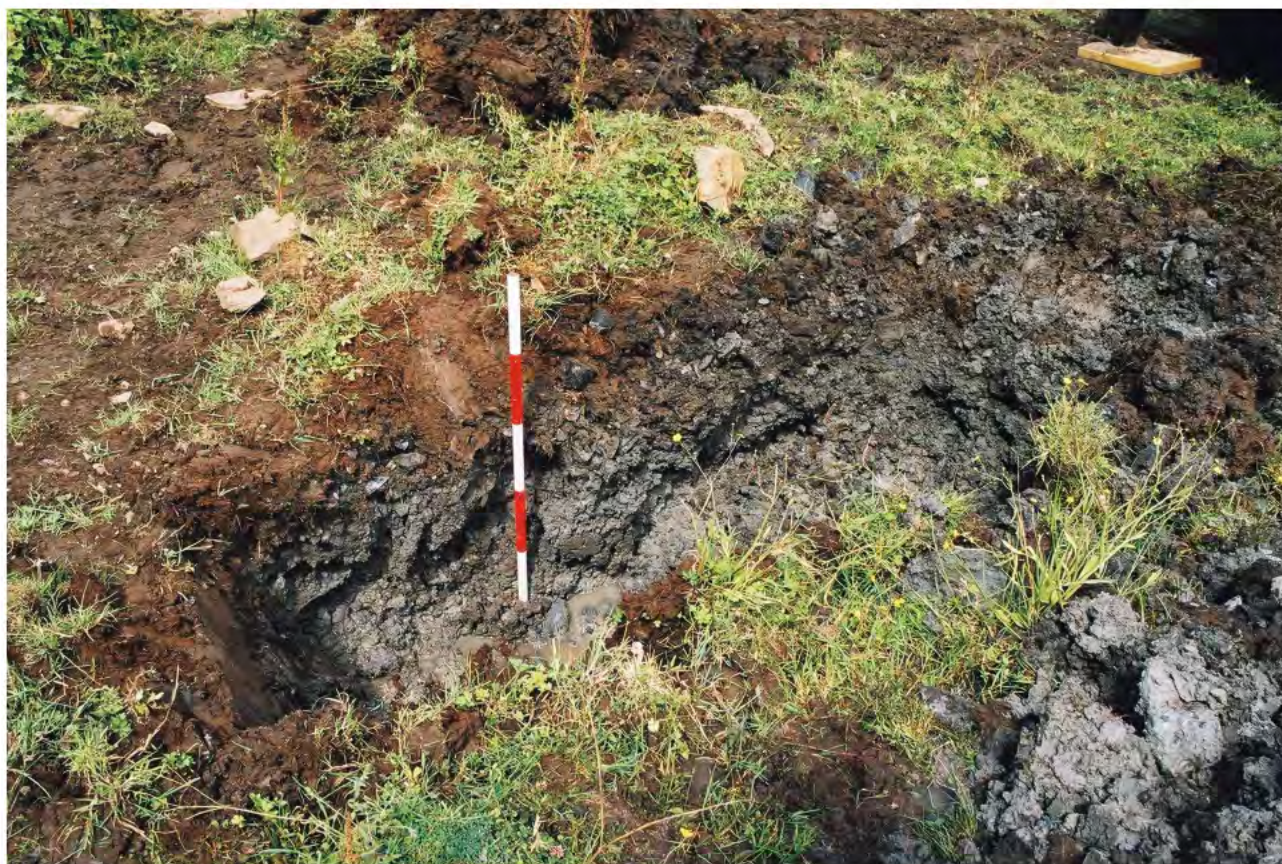
Plate 17. Test Pit 126

Size: 1.20m x 0.60m x 2.00m (l x w x d)

The topsoil was extant to a depth of 0.25m and contained a corroded 2.54cm wide iron water pipe that would originally have fed from the stream. Mixed into the topsoil were fragments of brick and slate as well as sherds of modern glazed pottery. Below the topsoil were a series of glacial silts. The bedrock was identified at a depth of 2.20m.

The test pit was archaeologically sterile save for twentieth century building material and a water pipe associated with the farm.

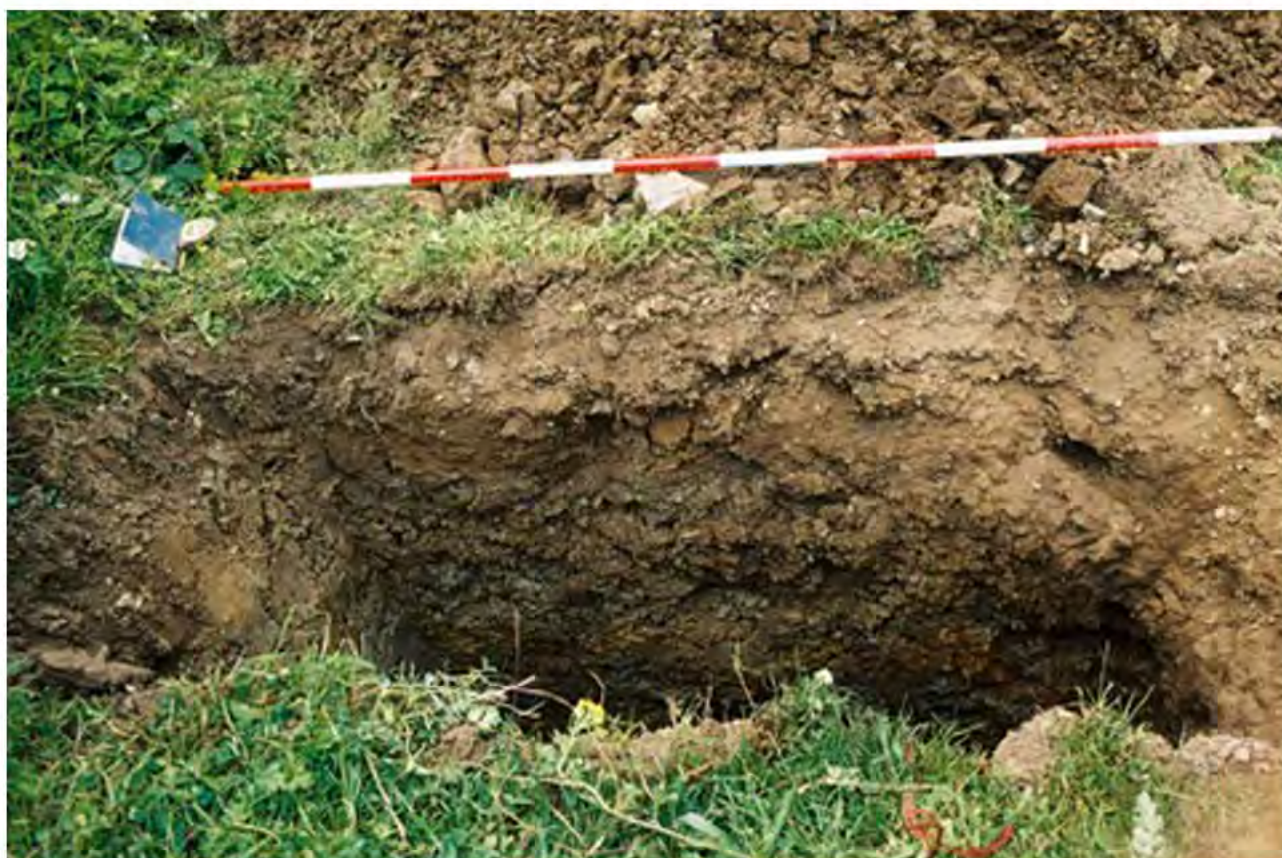
Plate 18. Test Pit 128

Size: 1.20m x 0.60m x 2.00m (l x w x d)

The test pit was located within an area of poor drainage, c.10-12 metres east of the stream. The topsoil was extant to a depth of 0.25m, below was a series of glacial silts, included in which were possible carboniferous remains.

The test pit was archaeologically sterile save for a sherd of white glazed modern pottery and a lump of coal.
