CONSTRUCTION OF A NEW POLICE STATION ON THE SITE OF THE BISHOP'S PALACE, BANGOR

ARCHAEOLOGICAL WATCHING BRIEF 2004 – 2005

GAT Project No. G1785

Report No. 600

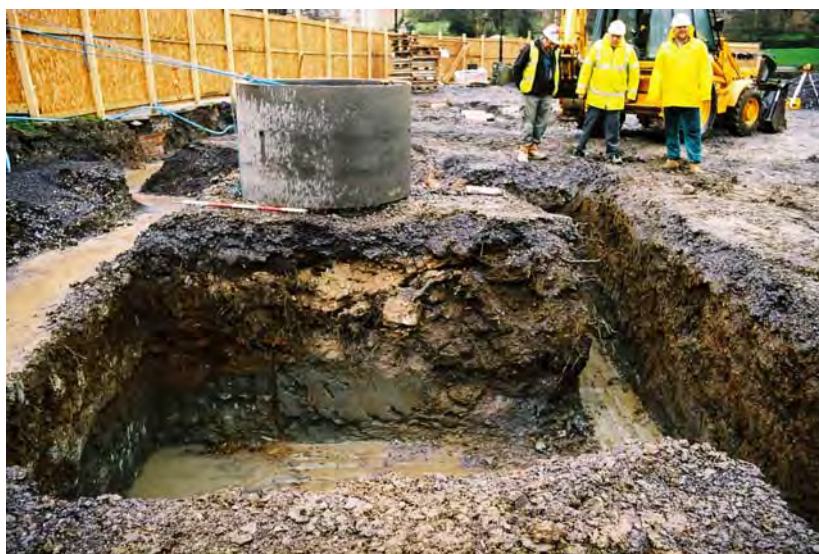
Cover: 16th century ditch and later garden perimeter wall exposed in section at the east side of the site.
From the north-west. 1m scale. 5th January 2005

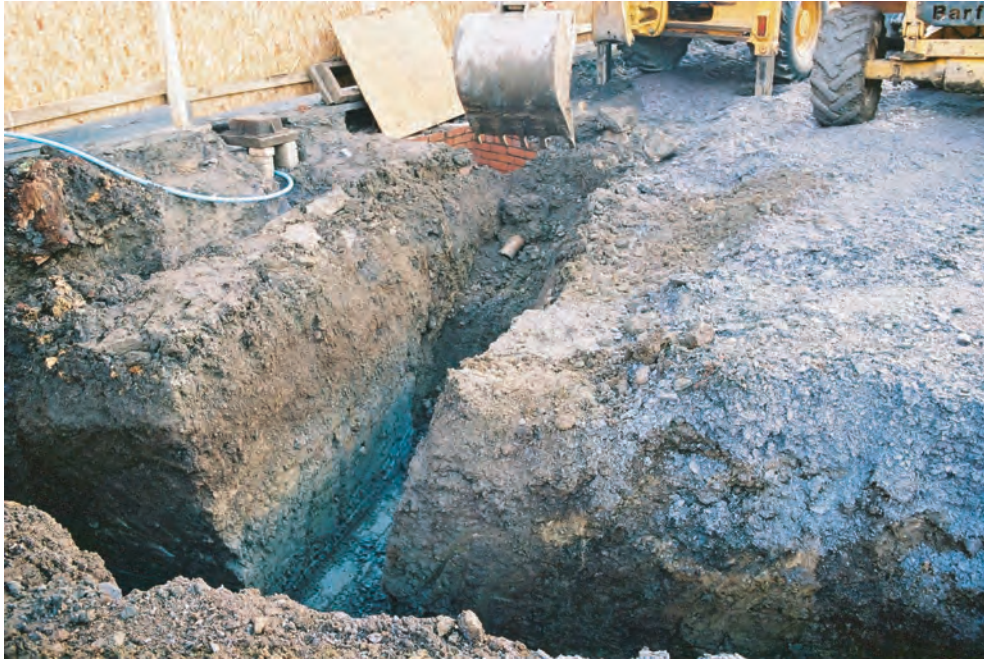
Bangor Bishop's Palace Archaeological Watching brief
 Fig. 3 Subsoil section at the east edge of the site, beneath former pavement. From north-west

5.3 At the east side of the site, in the area that was not available for excavation in 2004, the foundation trenches for the east side of the Office/Admin and Reception areas (Fig. 2) revealed a layer of fine gravel at -0.4m to -0.8m (Fig. 3). This is likely to be the same as layer 317 at the east side of Trench 8 excavated in 2004. This was a dense gravelly layer with an iron-panned surface, quite different to any other layers or natural subsoil encountered on the site. It was interpreted as possibly a road surface belonging to a road oriented north-south at the east side of the place, shown on Speed's map of Bangor of 1610, prior to the construction of the extensive palace outbuildings in the 18th and 19th century.

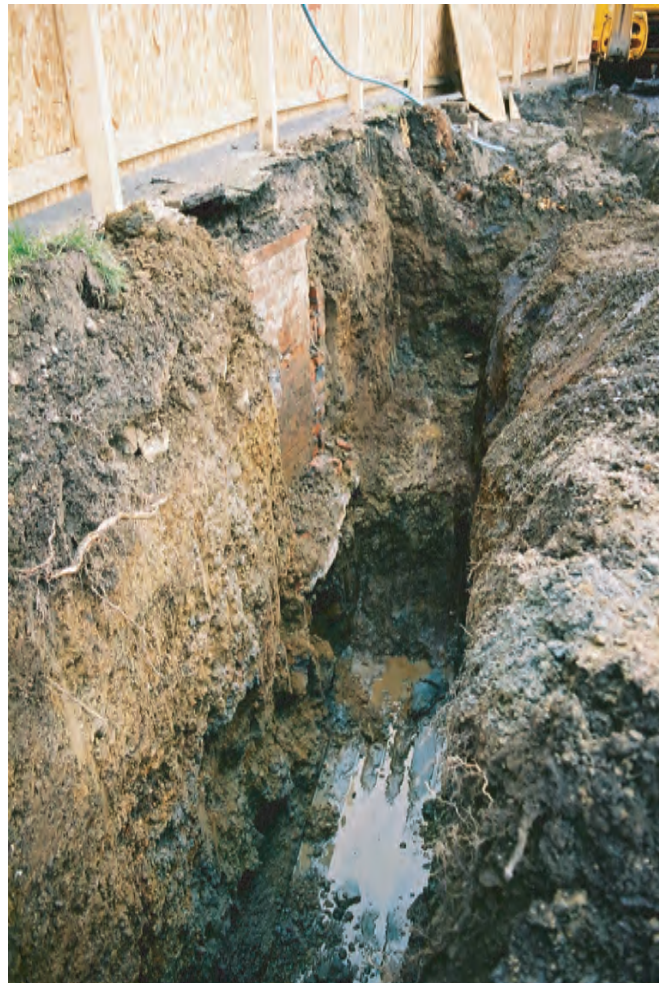
Bangor Bishop's Palace Archaeological Watching brief
 Fig. 4 Early 20th C sewer-cut beneath brick-built inspection chamber at the east edge of the site. From the north-west.

5.4 Foundation trenching at the east side of the site also removed two brick-built inspection chambers (Figs 3 and 4) belonging to two east-west sewers from the palace/town hall that were located in 2004 (Fig. 2). These sewers belong with the improvements carried out when the former Bishop's Palace land and buildings were acquired by Bangor City Council, c. 1900 (Roberts 1994, 38).

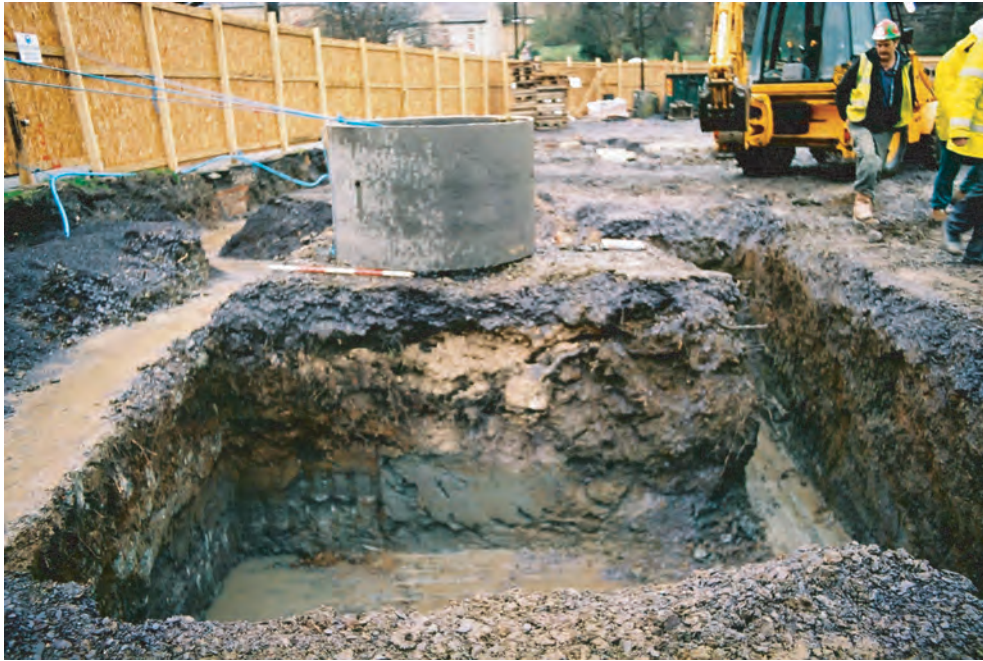
Bangor Bishop's Palace Archaeological Watching brief
 Fig. 5 16th century ditch and later garden perimeter wall exposed in section at the east side of site.
 From the north-west. 1m scale.

5.5 In one place a larger area than elsewhere was excavated to provide a concrete base for the Armoury (Fig. 2). This happened to cut across the line of a ditch and wall that were excavated and recorded in 2004. The wall was identified as a garden wall belonging to the later Bishop's Palace in the 17th-18th century. This had been built on the same line of an earlier ditch, which had probably also been a boundary, and which was dated to the 16th century on the basis of a large, fresh fragment of an imported German beer tankard from the base of the ditch, which also produced a carved wooden bowl or jug cover. The wall and ditch could be seen in cross-section (Figs 5 and 6) but no further artefacts were found. By a strange coincidence the concrete base for the armoury lay close to the position of a concrete block foundation found in 2003-4, which was identified as the base for a World War I tank, displayed there as a war monument until about 1937.

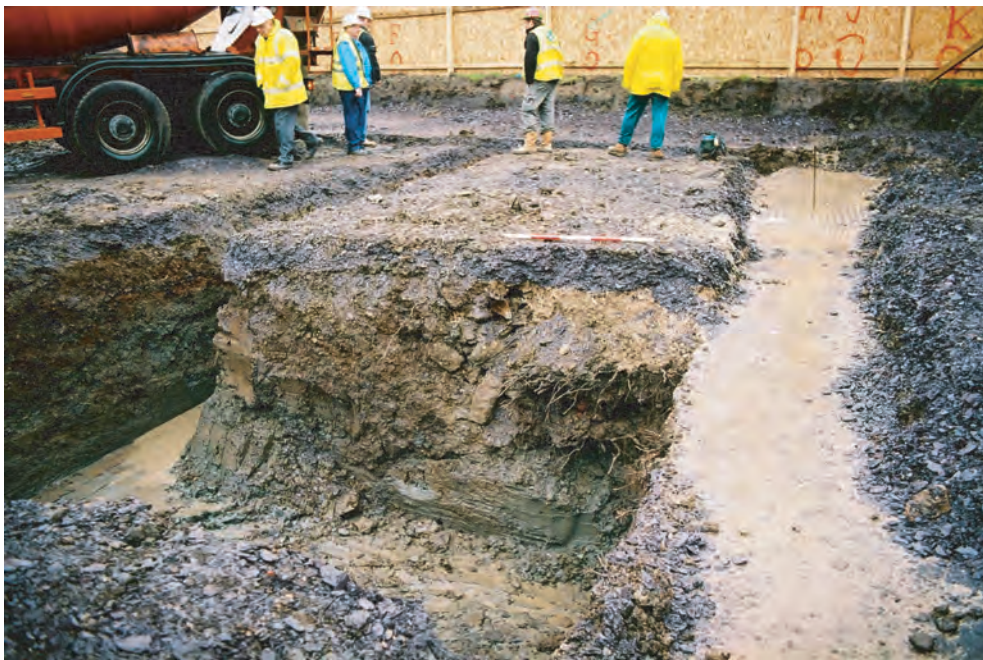
Bangor Bishop's Palace Archaeological Watching brief
 Fig. 6 16th century ditch and later garden perimeter wall exposed in section at the east side of site.
 From the south-east. 1m scale.

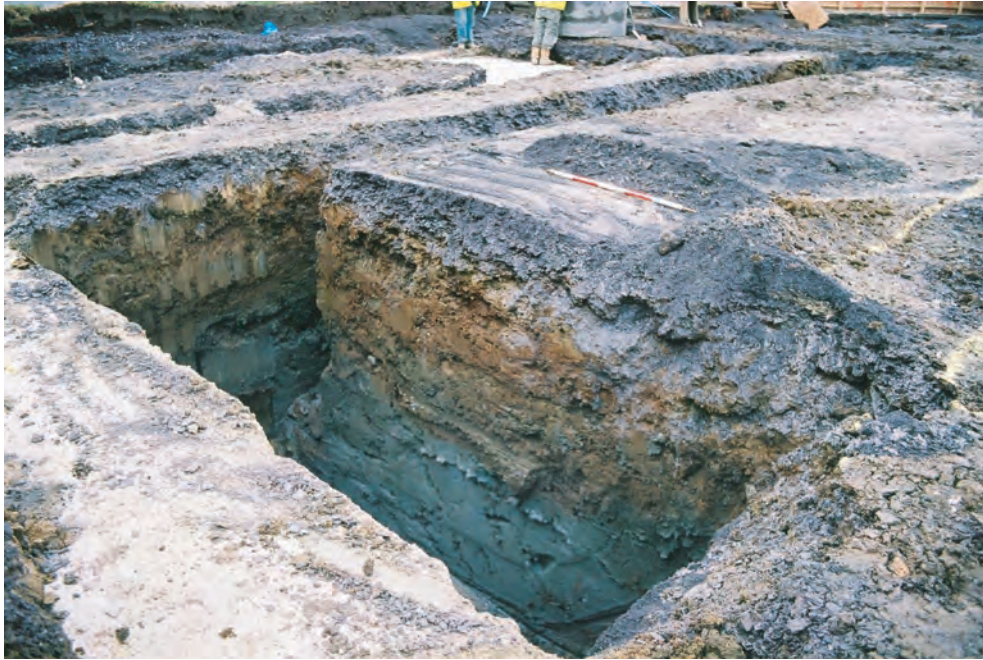
Bangor Bishop's Palace Archaeological Watching brief
 Fig. 7 General cross-section of subsoil in the centre of the site. From the north-west. 1m scale.

5.6 Trenching across the centre of site provided some good sections through the subsoil there (Figs 7-8), of which only the surface had been revealed during excavations in 2004, and so provides some information about the geomorphological history of the Adda Valley. The surface revealed then had been yellow-buff silty clay. This was the weathered surface of a deeper orange-brown stony clay horizon with patches of iron staining and panning. It was clearly not a fluvial deposit and may have resulted from slumping of fluvio-glacial deposits from the valley sides. This horizon overlies a deep, blue-grey clay, a layer that had also been encountered in 2004 at the base of a possibly Medieval drainage ditch, the deepest feature excavated in trench 6 (Fig. 2). This layer appears to be an estuarine rather than river deposit and may date from the later Post-Glacial period when sea-level temporarily rose above that of the present day.

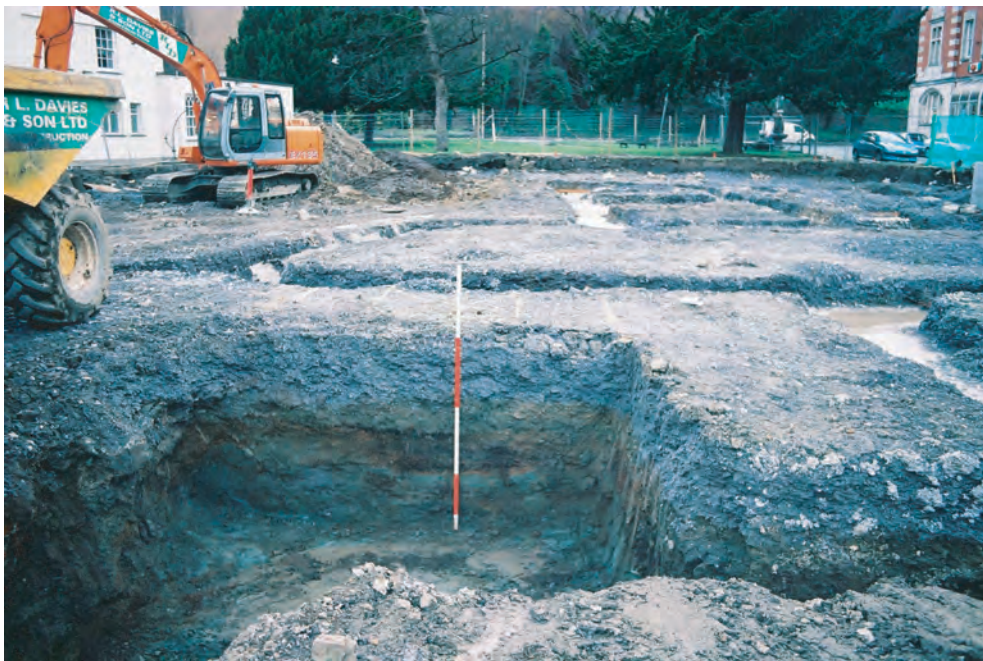
Bangor Bishop's Palace Archaeological Watching brief
 Fig. 8 General cross-section of subsoil at the south end of the site. From the south. 2m scale.

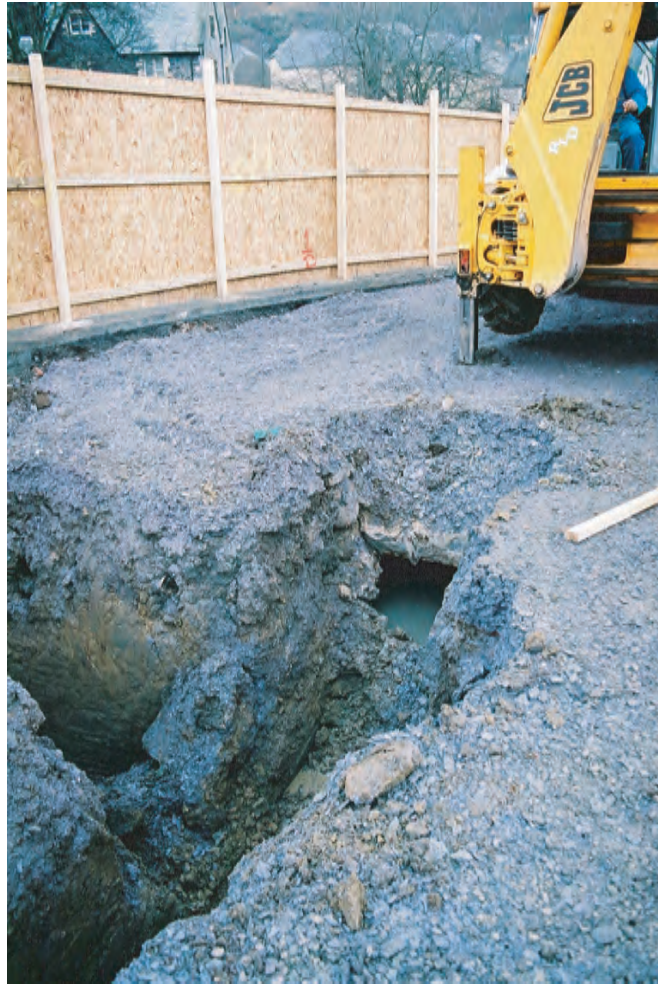
Bangor Bishop's Palace Archaeological Watching brief
Fig. 9 Water-filled brick tank or cellar at east side of site. From the north-west.

5.7 Excavation of foundations around the entrance to the new building at the south-east part of the site (Fig. 2) broke into a small water-filled underground tank or chamber (Fig. 9). This was built of bricks with a brick-vaulted ceiling. When fully revealed, during removal it proved to be only about 1m square. After construction the backfill around the structure had included a good deal of broken pottery, including coarse earthenware as well as finer cream tableware. A sample was collected. This was similar in type to crockery found during the 2004 excavations, in the backfill of an internal (sink?) drain at the east end of the former palace outbuilding at the west end of Trench 6 (a scullery). The pottery was interpreted as rubbish from the palace dumped either during 19th century renovations or when the buildings were taken over by Bangor City Council c. 1900 and presumably subject to alterations and renovations. This would have involved insertion of new drains and sewers. One of the drains was in the yard north of the former palace coach-house at the south-east of the site and this drain emptied into the brick-vaulted tank (Fig. 2), which was therefore also of the same date, presumably connecting with the sewer found further to the north.

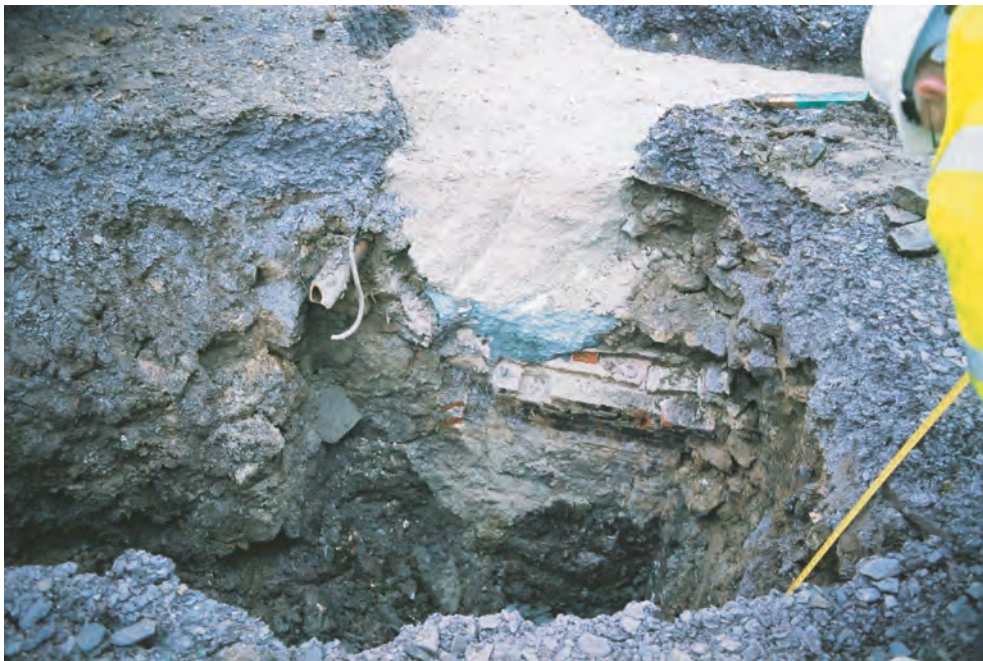
Bangor Bishop's Palace Archaeological Watching brief
Fig. 10 Water-filled brick tank at the south-east side of the site, showing surrounding backfill. From the south.
