Anglesey Biogas, Gwalchmai Anglesey

Archaeological Assessment

GAT Project No. 1882

Report No. 601

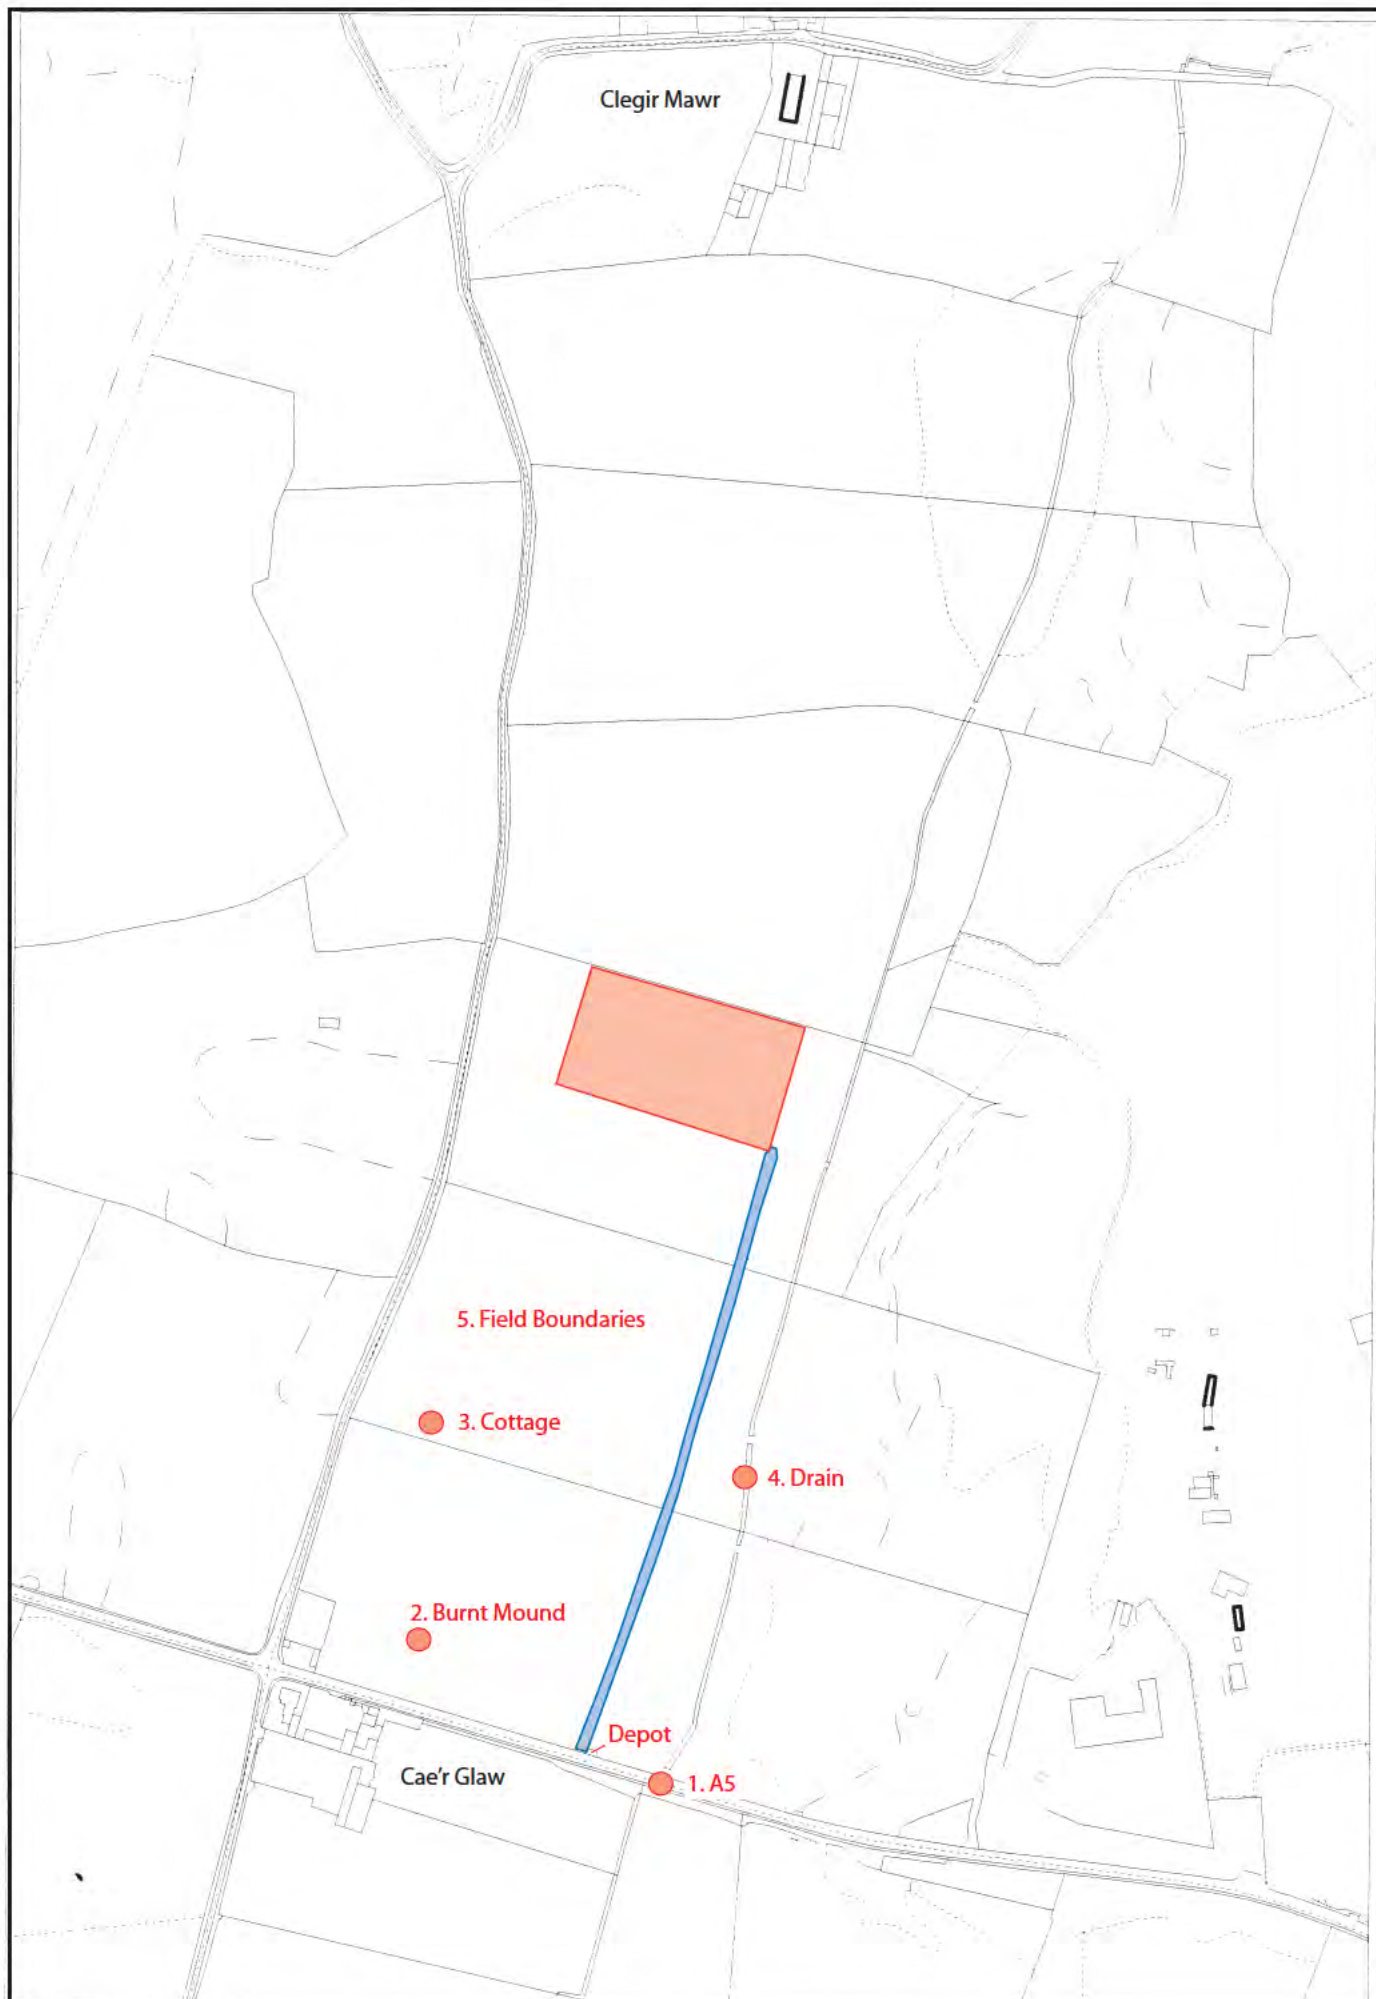
The following sites lie adjacent to the proposed development area and access road.

Figure 5. Map Showing sites Identified within the Study Area (Scale 1,3000)

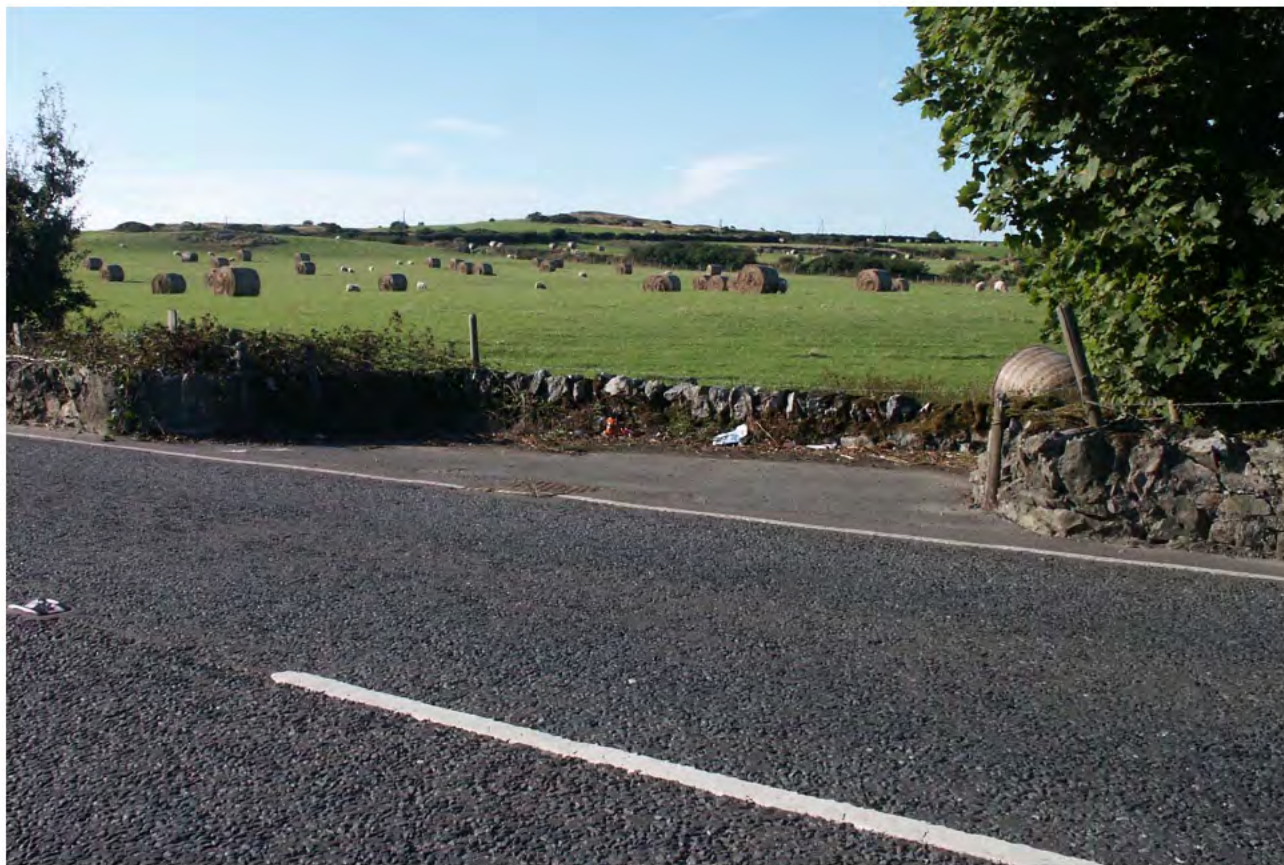
1. Telford's Holyhead Road

Category: B Impact: Slight

The access road to the site will lead off Telford's Holyhead road, requiring a new break to be made within the walling on the north side of the road. Though repaired in places, the masonry appears to be contemporary with the construction of the road. Telford ensured that adequate stone would be available for road repairs by building storage depots at regular intervals (generally no more than a quarter of a mile apart, to allow moving of materials in barrows) which were set out from the edge of the road. Each depot was designed to hold 24 cubic yards of stone (for details see Quartermaine *et al* 2003, 33). One such rectangular depot lies close to the proposed access route. East of the proposed access route the drain (site 4 below) passes under the road. It was not possible to gain access to examine the drain, but it may well be contemporary with the original construction of the road.

Plate 1. Feature 1. Telford's Holyhead Road.

1. Telford's Holyhead Road

The principal impact is likely to be on the parapet wall, where the proposed access road will require the creation of a new opening through the wall. It is recommended a basic record is made of the wall prior to the start of work, and any new work is undertaken in a matching style. It is recommended that the storage depot is avoided and left *in situ*.

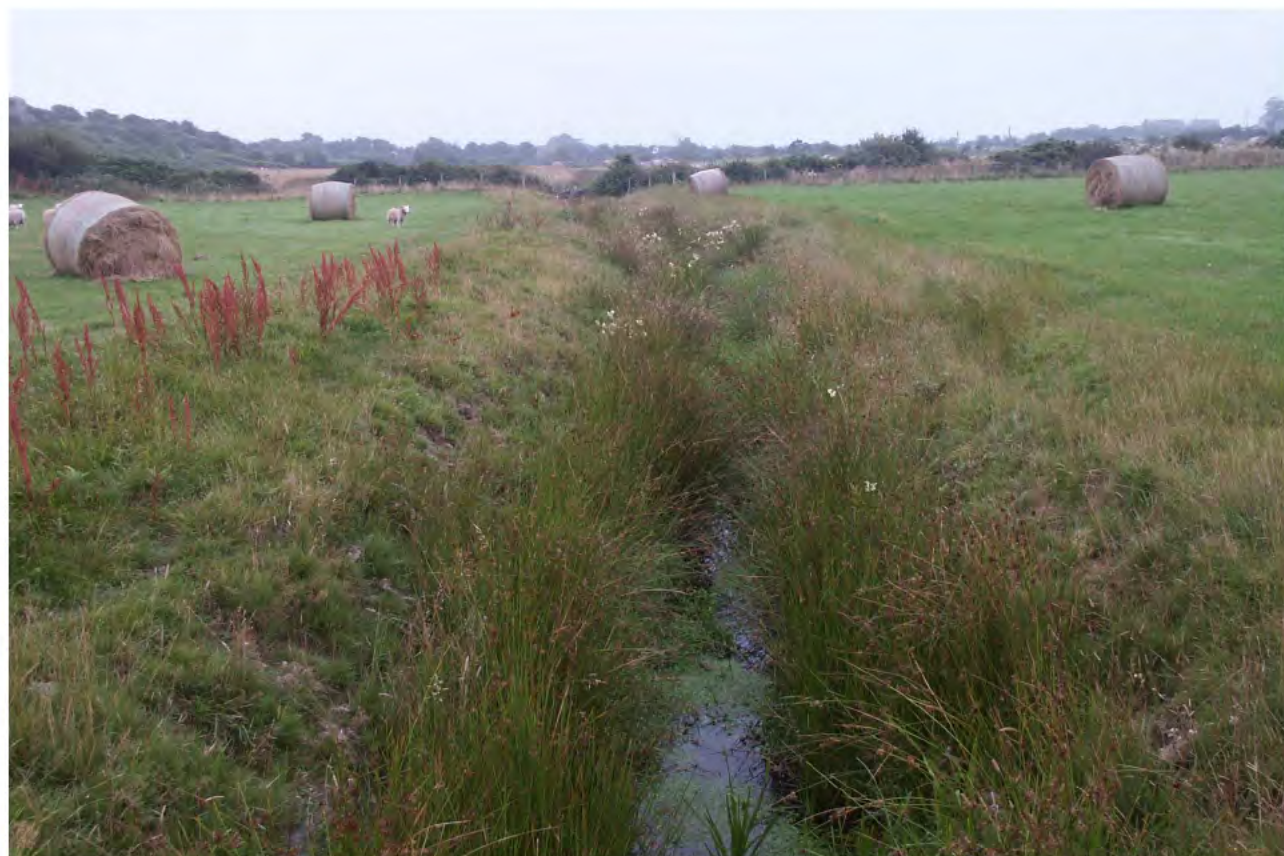
4. Drain or leat

Category: D Impact: None

The drain, though presumably following a natural water course as it runs along the bottom of the valley, appears to have been straightened and enhanced to allow it both to act as main drain, and to take water to the mill pond that served Strydan (see above).

Plate 2. Feature 4. Drain

4. Drain or leat

There is unlikely to be any direct impact upon the drain. A watching brief should be maintained during any works that may impact upon it directly.
