# WELLFIELD REDEVELOPMENT THE MENAI SHOPPING CENTRE BANGOR

## ARCHAEOLOGICAL MITIGATION PHASE 1: BUILDING RECORDING

G1880

Report number : 605

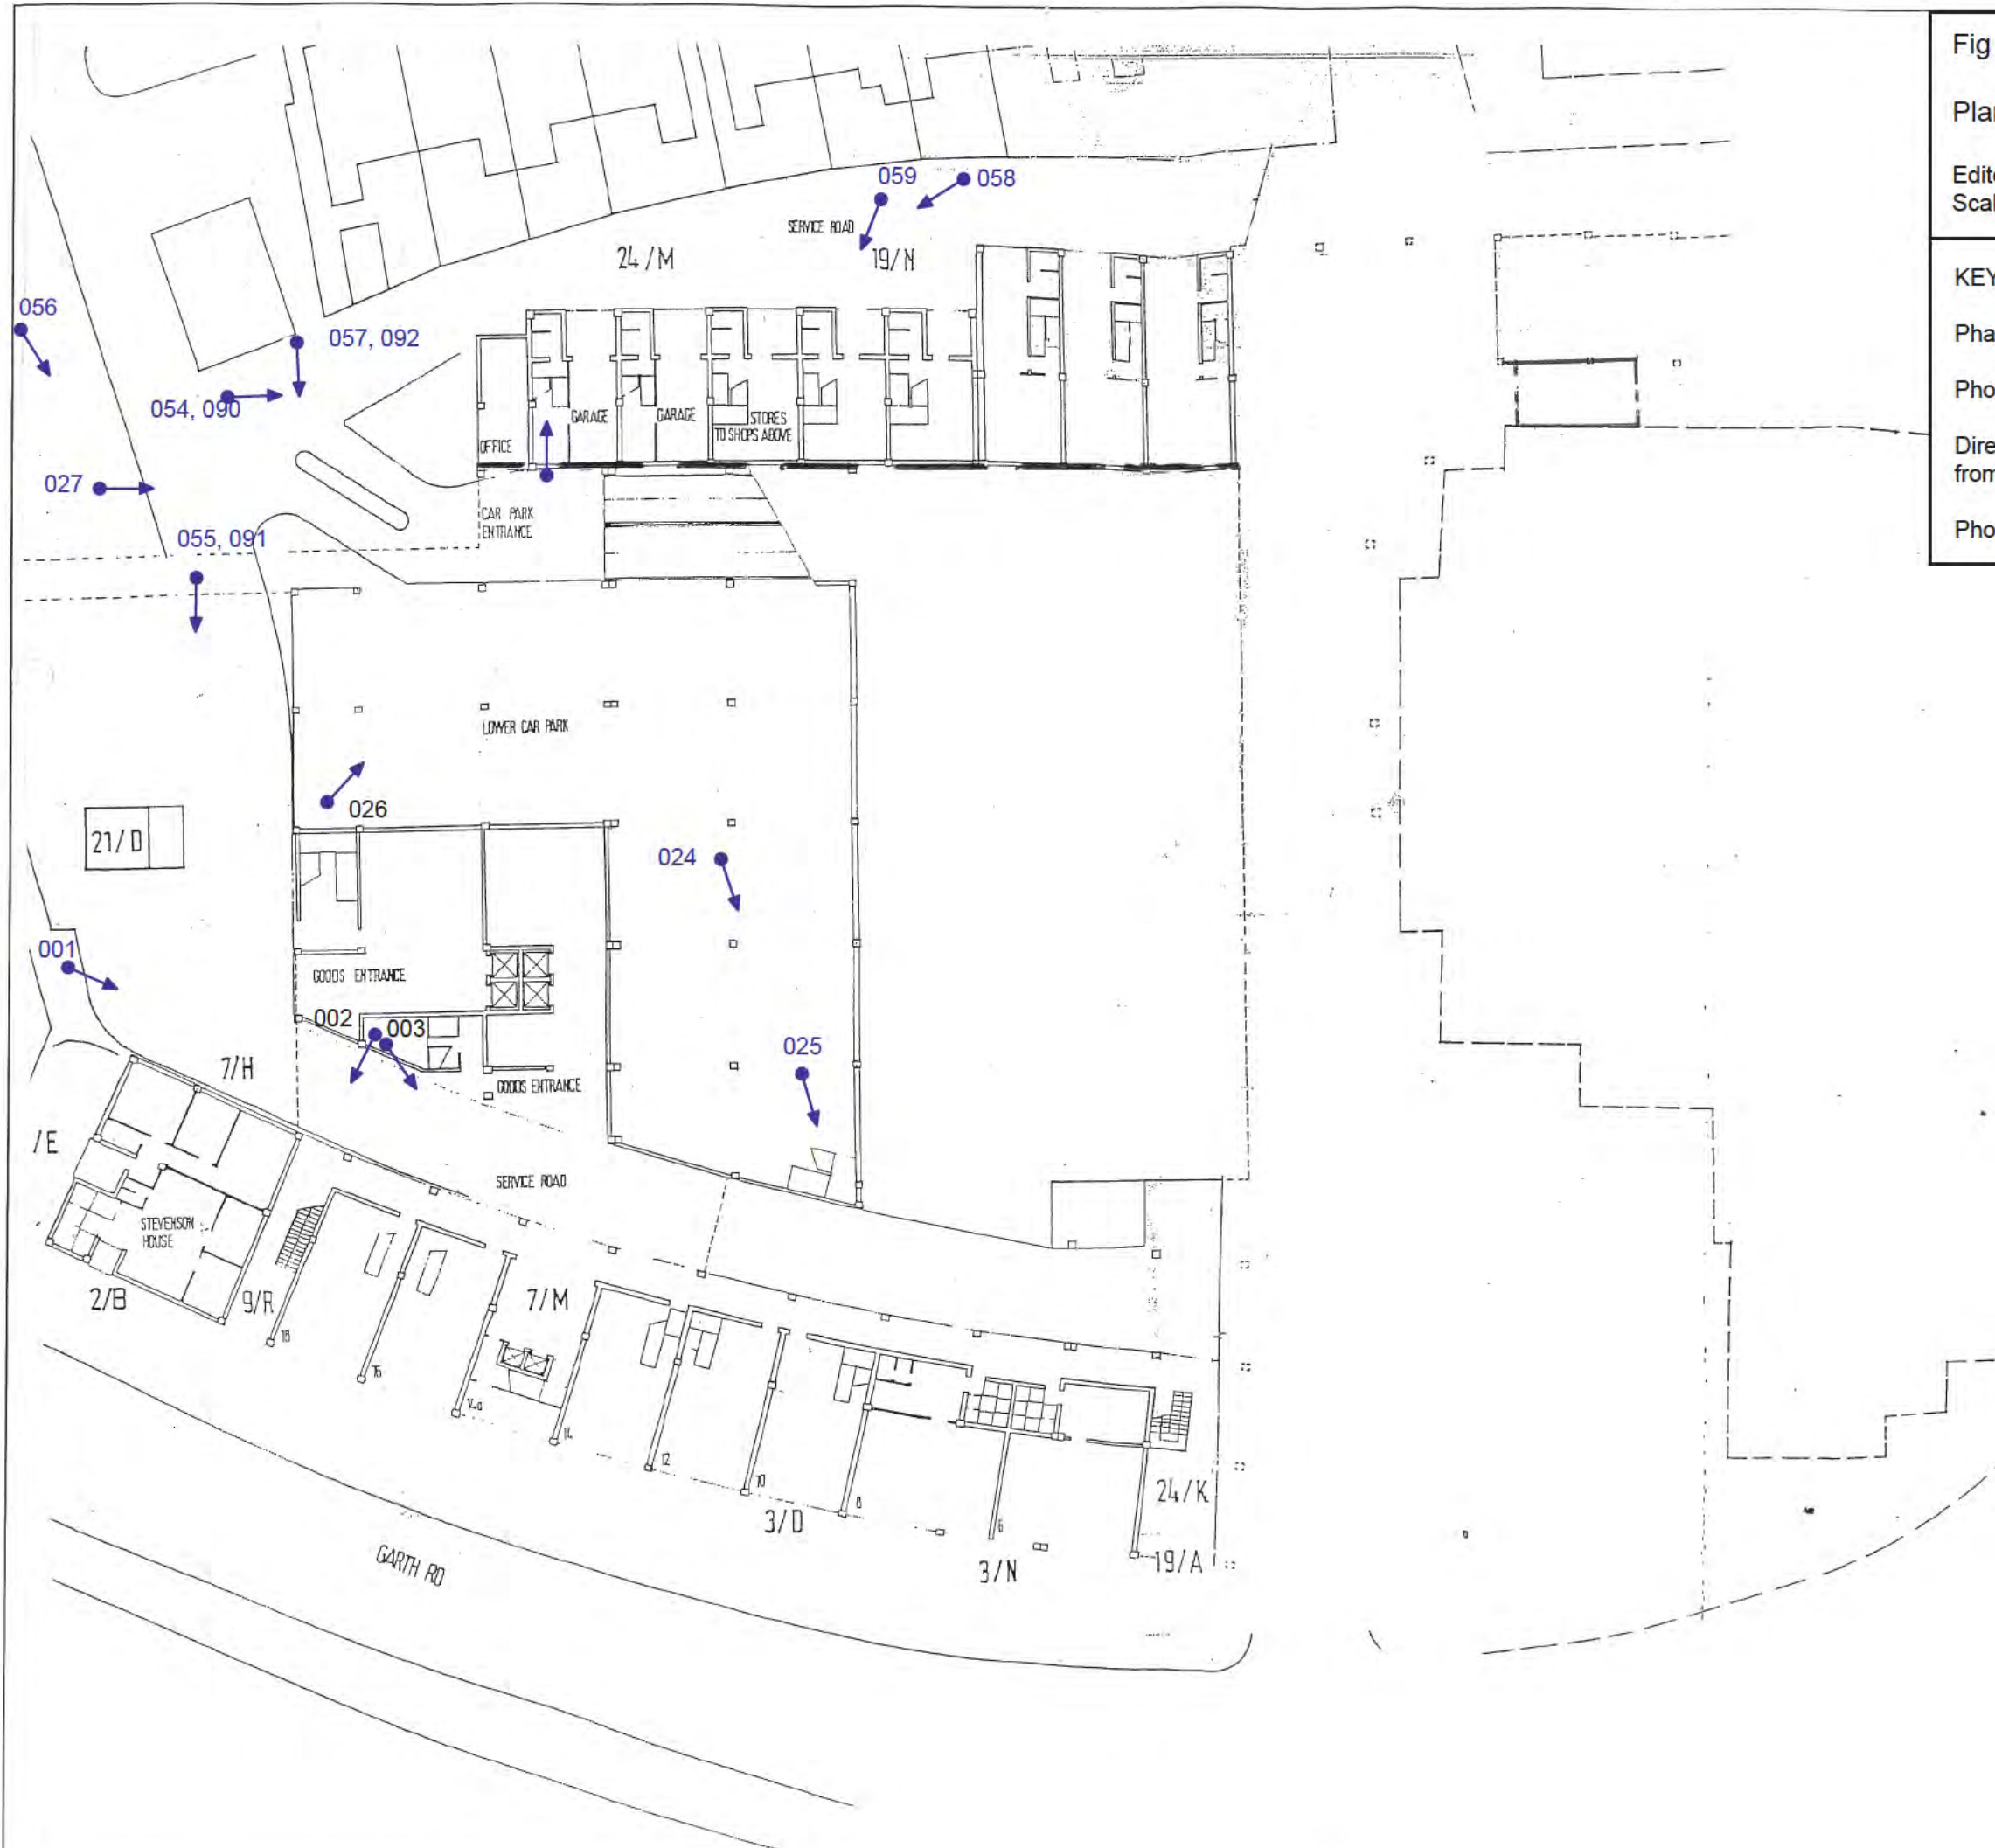
Fig 5 WELLFIELD SHOPPING CENTRE, BANGOR

Plan and Location of Photographs (level 1)

Edited from Shepherd Gilmour Drawing M30704/SK01  
Scale: NTS

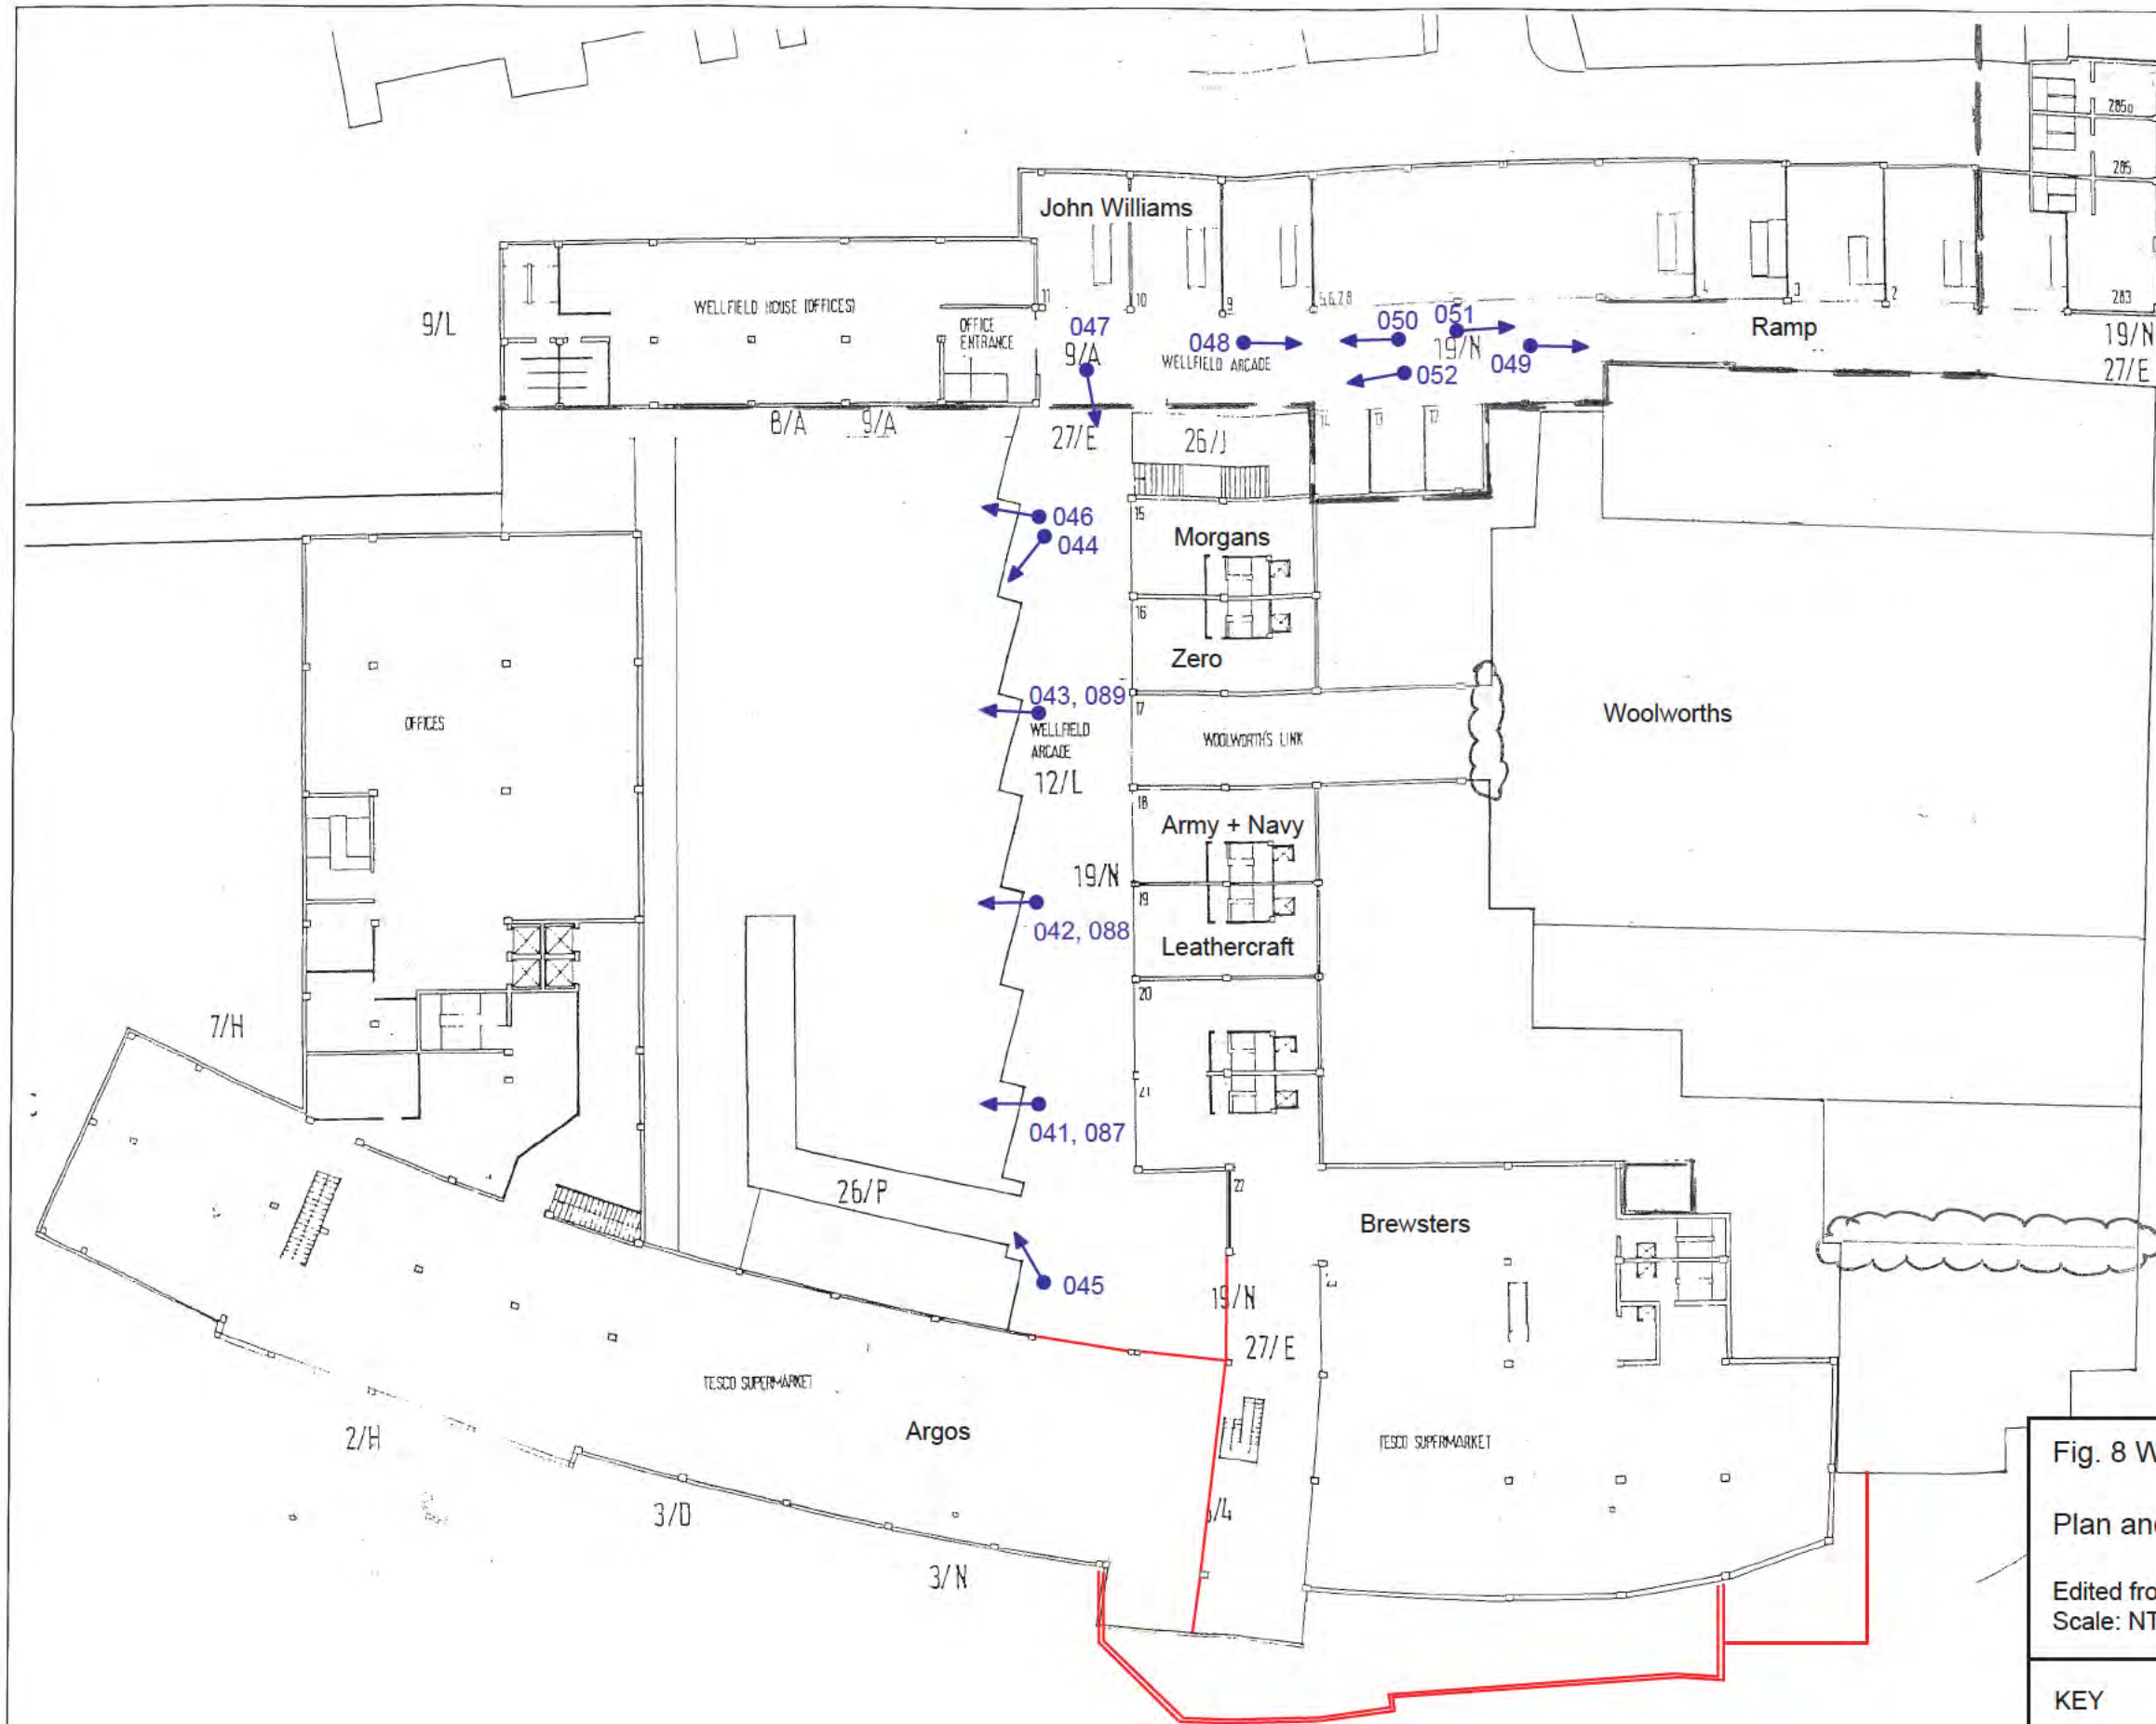
Fig. 8 WELLFIELD SHOPPING CENTRE, BANGOR

Plan and Location of Photographs (level 4)

Edited from Shepherd Gilmour Drawing M30704/SK04  
Scale: NTS

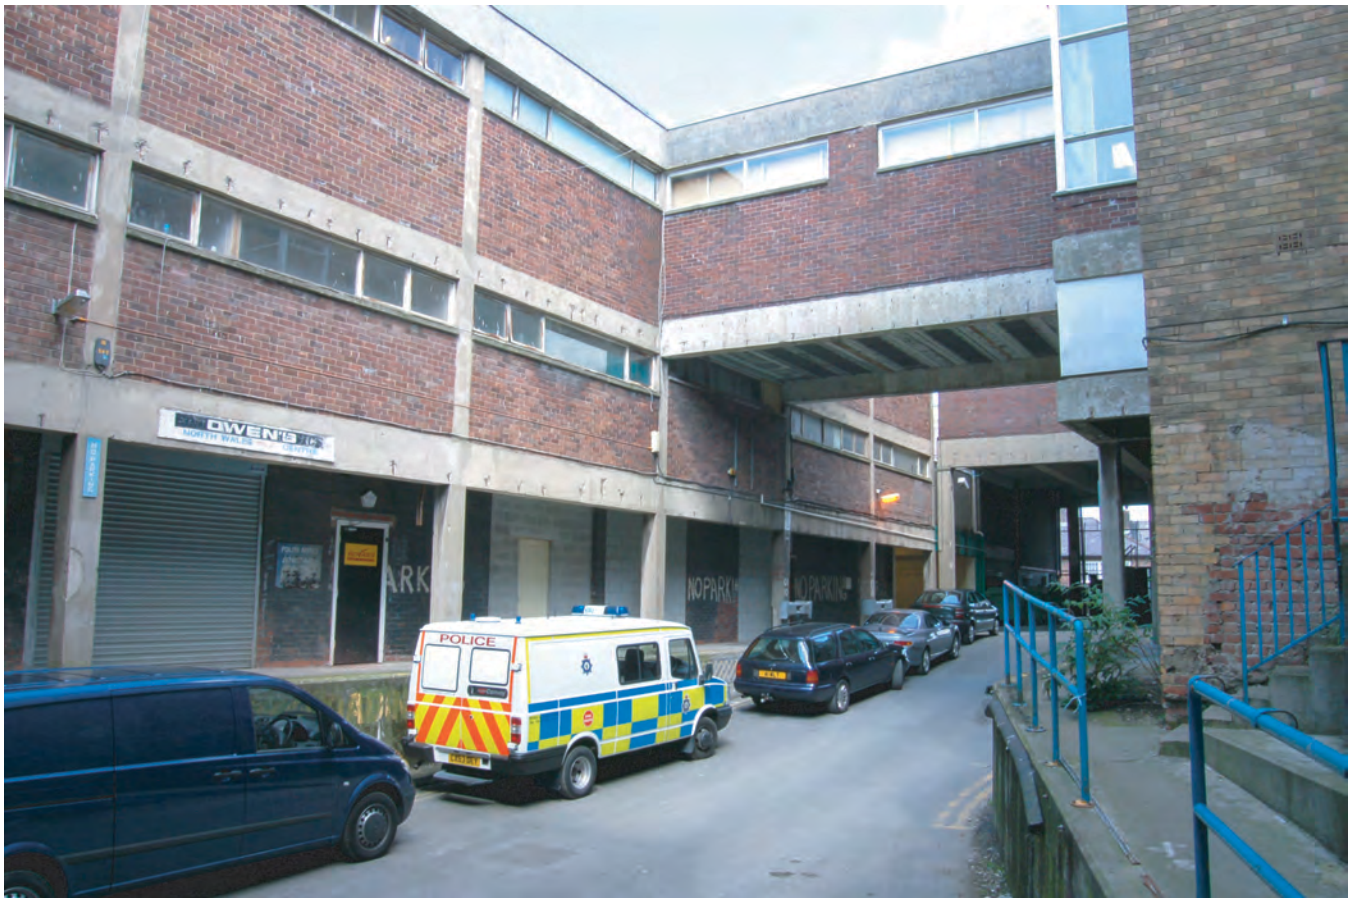
Plate 1. The SE side of the Wellfield Centre showing service road, and Woolworths link

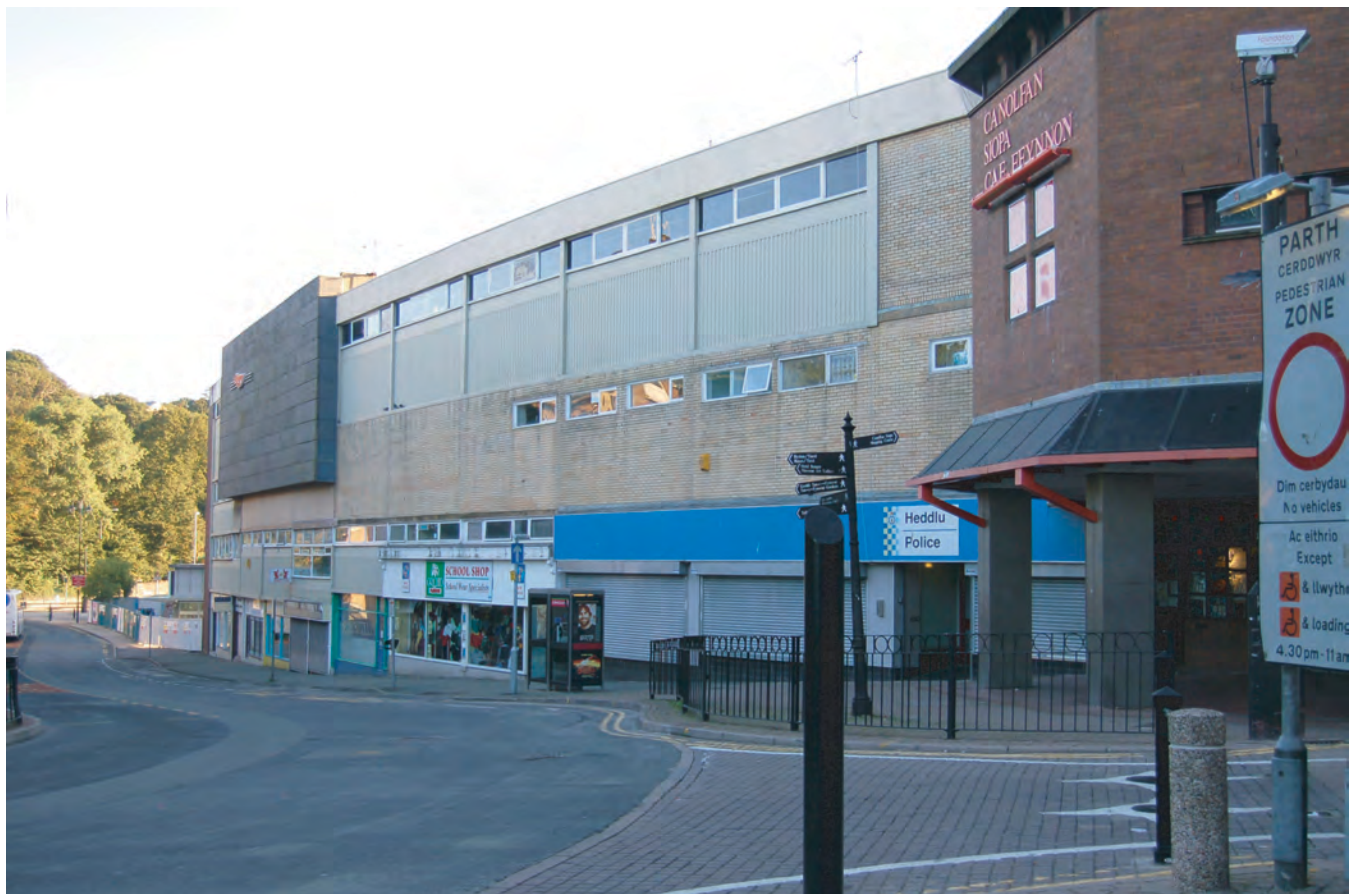
Plate 2. The Wellfield Centre from the top of Garth Road

The second storey is taken up on the north-west by a further level of car parking. Stairs lead from the car park to the lower shopping level. The original stairs run from both the service road and the car park on the eastern side, a further set of stairs was added to join up with the end of the new mall in 1984. The service road continues from level 1 to run under the south-eastern side of the centre (Plate 1) before exiting and joining the external service road to the north-east. This road is again flanked by loading bays and stores. This was seen as an essential and somewhat revolutionary feature of the shopping centre in 1964. In contrast to the High Street shops, the customers were totally separated from delivery lorries and traffic. The second level also contains much of the infrastructure of the centre including air extraction ducting and an electricity substation. The lower level of the former public house also appears to have been adjacent to the original access stairs. A series of retail units one of which currently houses the Police Station run alongside Garth Road (Plate 2). The area around the

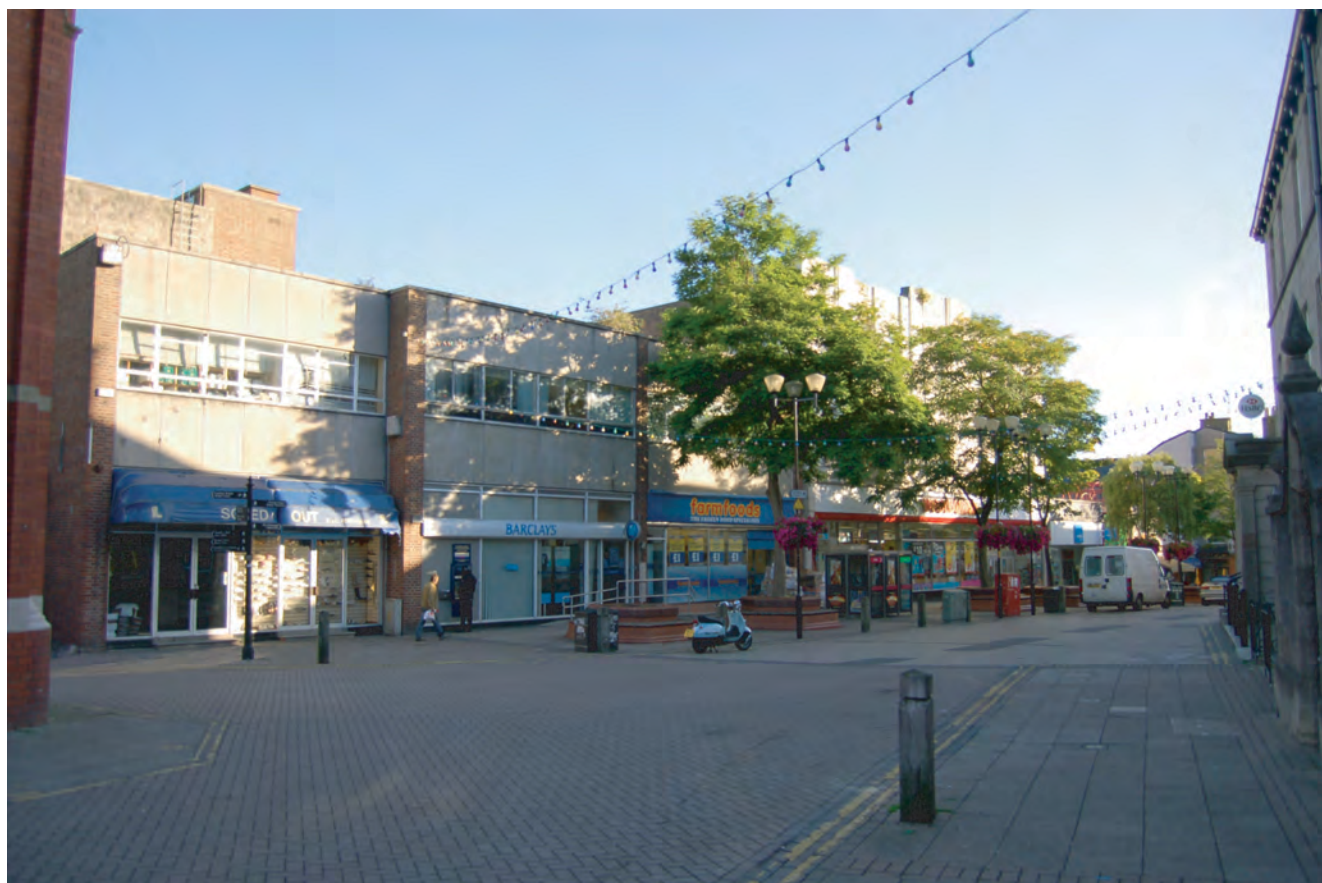
Plate 3. The Wellfield Centre from the High Street

The third level storey contains most of the retail units and is roughly at the same level as the High Street and the top of Garth Road. Retail units fronting on to the High Street stand to either side of the earlier Woolworths building along with a ramp leading to the fourth level (Plate 3). An ornate steel arch was constructed over the entrance to the ramp as part of the 1984 refurbishments. The central open courtyard of the Wellfield Centre is surrounded on all sides by retail units (Plate 4). The pre-1984 refurbishment plans show that this was originally divided up into 20 small units with a larger unit on the north-western side. A feature of the original design was a tall, four-sided advertisement hoarding standing in the courtyard (Fig. 1c). This was removed during the 1980s. A concrete ramp joins the third and fourth levels thus providing a link with the High Street. Alternative access was either via stairs from Garth Road or stairs from the car park below. Public toilets were also on this level.

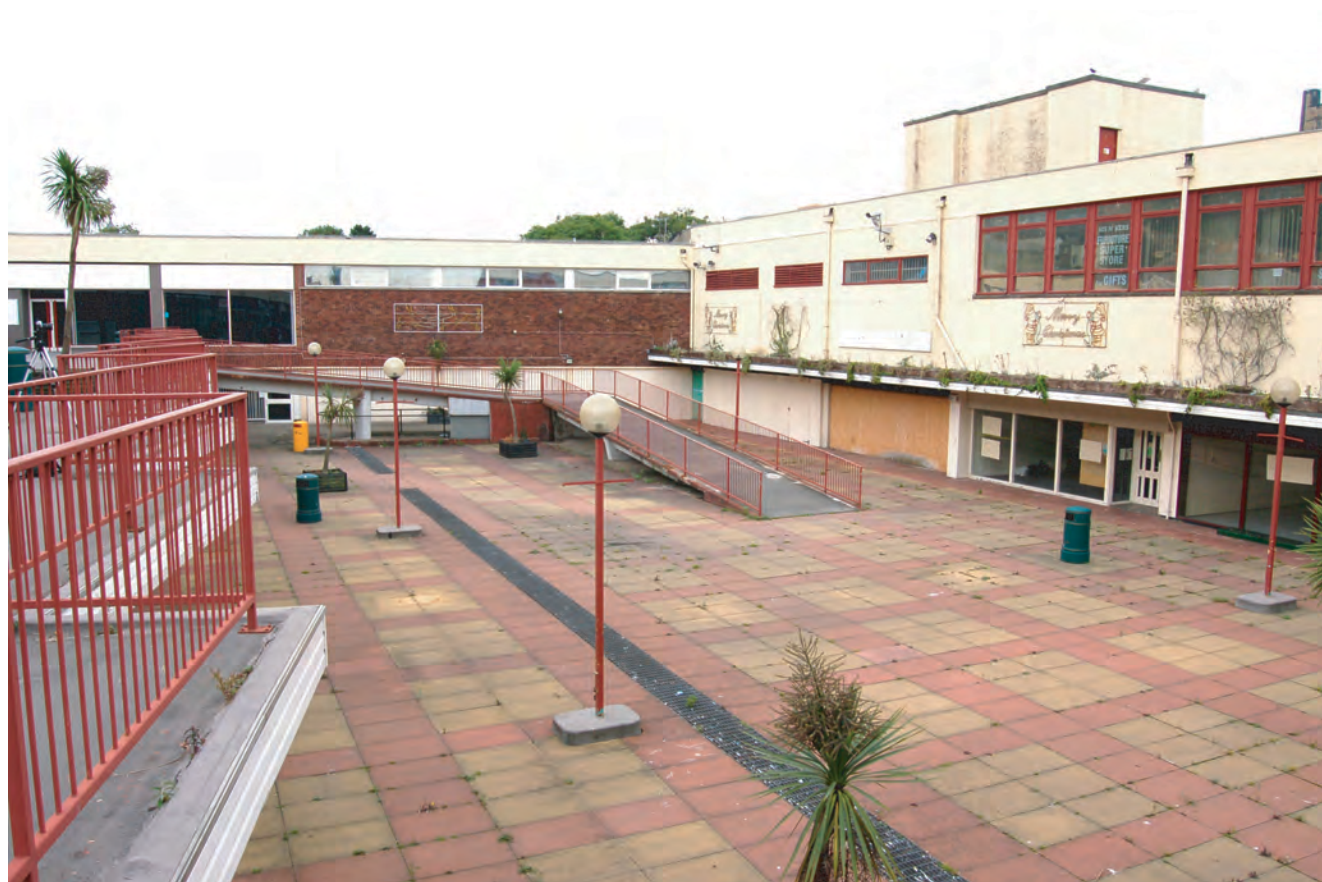
Plate 4. The central courtyard

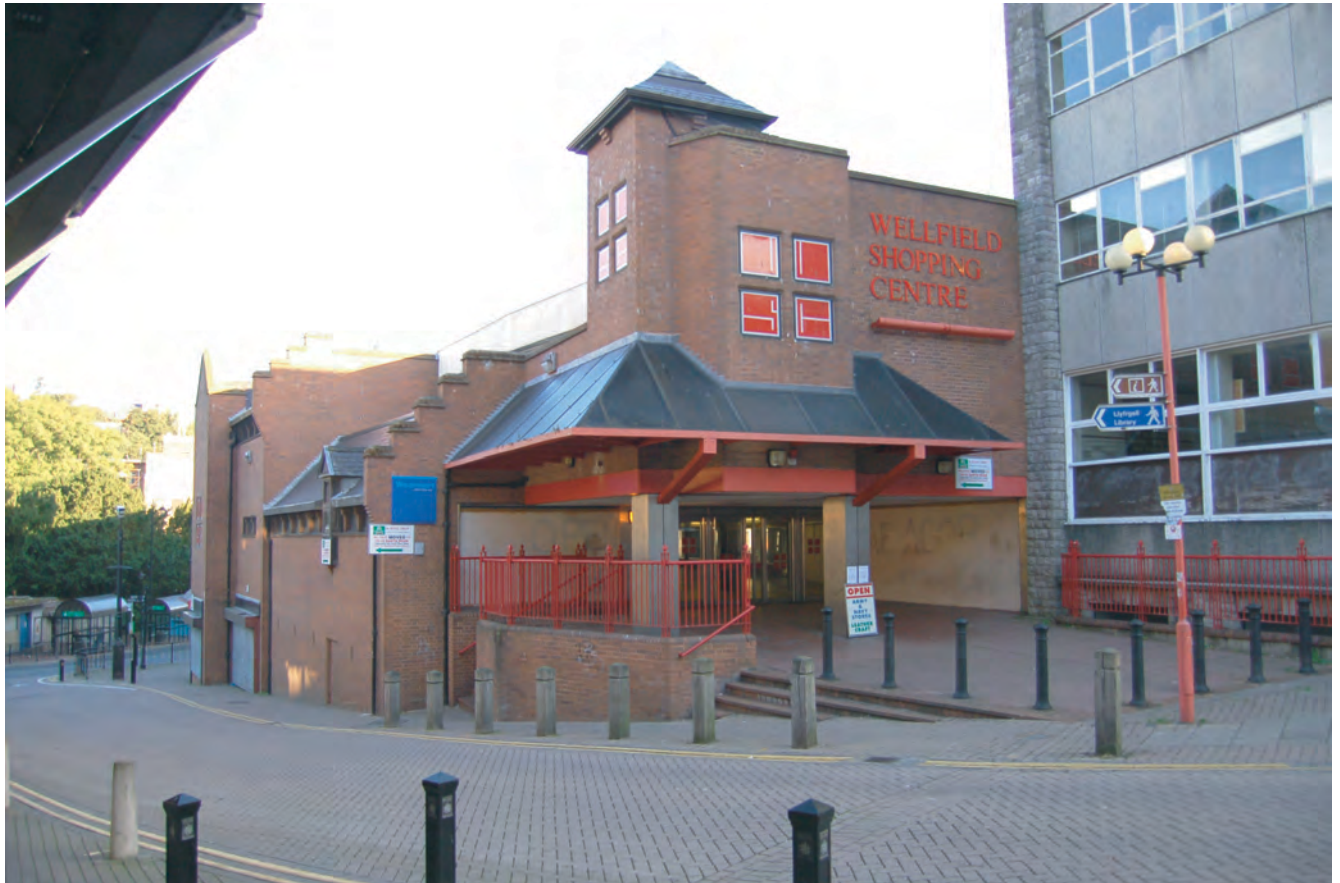
Plate 5. The 1984 extension housing the new mall and lifts

Significant changes were made in 1984. A new covered mall was constructed running from the top of Garth Road to the central courtyard. The precipitous ramp leading to the fourth level was demolished and lifts were installed leading from lower down Garth Road to all levels of the centre. The foundation stone is now in the wall of the lower foyer leading to the lifts and stairs. The new entrances and mall also entailed extending the main body of the Wellfield Centre out into Garth Road by several metres. The new building was faced with red brick (Plate 5). Several of the smaller retail units in the courtyard were knocked into larger units around this time and additional stairs were added leading to the car park. A later addition to the courtyard in the later 1990s was an extended frontage on the north-eastern side housing a new B'wise shop. The most recent occupiers of the various units are indicated on the photographic location plans.

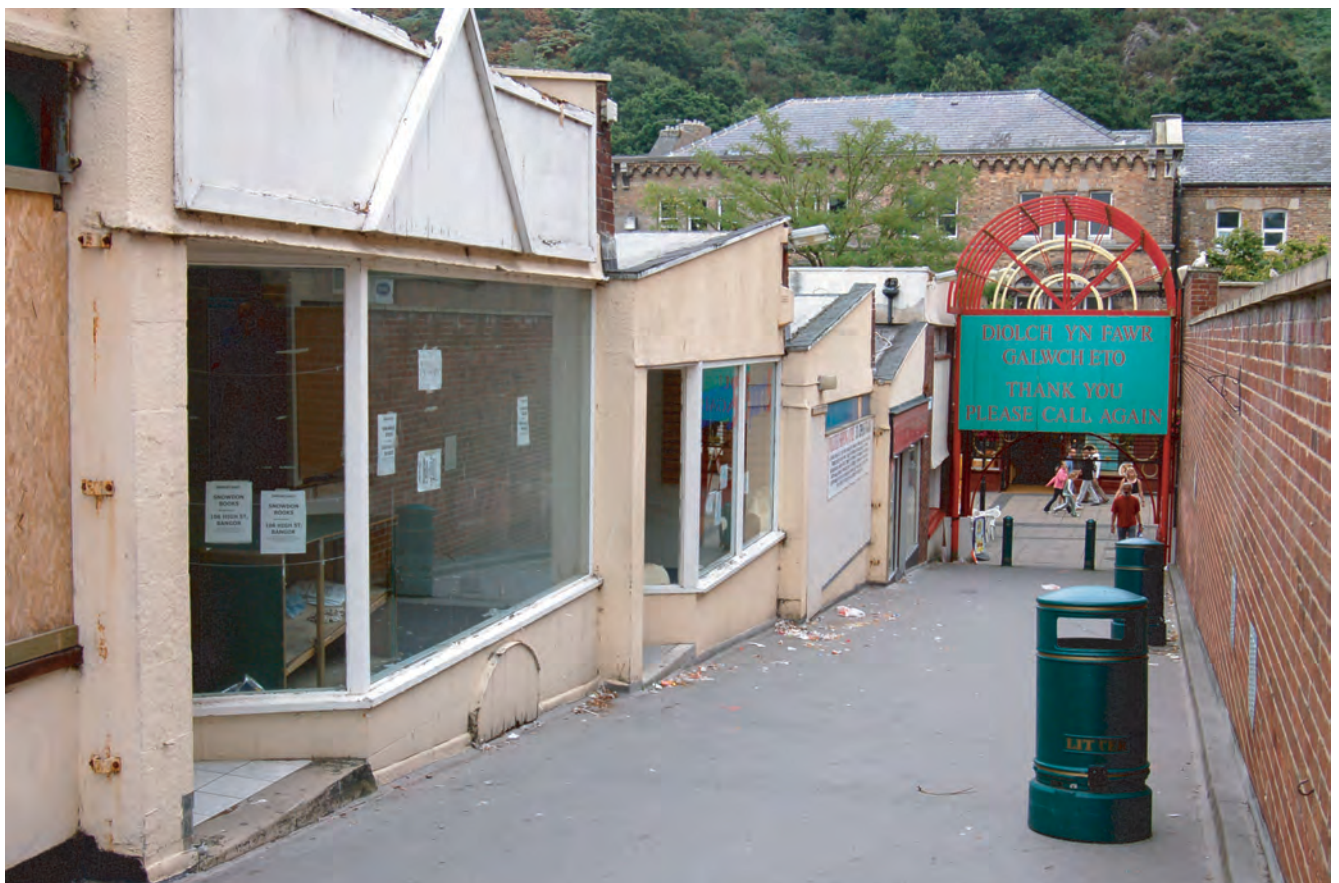
Plate 6. The Wellfield Arcade alongside the ramp leading to the High Street
