ABERDYFI TO DYSYNNI FLOOD ALLEVIATION SCHEME - PENLLYN MARSHES, TYWYN

ARCHAEOLOGICAL RECORDING

Report No. 612

GAT Project No. G1887

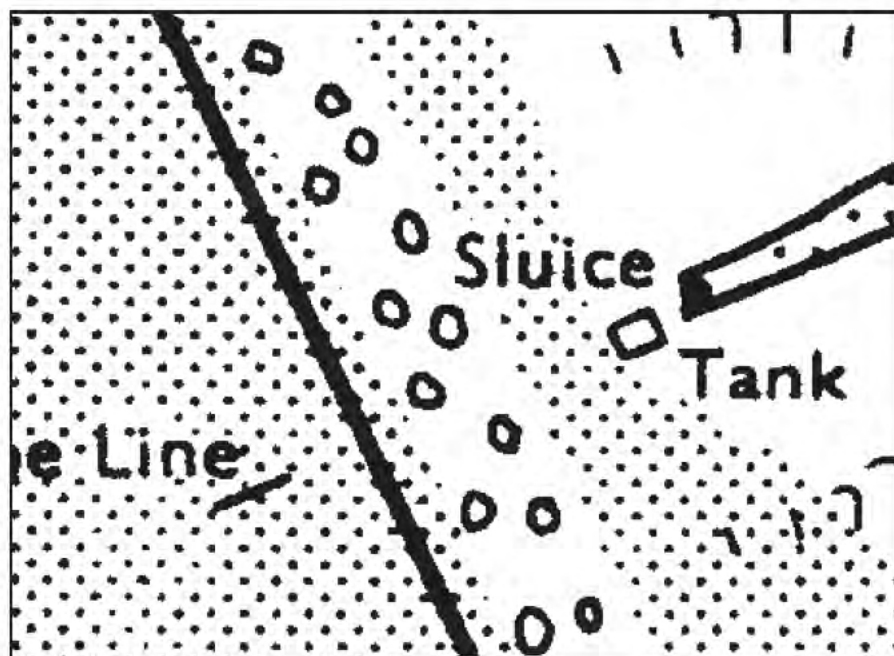
Fig. 3b Afon Dyffryn Gwyn Outfall and tidal gate Ordnance Survey 1:10,000 1976. Not to scale.

Later a single tidal chamber was built on the sea-ward side of the entrance to the outfall pipe and this was still in existence as late as 1976 as shown on the 1:10000 Ordnance Survey map of that date (Fig. 3b).

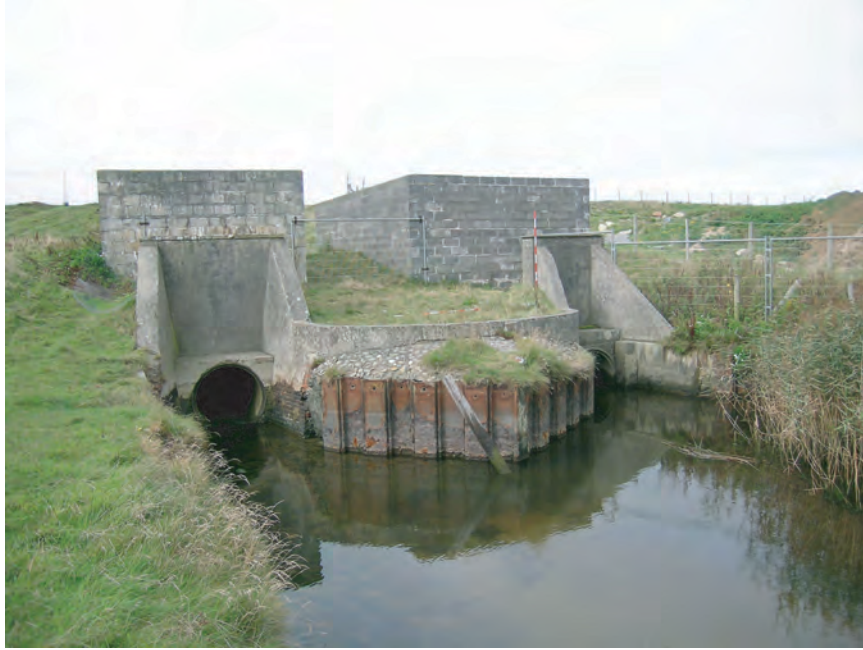
Fig. 4 Afon Dyffryn Gwyn tidal gate. The entrance to the outfall, the 19th century pipe inlet on the left.
From the east. Scales 2m long with 20cm divisions.

The existing double outfall incorporates the line of the original outfall, which forms the southern of the two pipes, where some of the original structure survives (Fig. 4). Its entrance is via a splayed brick-built wall, of similar purple bricks to those used in the first phase of the rifle range to the south (see below). Above this is a brick-built apron, possibly designed to prevent erosion around the entrance to the pipe when the river flooded faster than it could flow out. Two of the original stone capping slabs survive on the top. Behind this "apron" is a rectangular aperture in the ground covered by heavy timbers (Fig. 5). This is presumably an access chamber and suggests that there might have originally been a tidal flap valve here, within a small chamber.

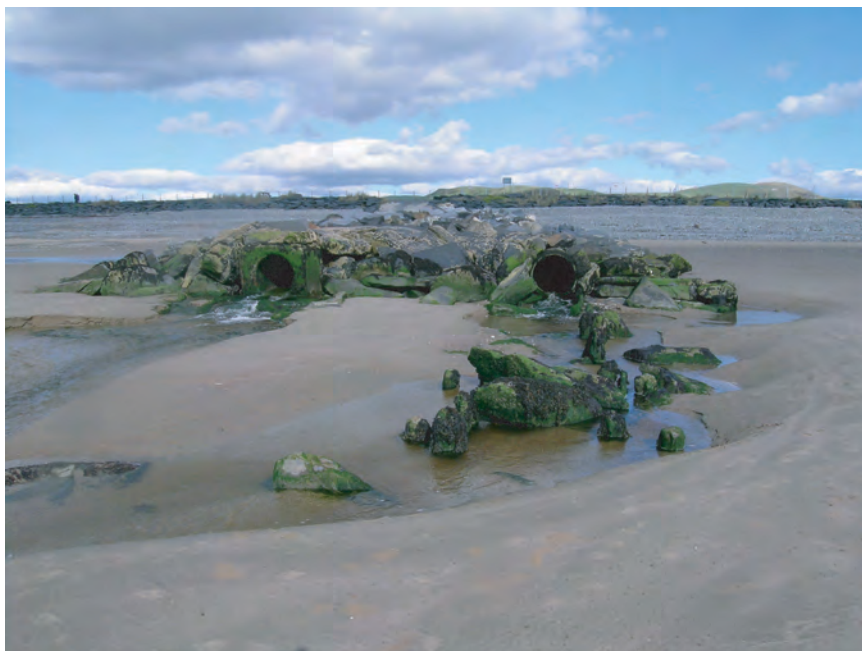
Fig. 6 Afon Dyffryn Gwyn beach outfall pipes, general view, from the west.

The outfall pipe onto the beach itself (Fig. 6) has suffered from erosion and has clearly been replaced, perhaps several times, and part of an earlier pipe in a brick setting is incorporated in the rubble protecting the present outfall (Fig. 7).

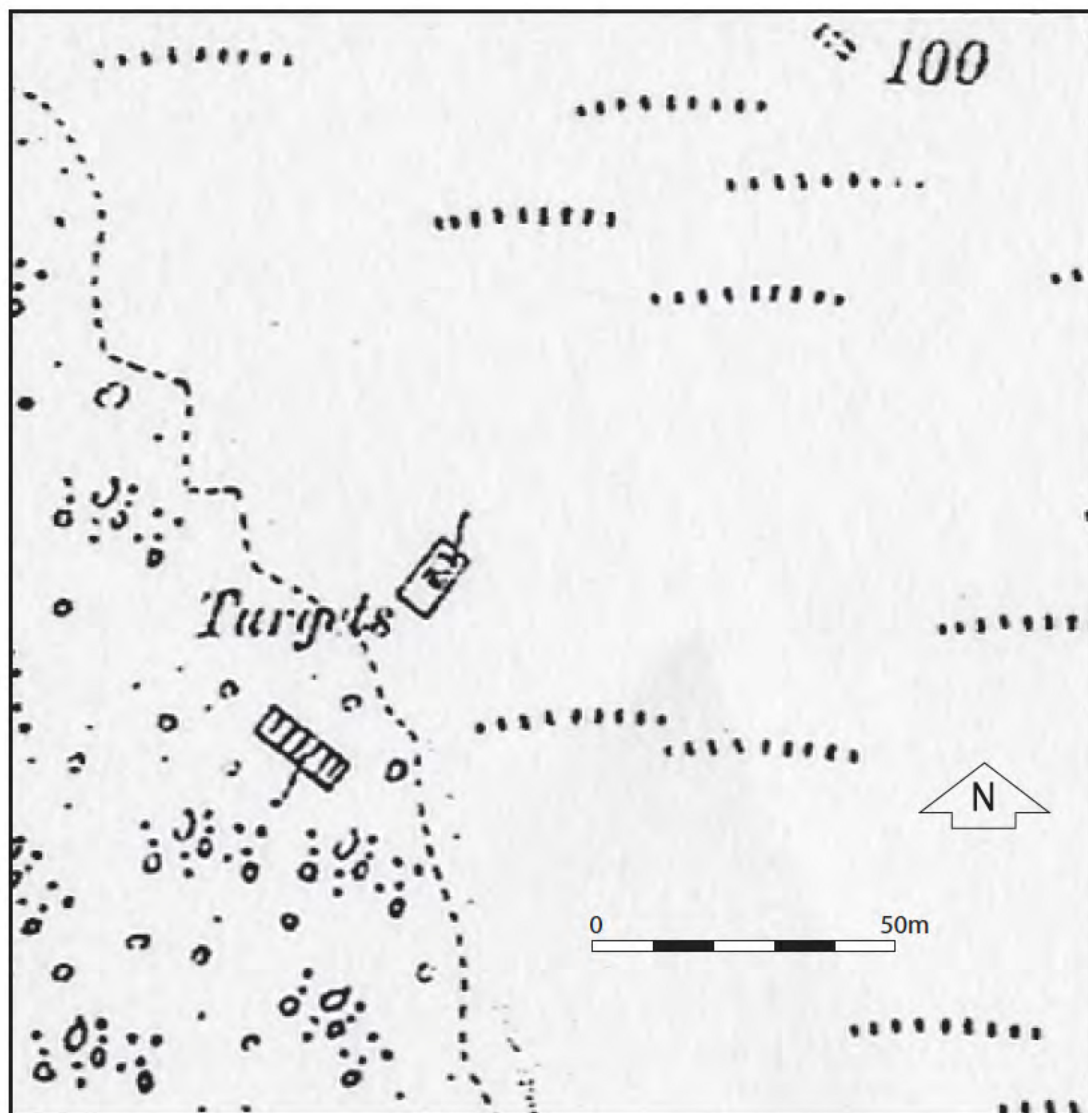
Fig. 8 The 19th century Rifle Range, targets and first shooting butt, enlarged from the Ordnance Survey Second Edition 1:2500 scale map, 1901.

The original rifle range was built approximately between 1888 and 1901, since it does not appear on the 1st Edition OS 25 inch map of 1888 but does appear on the 2nd Edition map of 1901. The maps were surveyed several years before their printing so it is possible that the range could have been constructed as early as 1880. Interestingly, the range as a whole was clearly deliberately aligned on Esguan Hall, to the north-east, and the field boundaries and a track that lay on the line of the rifle range were already in existence in 1888. These boundaries were laid out as part of the drainage works of the Penllyn Marshes *c.* 1862. Possibly therefore the rifle range was already planned at this early date.

The 1901 map shows shooting butts at 100yd intervals. However, these distances were not measured from the brick-built butt, but rather from a small rectangular feature shown on the map, labelled 'Targets' (Fig. 8). It may be that even in their Second World War phase the targets were set up some way in front of the butts. The position of the targets as shown on the 1901 map has now been obscured by the construction of a trackway.

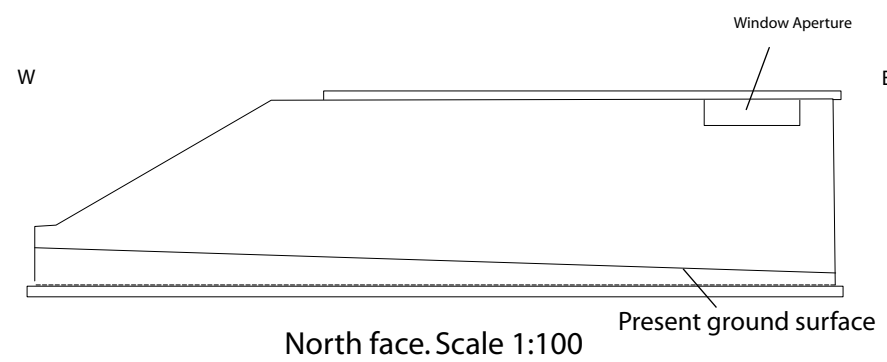
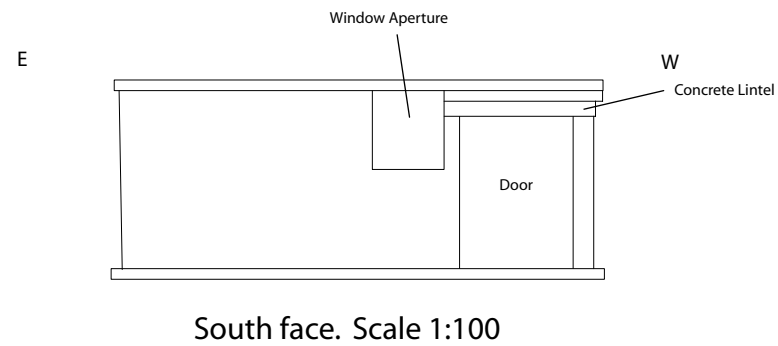
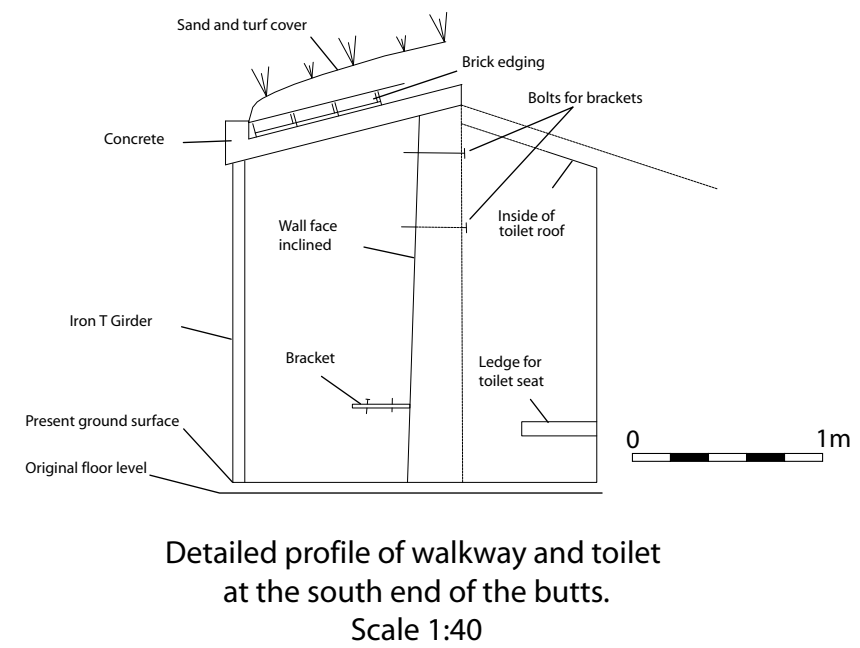
Fig. 9 Rifle range butts and command building. Plan and elevations

Both butts also had pairs of protruding flat iron bars let into joints in the brickwork at intervals along the butts. These were set at about seating height and may have held plank benches (Fig. 9).

At the south end of the butts and belonging to the first phase was a small rectangular compartment set into the rear of the butt (Fig. 9). This was whitewashed inside and had shallow ledges on both sides at about seat height. These seem to be supports for a toilet seat, probably over a bucket. Surprisingly the later, covered walkway was not built to cover the entrance to the toilet, which was not therefore protected by concrete but by sheet iron roof, over which sand was laid.

A fragment of thick twisted steel hawser is left in a channel in the brickwork through the wall by the command building door, possibly for an aerial (Fig. 9).

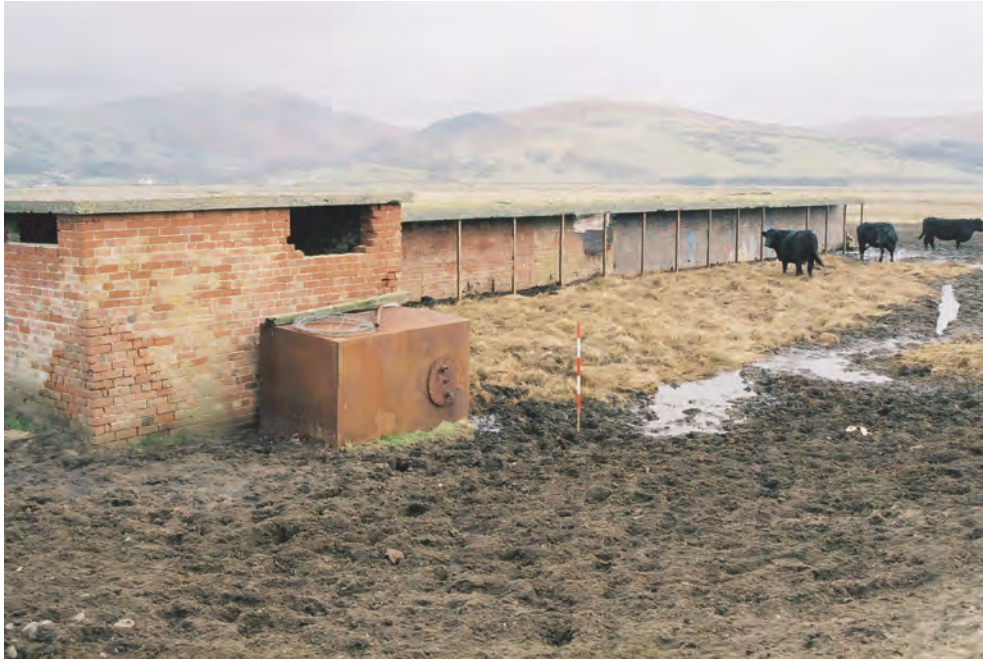
Fig. 10 Rifle Range butts and command building. General view of the west side of the building, from the north-west.
Scale 1m long with 20cm divisions.

The main rifle range building consists of a long low, brick-built target butt, with a sloping front and at its north end is a rectangular command building (Fig. 10).

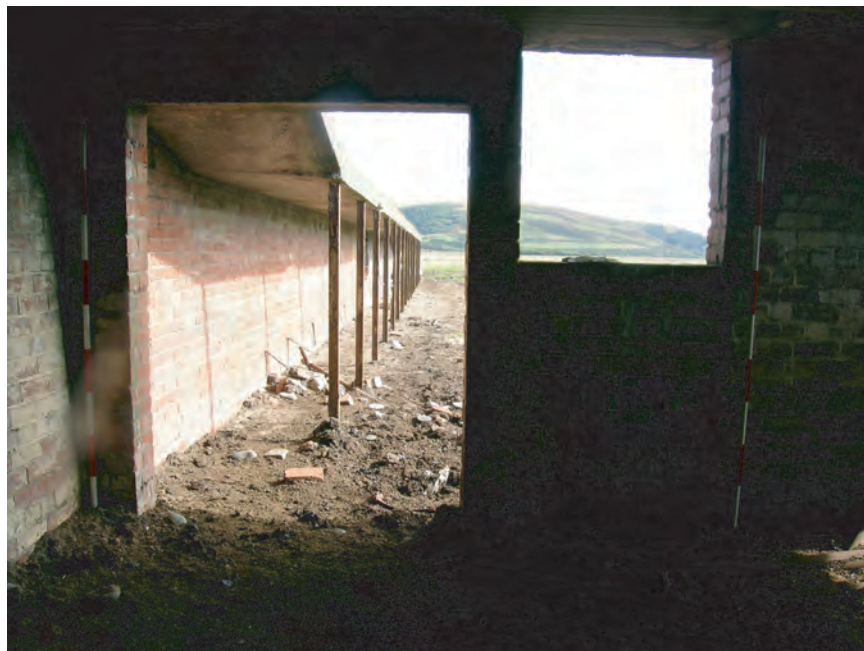
Fig. 11 Rifle Range butts. View of the covered walkway from inside the command building, from the north.
Scales 2m long with 20cm divisions and 3m apart.

Attached to the rear wall is a roofed walkway, 0.9m (3ft) wide allowing safe access along the rear of the targets (Fig. 11). The walkway has a concrete roof, topped supported on T-section steel girders at 1.83m (6ft) intervals.

The command building is 6.65m (22ft) E-W and 4.14m (14ft), N-S externally, built of solid double brick (Figs 11 and 13). It had a wide, probably double swing door at the south side leading into the covered walkway. At its side is a window aperture at quite a high level, the top being formed by the (presumably reinforced) concrete slab roof. The window originally had a wooden glazing frame. At the west and north side are long apertures at ceiling height, both probably originally glazed. Internally the building has no surviving structural features. However, it had a stove at the south-west corner where there is an aperture 0.14m diameter through the roof for a stove pipe chimney. There are traces of whitewash and green paint on the internal walls and rectangular gaps in the whitewash show that there were cupboards or shelf units along parts of the north and west sides.

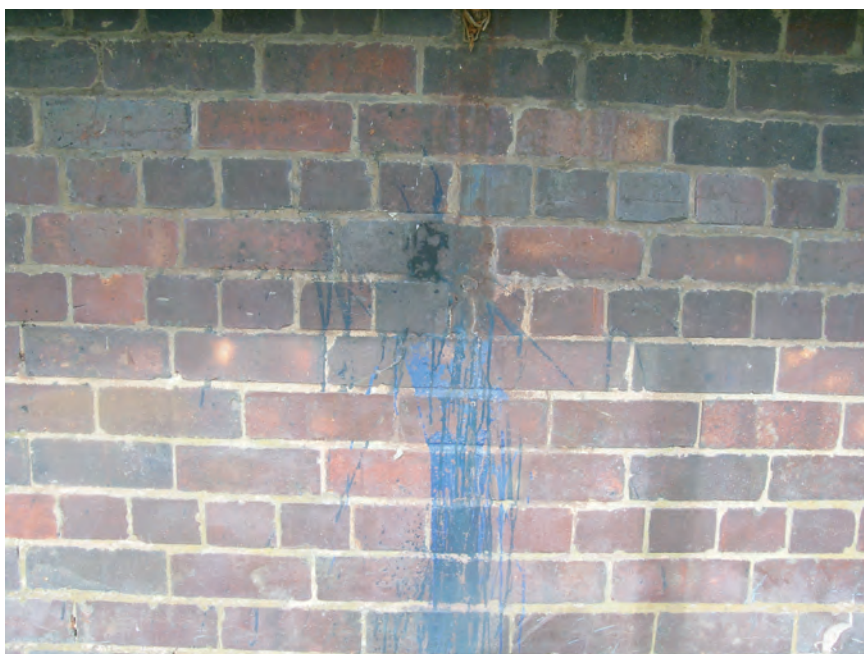
Fig. 12 Rifle Range butts. Bolt ends and stain of cast iron bracket on the rear wall of the Phase 1 part of the butts within the covered walkway.

The first phase butt had a series of pairs of large iron bolts fixed horizontally through the rear wall at about head height. These seem to have been the fixings for strong iron brackets, which have been taken away, perhaps for scrap. Impressions of the brackets remain on the brickwork (Fig. 12). The function of the brackets is not clear. They could have held paper targets or even have been a system for fixing targets from the shelter of the butt. The newer butt to the north had brackets in similar positions but these were much less substantially fixed, being attached to the wall by screws into wooden plugs let into joints in the brickwork.

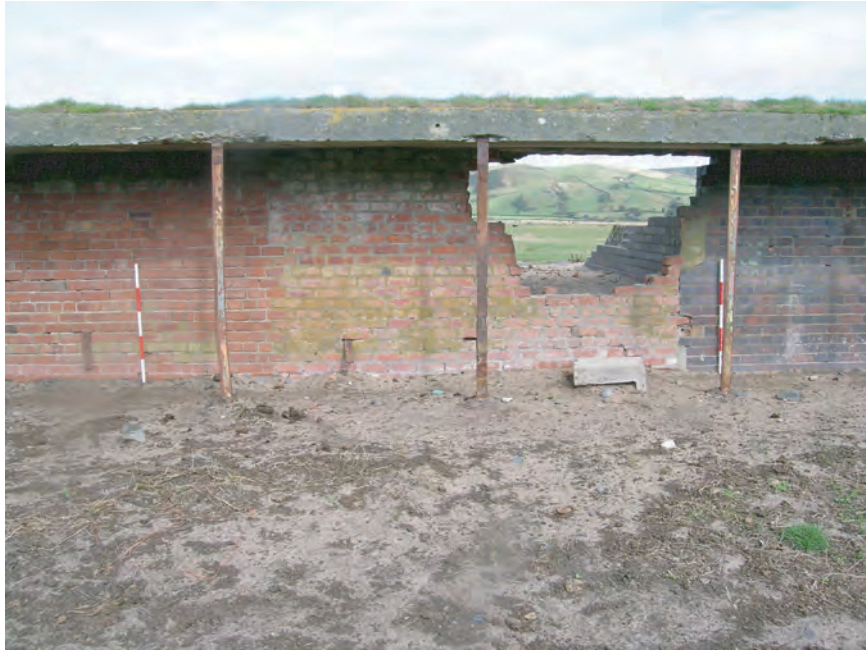
Fig. 14 Rifle Range butts. The central part of the covered walkway from the west showing the blocking between phases 1 and 2. Scales 1m long with 20cm divisions and 5m apart.

- a. The earliest was a short target butt, 18.42m (60ft) long, without a walkway. This was built of purple, hard-fired bricks and can be identified with a small rectangular structure shown on the 1901 Ordnance Survey map (Fig. 8).
- b. A second butt was built, to the north of, and continuing the line of and imitating the size and style of the first butt. This was built of poorer fired, gritty fabric, orange-red brick. A gap of 2.35m (8ft) was left between the two butts. The new butt incorporated a command building at its north end.
- c. The gap between the two butts was bricked-in rather crudely and the covered walkway was built along the whole length (Fig. 14).

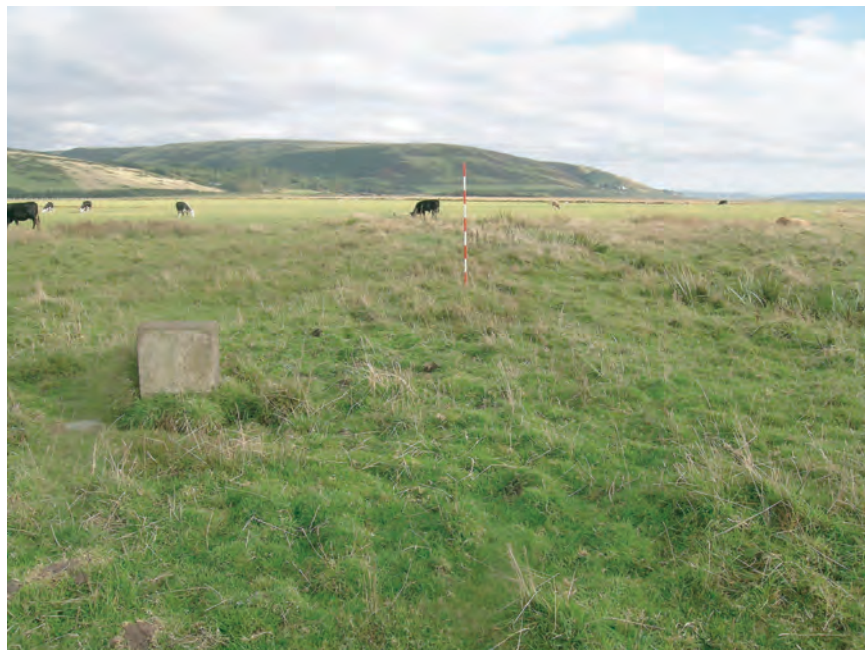
Fig. 15 Rifle Range shooting butt, from the north-west.
Scale 2m long with 20cm divisions.

This lies to the north-east of the target shooting butts. It survives as low earthen bank about 15m long, 4m wide and 0.4m high (Fig. 15). It must once have been higher and better defined and has presumably been trampled down by cattle. Just beyond its north end is a small, plain concrete marker post.

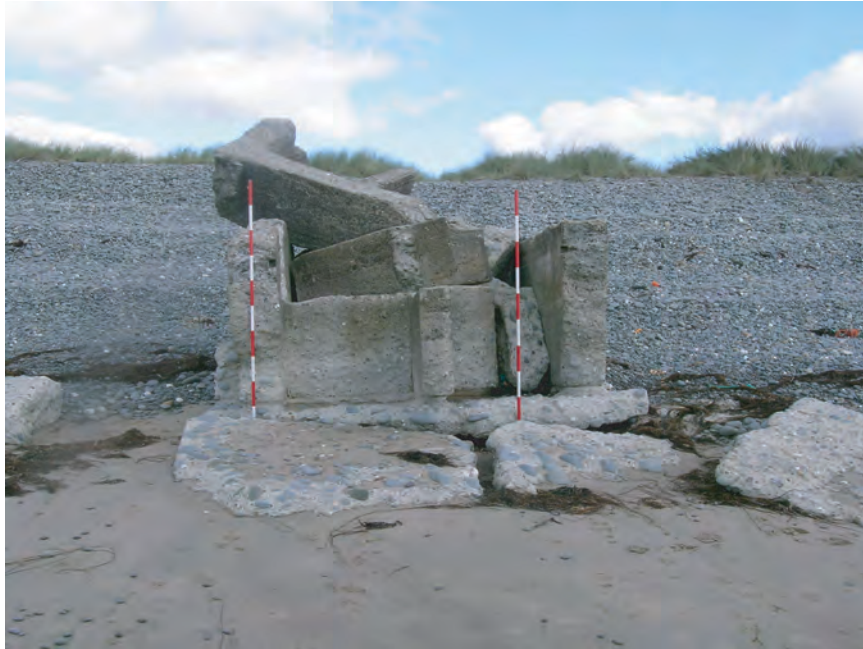
Fig. 20 Pillbox 270340. West side showing exposed interior and foundation plinth. Scales 2m long with 20cm divisions and 2m apart.

This has been partly demolished by wave action and seems to have slipped down the storm bank to rest on the beach itself (Fig. 20). Enough remains of the structure to reconstruct its plan, which is slightly different to that of pillbox 270343. It is again a variant of Type 23 but closer to the basic plan of this type, of two compartments, overall c. 3.07m (10ft) wide and about 5.2m (17ft) long, E-W. The front compartment is similar in all respects to that of pillbox 270343. The rear compartment however, is the full width of the pillbox, c. 2.35m by 1.85m (8ft by 6ft) internally with a central concrete pillar. As it was not roofed this probably supported a mount for a light anti-aircraft gun as described by Lowry (1995, 82). The main chamber was accessed via steps down from the rear chamber. The rear chamber was accessed from outside via a series of iron rungs set into the inside face of the wall, as in pillbox 270343. The rear chamber also had a gun embrasure in the east wall, with a double splay, which would have allowed a view of the rear approach to the pillbox (Fig. 21).

Erosion of the structure by the sea has exposed the base of the pillbox showing that a clay drain-pipe was incorporated into the foundation plinth providing drainage of rainwater from the bottom of the steps down from the rear compartment. This feature was probably common to all three pillboxes here, although this was the only one where the area of the drain was exposed.

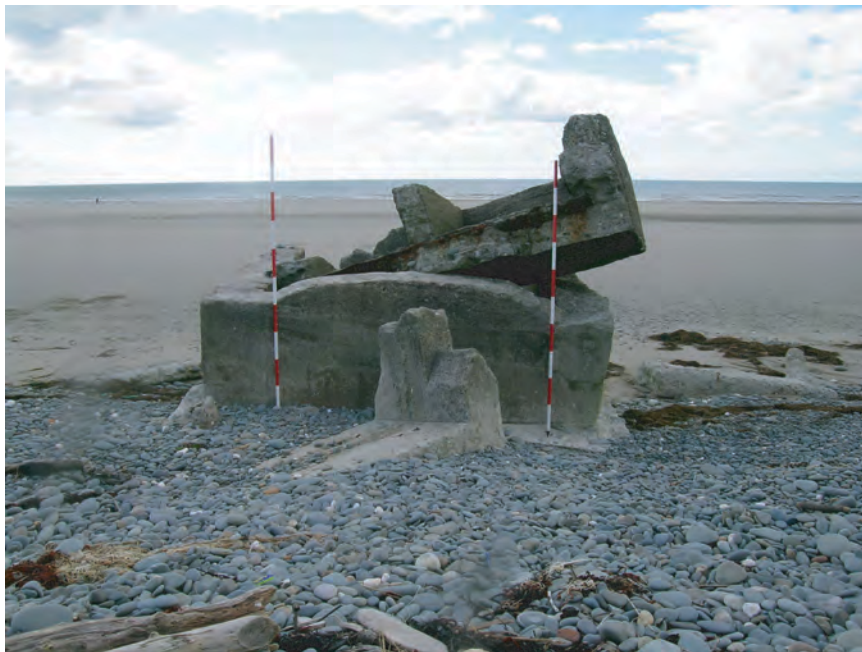
Fig. 21 Pillbox 270340. East side showing rear firing aperture (in fallen wall fragment) and exposed steel plate reinforcement for roof. Scales 2m long with 20cm divisions and 2m apart.

Part of the broken, exposed roof of the main compartment shows it to have incorporated steel plate reinforcement, possibly corrugated, of about 20mm (¾in) thickness, for additional strength (Fig. 21).

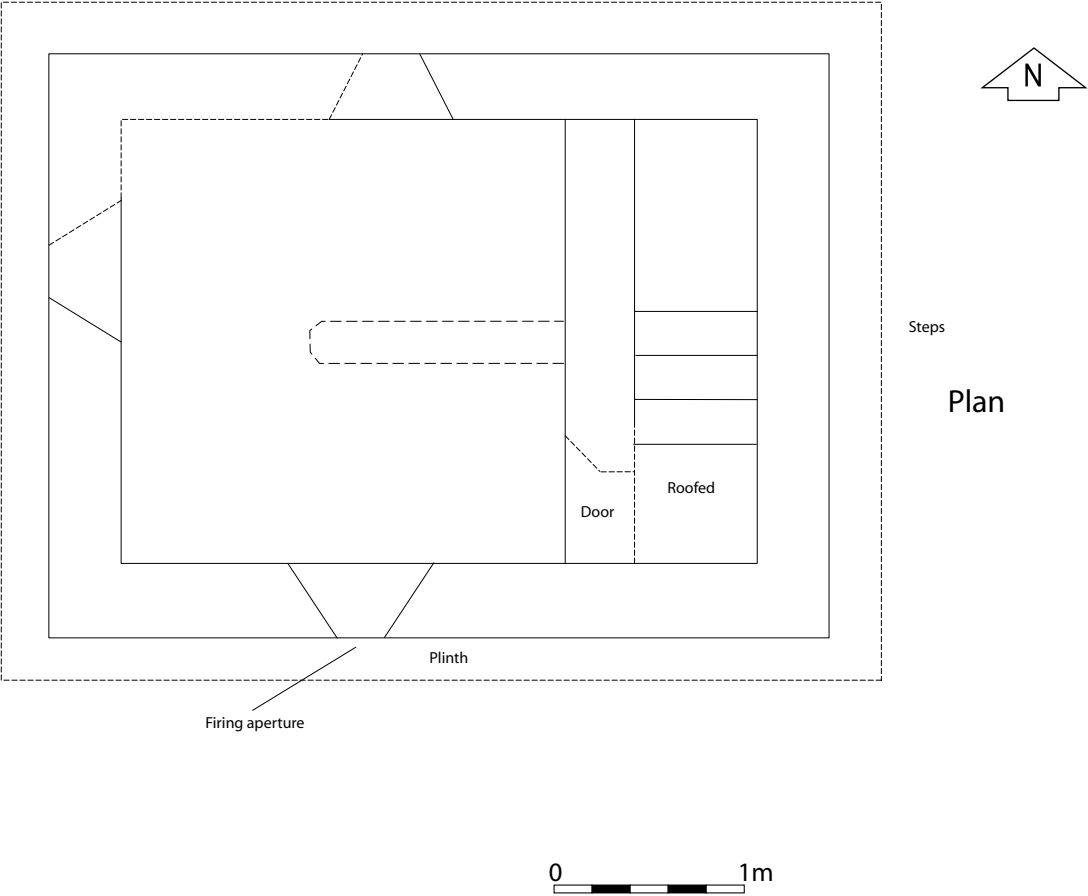
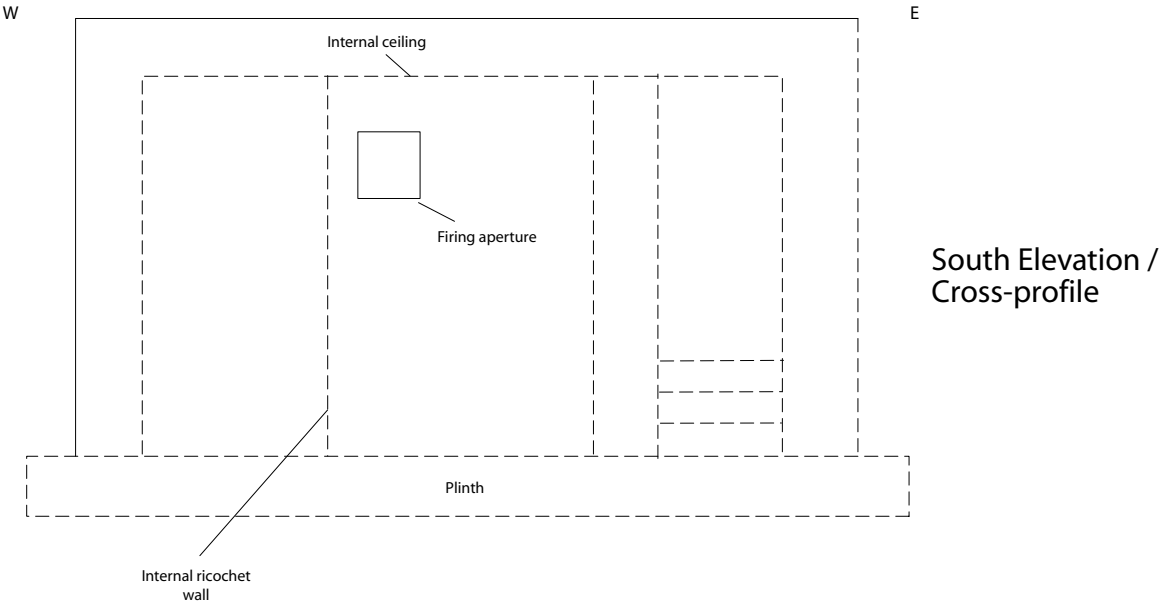
Fig. 22 Pillbox 270339. Reconstructed Plan and Elevation / Cross-profile. Scale 1:40

When visited in 2004 this pillbox appeared to survive only as flat pieces of slab lying on the beach. However, in 2005 these pieces had been further exposed by wave action showing that parts of the structure still survive, although collapsed (Figs 23-24). Sufficient remains to allow the overall plan to be identified. This pillbox was another variant on Type 23, a simple rectangle 4.11m (13ft 6in) long, E-W, by 3.07m (10ft) wide. It had one main gun compartment with three gun apertures, on the north, west and south, and probably an internal ricochet partition. It was accessed via a narrow rear compartment containing steps down into the main compartment.
