# Conwy Valley Flood Alleviation Scheme

## Archaeological Assessment

GAT Project No. 1877

Report No. 618

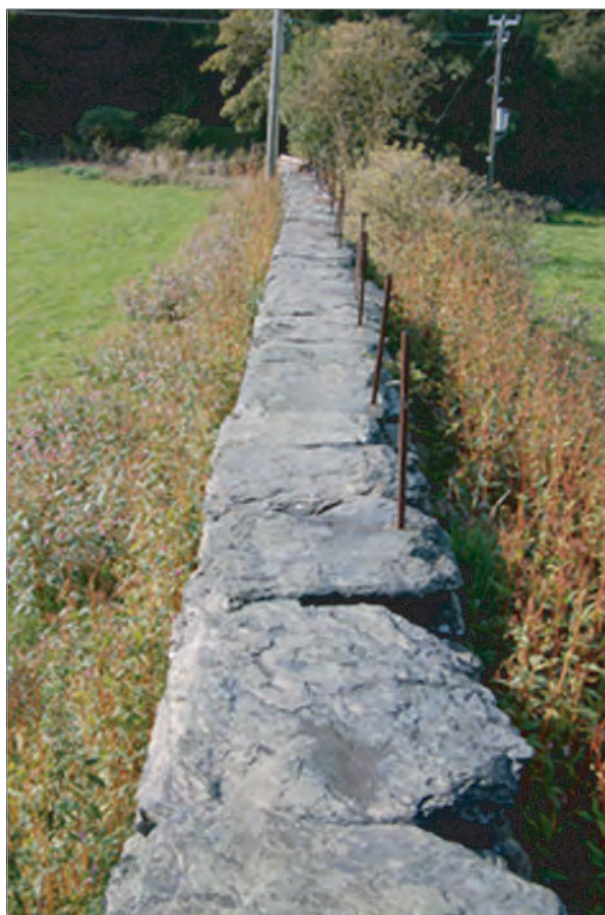
Plate 5. Site A2. Raised walk

A stone wall, approximately 2m high and 1.5m wide, runs from the south end of Gwydir gardens west to the river. The top of the wall is of large flat slabs, and at the Gwydir end steps lead up to the wall top. It was therefore designed to be walked along, and is marked as a footpath on the later Ordnance Survey maps (on the 1913 map described as 'F.P. on top of wall'. In style the wall and steps are late 16<sup>th</sup> century, contemporary with much of the other work at Gwydir, and therefore probably built by Sir John Wynn during other improvements in the 1590's. A drawing by Colt Hoare c. 1810 shows a pyramidal roofed structure within the garden close to the steps leading up to the walk, though the structure no longer stands, and its exact location is difficult to ascertain. It is likely the wall served several purposes, including flood defence, deer park boundary and raised access to the river. The wall turns to the north when it reaches the river, and runs towards Llanrwst, for a distance of about 120m, when it terminates, and is replaced by a 19<sup>th</sup> century stone wall. The 1913 OS map shows the footpath leaving the wall, and running alongside the river. 19<sup>th</sup> century photographs show a rough cobbled track here, that is probably still visible as terraces alongside the river bank. It is possible the 16<sup>th</sup> century wall once continued to the bridge. Though much of the main stretch of wall from Gwydir to the river is in good condition, a gap has been created at the river end for allowing tractors through, and a large gap towards the centre section was created by flooding during the last couple of years. The length along the river is in much poorer condition, though one relatively good short length survives towards the north end.

*Recommendations for further assessment:* Evaluation excavation between the current end of the wall and the bridge to ascertain former existence and location of this feature.

*Recommendations for mitigatory measures:* Avoid direct impact. Detailed record in advance of any works that may impact.

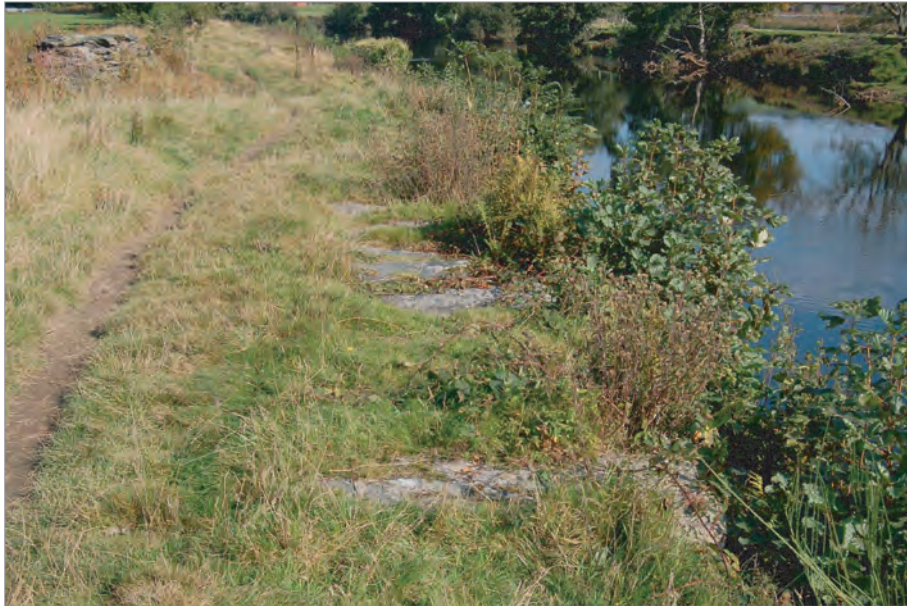
Plate 7. Site A3. River revetment

At the point where the Chinese walk meets the R Conwy, the side of the river is revetted in stone for a length of some 50m. The top of the revetment is marked by long stone blocks now largely buried in the grass. It has been suggested that this was once a quay, perhaps built by Sir John Wynn in the 16<sup>th</sup> century, as there is a tradition that he improved the navigability of the river as far as Gwydir. However, only very small boats could ever have made it this far up river – it is some way beyond the tidal reaches, and if there were sufficient depth of water in the river to allow boats to travel up, then it is probable the speed of the flow down river would have been prohibitive. The stones are more likely to be a revetment to prevent erosion of the river bank onto the parkland, though small, flat-bottomed boats may have been used for transporting goods in a very localized area. The date of the stone revetment is not known, and though it has not quite the same characteristics of the 16<sup>th</sup> century masonry, it could have been built at any point between the late 16<sup>th</sup> century and the 19<sup>th</sup> century.

*Recommendations for mitigatory measures:* Avoid any impact. Detailed record in advance of any works that may impact.

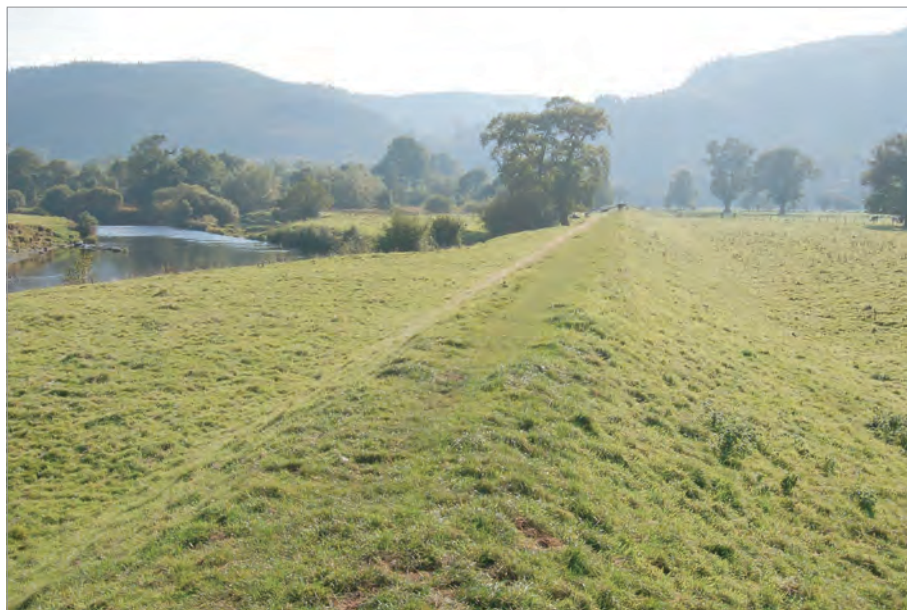
Plate 8. Site C2. Flood defence banks

The flood defences presently consist of a series of strong earth and stone banks, approximately 2m high and some 6m wide at the base and just under 2m wide at the top. They are designed to constrain the R Conwy on the west side, whilst other banks are constructed to constrain the feeders into the Conwy that run down from the hills on the west side of the valley. They were originally constructed within the early 19<sup>th</sup> century by the Gwydyr estate, but have since been regularly maintained and occasionally altered.

*Recommendations for mitigatory measures:* Basic record prior to removal of banks, to include detailed cross sections at selected points in order to determine method, and if possible date, of construction.
