THE BISHOP'S PALACE, BANGOR
ARCHAEOLOGICAL EXCAVATION
2003 AND 2004

GAT Project No. G1785

Report No. 619

By G.H. Smith

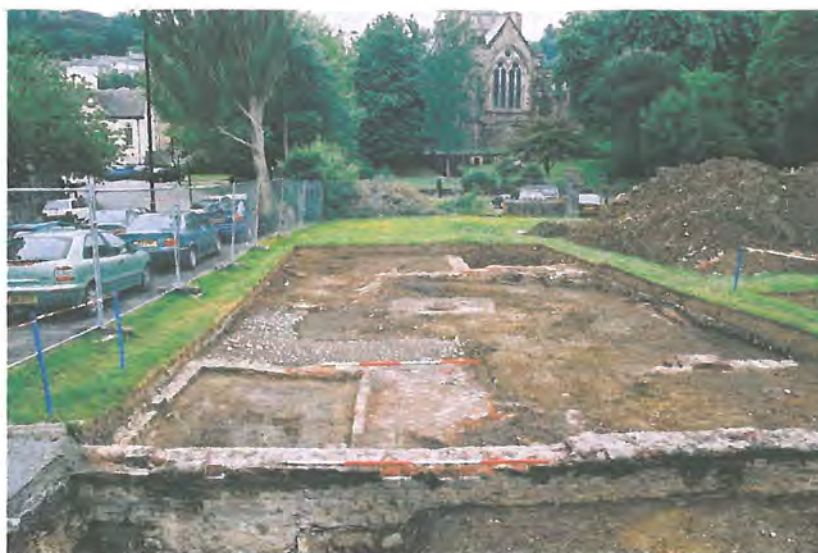
Footings of former palace outbuildings during excavation

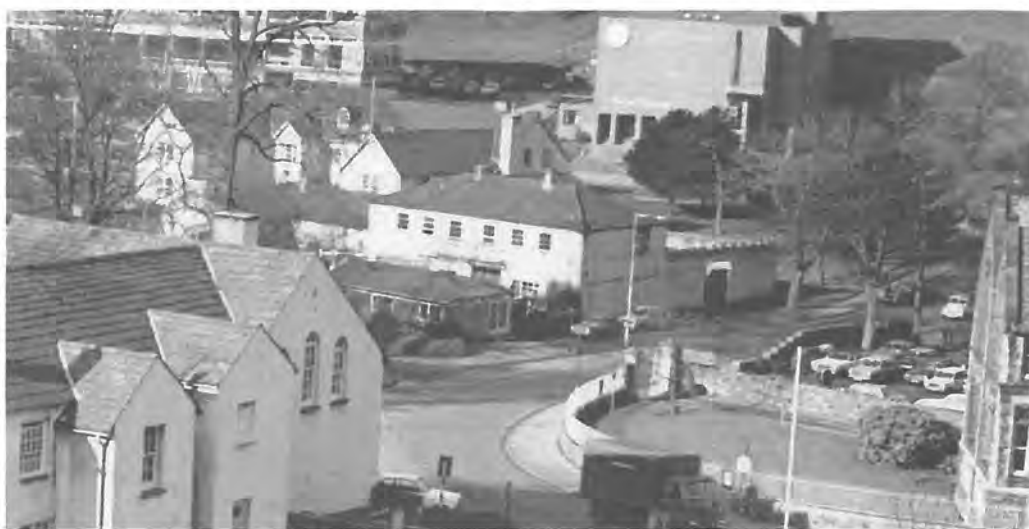
Fig. 2. The 18th and 19th century outbuildings of the palace before demolition in 1996

The area of the immediate enquiry formerly held a stable block belonging to the Bishop's Palace, mentioned by Browne Willis in 1721 and surveyed by the Royal Commission before demolition in 1996. These do not appear on Speed's map of 1610 (Fig. 4) but can be seen on drawings of the mid 18th century (Figs 6-7) and in more detail on Wood's map of 1834 (Fig. 8), the Tithe map of 1841 (Fig. 9) and the OS 1:2500 map of 1890 (Fig. 10). The stable block consisted of two parallel ranges, a northern and a southern, separated by yards. The northern was an extension from the south-east wing of the palace and is likely therefore be the earliest and its size, on the earlier maps, before truncation in the early 20th century, matches the '30 yards length' of Browne Willis' description. Thus, the Royal Commission's comment that the stables may belong to the work of Bishop Majendie (1809-30) is not entirely correct although the southern range, consisting of three coach houses and adjoining L-shaped cottage may be of his time.

The Royal Commission commented that the stables might be the work of Bishop Majendie (in office 1809-30). However, a stable block of similar size belonging to the Bishop's Palace is mentioned in 1721 – 'The Bishops House... is in good repair. The Entrance to it is through an arch which belongs to the stables, over which are granaries about 30 yards in length.' (Willis 1721, 41). This arch could be the same as that which still stood in 1996 (Fig. 2). It was certainly not that in use at the time of Wood's map, when the entrance to the driveway was via the stone arch with the inscription 'HB 1812' (for *Henricus Bangoriensis* – Bishop Majendie's monogram), which now forms the entrance to the Bible Garden. However, there is a possibility that Willis' description could refer to the east wing of the Palace itself, because the sketch of it by Dineley of 1684 seems to show a flight of external stone-built steps leading up to an upper floor (Fig. 5). Several outbuildings are shown on engravings of 1740 and 1776 (Figs 6 and 7). However, both of these views are from the west and most of the outbuildings are single storey and south of the palace, not east of it, so none can be the coach-house. Both engravings show a

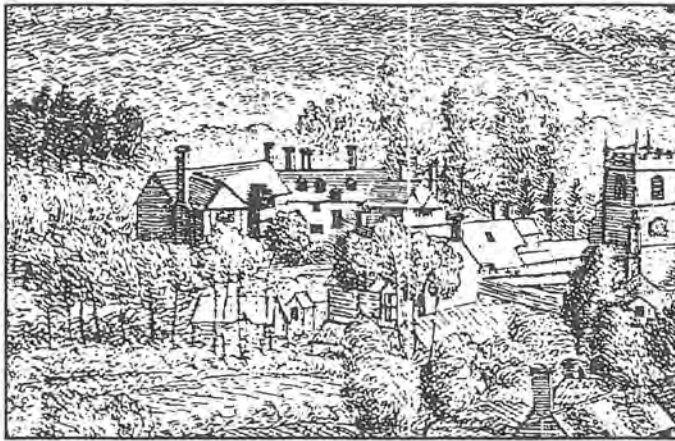
Fig. 6. Bishop's Palace, Bangor: View from the south-west by J. Lewis 1740, showing the outbuildings.

5. Dineley's drawing of the south front of the Bishop's Palace in 1684.
6. Bishop's Palace, Bangor. View from the south-west by J. Lewis, 1740 showing outbuildings south of the palace.

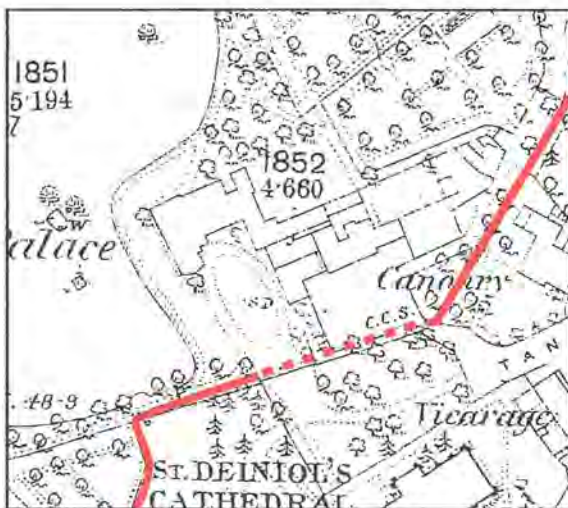
Fig. 10. Bishop's Palace, Bangor, Ordnance Survey 1:2500, 1890

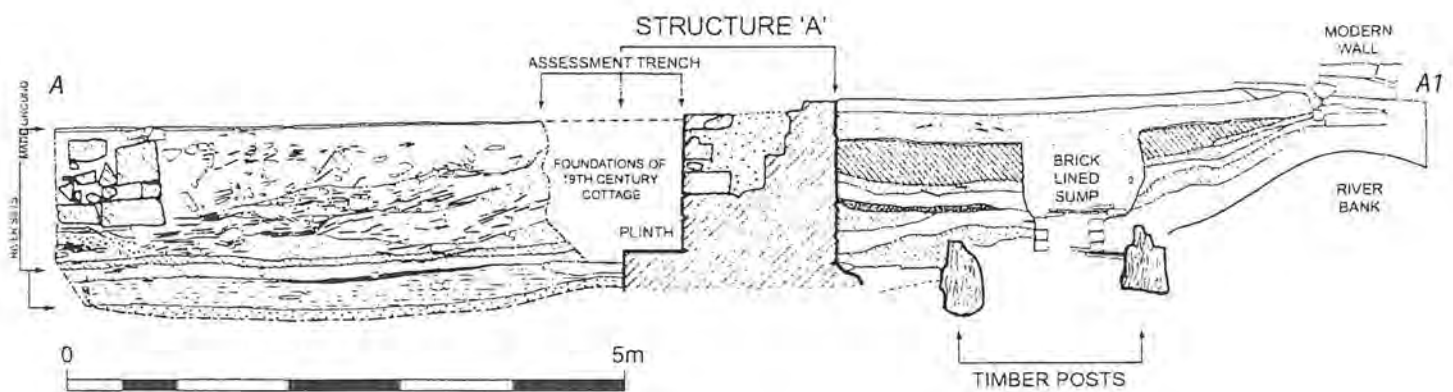
Fig. 12b. North-South section of structures excavated in 1996 (Johnstone 1996)

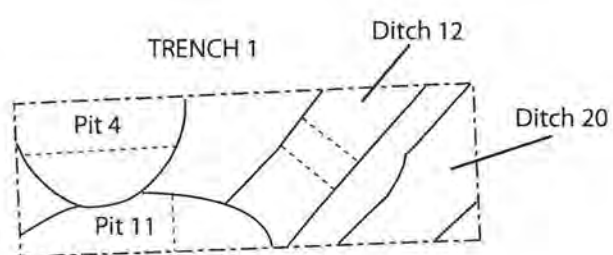
Fig. 16. Trenches 1 and 7: Plan of excavated features 2003 and 2004

Other features that may belong with phase 1 were two narrow parallel small ditches, 12 and 20, found during the site assessment in 2003 in trench 1 (Fig. 16), but not excavated further in 2004 because that area was to be preserved under a car park. Part of ditch 12 was excavated, showing it to be vee-shaped and round-bottomed in profile, 0.80m wide and 0.25m deep (Fig. 21). Its fill was a mid to dark grey clay-silt with occasional charcoal fragments. There were no finds from the ditch but it was cut by a large pit, 11, which was itself not dated but identified as belonging to a period of building activity, perhaps related to the 15th-16th century palace construction (see Phase 2, below). Similar parallel pairs of ditches to 12 and 20 are usually found to demarcate field boundaries but are usually further apart with a hedge bank between, derived from excavation of the ditches. The close proximity of 12 and 20 suggests that there was no hedge bank between them. Their alignment is at odds with the plan of the palace buildings and later boundaries in a similar way to the alignment of gully 142/304 and so there is a possibility that they belong to the same phase of activity. The fill of 12 is quite different to that of 142/303 lacking the waterlogging and animal bones but that could be because it lies on better drained land higher up the slope.

A number of other pits, possible postholes and a curving linear feature were also found in trench 7 (Figs 16 and 25). These were mainly filled with dark loam and were interpreted as planting activity within the garden except for two larger pits, nos. 213 and 215. These had a stiff clay-rich fill and were interpreted as clay quarry pits belonging to a phase of construction although there was no dating evidence as to which phase this might be. The 15th-16th century west and central ranges of the palace and the 16th-17th century east wing were all of half-timbered construction and would have required large amounts of clay for the wattle and daub infill and plasterwork and 4, 11, 213 and 215 may belong to either of those phases of construction.

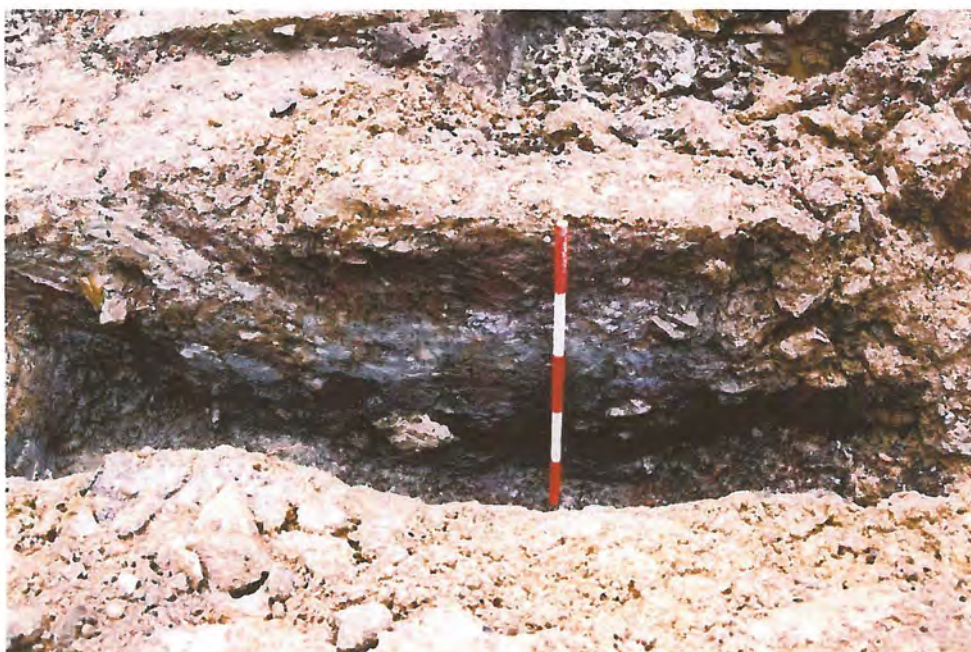
Fig. 19. Ditch 162, showing clay and peat layers. From the south. Scale with 20cm divisions

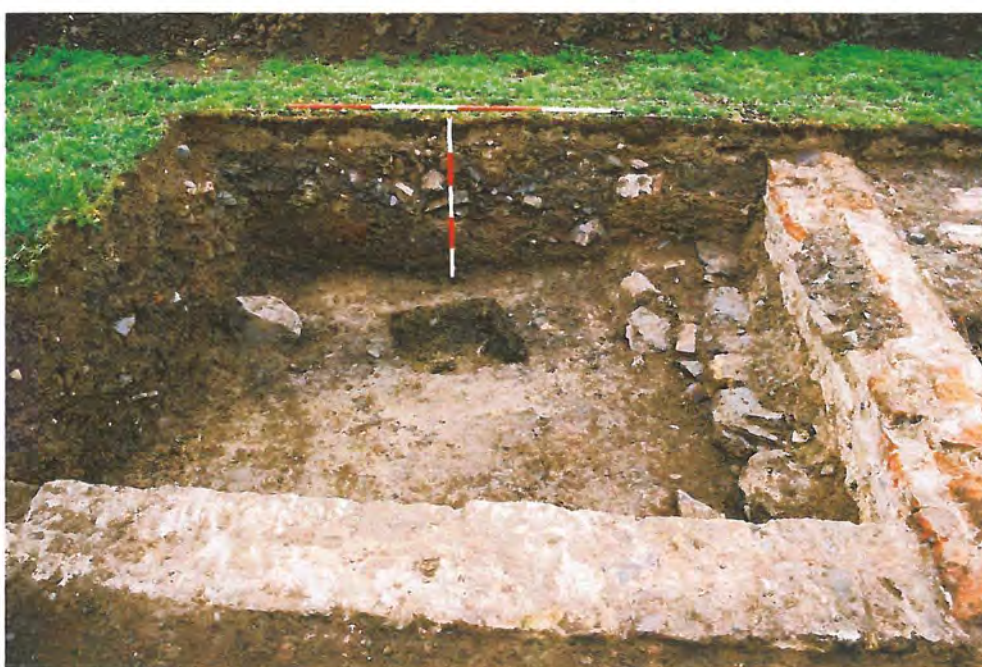
Fig. 20. Gully 303 below coach-house footings. From the east.
Vertical scale with 20cm divisions. Horizontal scale with 50cm divisions

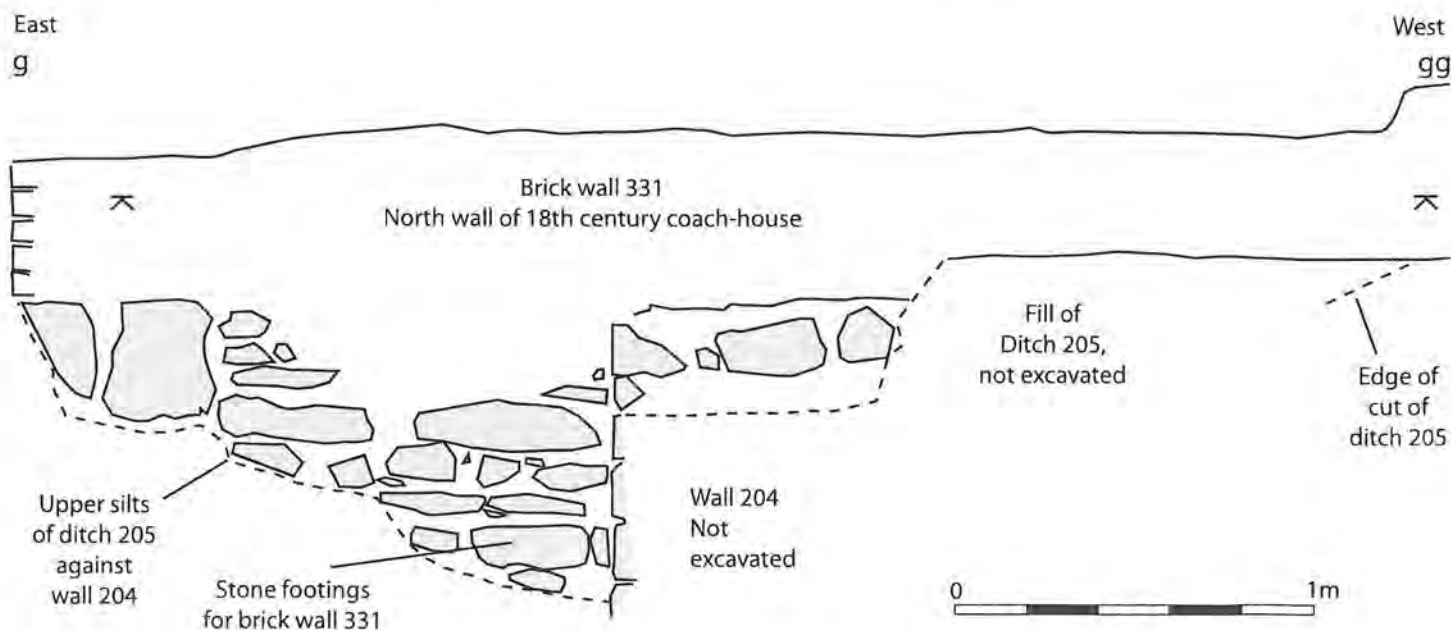
Fig. 22b. Wall 204 and Ditch 205. North-facing section in Trench 8 showing junction of walls 204 and 331

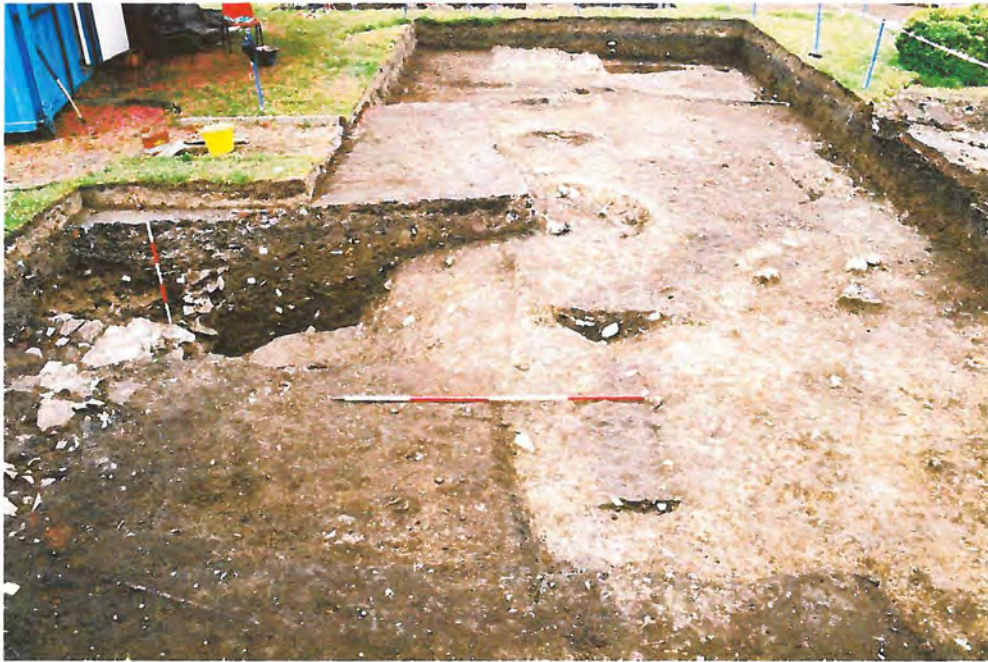
Fig. 23. Ditch 205 and Wall 204. General view, trench 7, from the north.
Horizontal scale with 50cm divisions, vertical scale with 20cm divisions

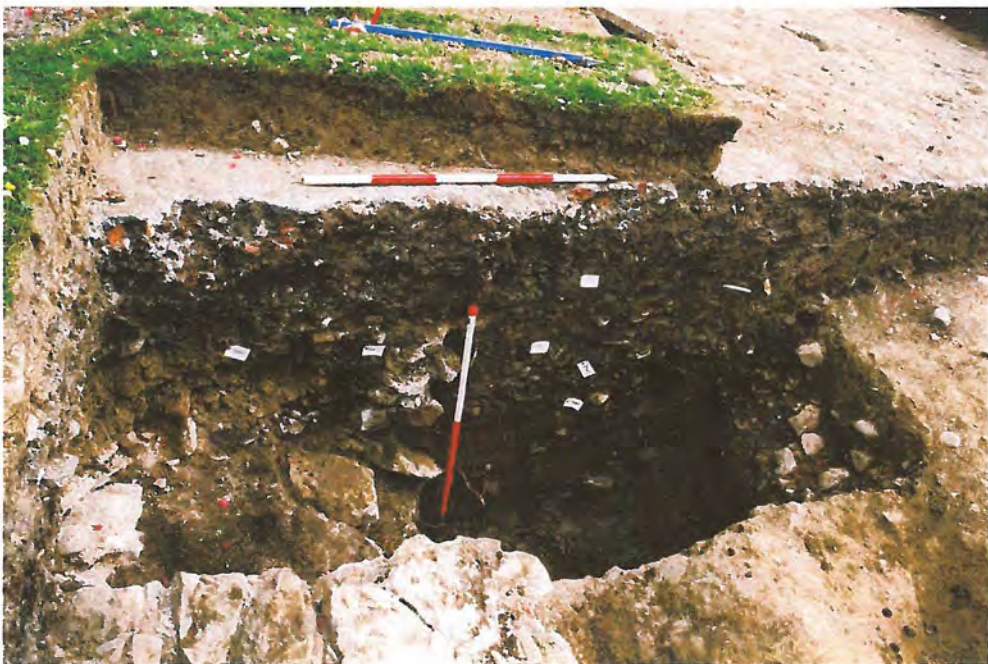
Fig. 24. Ditch 205 and Wall 204. Detailed view of section, trench 7, from the north-east.
Horizontal scale with 20cm divisions, vertical scale with 50cm divisions

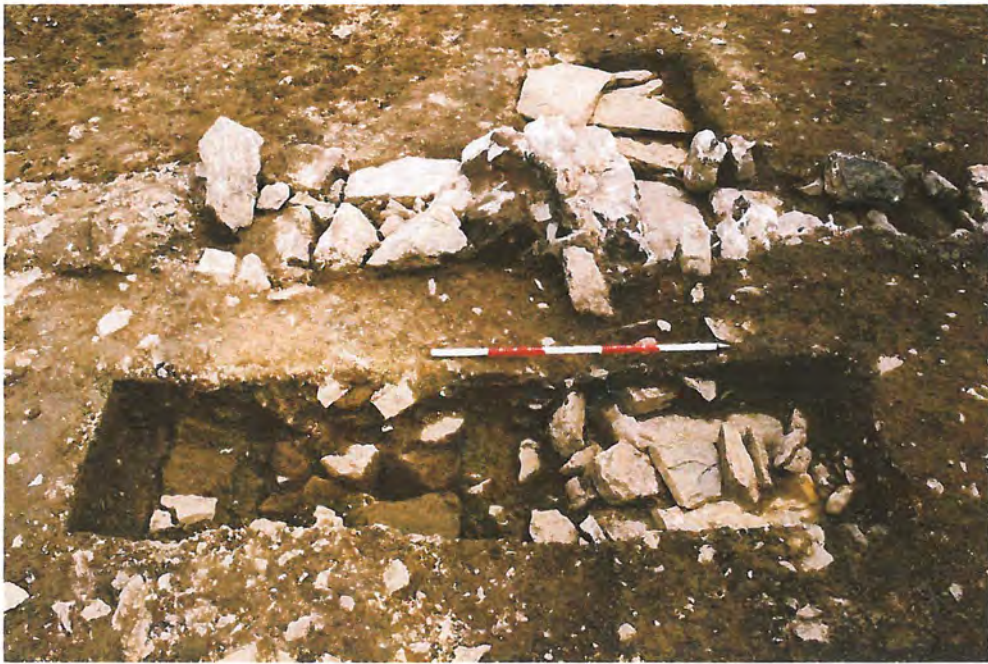
Fig. 27. Trench 6. Culvert 116 and wall 122, from the south. Scale with 20cm divisions

Cut into this soil layer was a large rectangular-sectioned slate slab floored and roofed culvert, 116 (Fig. 18). Alongside it and parallel to it at the east had been a wide stone wall of 1m width, of mortared construction. Only a few footings and the foundation trench of this wall survived (Figs 26 and 27) because it had been demolished when an extension to the palace was built across its line in the late 18th or early 19th century (phase 4). The function of the wall is unclear. It was wider than that of the eastern boundary wall 204 built along the line of ditch 205 and was closely associated with the culvert. A continuation of the same culvert and possibly the same adjoining wall had also been found further to the south during the 1996 excavations (Figs 12 and 13). The culvert at that point had emptied into the side of the Afon Adda. The culvert lay directly alongside ditch 162 described in Phase 2 and its construction had cut into the fill of the ditch. Ditch 162 was only discovered when the edge of the culvert cut could not be found. Ditch 162 was almost entirely filled in by the time the culvert was constructed but because its fill was so peaty and waterlogged a good deal of rubble had to be placed into the side of the ditch to stabilise it before the west wall of the culvert could be built (Fig. 18). Although ditch 162 was more or less defunct when the culvert was built, the close juxtaposition of the two seems significant. Possibly both were performing the same function, perhaps draining a spring at the east side of or north of the palace.

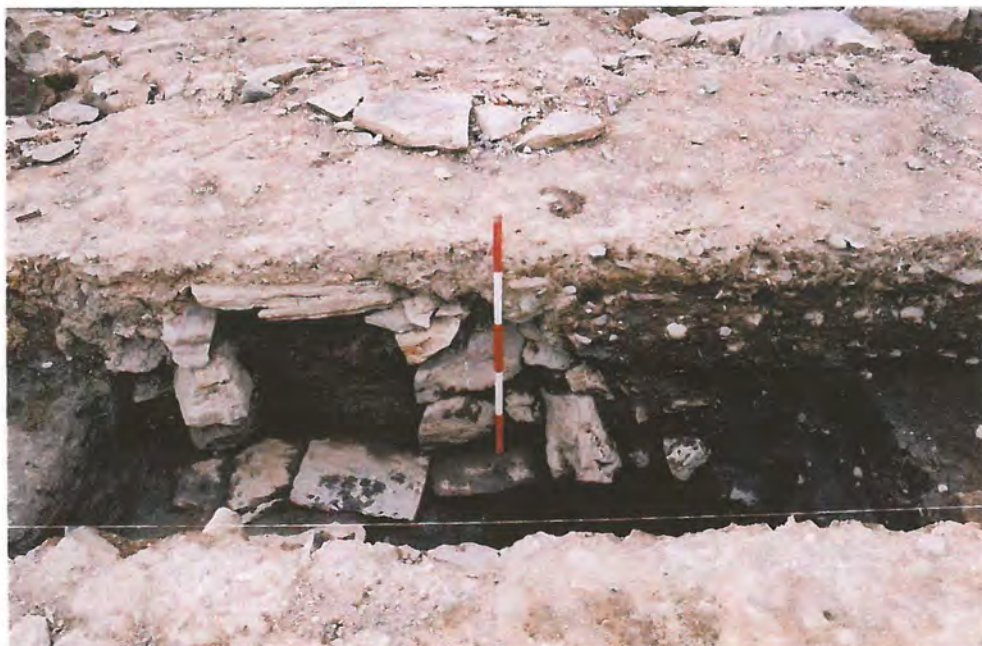
Fig. 28. Trench 6. Culvert 116 in section, from the north. Scale with 20cm divisions

The culvert was still in good condition but silted up with fairly clean gritty silts, not humic as might be expected of a sewer. If it did serve as a sewer it must have been designed to flushed from a natural spring source. It is uncertain when it was built but it is pertinent that it was designed to flow into the Adda when the river still flowed past the south edge of the site. The river itself was culverted and moved further to the south, probably before 1776, when Sandby's engraving (Fig. 7) appears to show outbuildings over its original course but after 1610 when Speed's map shows the Adda as an entirely open river (Fig. 4). The culvert was clearly not part of the late 15th to early 16th century palace construction and a sewer culvert of similar size and construction, but with mortared side-walls has been recorded from a 19th century context at Beaumaris Gaol, constructed in 1829 (Smith 2004). The timber-framed palace was recorded as being 'of timber construction, one storey high and much-decayed' in 1647 (RCAHMW 1960, 10) but was altered and improved on a large scale by Bishop John

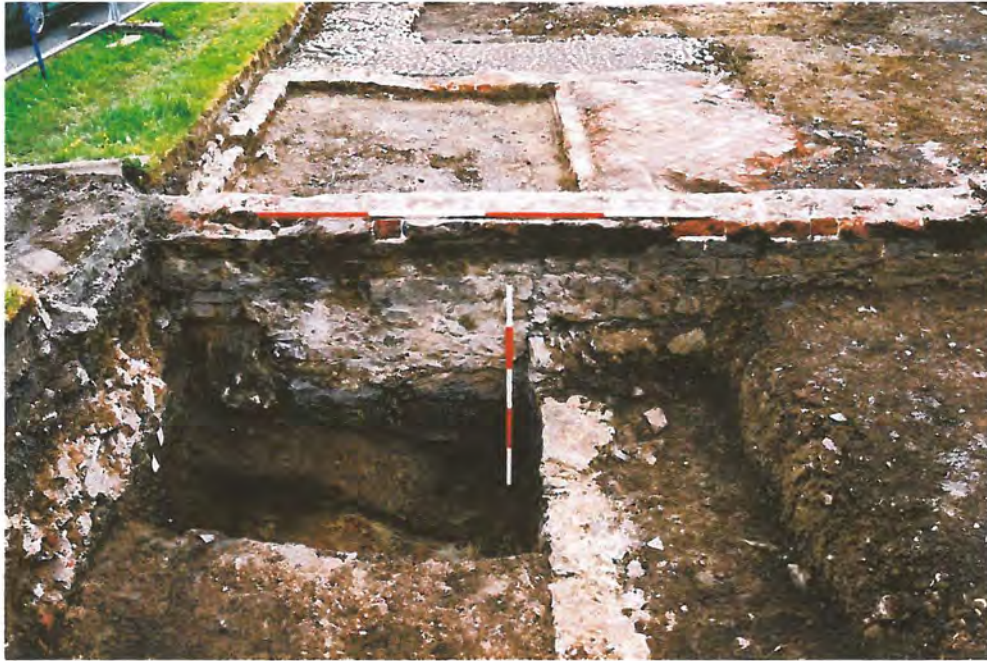
Fig. 29. Trench 8. Wall 204 below yard wall, showing the external wall ditch, from the north.
Horizontal scale with 50cm divisions. Vertical scale with 20cm divisions

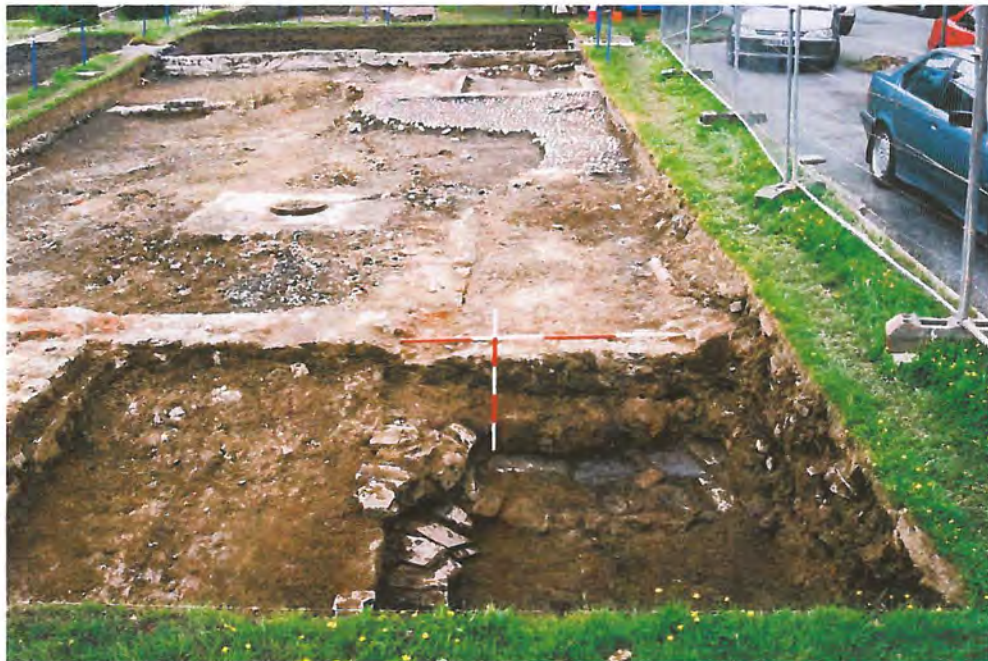
Fig. 30. Trench 8. Wall 204 below the north wall of the coach-house and subsidence
into the top of ditch 205, from the south.
Horizontal scale with 50cm divisions, vertical scale with 20cm divisions

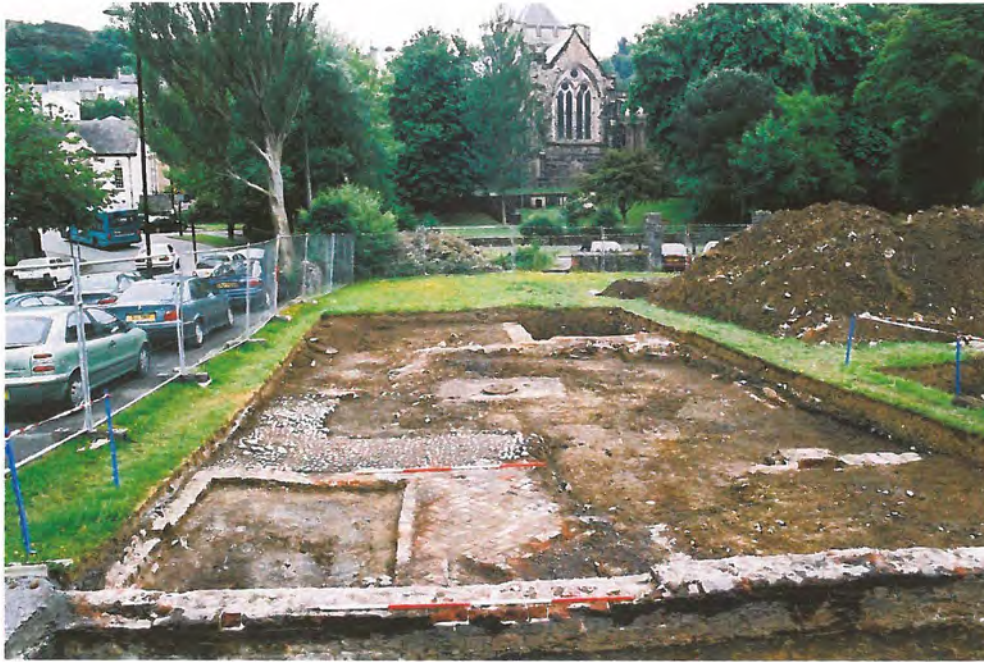
Fig. 31. Trench 8. Cobbled yard and brick floor and wall footings of demolished stable building, from the north. Scales with 50cm divisions

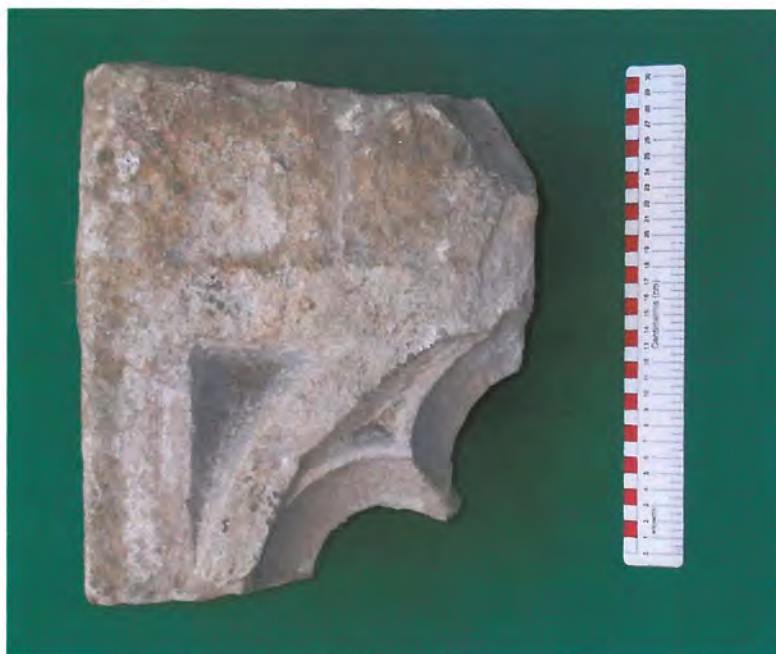
Fig. 32. Window fragment RF 1 from trench 6 showing traces of paint and plaster. Scale with 1cm divisions

RF 1. Part of the trefoil-heading of a small unglazed internal window, arch or arcade. It is almost complete but damaged during re-use. The piece is carved on both sides but had a front face, which has additional decoration and this has traces of paint and the original plaster setting (Fig. 32). This indicates that the piece was an internal feature and the lack of moulding on the rear suggests that it was part of a niche or blind wall arcade.

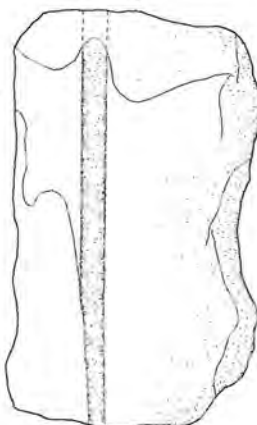
RF 19.

- RF19** Pale buff medium (rounded grains 1-2mm) quartzose sandstone with occasional grains up to 5mm. Shows weak bedding, porous but well cemented with white interstitial powdery material. Pale brown stained surface. Non calcareous.
i.e. **Orthoquartzite** (probably basal Carboniferous *e.g.* NE Anglesey?)

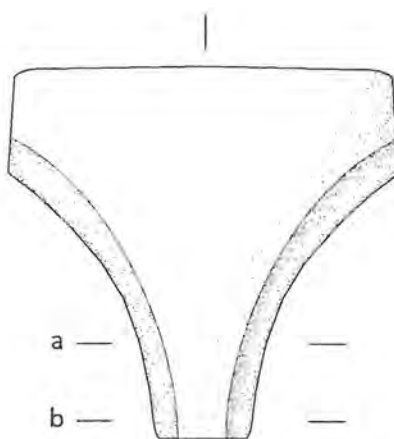
RF 20.

- RF 20** Pale buff medium (rounded grains 1-2mm) quartzose sandstone with occasional grains up to 5mm. Shows weak bedding, porous but well cemented with white interstitial powdery material. Fresh rock non-calcareous. Pale brown stained surface mostly obscured with mortar, soil etc.
i.e. Orthoquartzite (probably basal Carboniferous e.g. NE Anglesey?)
- RF 21** Grey medium-fine (sub-rounded grains 1-2mm) quartzose sandstone. Shows weak bedding, well-cemented and moderate porosity. Surface mostly obscured by mortar, etc. but fresh rock a slightly greenish grey colour.
i.e. Quartz sandstone (with a chloritic cement – probably Carboniferous, source unknown)

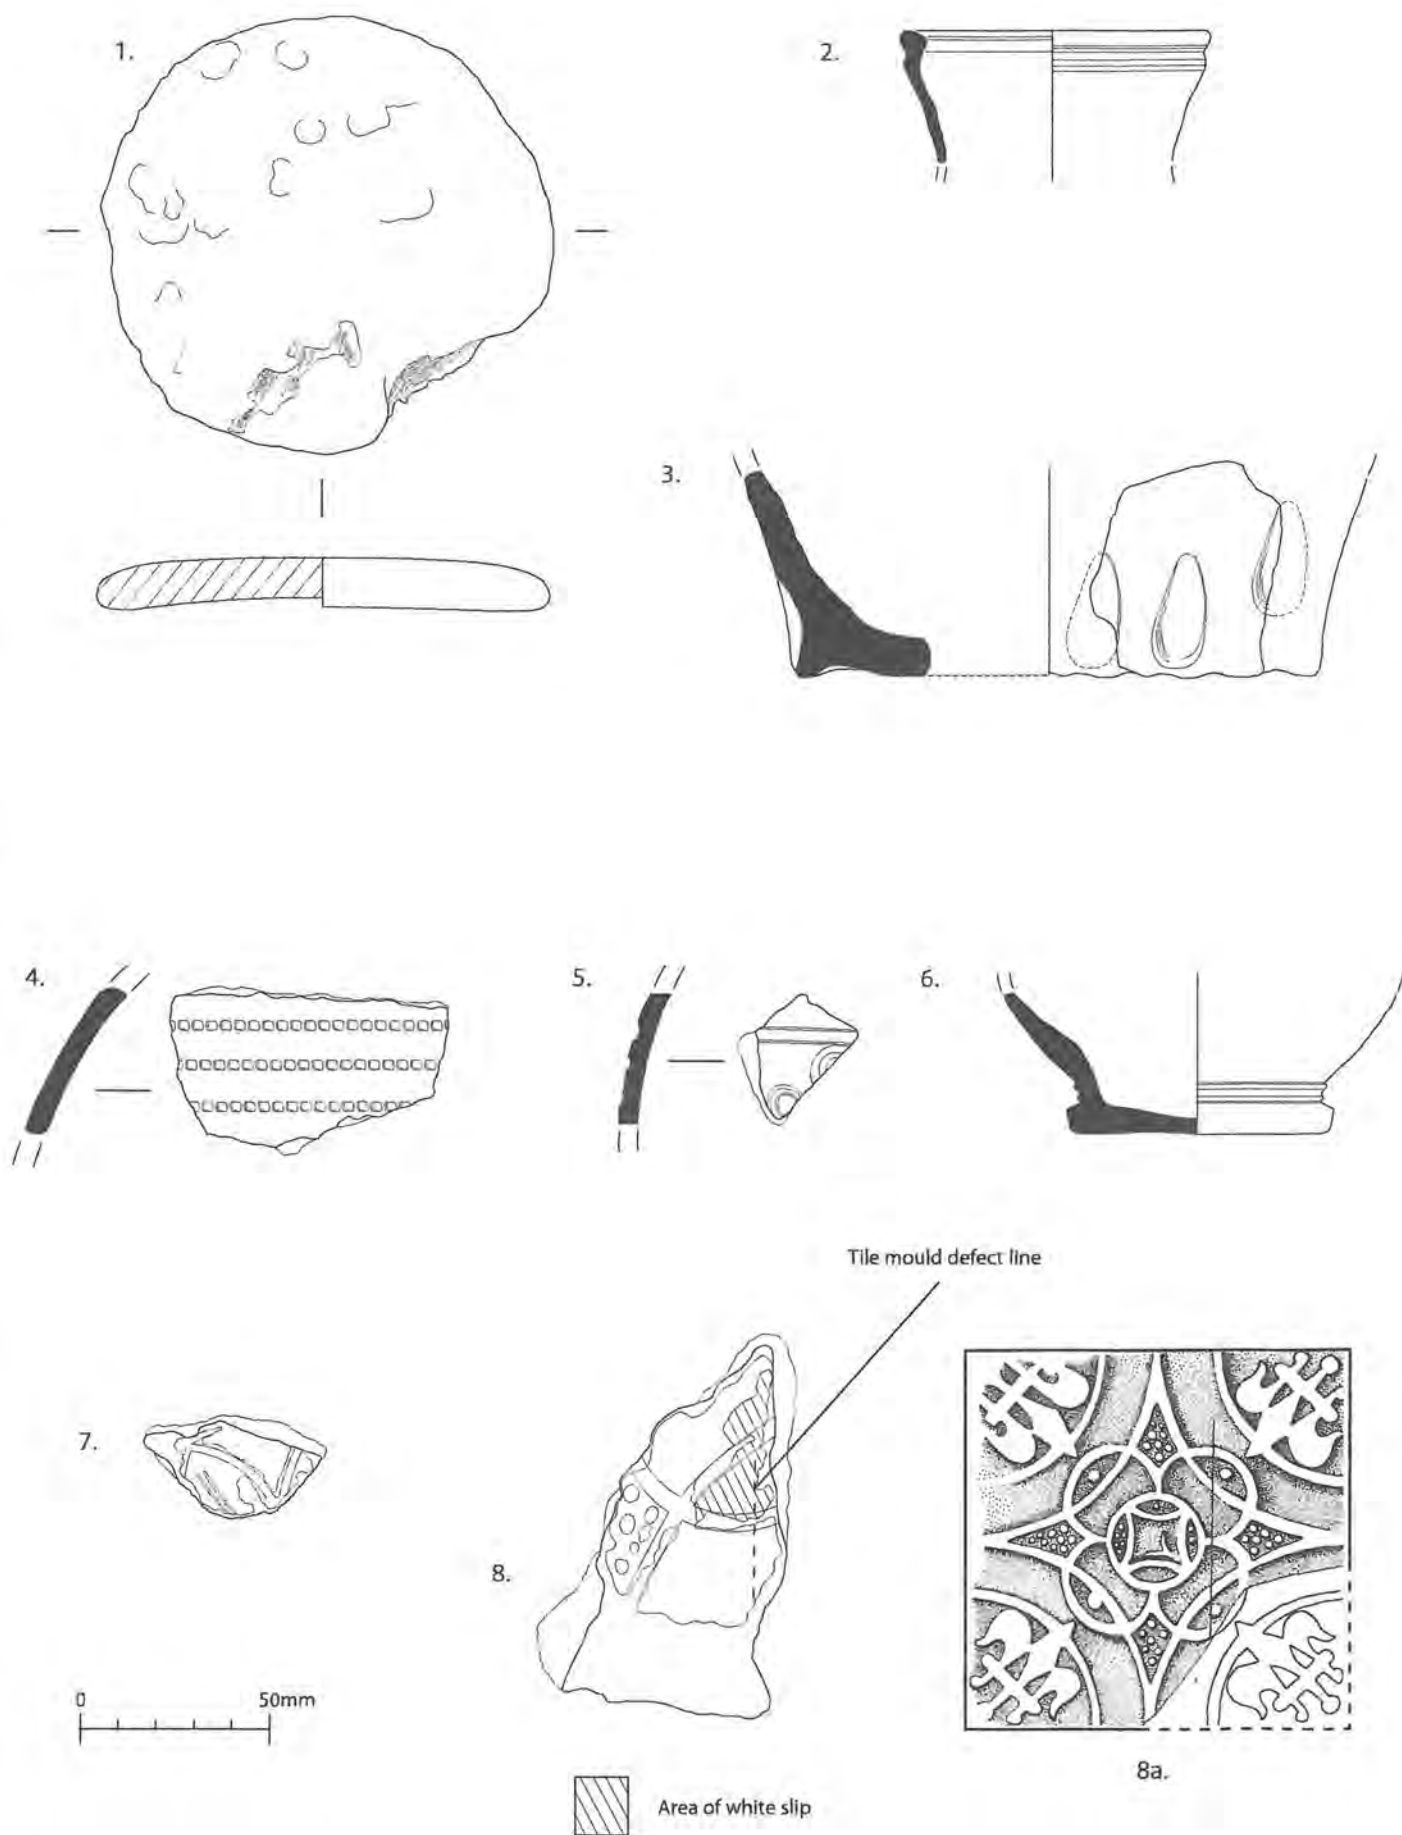
Fig. 34. 1. Wooden pot-lid, RF 5. 2-6, Pottery. 7-8, Decorated floor tile. Scale 1:2. (8a Scale 1:4, after Lewis 1999, 192)

[144] - base from a red/grey ware jug (Fig. 34, 2). There is thumbing around the perimeter of the base and the lower part of the body shows evidence of knife-trimming, where the surface has been shaved or smoothed with a blade of some description. A fragment which appears to be from the same vessel as this was found in [126].

[112] - a small fragment (21 mm thick) with an impressed-line design and a white slip under a clear glaze (Fig. 34, 7). The slip and glaze has been partly worn away. Not enough of the design survives by which it can be confidently identified.

[247] - fragment (39 mm thick) from a large square floor tile with a counter relief design (Fig. 34, 8). The pattern appears to be the same as Lewis's group 48 (Lewis 1999, 86; fig 711, 192), which was found in the chancel of Bangor Cathedral and dated by him to the early sixteenth century. A tile fragment with a similar pattern has also been found in Chester (Rutter 1990, 270 figure 176), numbered 116 in the Chester City stamp series and 178 in the Cheshire series. Three slightly different versions of the design have been found in Cheshire (including number 178) but only fragmentary examples of each have survived (pers. comm. E. Brotherton-Ratcliffe, Cheshire Floor Tile Census). A version has also been found at Rushen Abbey on the Isle of Man (Helen Skillan pers. comm.). John Lewis also quotes an example in Christ Church Cathedral, Dublin (Lewis 1999, 86). It is interesting that the example illustrated from Bangor Cathedral has an additional line cutting across the design parallel to one of the sides; the example from the Bishop's Palace has a similar feature. The line may have been caused by a crack in the wooden stamp used to impress the design; the suggestion is that the two tiles were made using the same stamp but without comparing the tiles it is difficult to definitely identify them as the same. It is possible that this fragment may have originated in the Cathedral, alternatively both the Palace and the Cathedral may have had similar floors installed at the same time made by the same tile-maker.

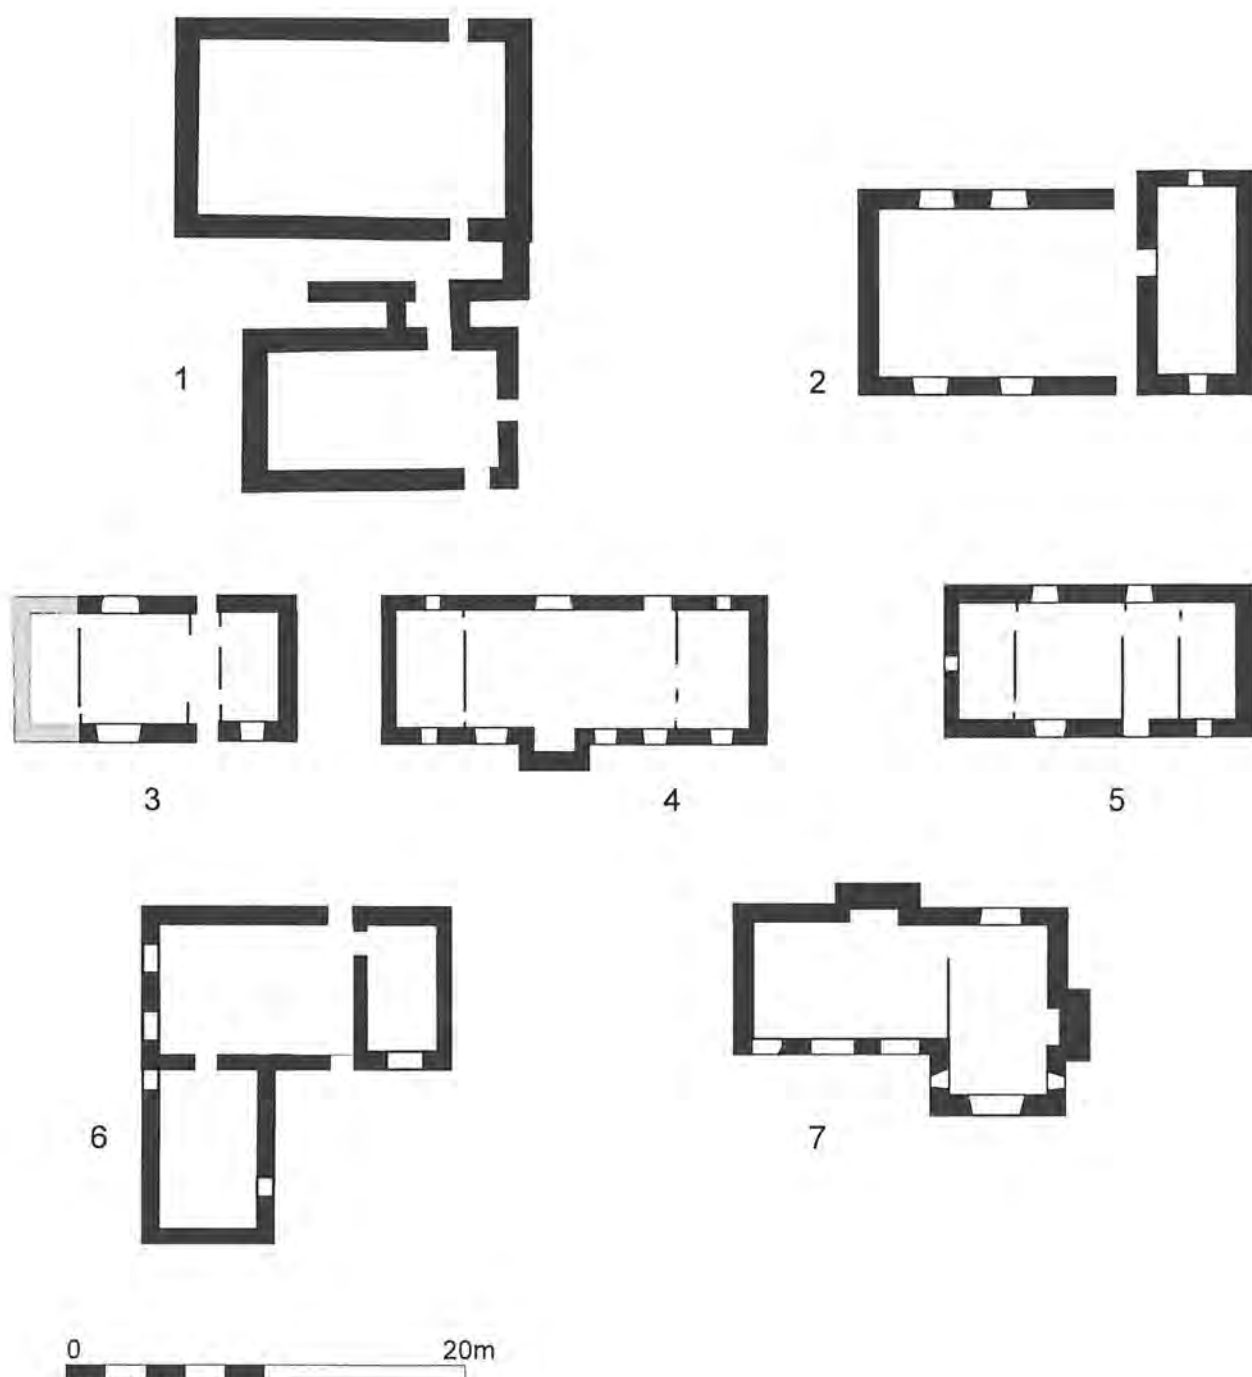
Fig. 35. Bishop's Palace, Bangor. The late 15th century hall compared to other medieval halls in North Wales (after RCAHMW 1964, clx and Johnstone 1999, 265)

1. Rhosyr, Anglesey, 13th century, 2. Bishop's Palace, Gogarth, Llandudno, 12-13th century,
3. Penarth-fawr, Chwillog, 15th century, 4. Cochwillan, Bangor, 15th century, 5. Ty Mawr II, Beddgelert, 15th century,
6. Bishop's Palace, Bangor. Late 15th century, 7. Gloddaeth, Llandudno, 16th century
