# **Wellfield Redevelopment The Menai Shopping Centre Bangor**

## **Archaeological Evaluation**

**GAT Project No. 1880**

**Report No. 643**

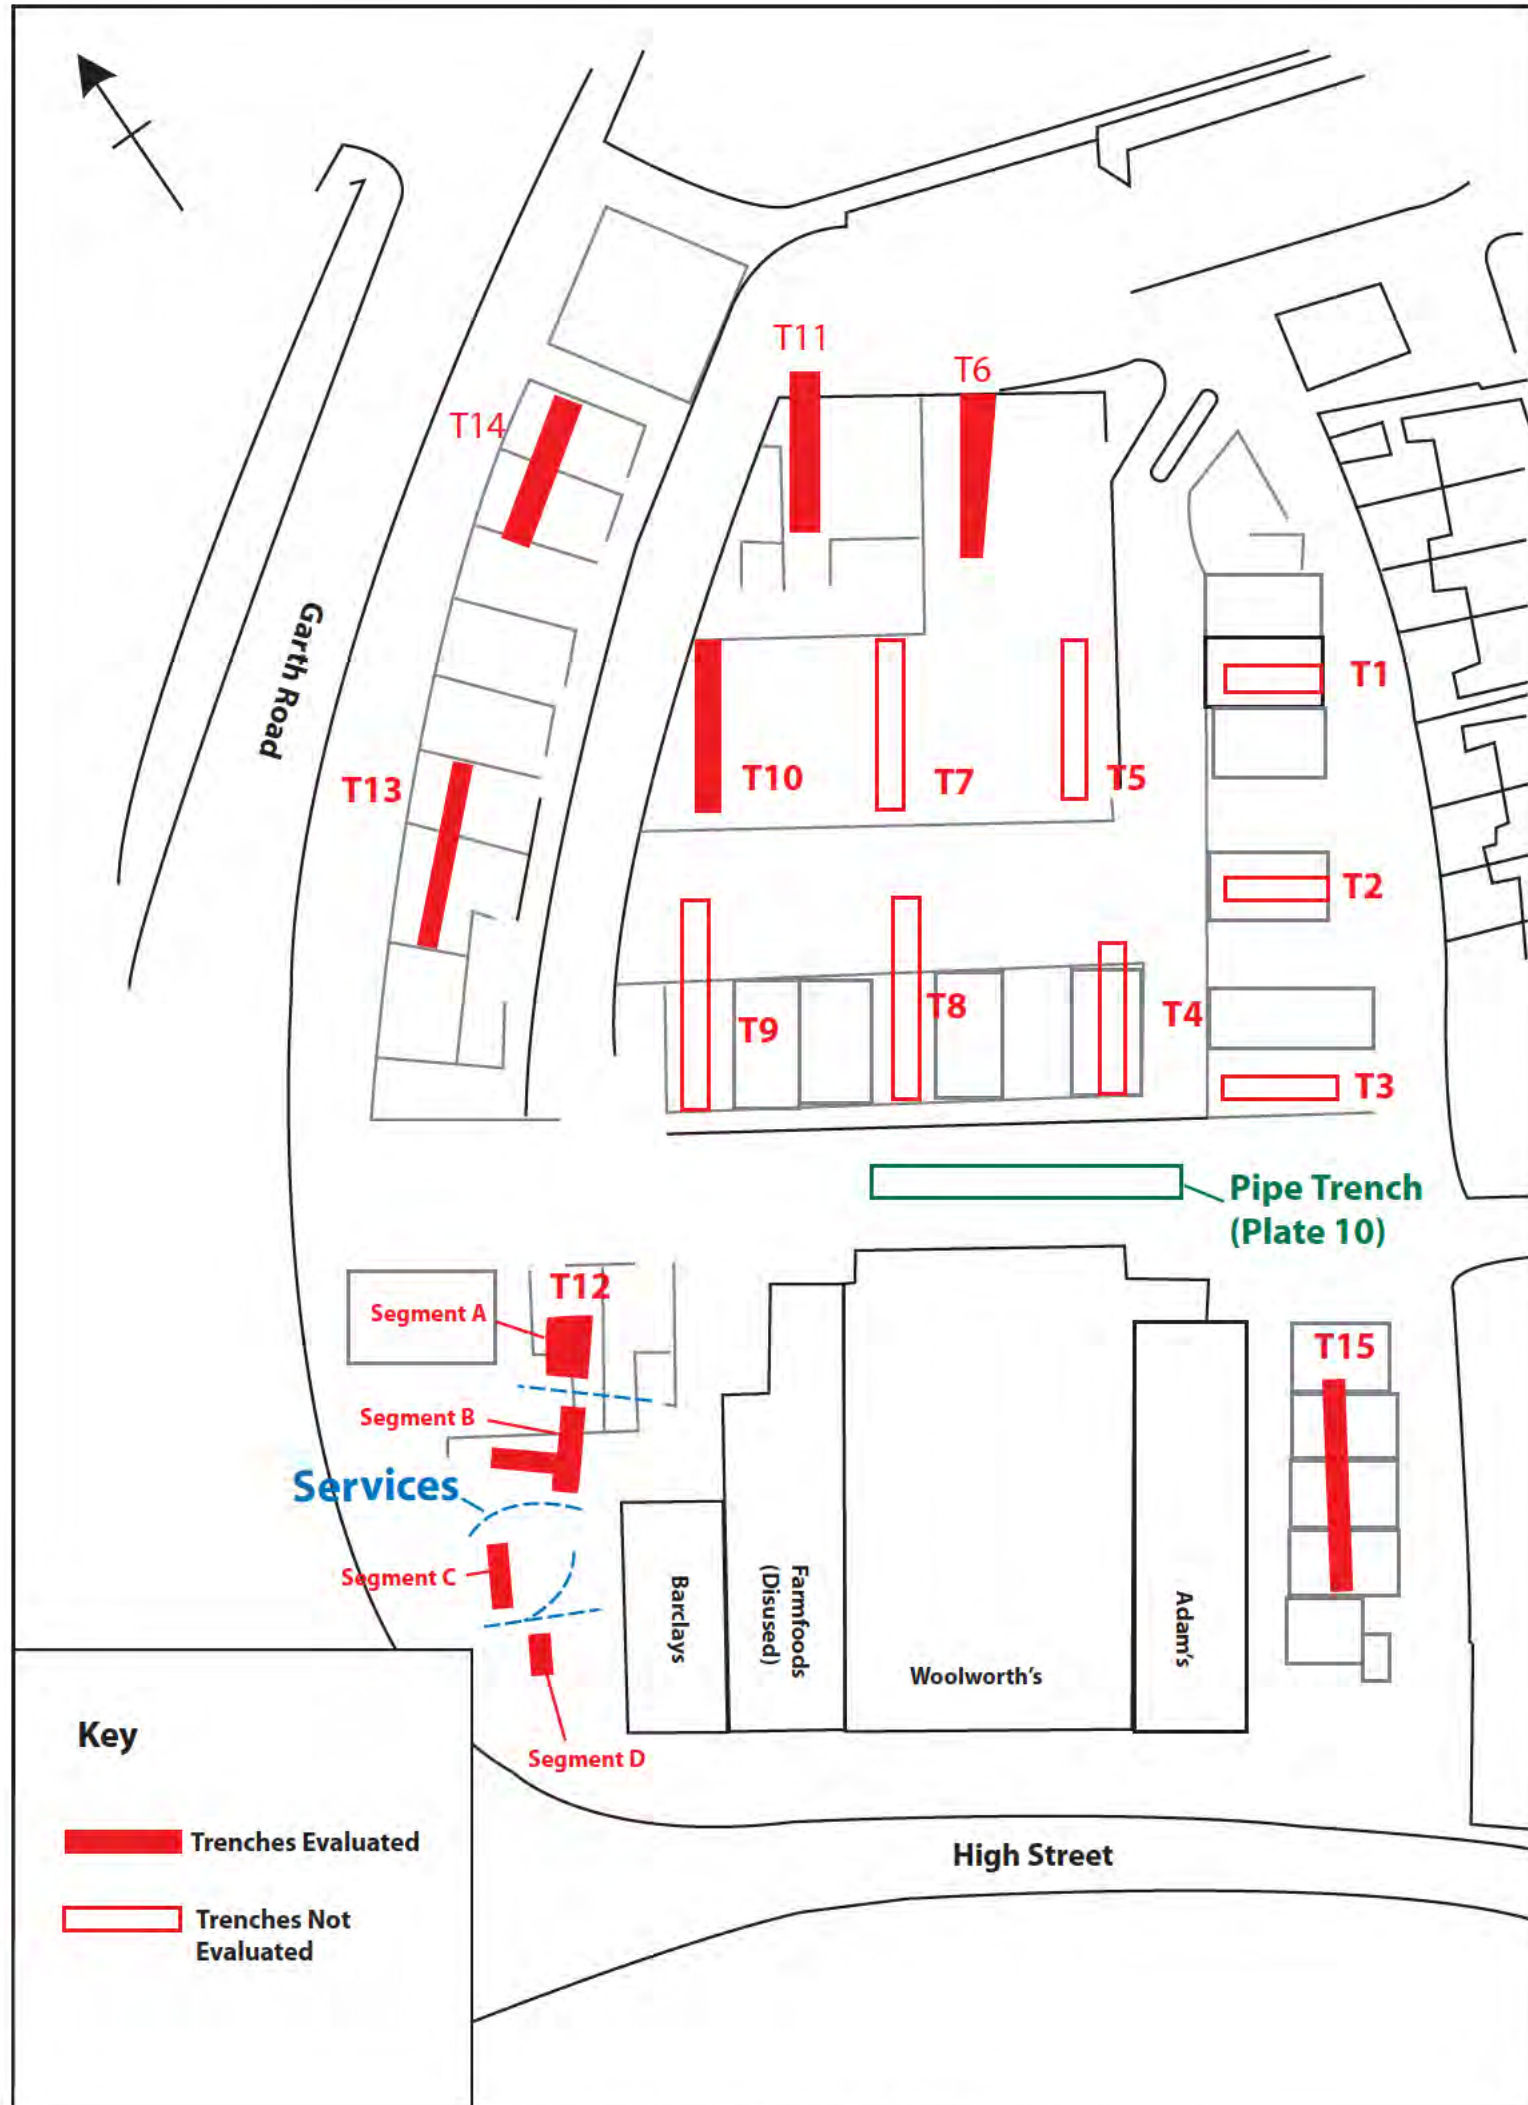
Figure 2: Location of Evaluation Trenches 1-15  
(Figure based on Alfred McApaine Site Drawing: Not to Scale)

The evaluation phase required a total of fifteen trenches to be opened (Figure 2). The trenches were positioned in accordance with the Ordnance Survey historic map evidence, with the aim to locate any

below ground post-medieval features in existence on the site, and to ensure any remains of prehistoric or medieval date would be located and recorded prior to disturbance. Prior to the construction of the shopping centre the site had been occupied by Wellfield House, and the Masonic Hall (see figure 6). Both structures dated to the 19<sup>th</sup> century and were demolished prior to the construction of the Wellfield Centre. West of Wellfield house lay another large unnamed building (see First Edition 25" Ordnance Survey Map, figure 6).

For the location of individual trenches see Figure 2.

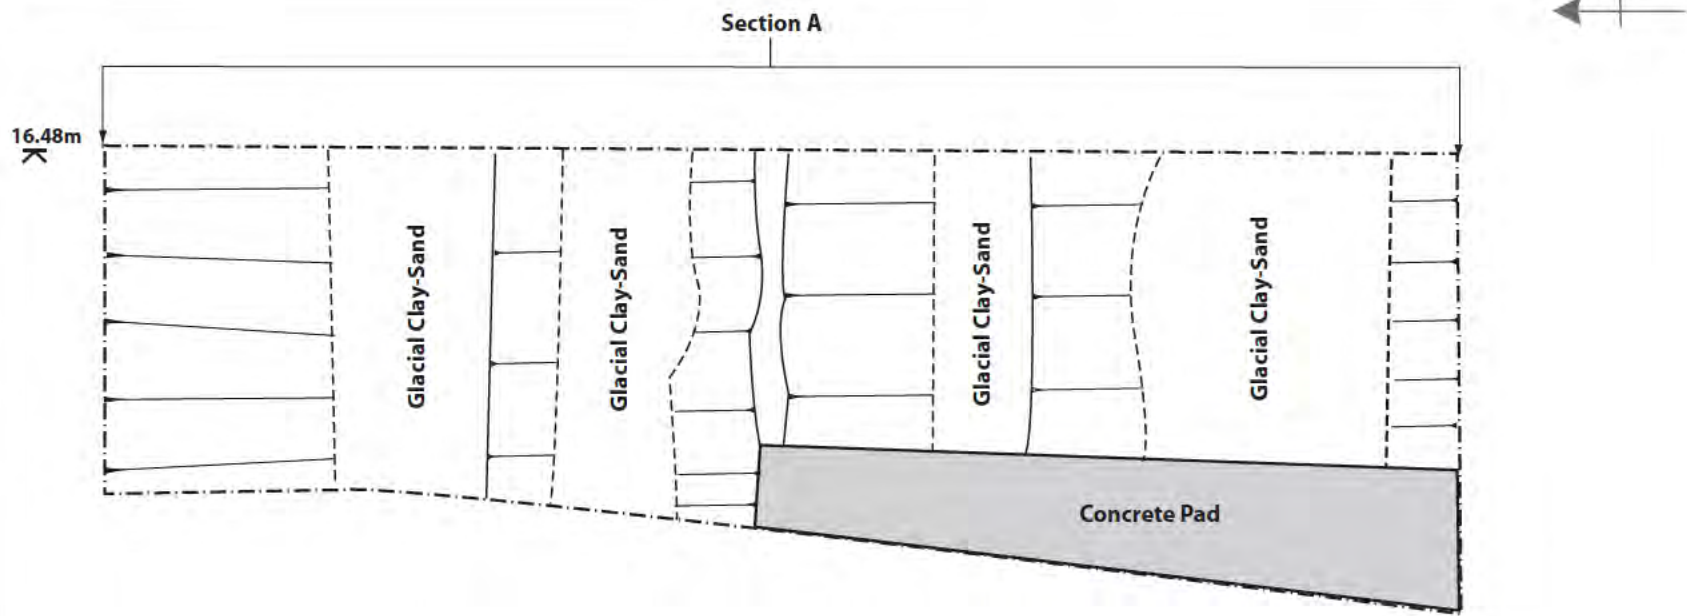
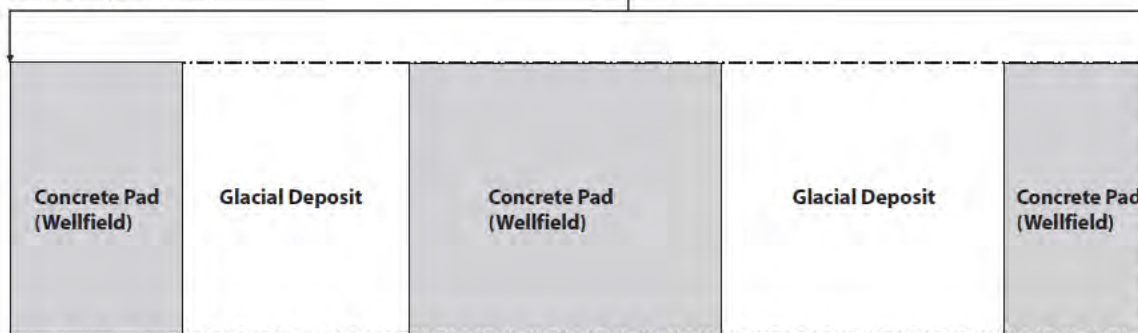
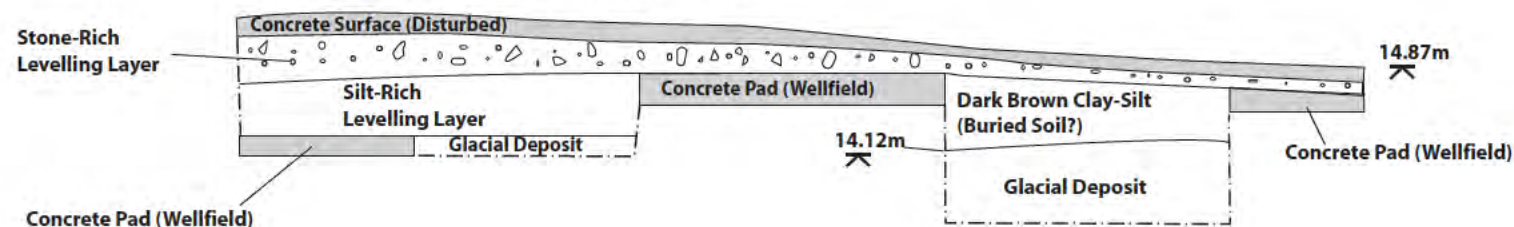
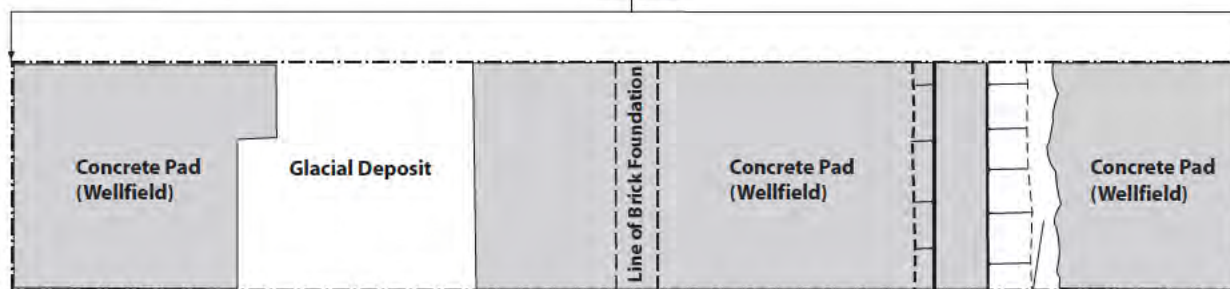
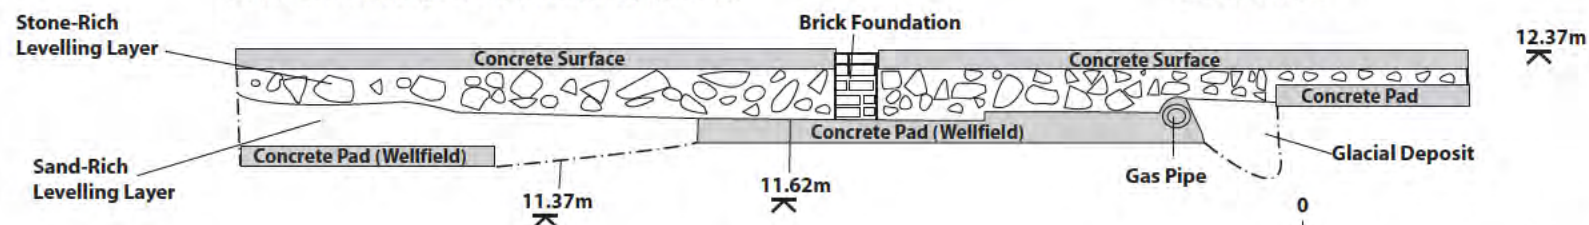
Figure 8: Trenches 13 & 14  
Scale 1:80@A4

Trench 13 was located at the western end of the site and ran parallel to Garth Road. The trench was situated within the ground floor of the Wellfield Centre across a series of office spaces. The ground surface comprised 0.20m of reinforced concrete, which was broken and removed. Below this was a 0.25m thick deposit of levelling material, which in turn sealed a 0.30m thick deposit of dark-brown clay-silt (Plate 7). This deposit was similar to that identified in Trenches 06 and 11 and was interpreted as a possible buried soil associated with Wellfield House (extant at 14.12m AOD; see Figure 8 section A). This deposit was only extent in the southern half of the trench as the centre of trench was dominated by a 3.00m long concrete pad, 0.30m thick, which cut through the buried soil. There were also concrete pads at the northern and southern ends of the trench. At the base of the trench was a manganese flecked glacial deposit.

The trench contained activity associated with the construction of Phase 1 of the Wellfield Centre in 1964. According to the First to Third Edition 25" Ordnance Survey Maps, this area was part of the grounds of Wellfield House. It appeared from the trench that all evidence for this had been removed during the Phase 1 construction of the Wellfield. Some evidence of the Wellfield House was identified in trenches 06 and 11 to the east, both of which contained a buried soil horizon.

This trench was located c.15.0m northeast of Trench 13 and also ran parallel to Garth Road within former office space. The ground comprised 0.20m of reinforced concrete, which was broken and removed. Below this was a 0.35m thick levelling deposit comprising redundant building material (Plate 8; Figure 8). Noticeably, the majority of the material used was sub-angular blocks of granite, of various sizes but no more than 0.30m in width. This material may well have been sourced from structures within the Wellfield House property. However, there was no way to tell definitively. At the middle and southern end of the trench, the levelling deposit covered large concrete pads, with a brick foundation wall running through the centre of the middle concrete pad. Between the two pads was a gas pipe and

below this, a glacial deposit. At the northern end of the trench, the levelling layer was removed to expose more glacial activity (extant at 11.37m AOD; see Figure 8; Section B).

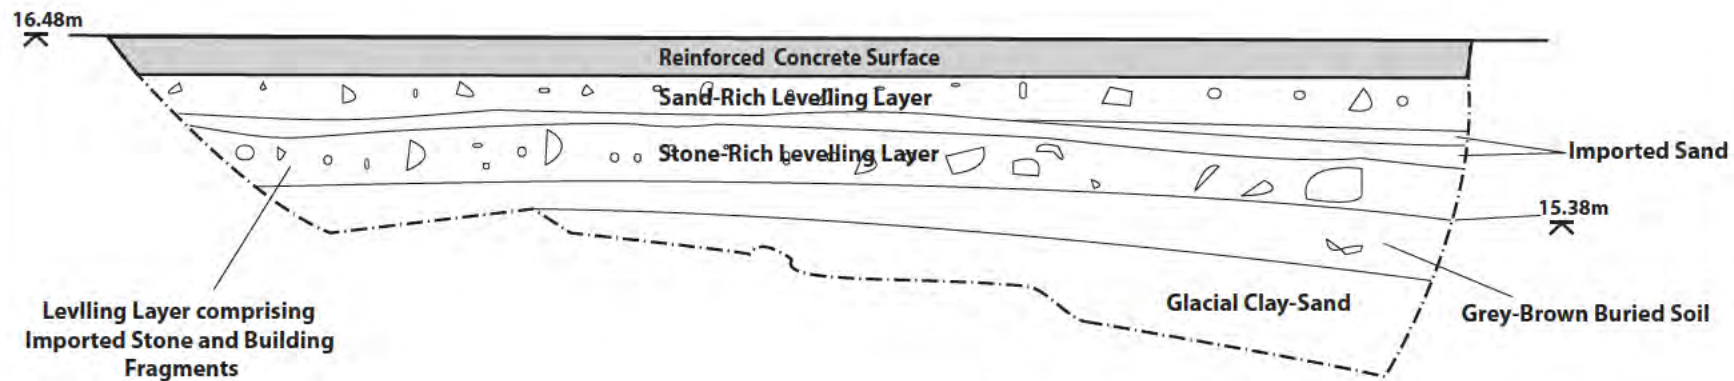
**Figure 7: Trench 06  
Scale 1:50@A4**

Trench 06 is located at the northern end of the site in what was formerly the lower car park of the Wellfield Centre. The surface prior to excavation comprised a level surface c.35m long and c.20m wide built from reinforced concrete and surrounded by a series of reinforced steel joists (RSJ's) that formerly supported the superstructure. The trench was orientated north to south. Directly below the ground level (comprising 0.20m of reinforced concrete), was a c.1.00m thick deposit of demolition material, comprising fragments of granite stone, slate and brick. This deposit was used as a levelling layer during the Phase 1 construction of the Wellfield Centre and was used to create a flat surface on which to build the ground level. As with Trenches 13 and 14, the granite stone could have been reused stone from the former Wellfield House buildings. Below the levelling deposit was a 0.30m thick deposit of grey-brown clay-silt (extant at 15.38m AOD; Figure 7; Plate 1). This deposit matched that identified in Trench 11 located 9.0m to the west of Trench 06 and was interpreted as a former buried soil associated with Wellfield House. The buried soil followed the gradient of the valley slope and contained small fragments of coal, slate, brick, glass and white glazed ware; all of which were indicative of post-medieval activity, and by extension, Wellfield House. This buried soil was only extant in the northern half of the trench: the southern half appeared to have been truncated during the construction of the Wellfield Centre (a similar scenario was identified in Trench 11). The buried soil was cut on the eastern side of the trench by a large foundation footing, into which was set a 1.00m thick concrete pad. The gap between the concrete pad and the edge of the foundation was filled with stone. Below the buried soil was the manganese-flecked glacial deposit that had been identified in trenches 10, 11, 12, 13, 14 and 15. No other activity was identified.

The trench contained activity associated with the construction of Phase 1 of the Wellfield Centre in 1964, in the form of a concrete foundation pad, followed by a sequence of levelling deposits and a concrete floor surface. The only evidence for activity associated with the 19<sup>th</sup> Century Wellfield House was a buried soil, possibly from the grounds of the house. An inspection of the First to Third Edition 25" Ordnance Survey Maps shows the location to be an orchard. A similar deposit was identified in Trench 11, 9.0m to the west

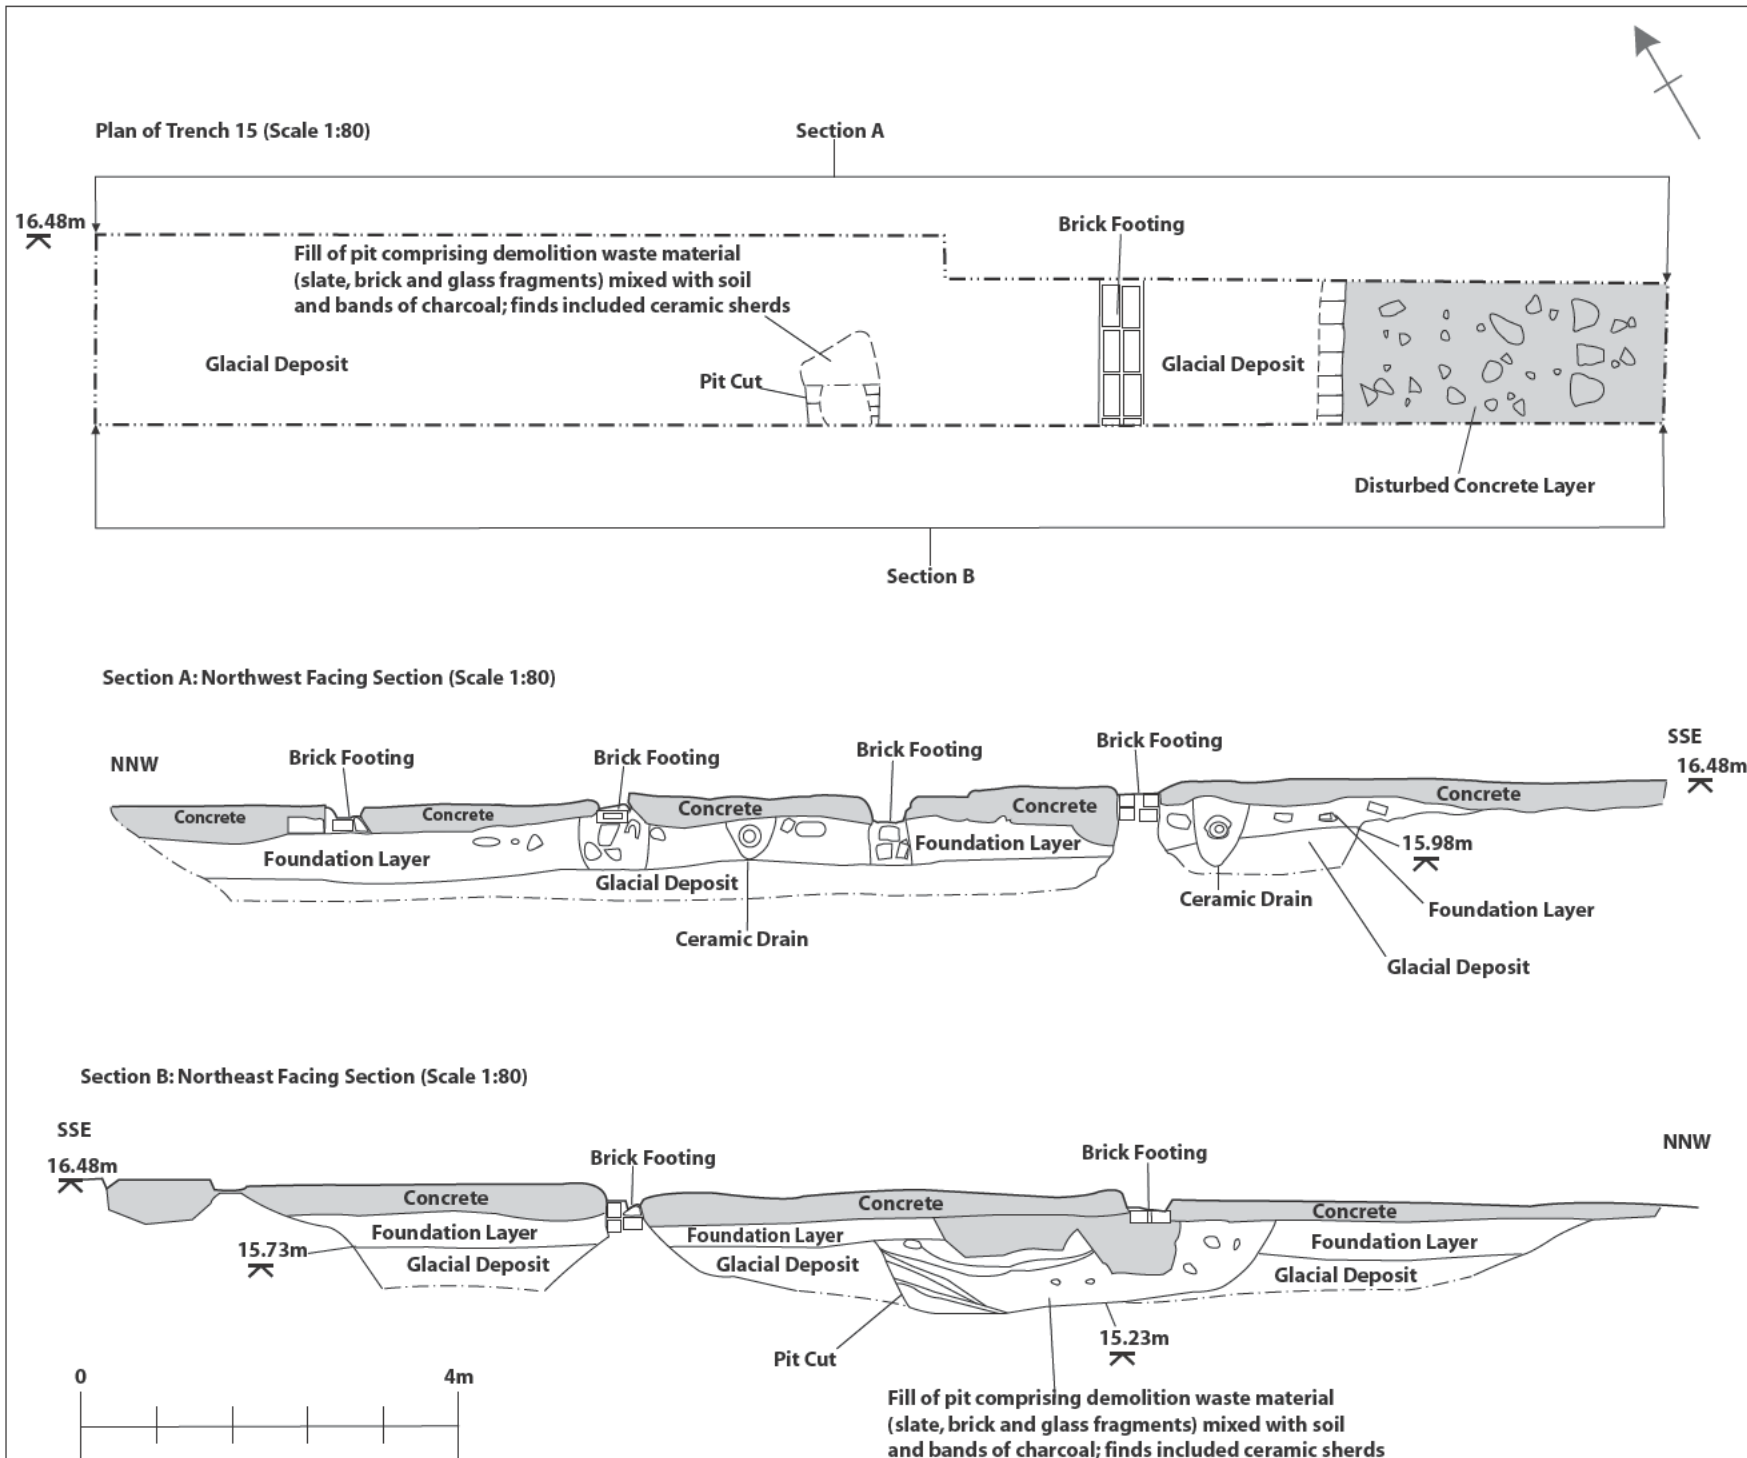
Figure 9: Trench 15  
Scale: 1:80@A4

Trench 15 was positioned at the eastern corner of the site at the location of the former stores for the shops that ran up the slope into the shopping centre. The stores had been demolished but the partitions were still visible at foundation level. The trench was orientated NNW to SSE and measured 16.5m by 1.50m (Plate 9; Figure 9). The brick-built partitions were visible on the southwest facing section, positioned c.2.5m apart. The foundations had been cut into a 0.50m thick levelling layer comprising modern building waste, including brick and slate fragments (extant at 15.98m AOD; see Figure 9). This levelling layer had also been cut by two ceramic drains. The levelling layer sealed a deposit of sand that was assumed to be glacial in origin rather than imported (extant at 15.73m AOD; see Figure 9). Above the levelling layer and forming the floor surface was a 0.40m thick deposit of concrete. The northeast facing section revealed a similar relationship except that only two of the four brick-built foundations were visible in section. The only major difference was a four metre wide pit visible below the levelling layer. The pit was located towards the centre of the trench and was filled with demolition waste, including brick, slate and mortar fragments (base of pit at 15.23m AOD; see Figure 9). Several sherds of white glazed pottery and a small stem fragment from a clay pipe were also recovered. The pit appeared to be associated with the construction of the Wellfield Centre, possibly a refuse pit. A large concrete footing was set into the pit below the concrete flooring and one of the brick foundations, suggesting that the pit may have been associated with this activity. It did not appear to be a backfilled tree-bowl. Another option is that it could have been a refuse pit associated with the Wellfield House as the trench was located in what would have been the grounds for the house.

The trench contained activity associated with the construction of the Wellfield Centre, viz., the foundations and floor level of the garage and stores below a series of shops. There did not appear to be any activity associated with Wellfield House, suggesting that the area was levelled and landscaped prior to building the shopping centre. However, there was a slim possibility that the large pit towards the centre of the trench could have been a refuse pit associated with the house, although there was no way to confirm this.

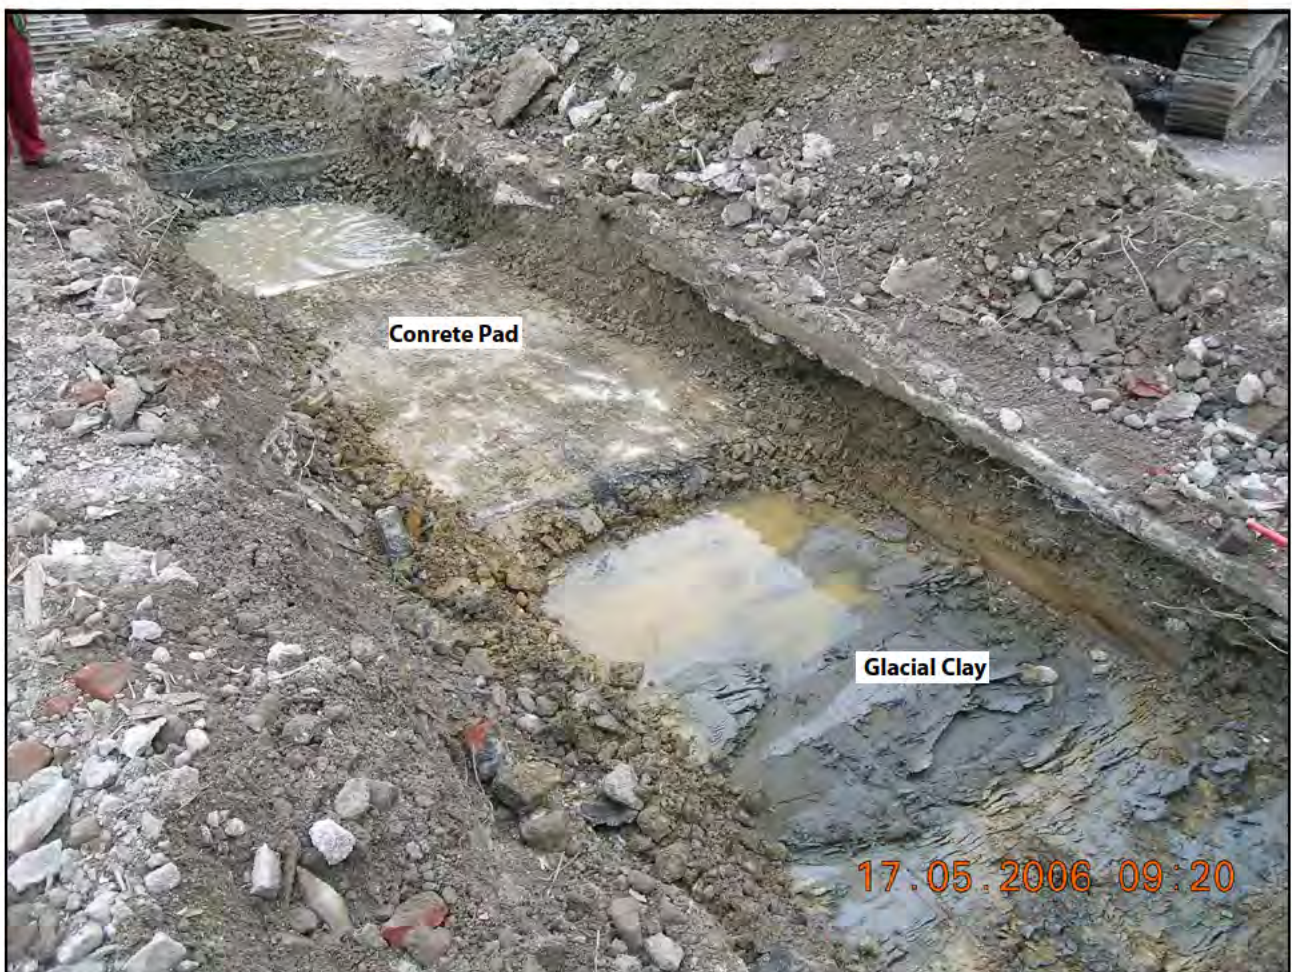
Plate 2: Trench 10: View Northeast

Trench 10 was located c.25m southwest of Trench 06 in what was the loading bay area of the Wellfield Centre. The trench was orientated north to south and was located in what would have been the grounds of Wellfield House. The ground level comprised reinforced concrete, which was broken up and removed. This layer was 0.20m thick and covered a layer of demolition material. This layer was used to level off the gradient of the valley side so as to facilitate a level surface on which to lay the concrete. At the southern end of the trench, this deposit was very thin, but gradually thickened to a depth of 0.40m as the slope of the valley continued northwards (Plate 2). At the southern end of the trench the levelling layer sealed the manganese-flecked glacial deposit. In the centre and northern end of the trench the levelling layer covered two concrete pads. The central pad measured 3.00m in length and 0.30m in depth and was cut into the glacial deposit. The northern concrete pad continued outside the extent of the trench. The glacial deposit was visible between the two pads. No other activity was identified.

The trench contained activity associated with the construction of Phase 1 of the Wellfield Centre in 1964, in the form of a concrete foundation pad, followed by a levelling deposit and a concrete floor surface. There was no evidence of the 19<sup>th</sup> century Wellfield House.

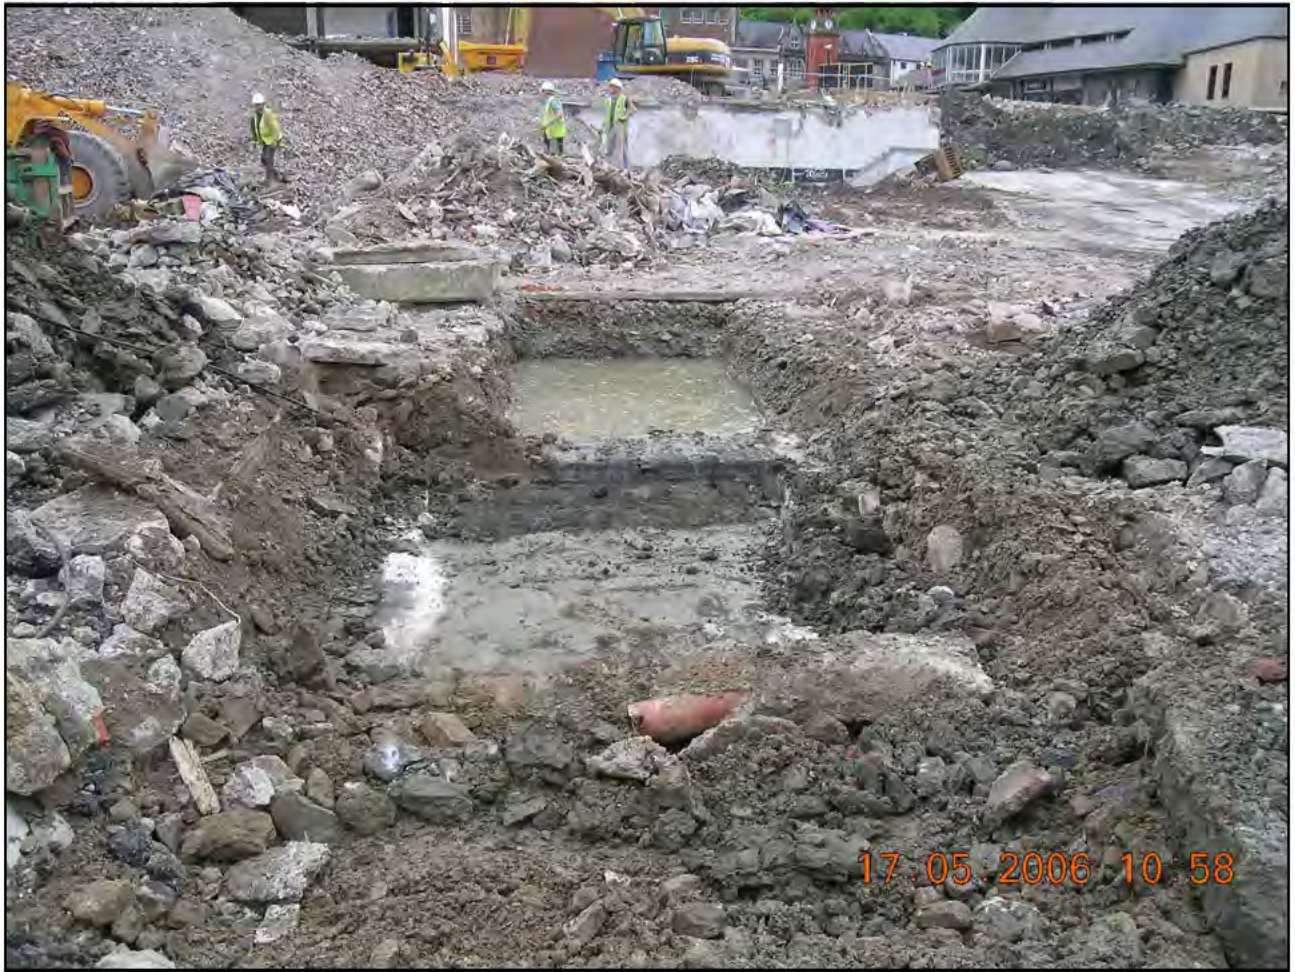
**Plate 3: Trench 11: View South**

Trench 11 was located 9.0m west of Trench 06 in a former goods entrance associated with the Wellfield Centre. The trench was orientated north to south. The ground surface comprised reinforced concrete, which was broken up and removed. The concrete was 0.20m thick and sealed a deposit of demolition material, between 0.70 and 0.80m thick. This deposit had been used to level off the ground to facilitate laying the concrete surface. In the centre of the trench was the foundation of a brick wall, two courses wide. The bricks were "frogged" and of twentieth century date. The brick wall was interpreted as an internal partition wall. Below the levelling layer on the southern side of the trench was the manganese-flecked glacial deposit. To the north of the brick foundation wall was a 0.30m thick deposit of grey-brown clay-silt (Plate 3). This deposit matched that identified in Trench 06 located 9.0m to the west of Trench 11 and was interpreted as a former buried soil associated with Wellfield House. The buried soil followed the gradient of the valley slope and contained small fragments of coal, slate, brick, glass and white glazed ware; all of which were indicative of post-medieval activity, and by extension, Wellfield House. This buried soil was only extant in the northern half of the trench: the southern half appeared to have been truncated during the construction of the Wellfield Centre (a similar scenario was identified in Trench 06). Below the buried soil was the manganese-flecked glacial deposit found also in trenches 06, 12, 13, 14 and 15.

The trench contained activity associated with the construction of Phase 1 of the Wellfield Centre in 1964, in the form of a concrete foundation pad, followed by a levelling deposit and a concrete floor surface. The only evidence for activity associated with the 19<sup>th</sup> Century Wellfield House was a buried soil, possibly from the grounds of the house. An inspection of the First to Third Edition 25" Ordnance Survey Maps shows the location to be an open area surrounded by an orchard. A similar deposit was identified in Trench 06, 9.0m to the east.

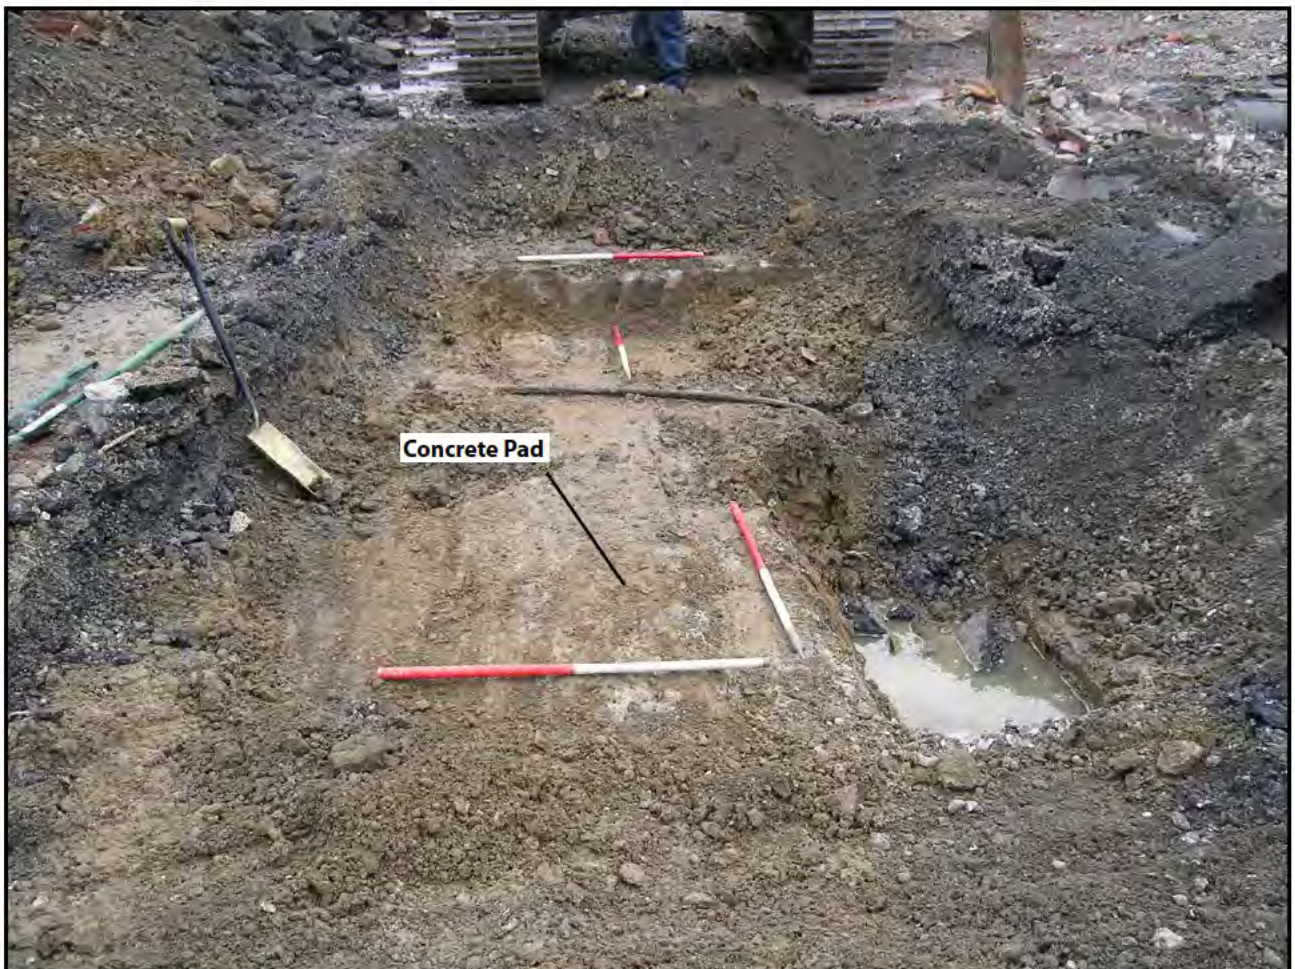
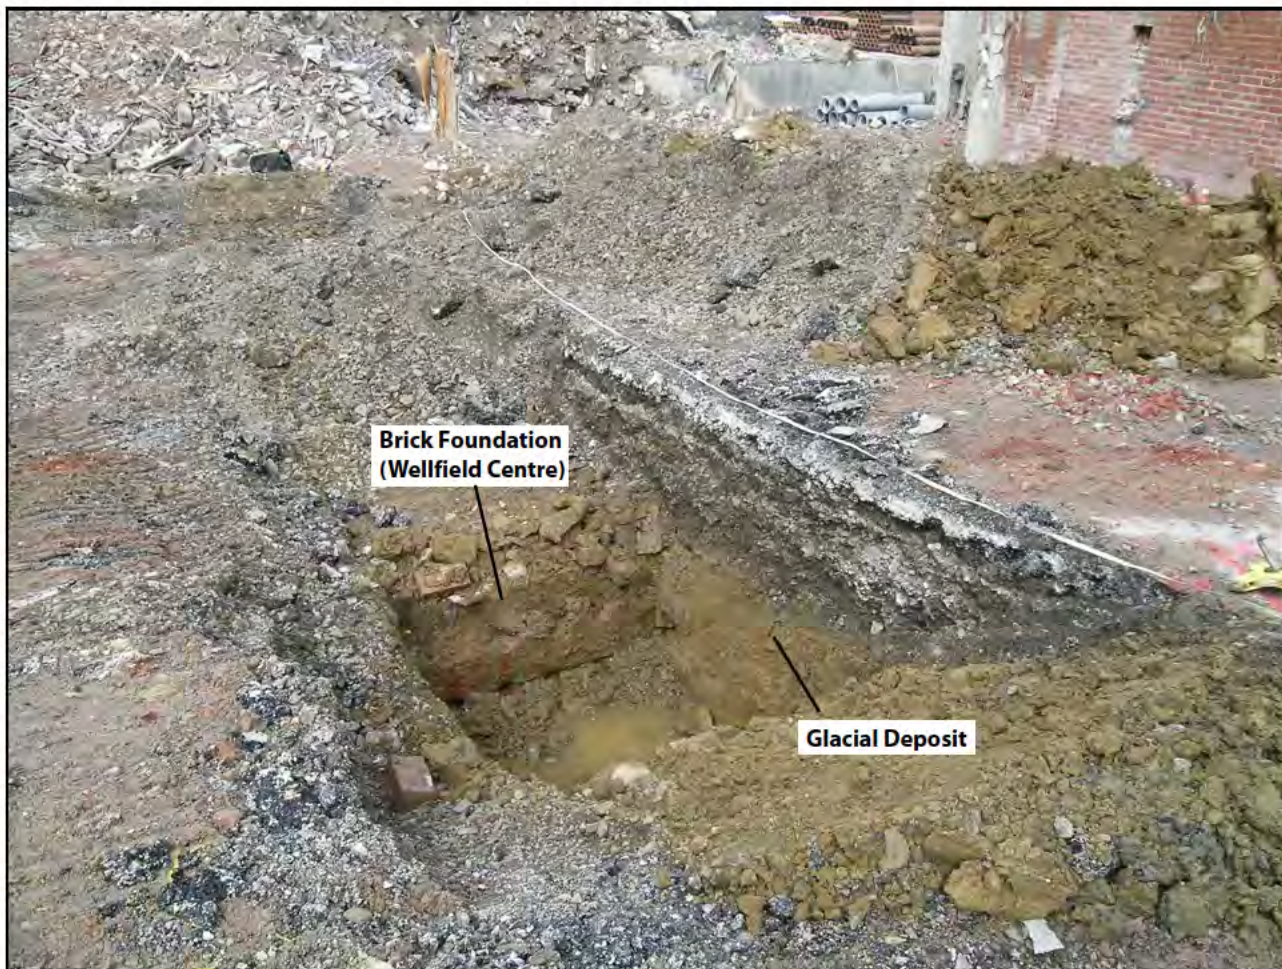
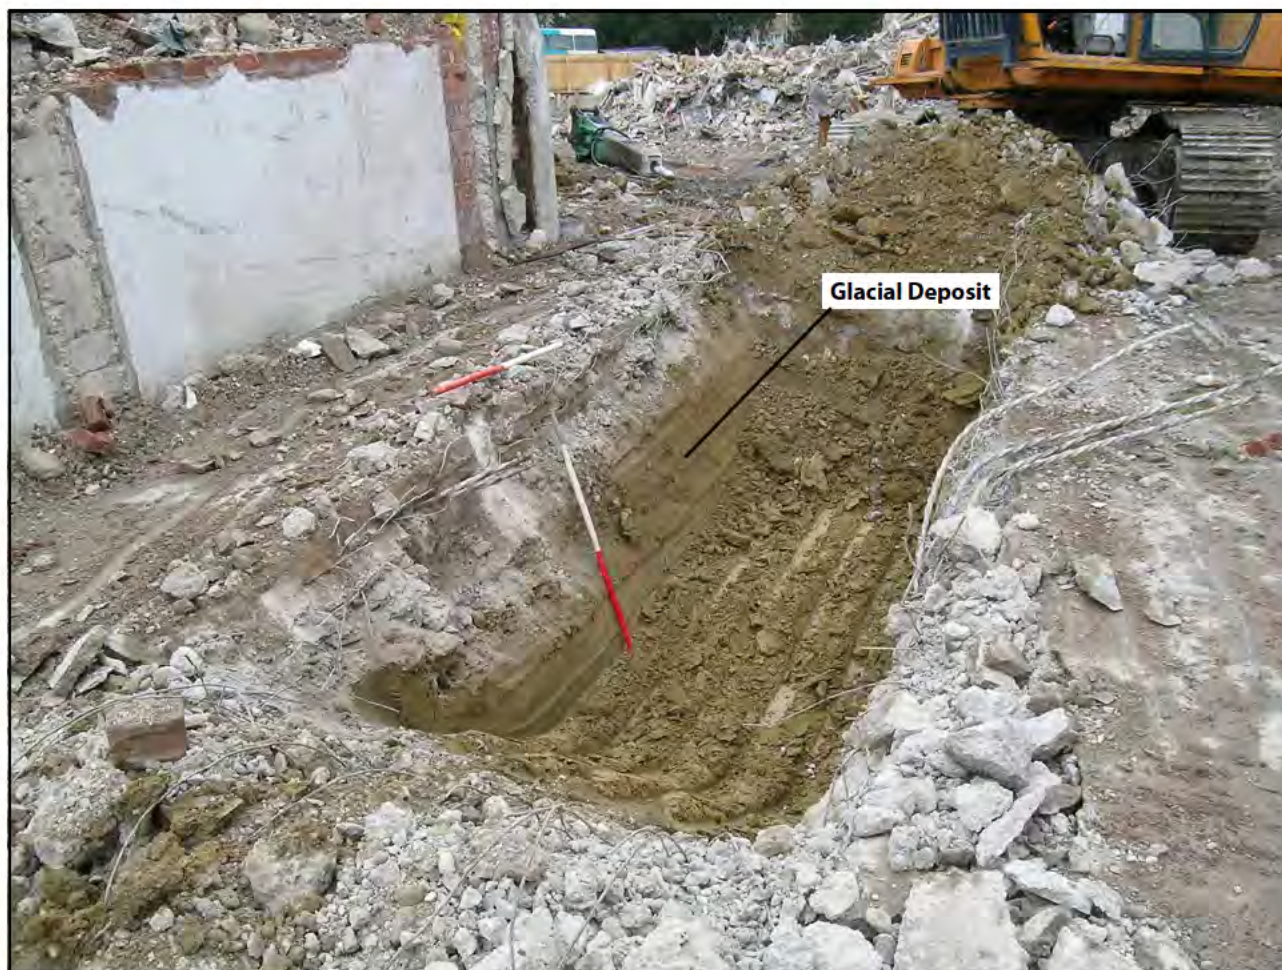
**Plate 4: Trench 12: View South**

Trench 12 was positioned at the southwestern end of the site to the rear of what was "Soled Out" shoe shop (basement level), to the east of the Phase 2 "Mall". The trench was positioned on a southeast to northwest alignment and was hoped to reveal information regarding the foundation level of the former

Masonic Lodge, demolished during the Phase 1 construction of the Wellfield Centre in 1964 and also any Medieval activity associated with the Cathedral. The position of the trench had to be altered due to the proximity of live services and the trench was separated into four segments to accommodate this. The first segment, Segment A (Plate 4), was dug to a depth of 2.0m, cutting through a top layer of tarmac and levelling material (1.00m thick), followed by a 1.00m thick layer of concrete. In the centre of the trench there was a 1.00m wide and 3.00m long gap in the concrete, exposing a deposit of glacial sand. The concrete was interpreted as part of the construction for Phase 1 of the Wellfield, which utilised extensive concrete pads terraced into the valley side, onto which were built the superstructure. The second segment, Segment B, confirmed this. This segment was 7.0m long and 2.0m wide and was located c.2.5m southwest of Segment A. The concrete extended for c.5.0m along the trench. The pad differed in this instance as the concrete sealed a series of brick-built courses, 1.0m in height. The bricks were frogged and were interpreted as part of the Phase 1 construction. The brick courses were cut into the glacial sand and were sealed, along with the concrete, by a deposit of tarmac and overburden, 1.0m thick. An extension was made to the western side of Segment B to investigate further the concrete pad and the brick-built foundations. The trench was extended c.5.50m to the southwest and revealed a continuation of the concrete pad. No further evidence of the brick-built foundation was recovered. Segment C was located 6.0m to the southwest of Segment B. Segment C was dug to a mean depth of 1.10m and measured 2.00 wide and 5.60m long (Plate 5). The segment comprised 0.50m of reinforced concrete followed by 0.60m of glacial sand. The concrete was interpreted as foundation for Phase 1 of the Wellfield Centre. Segment D was located c.3.00m to the southeast of Segment C and measured 2.00m in width and 3.10m in length (Plate 6). This segment could not be fully excavated due to the reinforced concrete that covered the area. This concrete could not be removed successfully within the confines of the trench but was interpreted as part of the foundation layer of Phase 1 Wellfield Centre.

The trench contained activity associated with the construction of Phase 1 of the Wellfield Centre in 1964. There was no evidence for the Masonic Lodge, formerly extant in this area. The brickwork associated with Segment B was interpreted as part of the Wellfield Centre Phase 1 construction. The glacial sand did not contain evidence for Medieval activity.

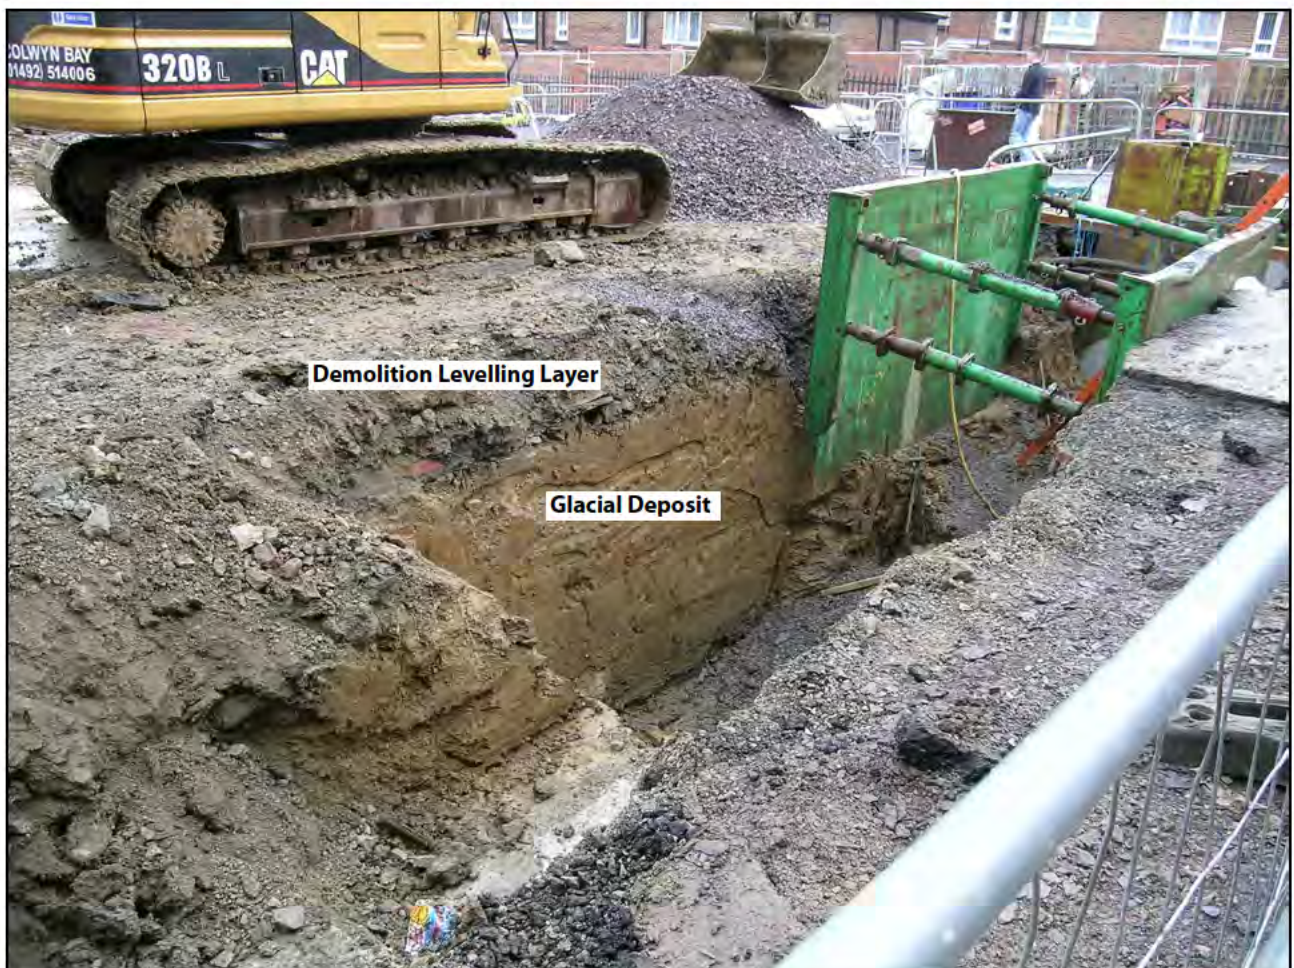
**Plate 10: Pipe Trench**

A large pipe trench opened along the former loading bay area of the Wellfield Centre by Jennings for laying pipes was inspected. The only activity noted was from the construction of the Wellfield Centre, with a thick layer of levelling material placed over a glacial deposit (see location Figure 2; Plate 10).
