# **SIR HUGH OWEN LOWER SCHOOL (SEGONTIUM SCHOOL) ARCHAEOLOGICAL EVALUATION**

**Report No. 651**

# **SIR HUGH OWEN LOWER SCHOOL DEVELOPMENT**

## **ARCHAEOLOGICAL EVALUATION**

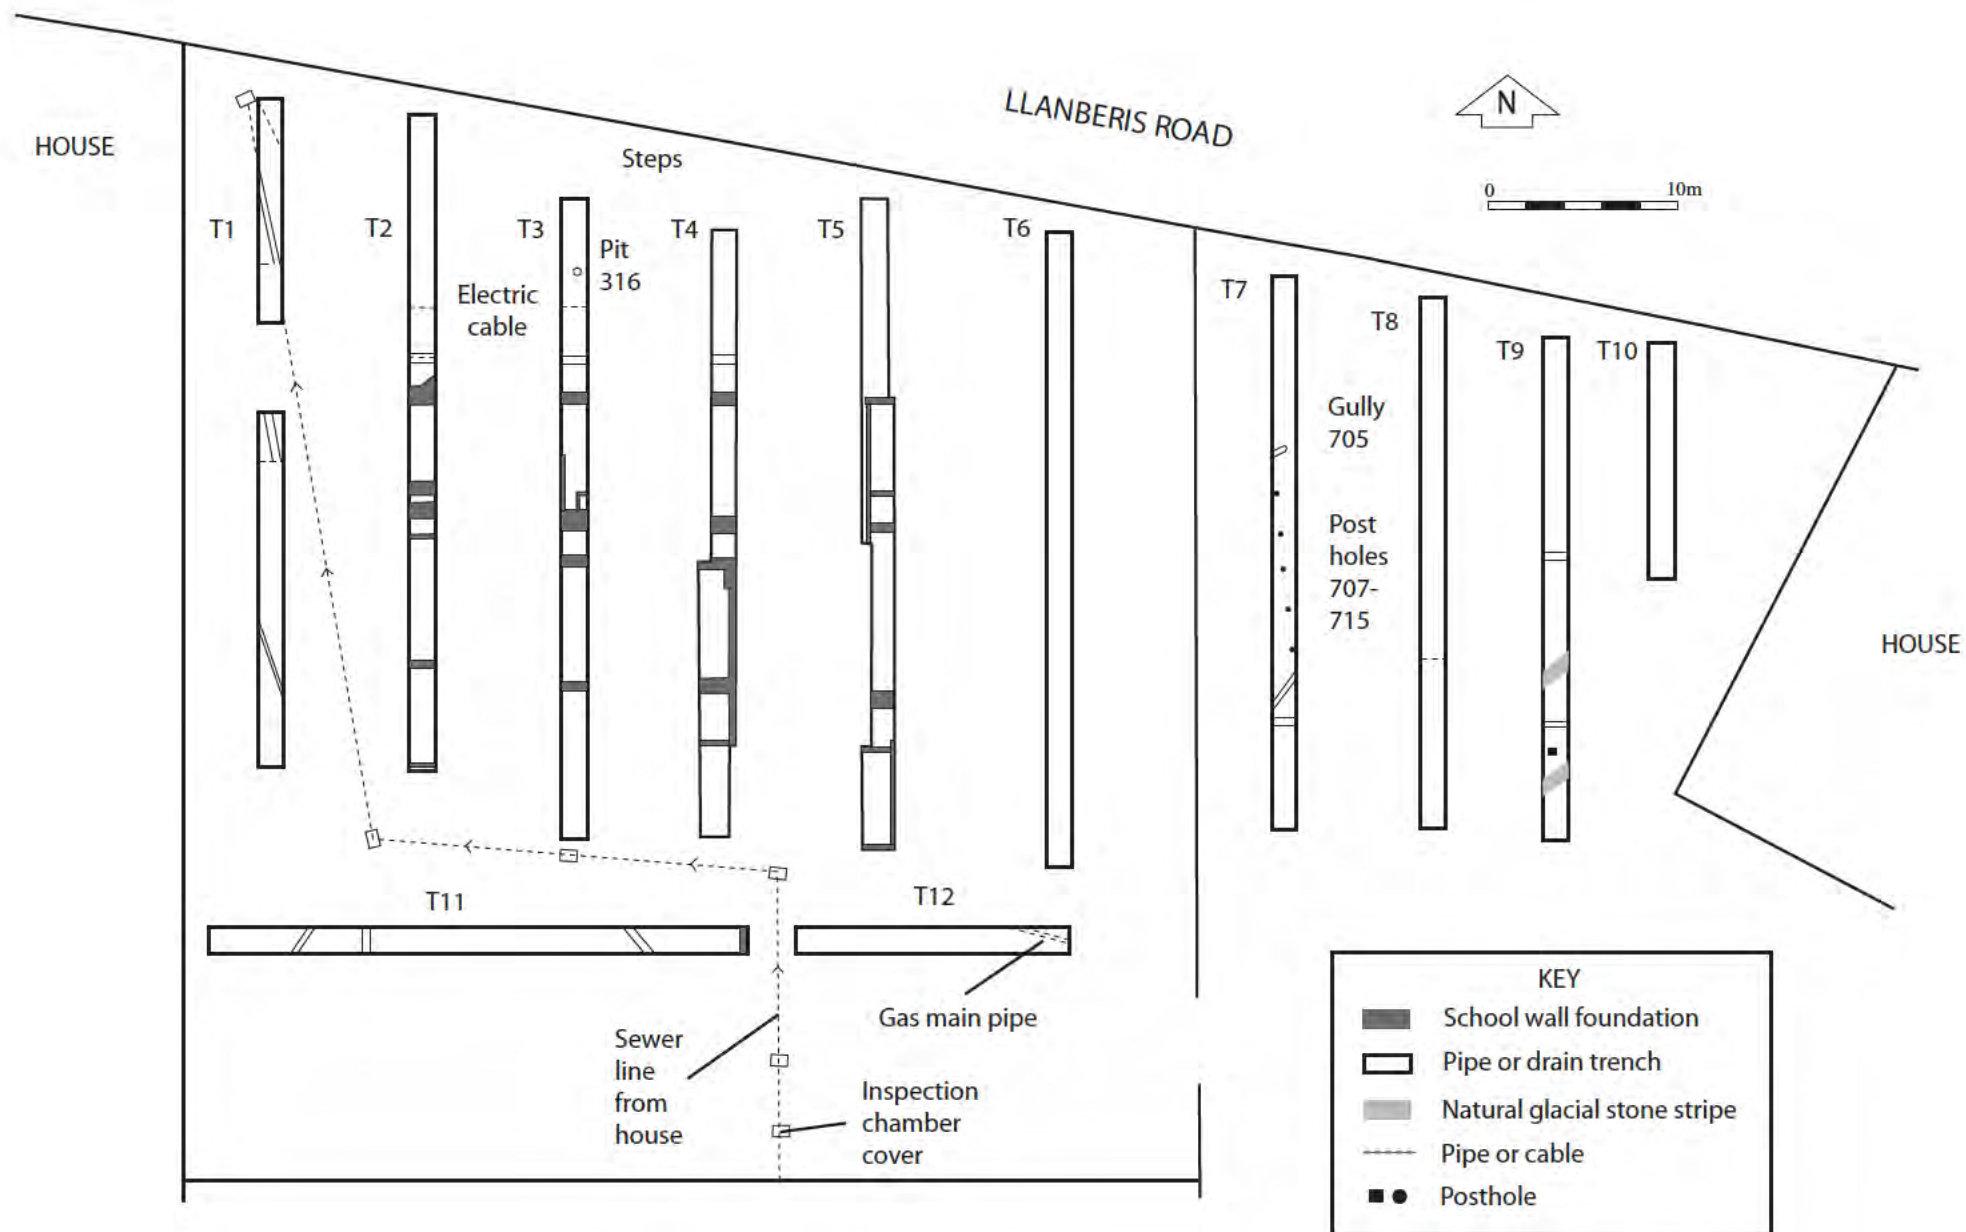
Sir Hugh Owen Lower School Development Fig. 4 Location of the main features recorded during the evaluation.

The main features recorded are shown in plan in Fig. 4. All trenches were also recorded by levelling and three example profiles are shown in Fig. 5.

In the centre of the trench were a narrow linear gully or slot (705) and a line of six shallow post-holes (Fig. 4, 707-715). These features were associated with some pieces of coal, fragments of glazed tableware and a clay tobacco-pipe stem.

In the eastern field a few features were found that predated the construction of the school. These consisted of a small linear cut, probably a gully or field drain, 705, and a line of small post-holes, 707-715 (Fig. 4). These features were associated with pieces of coal, fragments of 19<sup>th</sup> century transfer-printed tableware and a clay tobacco-pipe stem fragment. The post-holes were about 6ft apart and suggested probably belonged to a timber post and rail fence. The orientation of the post line did not relate to the existing boundaries. However, if the post-line was projected it would form a continuation of a former north-west to south-east oriented field boundary of the next field to the south, which can be seen on the OS map of 1918 (Fig. 2) and earlier maps, before the construction of the Maes Barcer Estate.

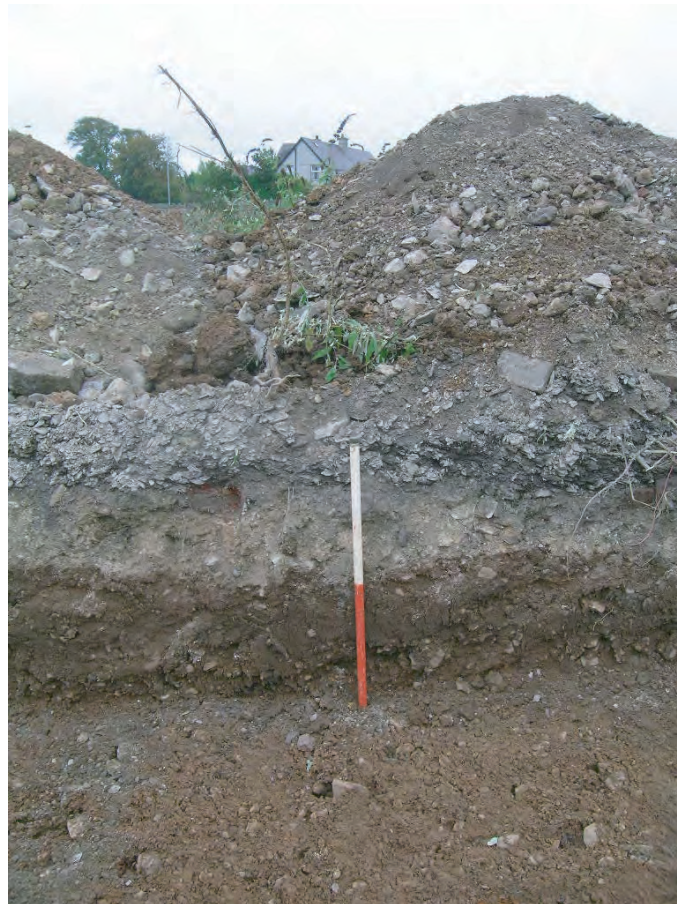
Six areas of concrete foundation lay east-west across the trench. The lowest layer was the 19<sup>th</sup> century ploughsoil (206) from which a piece of white glazed tableware was found. This soil was sealed by a layer of clayey made-ground (212), laid down to level up the ground for the floor of the school.

The made-ground for the school floor levelling seems to be redeposited subsoil brought in from elsewhere. The subsoil was clear and undisturbed with no evidence of earlier features.

Sir Hugh Owen Lower School Development Fig. 6 Trench 2 excavated to the subsoil surface.  
 Section detail showing the buried 19th century ploughsoil and school construction made-ground.  
 From the west. Scale with 0.50m divisions

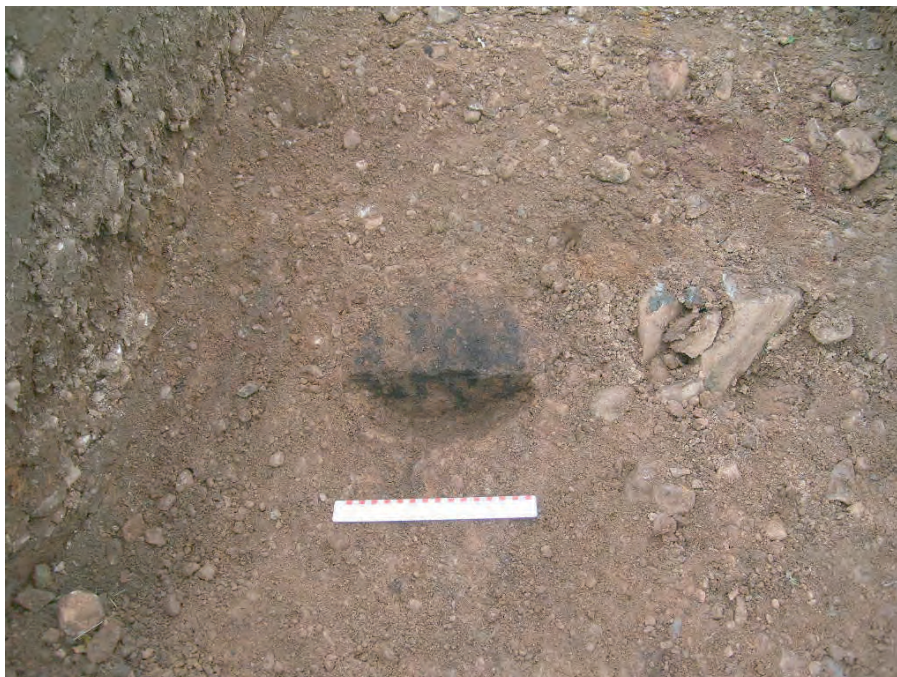
At the north end a small sub-circular feature, pit 316, was found (Fig. 4). This was 0.31m diameter and 0.14m deep with a rounded profile and contained a black fill suggesting that it contained charcoal (Fig. 7). This was half-sectioned and recorded and the whole of its fill, about 10litres, was retained for flotation and sieving (Sample 1).

The small pit was interpreted as a possible unaccompanied cremation burial of Roman or Prehistoric date, although no charcoal or burnt bone was seen in the fill at the time of excavation.

One feature was found that was considered to be possibly of Roman or earlier date. This was a small pit, which could have been interpreted as a cremation burial because it contained a black fill that appeared to be rich in charcoal. The pit, 316, was found at the north end of Trench 3. It was sub-circular, 0.31m diameter and 0.14m deep with a rounded profile (Fig. 4). It was cut into the red-brown gravelly subsoil (Fig. 7). The edges and base of the feature were well defined suggesting that it was a dug feature and not just geological, such as an ice-wedge or tree-hole. The fill was black and gritty but mottled with orange-brown patches. The mottling could have resulted from mixing of the black fill with the subsoil, if it was backfilled soon after excavation.

No charcoal fragments were seen in the fill and no white flecks to suggest the presence of burnt bone. The fill was stone-free and no artefacts were found in it. Subsequently, a sample of the fill was soaked in water and subject to flotation and sieving through a 1mm mesh sieve. No charcoal or bone floated and no identifiable charcoal or bone fragments were seen in the sieved residue. Some pieces of black material, when viewed under magnification, appeared to be clumps of finer grained material. These smeared like charcoal suggesting that the dark fill was of finely comminuted charcoal, but this would not be typical of cremation material, which requires considerable amounts of timber. The fact that none of the black material floated suggests either that it is not charcoal but mineral manganese or iron, or that it is charcoal but indurated with iron or manganese. If the latter this would suggest that the feature is of some geological age and perhaps a natural feature from the early post-glacial period when much of this area would have been forested and the poorer-drained areas may have had a cover of peat. One side of the pit was not clearly defined and some of the dark material continued into a small cavity in the subsoil, which suggests some animal burrowing. It is possible, therefore, that the feature is a filled-in burrow or the mottling may be the result of a small mammal burrowing into the pit fill.

Generally, the absence of identifiable charcoal or any evidence of human activity suggests it is a natural feature. If it was a cremation burial of the Roman period it would most likely be part of a more widespread cemetery, perhaps continuous with the burial found in 1936 but no evidence of any other possible burial features were found.

Sir Hugh Owen Lower School Development Fig. 7 Trench 3 excavated to the subsoil surface.  
 Detail of pit 316, half-sectioned. From the north. Scale with 1cm divisions

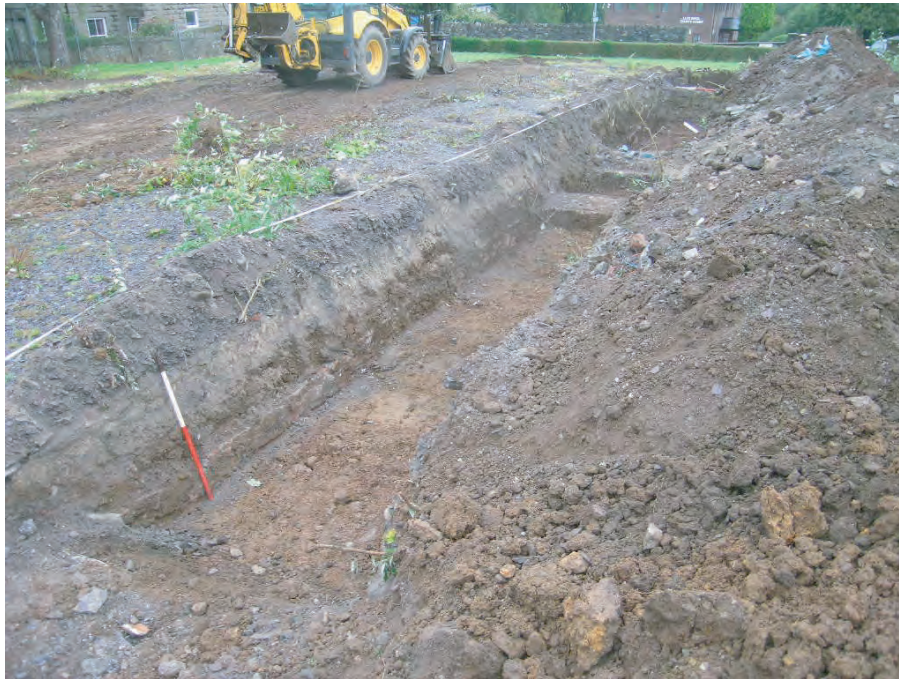
The main features were east-west lengths of concrete foundation of the former school. There was also one north-south length and a more recent grey brick-built underground compartment with electric cabling, identified as part of the former school boiler room. To the north were a drain cut and an electric cable.

Sir Hugh Owen Lower School Development Fig. 8 Trench 3, General view from south-east excavated to the subsoil surface, showing in section the buried 19th century ploughsoil, school construction made-ground and demolition debris. Scale with 0.50m divisions

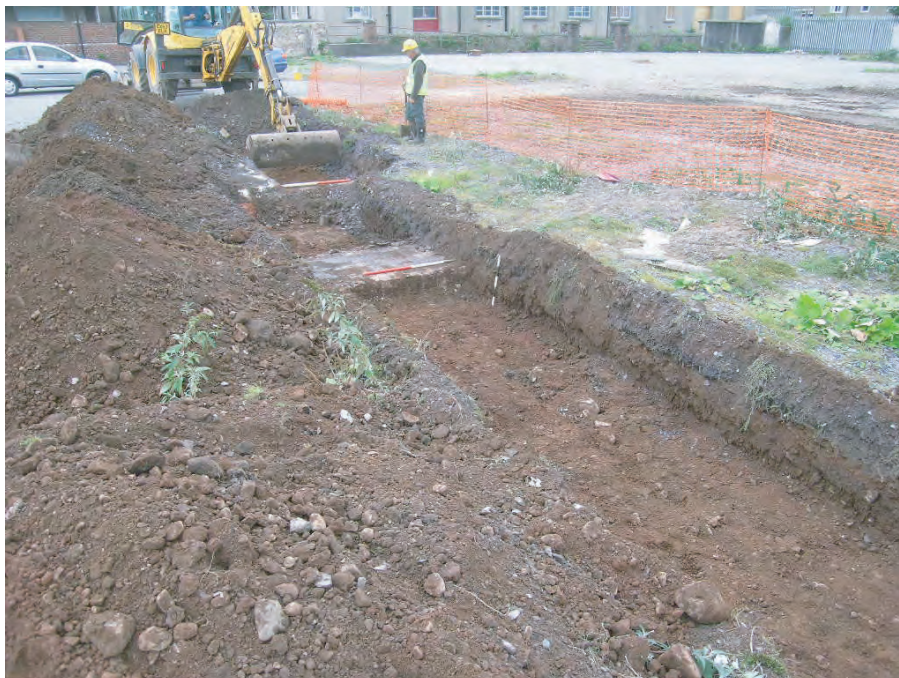
Five east-west lengths of the former school walls were found (Fig. 9). The 19<sup>th</sup> century ploughsoil was well preserved in the north half but truncated to the south beneath the former school floors.

Sir Hugh Owen Lower School Development Fig. 9 Trench 5 from the north-east excavated to the subsoil surface. General working shot.

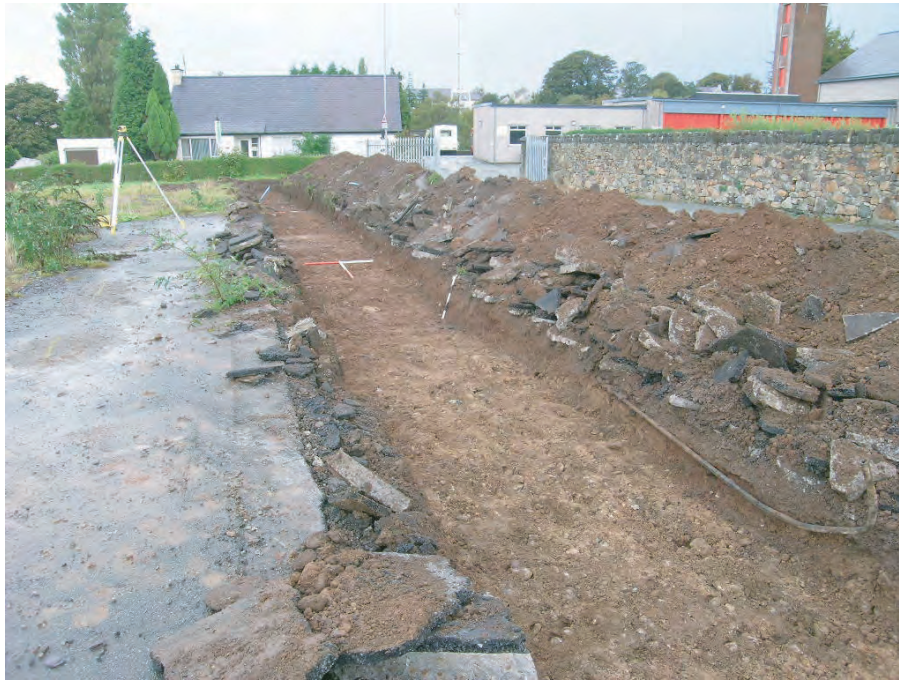
The trench lay just beyond the east edge of the former school building and cut through the former school yard and then through a deep topsoil layer, with no walls or other features present (Fig. 11).

Sir Hugh Owen Lower School Development Fig. 10 Trench 6 excavated to the subsoil surface. General view from south-west. Red and white scale with 0.25m divisions. Black and white scale with 0.10m divisions

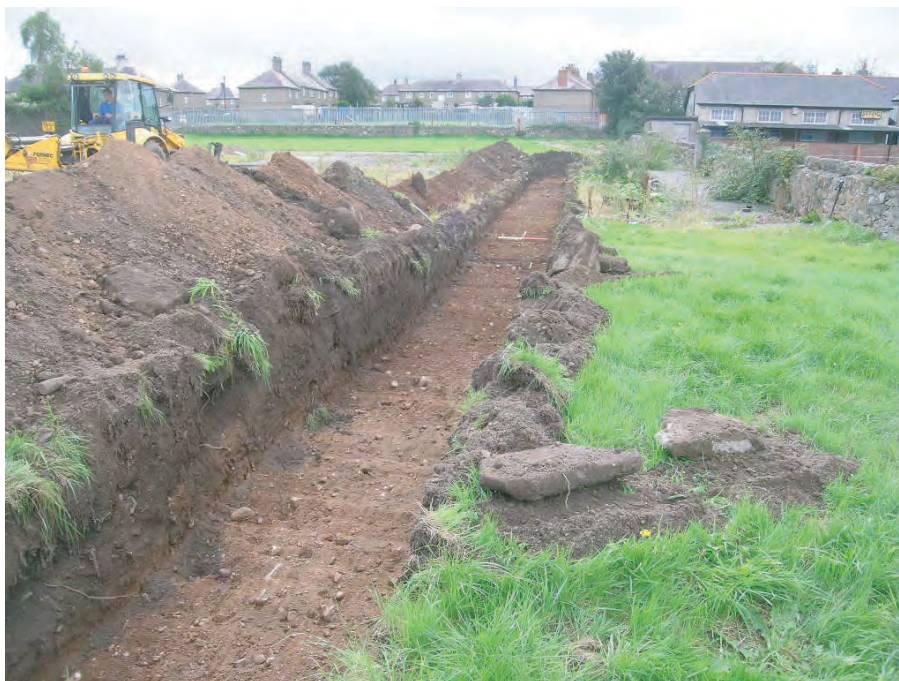
At the north end this cut through a deep, broad bank of soil (Figs 5 and 11). This proved to consist of a layer of old ploughsoil covered by a further layer of redeposited topsoil, containing some slabs of concrete.

At the west and south side of the school and in the field to the east had been various outbuildings, some of which had been pre-fabricated structures. These had slighter brick foundations. The area of the building in the field at the east had been stripped of topsoil before construction of the school outbuildings there and the soil dumped in a low mound against the northern boundary and over the pre-existing ploughsoil (Fig. 11).

Sir Hugh Owen Lower School Development Fig. 11 Trench 7 excavated to the subsoil surface. General view from the north-west showing in section buried 19th century ploughsoil beneath redeposited topsoil. Scale with 0.50m divisions
