# DEAN STREET MULTI-STOREY CAR PARK DEVELOPMENT, BANGOR

## ARCHAEOLOGICAL EXCAVATION OF 19<sup>TH</sup> CENTURY WORKERS' HOUSING : PRELIMINARY REPORT AND POST- EXCAVATION ASSESSMENT

Project No. G1880

Report No. 672

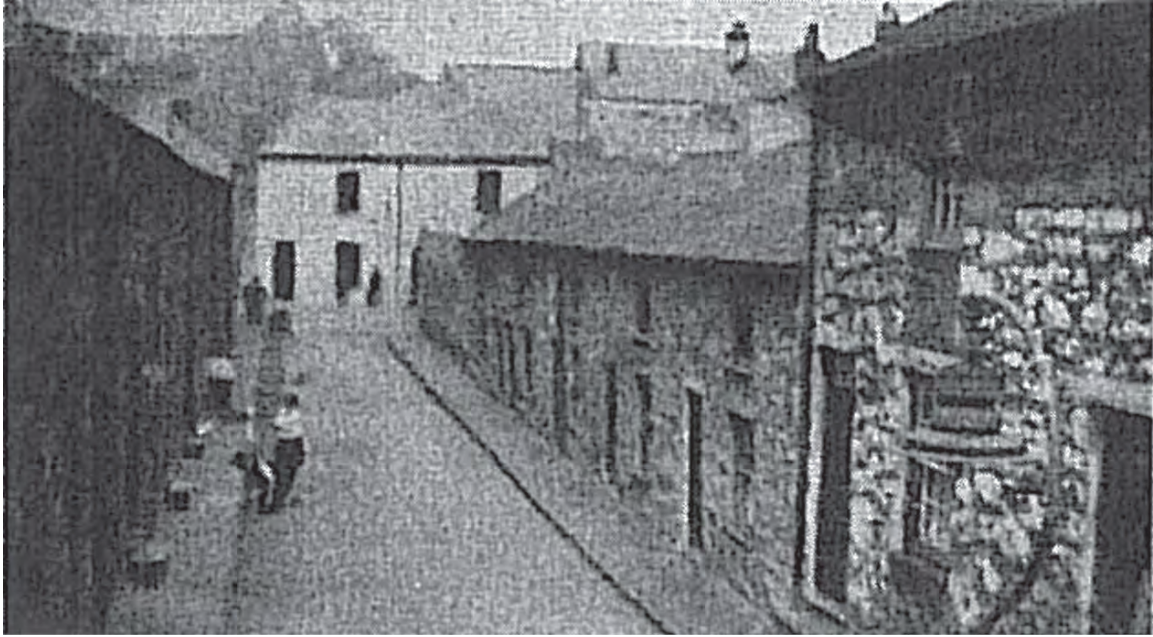
Fig. 6 View of Dean's Court facing east towards Dean Street, taken in the early 1930s. The excavated house is at the far end of the row on the left. Note the higher roof line of these houses and of the presence of raised entrance steps, compared to those on the other side of the street

Fig. 6 View of Dean's Court facing east towards Dean Street, taken in the early 1930s.

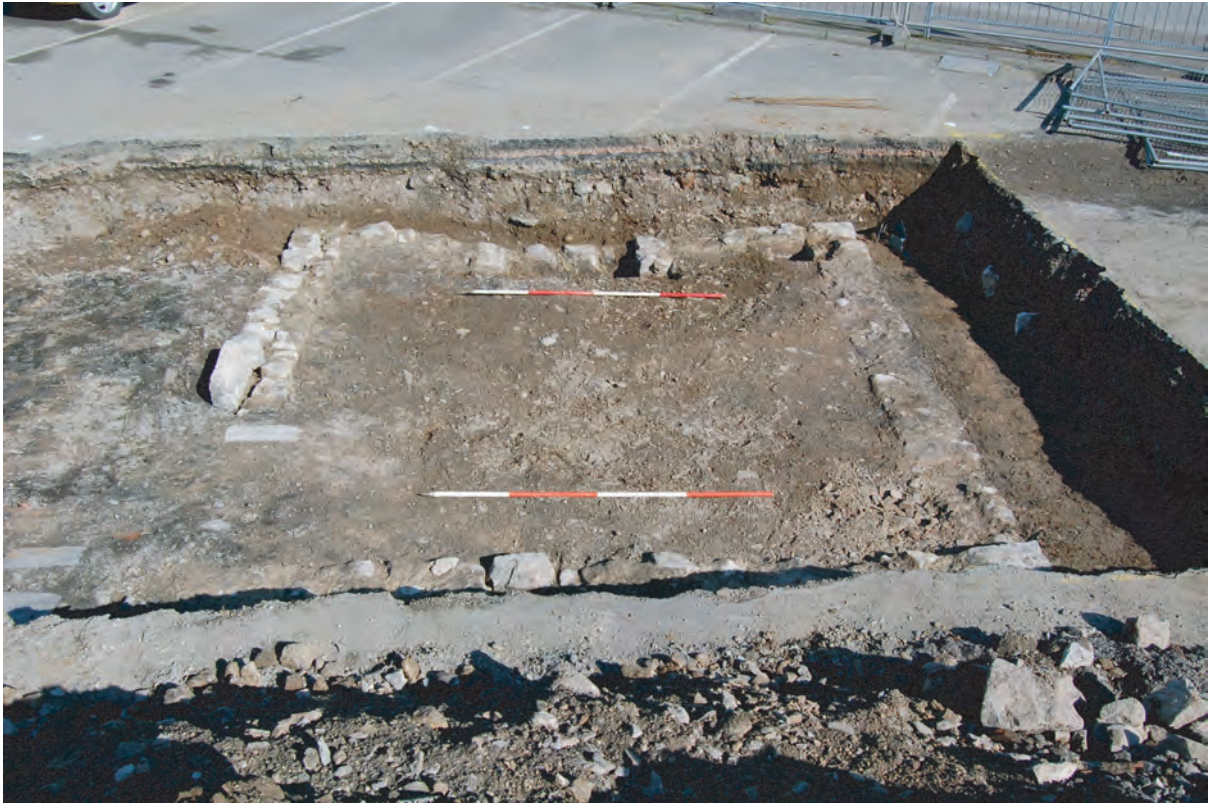
Fig. 12a The later house floor and yard, from the west. Scales with 50cm divisions.

At some point, possibly as a result of flooding problems in the area, the ground surface across the whole site was raised by about 0.4m (Fig. 12a). The make up layer (624) in the house, and (635) over the rear yard consisted of shale fragments mixed with a small amount of relatively clean mid orange- brown silty clay. An 1831 William IV farthing was found within the house in layer (624), suggesting that this development may have taken place earlier rather than later in the house's development. Contemporary with this deposit a system of drainage was inserted, demonstrating that the new drainage system was conceived at the same time as the decision to raise the floor levels, suggesting an overall plan of remedial action (Fig. 7, 9 and 16). A culvert (656) ran from the property entrance on Dean's Court curving somewhat through the house to enable it to exit through the rear door into the yard, where there was a junction with a north south running drain (631) (Fig. 16). The culverts were stone lined with the side walls made up from shale blocks, with the drain opening about 0.3m by 0.2m wide (figs. 15, 16). Within the house a layer (623) made up the later house floor, and in the rear yard a layer of topsoil 0.18m thick (606) overlay make-up layer (635). No internal house features of the period were noted as the house was truncated at this level at the time of demolition and levelling, although stone sills to both doorways were still *in situ* (Fig. 7, 16). The north-south dividing walls (634, 652) of the yard were inserted at this time as they were laid on the old yard surface (642), and butted the house walls (604) and boundary wall (653) to the west and closet wall (649) to the east. The old Tarmacadam road surface (607) of Dean's Court was noted about 1m south of the front wall of the house, with an area of crushed rubble and tile (621) between it and the house front wall that probably formed a make-up layer for paving slabs that were removed at the time of demolition. Beneath this rubble was another stone lined drain (622) oriented east to west under the probable pavement. Although it cannot be demonstrated conclusively, this drain

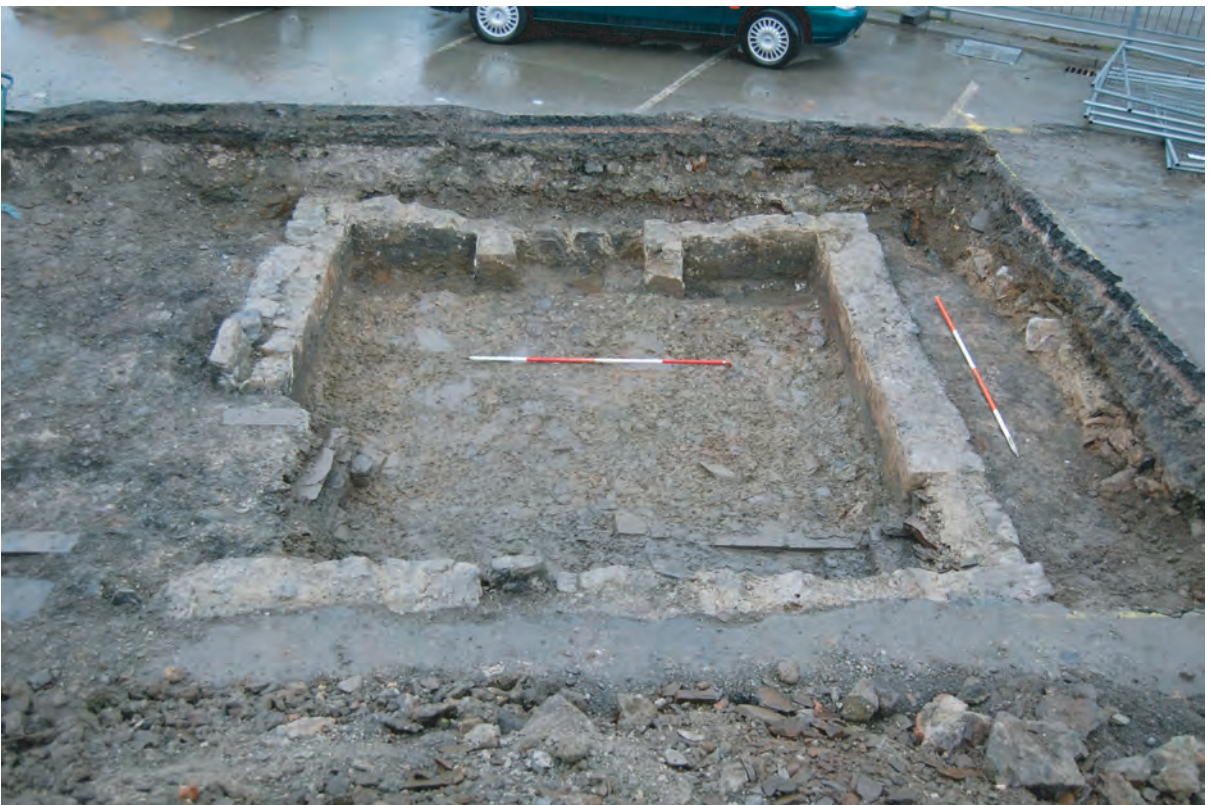
Fig. 12b The intermediate, reconstruction phase floor of the house, from the west. Scales with 50cm divisions.

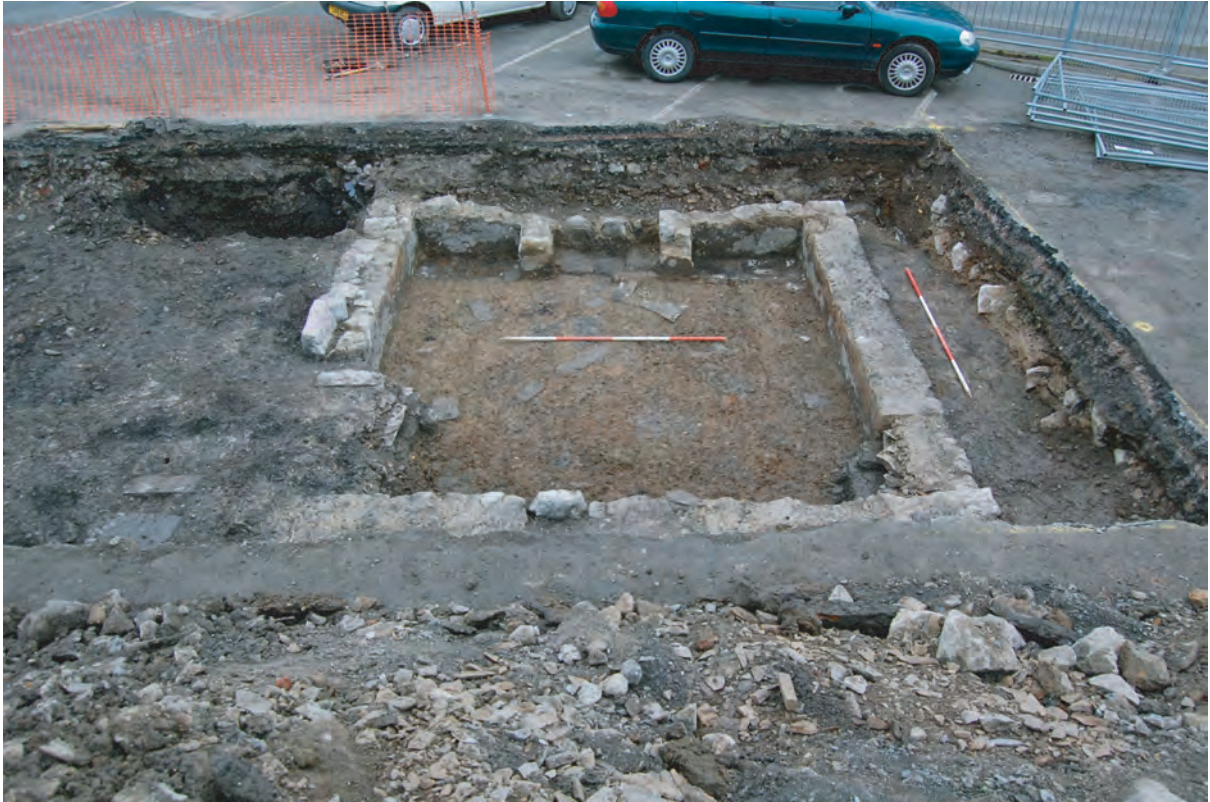
Fig. 13 The early house floor with the later yard surface still in place, from the west. Scales with 50cm divisions.

Construction of dwellings appears to have been begun by placing the footings of the main house walls on the silty clay subsoil. Wall (604) was observed in section and the foundation trenches for the initial building appears to have consisted of removing the topsoil (655) from the field and constructing the foundations on wider stones placed directly on the natural subsoil (Fig. 10). Walls (604), (608), (609) and (658) were built in this way, forming the walls of the house, constructed of mortared limestone blocks with plastered internal surfaces and surviving in places to a height of 0.8m. The doorway from the street on the southern side, 0.85m wide, was located at the westernmost end of the property where it joins the adjacent house. At the rear of the house the opening into the yard was offset to the east by 0.65m (Fig. 9). Within the house two stub walls (610) and (611), 0.4m by 0.3m, and bonded with the east wall of the property (608) formed the northern and southern buttresses of the hearth opening, 1m wide by 0.41m deep (Fig. 8, 13).

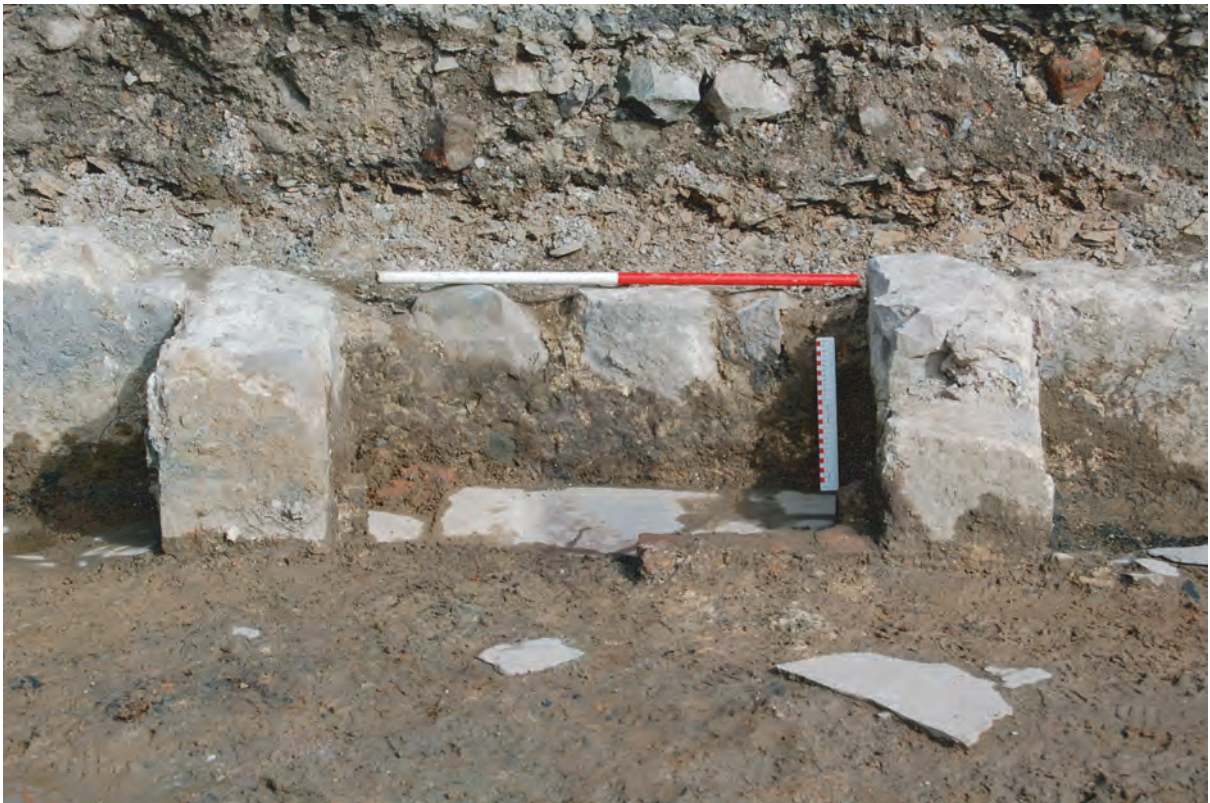
Fig. 14 Detailed view of the early house fireplace with its contemporary floor, from the west. 1m and 30cm scales.

Within the house the hearth (Fig. 14) had a slate slab floor (615) and remains of the grate structure were *in situ* including brickwork forming the front of the fire surround (616). A purple ash deposit (614) may be a remnant of the last fire in the grate prior to the raising of the floor levels. A metalwork object was found that probably formed part of an ornamental front to the grate itself. In the alcoves on either side of the fireplace (Figs. 15a and b) slate floors were present (638, 639) above (626). On the internal north and south walls of the house (604, 609) a groove was noted in the plasterwork suggesting that some timber structure occupied the alcoves, probably cupboards. Along the south wall of the house (609) a discrete deposit extending 0.7m north from this wall and 2.2m towards the front doorway of the property was observed. It was only about 0.1m deep, overlying floor surface (626). It is difficult to interpret, but is possibly an undisturbed surface below a long term piece of furniture or internal fitting that resulted in this area not becoming worn. The threshold into the front door of the property was disturbed by the insertion of a later drain. However that belonging to the adjacent house along Dean's Court to the east was observed during the evaluation work, and consisted of a slate slab surface (620).

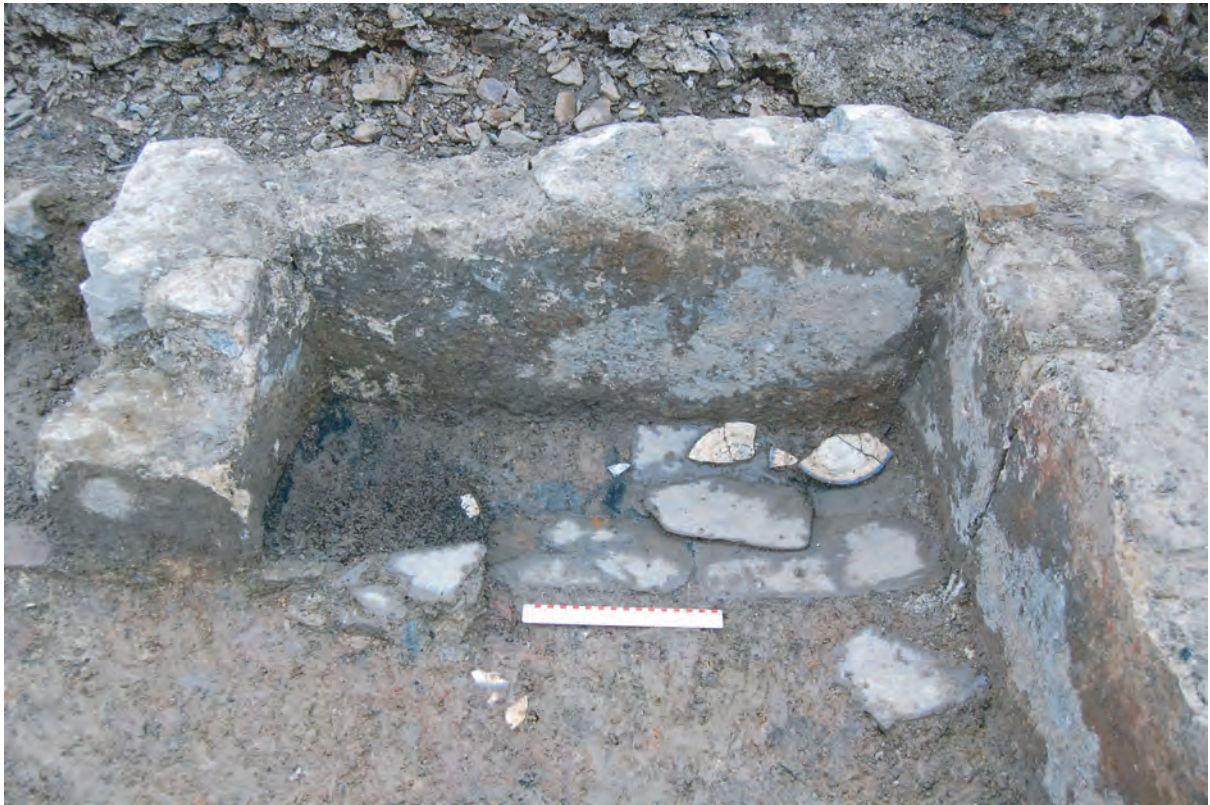
Fig. 15a The southern wall alcove of the early house showing its slate floor, heap of coal fragments on the left, and abandoned broken tableware on the right. 30cm scale.

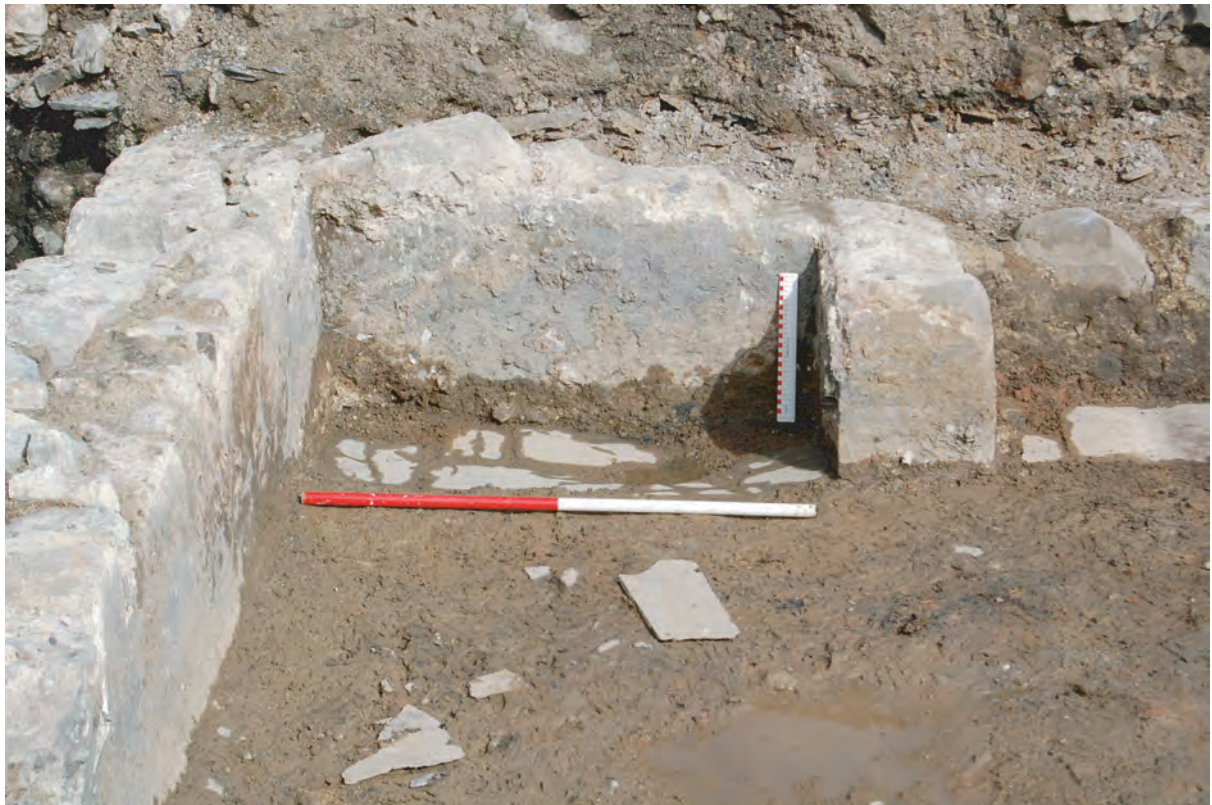
Fig. 15b The northern wall alcove of the early house showing its slate floor. 1m and 30cm scales.

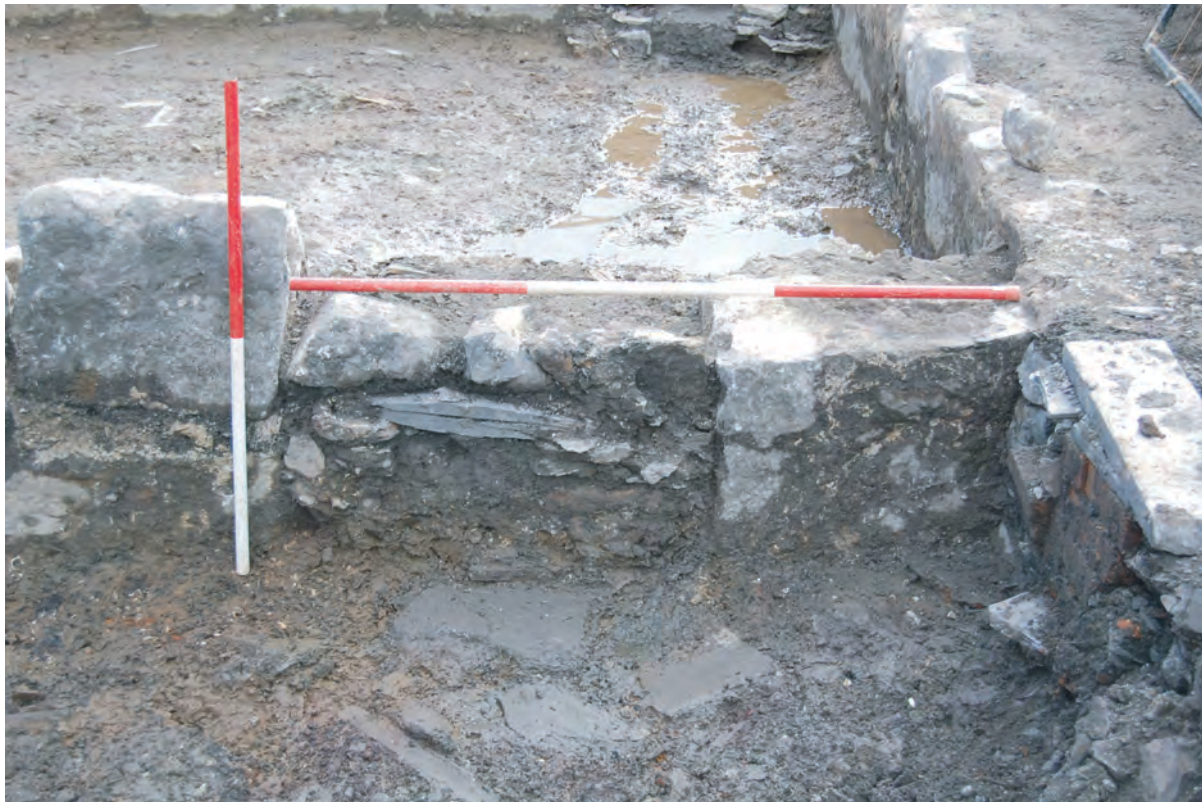
Fig. 16 The rear door of the house and part of the early yard surface, from the north, showing the culvert constructed through the doorway and overlaid by the door cill of the later floor. Scales with 50cm divisions.

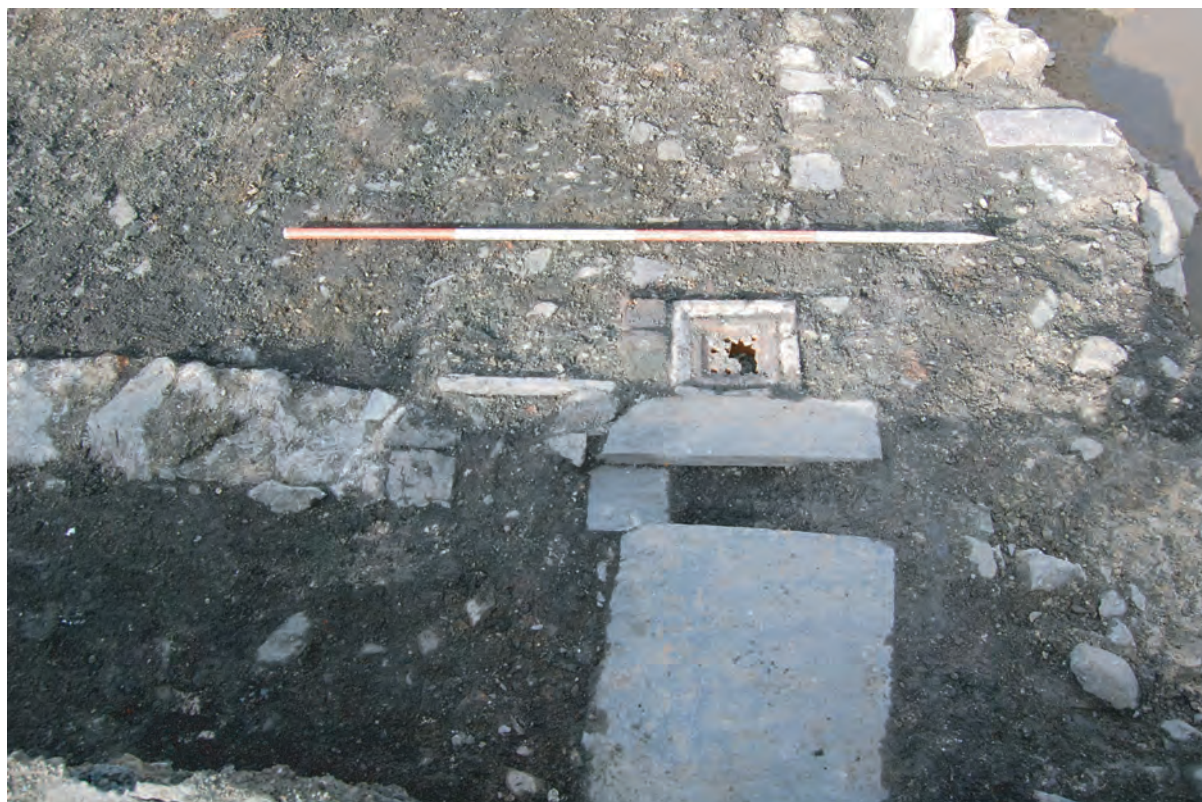
Fig. 17 The later yard surface by the rear door of the house showing the slate covered external culvert with a ceramic drain trap for the later piped drain inserted, from the south. Scale with 50cm divisions.

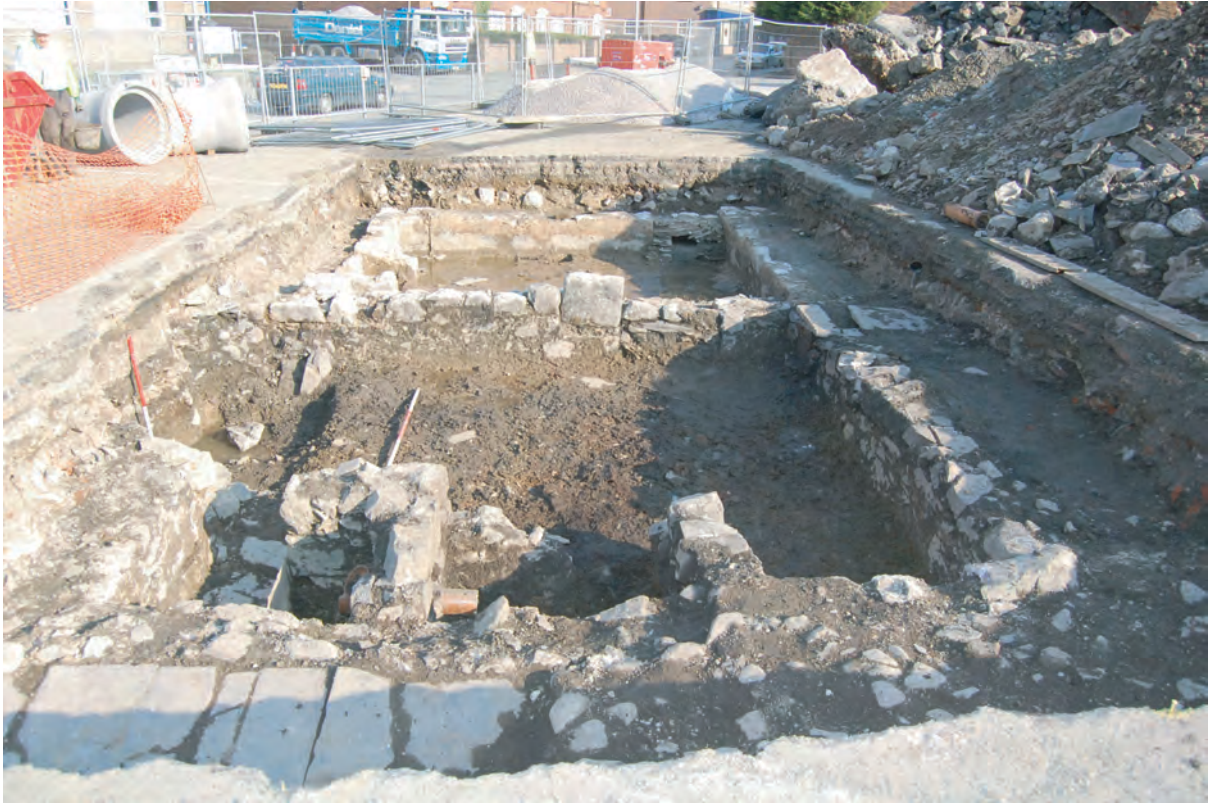
Fig. 18. The early yard surface from the north showing the rear wall of the house with the later culvert and raised floor still in place in the doorway. Excavated privy and cess-pit chamber in the foreground. Scales with 50cm divisions.

A make up layer about 0.4m thick was deposited on the field topsoil surface in both the house and the rear yard (654), which was covered by floor surfaces. In the house a light yellowish brown sandy clay surface about 0.2m thick formed an earthen floor (626), on which were placed a number of slate pieces (Figs. 7, 12), above which a rough laid slate surface (619) must have served as the floor for a while, possibly laid when flooding was causing problems. In the rear yard the floor surface was made up of a dark purple brown silty clay layer with pebble inclusions and 0.14m thick (642) (Fig. 18).

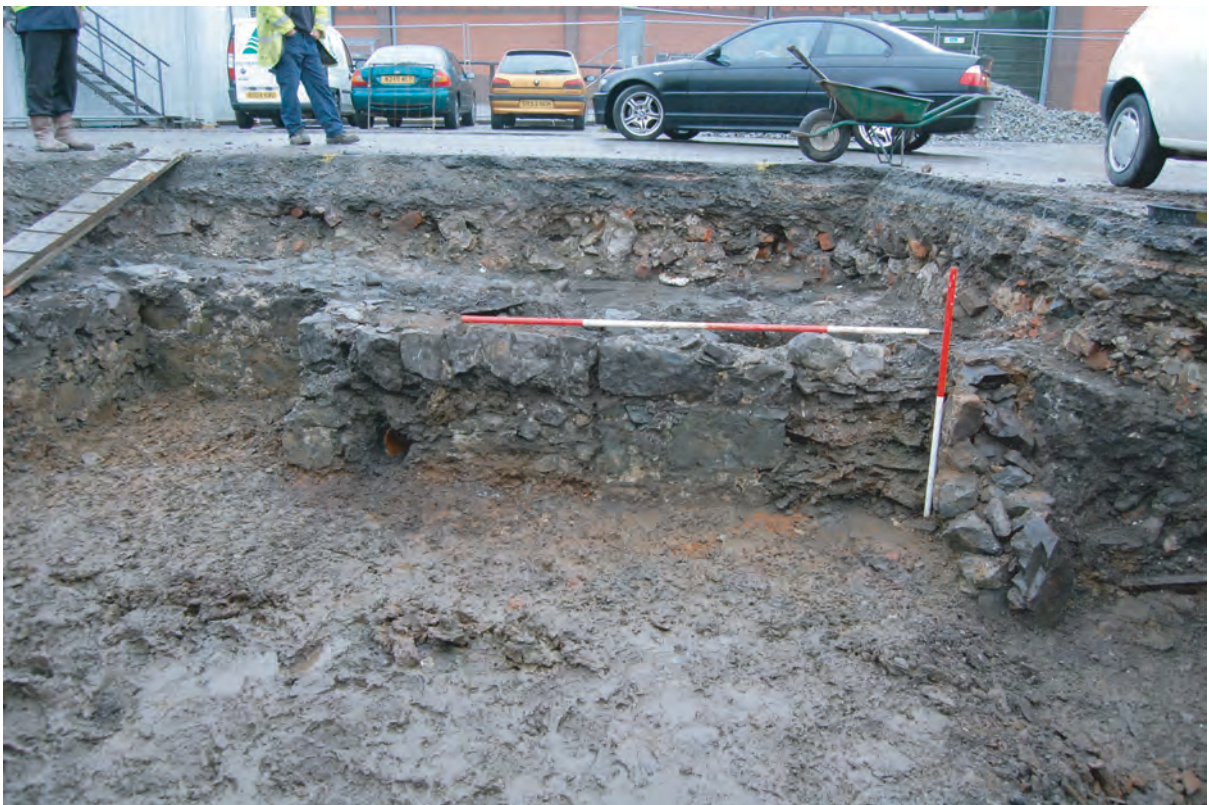
Fig. 19. The early yard surface from the south showing the front wall of the privy with the infilling associated with the later raised floor and piped toilet still in place. Scales with 50cm divisions.

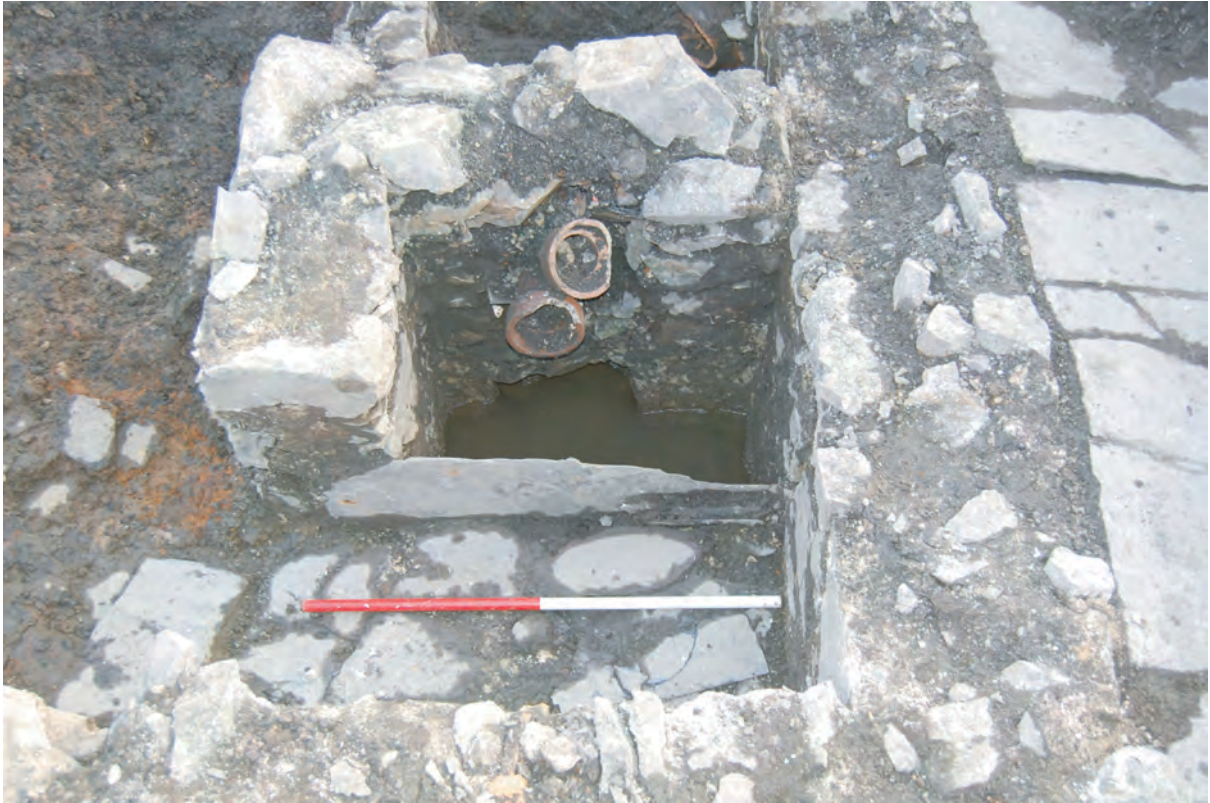
Fig. 20. The privy from the east, excavated to its original floor level, with the rear drain hole and slate front to the seat still in place, showing the inserted pipes of the later toilet at a higher level. Scale with 50cm divisions.

In the rear yard a privy structure (649) was located in the north east corner of the yard. It consisted of a structure 1.2m by 1m with a doorway to the east 0.6m wide (Figs. 7, 20). Adjacent to it to the west was another chamber (647) which butted against (649) (Figs. 7, 21). This consisted of a chamber 1.4m by 1m with a narrow opening 0.45m wide to the north-west. This proved to be a pit for the night soil coming through a hole in the privy wall that connected it to the earth closet (Fig. 21). Both structures butted against the rear property boundary wall (653) which separated this property

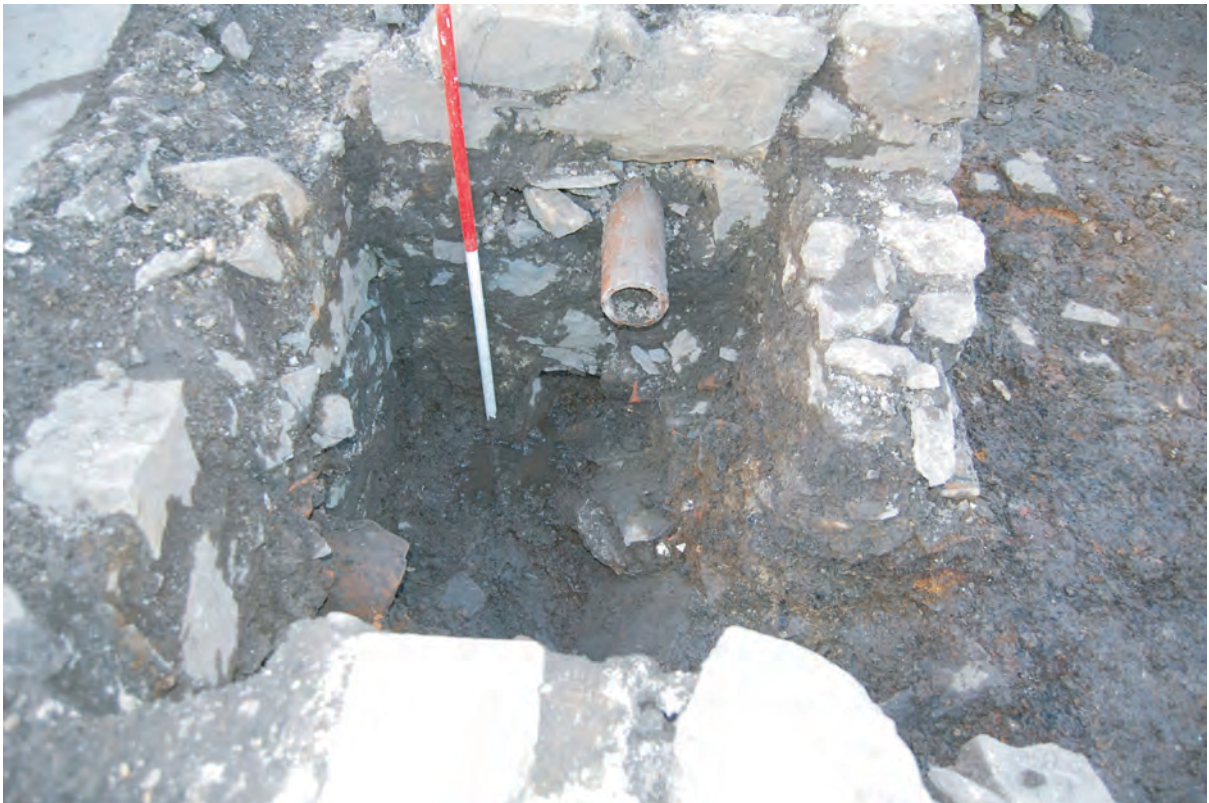
Fig. 21. The privy cess pit chamber from the west with the pit emptied, showing the original rear drain hole and the inserted pipes of the later toilet at a higher level. Scale with 50cm divisions.

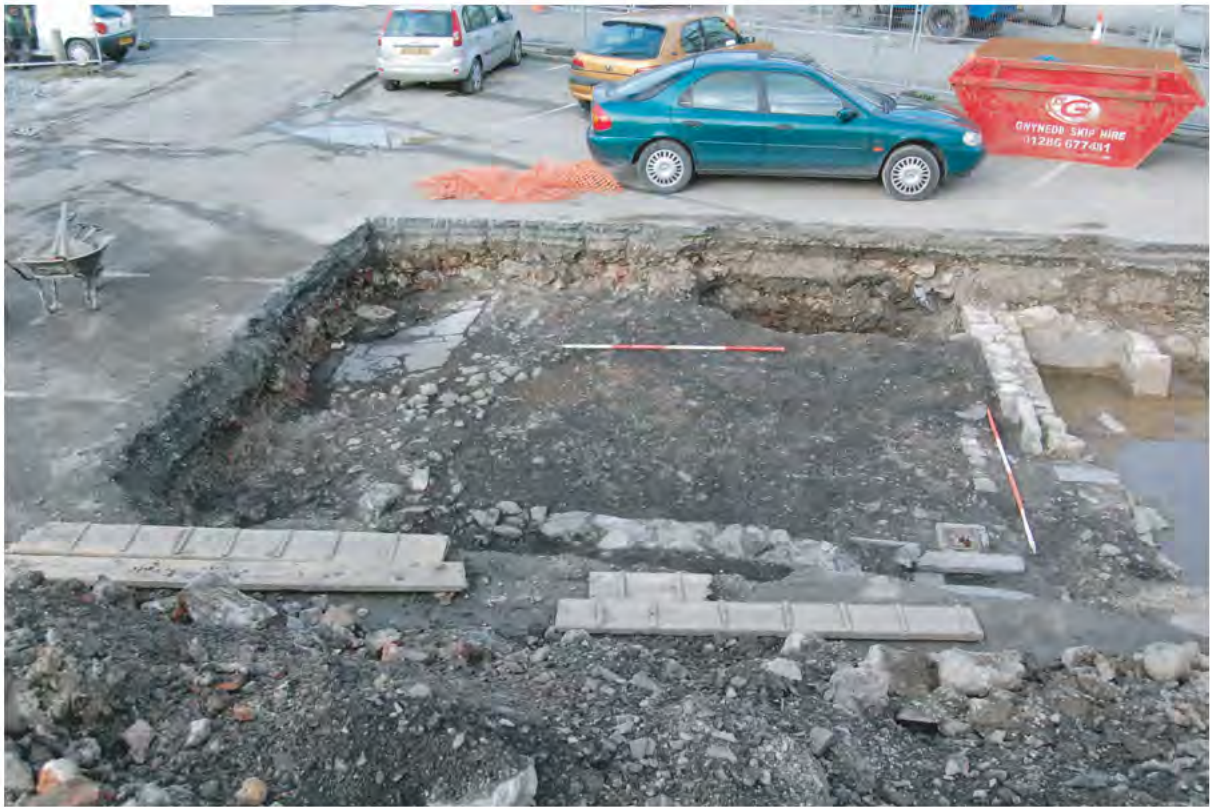
Fig. 22. The latest surface of the house yard from the west, showing the rough cobbling lying over the boundary between the Brook Row and Dean's Court house yards and the slate slab floor of the Brook Row outhouse. Scales with 50cm divisions.

During 1936 the whole of the Dean Street area workers housing was demolished and the land cleared for a car park (Jones 1986, 158-9). A debris layer over the rear yard (629) and later toilet floor was noted (640), dating from the demolition phase, beneath a levelling deposit of demolition rubble and building debris (603), about 0.5m thick, which was spread over the remains of the whole plot after it had been demolished to ground level. This was overlain by a number of lenses of car park surfacing 0.15m thick (602) below the modern Tarmacadam car park surface (601) (Fig. 22).
