Bishop's Palace Gogarth Llandudno

**Archaeological Excavation
May 2007**

GAT Project No. 1865

Report No. 674

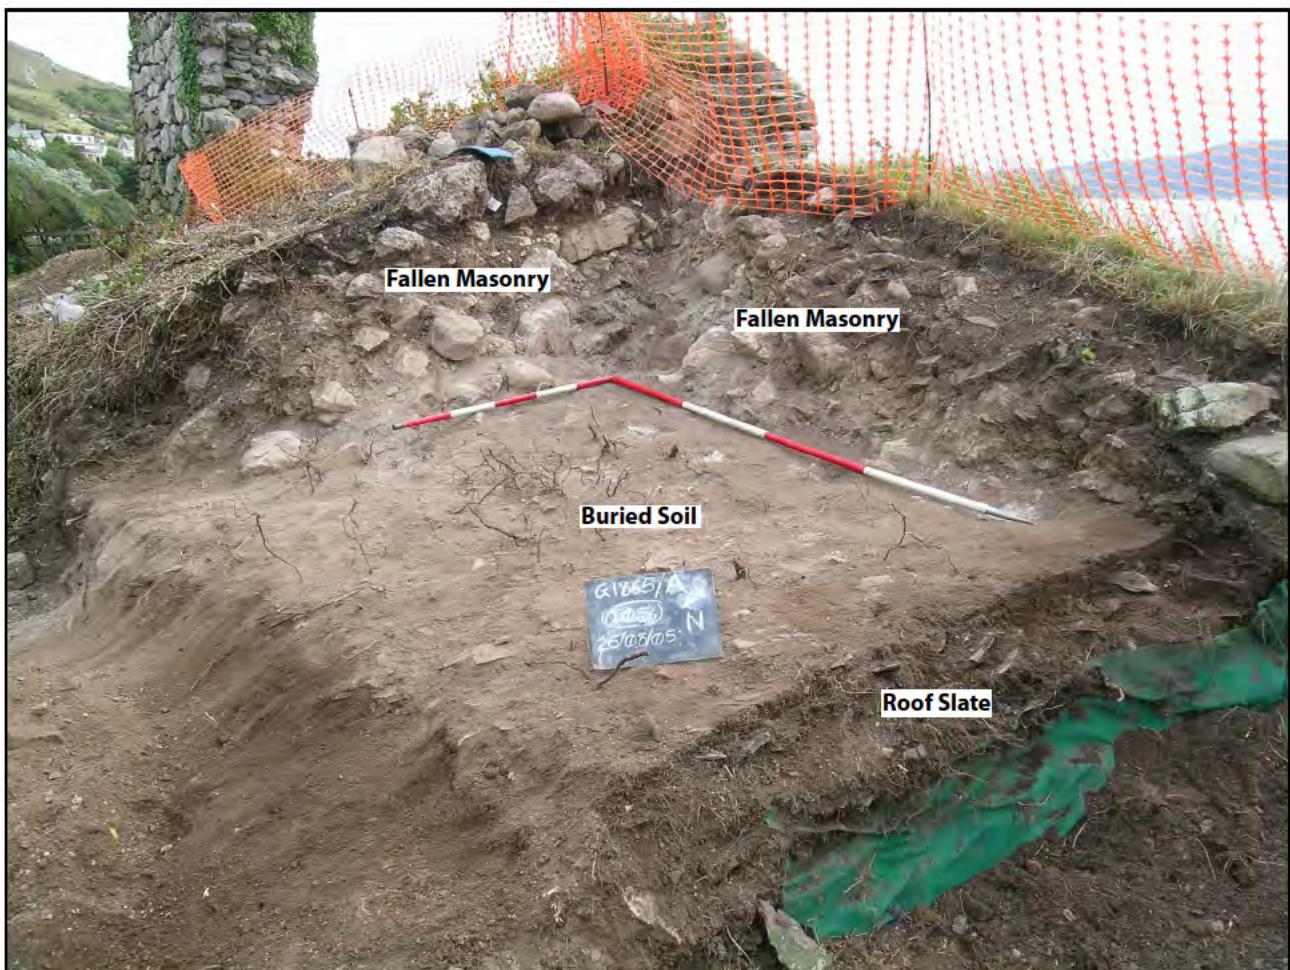
Plate 4: Block A: Demolition/Collapse Layers. Note: Green Mesh Represents Edge of 1996 Excavation

A series of demolition/collapse layers surrounded Block A, forming a distinctive bank that hid the majority of the batter (Plates 3 to 5). Part of this bank was removed during the 1997 excavation programme in an attempt to investigate the batter and two distinct phases of demolition/collapse were identified: an initial phase of slate and other building debris thought to have come from either Block A or structure A1 (Davidson: 66); a second phase of collapsed upstanding masonry thought to have resulted from the clearing of stone from the structure. It was thought that the wall described above (Context 116) was cut through the earlier phase of collapse, whilst remnants of this wall were incorporated into the secondary phase of collapse/demolition, suggesting it was built between these two phases.

Immediately above the slate-rich layer was a shell and mortar-rich deposit (Context 110), interpreted as another demolition/collapse layer. This was covered by a 0.20m thick silt-rich layer that did not contain extensive demolition material (Context 104; Figure 5; Plates 4 and 5). This deposit was thought to be a buried soil, representing a period of structural stability during a bank of topsoil may have formed over the initial layers of building collapse. This must have happened after the deposition of the sixteenth century pottery sherd in Context 114, although a precise date is not available.

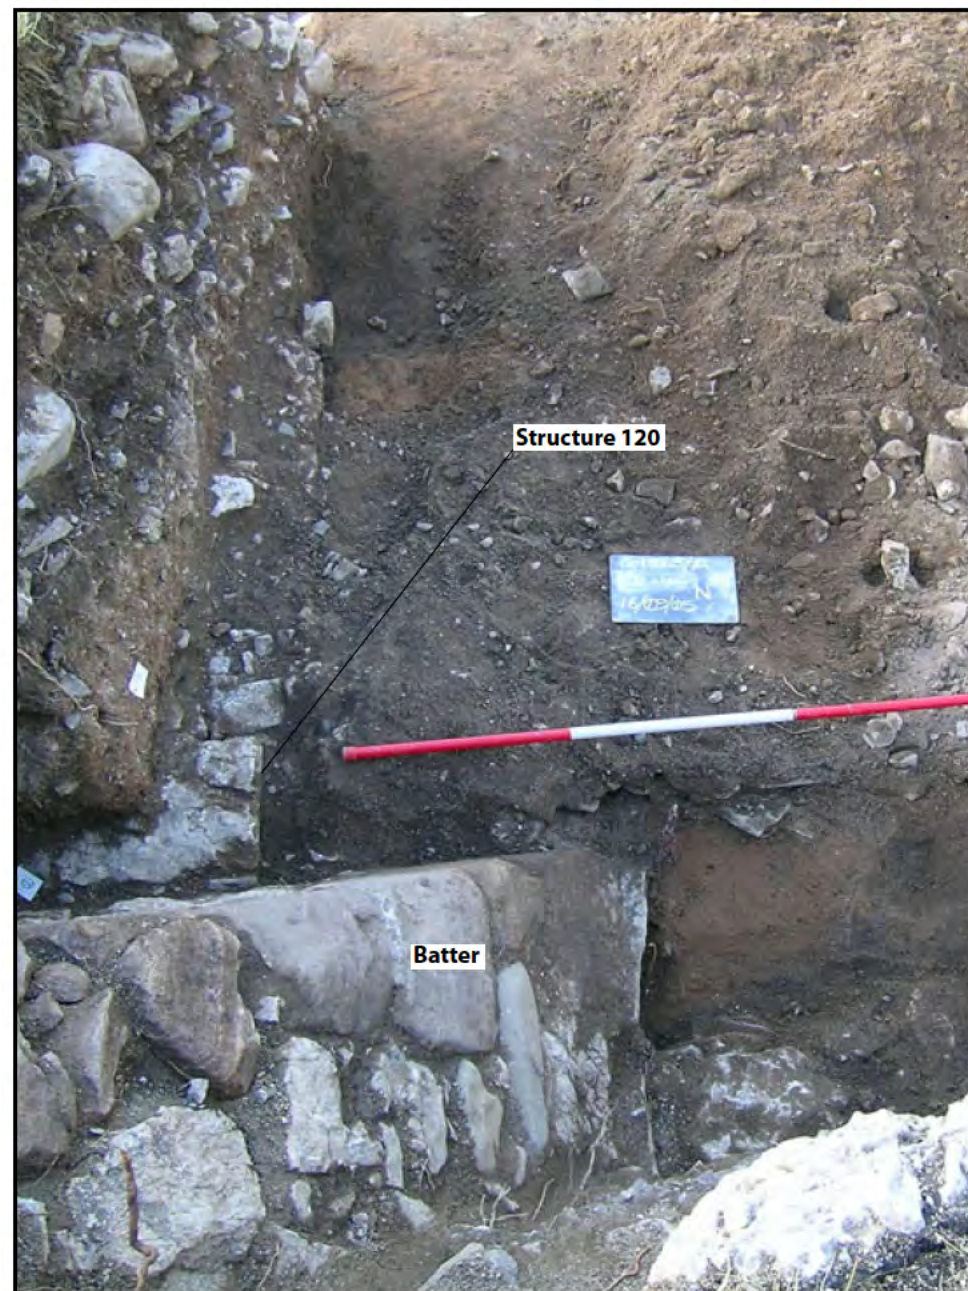
Plate 8: Block A: Batter with Metalled Surface Removed. Foundation level of Structure 120 is visible

Abutting the Block A batter was a four-metre long wall foundation, identified in the 1997 excavation as the remaining wall of a small structure that had nearly all been lost to erosion (Context 120; Figures 2 and 8; Plates 6 and 9). The relationship between the two was originally visible on the seaward-facing section of the exposed cliff face (Plate 9). The surviving wall foundation (constructed from limestone and white lime mortar) was at least one metre wide and may originally have been wider, with most of the inner face of the wall having succumbed to sea erosion (Plate 9). The foundation course was cut into the natural and the foundation cut was covered by the metallised surface suggesting it was built prior to the metallised surface, though after the construction of Block A (cf. Plates 7 and 8).

The width of the foundation trench on the landward side may argue for the presence of a stone batter below the surface level (see plate 8), though it was not possible to excavate down to confirm this. Hague, however, recorded a batter on the west wall of this building.

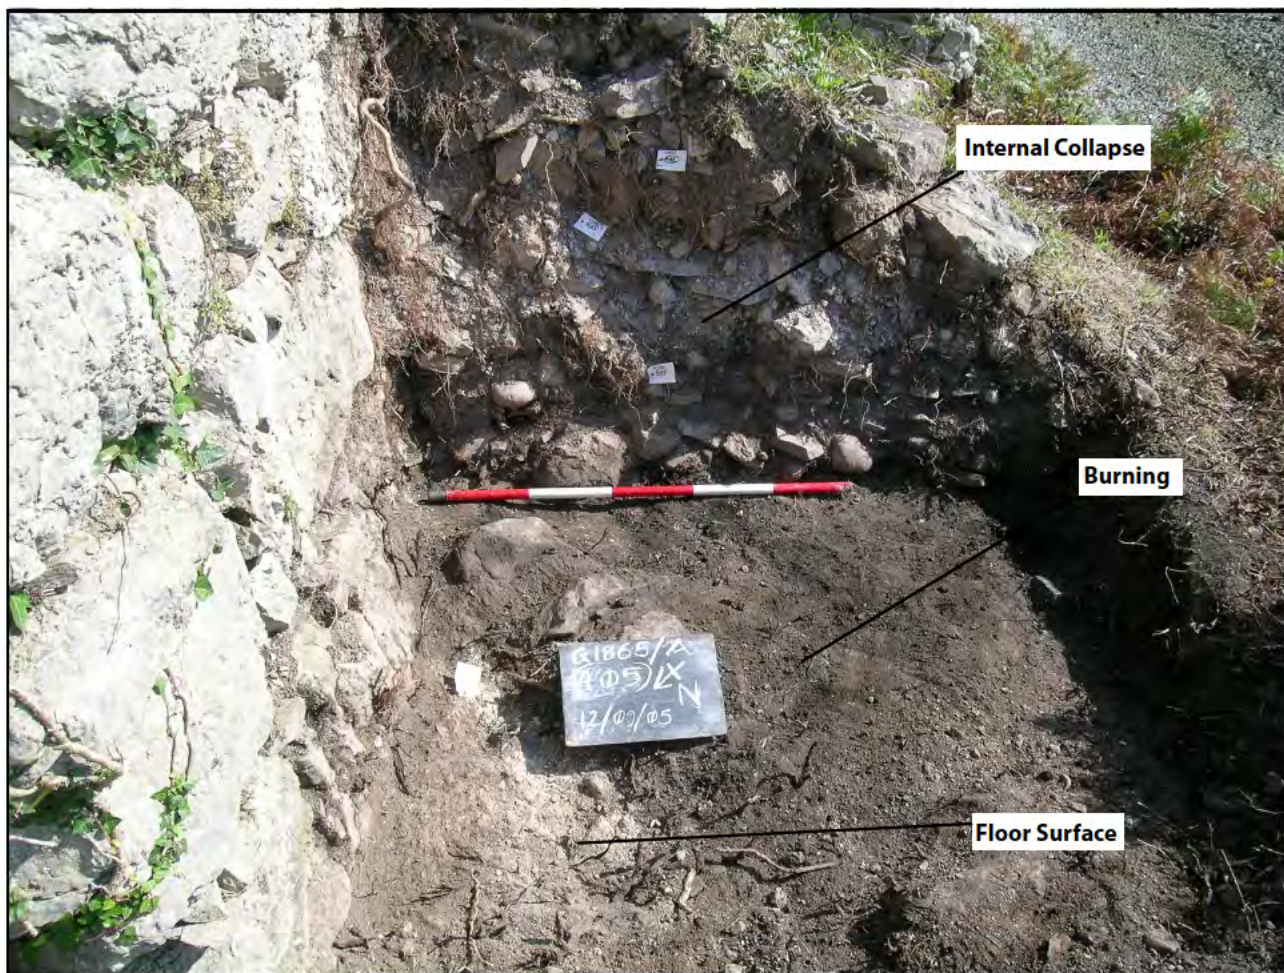
Plate 11: Block A: Internal Collapse, Burning and Floor Surface (Location of Hague Excavation)
