# Industrial Recording

CN159: Klondyke Lead Mill  
CN331: Afon Llugwy Lead Mill  
CN332: Coed Mawr Pool

**Archaeological Survey and Record**

**GAT Project No. G1910**

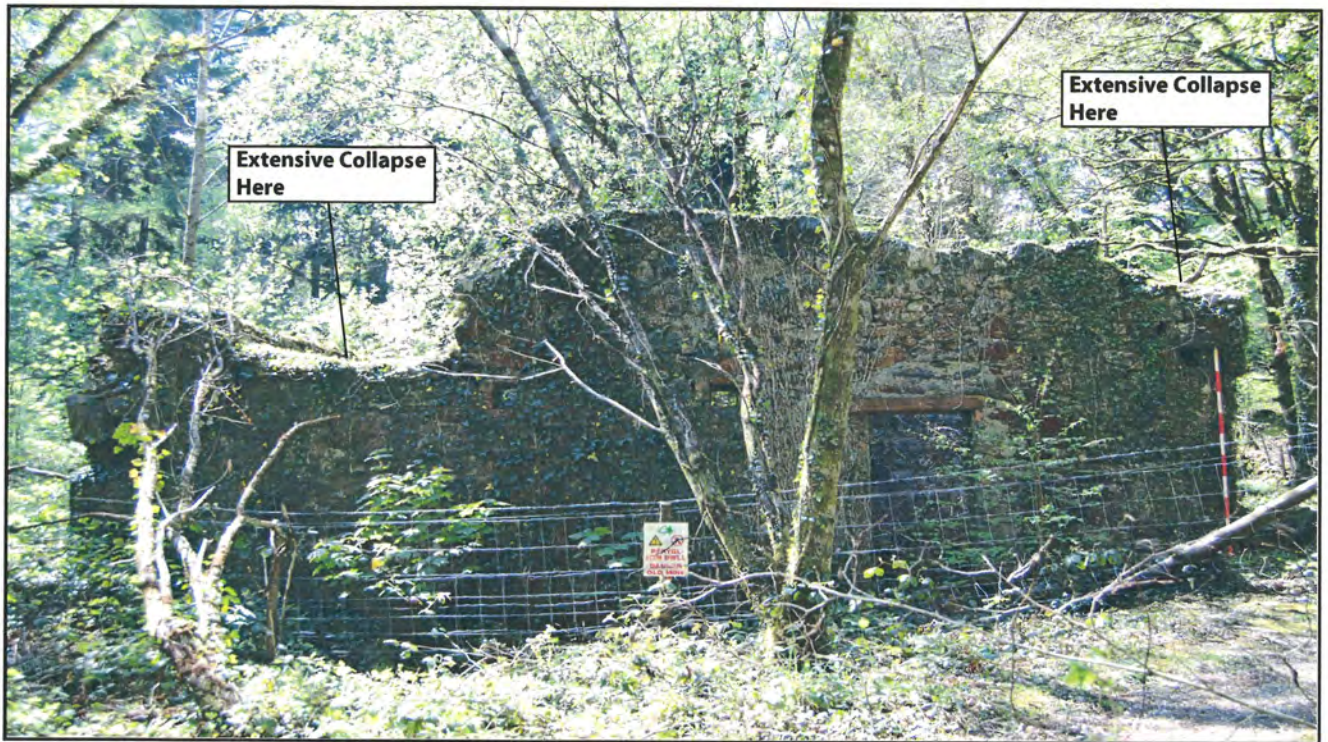
**Plate 1: CN331: Northeast Facing Elevation of Mill Building**

Northeast facing aspect constructed from irregular igneous stone. Elevation measures c.7.00m in length and 2.80m in height. Two 0.60m wide entrances are visible, providing access to a large rectangular room with an internal partition. The entrance on the eastern side is blocked with mortar, irregular igneous stone and brick fragments. A stone lintel is visible (height above ground: 1.82m). The entrance on the western side is open, with a wooden lintel (height above ground: 1.82m). The sides of the entrance have been repaired with mortar, irregular igneous stone and brick fragments.

Two small brick lined ventilation holes are visible between the entrances, c.2.00m above ground level.

Evidence for disrepair is most apparent along the eastern and western ends of the elevation, with the eastern side in particular having collapsed to a height of c.2.20m above ground level.

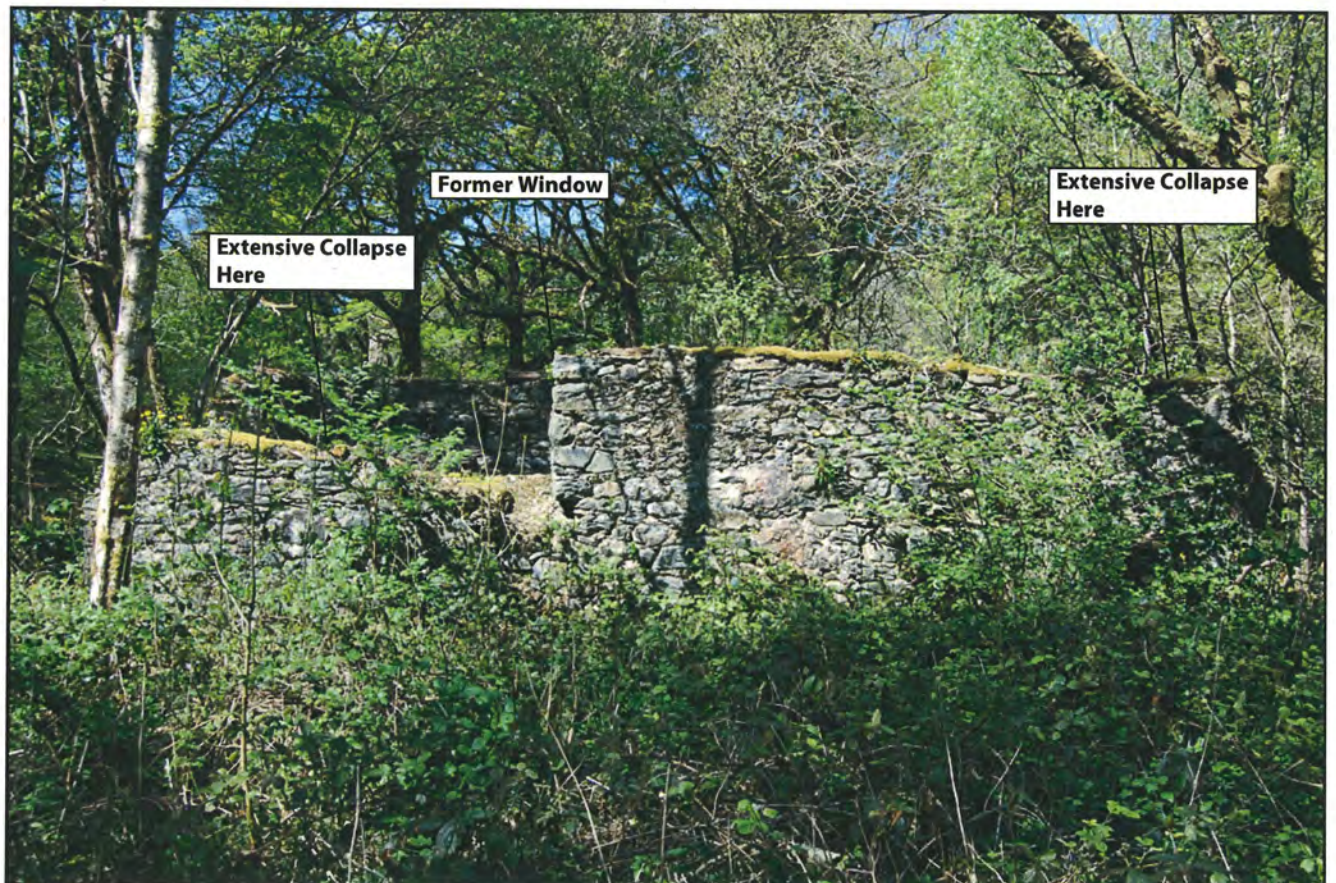
**Plate 2: CN331: East Facing Elevation Mill Building**

Evidence for collapse and impending collapse is most apparent on this elevation. A large portion of the southern end of this elevation has collapsed, leaving a standing height of c.1.20m. The collapse has removed a former window, now extant as one jamb with a fragment of wooden lintel. There is evidence of brick and mortar repair to the centre of the elevation. A doorway is located towards the northern end of the elevation. The wooden lintel is cracked and the stone above is subsiding northwards. The lintel is providing the only support in this area.

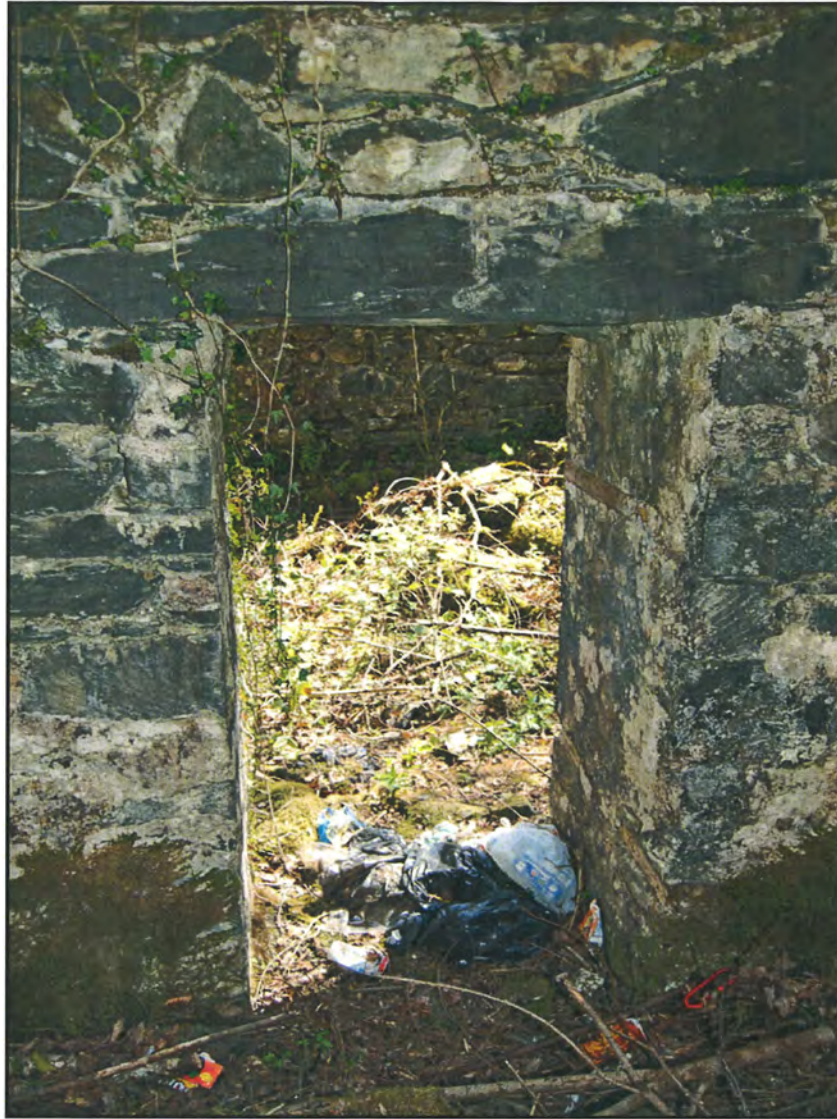
**Plate 5: CN331: Internal Partition: Entrance**

The internal partition measures 0.93m wide and 2.80m high and is surmounted by a wooden beam/wall brace. Construction matches the external elevations.

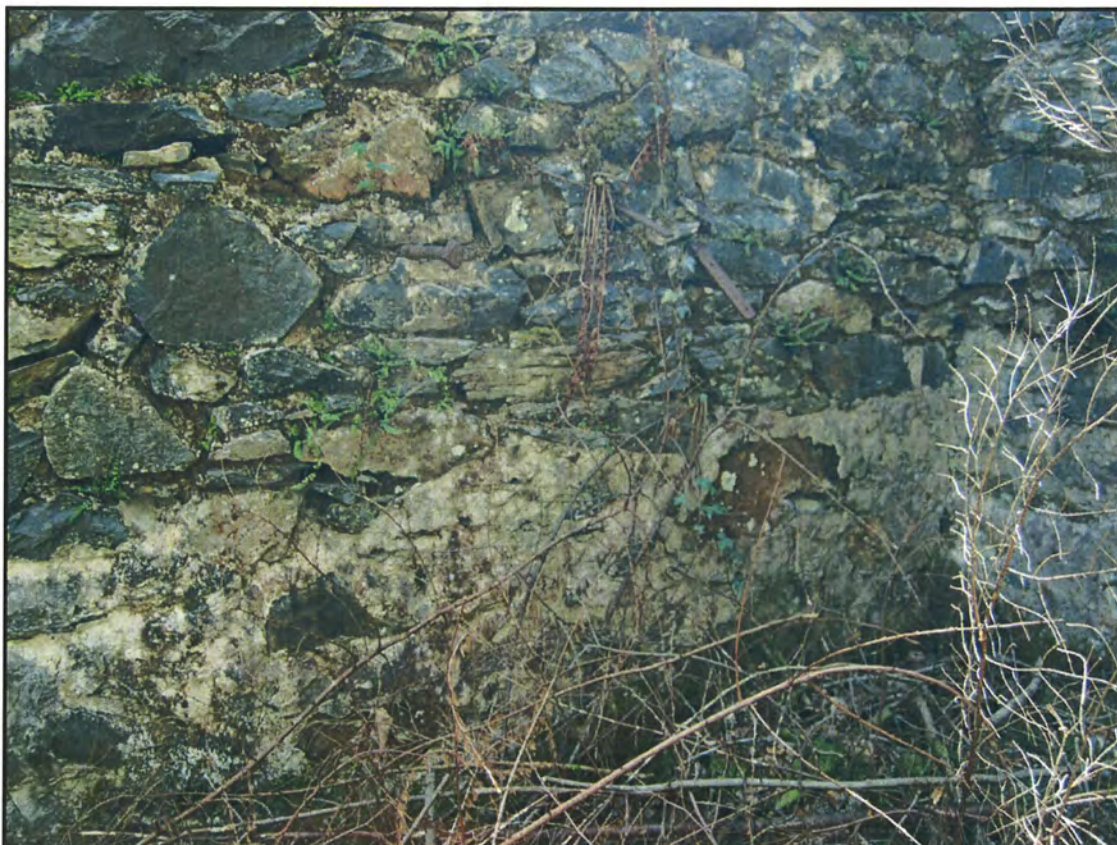
**Plate 6: CN331: Internal Partition: Detail of Limewash and Fittings**

The larger room measures 4.00m wide and the smaller room, 2.00m wide. The smaller room is accessed by an entrance on the northeast-facing elevation. Within the room, three metal fixings are visible on the west-facing elevation of the partition wall, with limewash also evident across this wall, up to a height of 1.00m above current ground level. No other fixtures/fittings are visible.

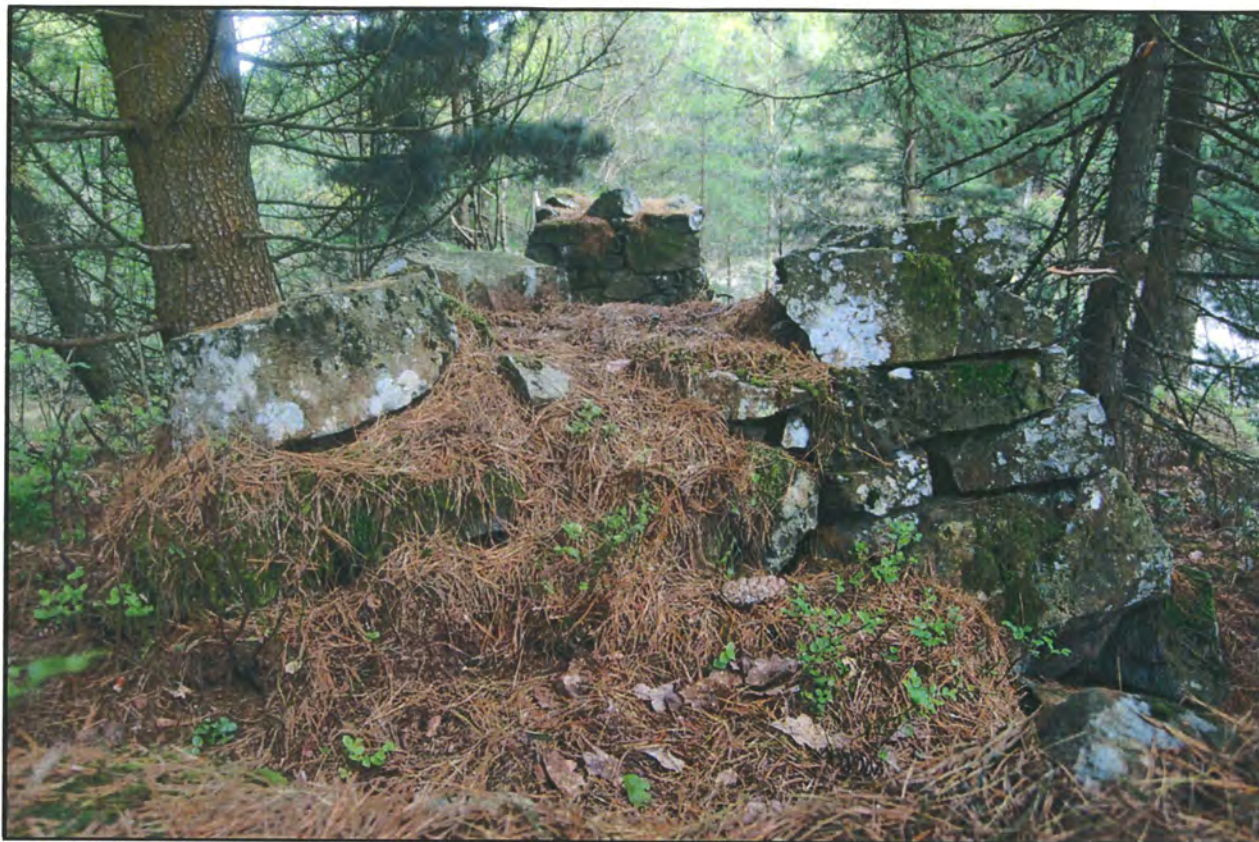
**Plate 1: CN332: Aqueduct Platforms (View North)**

Comprises three stone-built platforms designed to support water pipes/compressed air pipes for the wheel pit located to the south. The platforms are built into a rock outcrop and vary in height in response to the topography (0.80m, 1.10m and 1.60m respectively). They are constructed from locally sourced stone; no bonding visible.

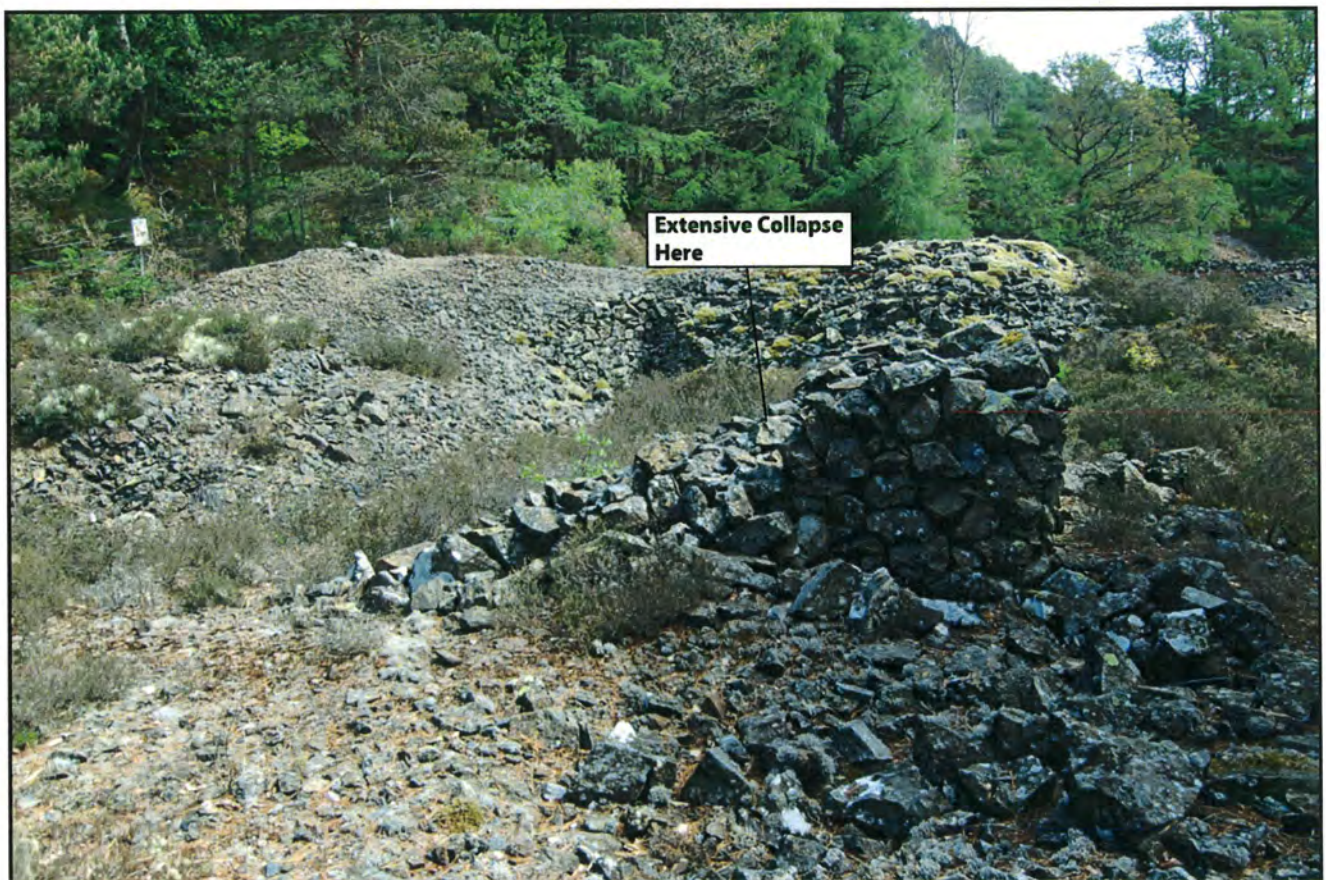
**Plate 4: CN332: Shaft Entrance**

The remains of a shaft entrance, located c.30.0m to the north of the No. 1 wheel pit. Three elevations are still extant; the fourth is a pile of rubble. Constructed from locally sourced stone; no bonding. Built onto a low-lying platform of stone and is surrounded by mining waste. Another, similar example, is located c.12.0m to the northeast. Three elevations extant (two partially collapsed; south-facing is complete). Same construction as example to southwest. Partially subsumed by waste tipping.

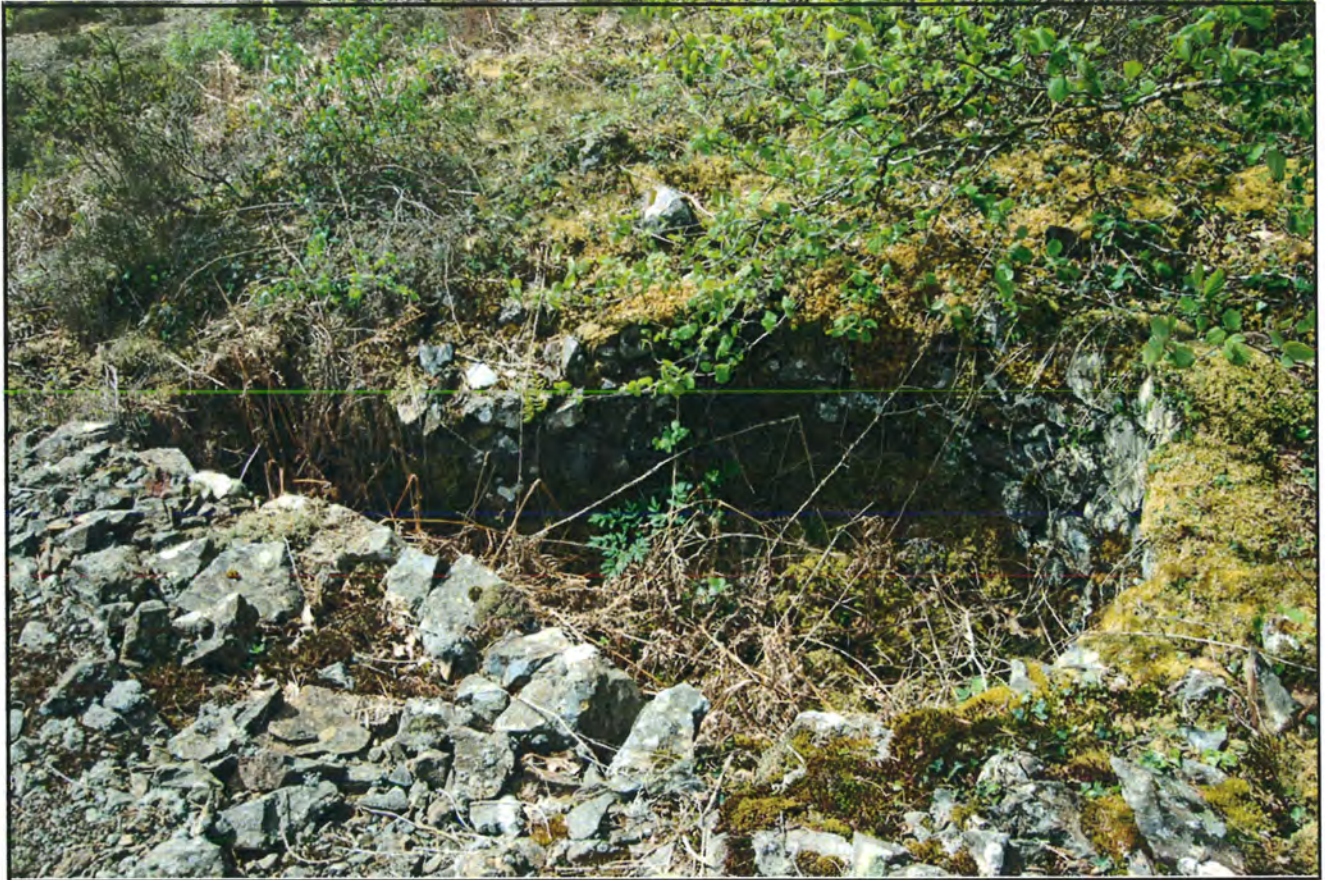
**Plate 7: CN332: Capstan Pit**

Stone-built platform with key-shaped capstan pit towards centre. Platform built from locally sourced stone; in a state of disrepair. Capstan appears intact; 3.20m long and 1.5m wide, built from stone. Base of pit obscured by vegetation and rubble. Hillock incorporating aqueduct and magazine store to immediate west; No.1 wheelhouse c.10.0m to the southwest. Waste tips surrounding pit to north, east and south.

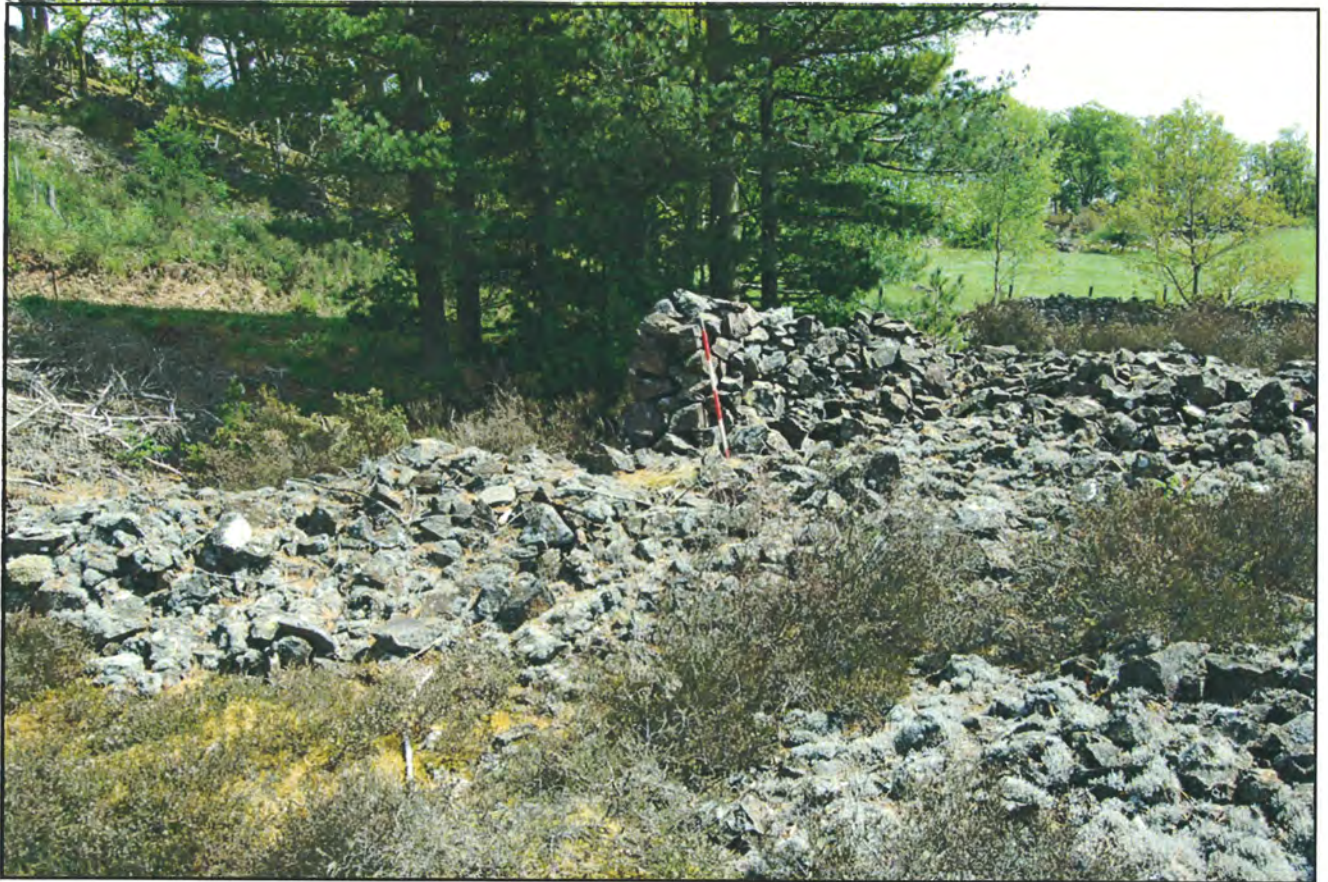
**Plate 9: CN332: Possible Boundary Wall**

Short, stone-built elevation of unknown function located at eastern end of site, c.15.0m west of the access road. Measures 4.00m in length, 1.10m in height and 0.65m in width. Tapered construction: wider at the base; no bonding used. Located c.40.0m to the north of the mine office. Surrounded by mine tipping waste.

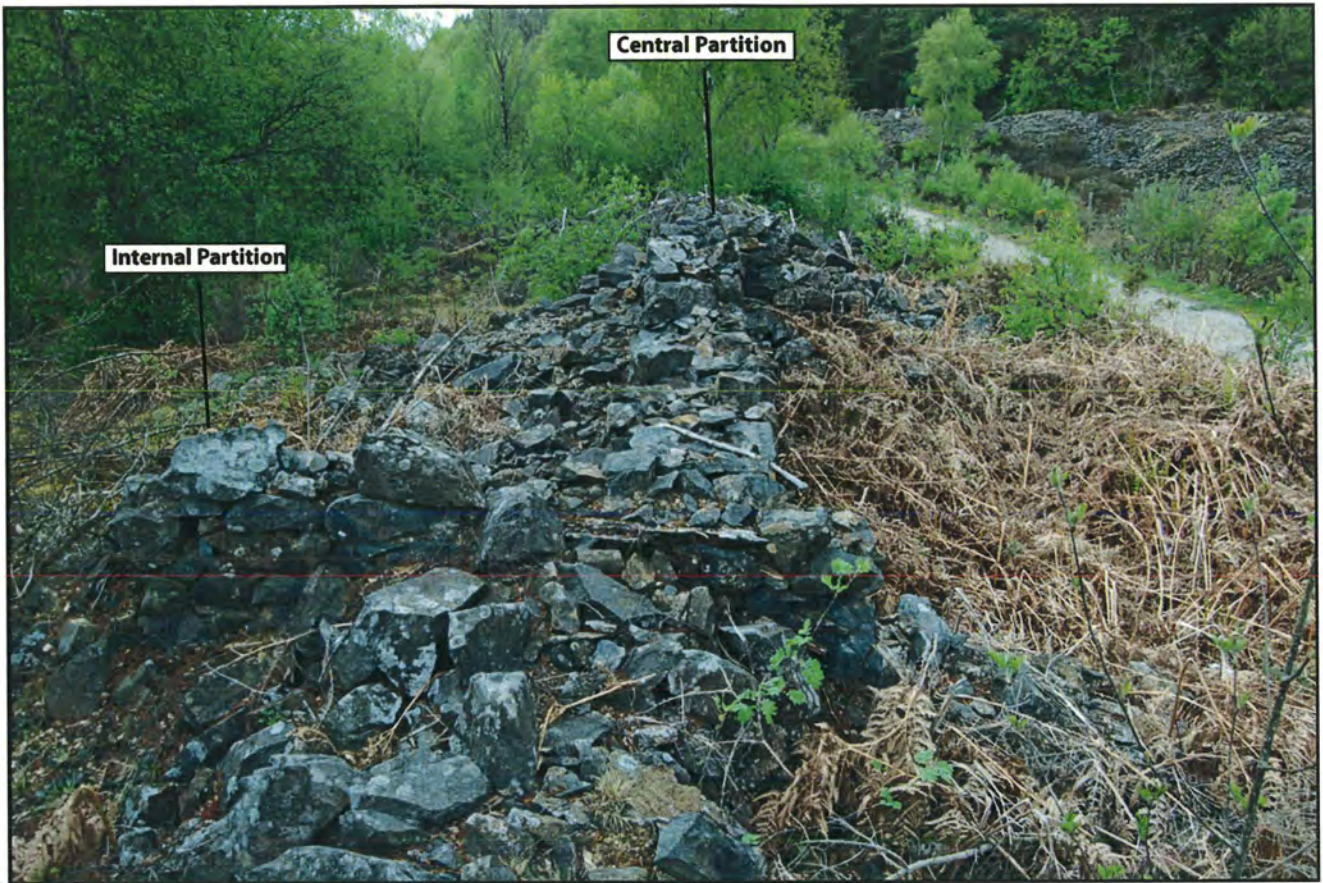
**Plate 11: CN332: Office: Central Partition et al.**

Partially extant rectangular-shaped stone-built structure. Measures 35.0m long and 20.0m wide, with a mean height of 1.20m. In a state of disrepair: external elevations have collapsed exposing central

partition and internal divisions. Central partition measures 0.60m in width; internal partitions are 0.50m wide. No further details visible due to collapse and extensive overgrowth.

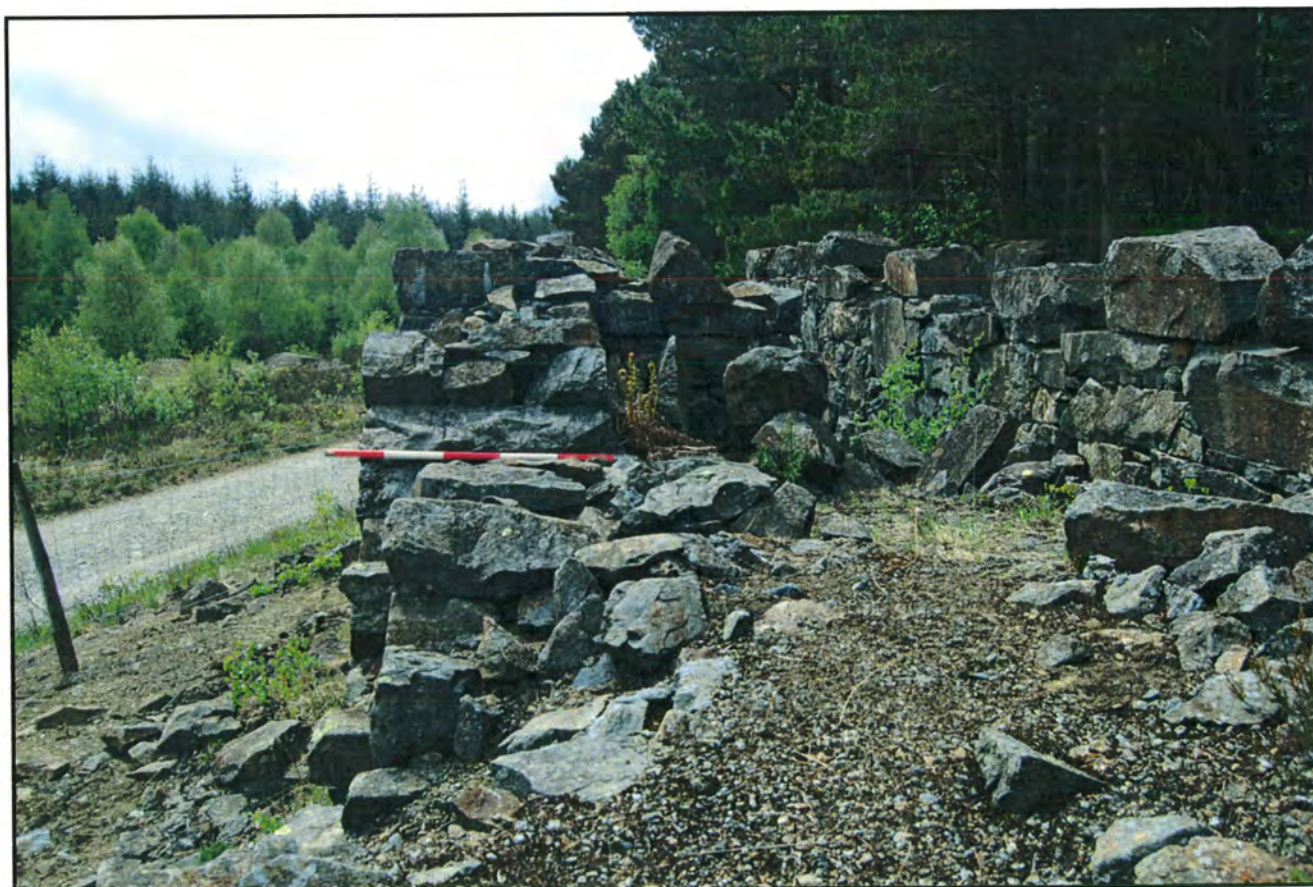
**Plate 16: CN332: Wheel Pit No. 1: Detail of Ruined East Facing Elevation**

Several structures lie within the scheduled area, including a substantial wheel pit, a bob pit, a circular powder store and various lengths of upstanding walling. A part of the wheel pit, particularly the south wall, is eroding and the other structures, mostly of drystone build, are also very vulnerable to collapse. No detailed plan exists of the location of all the masonry structures. This site has been surveyed in its entirety using a total station and then each feature has been recorded by photograph and written description.

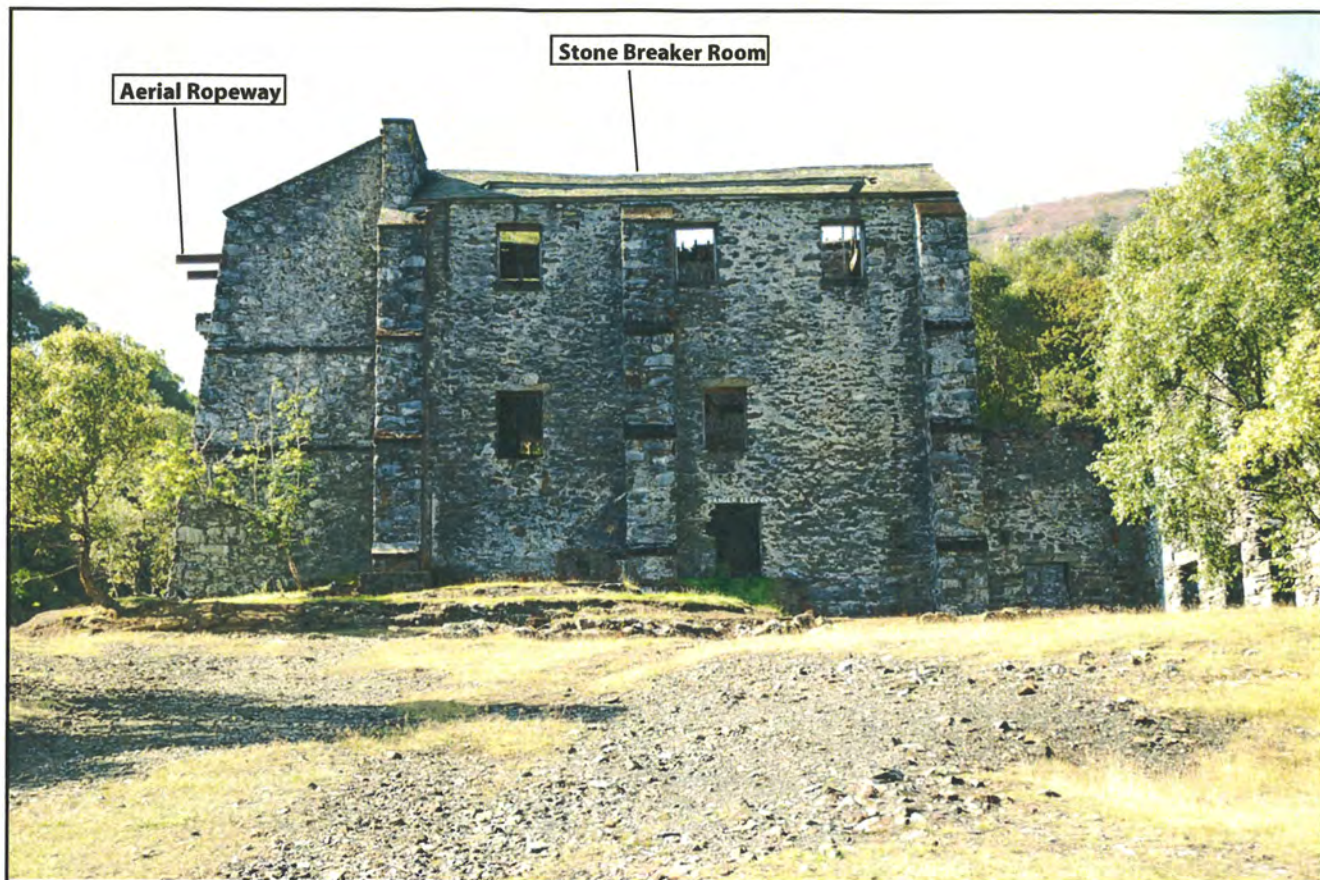
**Plate 1: CN156: North Facing Elevation Turbine House/Stone Breaker Room and Aerial Ropeway**

One small area of collapse has recently occurred on the east wall of the turbine house, though the remainder of the wall appears relatively stable. Despite the height of the walls, the remainder of the building also appears relatively stable and it is the timber work that once supported the roofs, floors and machinery that is at greatest risk. The rotting of the timbers will have a direct impact upon the masonry, which will be dislodged by falling timbers and in danger of collapse where wooden lintels occur. A full record of this structure, including masonry and timber elements, has therefore been undertaken using a reflectorless total station.
