Afon Trweunydd Hydro-Power Scheme

Archaeological Record and Watching Brief 2007

Report No. 693

Prepared for Shawater Limited

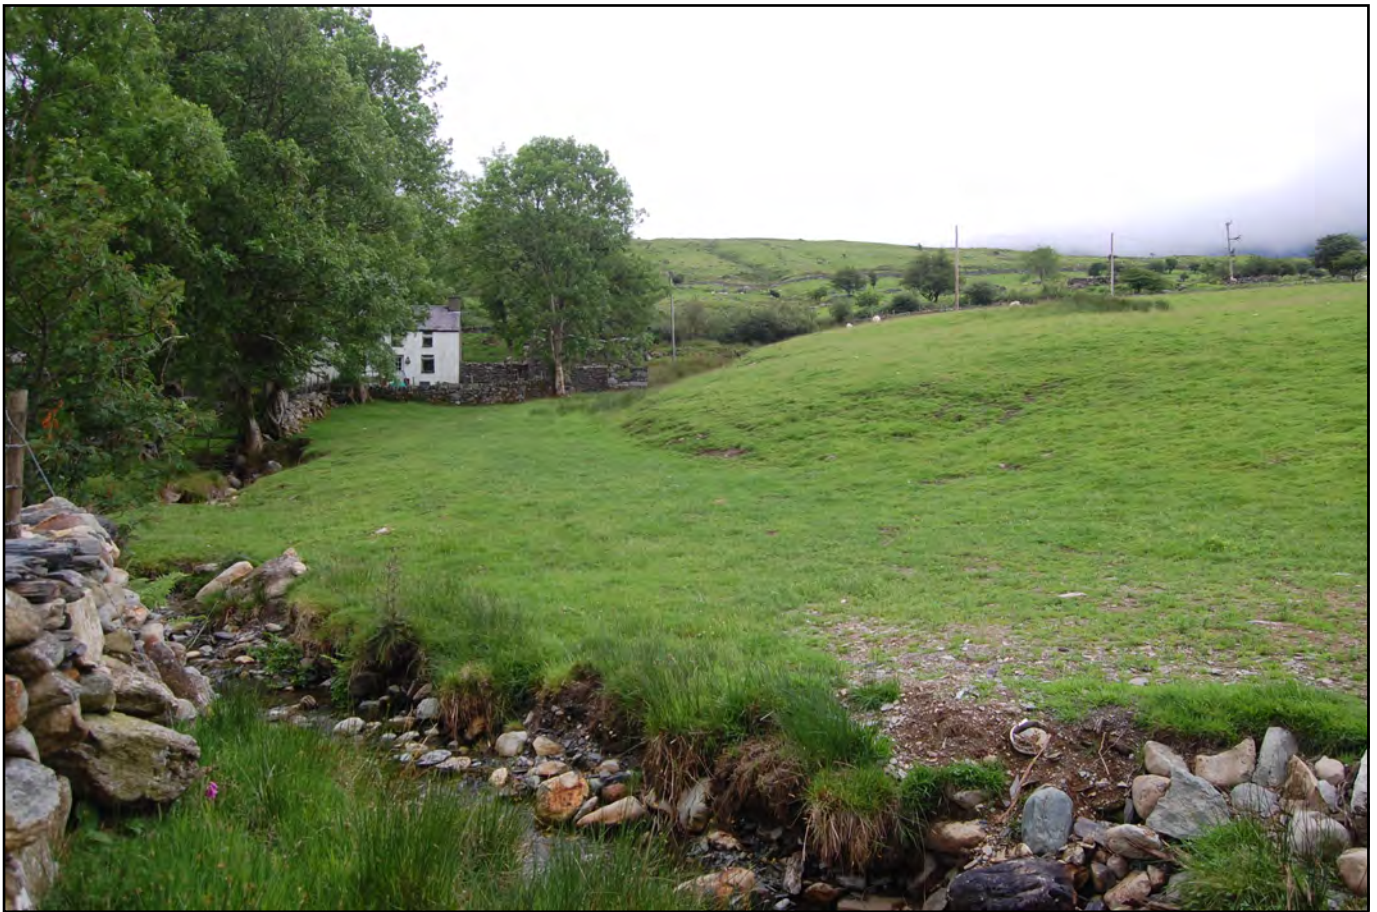
Plate 01: View East of Powerhouse Location

The powerhouse was located c.20.0m east of Bron-y-Fedw Uchaf Farm and was monitored with a partial watching brief (defined as “when appropriate”, IFA. 2001. *Institute of Field Archaeologists 2001 Standard and Guidance for an archaeological watching brief* para. 3.2.10). The powerhouse was terraced into a low-lying slope (Plates 01 and 02).

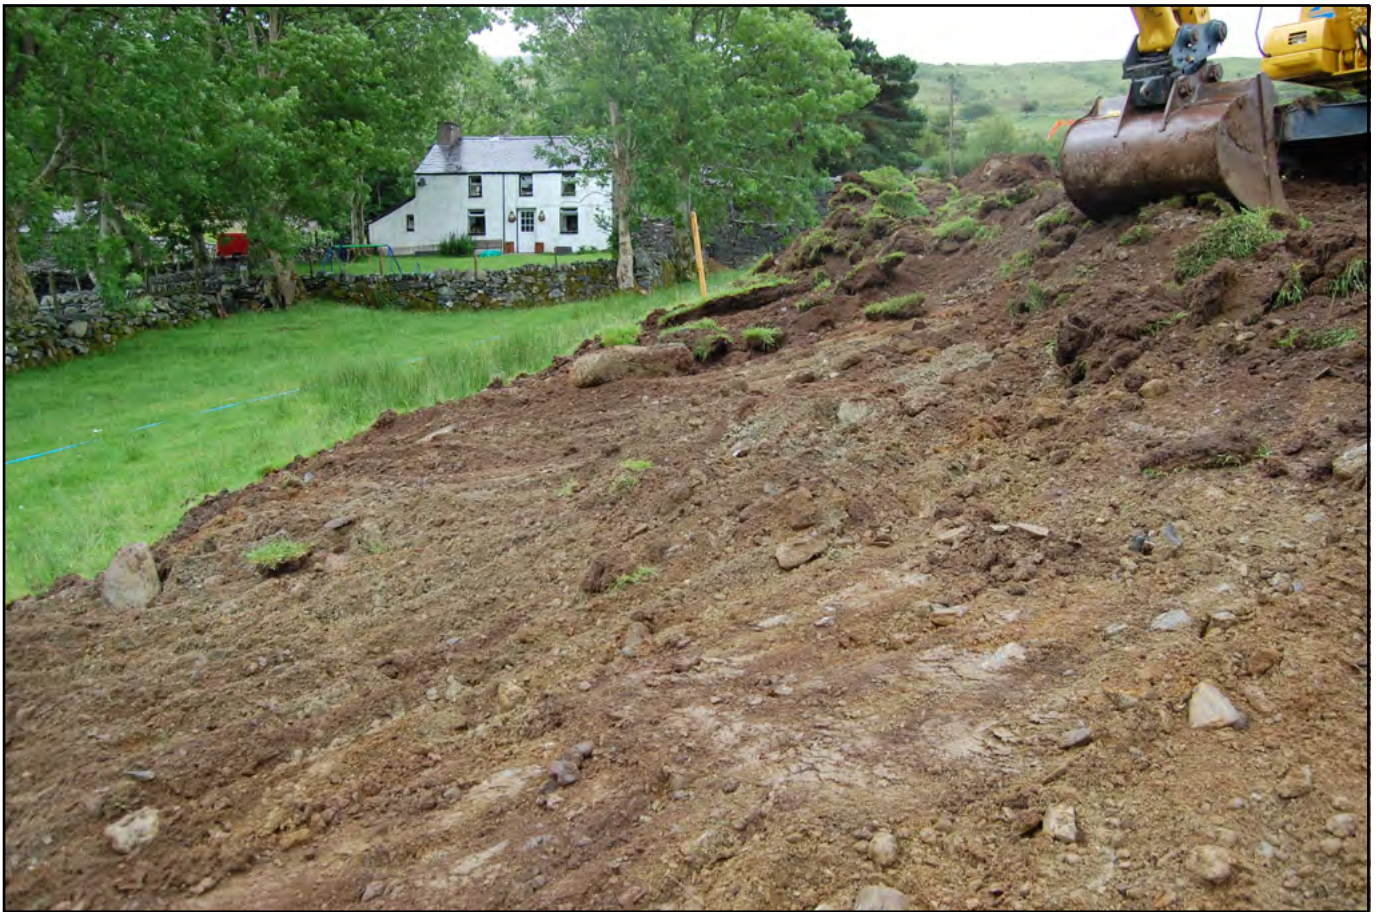
The machine strip of the building plot for the powerhouse was supervised, which revealed a thin deposit of topsoil (<0.20m), atop a shale-rich subsoil/colluvium (<0.15m) (Plate 03). Beneath the subsoil was an outcrop of Ordovician stone.

Plate 03: View East of Powerhouse Location during works. Shale-rich Subsoil exposed.

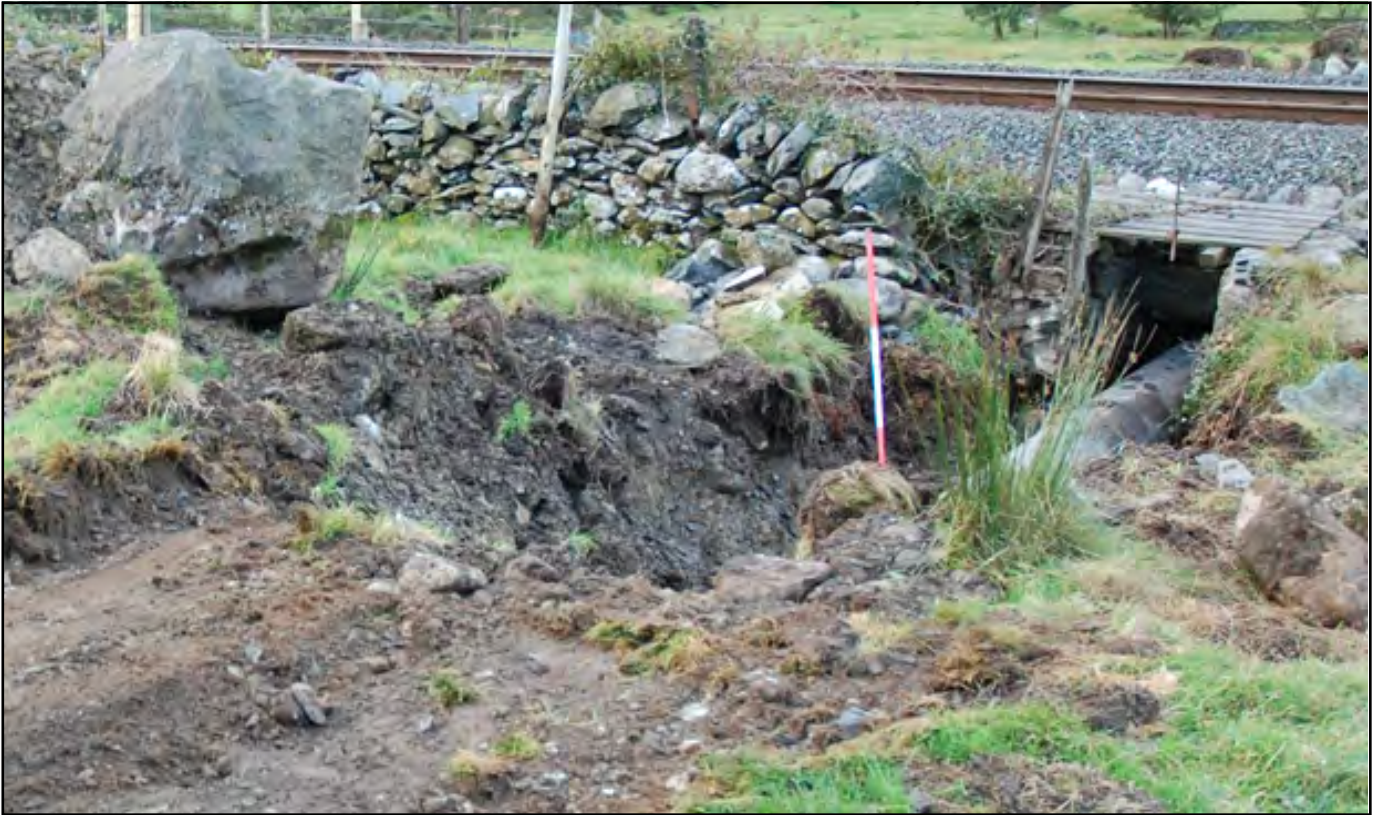
The report was published in 2000 when the line was closed. It was subsequently reopened to passengers in 2003 following the complete reconstruction of the railway from Waunfawr to Rhyd Ddu by the Ffestiniog Railway Company. As such, this feature did not require a basic record as there was no direct impact on the feature by the pipeline. During the construction of the hydroelectric power scheme, the pipeline was carried beneath the railway line, utilising an extant sheep run as a permanent passageway (Plate 05).

Site 3 (Railway), the pipeline passed below the railway, through a former sheep run (Plate 05). No archaeological activity was identified within the localised area. A photographic record was maintained.

Plate 05: Site 03: During Works. Note Pipe through Sheep Run

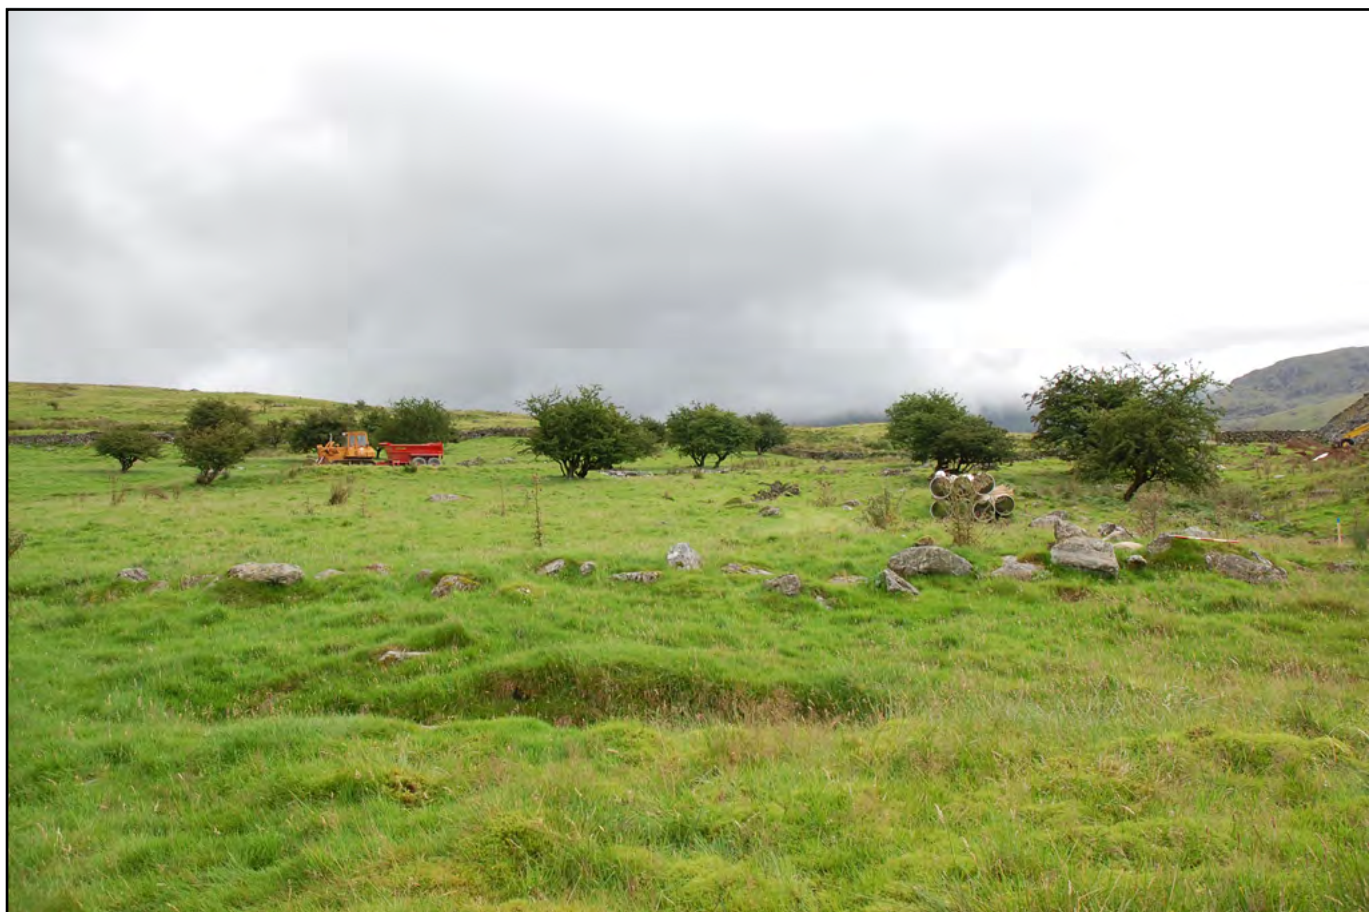
A terrace comprising a line of stones thought to be part of a relict field system (GAT Report 364). Further inspection, as part of the detailed record for the current report, identified the terrace as comprising large sub-angular stones forming a rectangular-shape (Plates 07 and 08). The terrace utilised a natural northeast to southwest slope, with the longest length of the terrace, 20.70m, running across the slope. A 10.50m long return then ran up the slope, followed by a second return, 3.0m long, running across the slope (Figure 02). The width of the terrace varied between 0.50m and 0.80m. On the eastern side (the location of the 10.50m length of wall) a 2.0m long bank stretched away from the terrace.

A short length of bank was also located, c.6.0m to the south of Site 7 (Plate 07). This terrace comprised a line of grass covered, 27.0m in length, running towards a stream. The pipeline route bisected this feature and proved it was a large stone-filled drain of post-medieval provenance (Plate 10).

Plate 07: Site 07: View East. Note low bank of stones in foreground forming terrace.

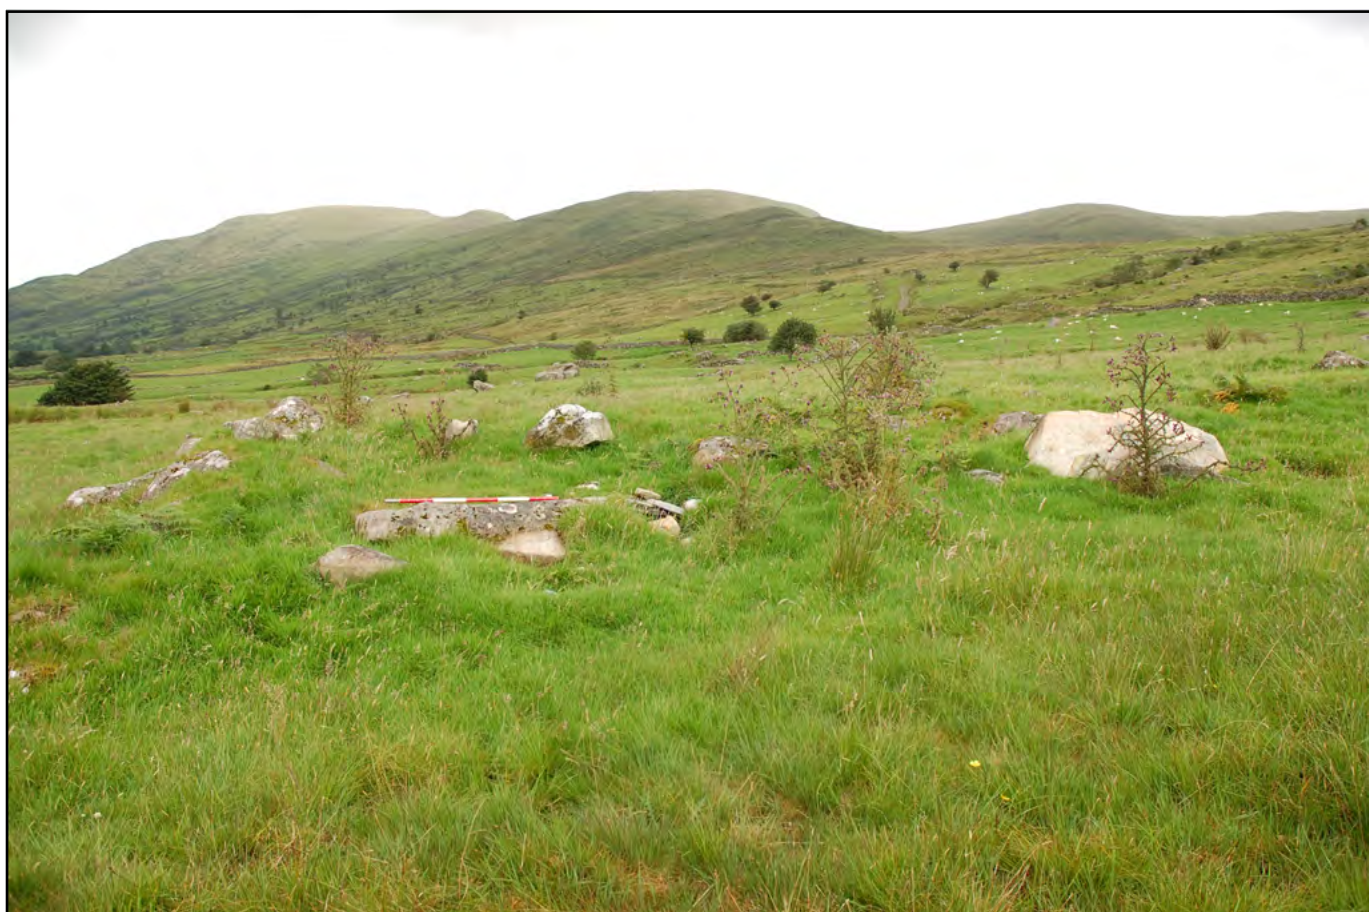
Plate 08: Site 07: View North. Note low bank of stones in foreground forming terrace.

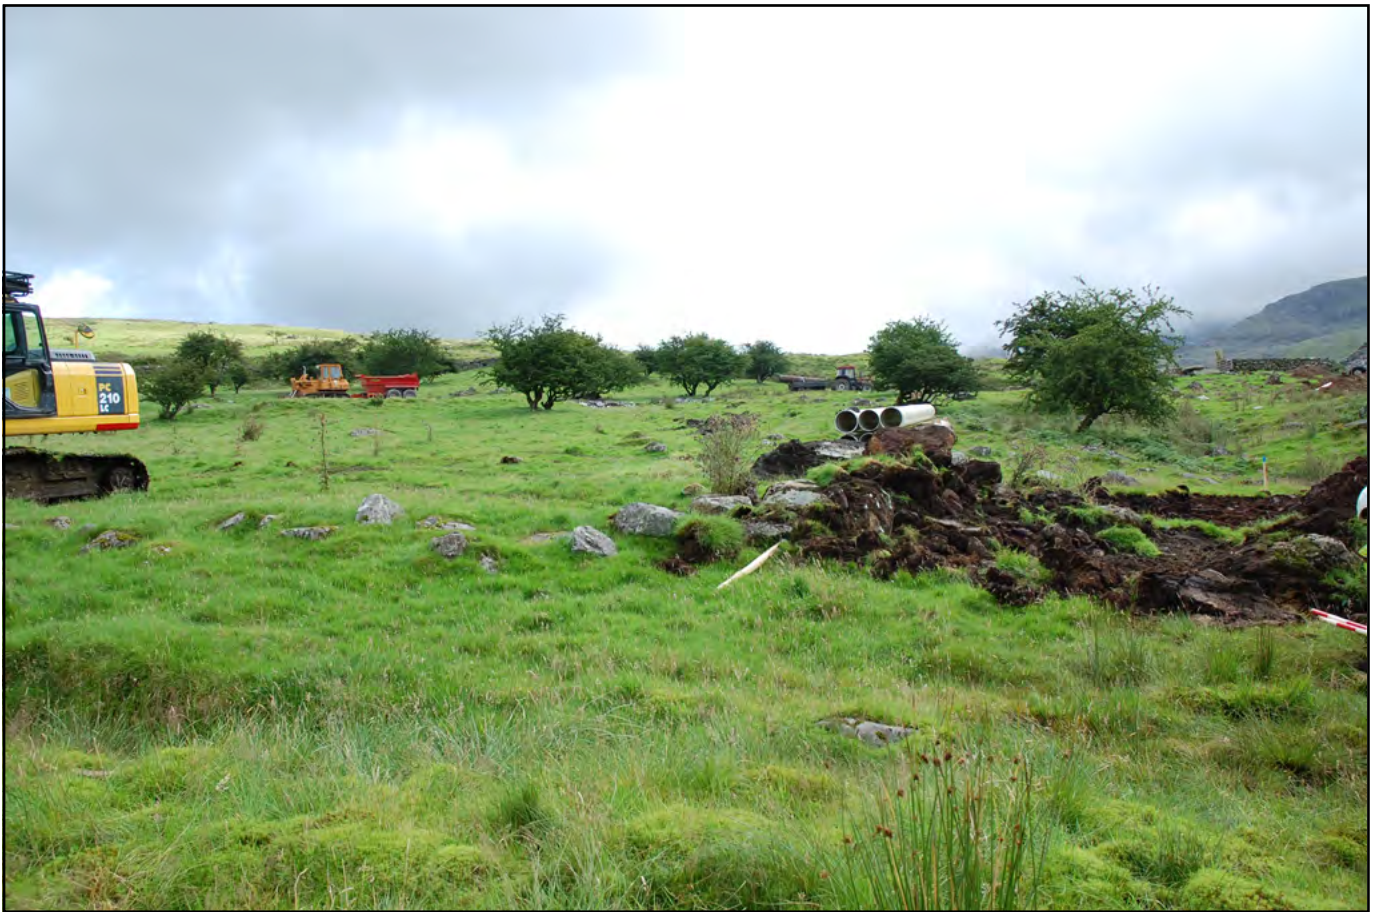
The function of the terrace could not be determined during the project. The pipeline route removed part of the bank attached to the east facing part of the terrace but did not affect the composition of the terrace. The bank comprised organically-rich soil indicative of a waterlogged environment (it appeared to have built up naturally rather than as a purpose built bank). A photographic record was maintained during this event (Plate 09). The removal of the bank enabled an inspection of a short length of the east-facing elevation, which appeared to be a loose conglomeration of medium to large sized sub-angular stones (<0.80m long), set into the natural. It was unclear if all examples were structural and/or clearance dumps.

Plate 09: Site 07: View East during works. Note exposed terrace, detailing stones

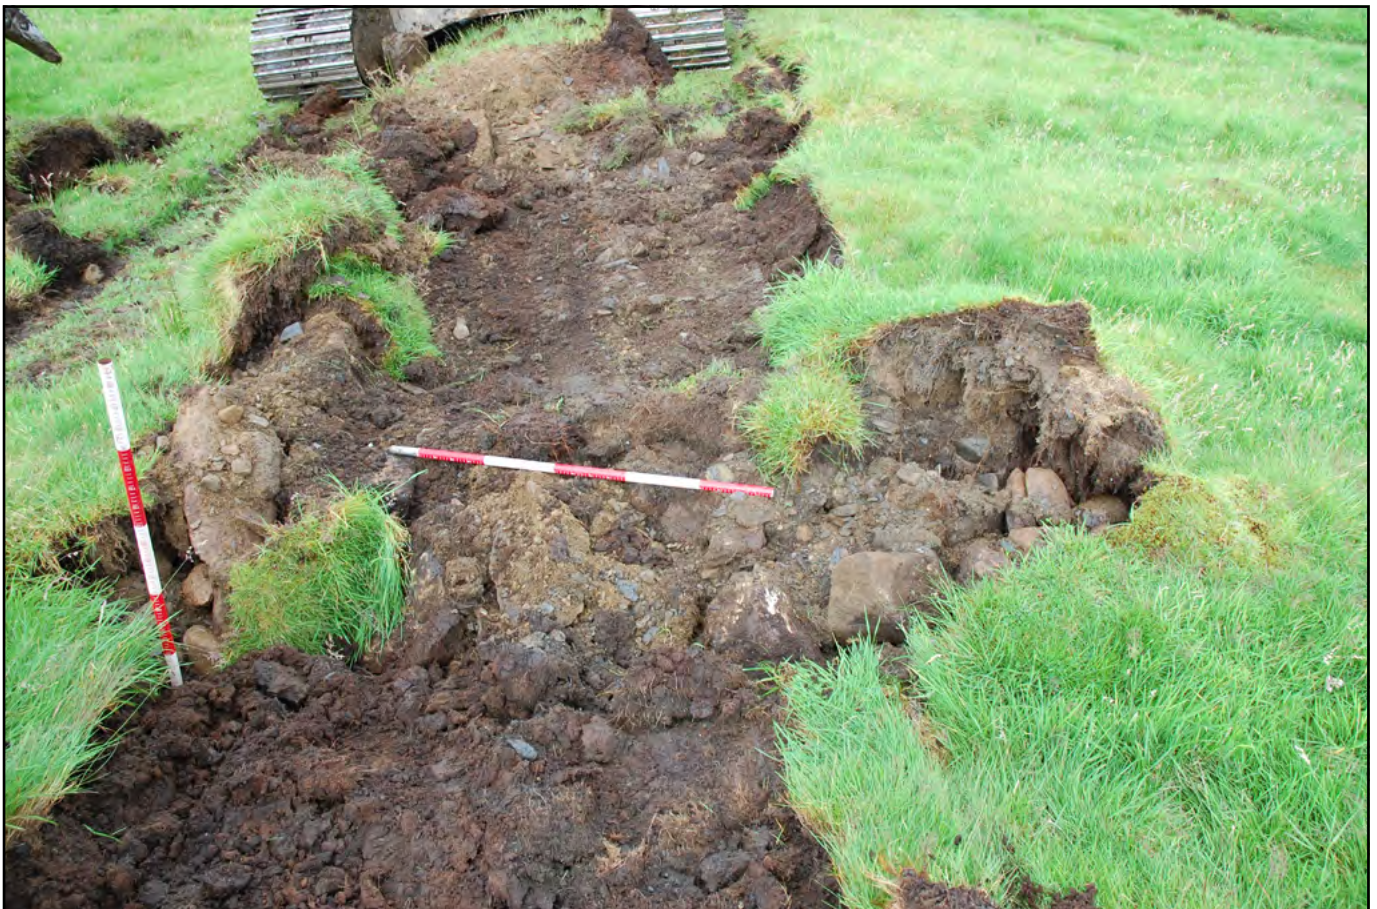
Plate 10: Site 07: Detail of Modern Drain close to terrace.

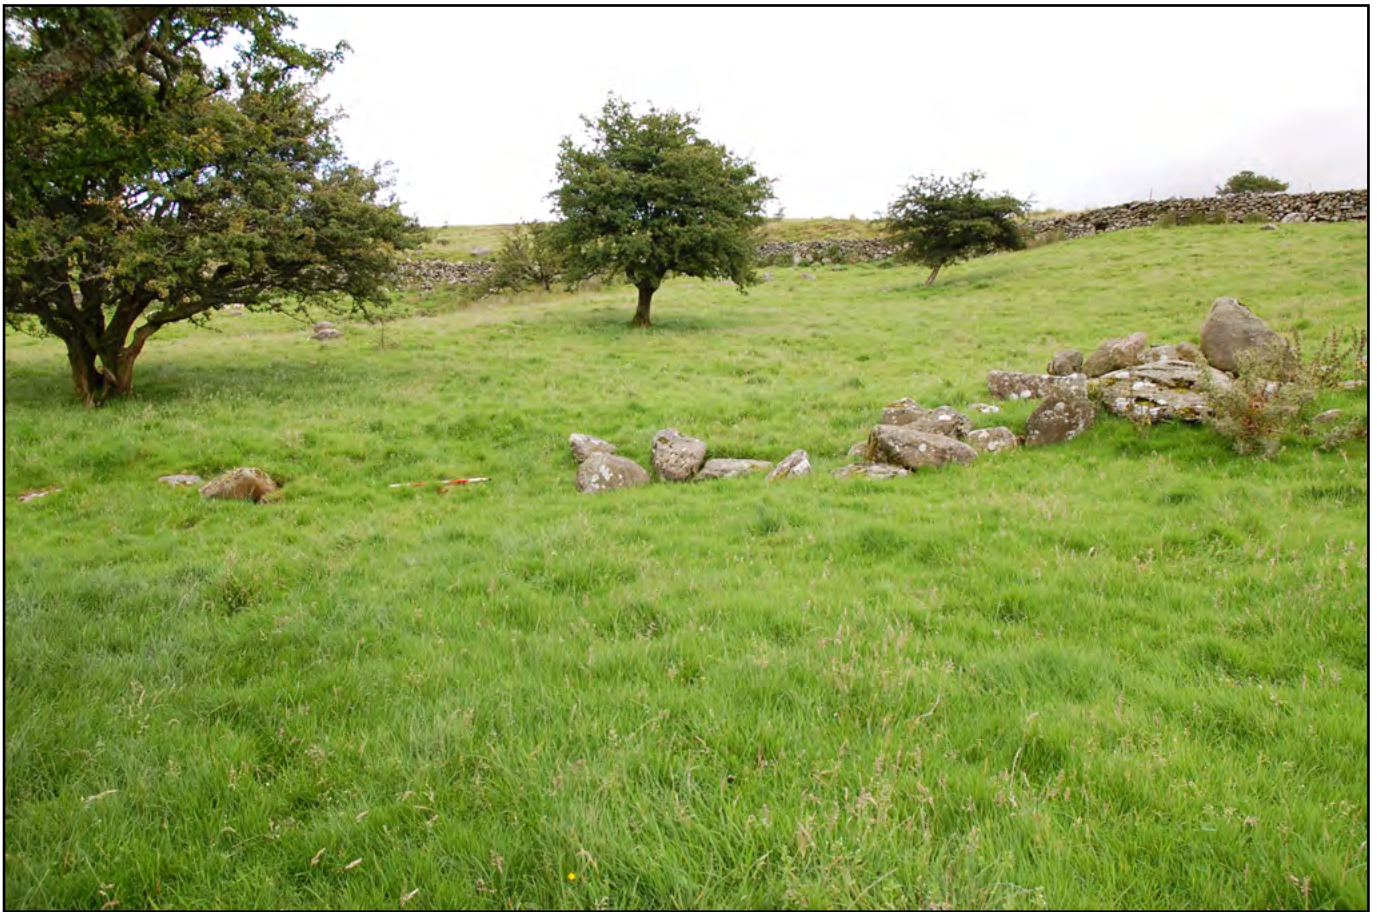
A short, curving length of terracing with stone revetting. The GAT assessment report (GAT Report 364) described the terrace as c.50.0m in length and 0.60m in height with an associated 10.0m long denuded wall and various field clearance cairns. The pipeline route did not affect the site and was located a considerable distance to the southeast. A photographic record was taken of the site for the archive (Plate 11).

Plate 11: Site 08: View North. Site suggested by collection of sub-angular stones forming possible terrace

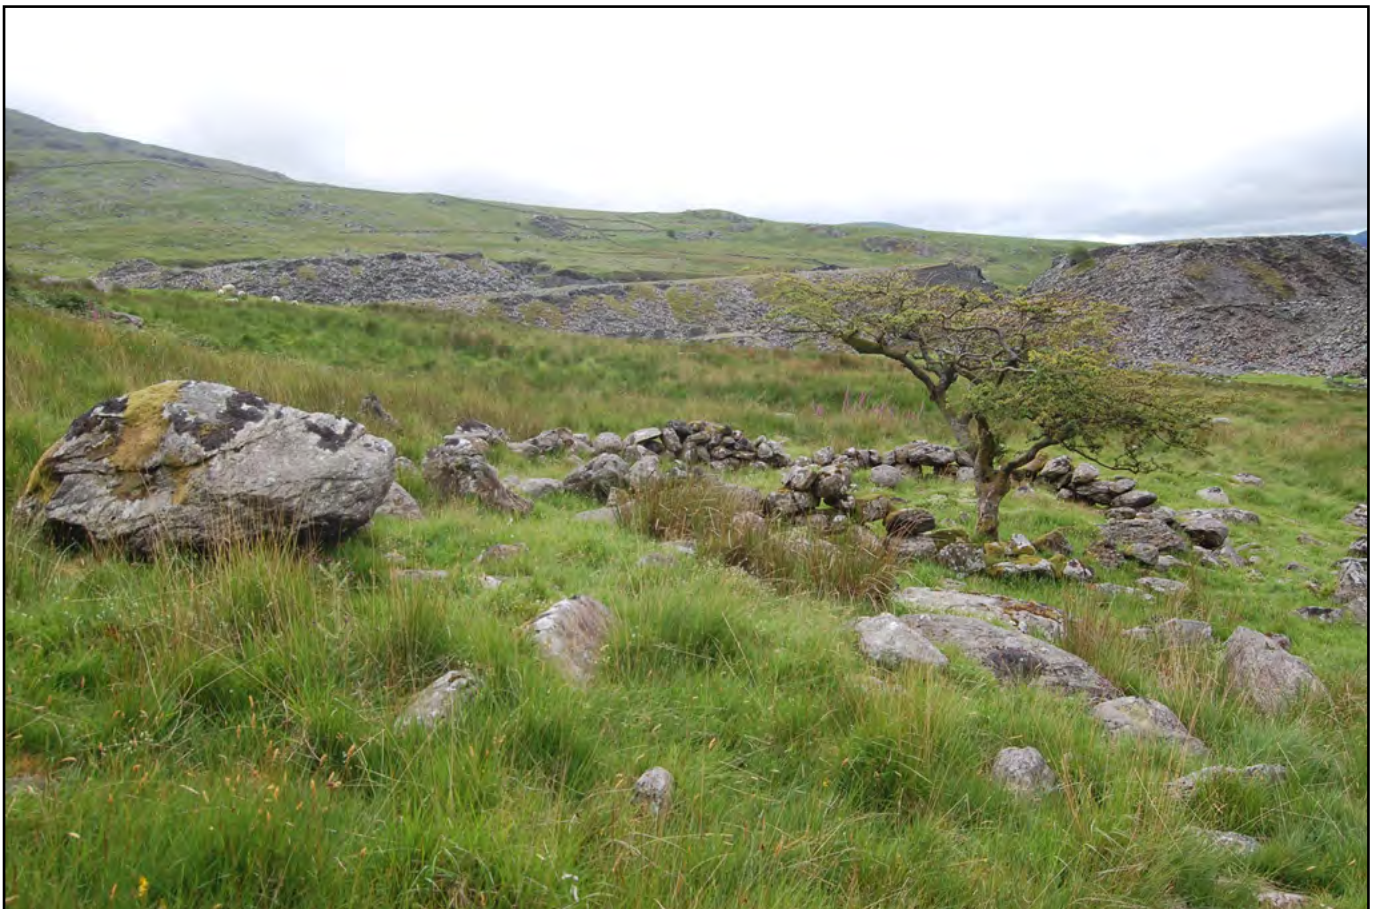
An enclosure, constructed of roughly built drystone walling of medium sized sub-rounded and sub-angular boulders (<0.60m in size; Plate 12). The site is oval in shape and 10.0m x 6.0m in size, with walls standing between 0.20m and 0.90m in height (dependant on extent of decay). The width of the walling varied but measures up to 1.00m. The site is located c.7.00m to the southwest of Site 10.

Plate 12: Site 09: View South of Enclosure.

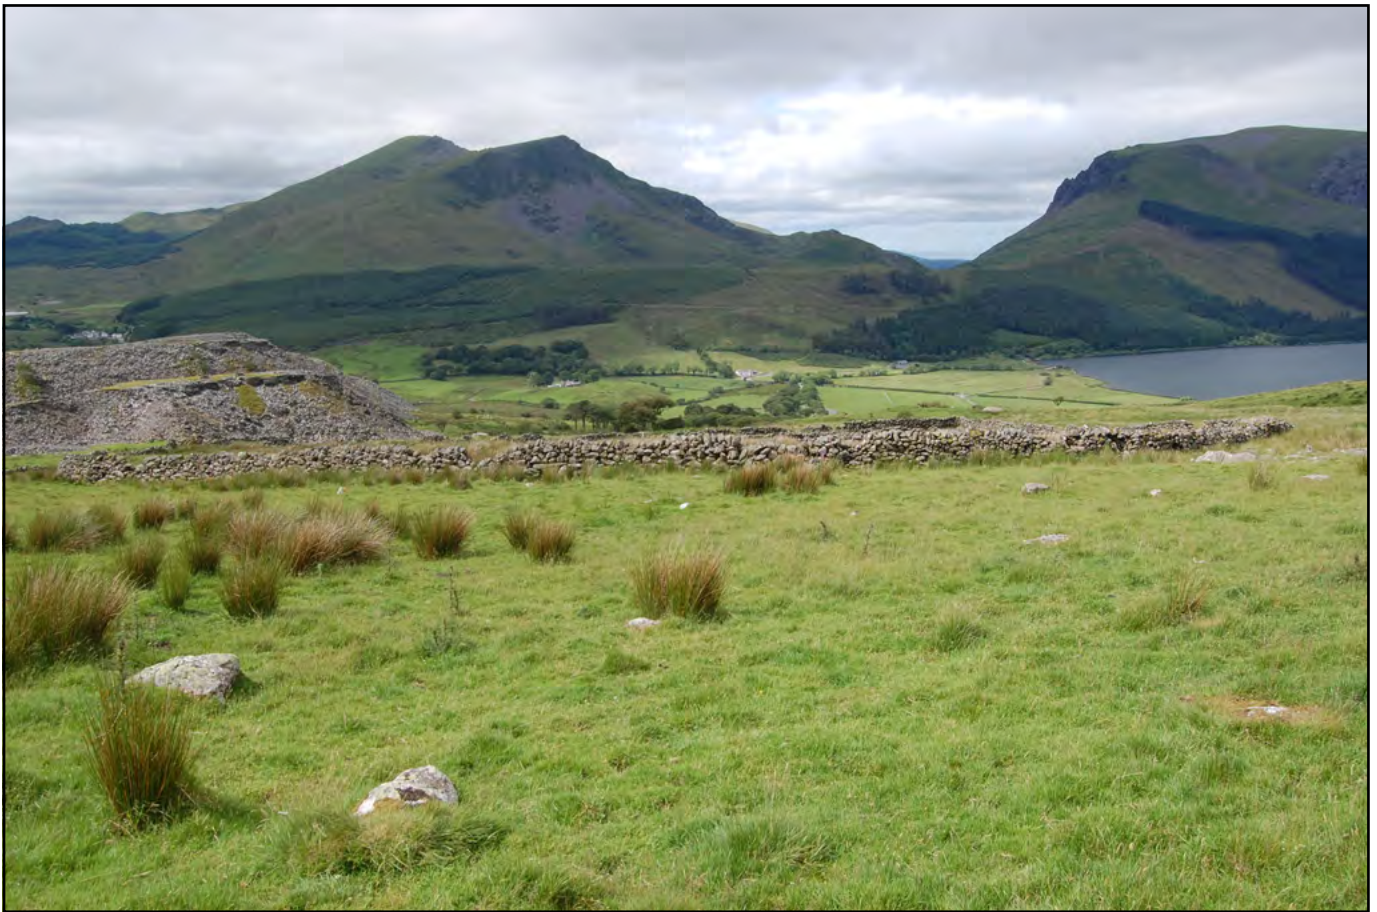
A large D-shaped enclosure (80.0m x 60.0m; Plate 13) enclosing three smaller interconnected enclosures (for the purposes of this report: A, B & C; Plate 14). The main enclosure comprises drystone walls (up to 1.00m in height) built from sub-rounded and sub-angular stone and is located across a north to south orientated slope within semi-improved pasture.

Plate 13: Site 10: View south of enclosure (located in centre of image)

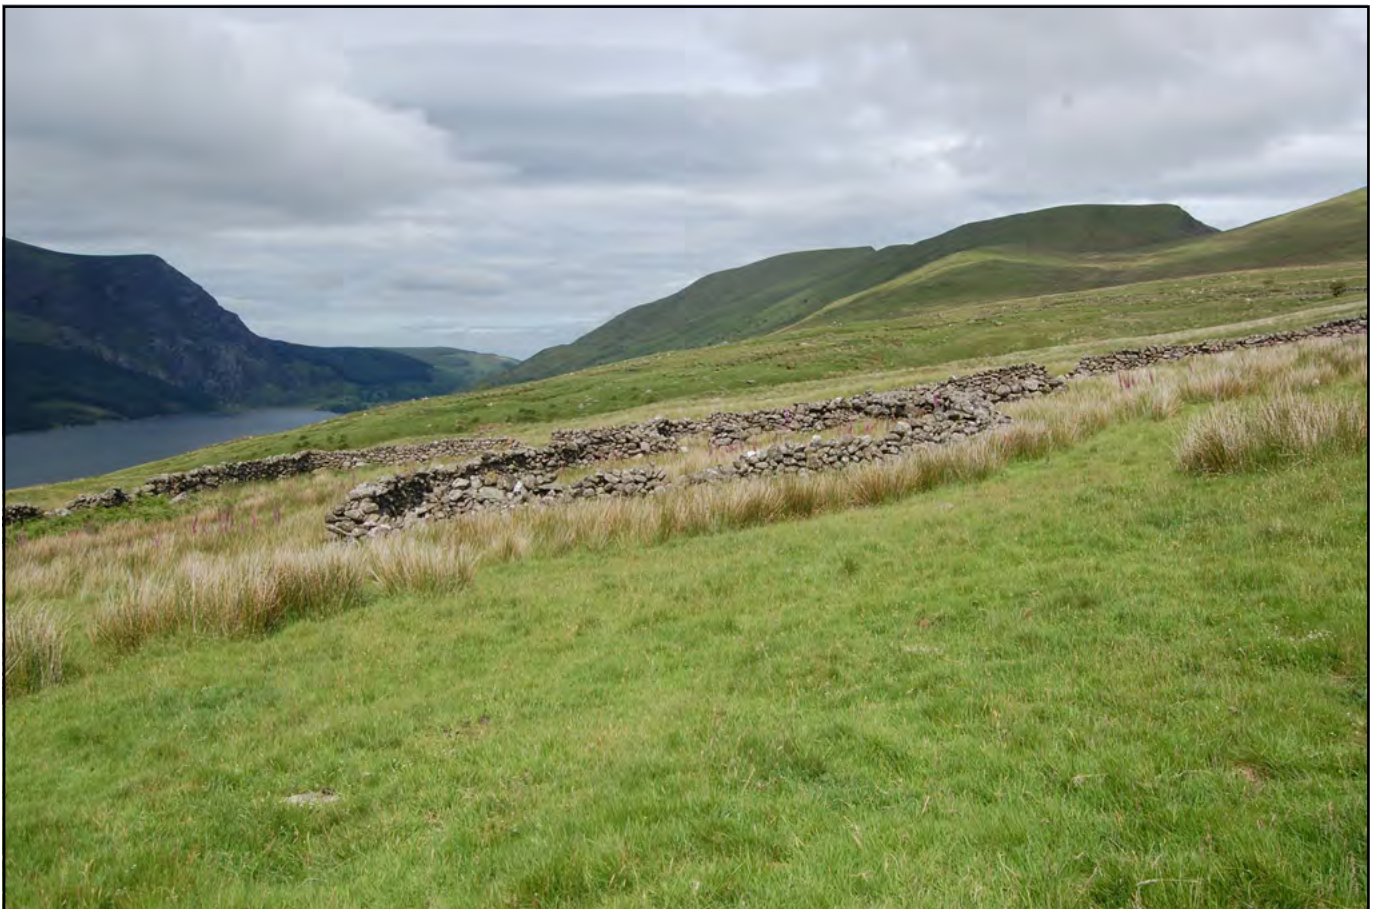
Plate 14: Site 10: View Northwest of Internal Enclosures

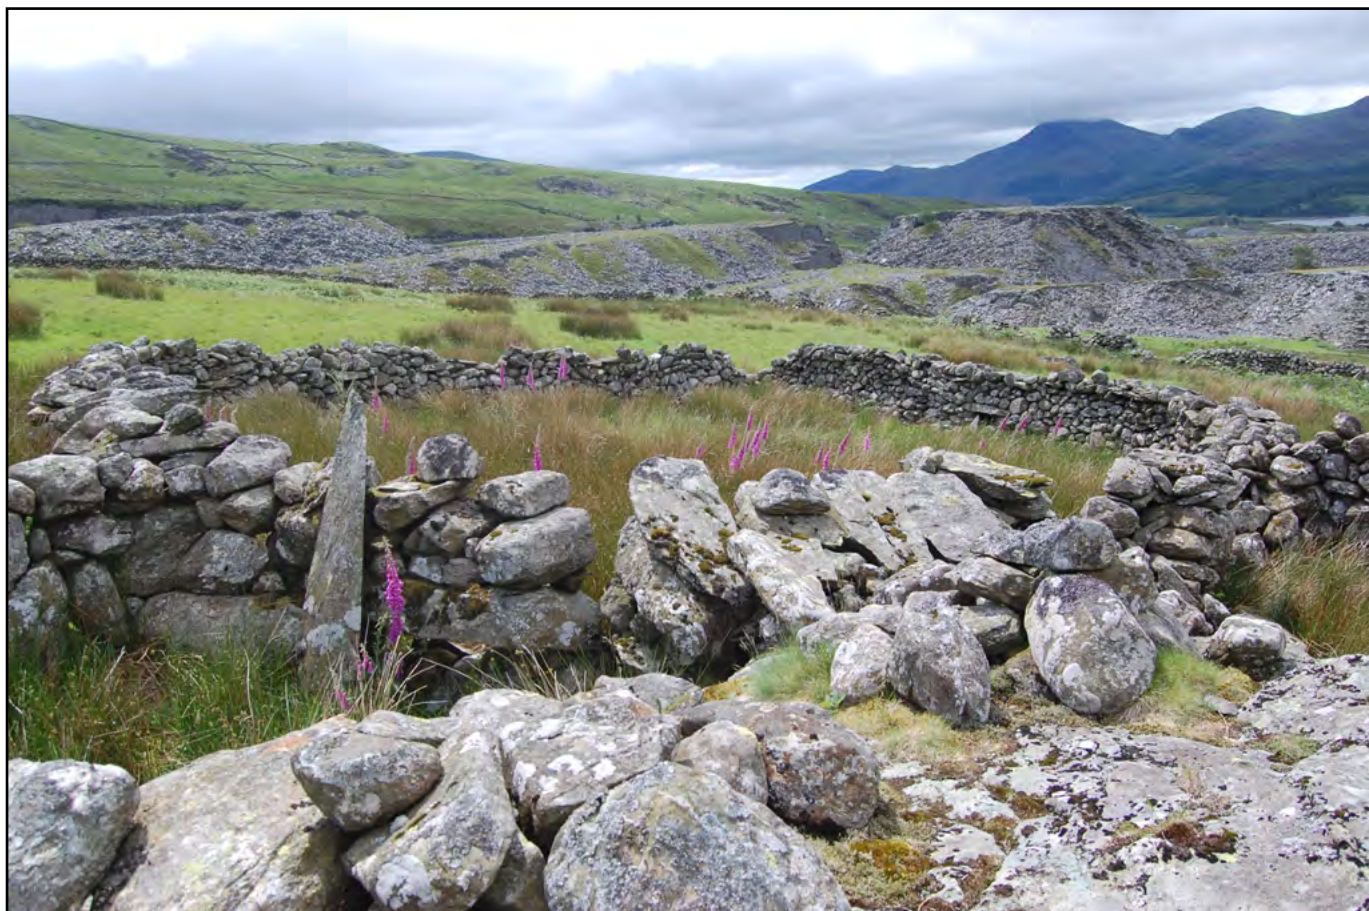
- Internal enclosure A: 5.0m x 3.0m, oval-shaped. Entrance may have been through internal enclosure B. As with B, the enclosure utilised a natural boulder as part of the structure (Plate 16).
- Internal enclosure B: 5.0 x 6.0m, oval shaped. Wall height is a maximum of 1.10m and width of 0.80m. The 0.50m wide entrance is at the southwestern end. The structure utilises a natural boulder as part of the structure and is interlinked with internal enclosure A (Plate 16).
- Internal enclosure C: 10.0 x 10.0m, oval-shaped. Wall height is a maximum of 1.10m and width of 0.80m. The enclosure is accessed from B, to which it is linked. A separate entrance is located at the southern end of the enclosure.

Plate 16: Site 10: Detail of Internal Enclosure. Note use of natural boulder in foreground

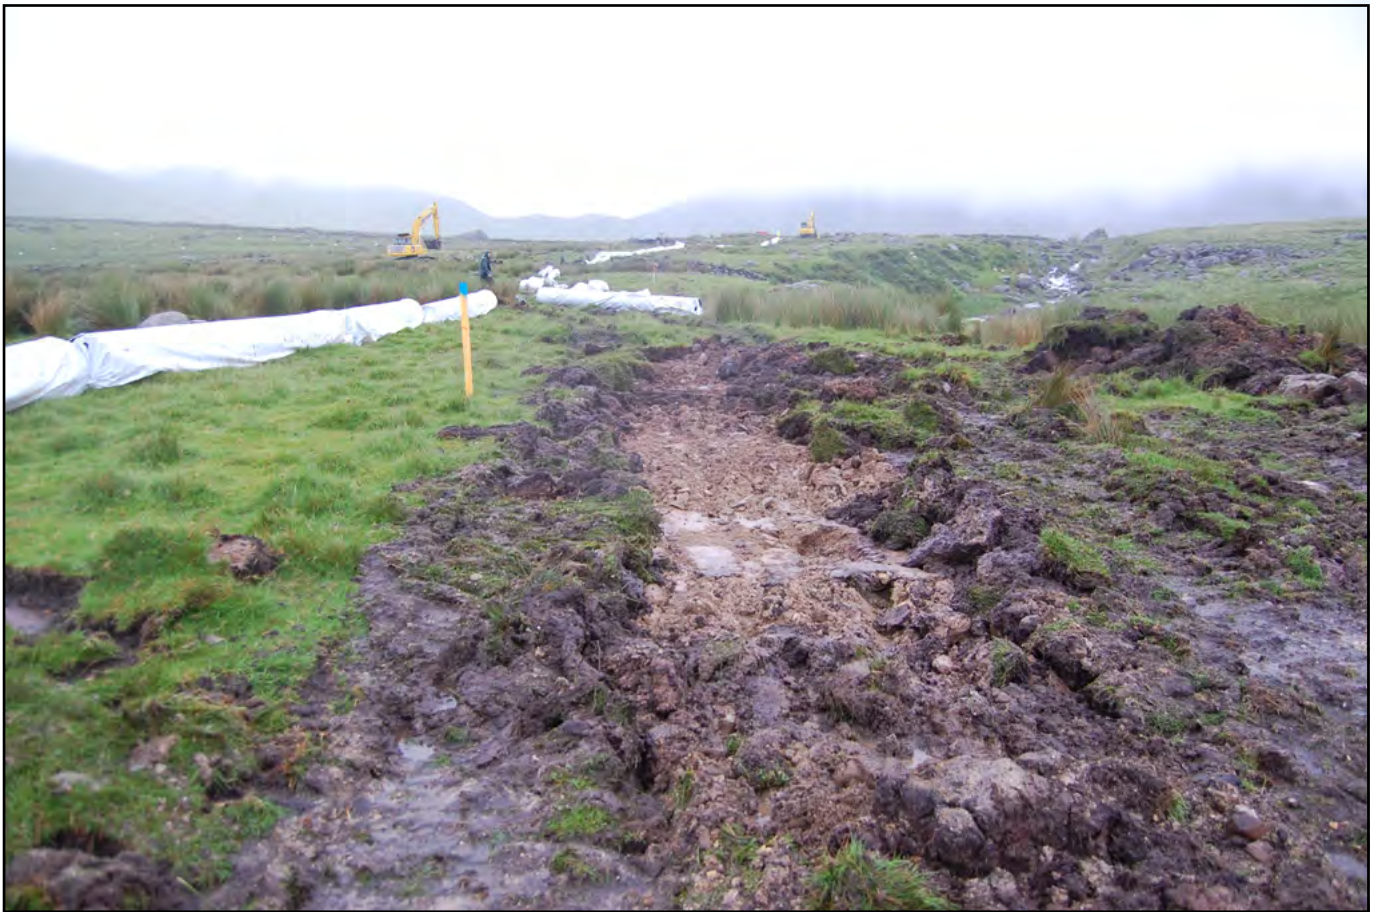
A possible rectangular structure comprising low grassed over stony banks <0.20m high, forming a sub-rectangular plan, 7.0m x 4.50m in size with a northeast to southwest orientation. GAT Report 364 also described internal facing with an uneven hollowed interior, with traces of a track skirting the south side of the feature. The general area is stony and is perennially waterlogged. The site is not recorded on any available maps but was thought to be the remains of a medieval structure (GAT Report 364: 8). An inspection of the area for the current report did not identify these features except for a possible stony bank to the south of the pipeline route. It appeared the area had become overgrown in the interim. A photographic record was maintained of the area during the works (Plate 17). No further features were forthcoming.

Plate 17: Site 12: Location of Site during Works.

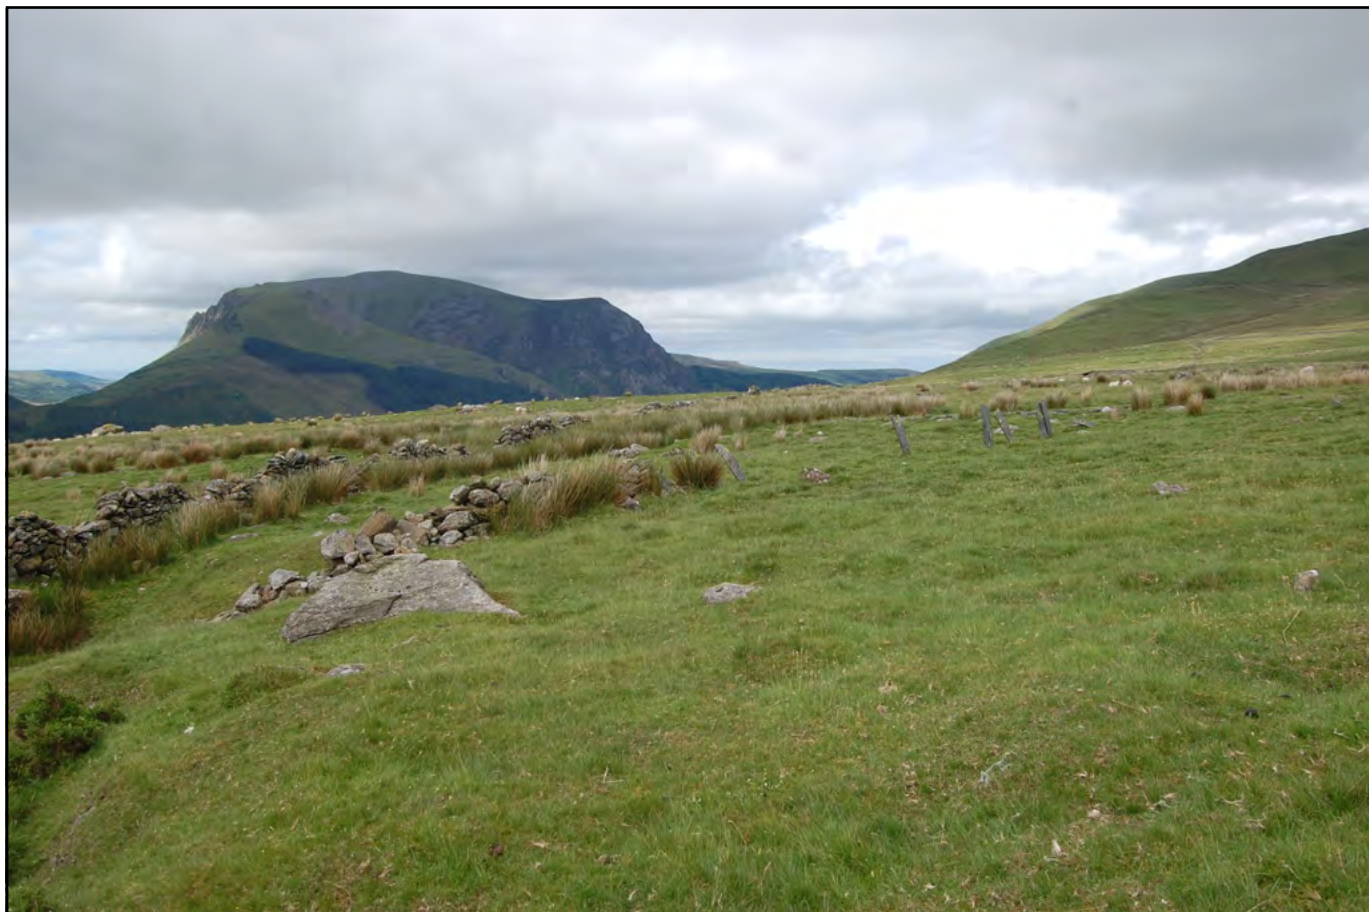
Located at the base of a steep slope on the west bank of Afon Treweunydd and incorporated with a field boundary wall which forms part of the south side. A funnelled droveway, comprised of slate and wire fence on the north side (Plate 19), leads to a counterscarp revetted, sub-circular sheepfold, divided into three compartments by slate pallisade walls (Plate 18). The feature covers a length of c.50.0m from the river to a metalled trackway (Plate 20). In common with Feature 18, there is an opening at the river edge facing an abutment – probably for a slate or wooden bridge – on the opposite bank. The site is marked on both the 1888 and 1915 Ordnance Survey maps as a sheepfold. The slate and wire fence was in a state of disrepair.

Plate 19: Site 13: View west detailing slate and wire fence/droeway

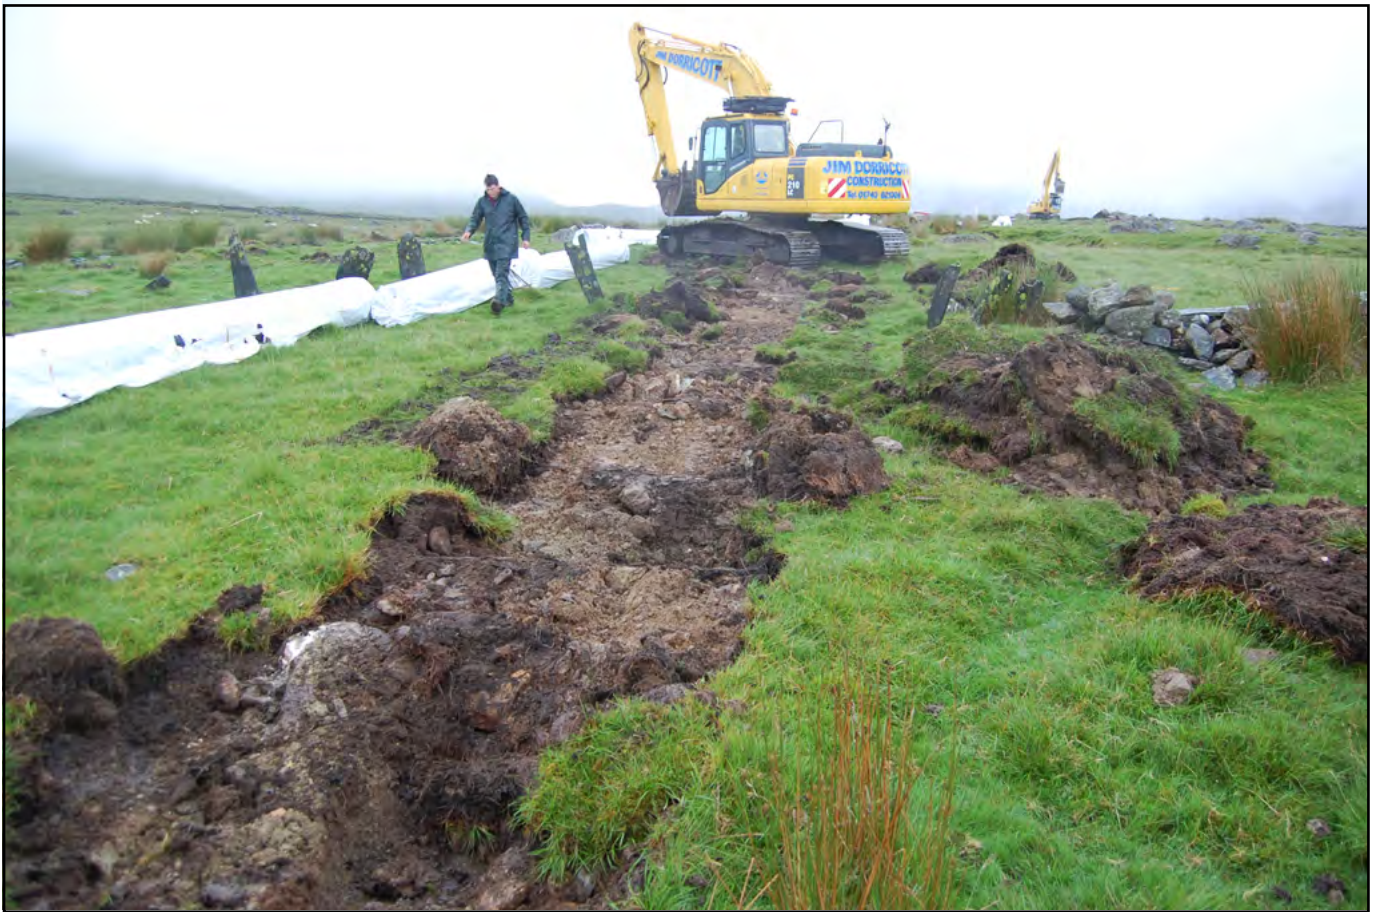
The slate and wire fence was “breached” during the excavation of the pipeline trench (Plate 21). No underlying features were identified however.

Site 13 (Sheepfold and Driveway), the pipeline breached a slate and wire fence associated with the sheepfold (Plate 21). The fence was in a state of disrepair prior to works. No underlying features were identified. A photographic record was maintained.

Plate 21: Site 13: View southwest during works

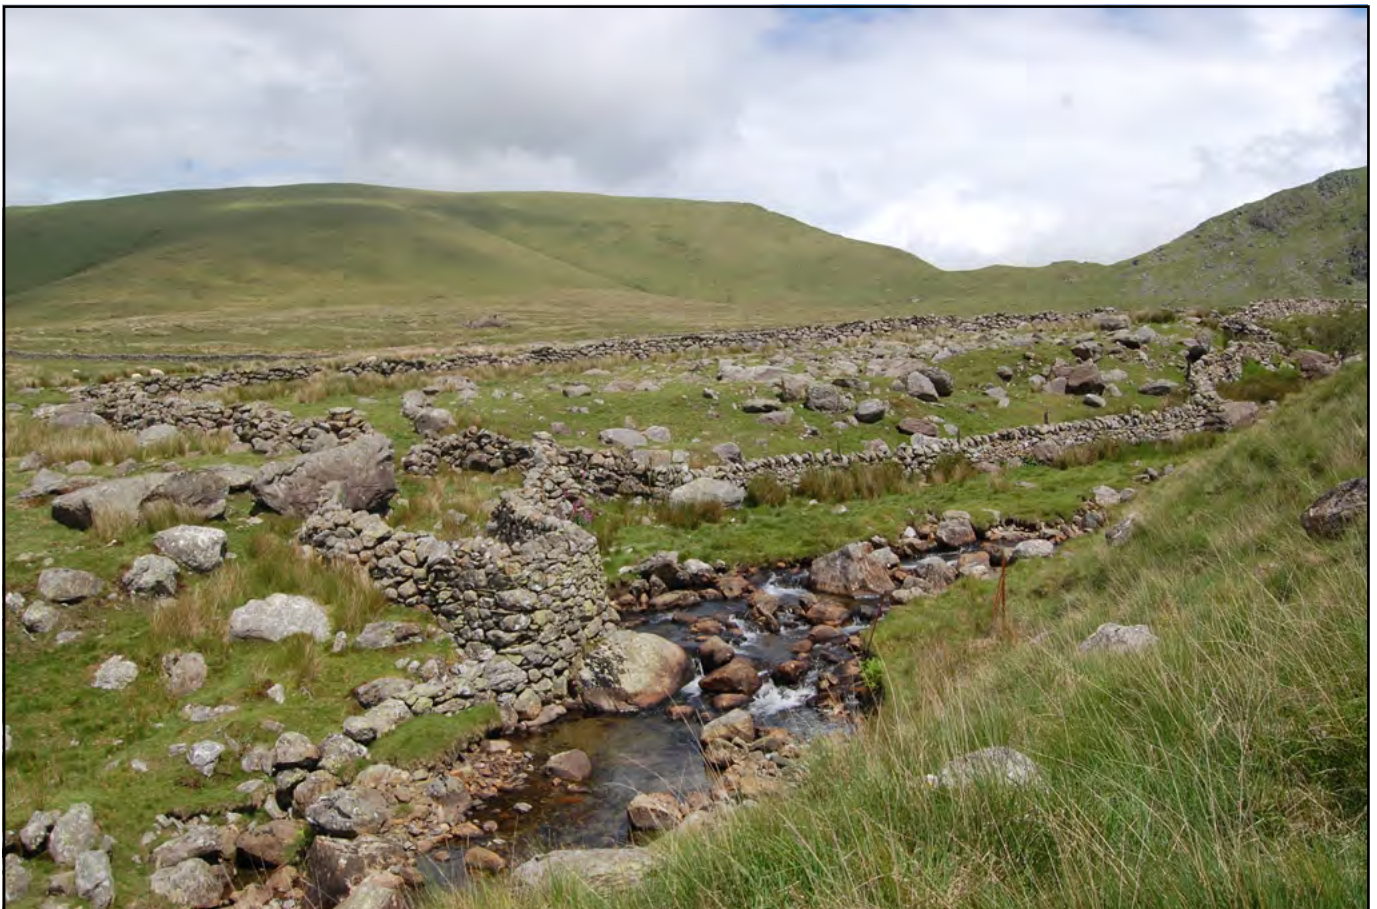
A large sub-oval enclosure, 75.0m x 30.0m in size, situated along the sloping west bank of the river, which incorporated a smaller sorting/lambing pen (SH58425468) at the southwest corner (Plate 22). The smaller single compartment, 20.0 x 10.0m, is accessed via a driveway, defined by a line of boulders, that segregates the west end of the main enclosure from the larger eastern side. Built of drystone construction and incorporating a number of large erratic boulders, the walls stand to over to c.1.50m high on average. Outside the main enclosure to the west are traces of a number of small terraced platforms, which form the riverbank at this location. This site is recorded on both the 1888 and 1915 Ordnance Survey Maps.

Plate 22: Site 14: View northeast of enclosure/sheepfold. Afon Treweunydd is in foreground
