Afon Trweunydd Hydro-Power Scheme

Archaeological Record and Watching Brief 2007

Report No. 693

Prepared for Shawater Limited

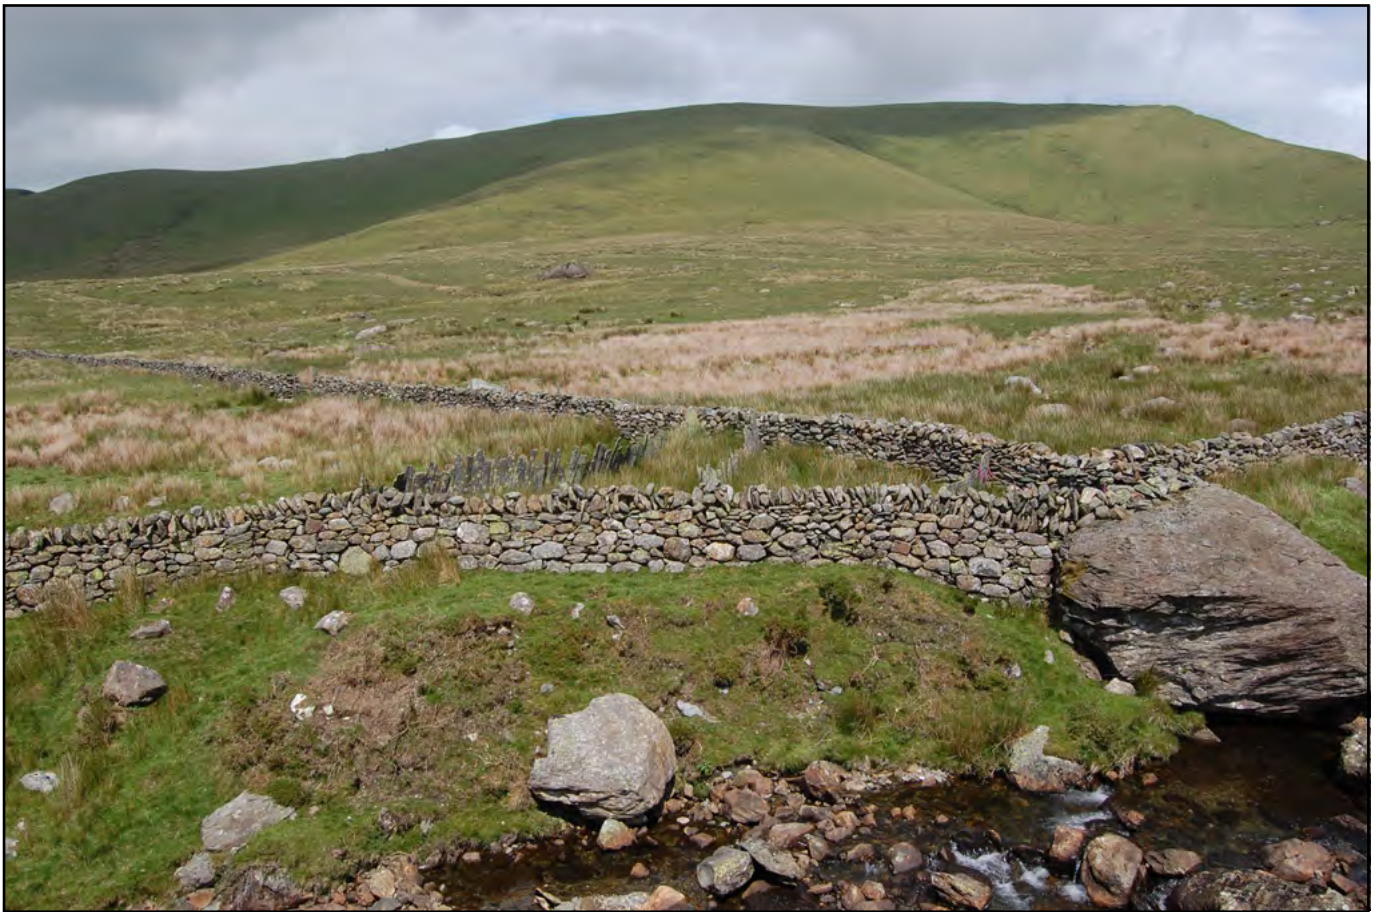
A small sheepfold formed from the apex of boundary walls and slate and wire fencing, comprising two compartments. A large glacial boulder was utilised towards the south end of the riverbank facing elevation (Plate 23). The site is located c.20.0m east of Site 14 and is marked both on the 1888 and 1915 Ordnance Survey Maps as a “sheepfold”.

Plate 23: Site 15: View north of sheepfold with slate pallisades. Note use of large natural boulder. Afon Treweunydd is in foreground

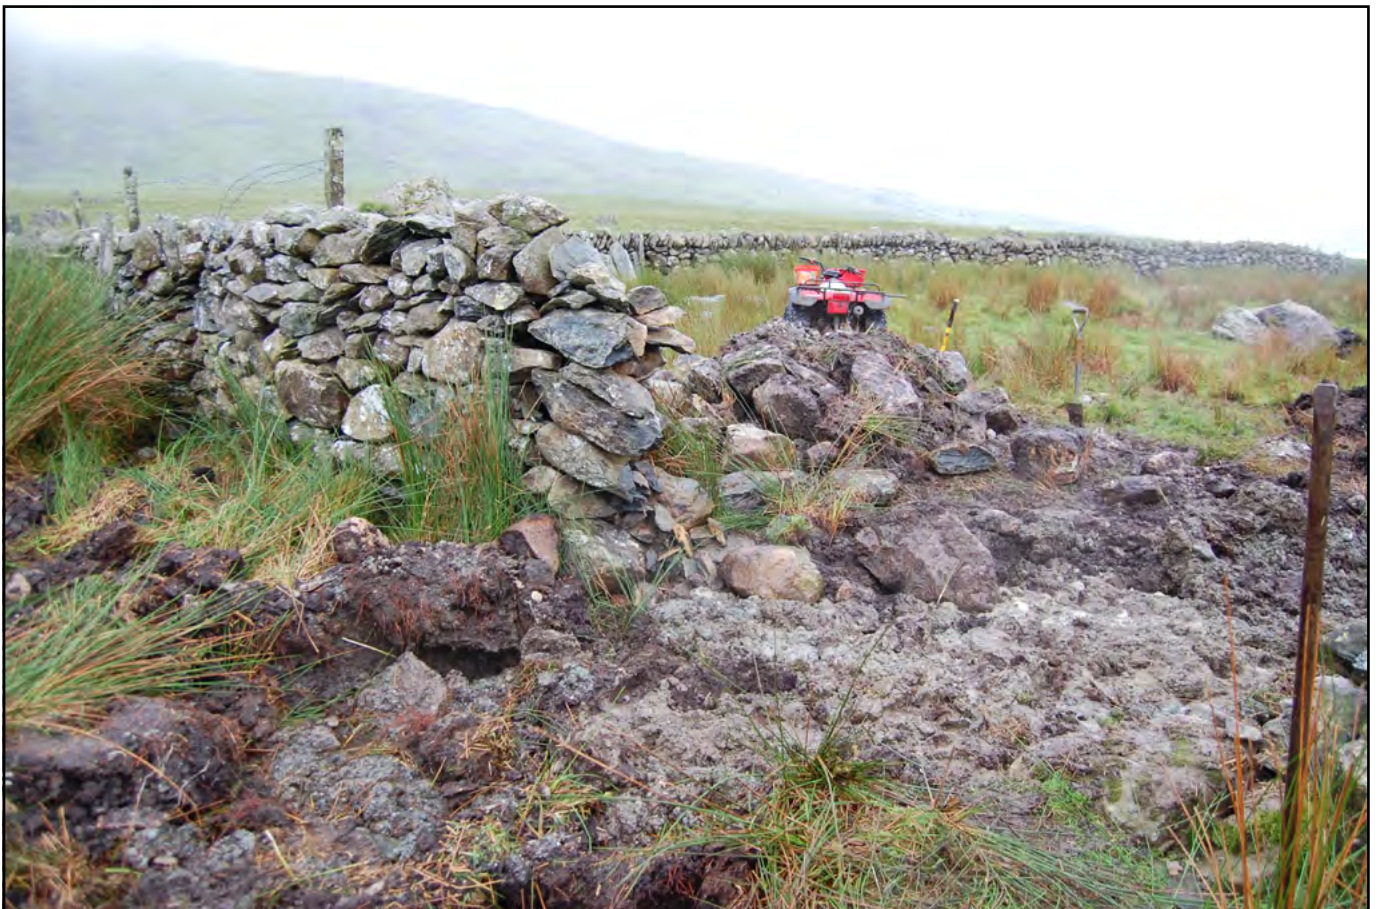
The pipeline route did not affect the site. A drystone wall several metres to the north was breached (Plate 24).

Plate 24: Watching Brief: Drystone wall breach near Site 15

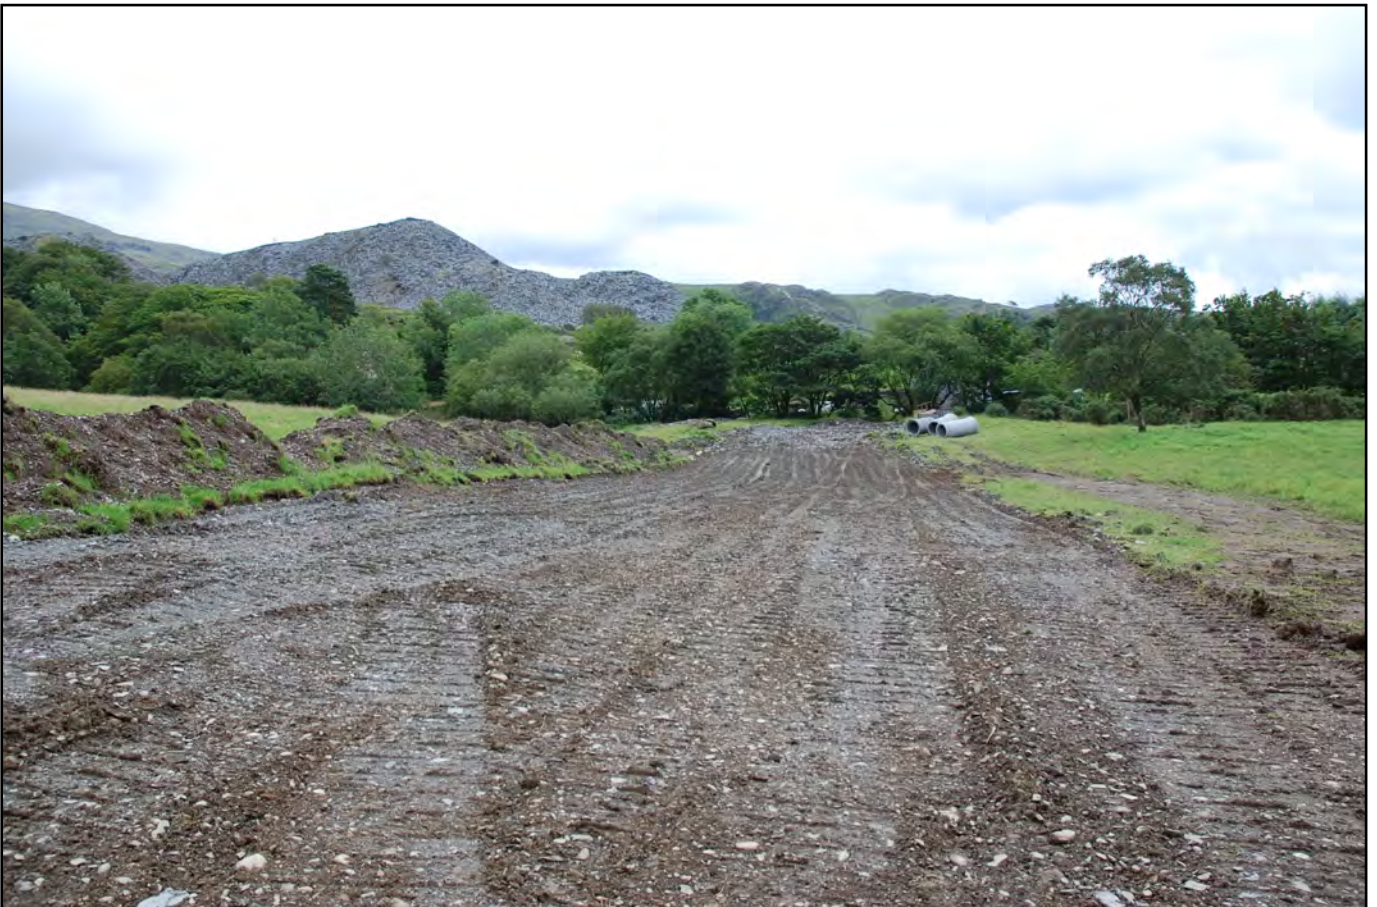
The pipeline route was excavated without an easement as the ground was too waterlogged: short lengths of the route were opened to the width of the machine bucket (1.60m) and the pipe was dropped in and sealed with the upcast material. An easement was used between the outfall from the powerhouse to the Afon Trewenydd, where an area, 10.0m wide and 200.0m long was stripped for the pipeline (Plate 26).

No archaeological features were identified within the confines of the easement: the topsoil was extant to a depth of 0.15m and was followed by a shale-rich subsoil (Plate 26). A photographic record was maintained during the works.

Plate 26: Watching Brief: Easement from powerhouse to Afon Treweunydd
