# Madyn Farm, Amlwch

## Archaeological Record (Level I)

GAT Project No. 1969

Report No. 701

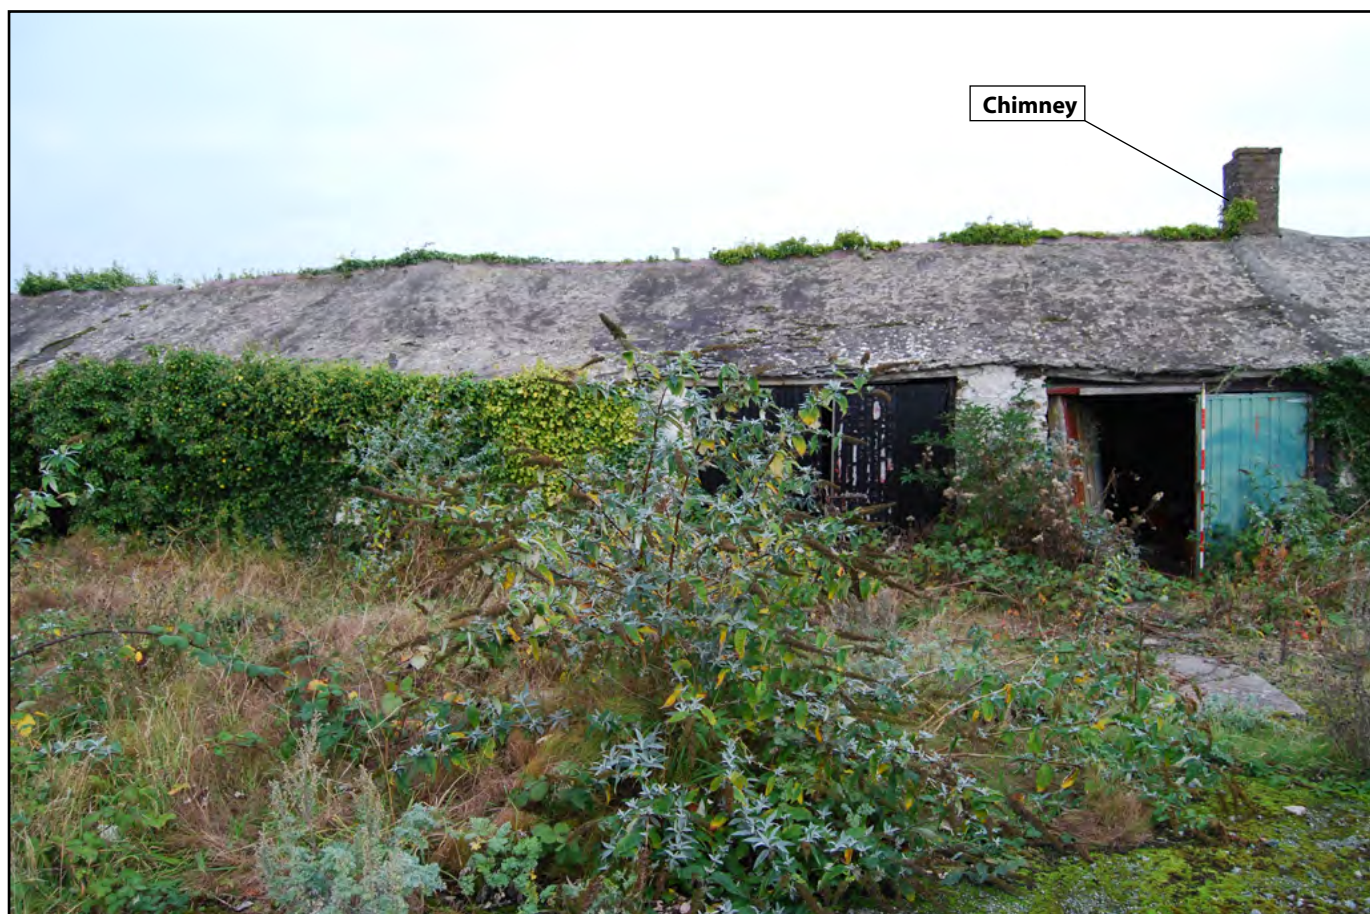
A semi-derelict block, 47.0m long and 6.0m wide, formed by several low-lying buildings (Figure 1; Plates 1 and 2). The gable ends stand at 3.70m above ground level; the long elevations stand at 2.10m above ground level. There are three visible entrances on the southeast facing elevation: two are double-

door constructions, 2.0m high and 2.5m wide, with modern corrugated iron and wood doors (Plate 1). The other entrance is partly disguised by overgrowth, but measures 2.0m high and 0.90m wide (Plate 2). The remainder of the elevation is covered by overgrowth, making further interpretation difficult. The slate roof is in a state of disrepair and has collapsed in several places. A brick-built chimney protrudes from the centre of the block (Plate 1).

**Plate 1: Southeast facing elevation of Block A: Roof detail, chimney and modern fittings**

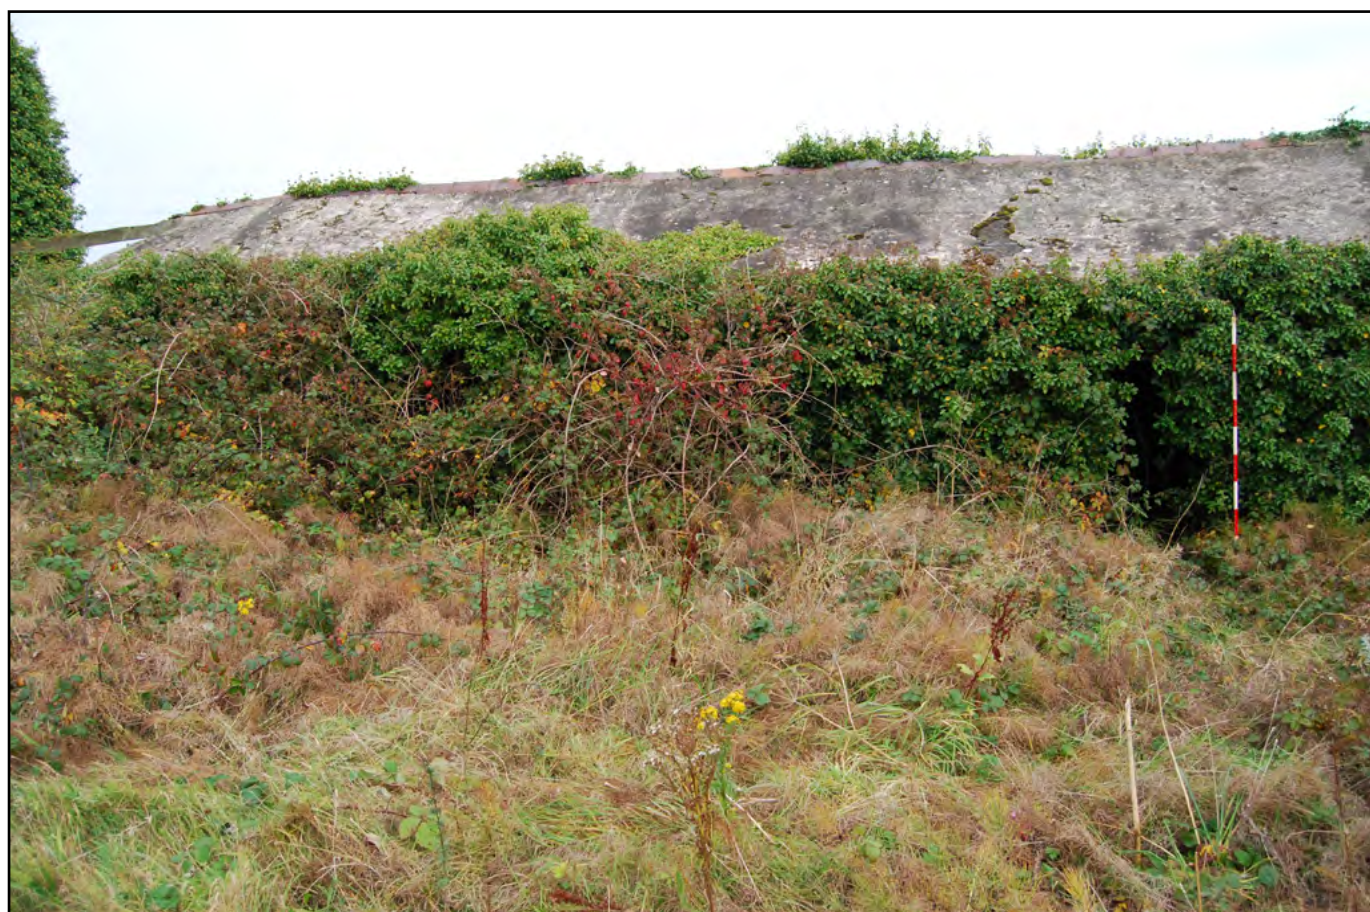
**Plate 2: Southeast facing elevation of Block A: Roof detail, entrance and extent of overgrowth**

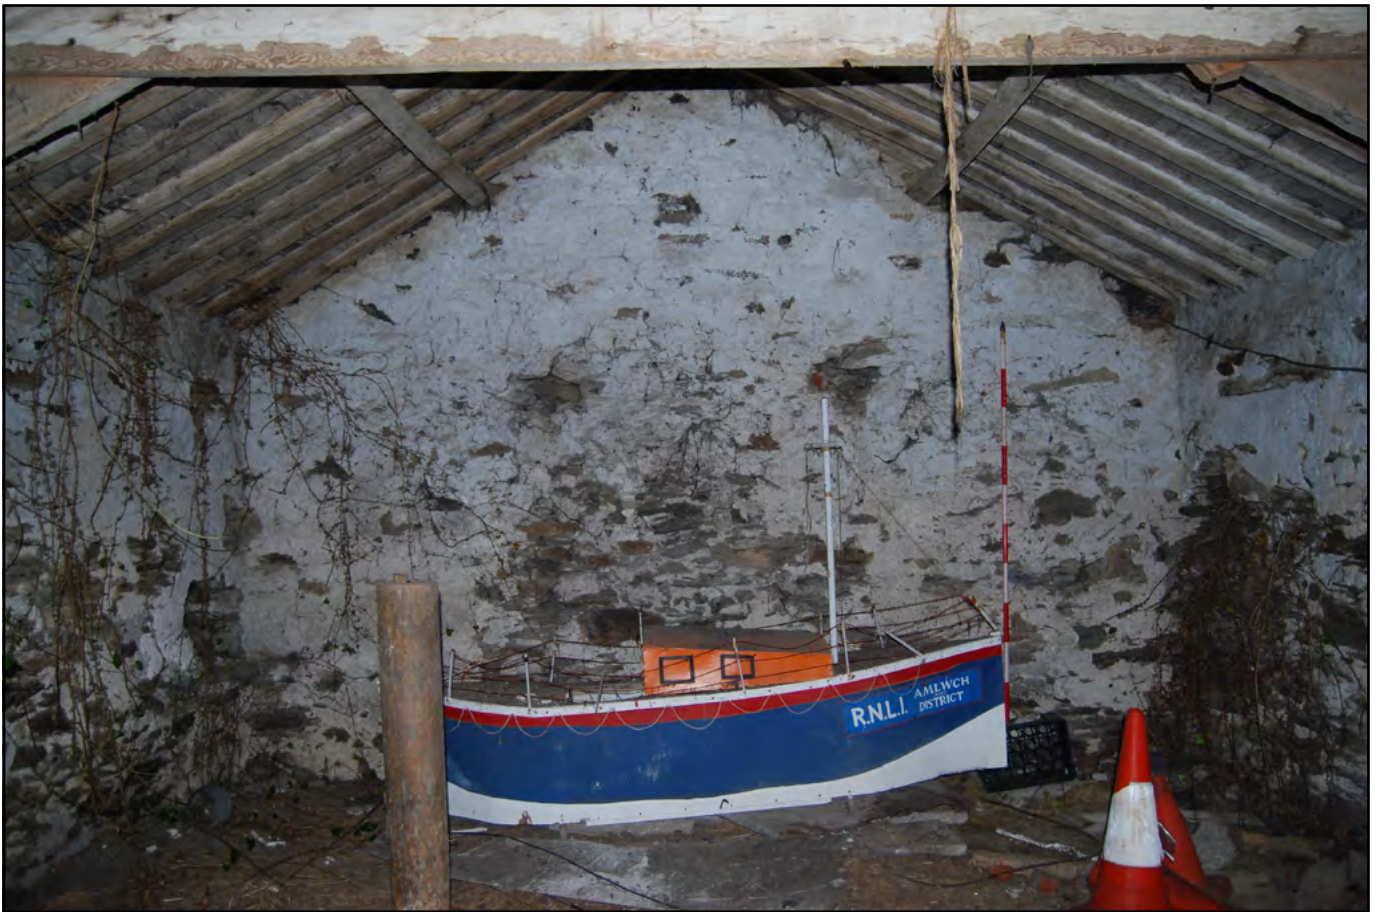
Only limited areas inside the block are accessible due to the derelict nature of the buildings. Access into the two buildings is via the double-door entrances and the single-door building. The latter contains internal elevations of irregular igneous stone, partially covered with whitewash and render. The floor includes quarry tiles and concrete. The roof has a timber frame with (possibly) original and replacement fittings: the rafters appear modern but the collar tie appears to be earlier. There are blocked windows on both long elevations. The only entrance is on the southeast facing elevation. This currently comprises a wooden door on a wooden frame. There are no visible entrance points at either gable end. A 1.50m high wooden post is set into the ground (Plate 3); its function is unknown. The room contains household debris.

**Plate 3: Southwest facing internal elevation of Block A building: detailing wall and roof construction and current use**

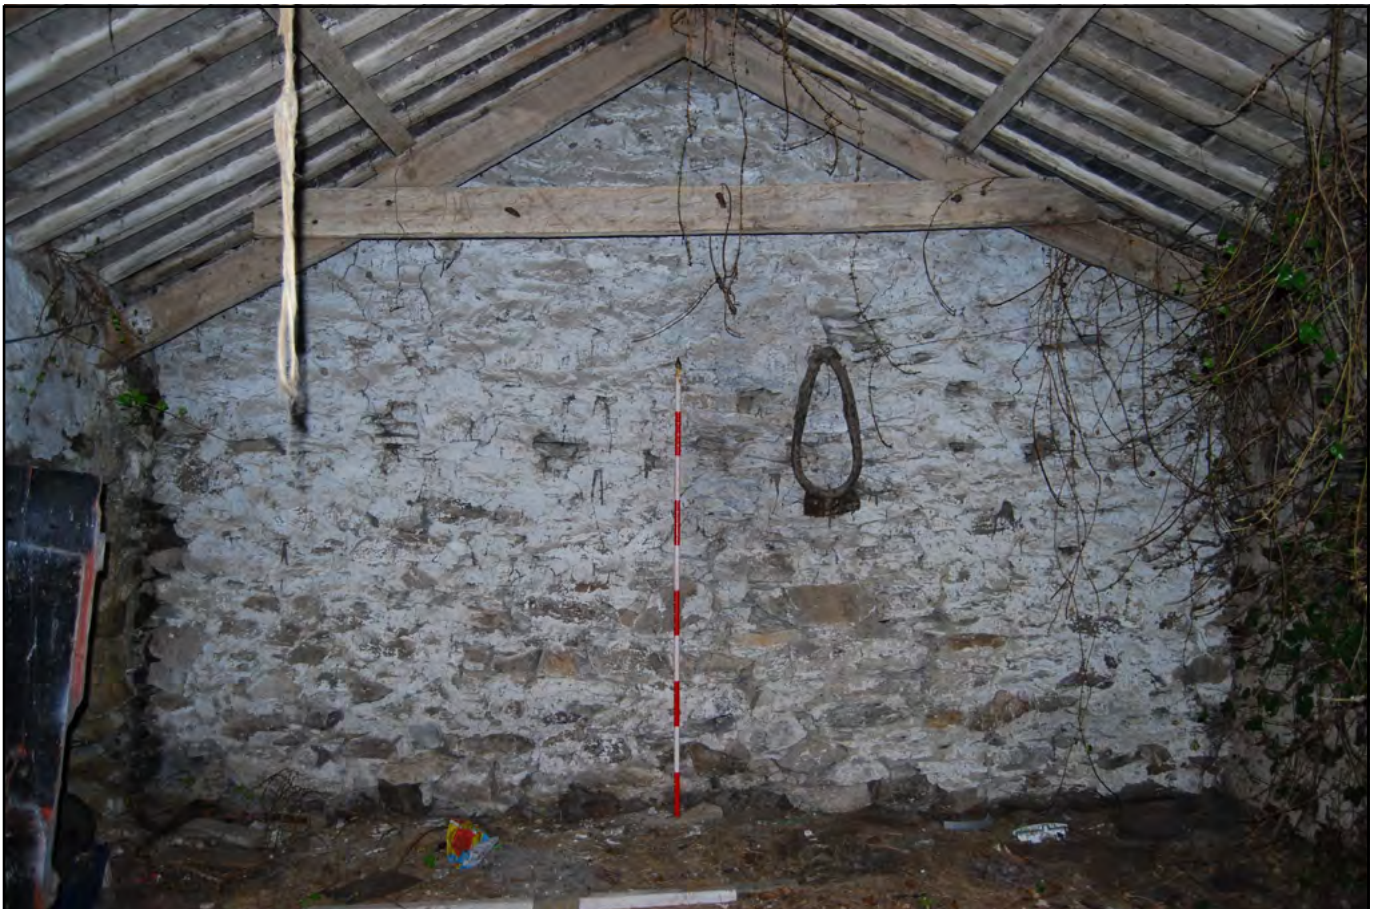
**Plate 4: Northeast facing internal elevation of Block A building: detailing wall and roof construction and current use**

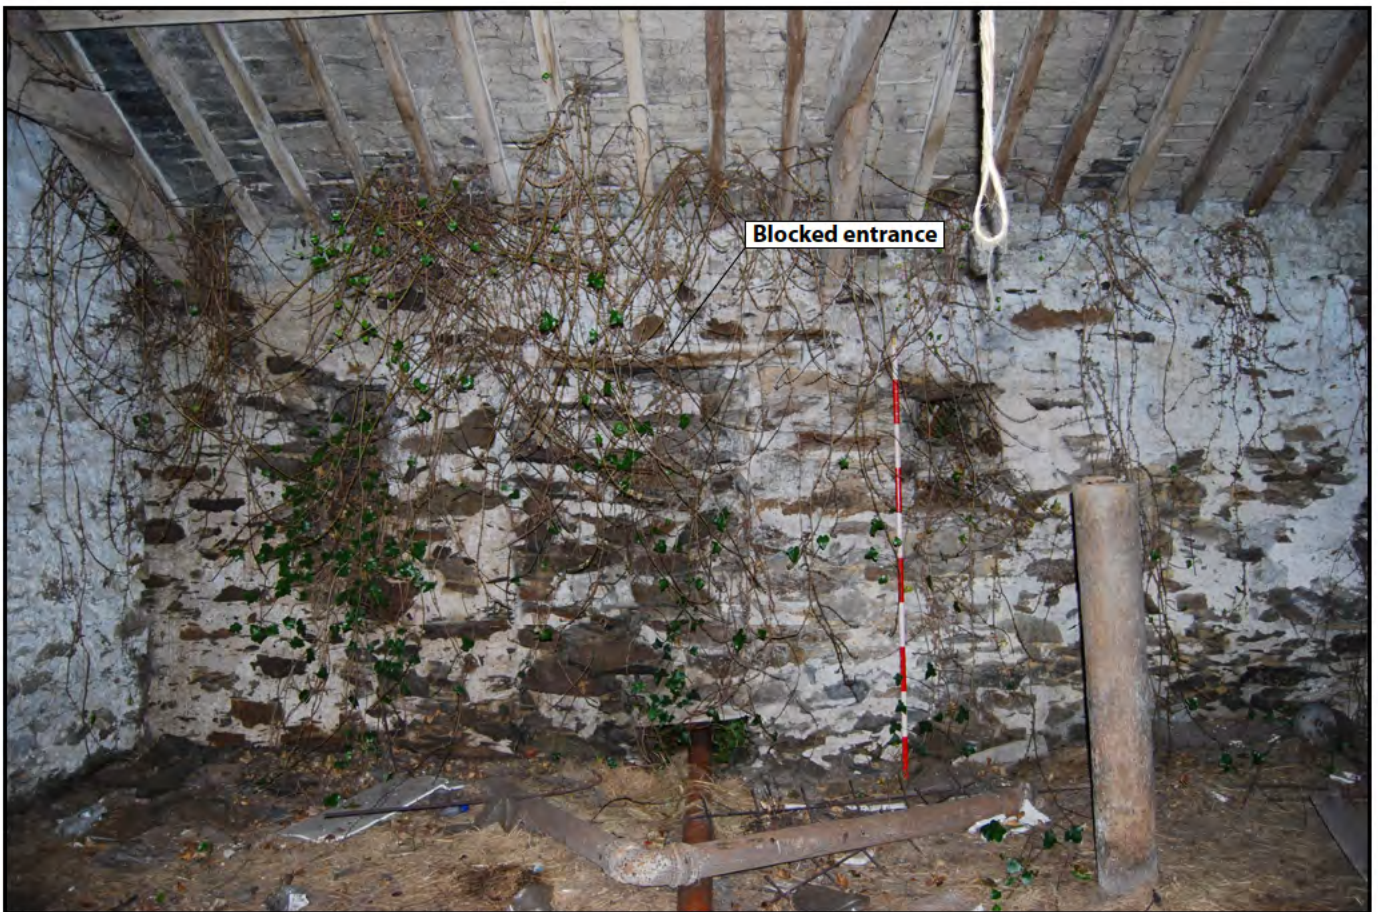
**Plate 5: Southeast facing internal elevation of Block A building: detailing wall and roof construction and current use. Note the blocked entrance and apertures either side.**

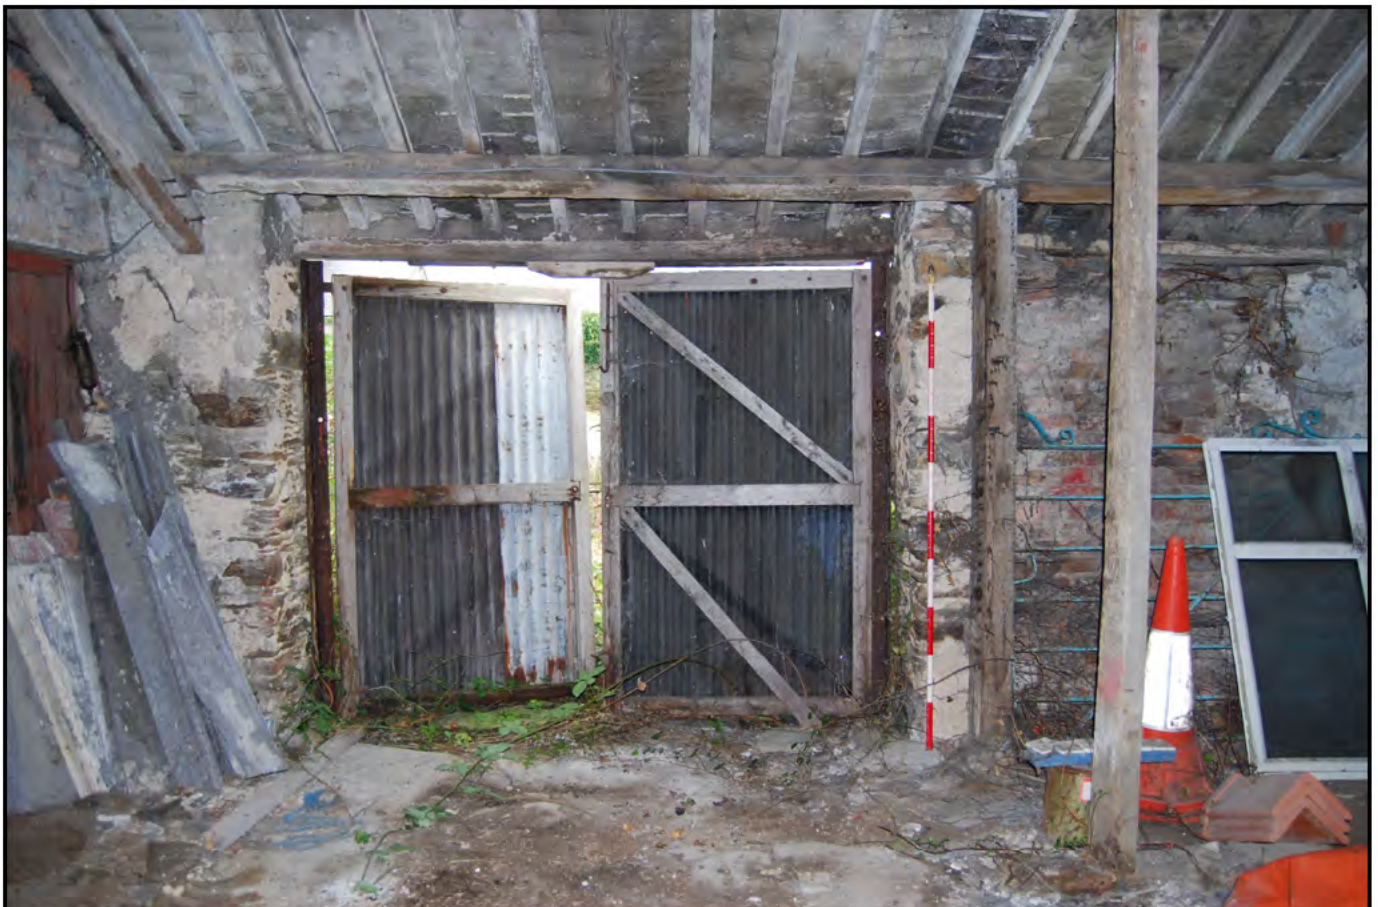
**Plate 6: Northwest facing internal elevation of Block A building: detailing wall and roof construction and current use. Note modern door fitting.**

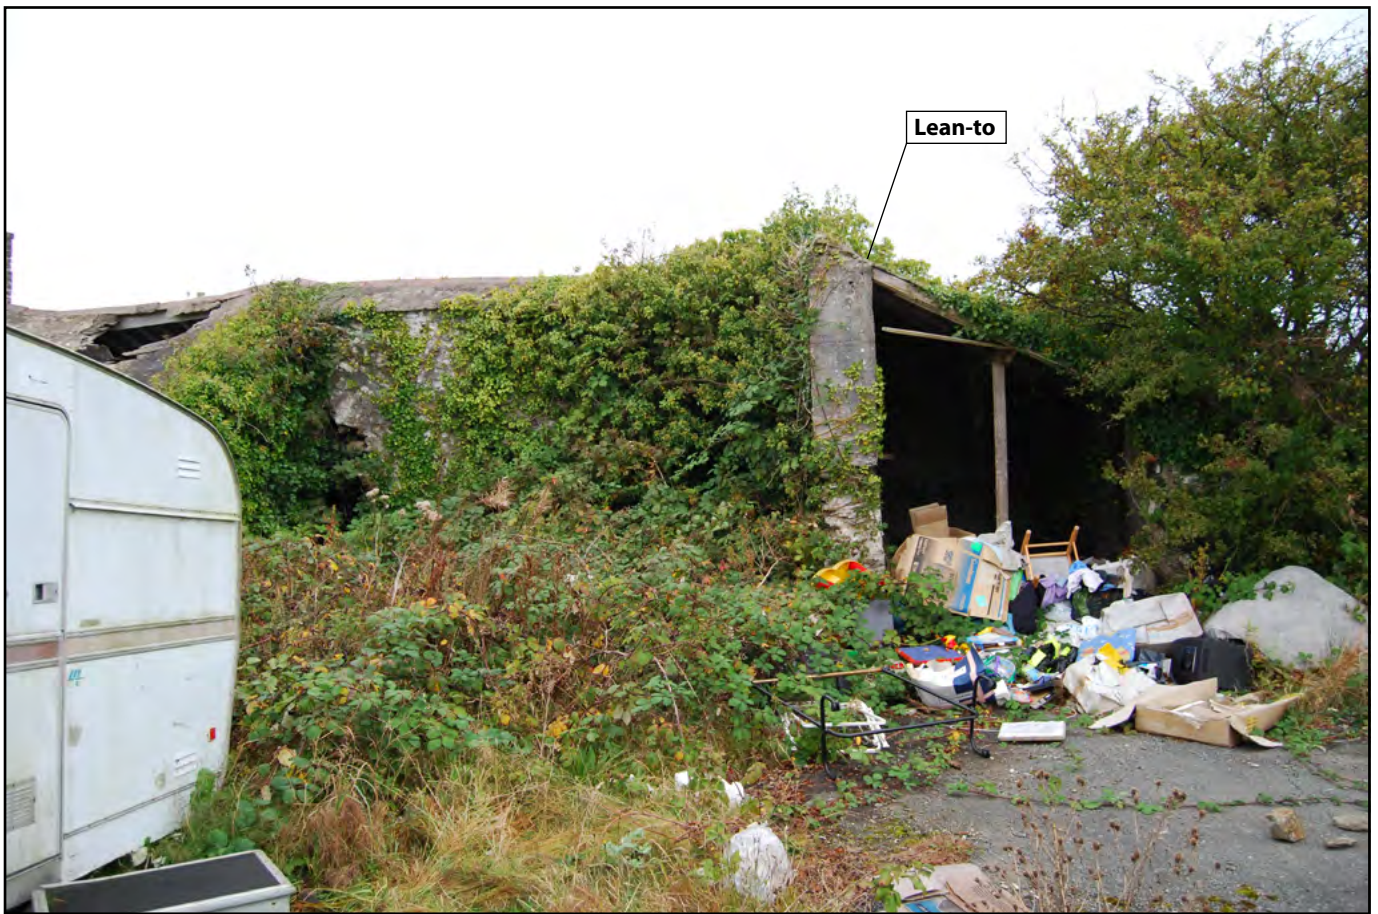
The northeastern most building within the block has collapsed, removing part of the northeast elevation. A brick-built “lean to” is attached to this end and appears twentieth century in construction (Plate 7).

**Plate 7: Southeast facing elevation of Block A: Detailing lean-to construction**

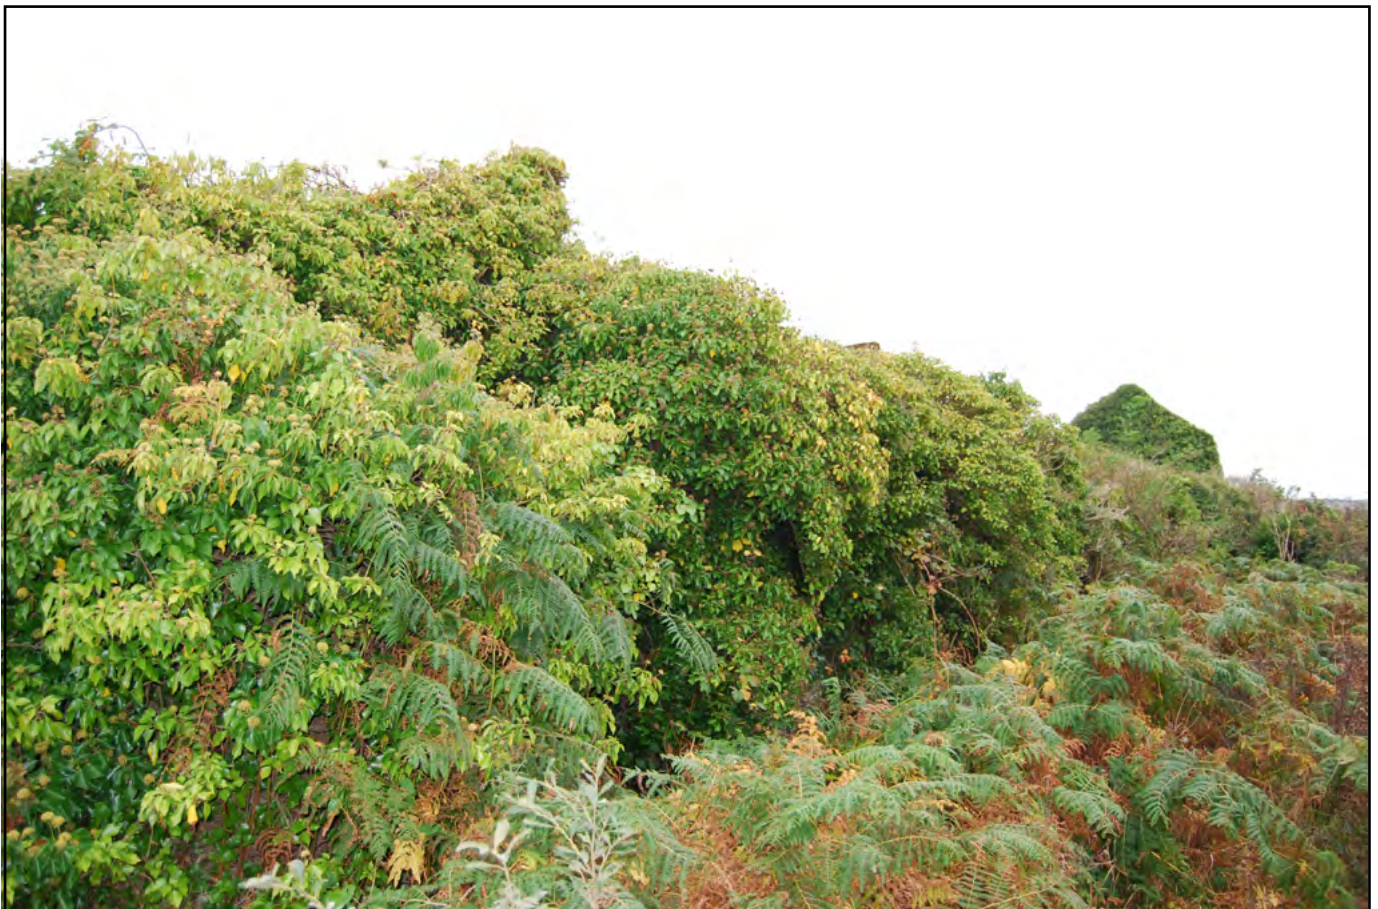
The northwest facing elevation is almost completely covered by overgrowth, with no visible entrances or windows (Plate 8). The elevation, where visible, is constructed from irregular igneous stone, lime mortar bonded, with frequent examples of re-pointing. Attached to this elevation is a small concrete yard, partitioned by wooden stockades attached to metal posts (Plate 9). The materials used are twentieth century in appearance (Plate 10). There is, however, evidence for a structure in this location on the 1<sup>st</sup> to 3<sup>rd</sup> Edition Ordnance Survey Maps (1899 to 1924 respectively; see Figures 3 and 4), suggesting it was replaced by a modern example.

**Plate 8: Northwest facing elevation of Block A: Detailing extent of overgrowth**

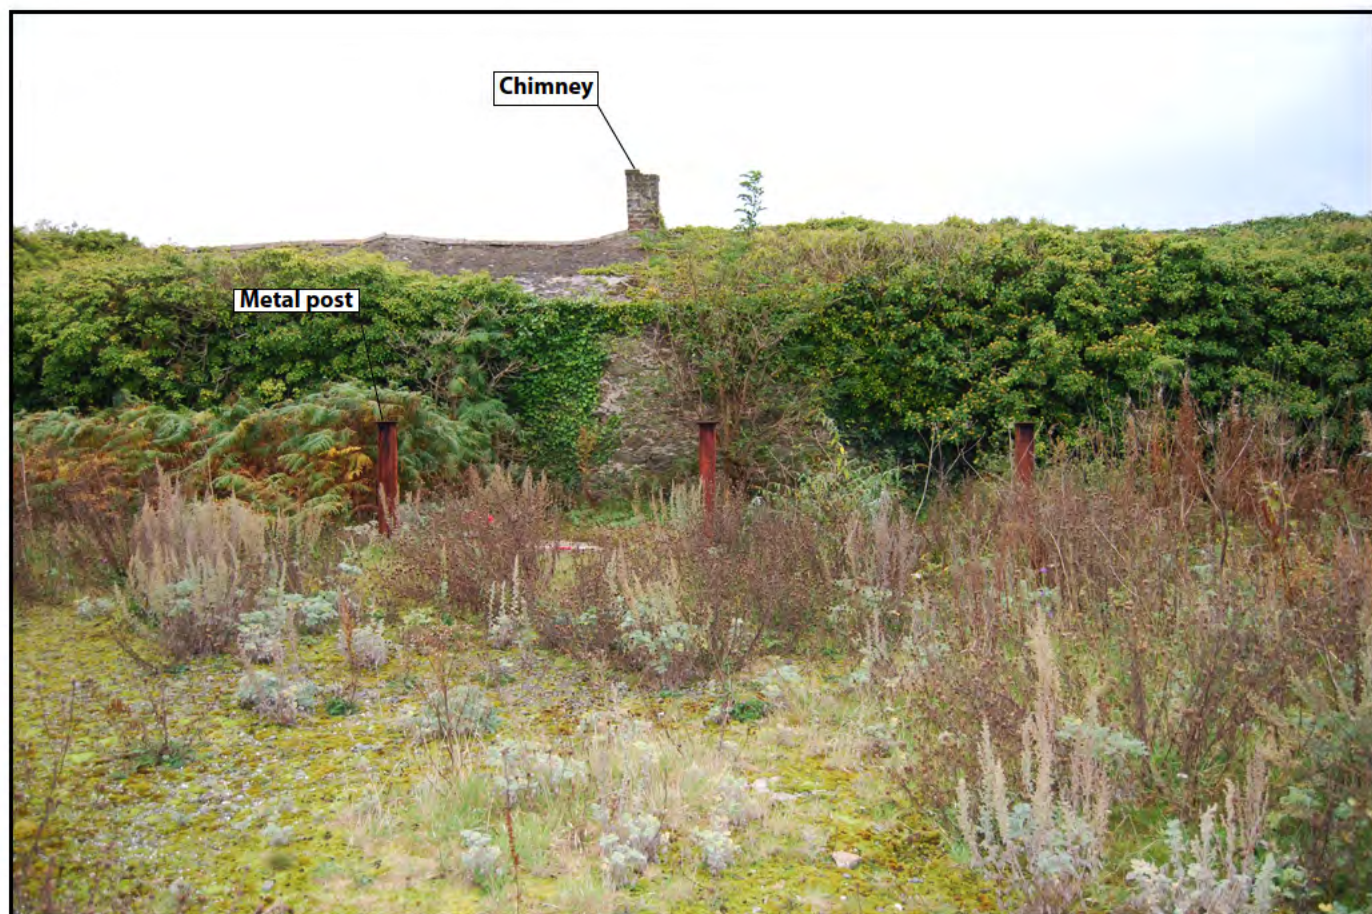
**Plate 9: Northwest facing elevation of Block A: Note chimney and metal posts in foreground**

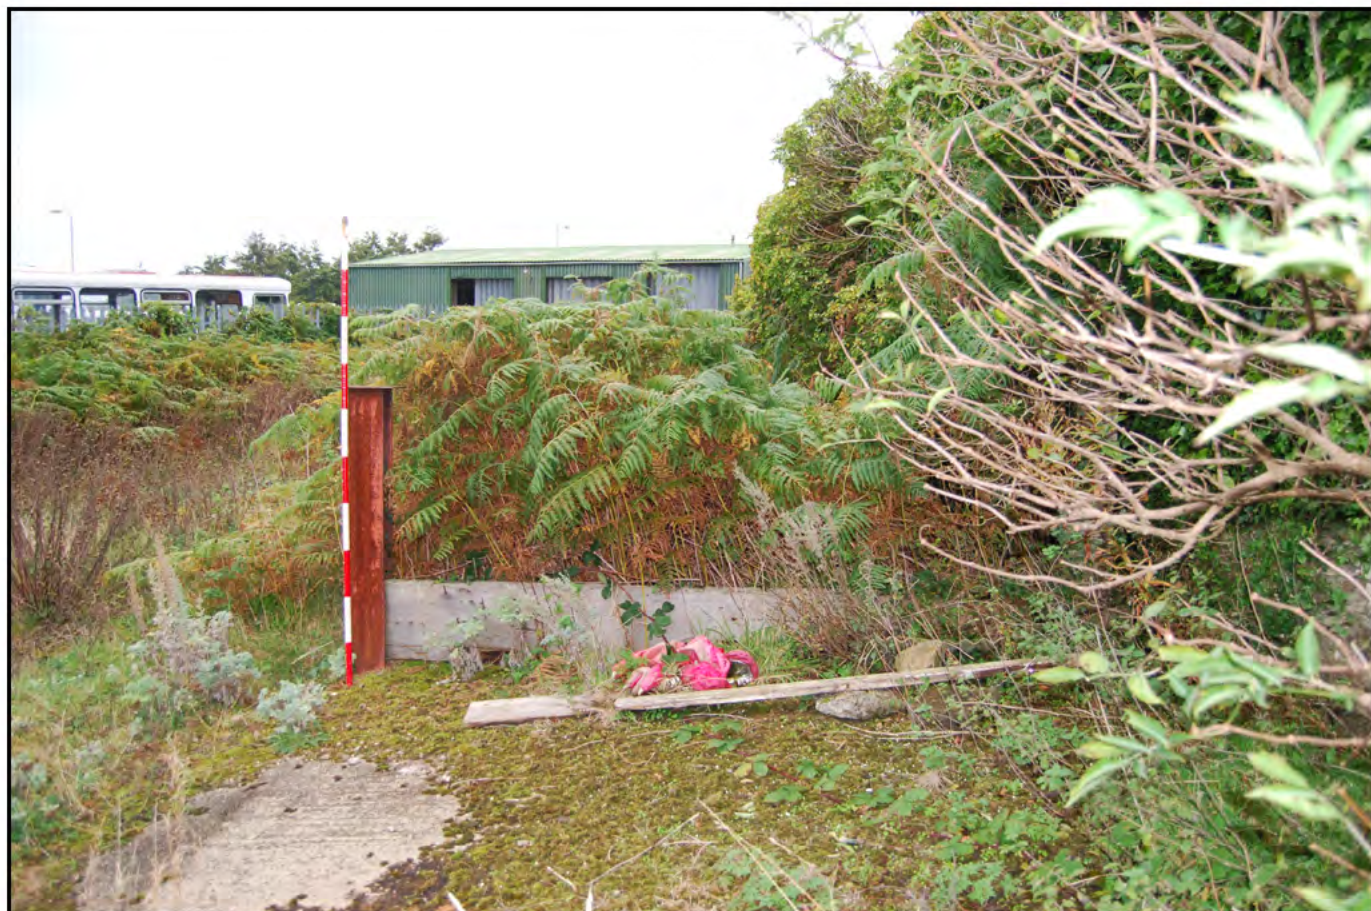
**Plate 10: Detail of twentieth century stockade attached to northwest facing elevation of Block A**

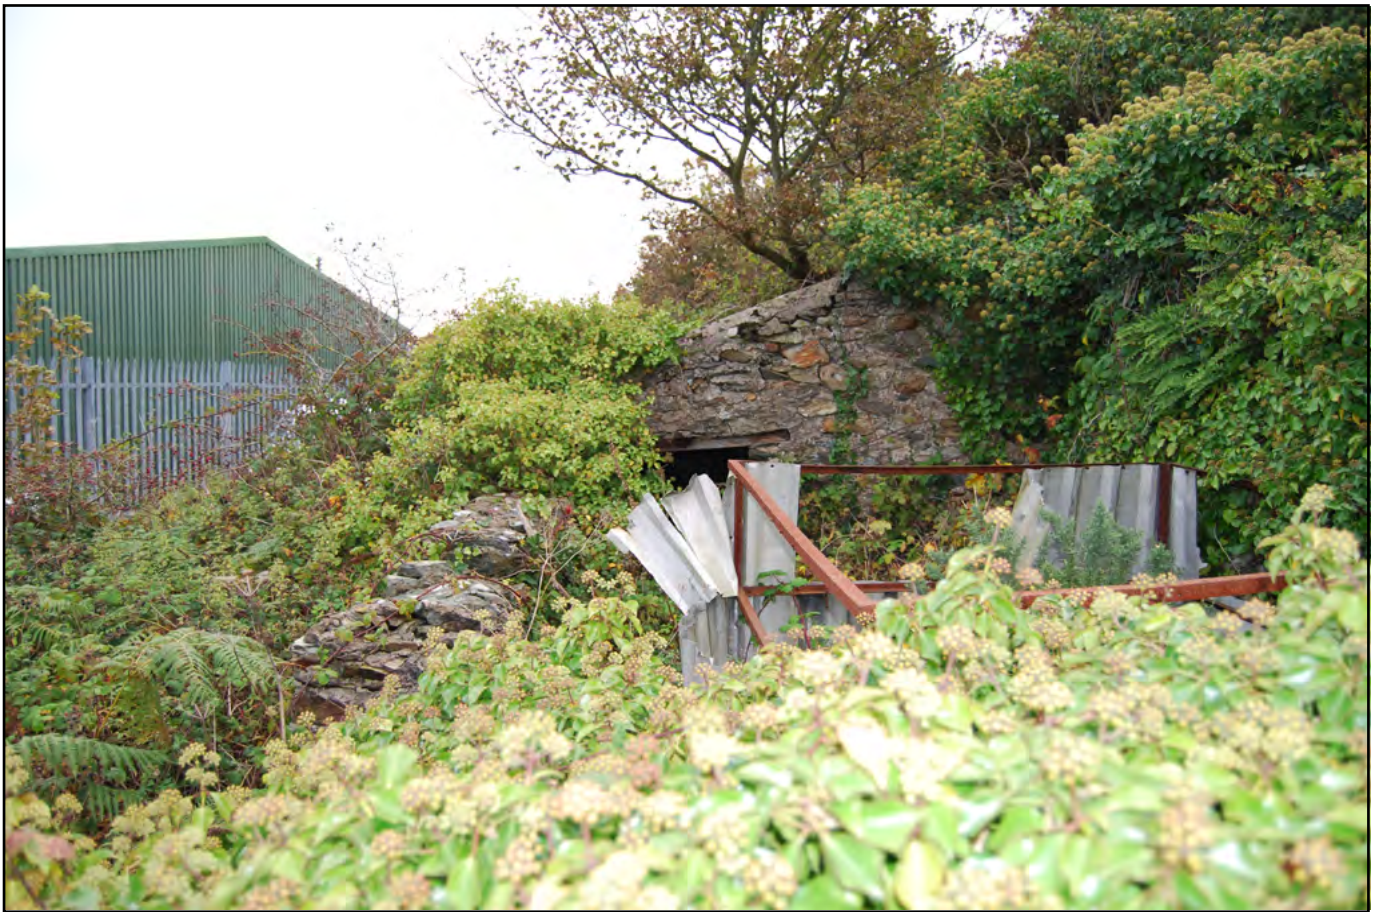
A small detached structure is also visible, c.5.0m to the north of Block A (Plate 11). The structure is built from similar irregular igneous stone, but is extant in an advanced state of decay and overgrowth making any functional interpretation impossible.

**Plate 11: Detached building to the north of Block A detailing state of disrepair**

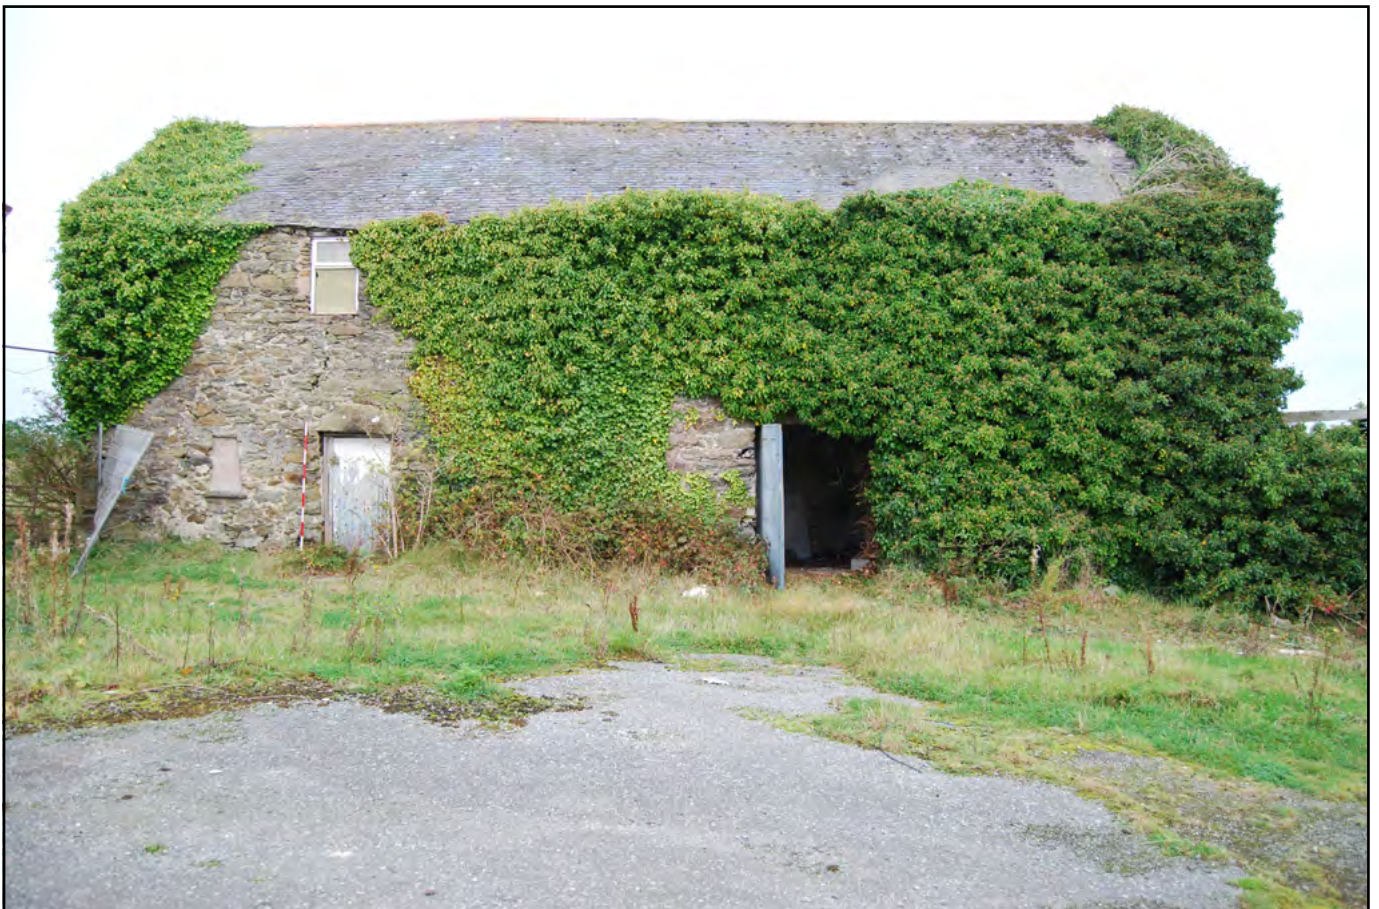
Block B is a two-storey structure, 13.0m long and 6.0m wide (Figure 1; Plate 12). The structure is 6.70m high on the gable end and 4.60m high on the long elevation. The main entrances are on the southeast facing elevation. The majority of the structure, including the gable ends, is covered by overgrowth. The roof is constructed from slate with a timber frame.

**Plate 12: East facing elevation of Block B detailing roof and fixtures. Note extent of overgrowth**

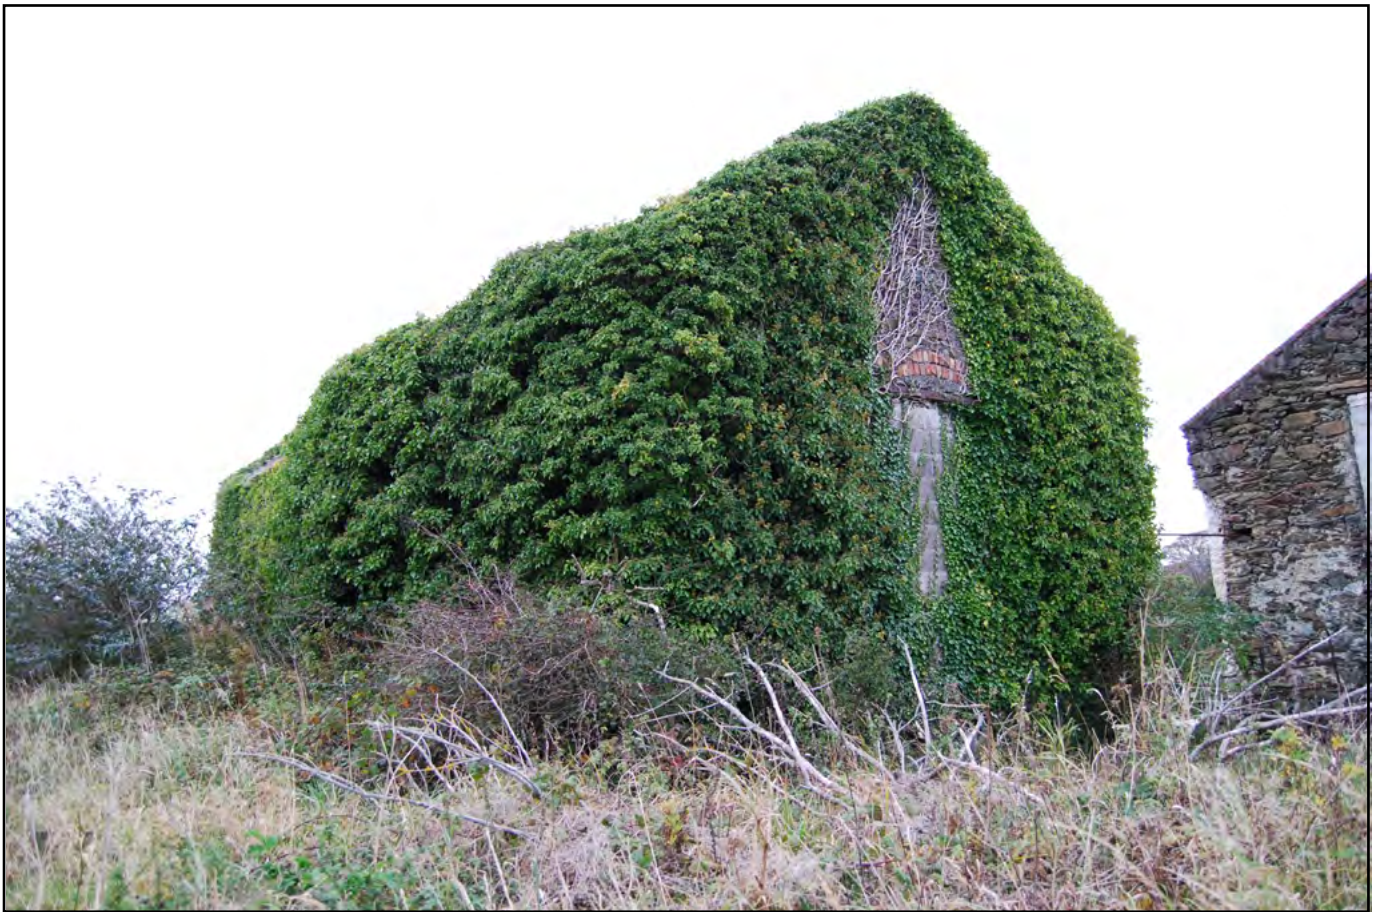
The northwest facing elevation is completely overgrown, with no visible detail (Plate 13).

**Plate 13: Northwest facing elevation and South facing gable end of Block B. Note extent of overgrowth**

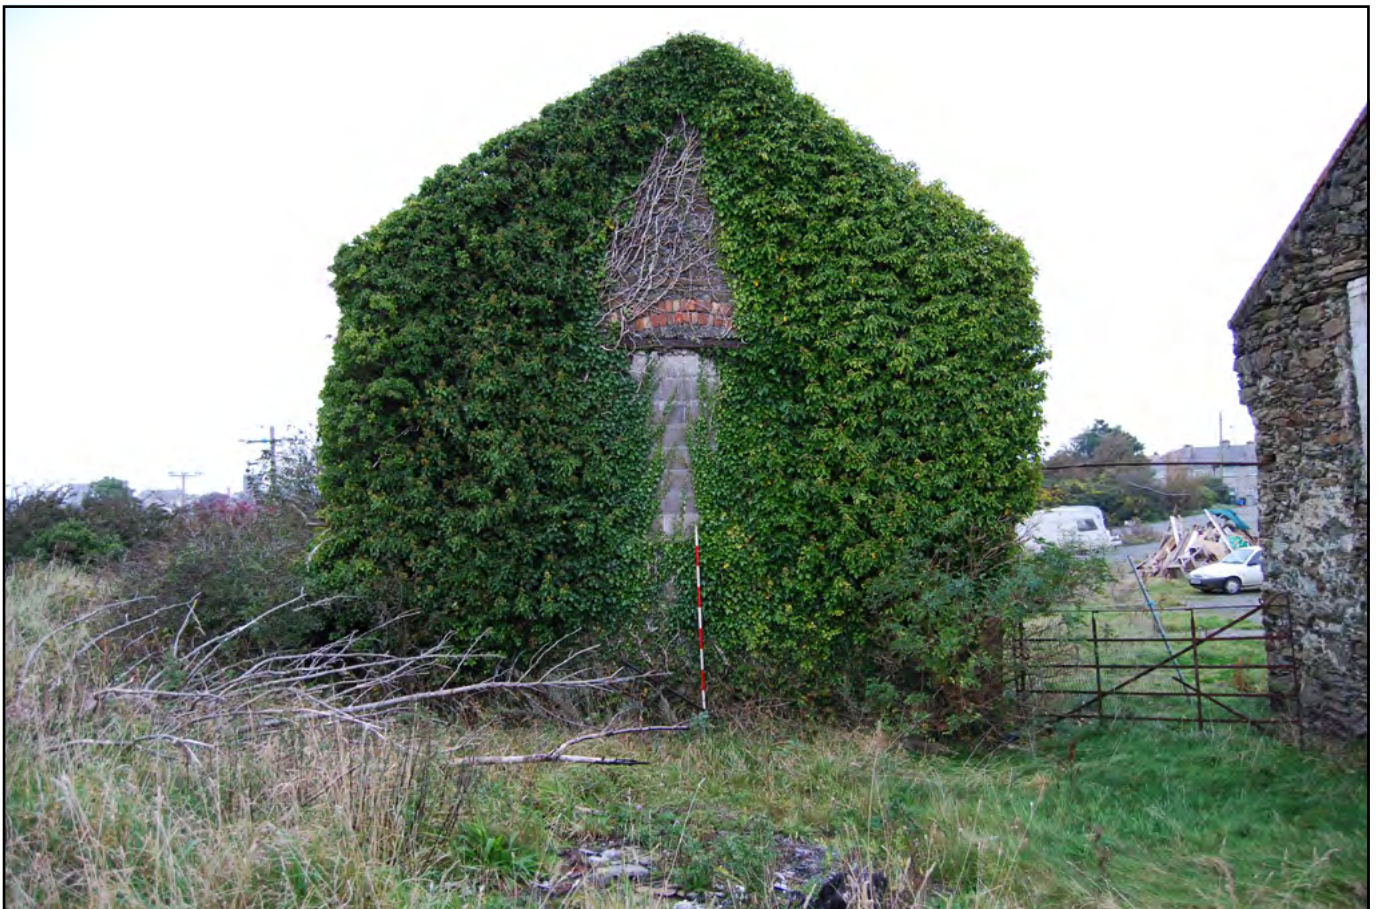
The southwest facing elevation comprises a gable end with a first floor window (Plate 14). The elevation is largely covered by overgrowth. The window is located in the centre of the elevation, c.2.00m above ground level and measures c.2.30m in height (width could not be determined due to the overgrowth). The window arch is constructed from brick (end on) and later alterations are visible in the form of a metal frame and the use of breezeblocks to seal the window.

**Plate 14: South facing gable end of Block B. Note blocked window**

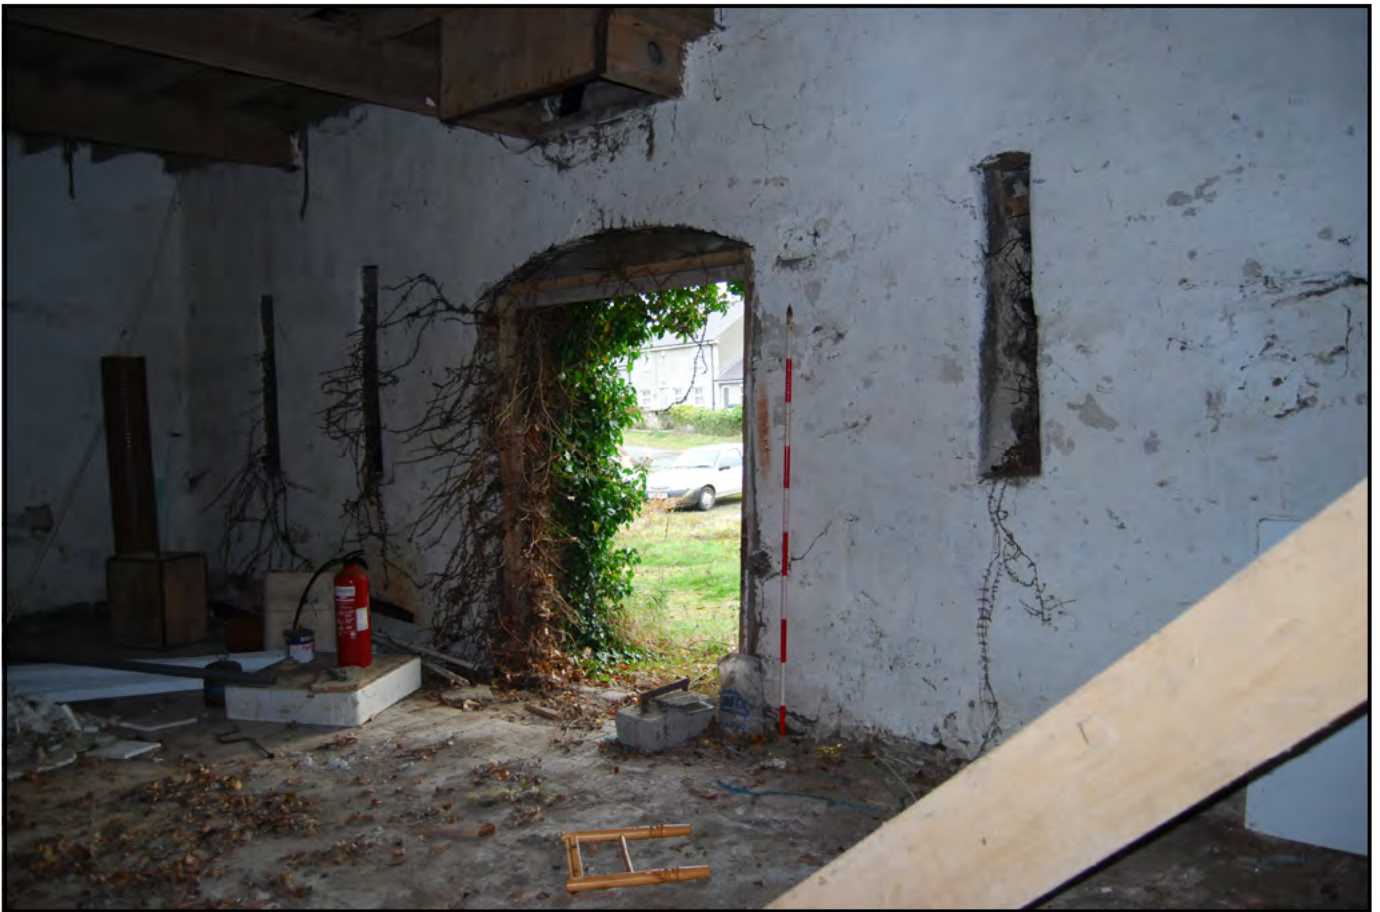
**Plate 15: Block B Northwest facing Internal elevation. Note remodelled archway entrance.**

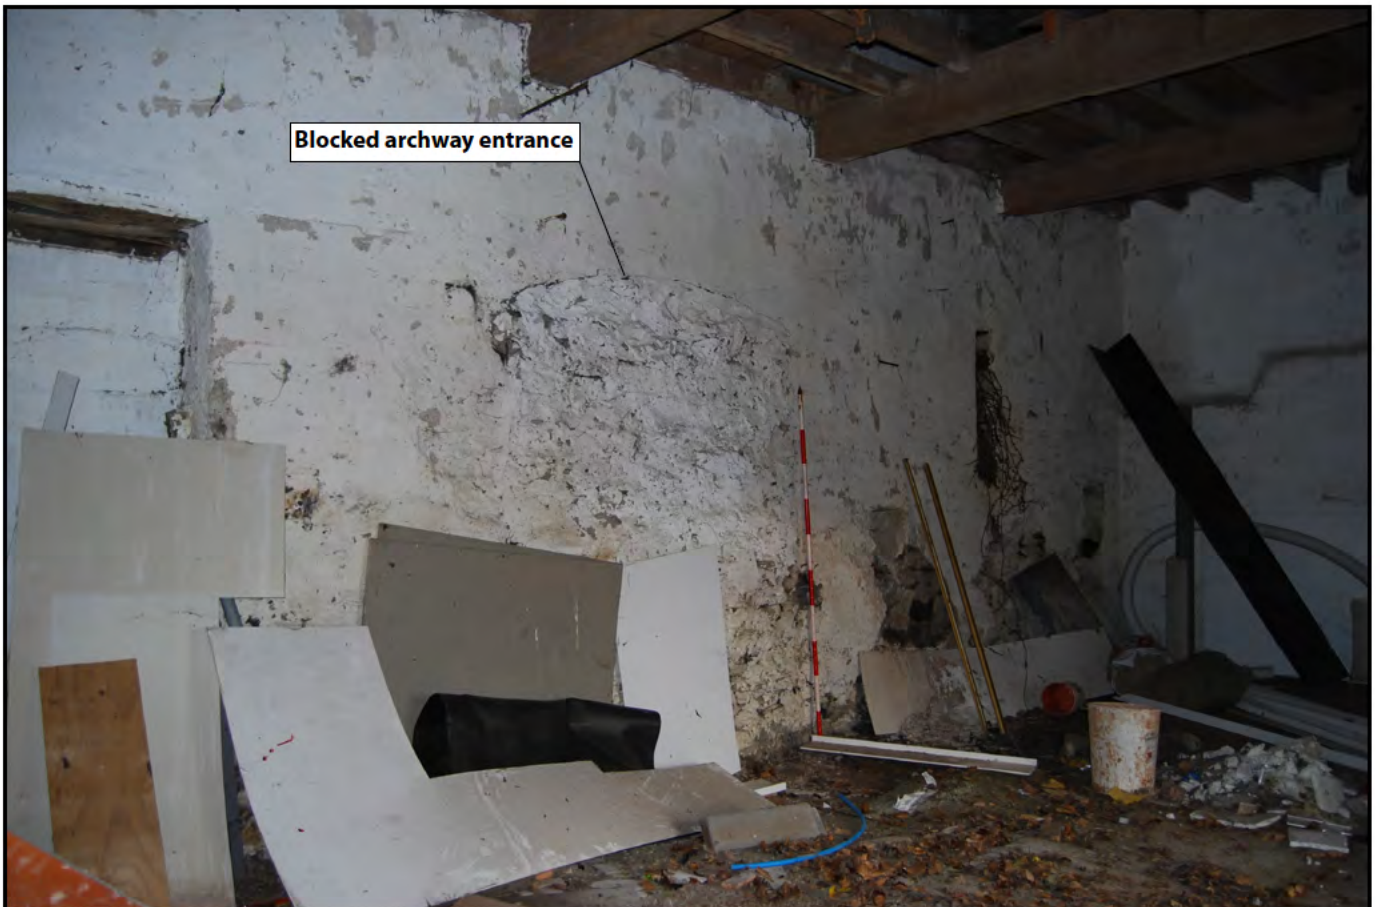
**Plate 16: Block B Southeast facing Internal elevation. Note blocked archway entrance.**

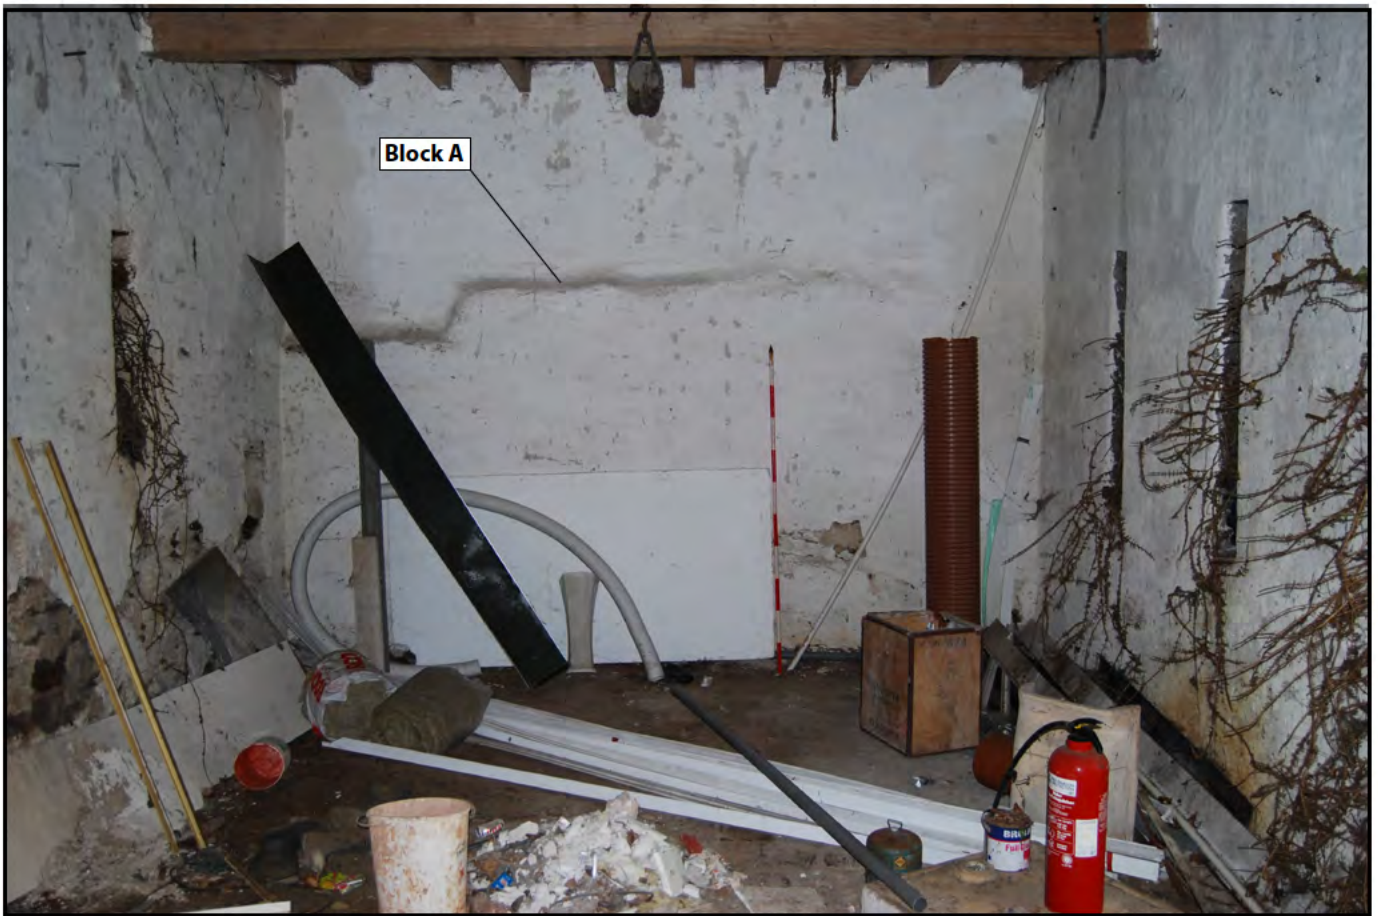
The southwest facing internal elevation stands at 3.55m above ground level. There is evidence of alteration work, with an “earlier” elevation incorporated into the structure. This elevation stands at 2.50m above ground level. No specific details were visible but it appears to be a part of Block A, where the two blocks are joined (Plate 17).

**Plate 17: Southwest facing internal elevation of Block B (Ground Floor).  
Note line defining where Block A and Block B are attached**
