# Madyn Farm, Amlwch

## Archaeological Record (Level I)

GAT Project No. 1969

Report No. 701

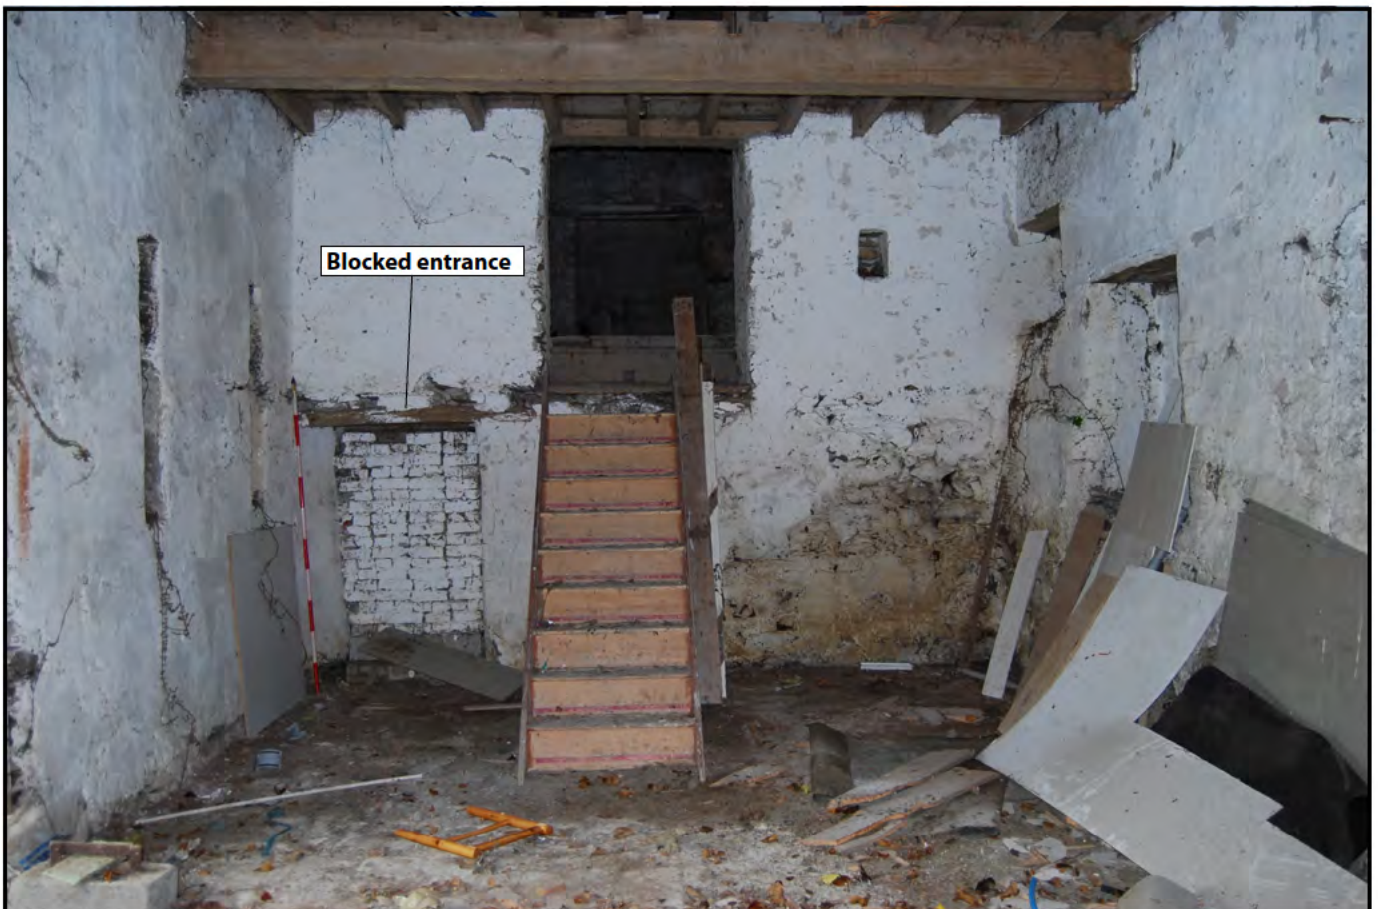
The northeast facing internal elevation incorporates a blocked entrance to the smaller ground floor room (Plate 18; inaccessible both from the inside and outside). The doorway measures 1.72m in height and 1.10m in width, with a 0.20m high wooden lintel atop. Bricks are used to block the entrance, suggesting it was a relatively recent event. A modern wooden stairway is attached to the elevation, providing access to a first floor entrance. This entrance measures 1.50m high and 1.30m wide and provides access to the first floor loft space (Plate 20). A floor surface had been laid and copper pipes suggest the existence of plumbing to some degree. The blocked window, visible from the southwest facing external elevation, is also visible (Plate 19). No further details of note were apparent. This first floor loft space appeared to be a twentieth century improvement to the original construction. This was apparent from the materials used, including the timber, the copper pipes and the breezeblocks.

**Plate 18: Northeast facing internal elevation of Block B detailing modern stairs leading to first floor.  
Note blocked entrance leading to adjacent ground floor room**

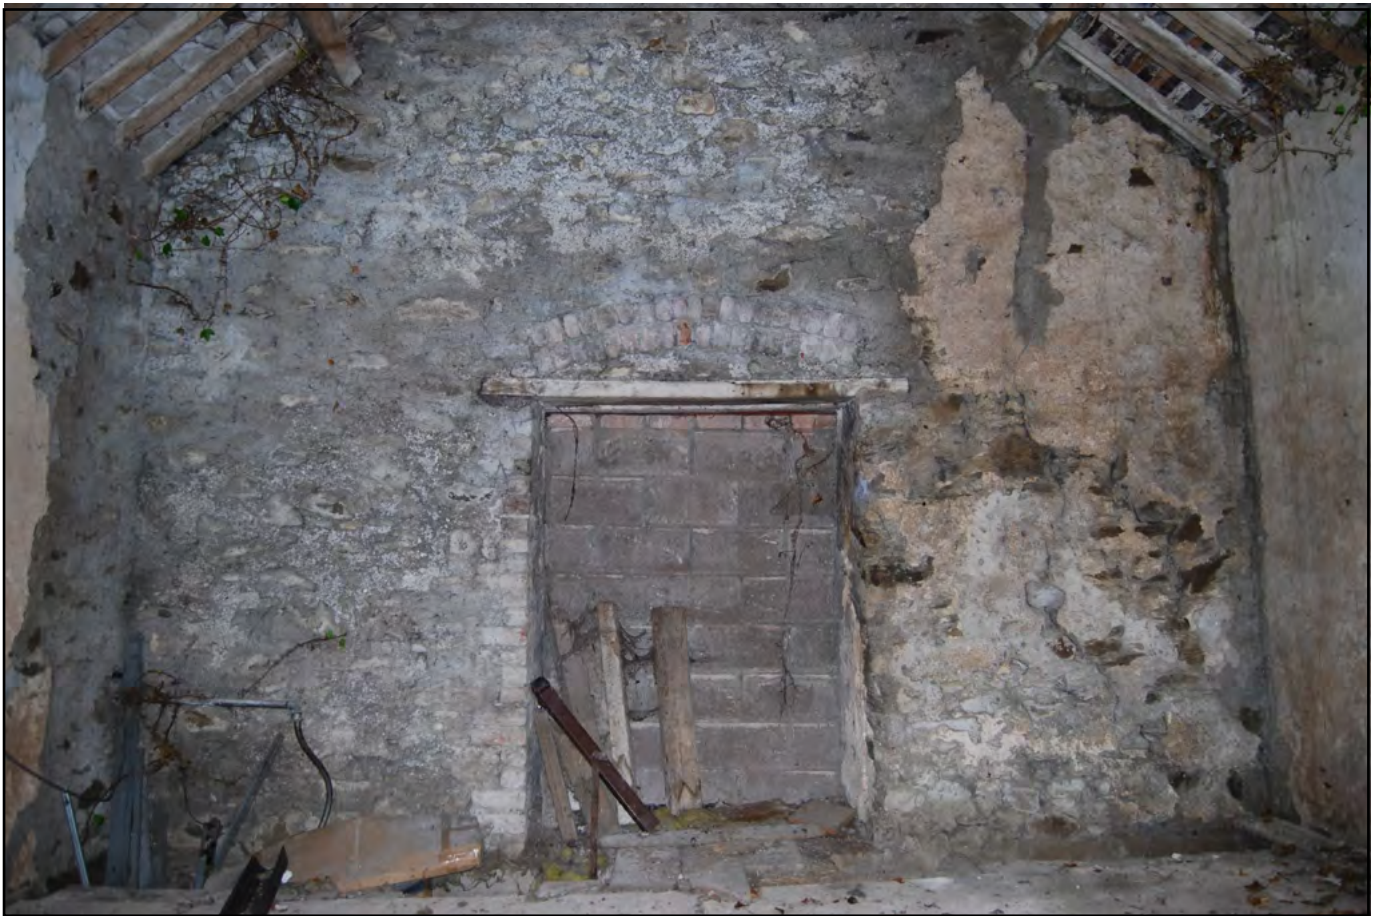
**Plate 19: Northeast facing internal elevation of Block B (First Floor). Note blocked window (For external view see Plate 14)**

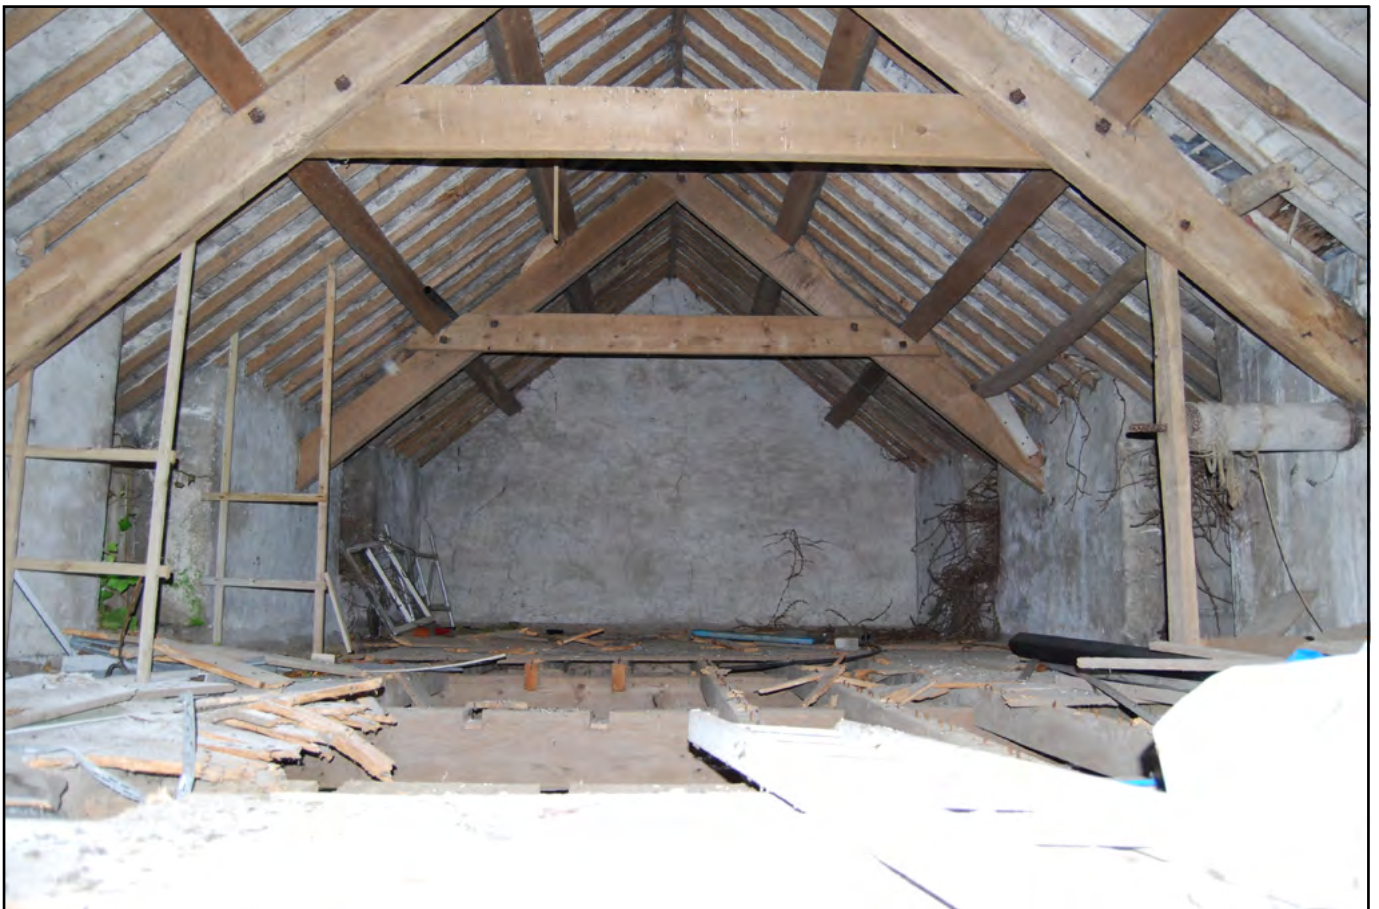
**Plate 20: Southwest facing internal elevation of Block B (First Floor) detailing timber fittings**

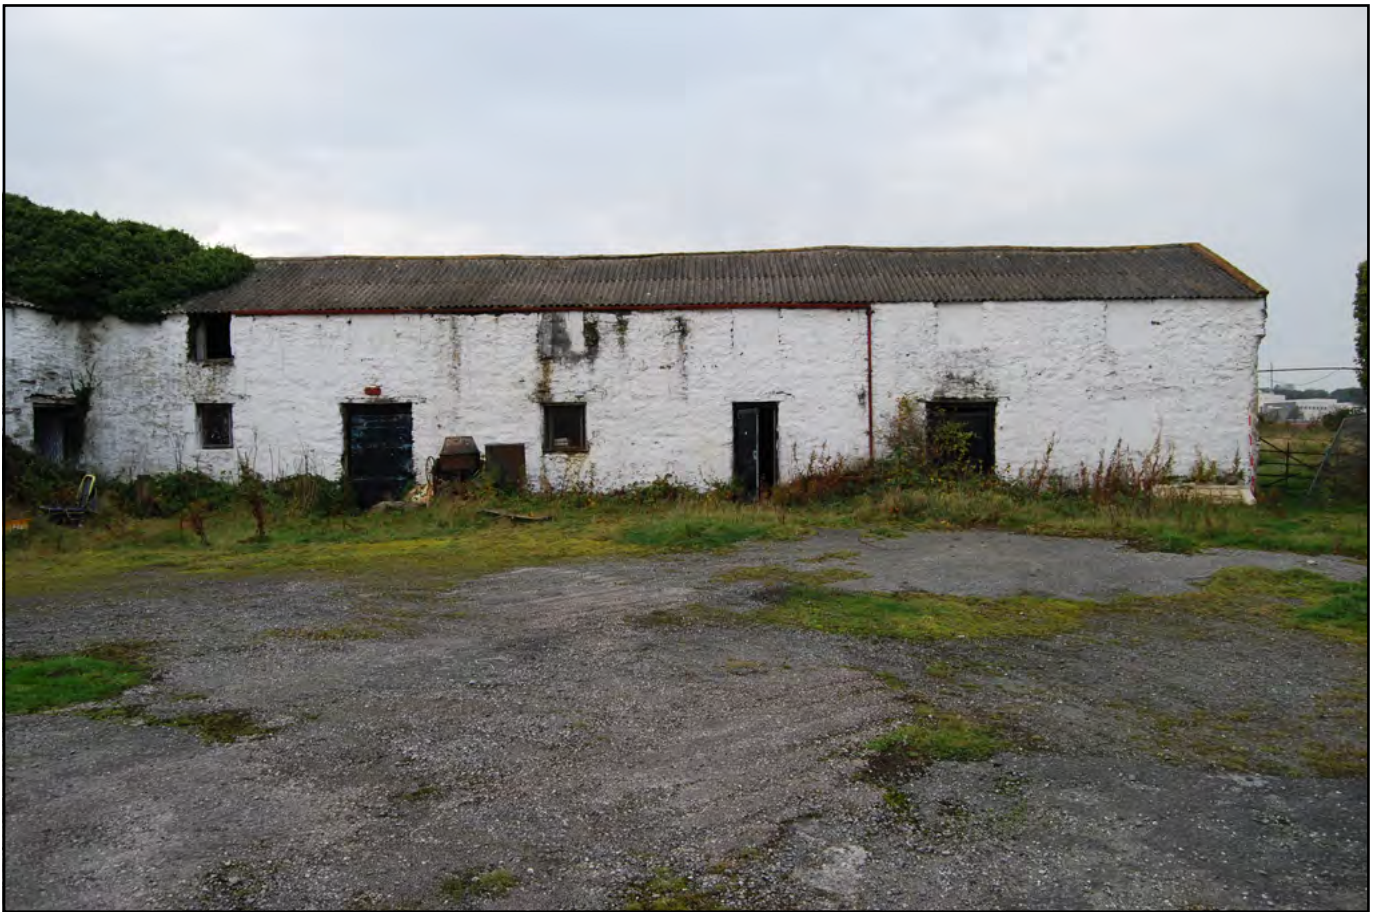
Stone-built two storey block, detached from Blocks B and D, but with similar architectural features to the latter. The block stands two storeys high, with gable ends and a corrugated iron roof (with modern gutters and downpipes). The block measures 23.0m in length, 4.20m in height and 6.0m in width and is constructed from irregular-shaped igneous stone whitewashed render on the northeast facing elevation (Figure 1; Plate 21).

The northeast facing elevation incorporates four entrances, roughly equidistant. There are three ground floor windows (two of which are blocked) and six first floor windows (five of which are blocked). All the windows are of the same design and shape and measure 1.20m in height and 1.00m in width. The appearance of this elevation suggests may have functioned as three dwellings built in a vernacular style that was also used for agricultural purposes. No external chimneys were identified, but the roof had been altered during the twentieth century. Two of the entrances have also been altered, with modern door materials and fittings used (both measure 1.50m in width and 2.20m in height). The entrance at the centre of the elevation is smaller in size: 2.00m high and 0.90m in width, suggesting it represents

**Plate 21: Northeast facing elevation of Block C. Note modern corrugated roof, blocked windows and modern entrances**

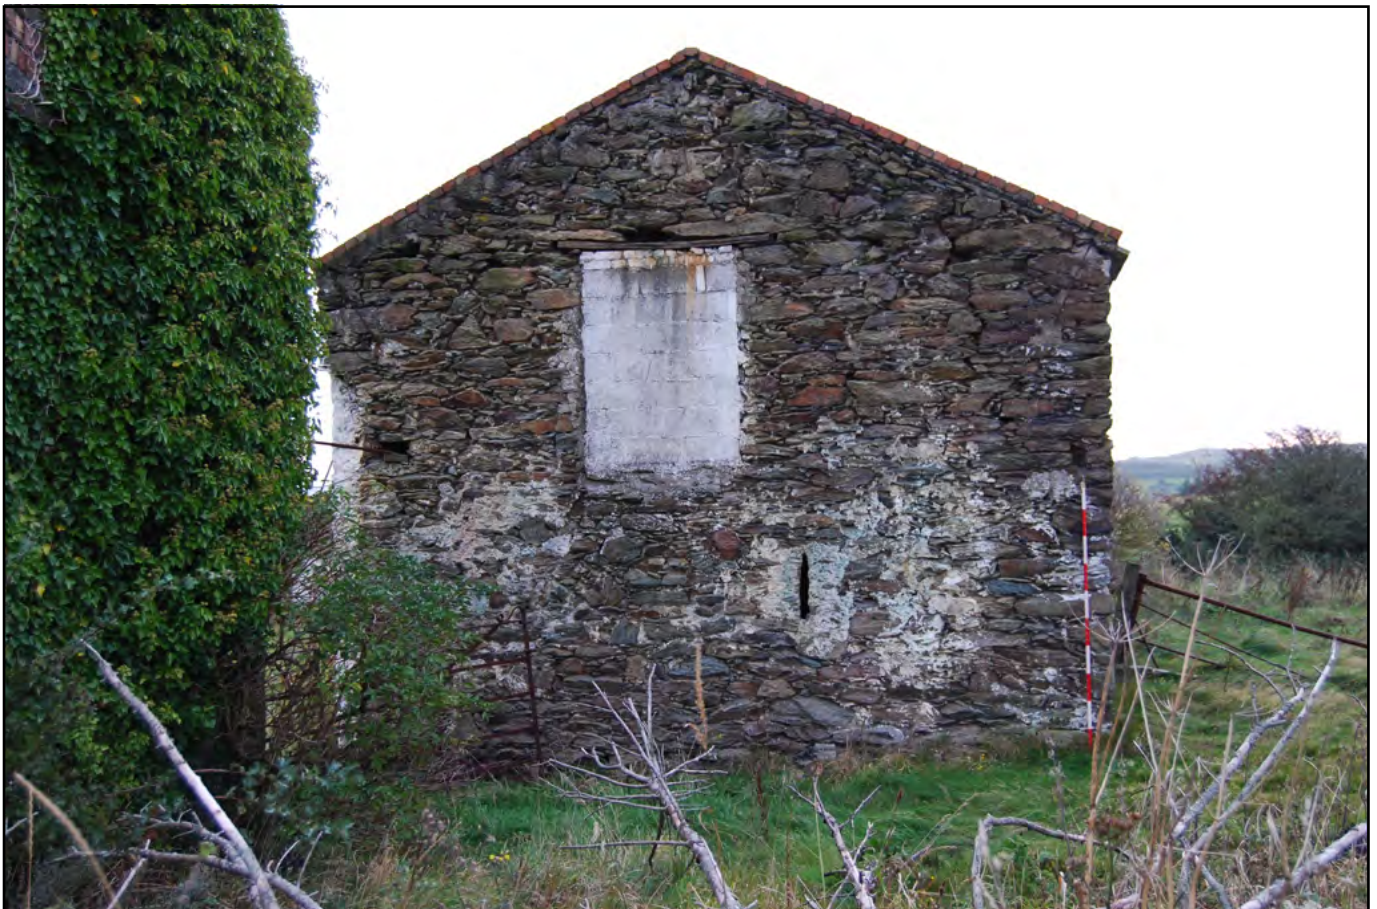
The northwest facing gable end measures 6.0m in width and 5.60m in height (Plate 22). A first floor window is located towards the centre, the window includes a wooden lintel and is currently blocked with breezeblocks. Evidence of repair/re-pointing is visible.

**Plate 22: Northwest facing elevation of Block C. Note blocked window**

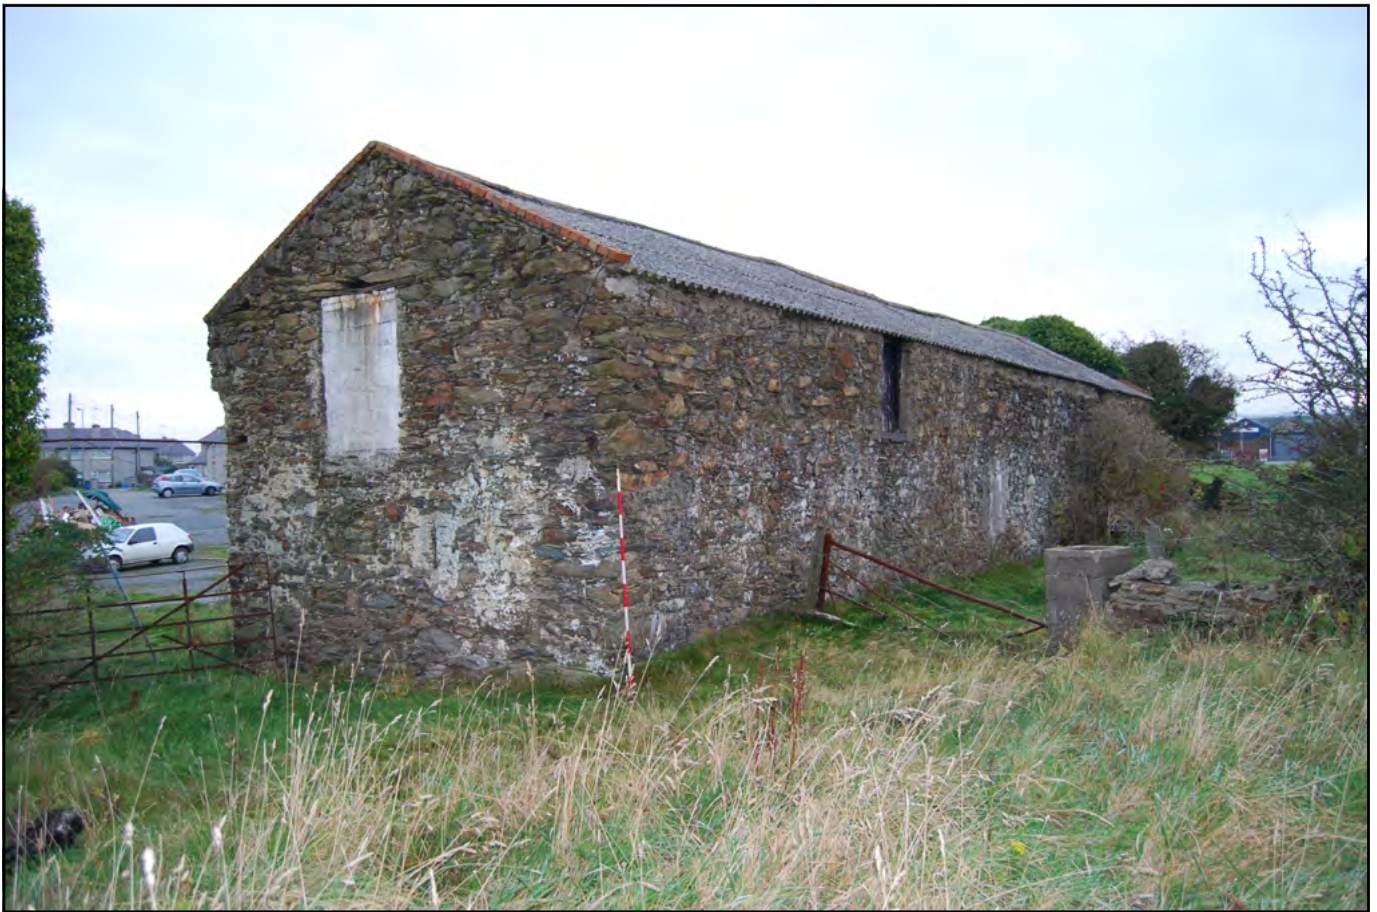
The southwest facing elevation measures 23.0m in length and 4.2m in height (Plate 23). There are three visible windows: one at ground floor level and two at first floor level. All three are blocked; the ground floor window, roughly towards the centre of the elevation, has recently been repaired/blocked, although earlier repair work is also evident (including a graffito with “1945” incised into the cement repair). Extensive repair work was also evident at eaves height along the length of the elevation.

**Plate 23: Southwest and south facing elevations of Block C**

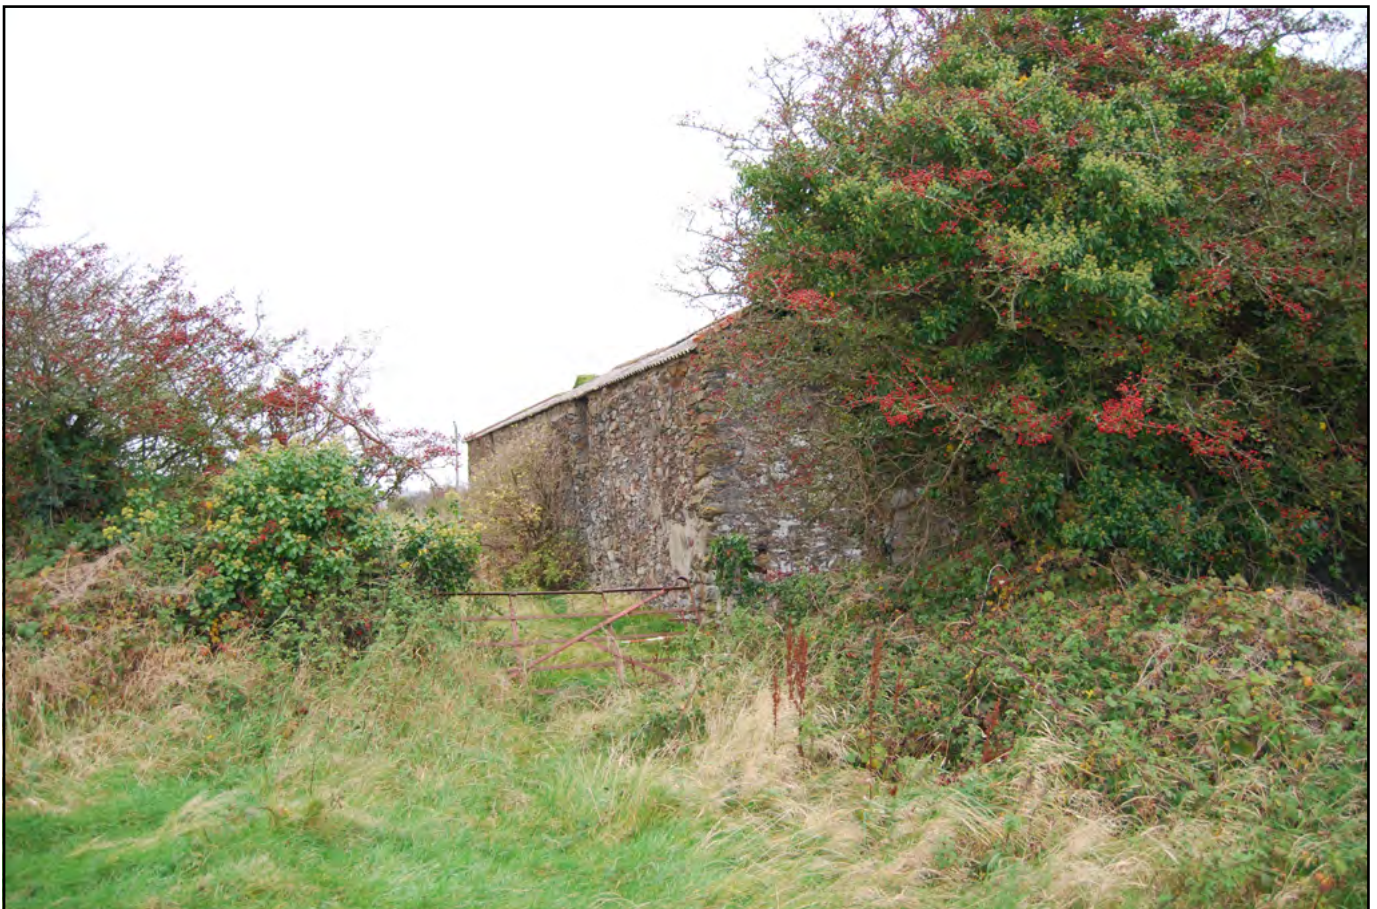
The southeast facing gable end is largely blocked from view by a large tree, but an entrance or window is visible at ground floor level (Plate 24).

**Plate 24: South and southeast facing elevations of Block C. Latter is obscured by overgrowth**

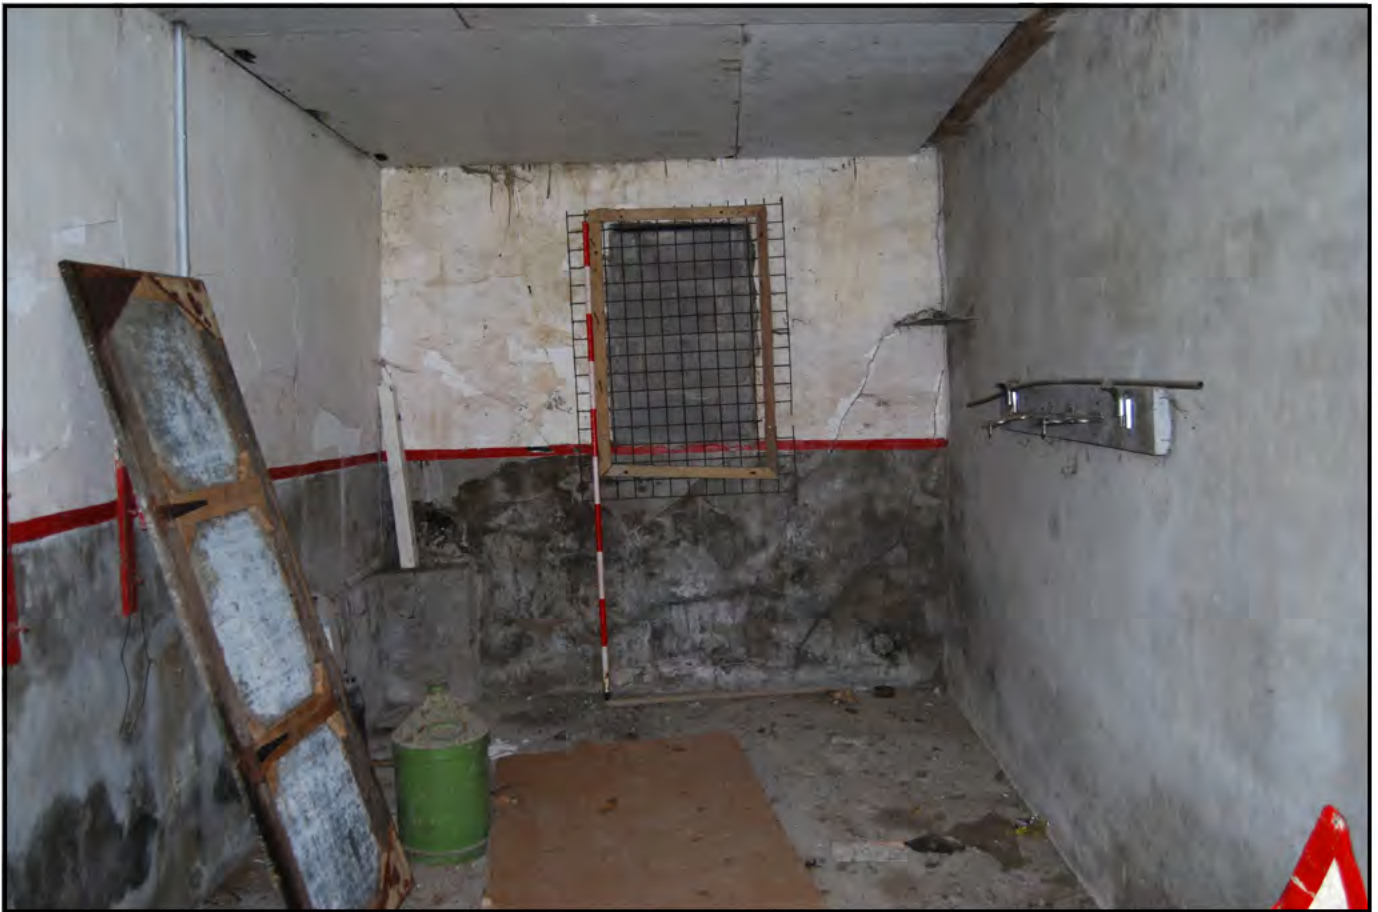
Only one room was accessible, via the central entrance (Plate 25). The room had recently been converted for commercial use (*c.*1990 – *pers. comm.* Dylan Jones). The walls had been plastered and the floor concreted, thereby disguising any earlier structural information.

**Plate 25: Internal view of room within Block C detailing modern usage**

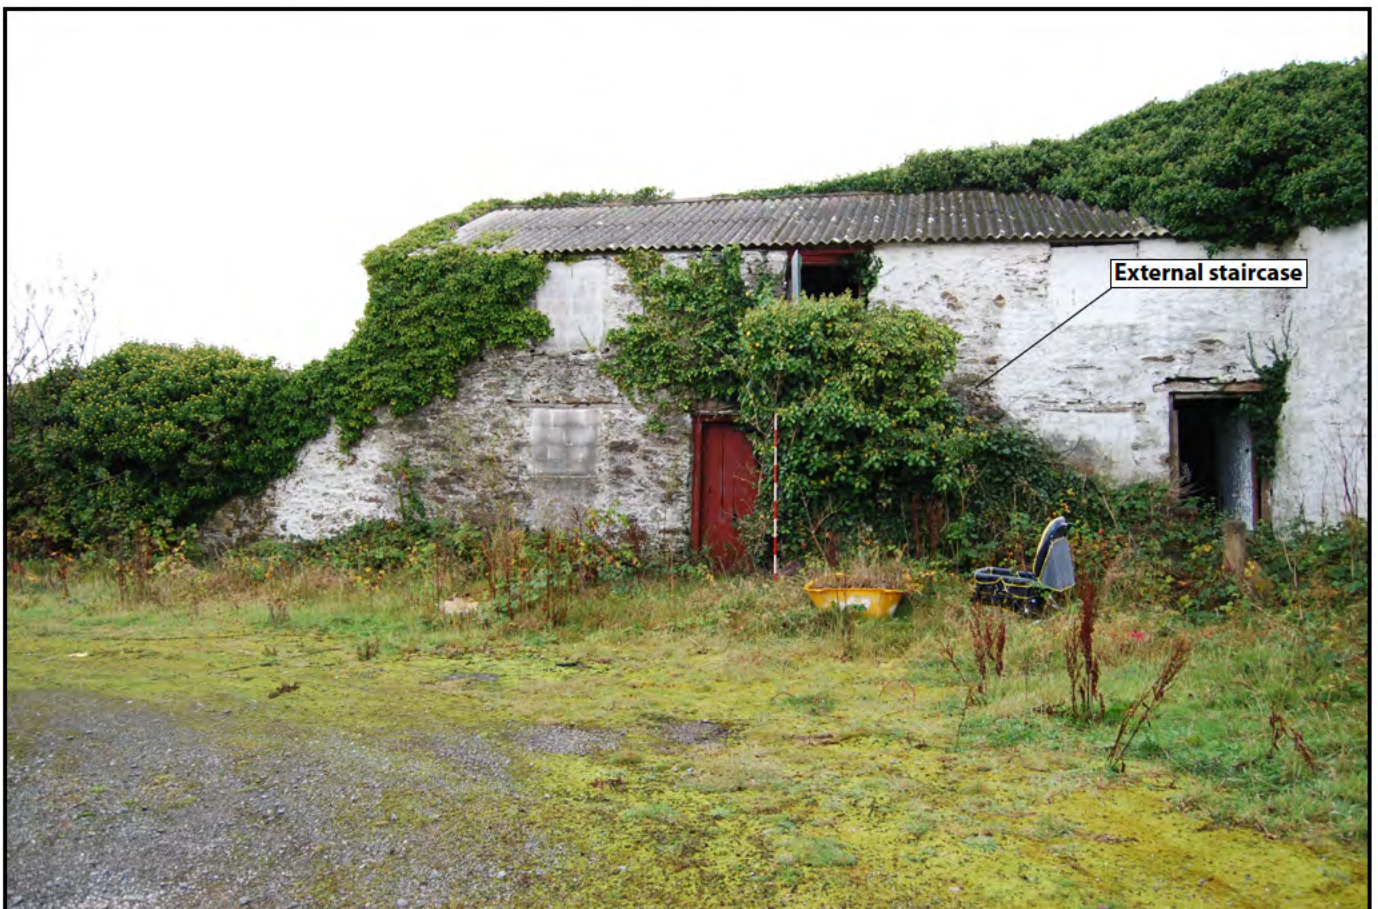
The northwest facing elevation comprises two ground floor entrances and five visible windows (two ground floor; three first floor). Four of the windows and one of the entrances are blocked (breezeblocks used). A stone-built stairway has been added to the elevation, 3.0m high and 1.35m wide (Plate 26). The stairway partly covers one of the blocked windows, suggesting it was a later addition (the stairway is extant on the 1<sup>st</sup> Edition 25” Ordnance Survey Map (1889), suggesting it was built prior to this date; Figure 3). The stairway provides access to the central first floor window, which has been converted to an entrance.

**Plate 26: Northwest facing elevation of Block D. Note modern roof, external staircase and blocked windows**

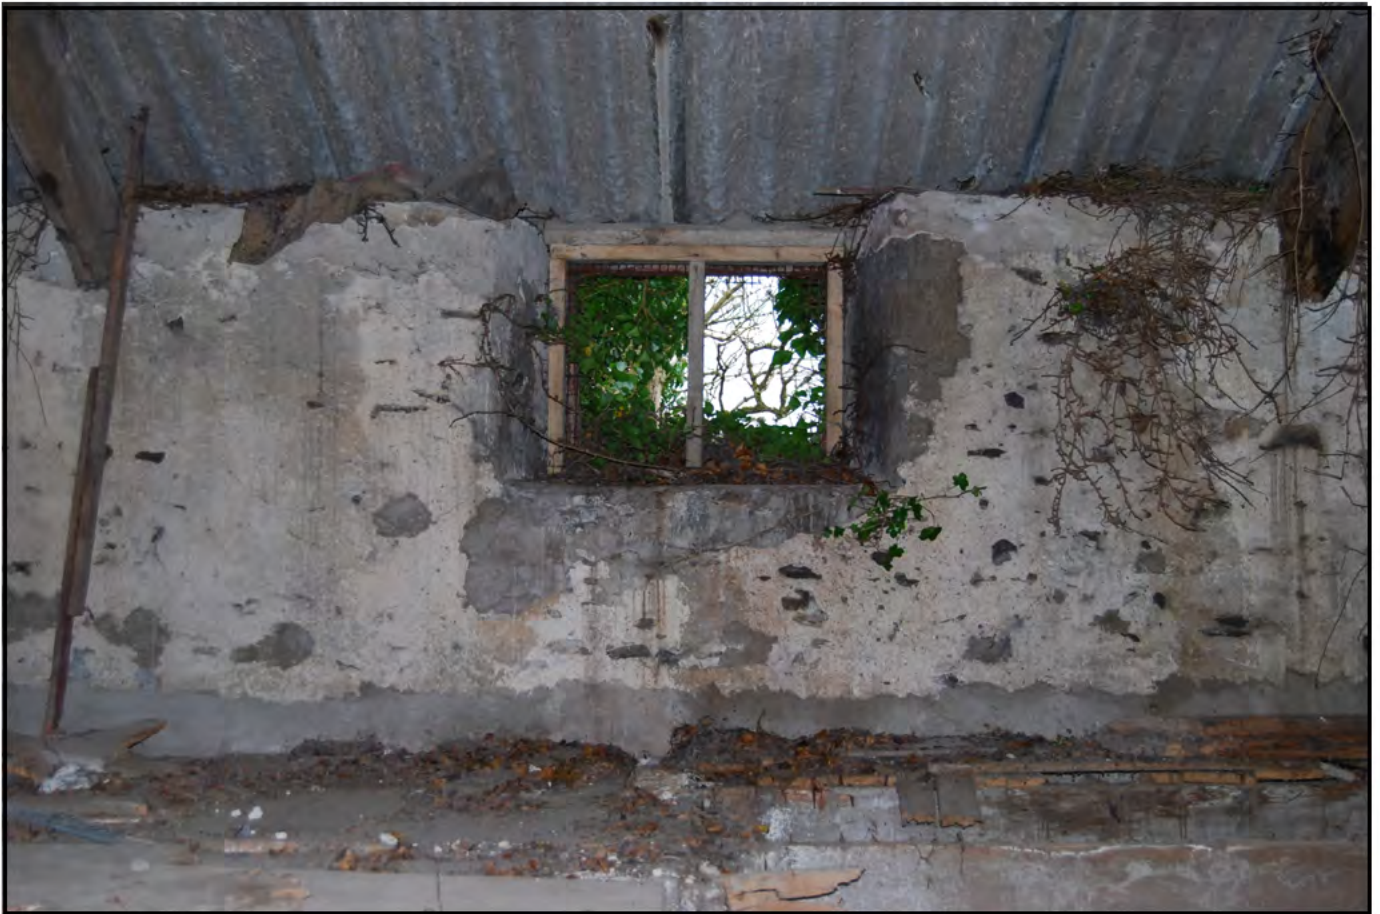
The first floor, accessed via the stairway, is a large room running the length and width of the block. A small window with modern fittings is visible on the northwest facing internal elevation (Plate 27). No other fittings are visible. The timber frame roof has (possibly) original and replacement fittings, covered with corrugated iron. The floor surface is constructed from timber floor boards.

**Plate 27: Northwest facing internal elevation of Block D (First floor) detailing modern window fitting**

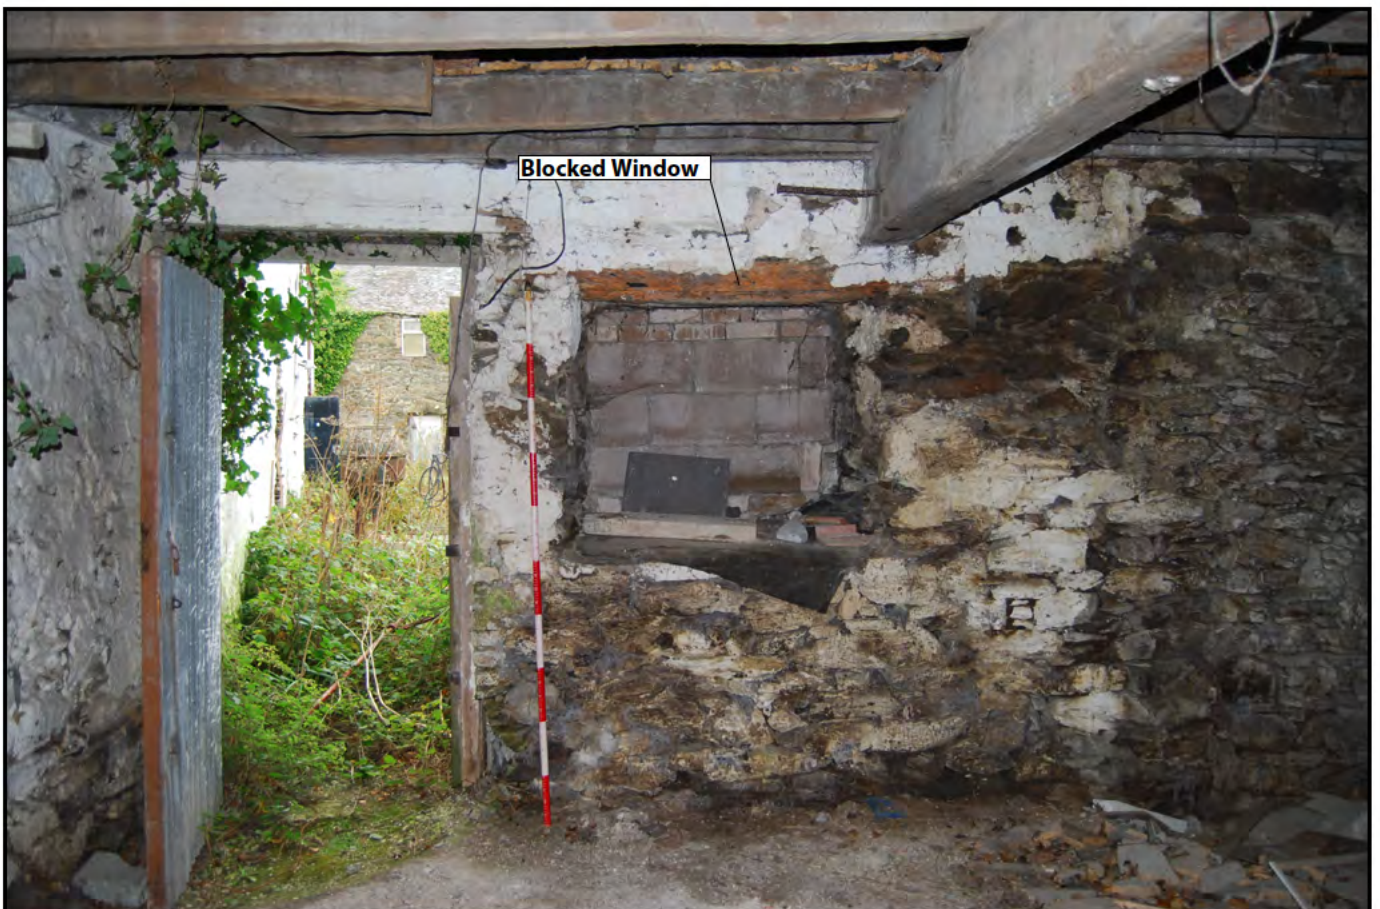
**Plate 28: Southeast facing internal elevation of Block D (First floor) with internal details**

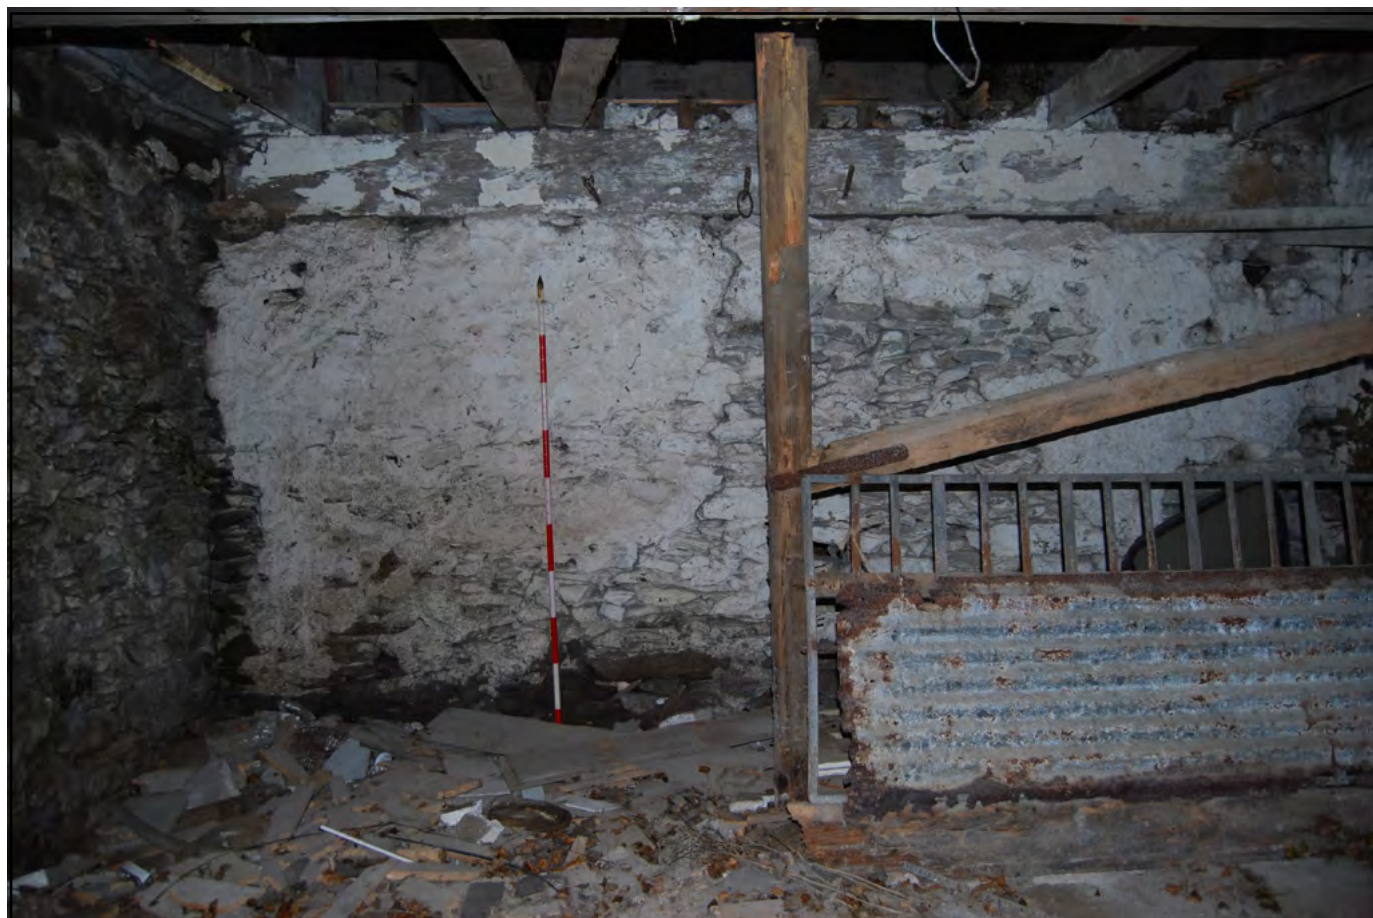
The ground floor, accessed via the entrance on the southern end of the elevation, measures 2.20m in height and is divided into two rooms of equal size, separated by a stone built partition wall. Only the room attached to the entrance is accessible. The walls are constructed from irregular sized igneous stone and are whitewashed (Plate 28). The floor is built from concrete and is littered with collapsed timber and floorboards from the first storey. A corrugated iron palisade in the centre of the room, attached to a wooden brace, suggests this room may have recently housed livestock and/or agricultural materials (Plate 29).

**Plate 29: Southwest facing internal elevation of Block D room (First floor).  
Note stockade constructed from timber and corrugated iron**

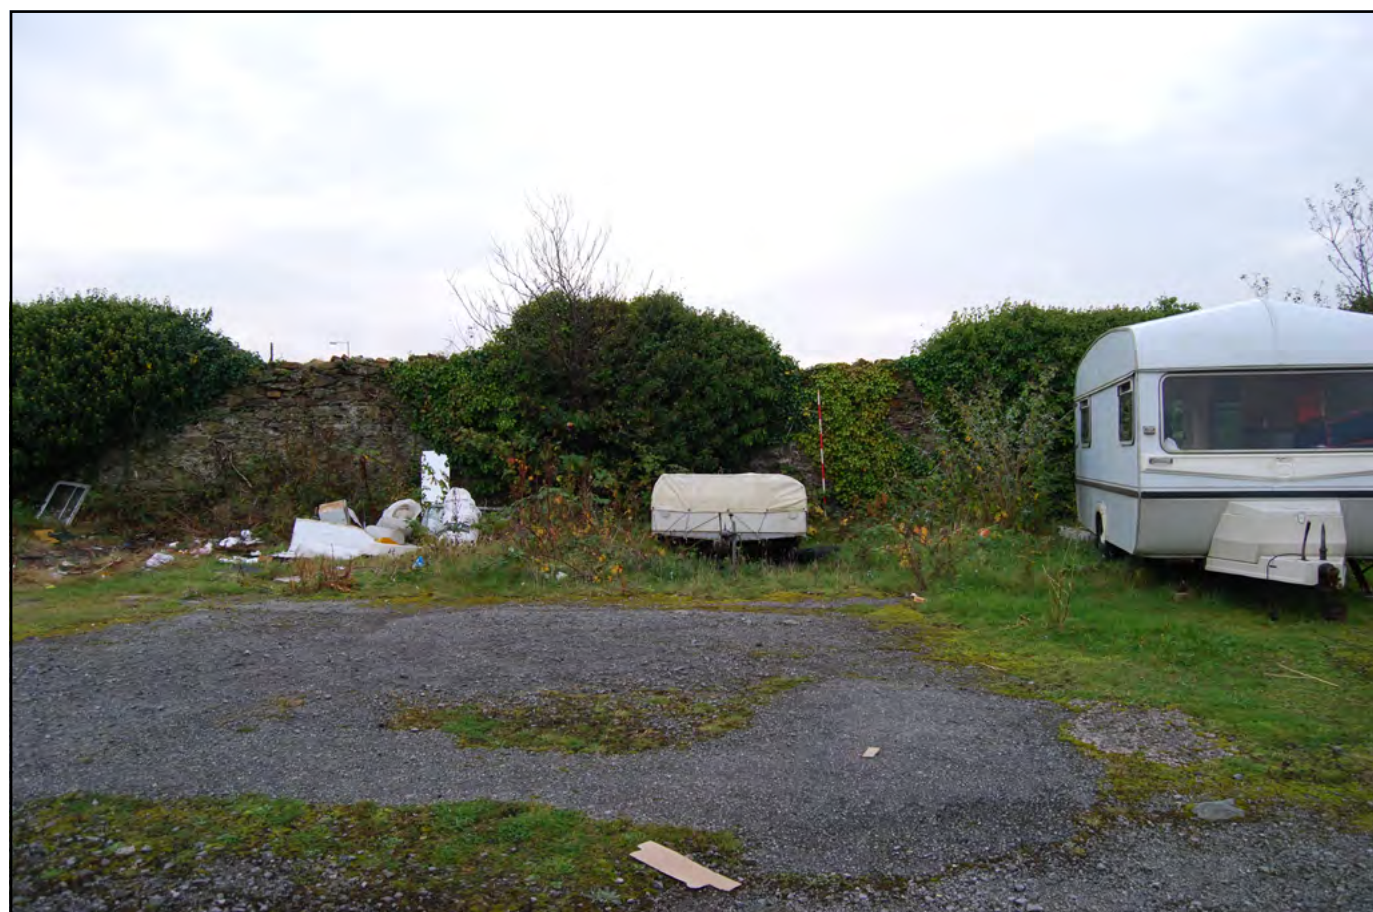
**Plate 30: Northeast facing boundary wall located between Block D and Ty Nesa Farm**
