# PONT BRYN Y FELIN, BEDDGELERT

## ARCHAEOLOGICAL WATCHING BRIEF

**GAT Project No. G2007**

**Report No. 731**

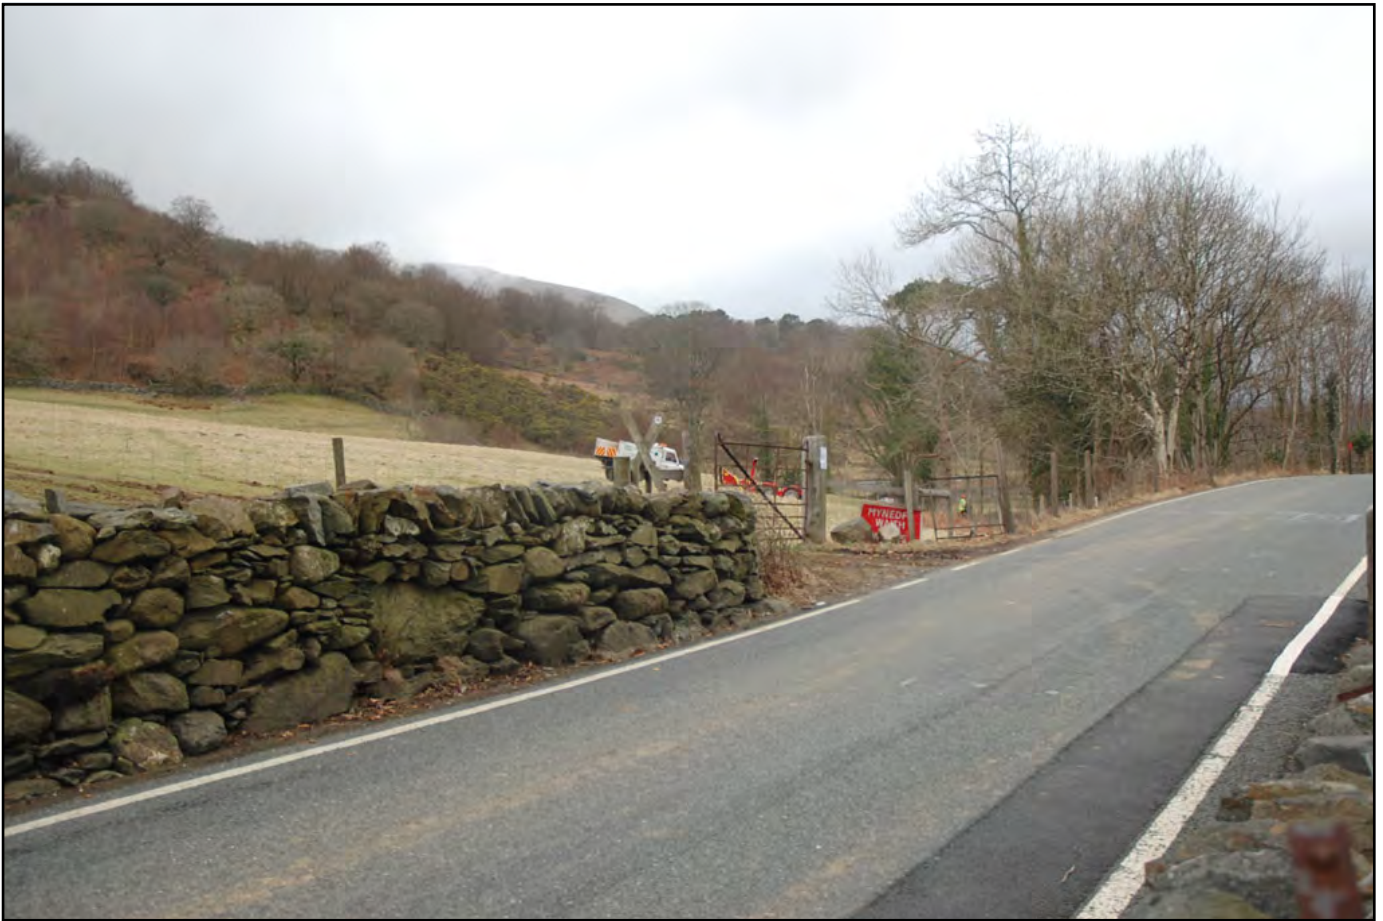
**Plate 01: Existing A498 Road and field entrance used as start point for temporary relief road**

The route of the relief road exploited the southeastern end of an enclosed field and utilised an existing field entrance as the starting point of the road (Figure 01; Plate 01). The road then continued through the field and breached an existing field boundary to then continue across the Welsh Highland railway track to rejoin the A498 (Plates 02 to 04).

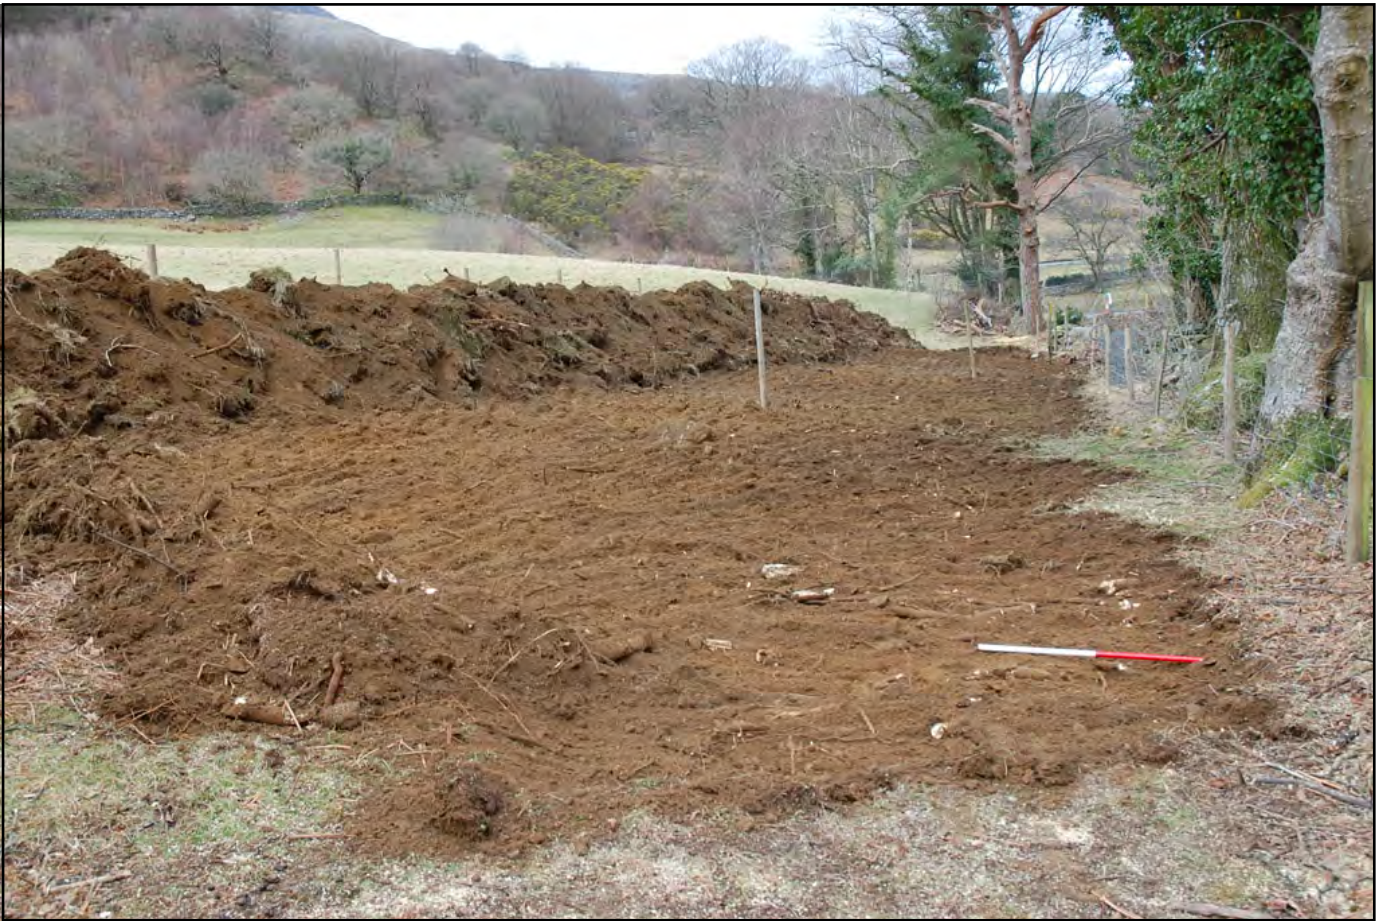
**Plate 05: view north of temporary relief road area during excavation. Note the shallow excavation depth; a geotextile membrane was placed over this area and the road surface on top**

The depth of excavation was shallow and was limited mainly to the topsoil horizon (Plates 05 to 07). As a result, there was limited potential for identifying archaeological activity. The only “feature” identified was a former watercourse, which was visible at the northern end of the relief road strip as a gravel-rich deposit (Plate 06). This feature could be seen as a depression running down the slope prior to the excavation works.

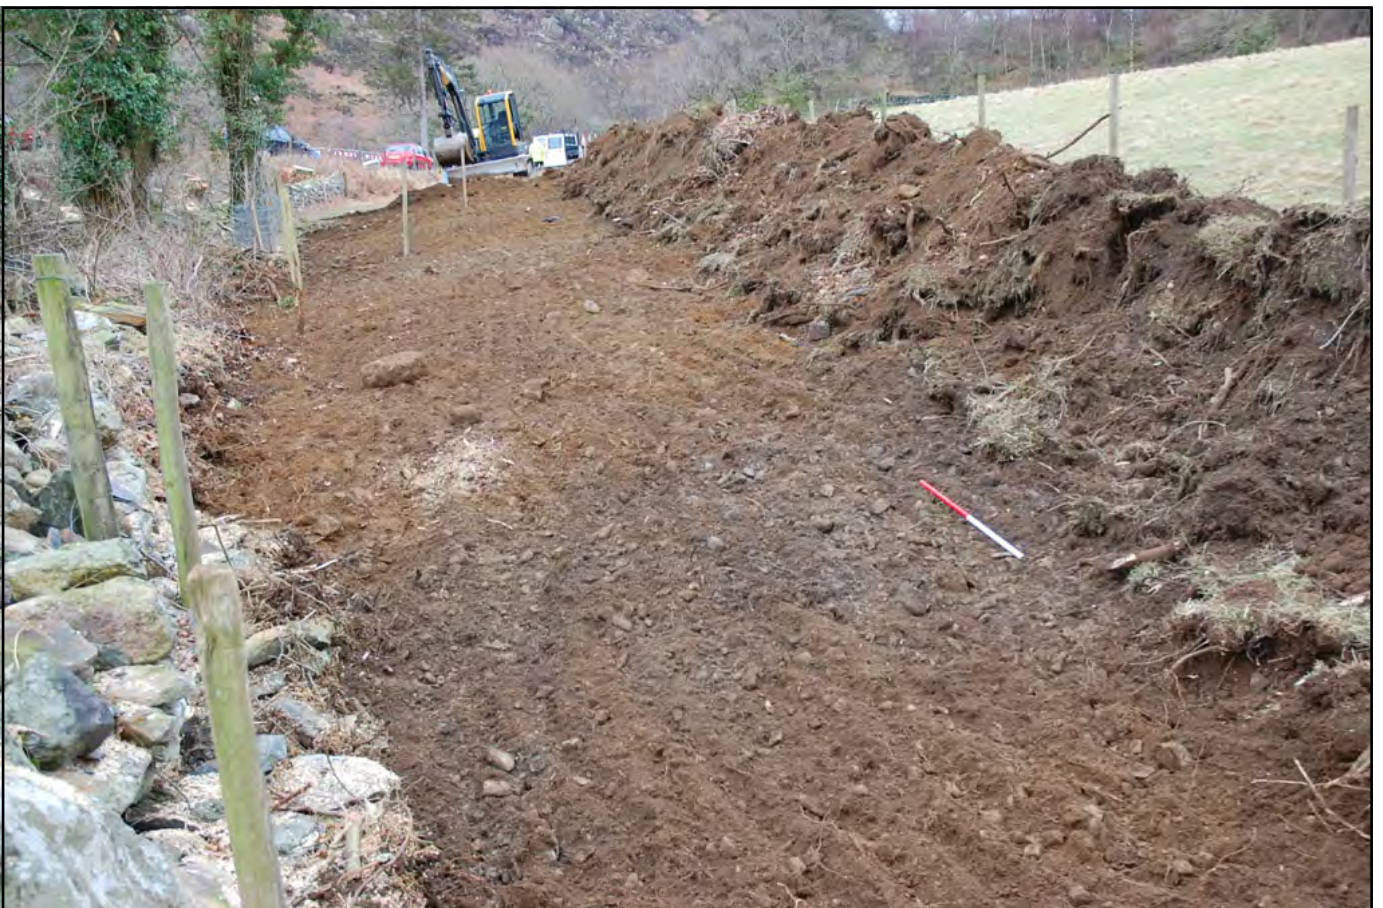
**Plate 06: view north of temporary relief road area during excavation. Note waterchannel in foreground**

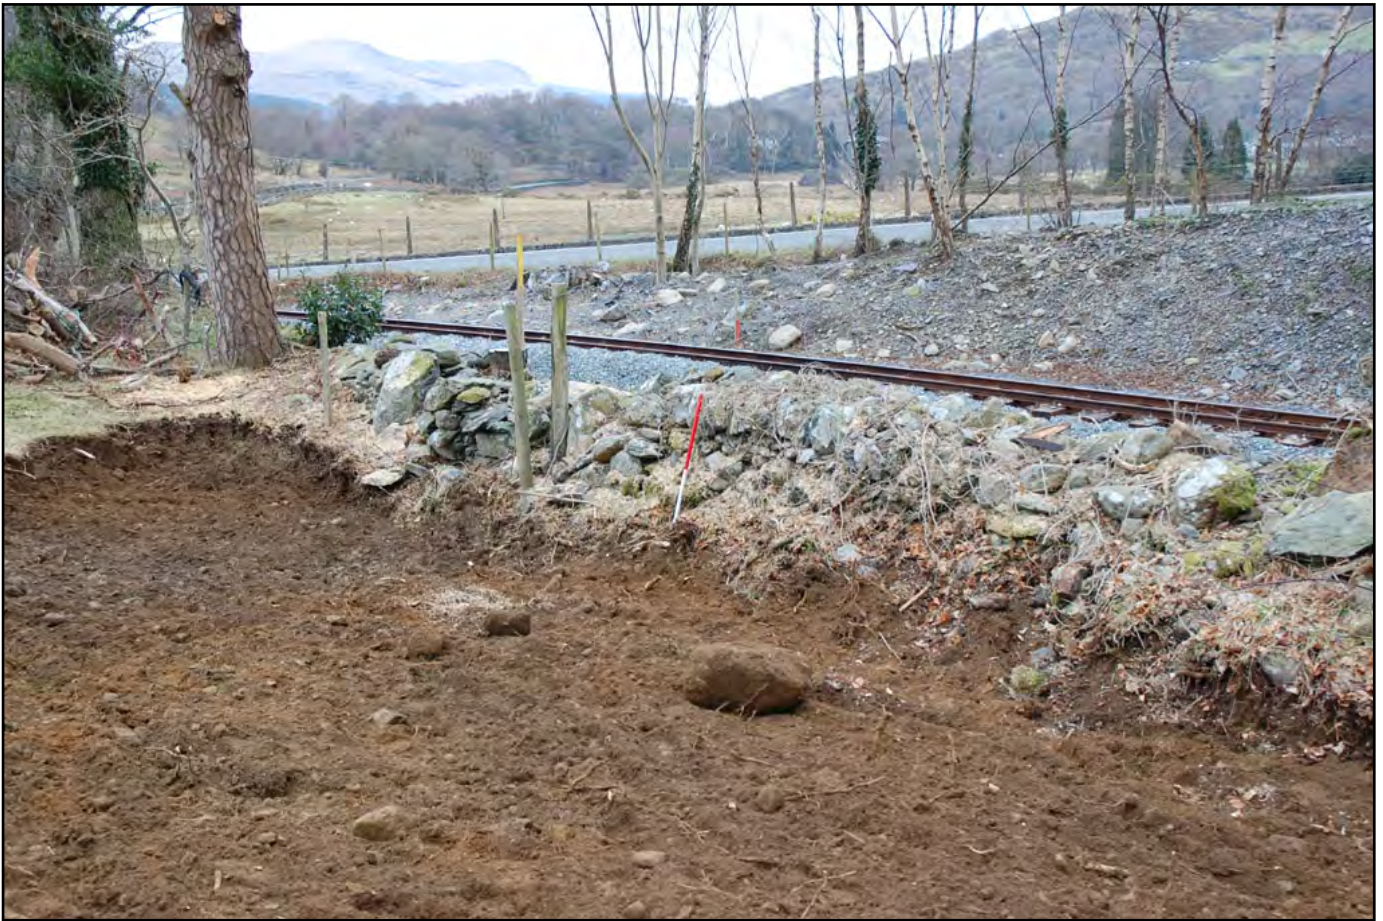
**Plate 07: view northeast of temporary relief road. The ranging pole is positioned against a boundary wall that was breached during works to allow the relief road to cross the railtrack**

A field boundary wall was breached during the works (Plates 07 to 09). This area was also monitored and particular attention was paid to the construction of the wall. The wall measured 1.0m in height and comprised roughly coursed stonework (sub-angular and sub-rounded), comprising horizontally laid slabs, which were capped with smaller sub-rounded stones (Plate 09). The breach measured 6.0m and the wall was removed within this area down to foundation level (Plate 10). A stone-built culvert was identified within the wall, built from the same material and located at foundation level (Plate 08). The culvert measured 0.75m in width and was exposed but not removed during the works.

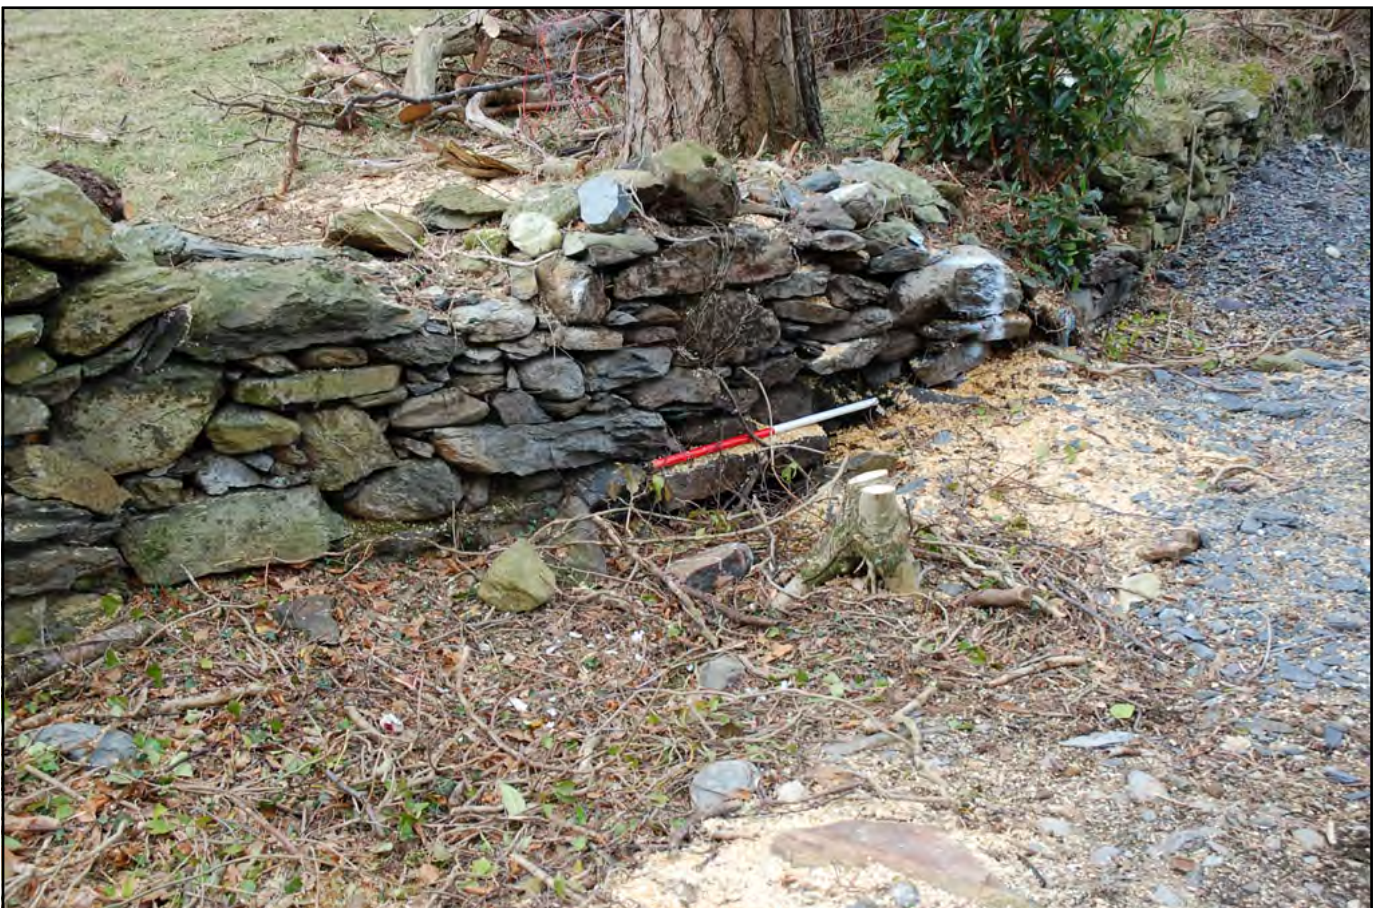
**Plate 08: view west of boundary wall prior to breach. Ranging pole is positioned across a stone-built culvert incorporated into the wall**

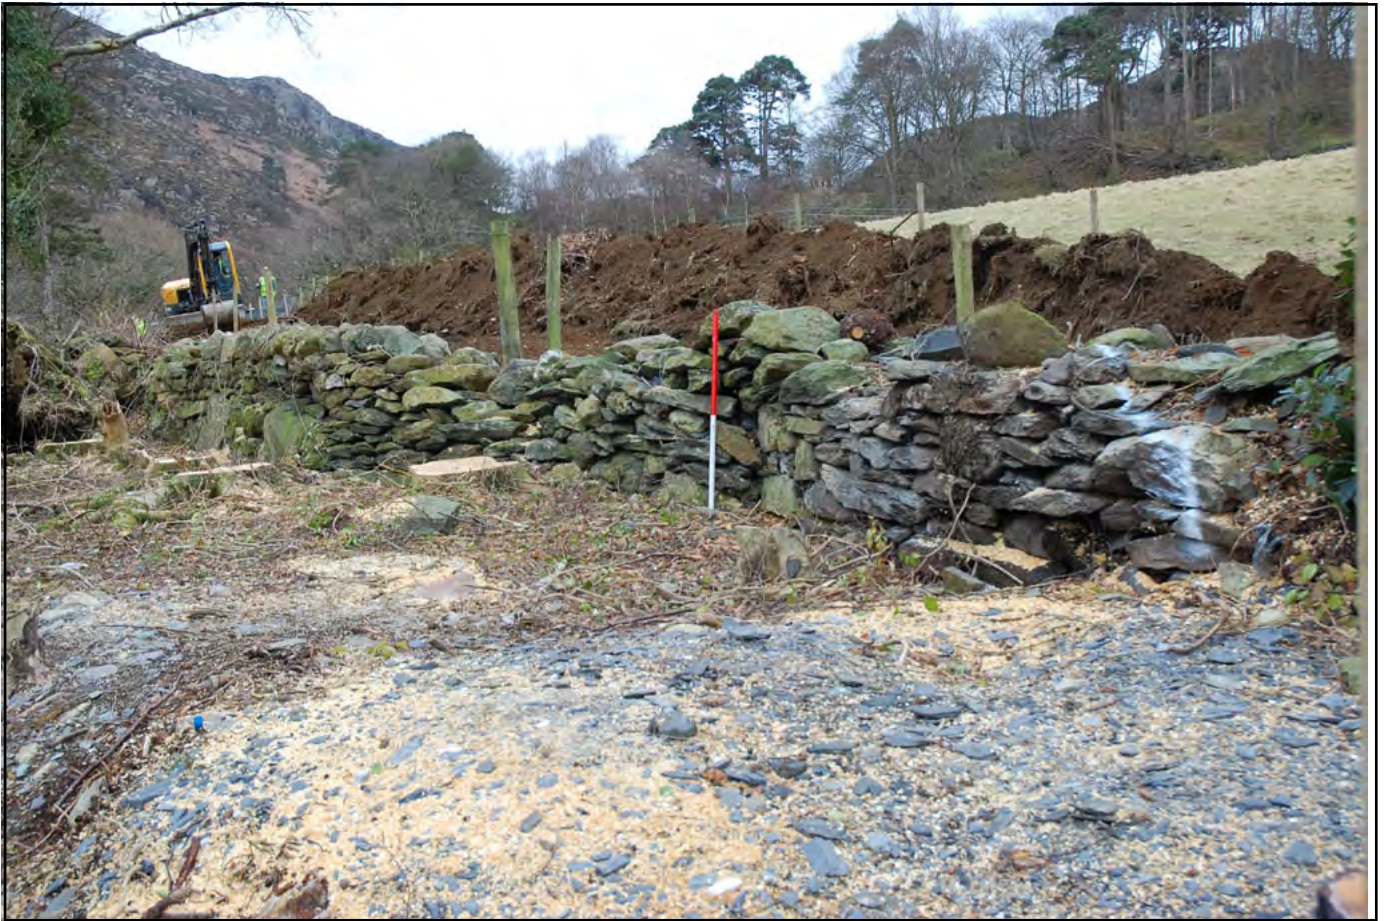
**Plate 09: view southwest of boundary wall prior to breach**

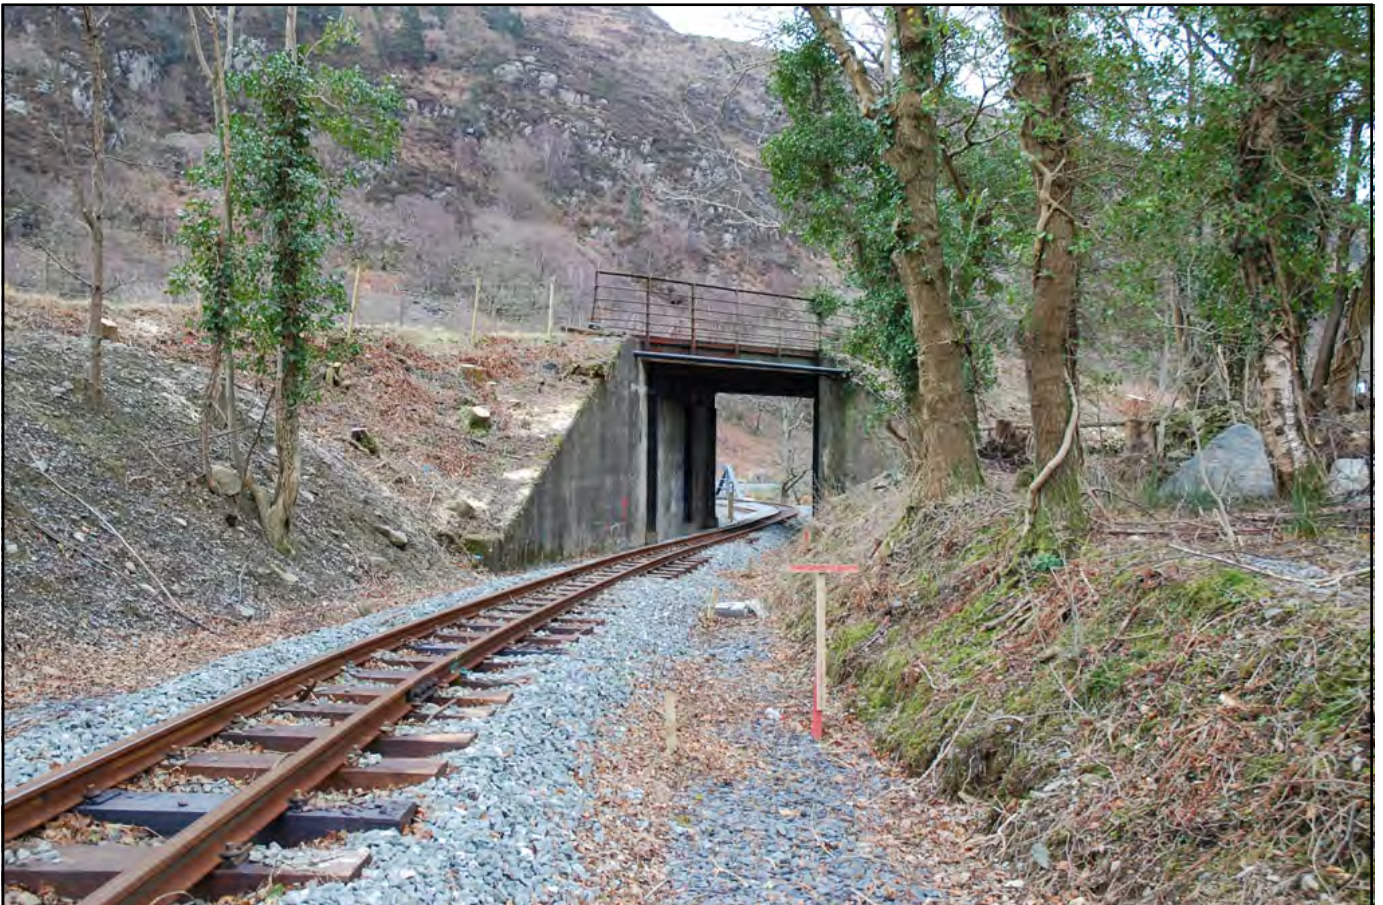
**Plate 12: existing north elevation of road bridge prior to demolition**

The existing structure measures 4.97m in height c.10.0m in length and 6.00m in width (Plates 12 to 19). Concrete abutments are attached to the existing north and south elevations (Plates 14 to 18). Eight steel girders onto which the road plate is set (Plate 15), support the road. The parapet is also constructed from steel.

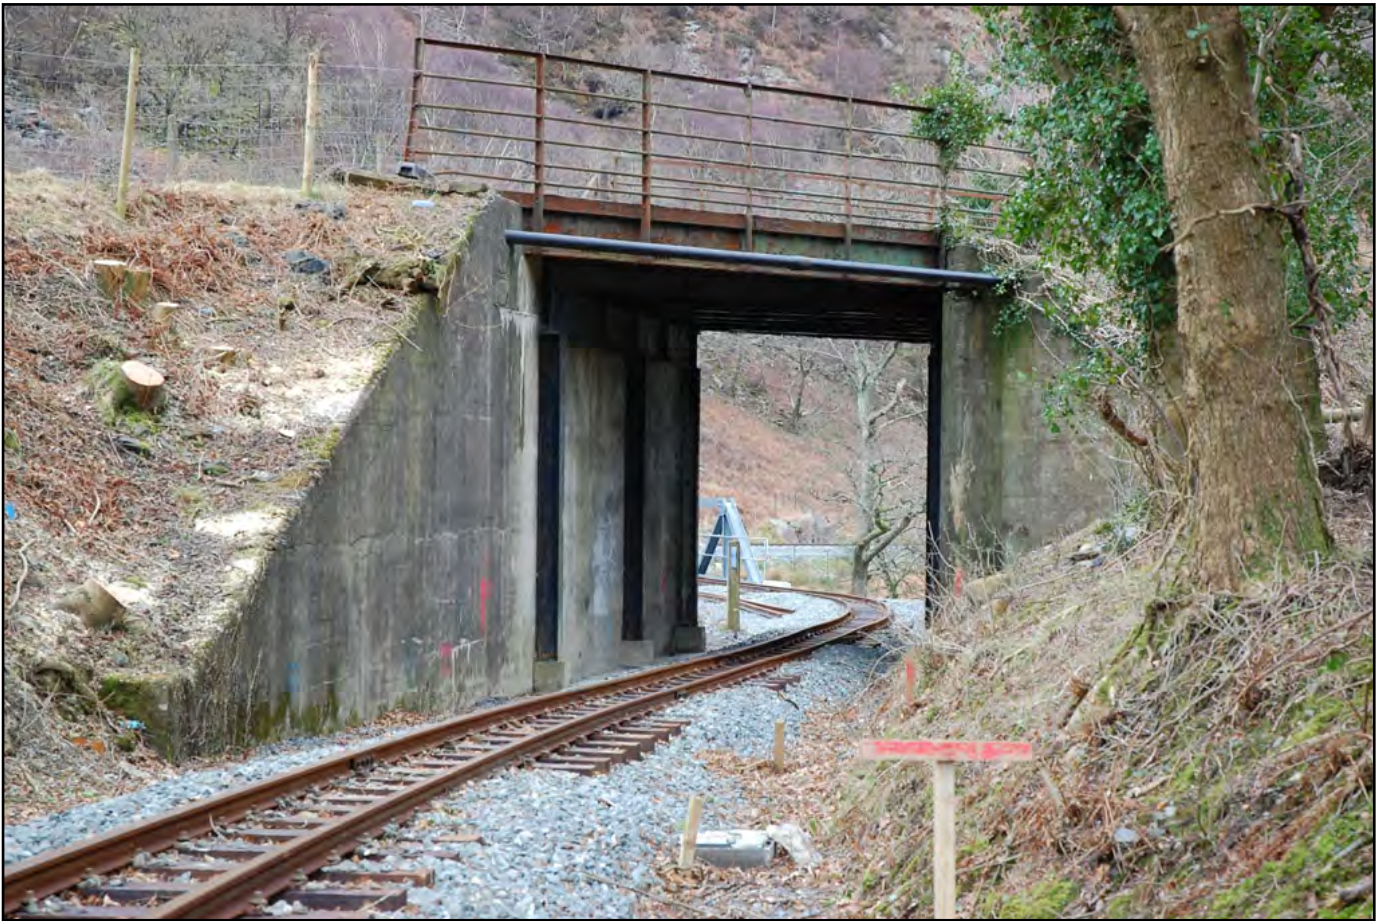
**Plate 13: close-up of north-facing elevation prior to demolition, detailing steel parapet, road plate, concrete abutment and steel girder shell**

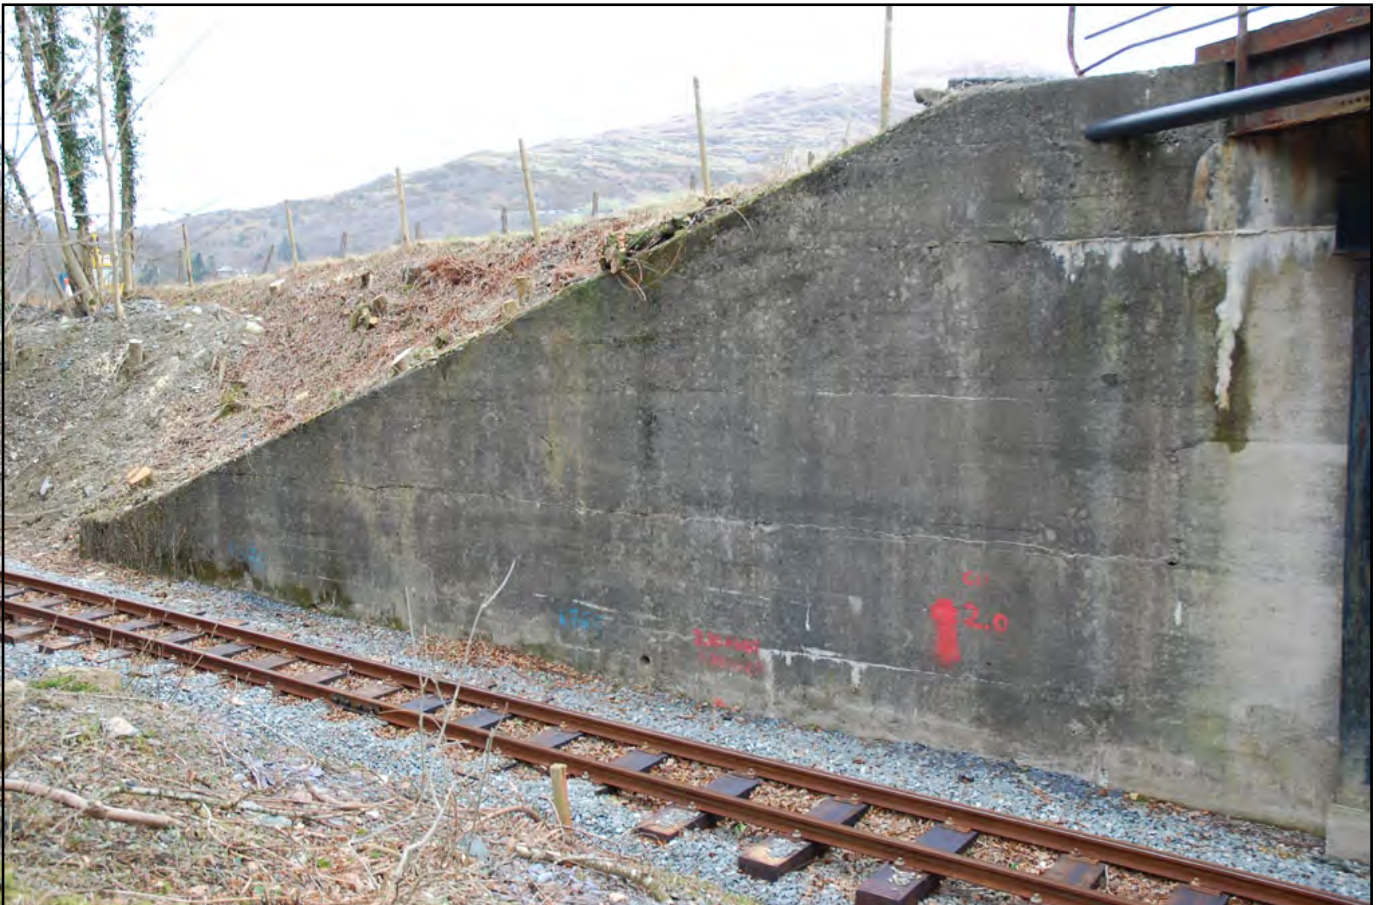
**Plate 14: close-up of concrete abutment attached to north-facing elevaton. Measures 4.97m in height and 12.2m in length**

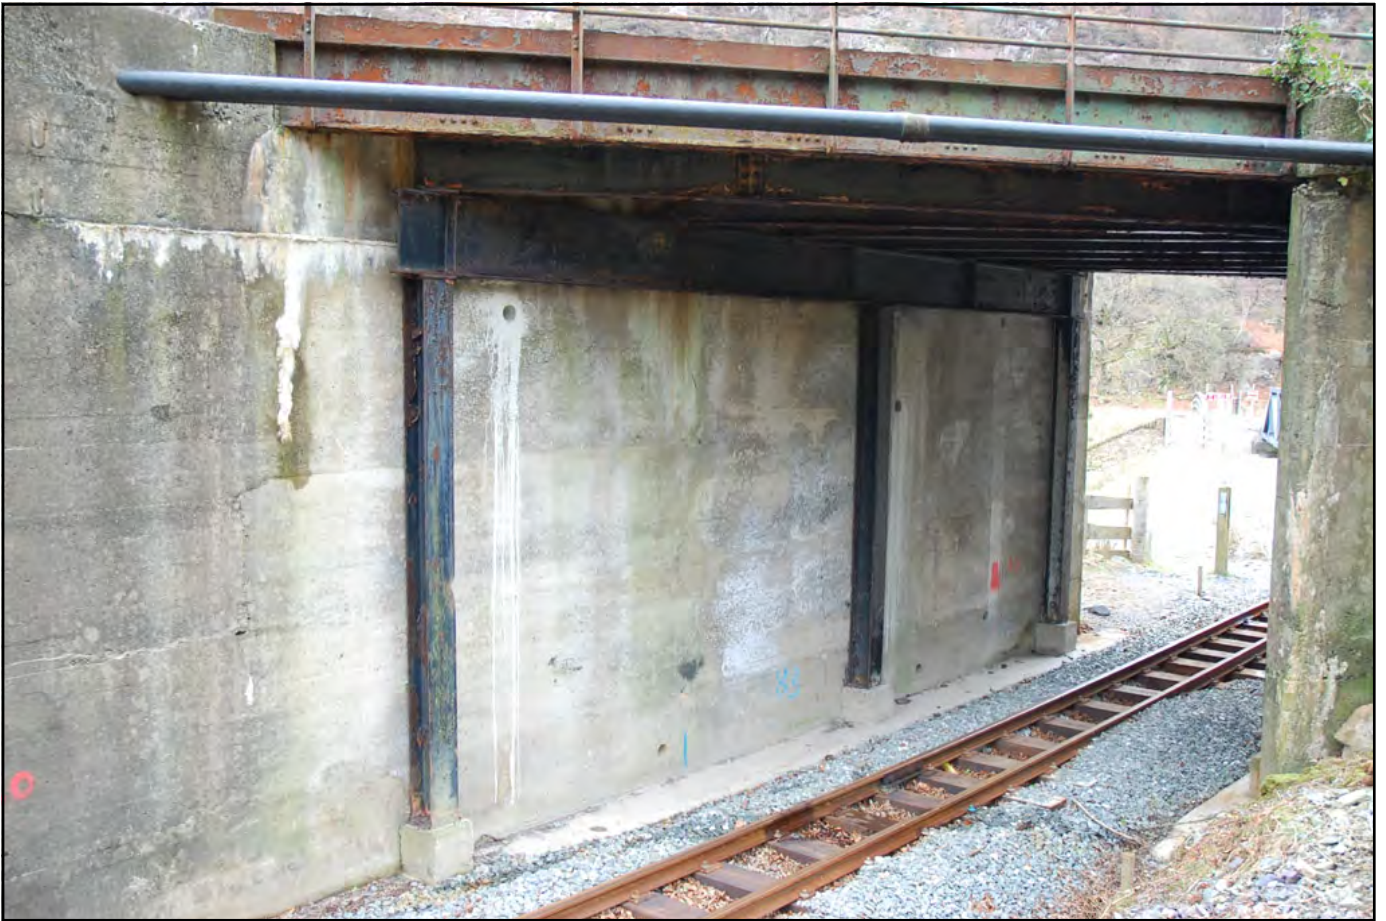
**Plate 15: detail of steel girders supporting bridge superstructure**

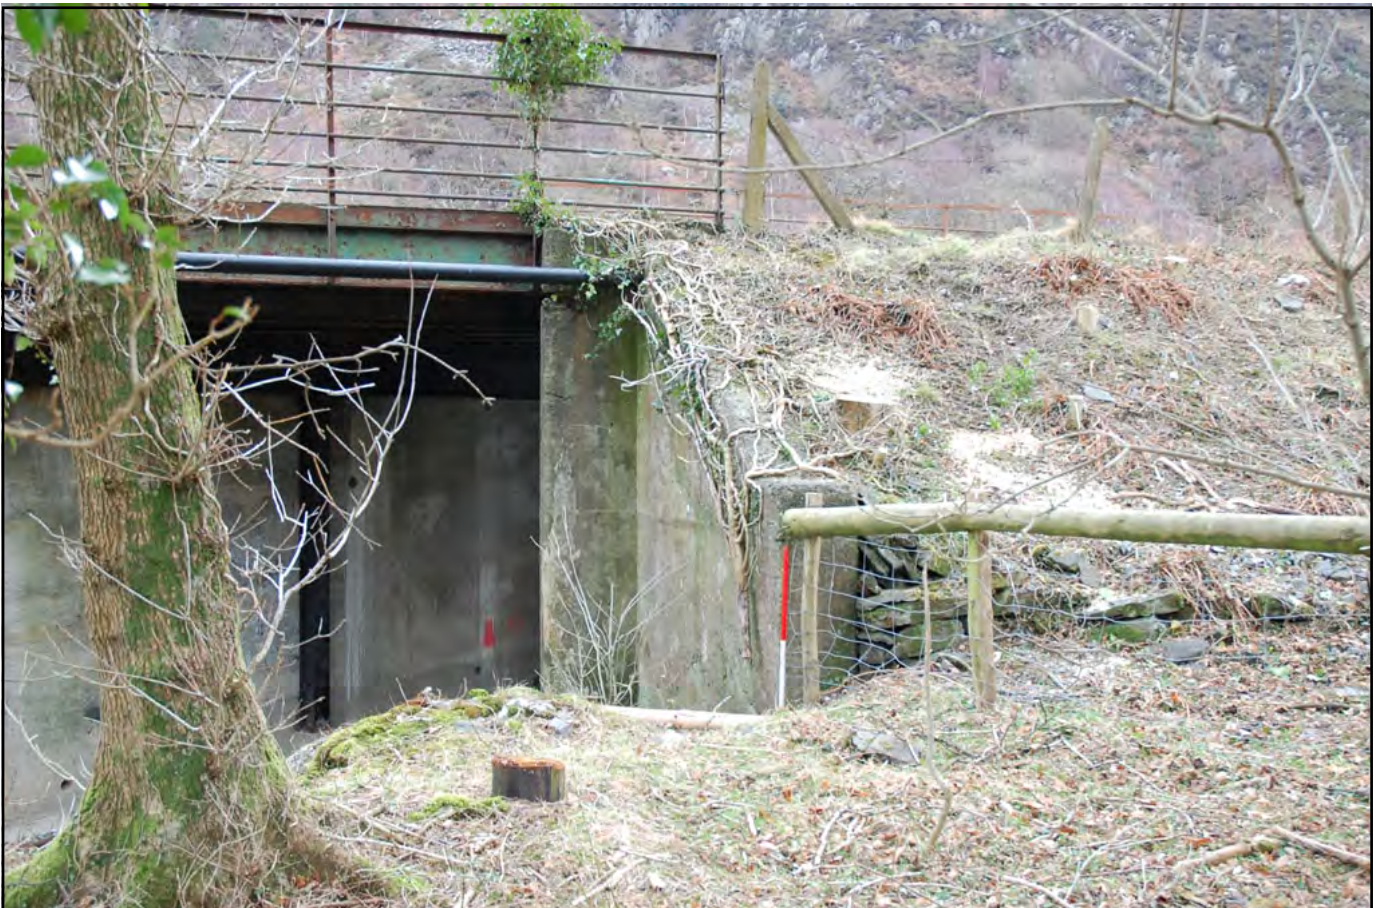
**Plate 16: detail of short concrete abutment attached to north facing elevation. Measures up to 4.97m in height and 4.06 in length**

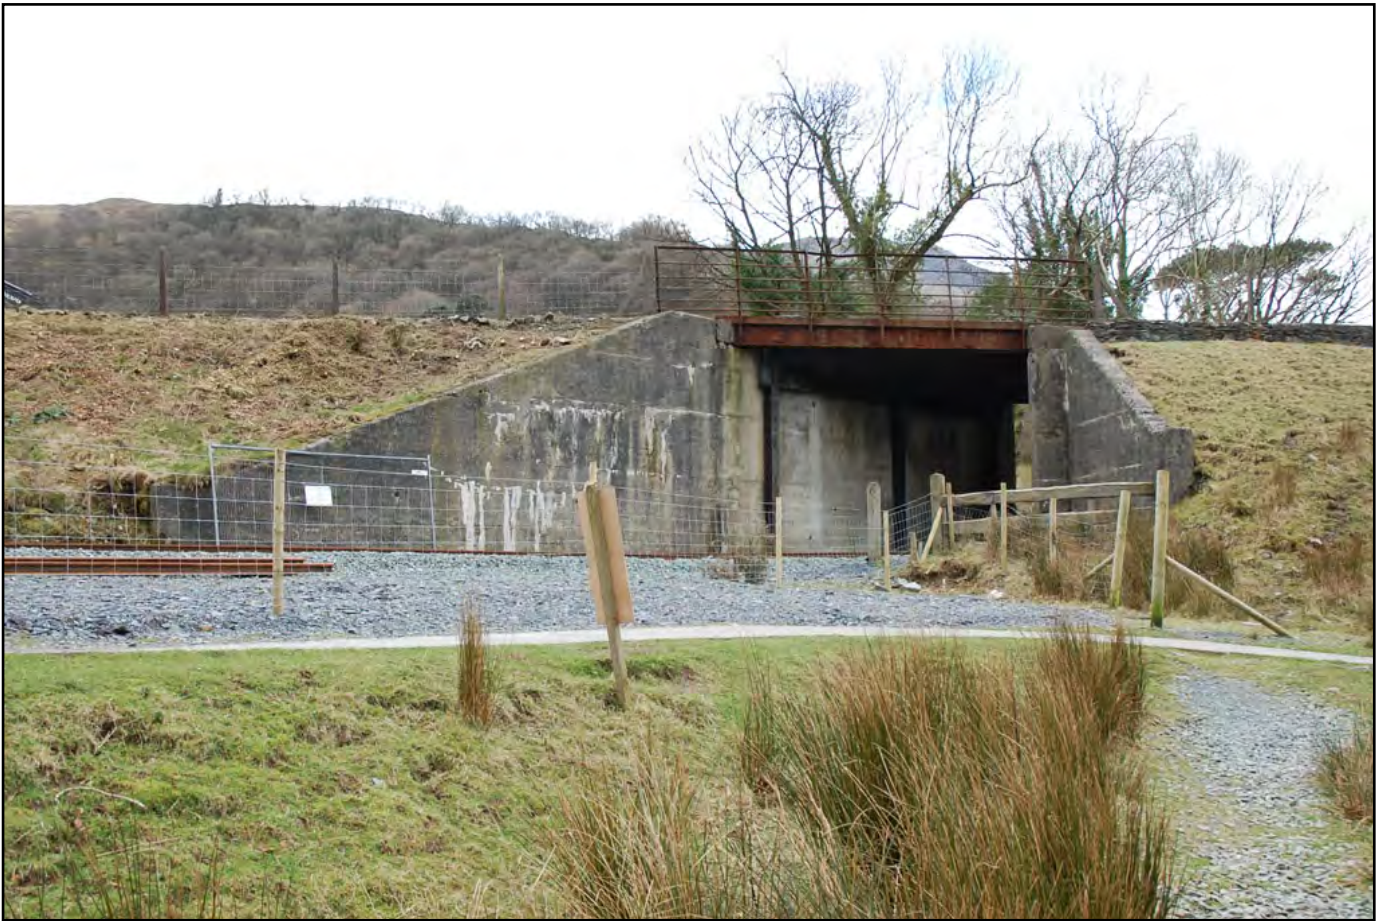
**Plate 17: south-facing elevation comprising two concrete abutments, steel girder shell, road plate and steel parapet**

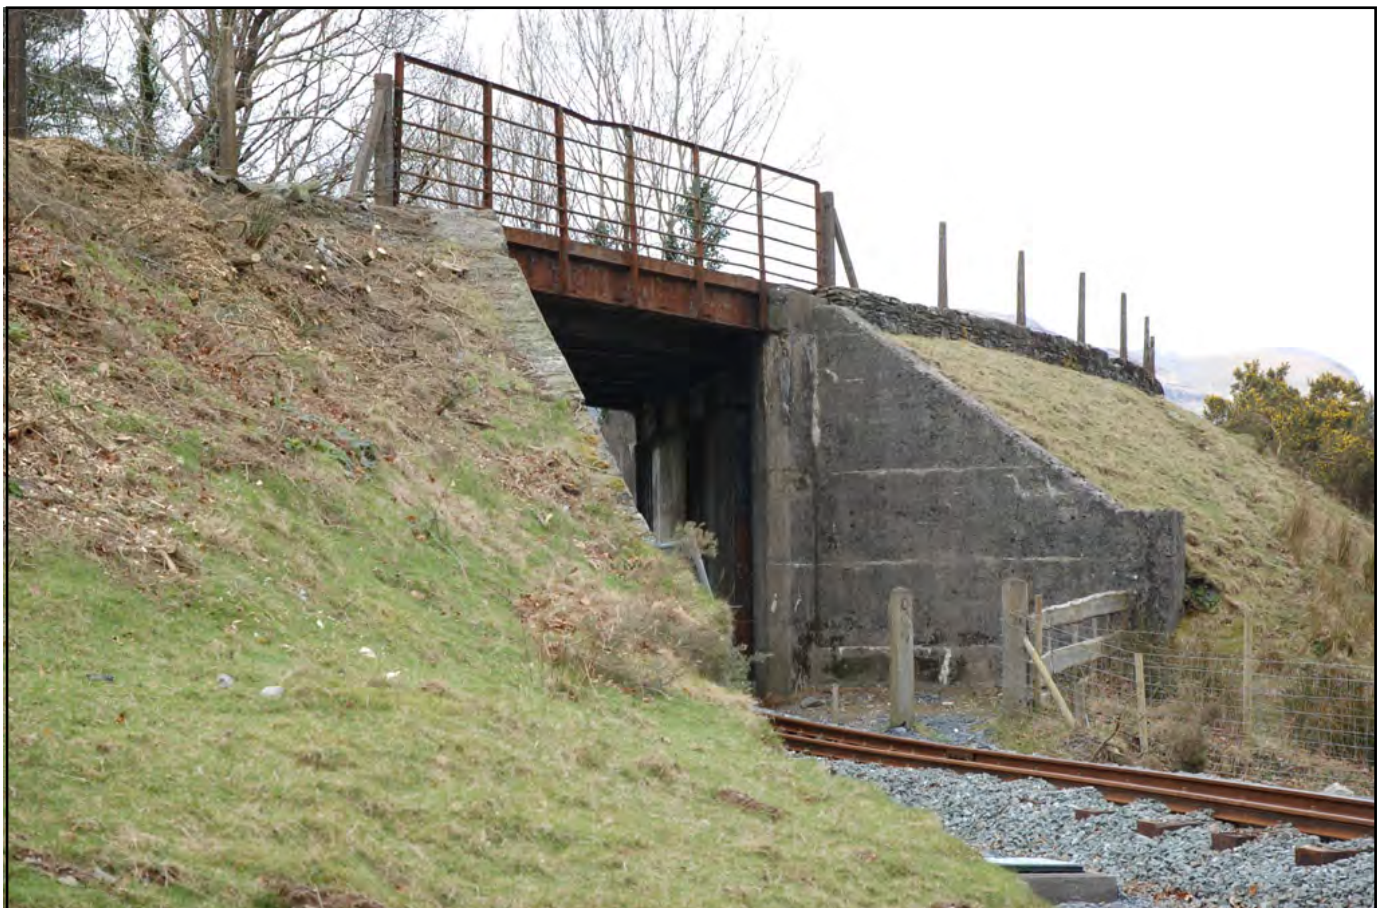
**Plate 18: short concrete abutment attached to south-facing elevation. Measures 4.97m and 3.26m in length**

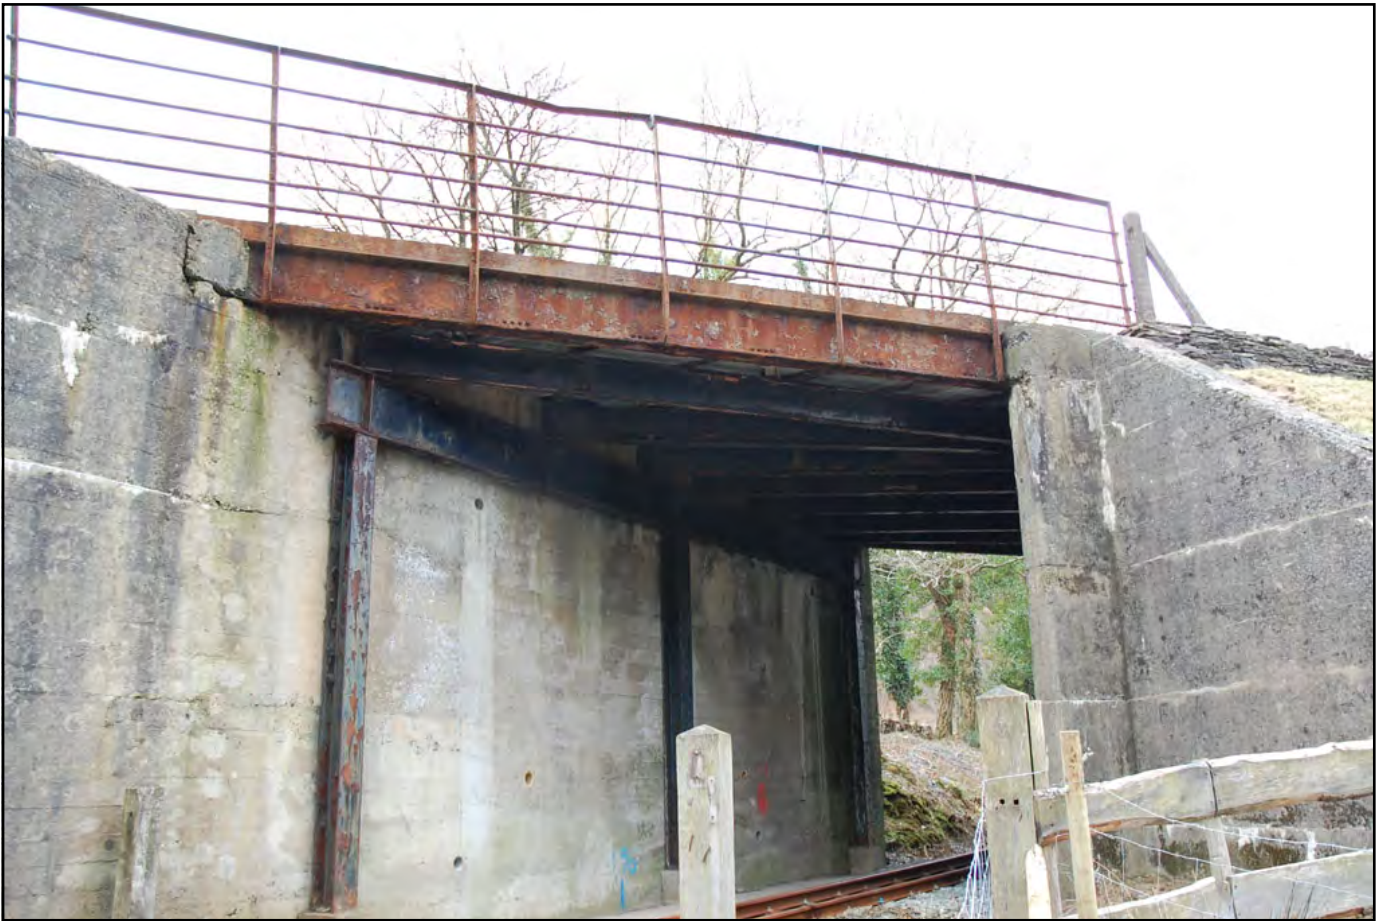
**Plate 19: detail of steel girders supporting road plate and existing parapet**

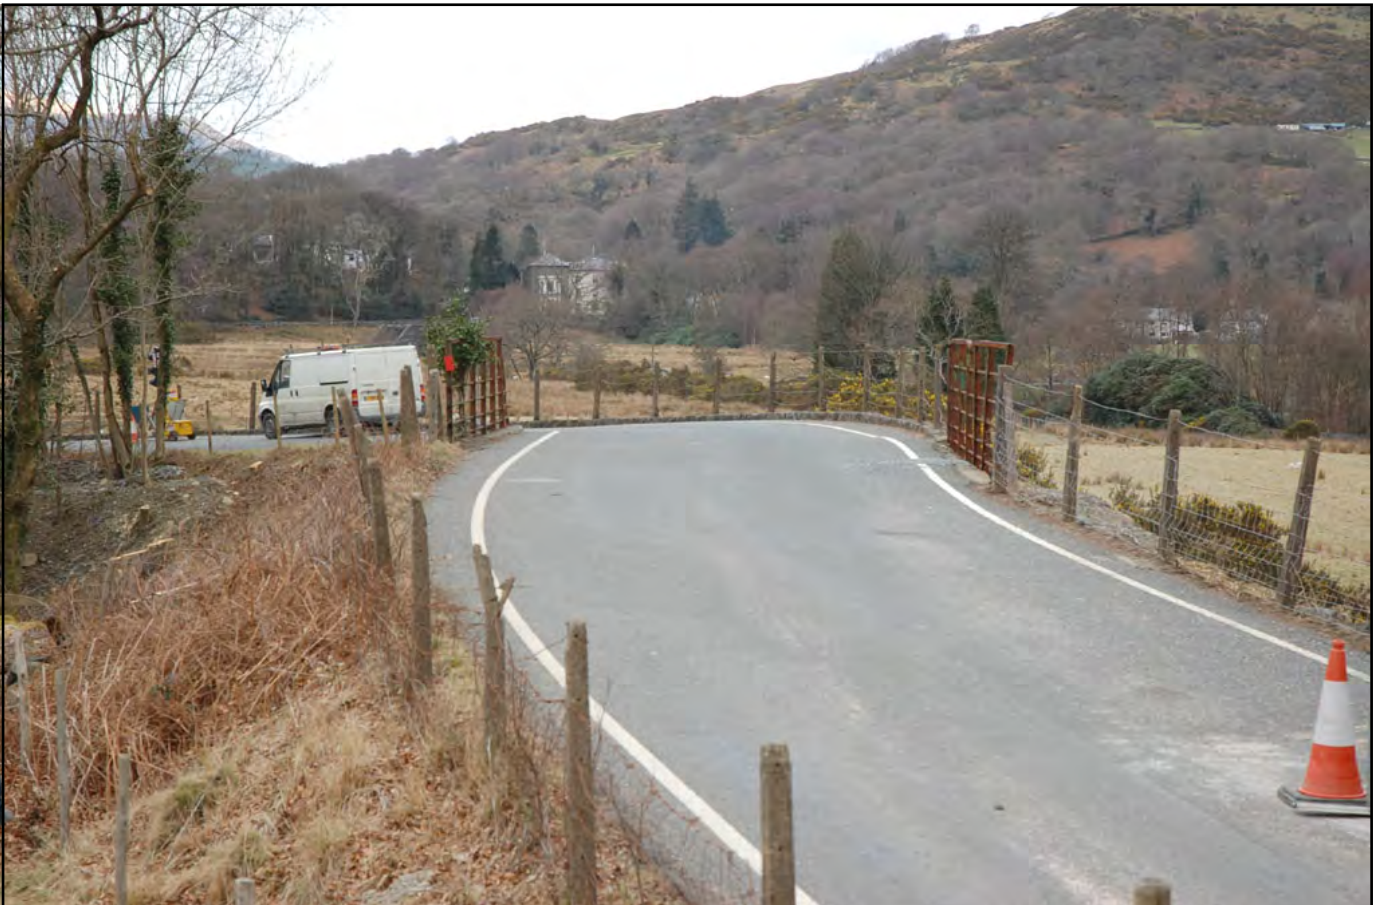
**Plate 20: view northeast of existing road bridge prior to demolition**

The road bridge was constructed between 1922 and 1923 and is built from concrete with a steel girder shell. The alteration works will include the demolition of this current structure and its replacement with a new concrete structure.

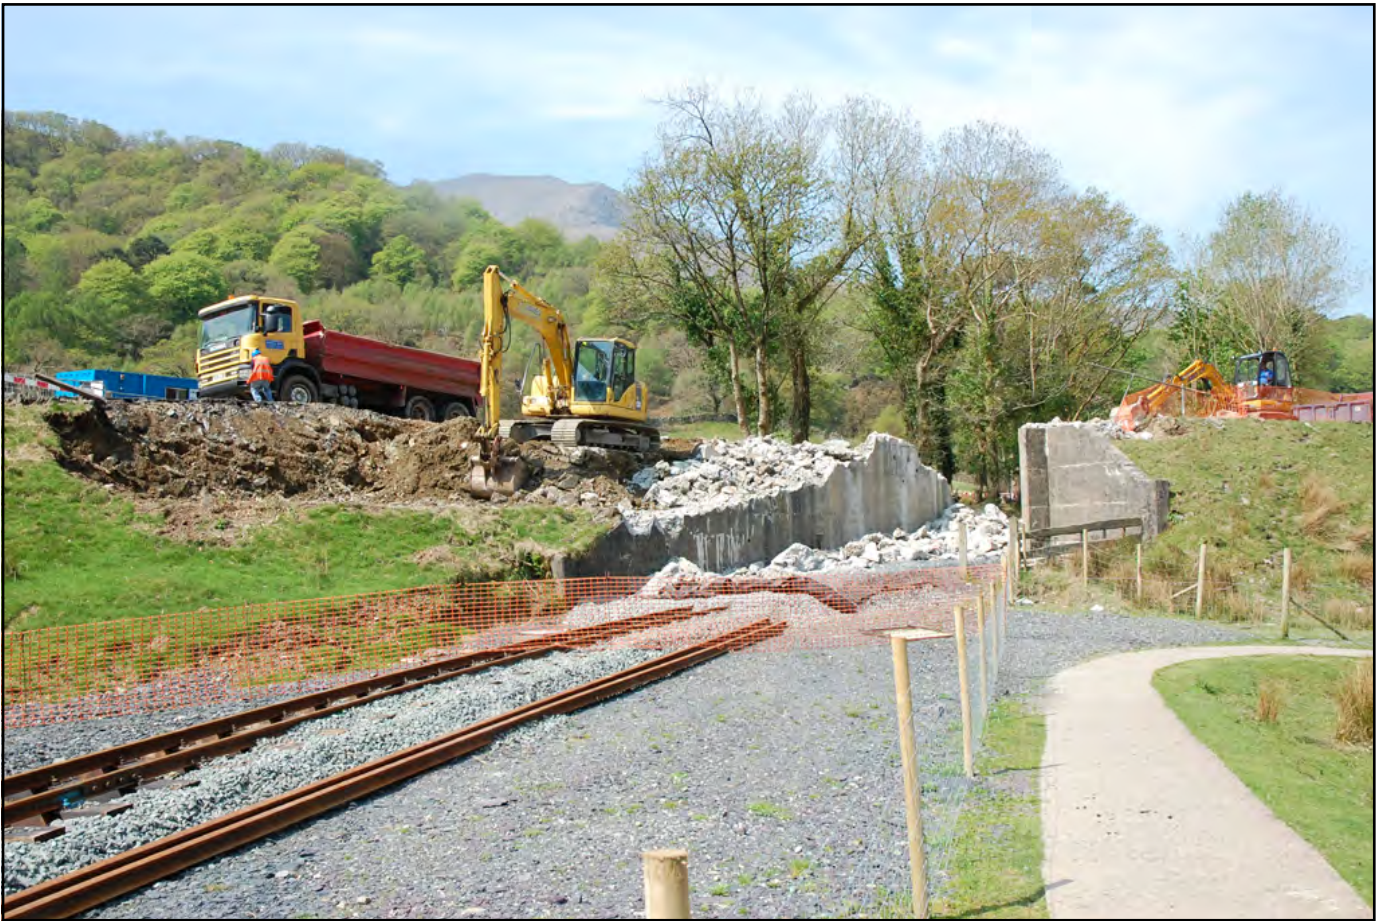
**Plate 21: View west of Pont y Felin road bridge during initial demolition phase**

Prior to the watching brief, the road and its support structure had been removed and the watching brief focused on the demolition of the main concrete abutments (north and south) and the excavation of the associated embankments that carried the road (Plates 21 and 22).

The embankments were constructed from imported material comprising building waste and bioturbated soil. Within the southern embankment, c.4.0m below the current road surface and sealed by the imported material, was a short length of stone walling, c.2.0m long and one course high, built from irregular sub-angular stone (Plate 23). This structure was interpreted as a truncated boundary wall that existed prior to the construction of the WHR railway track. An examination of the available map evidence (25” Ordnance Survey Map (1915) LXXX.5; Figure 02) suggested that the wall formed the western boundary of the original road prior to construction of the railway line/road bridge.

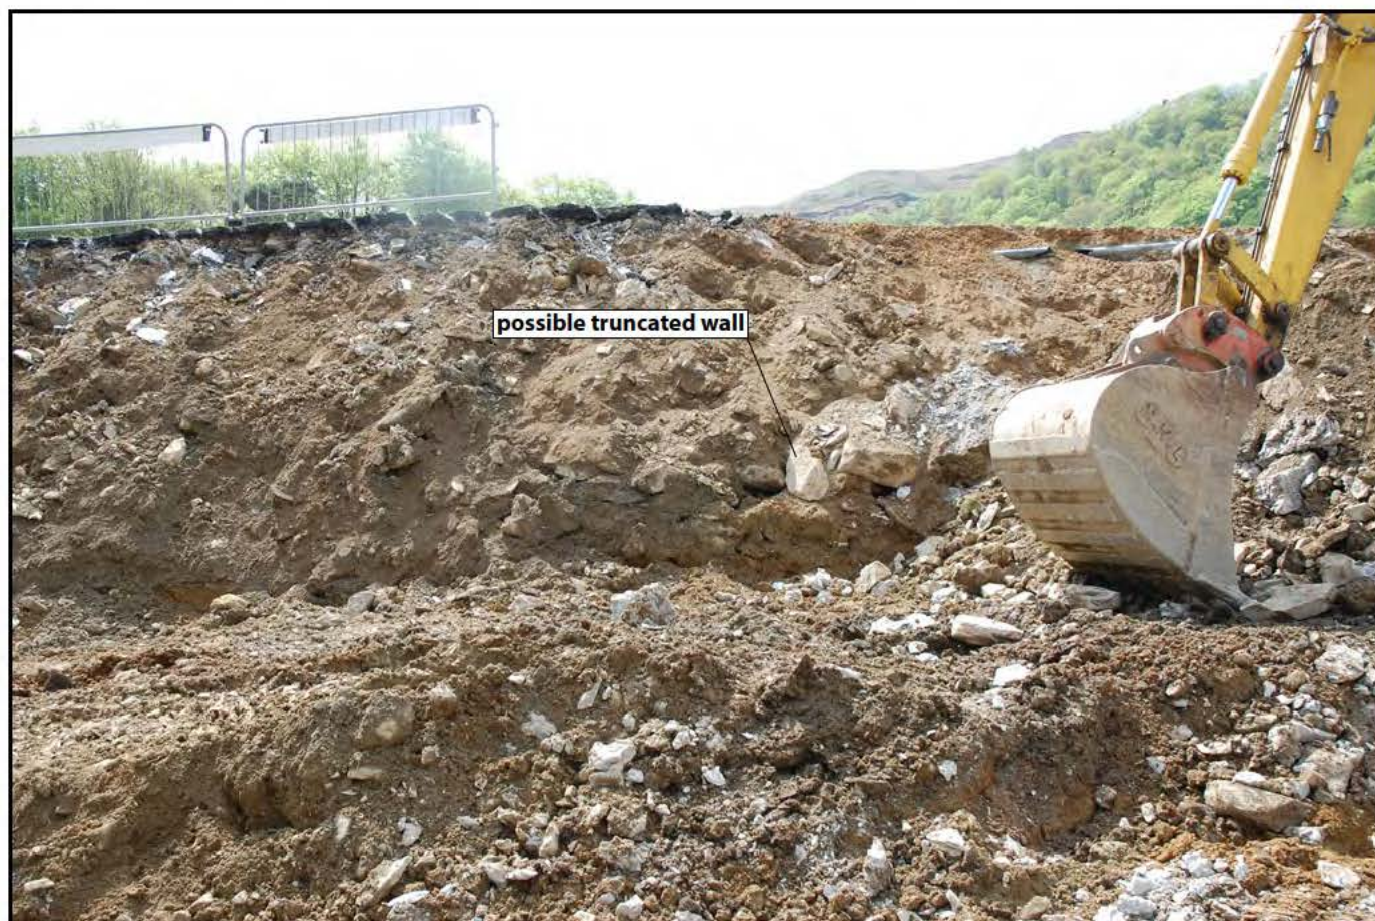
**Plate 23:** View west of the southern embankment during the excavation phase. Note the possible truncated wall to the left of the machine bucket
