# PONT BRYN Y FELIN, BEDDGELERT

## ARCHAEOLOGICAL WATCHING BRIEF

**GAT Project No. G2007**

**Report No. 731**

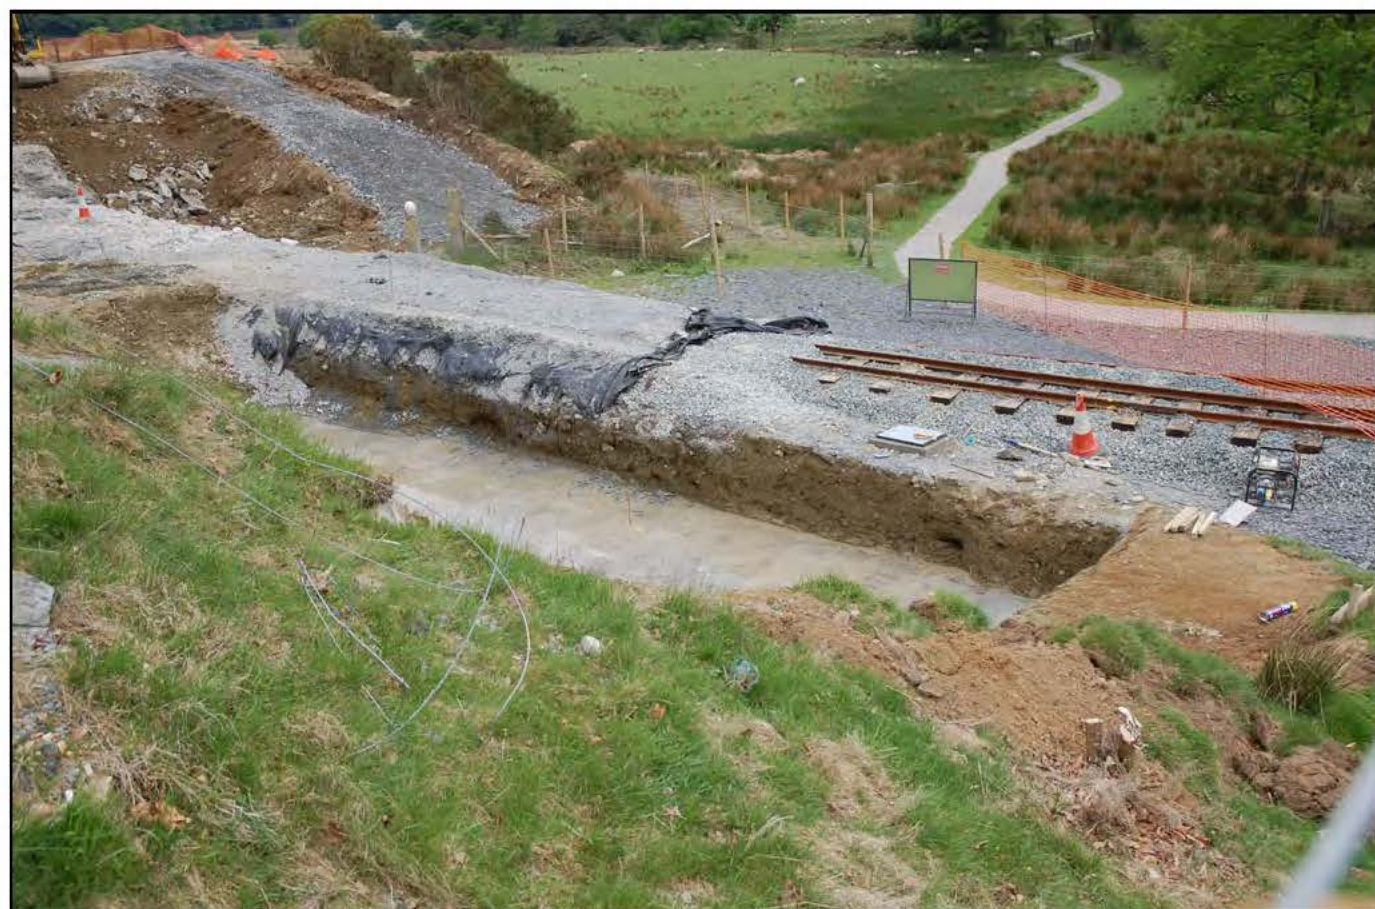
**Plate 24:** View east after excavation of southern embankment complete, detailing the glacial activity at the limit of excavation

No further activity was visible in either embankment and limit of excavation in both examples comprised Morainic Drift geology (Plate 24). No definitive evidence of the Roman Road was forthcoming at this location. The final excavation depth was 6.50m below the existing road surface.
