Industrial Recording: **Parys Mountain**

Archaeological Assessment

Report No. 743

Prepared for
CADW

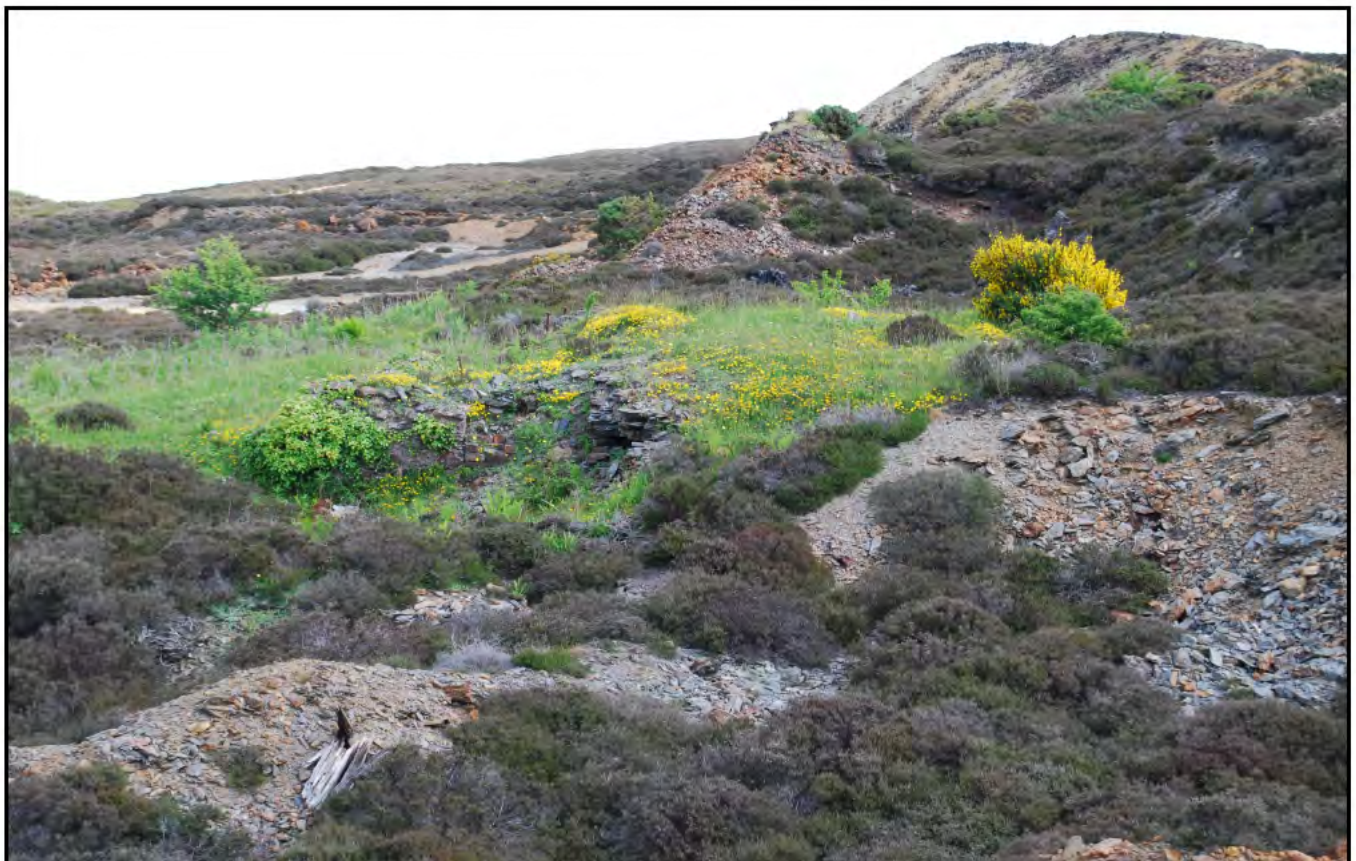
Plate 1: Gwens shaft complex facing north east

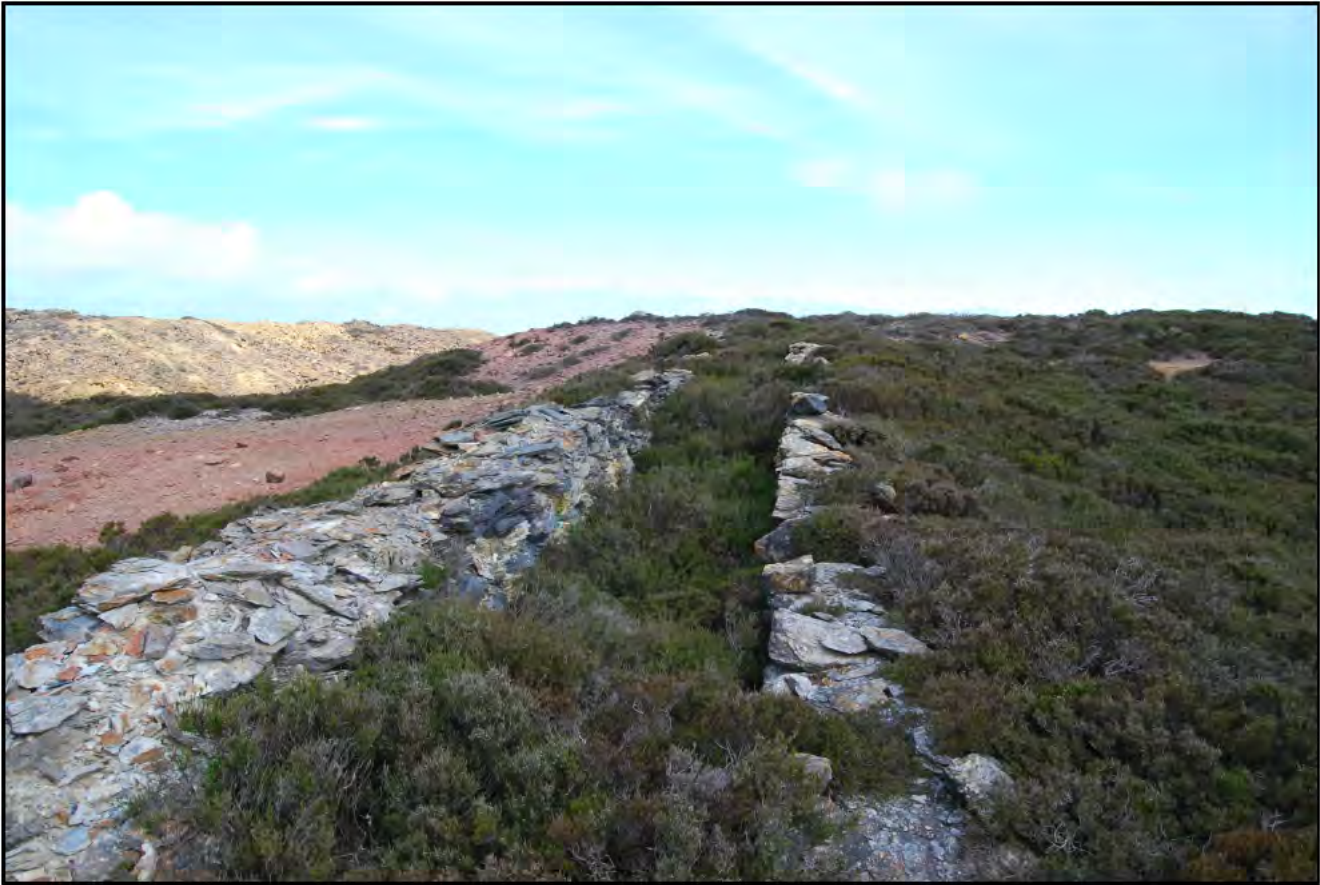
Plate 2: Feature 8 flue facing north

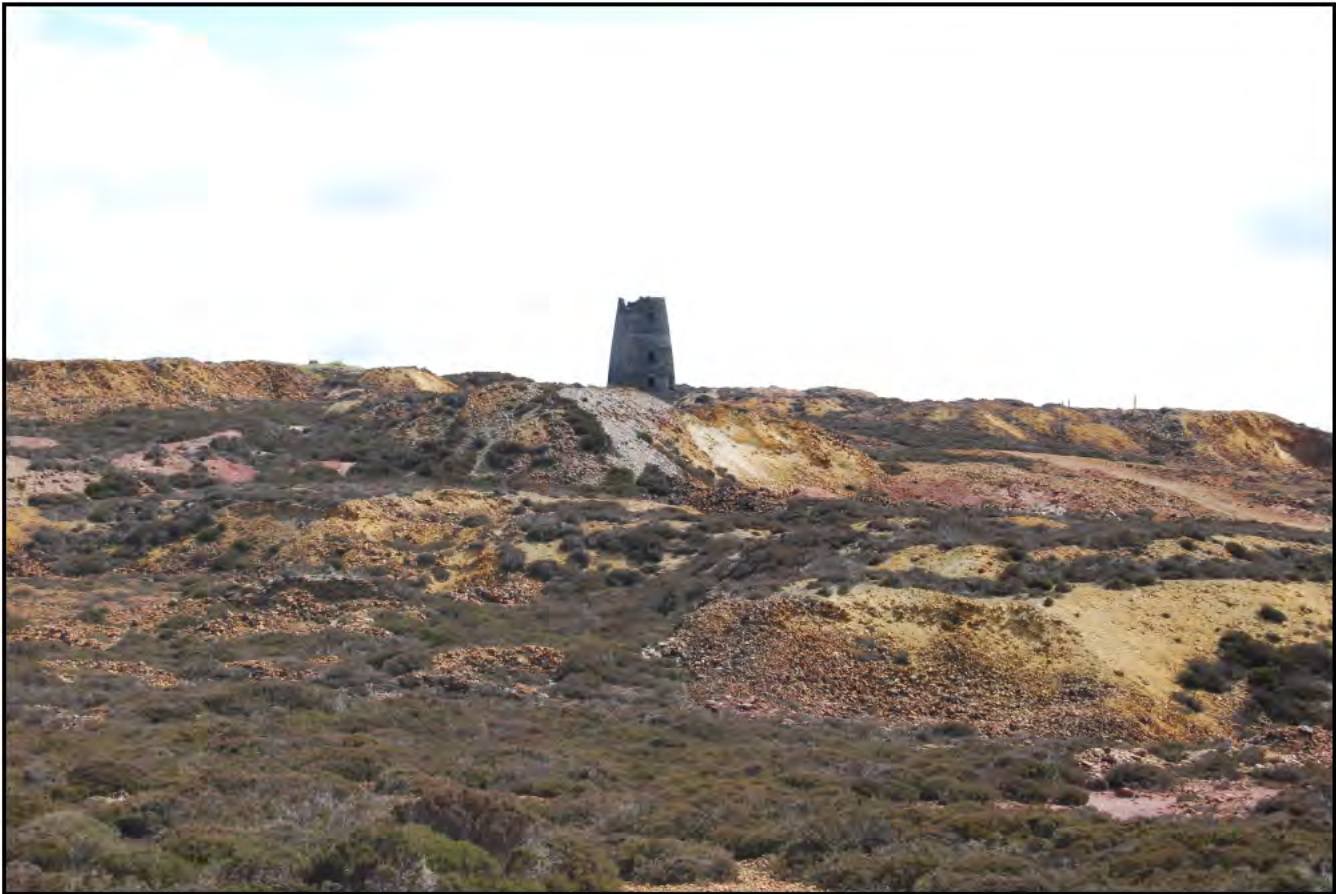
The Cairns windmill is a stone-built conical tower mill, which measures 8m in diameter across the base and stands approximately 20m high. Uniquely for Anglesey, it was a five-sailed mill; the cap and all the machinery are missing, but it is believed to have contained an upright shaft driven by bevel-gearing from the sail-shaft, which in turn operated 200' of flat-rods by means of a crank in its foot. The flat-rods operated a pump in Cairns' shaft, and were supported on intermediate dolly-posts. The windmill was still operating in 1901.⁹⁹ Its importance as the only surviving pump-windmill in an extractive industry in Britain was recognized by scheduling as an Ancient Monument in 1995.

Plate 3: Windmill facing north east

Mitigatory recommendations: Level 5 survey. This feature is a Scheduled Ancient Monument, and is also an element in a lichenological SSI.

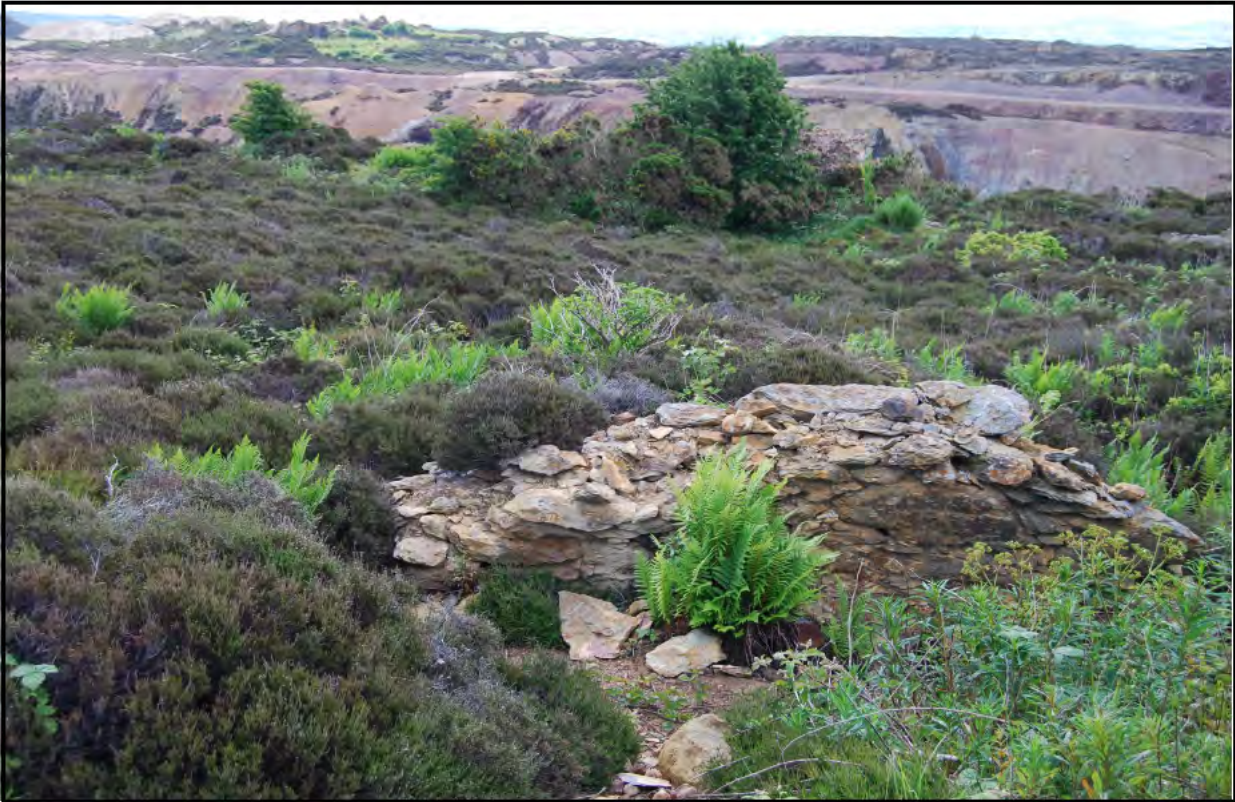
Plate 4: Parys mine yard facing east

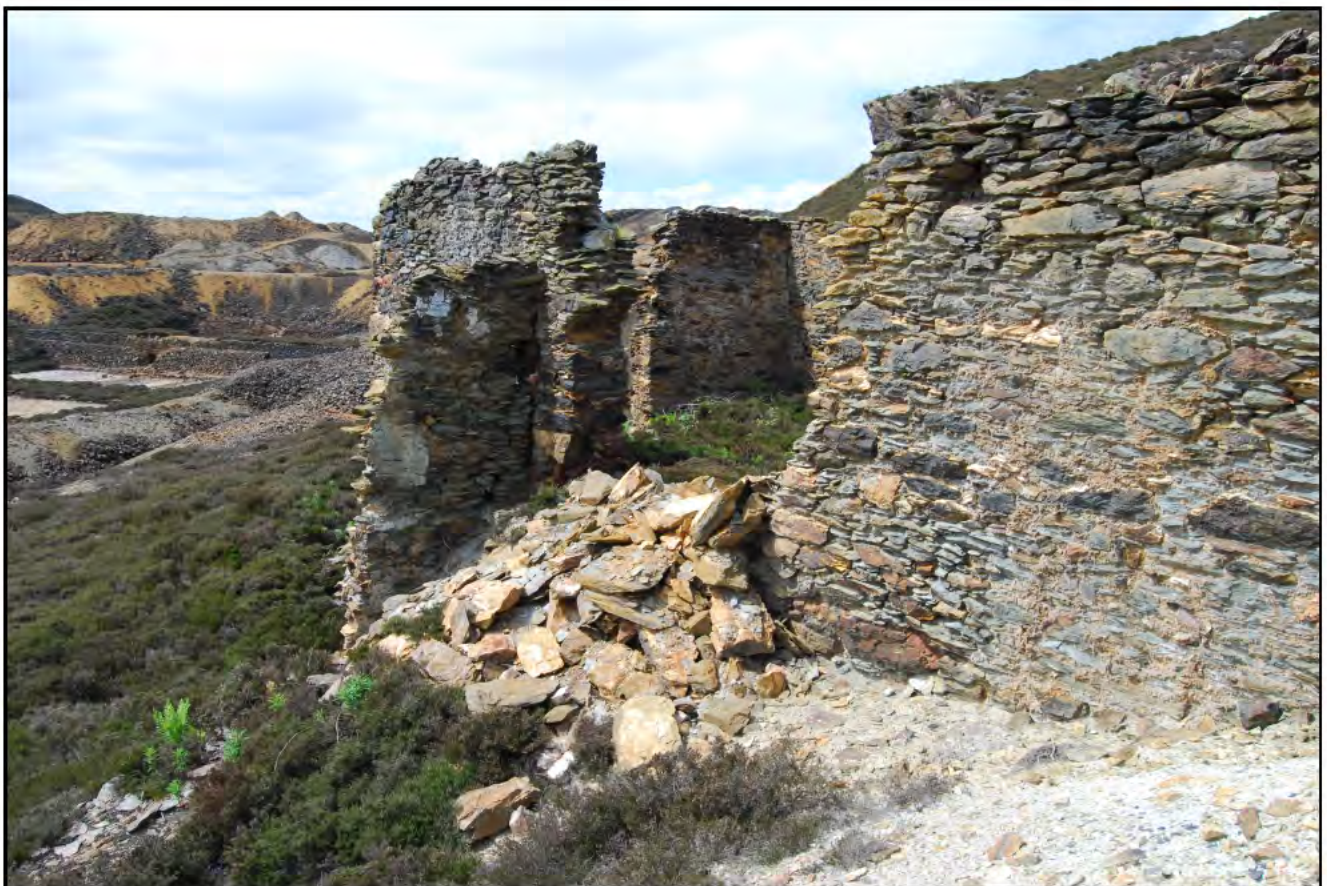
Plate 5: Mona calciner facing south west

Based on the results of the on-site assessment at Parys Mountain and the information detailed within the gazetteer, it is recommended that the Mona Calciner (Area 7) is in a very fragile state and a full EDM, REDM and photographic survey is recommended of this building as well as its associated features.
