## A470 CARDIFF TO GLAN CONWY TRUNK ROAD: **GELLIGEMLYN ARCHAEOLOGICAL RECORD (G1644)**

GAT Project No. 1644

Report No. 765

December 2008

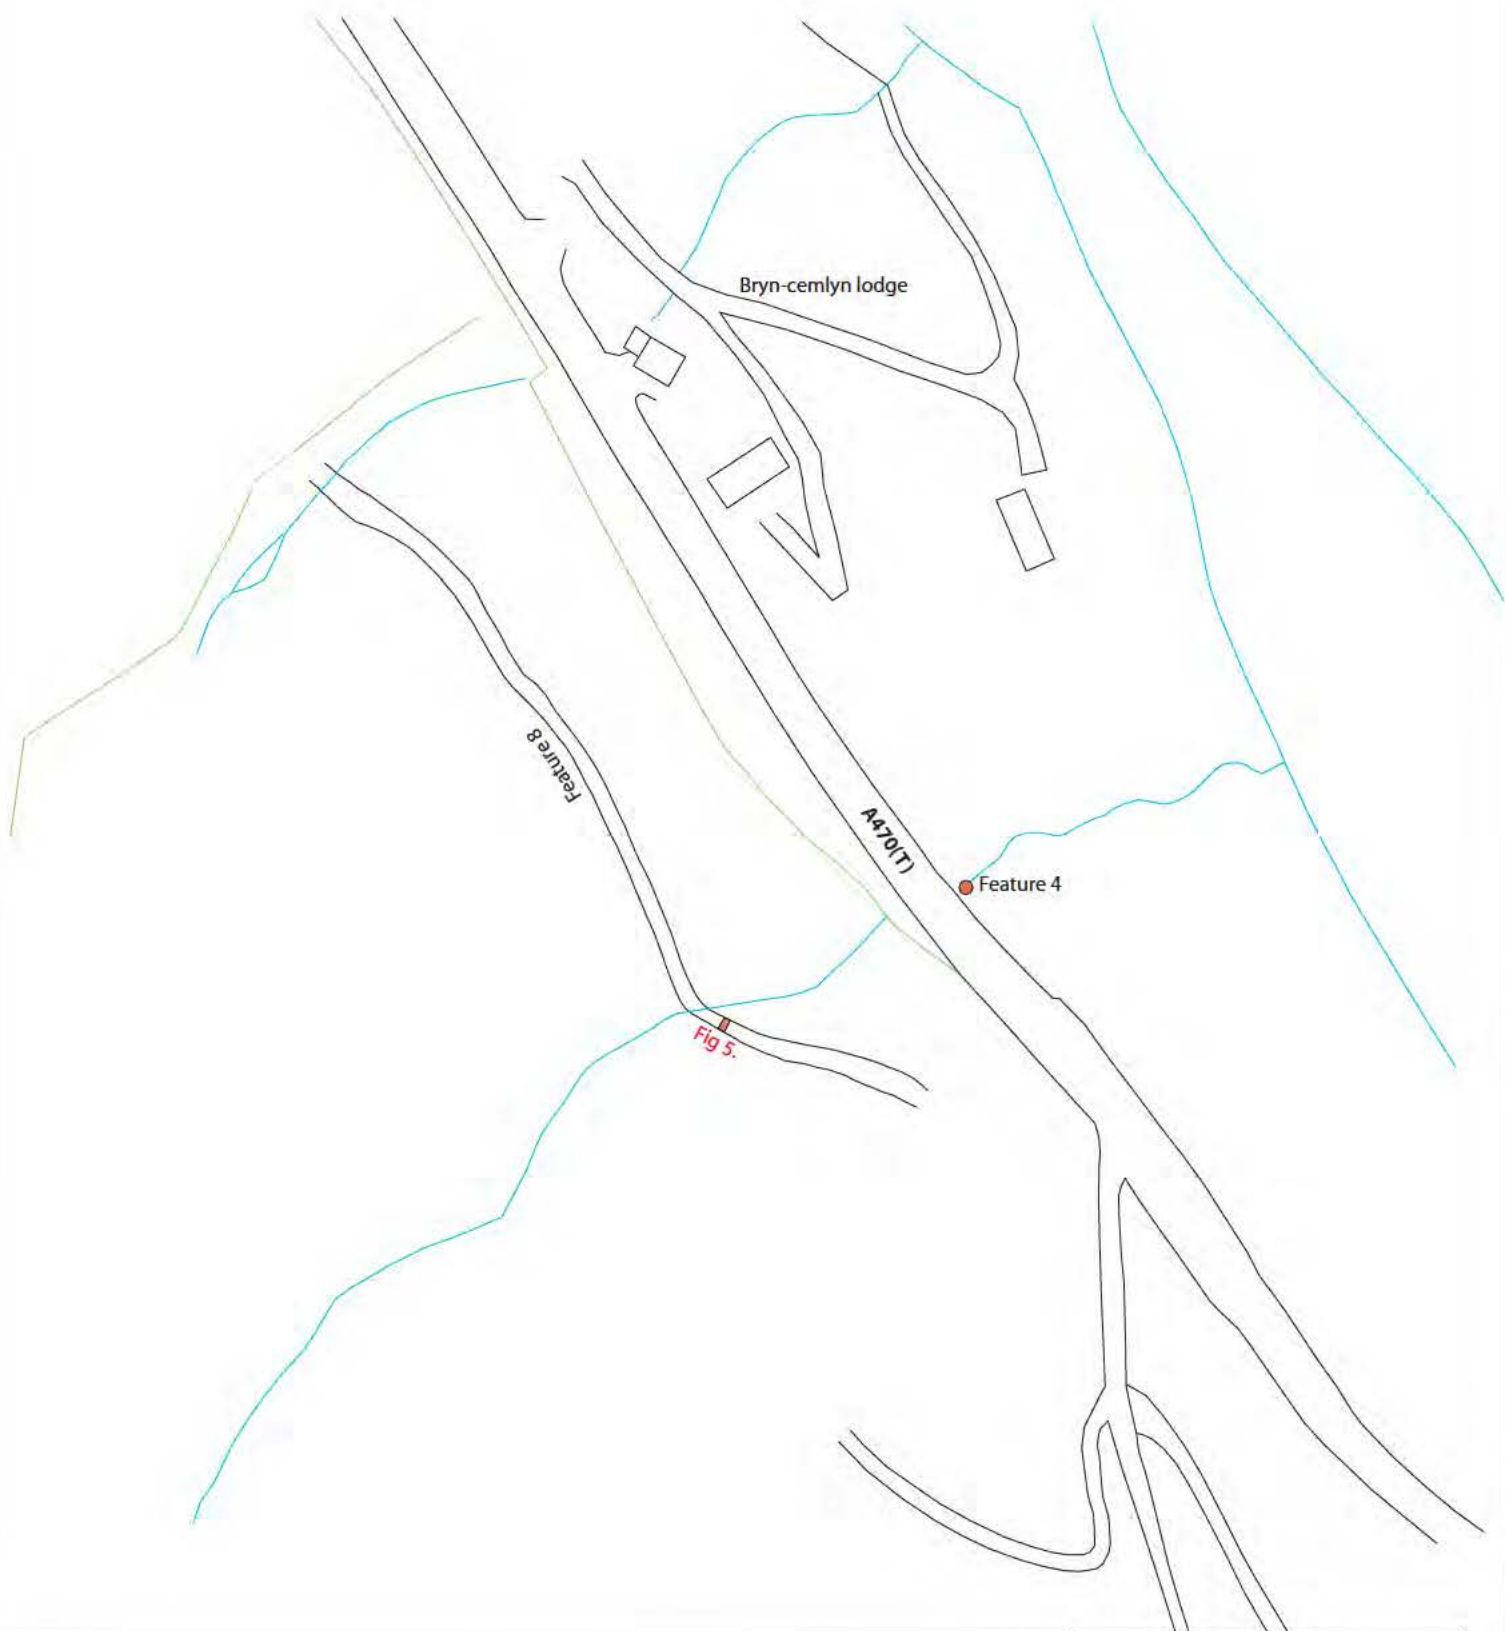
**Figure 3. Location of Features 4 and 8**  
Scale: 1:1250@A4

A concrete culvert in sections measuring 0.9m x 0.6m is built through the eastern revetment wall of the A470 (T) and channels the stream beneath the current A470 (T) for approximately 10.0m. A second, overflow culvert pipe 0.2m in diameter is located 3.0m above the top of the main pipe, and both feed into an iron trough of dimensions 3.5m long and 1.5m wide. The purpose of the iron trough is to clear the stream water well away from the revetment wall before re-feeding it into the original stream course.

A track or path averaging 1.0m in width but extending to 3.5m in width in places runs parallel to the existing A470 (T) to the northwest of the scheme. Occasional lengths of dry-stone revetment wall can be traced below the path in places, and the feature crosses two tributary streams as it heads south before becoming untraceable in the former plantation. The track is depicted on the OS 6 inch 1880 edition and may well be the remains of an early route along the valley. The track is particularly well preserved to the north of the most northerly stream crossing, with stone built buttresses three courses high, suggesting the remains of an early bridge construction. The feature remains only obvious as a terrace in the natural western valley slope south of this point, and becomes particularly difficult to locate once it has traversed the most southerly stream.

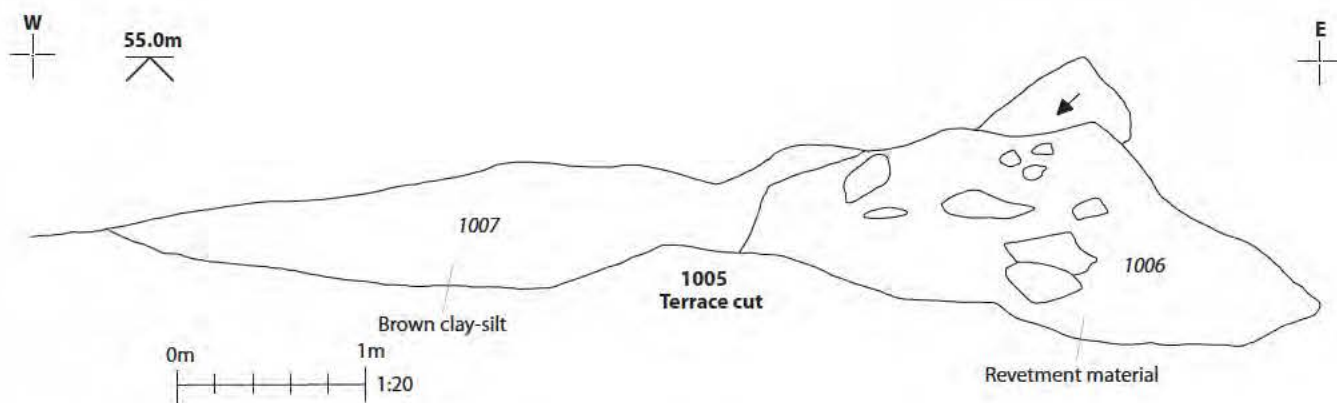
Figure 5: South facing section through feature 8, Track-way.

An excavated section across this feature (figure 5) has revealed that the track was constructed by a substantial terrace being cut (1005) into the hillside for approximately 180.0m throughout the steeper slopes of the valley. This terrace begins by running southeast to northwest for 20.0m, then turns west for 30.0m before running northwest again for 130.0m. Due to the very nature of the terrace being cut into the hillside the actual depth of the cut is not discernable, however it must total several metres deviation from the natural incline, especially on the western edge. The terrace created a flat footing for the construction of revetment material (1006) on the eastern edge, which undoubtedly reduced erosion of the oblique edge and reinforced the edge of the track. This revetment material consisted of orange-brown clay-silt with frequent large and medium sub-angular cobbles, with no binding medium. Despite the apparent natural silting of the track by a mixed brown clay-silt (1007), no finds were located or any direct dating evidence.

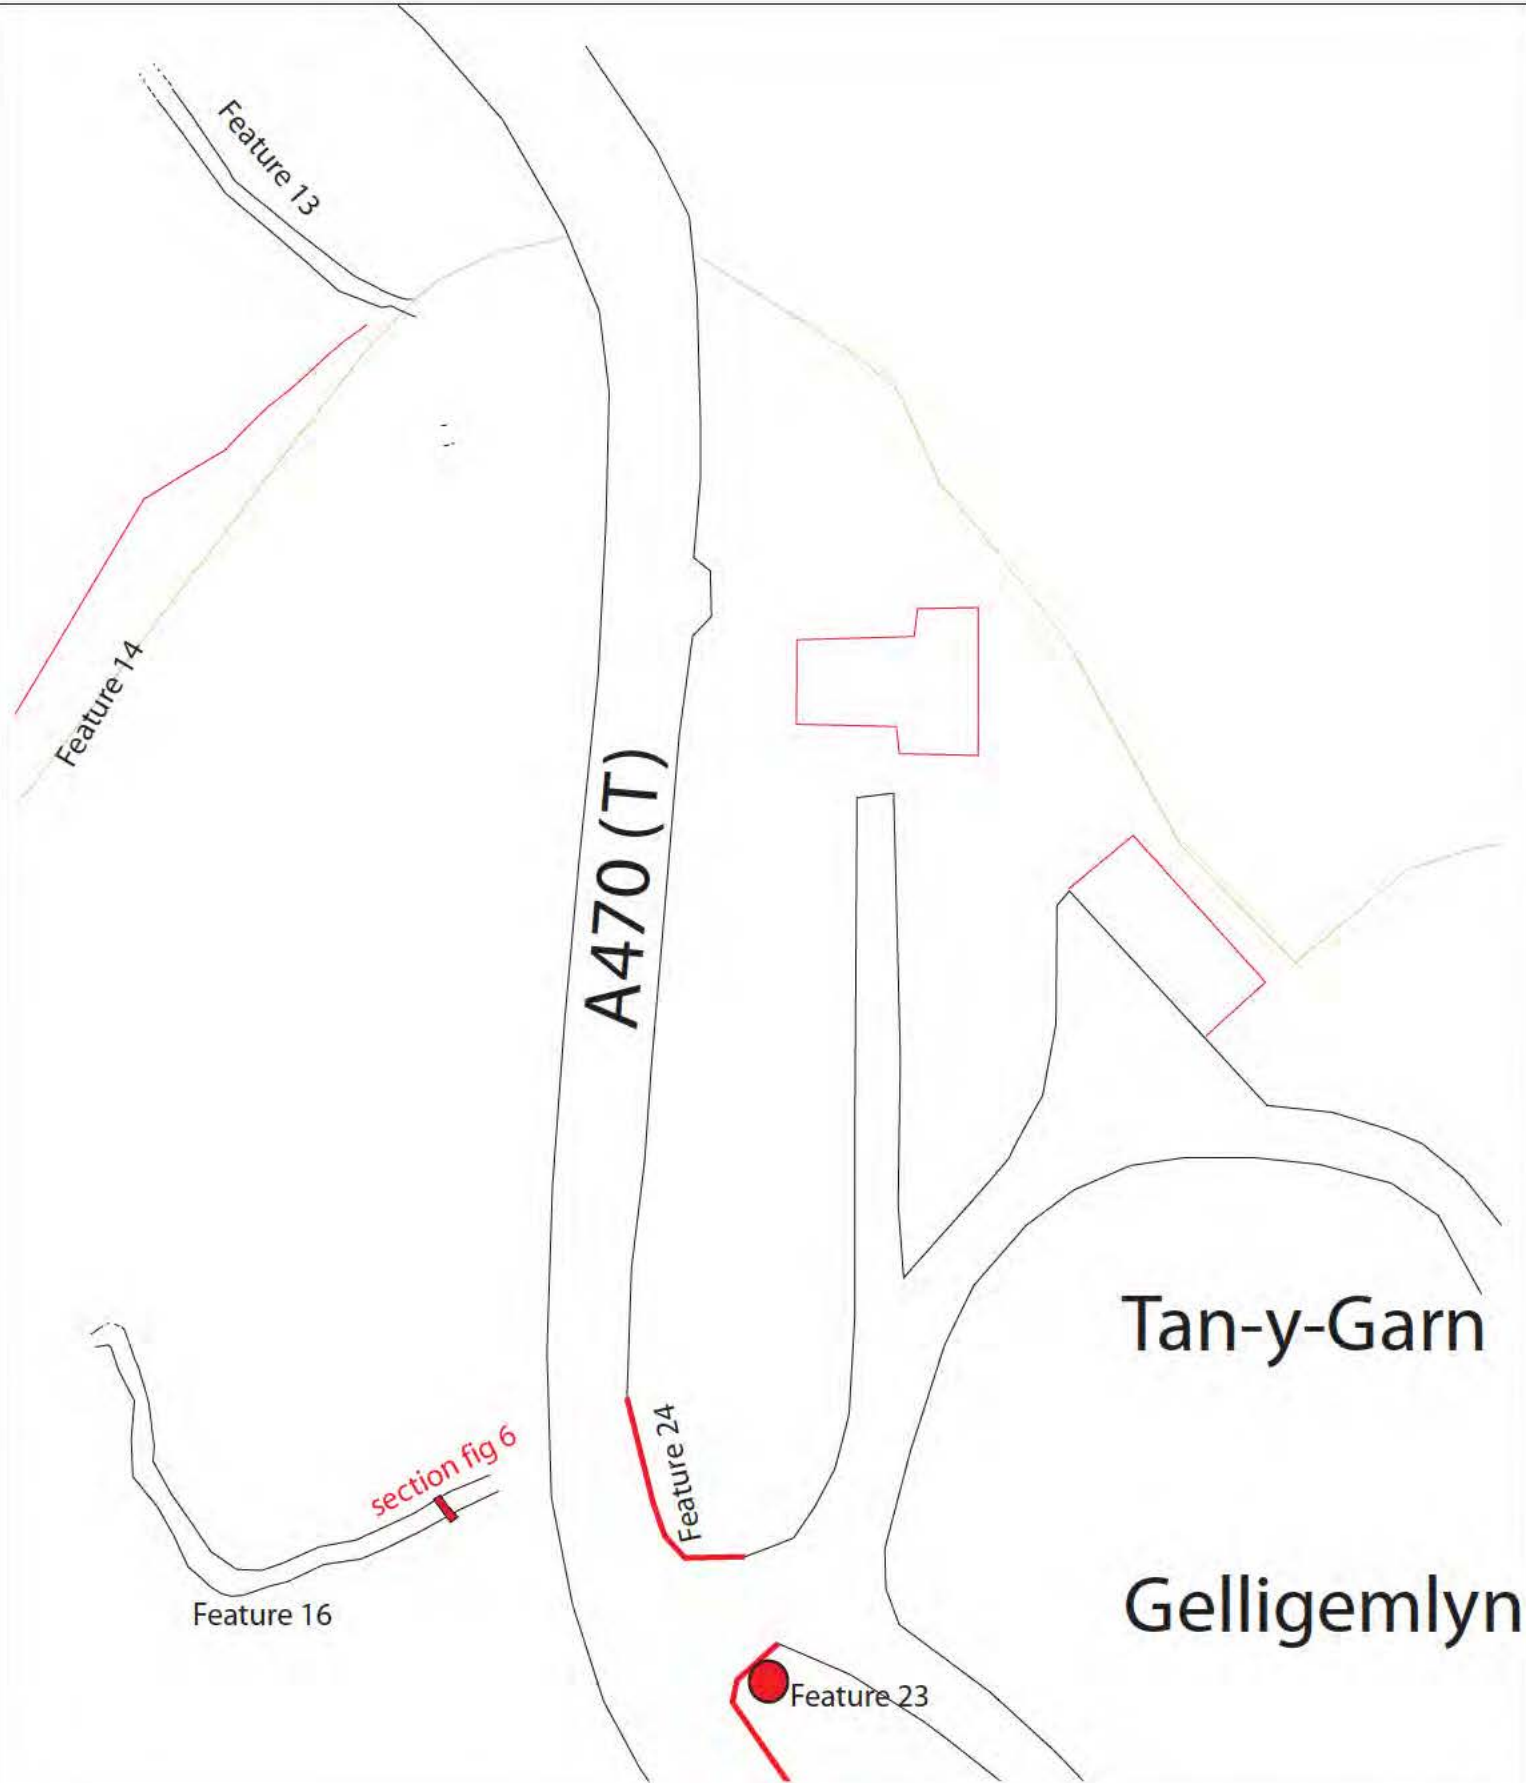
**G1644 Gelligemlyn,  
A470 (T) Scale: 1:500@A4**  
**Figure 7. Location of Features  
13, 16, 23 and 24**

This feature was particularly difficult to locate in its entirety and it must be conjectured that the dynamic flux of the dense vegetation has rendered substantial parts of it hidden. Nevertheless, upon removal of overlying vegetation a significant portion was rediscovered. The track consists of a roughly flat area approximately 2.0m in width, located 15.0-20.0m southwest of and running parallel to the A470 (T). Occasionally the feature becomes mildly concaved and has occasional large, angular schist blocks which are almost certainly the remnants of a revetment structure.

This track averaged approximately 1.5m in width and was terraced into the western hillside, zigzagging up the slope away from the current road. An excavated section (figure 4) across the track showed it to be well constructed, with a fairly regular terrace cut (1001) being concaved with a mildly undulating base. The cut was filled by a mid ginger-brown sand-silt with approximately 70% medium-sized, angular cobbles on its southerly edge (1002). This undoubtedly formed a revetment structure which prevented erosion on the outward edge. Despite the track having silted up naturally over time with a dark brown sand-silt (1003), its characteristics were still obvious, although no dating evidence could be found.

A single slab of dimensions 0.66m x 0.4m x 0.16m stands just within the grounds of the Gelligemlyn estate, immediately to the south of the most southerly entrance wall. The stone appears to be worn sandstone and is inscribed with 'To Dolgelley 4 Trewsfynydd ?'.

The stone built entranceway to the Gelligemlyn estate is 0.95m in height and is constructed of large and medium sized cut granite blocks averaging 0.6m long and 0.23m deep, bonded by mortar. The two stone entrance piers stand 1.43m in height with a roughly chiselled granite block 0.27m in diameter adorning the top. The wall is mostly four courses high and appears to be a more recent addition to an earlier dry-stone wall, constructed of medium rounded and sub-rounded river cobbles located 10.0m to the south. This earlier wall is 0.7m high and 1.0m wide, and projects 0.45m further to the east than the later entrance wall. This suggests that the Gelligemlyn entrance wall originally ran closer to the estate than the current alignment.

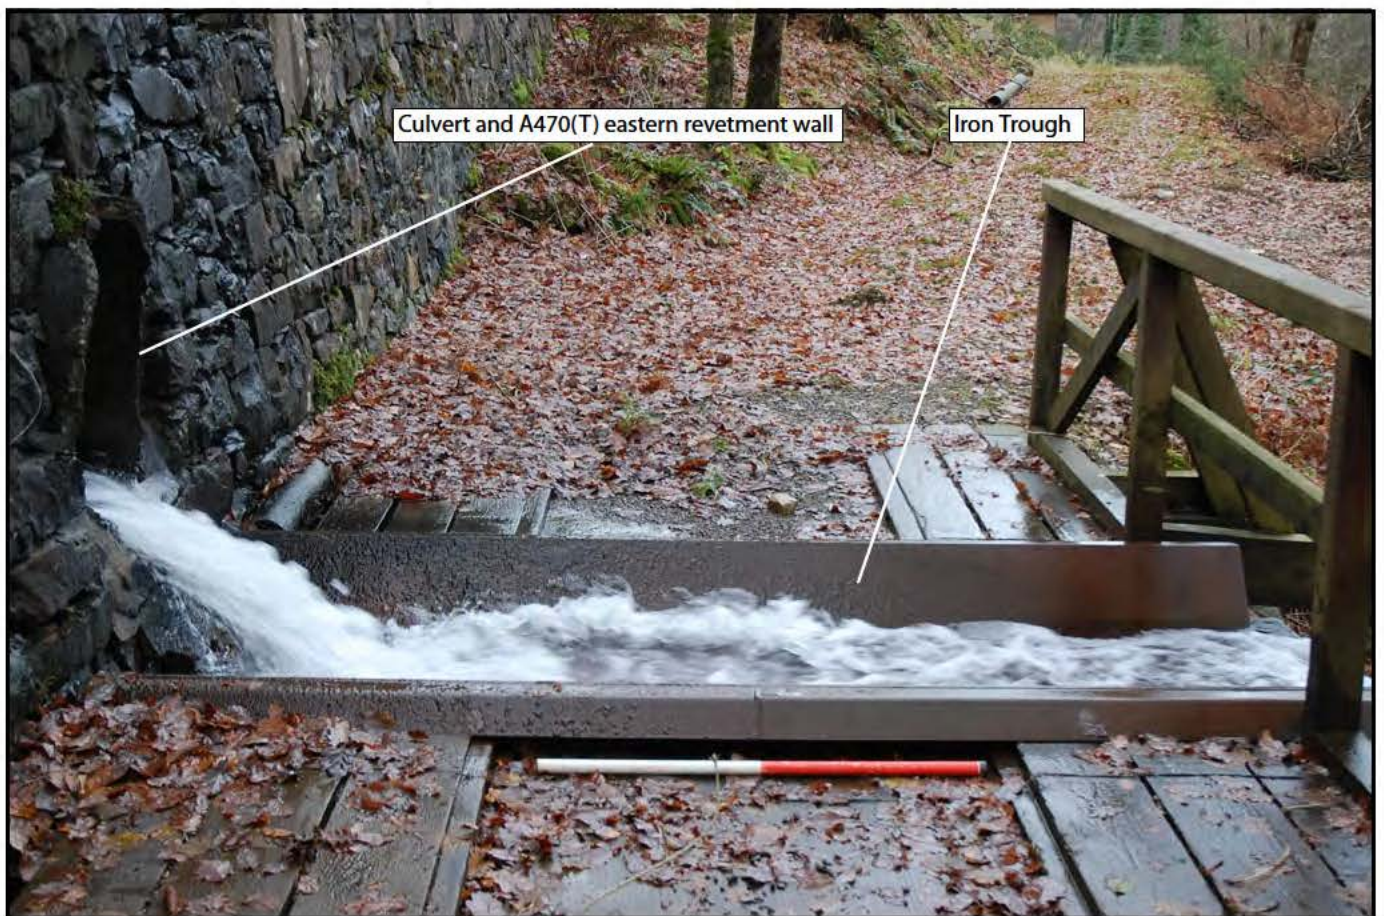
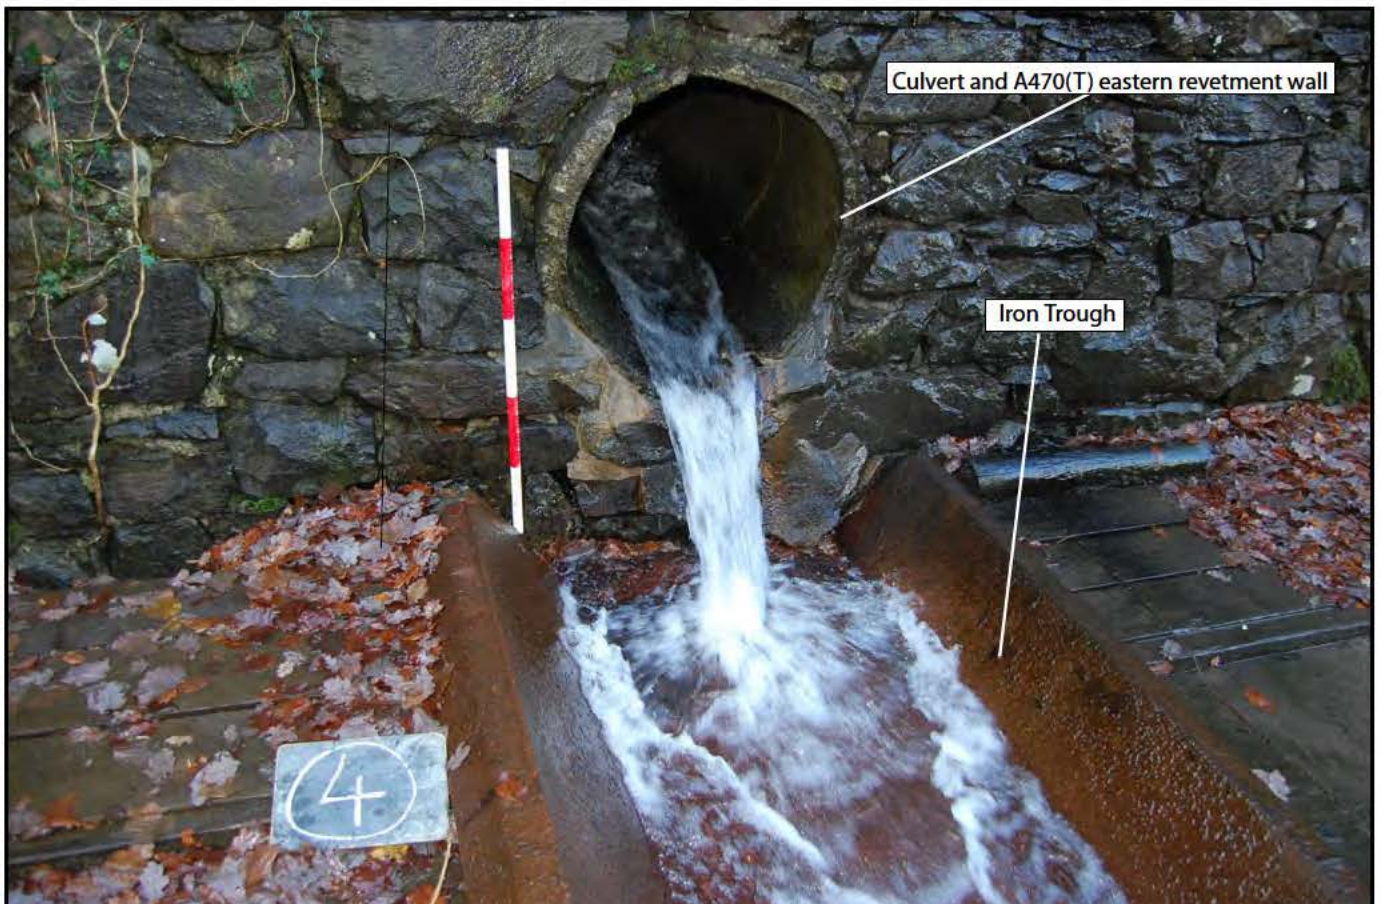
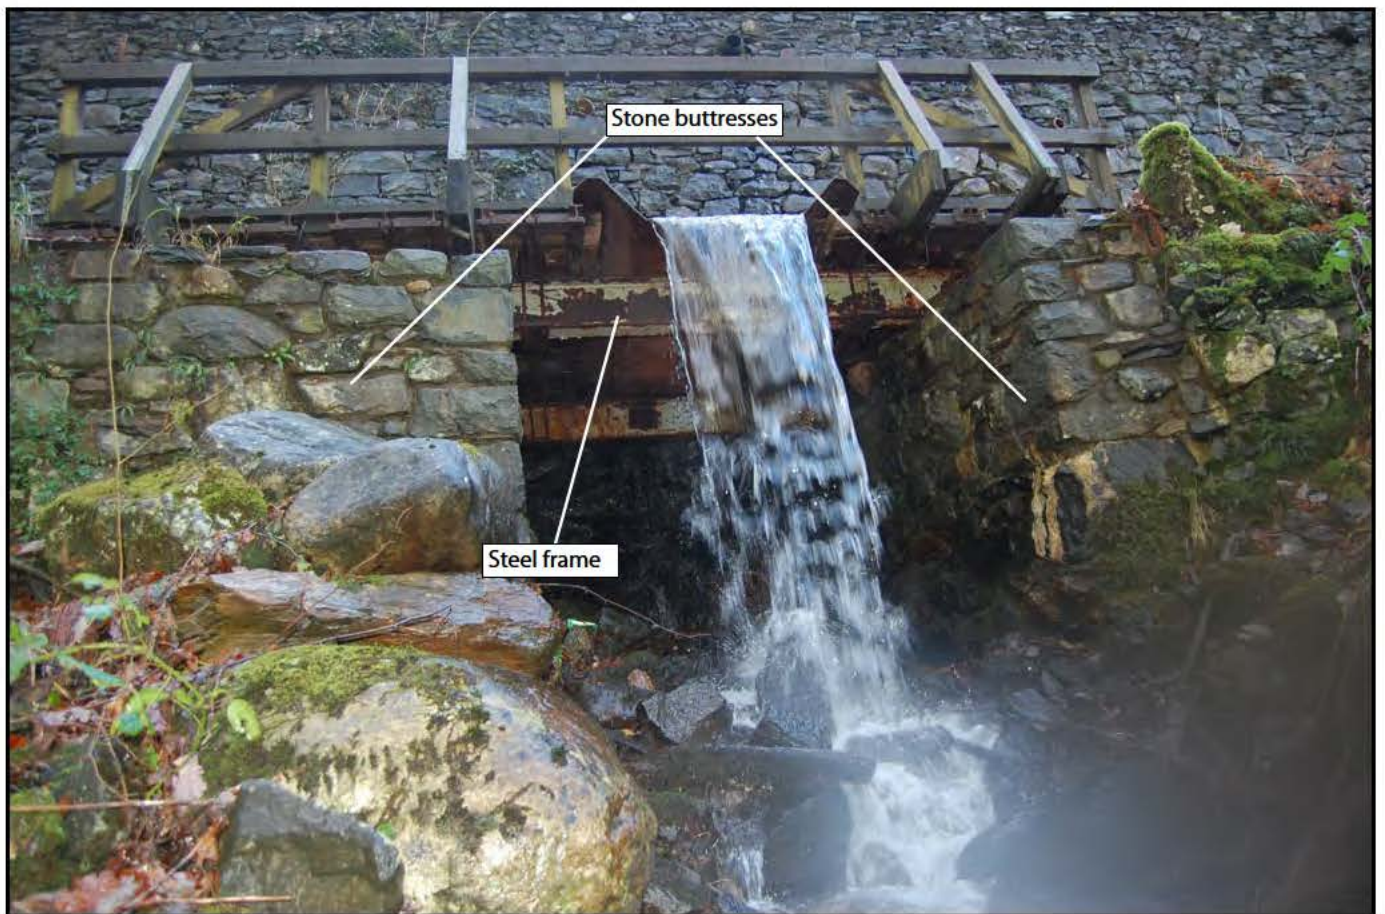
The iron trough rests upon wooden planking which are likely to be reused railway sleepers, which in turn is built upon a steel frame, the girders of which run east to west initially, and are then built upon larger girders running north to south. This steel frame is built into two opposing stone buttresses to the north and south.

There are possible traces of an earlier wall to the north of the culvert and trough, but no discerning evidence can be found to ascertain whether an earlier feature was situated on the site, or whether a build-up of material has been deposited over time to create a safe passing place across the stream. The constructed steel frame and buttresses have created a void between the stream bed and structure, in which the barrel of a probable Victorian lawn roller is located. This was most certainly deposited at the site before the most recent construction of the culvert and trough and as such suggests a date of the latter 19<sup>th</sup> Century.

Plate 01: View south of Feature 4, culvert and trough.

Plate 02: View southeast of Feature 4, culvert and trough

Plate 03: View east of Feature 4, culvert and trough structure.

The archaeological value of this feature is rated low (GAT report No.711) and no further recommendations are made for further assessment or works. The feature is now recorded in advance of impact, and as such is preserved via record.

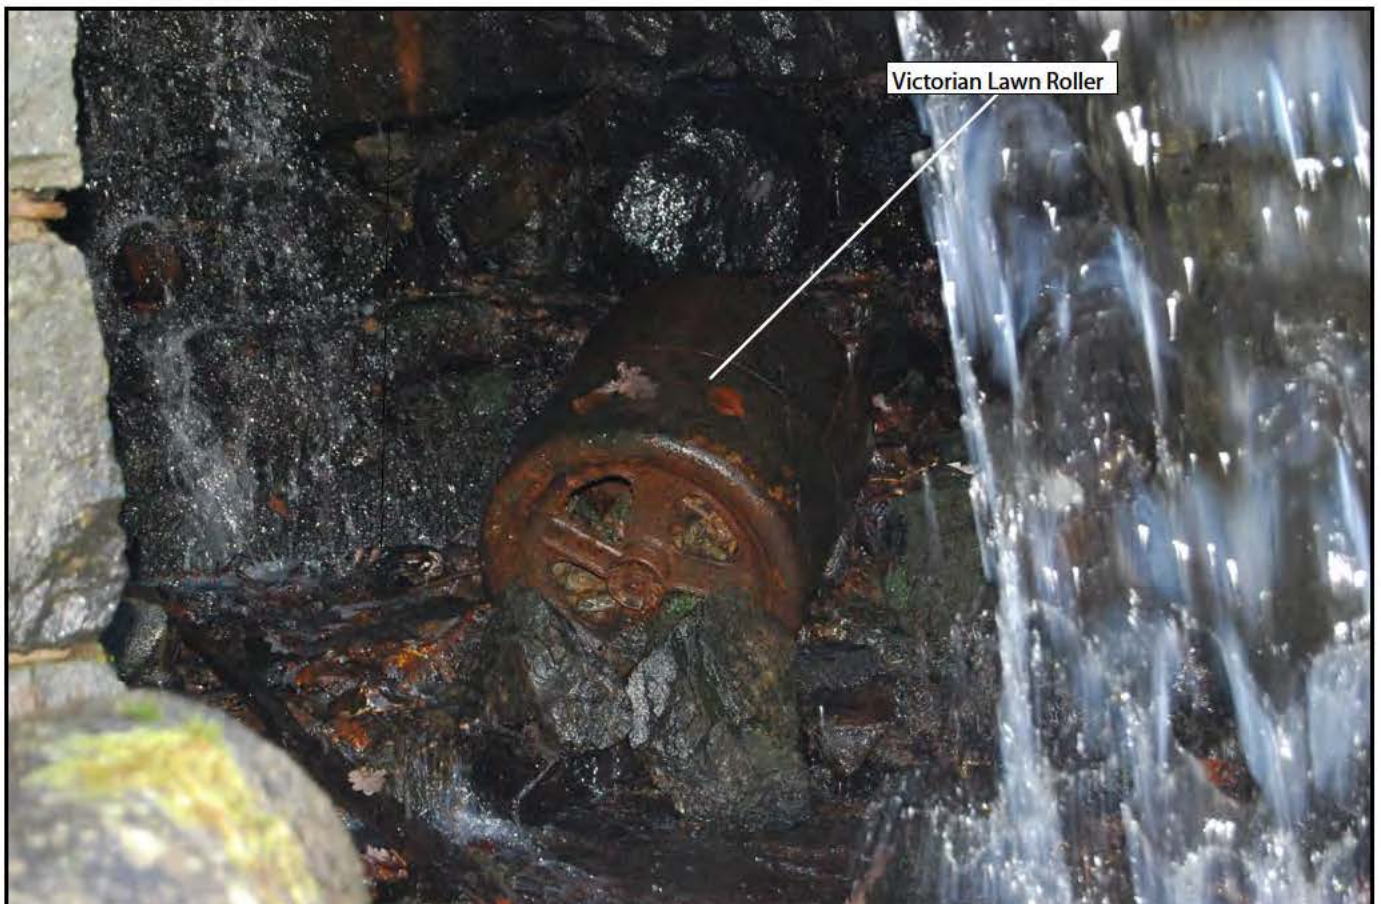
Plate 04: View east of Victorian lawn roller beneath Feature 4

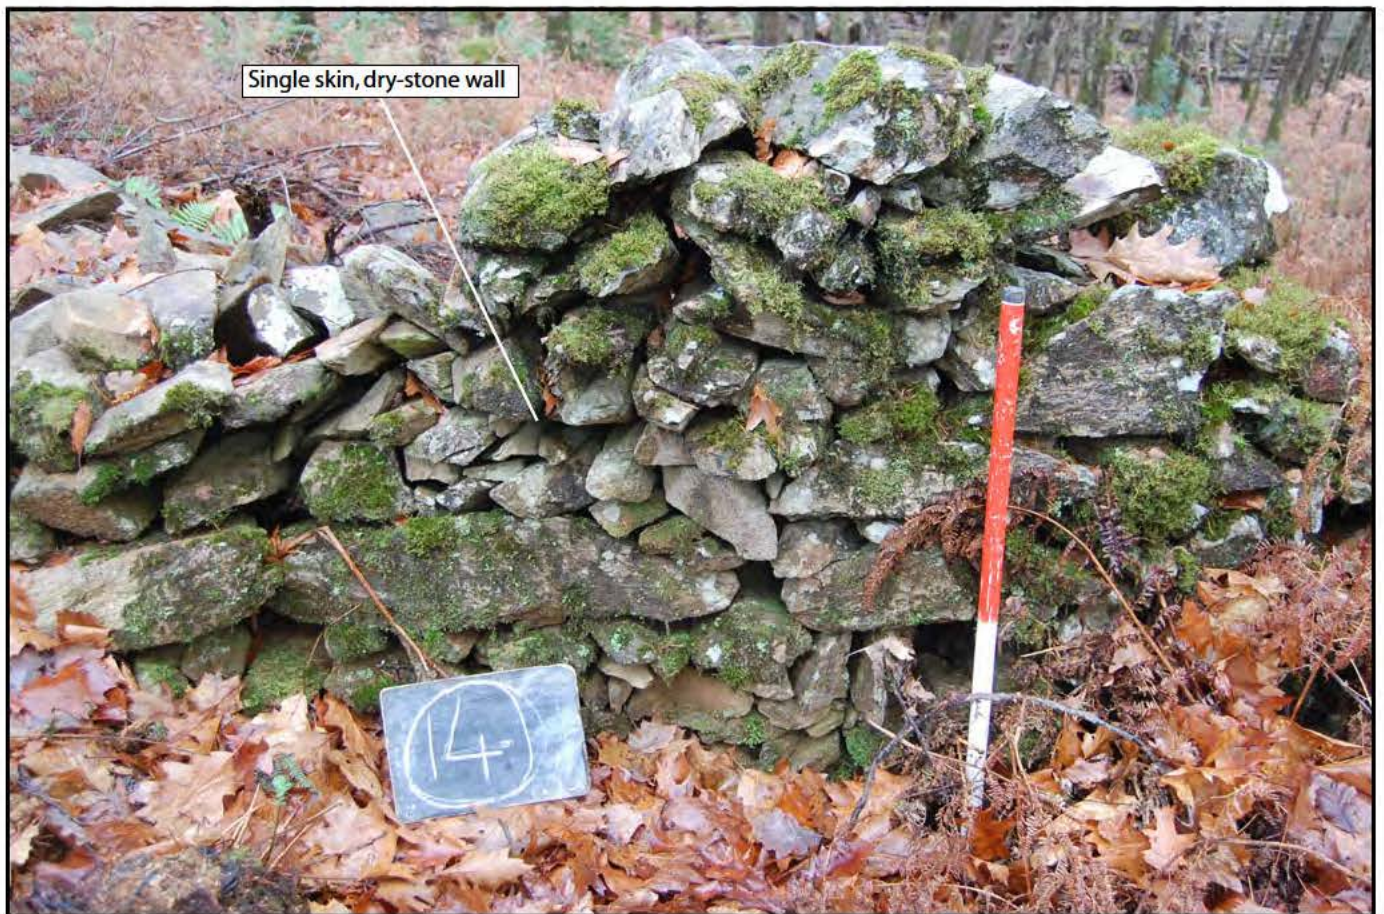
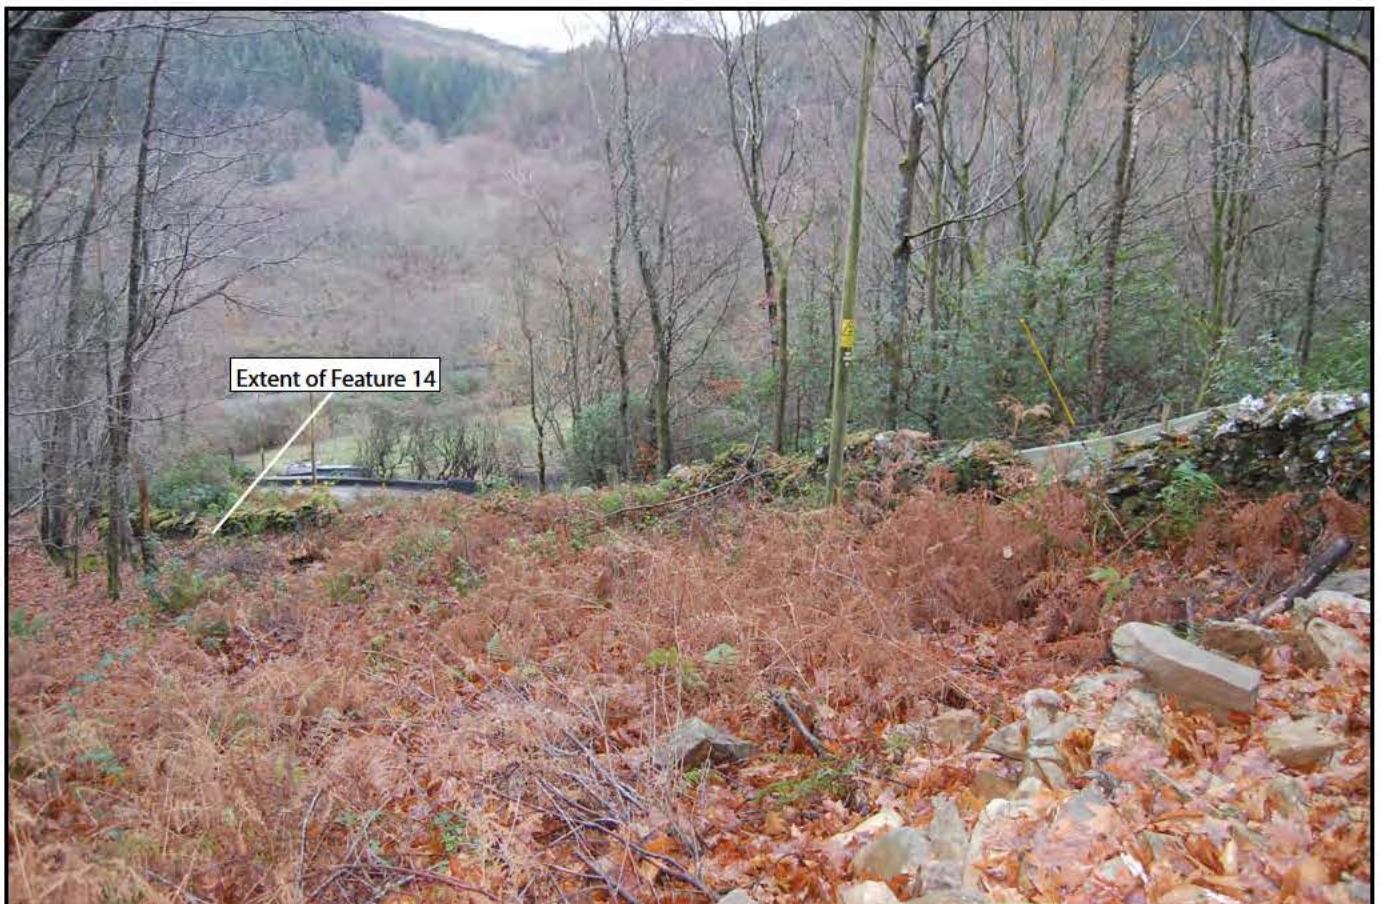
A single skin dry stone wall which represents a field boundary is located to the immediate west of the A470(T), forming an arced enclosure with the road. This feature is depicted on the 1880s OS map (figure 4) and respects the current road line, suggesting it was created during or after the construction of the road. Moreover, it can be seen from the early map that a significant portion of the area enclosed by the wall was not utilised as forestry plantation, and almost certainly was in use as pastoral land. The feature averages 1.2m in height and 0.6m in width, however in places the wall reaches 1.5m in height. The construction utilises frequent large river cobbles in its first course, transitioning to medium sized, angular grey-blue schist cobbles for the majority of the construction. The wall becomes significantly more substantial approximately 100m up the western slope, where it is better preserved. The feature has been demolished in places in order to allow the construction of herptile fencing, however it seems likely that this shadowed earlier demolition attempts in order to permit rights of way.

Plate 05: View south of Feature 14, dry-stone wall.

Plate 06: View west of Feature 14 extent, dry-stone wall.

The archaeological value of this feature is deemed negligible (GAT report No.711), and no further recommendations are made for further assessment or works. Sections of the feature will be demolished by the development scheme, however the remaining sections and preservation via record is acceptable.

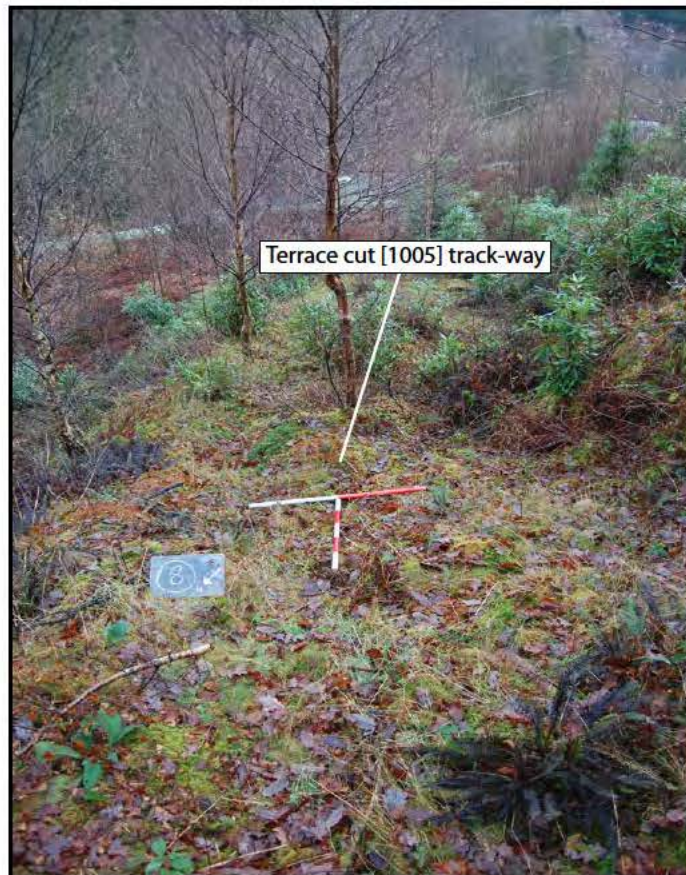
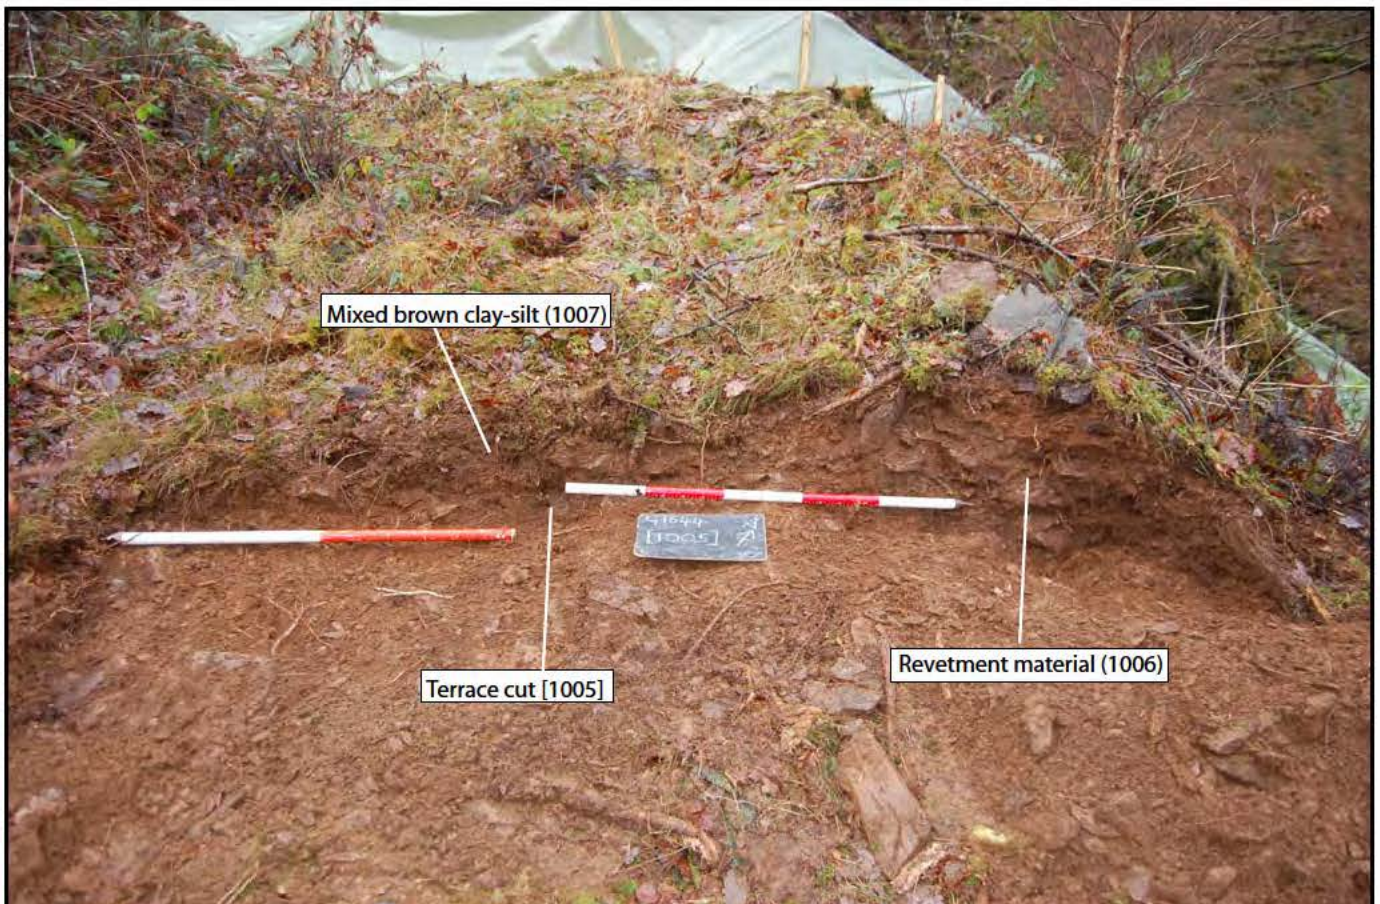
Plate 07: View north of Feature 8, track-way.

Plate 08: View south of section through Feature 8 .

The archaeological value of the feature is deemed medium (GAT Report No.711), however no recommendations are made for further mitigation. The effect of the development after mitigation is rated minor, as only the most southern part of the feature will be truncated by the scheme and the detailed records obtained ensure preservation of this section via record.

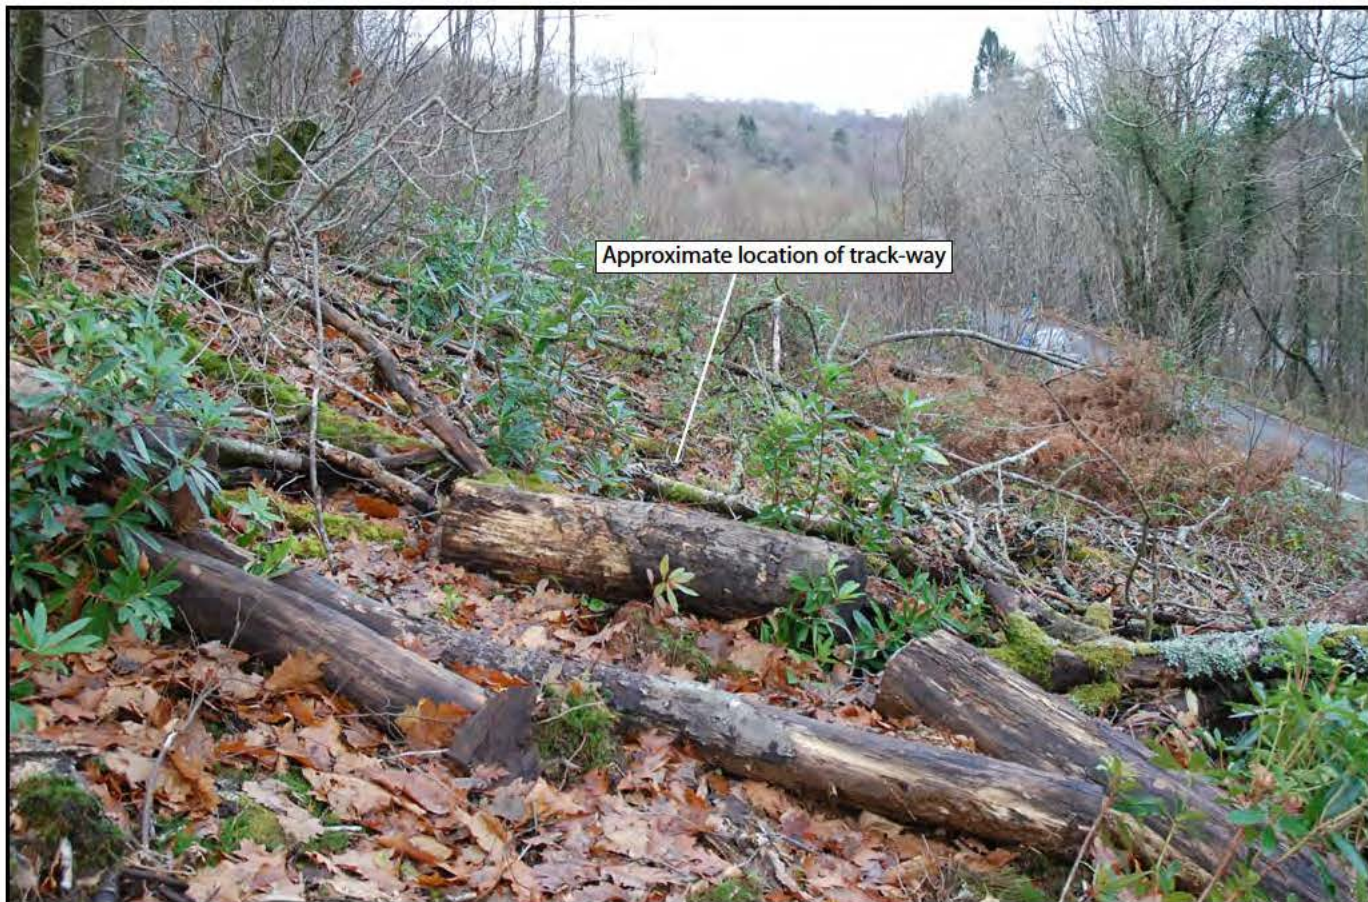
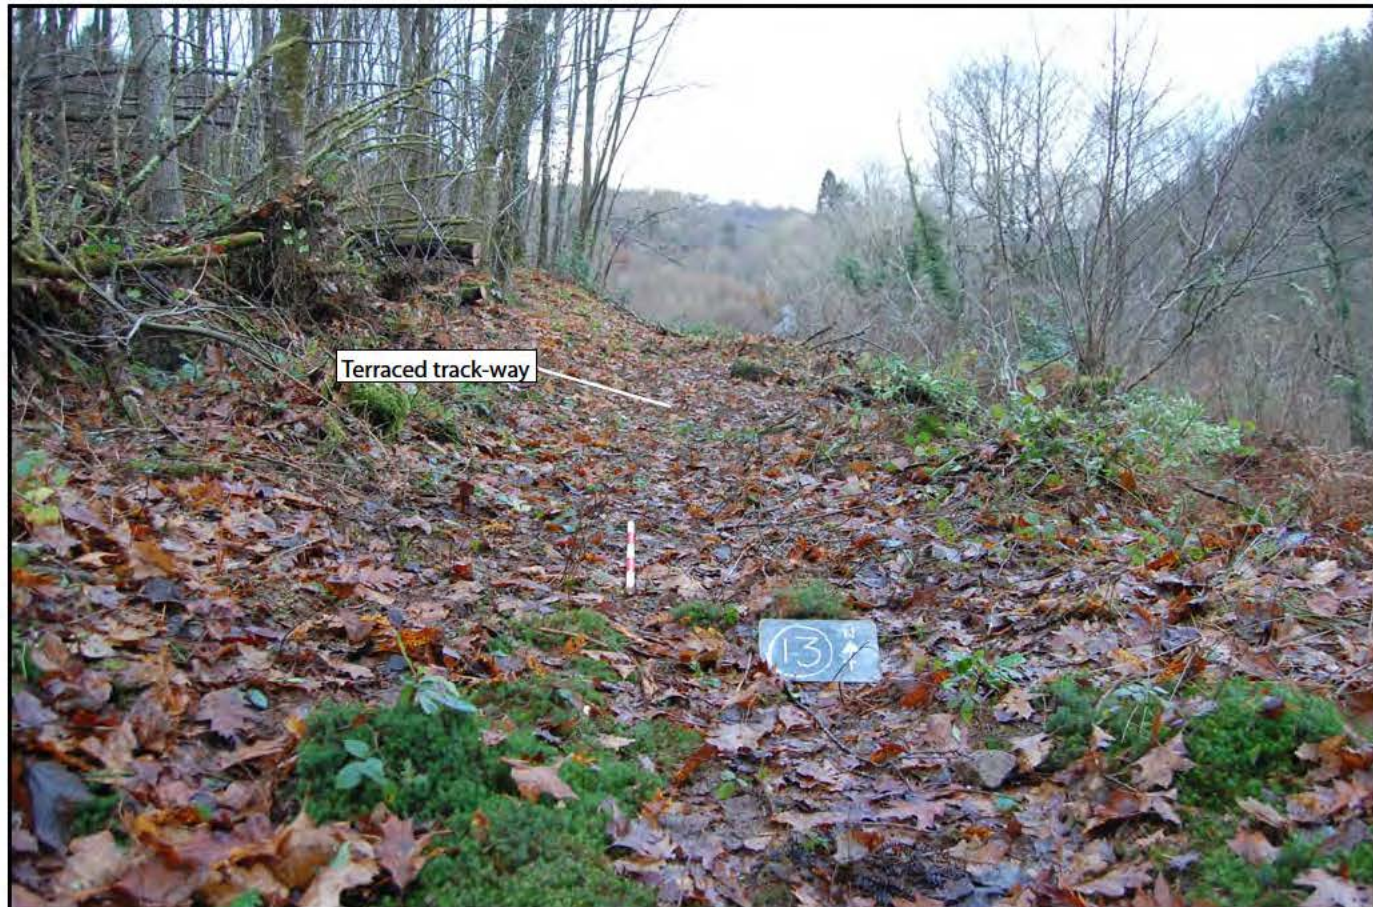
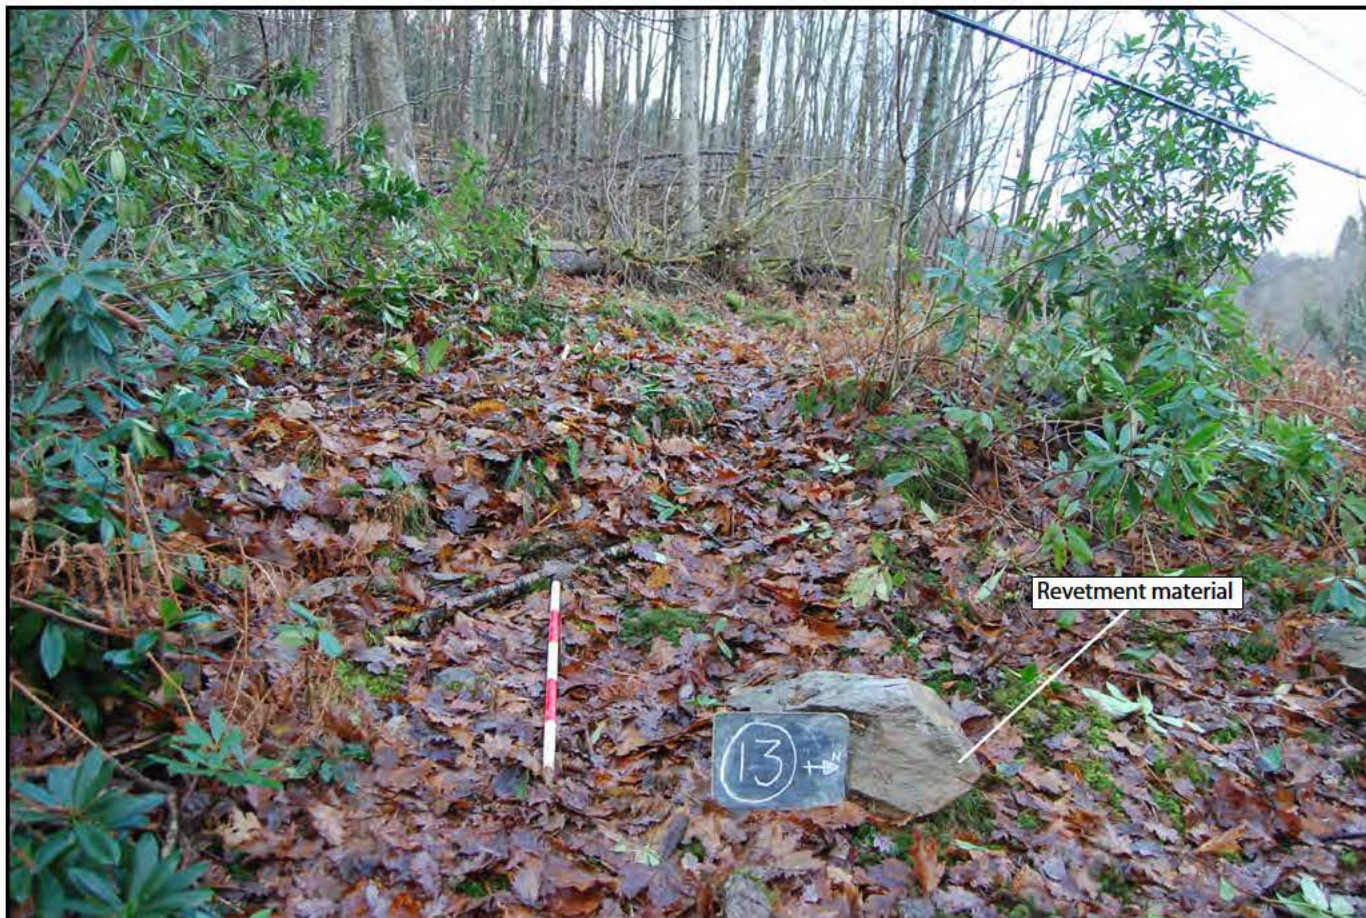
The feature presumably represents an earlier line of the present road, however it was not possible to ascertain an exact date for its construction. A fragment of trackway is depicted on the OS 6 inch and 25 inch maps from the 1880s, and it seems plausible that this track connected with other fragments of track, including feature 8. However, upon vegetation removal it became clear that this feature turns towards the current road for a short period at its southerly edge, suggesting that it originally joined up with a route which followed the current road line. This feature could only be traced for approximately 30.0m length before it became unclear.

Plate 09: View south of Feature 13, approximate location of track-way prior to bush removal.

Plate 10: View south of Feature 13 after bush removal.

Plate 11: View southeast of Feature 13, with remains of revetment material.

The archaeological value of the track is deemed medium (GAT report No.711), however no further recommendations are made for further mitigation. The effect of the scheme after mitigation is rated minor despite the expected destruction of the feature by the scheme. It is likely that it is part of a road running along the valley so the overall destruction in the context of the wider landscape should be no more than moderate.
