## A470 CARDIFF TO GLAN CONWY TRUNK ROAD: **GELLIGEMLYN ARCHAEOLOGICAL RECORD (G1644)**

GAT Project No. 1644

Report No. 765

December 2008

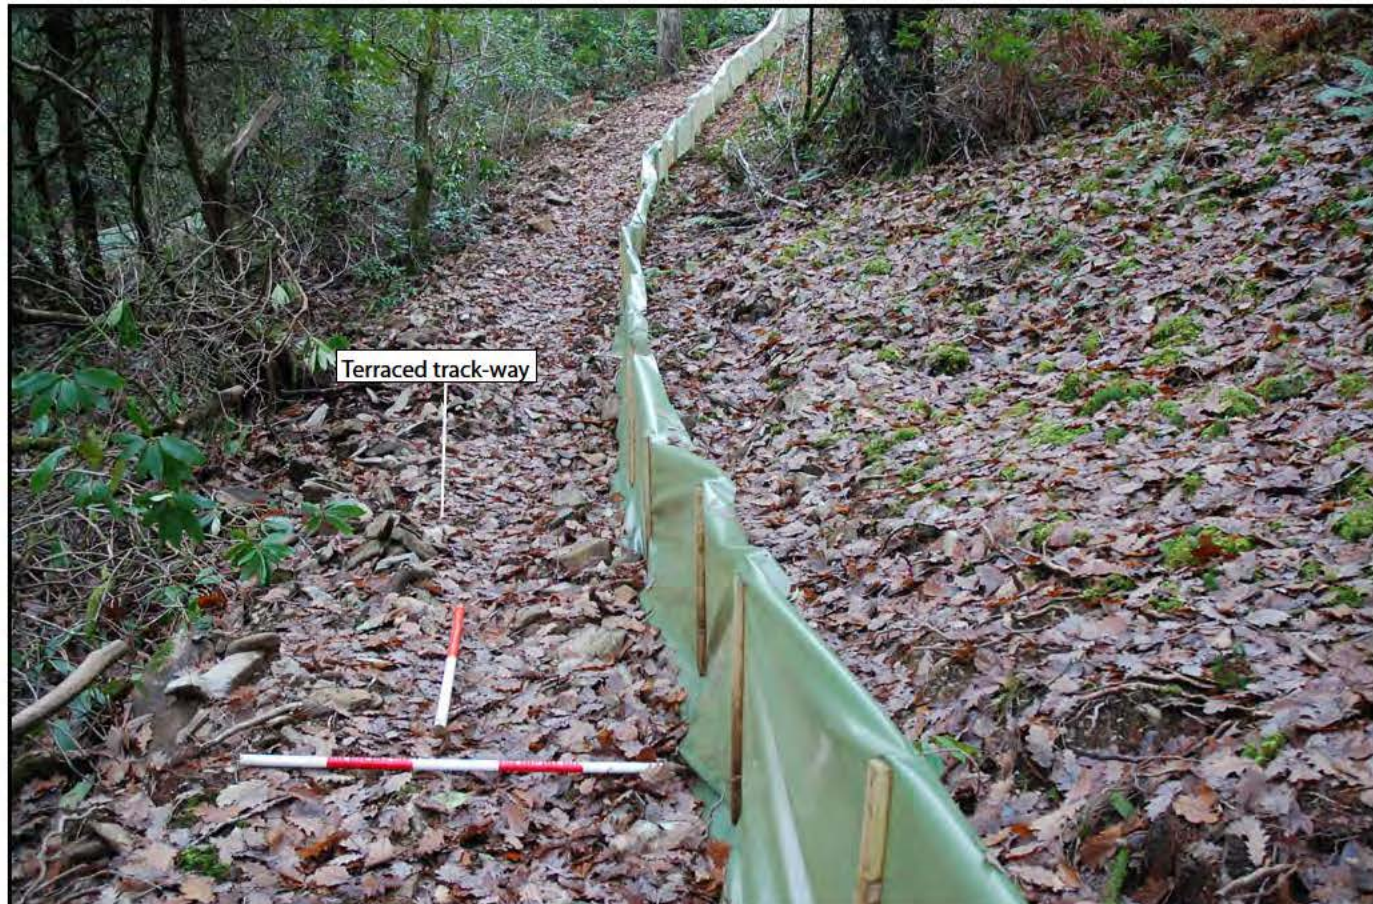
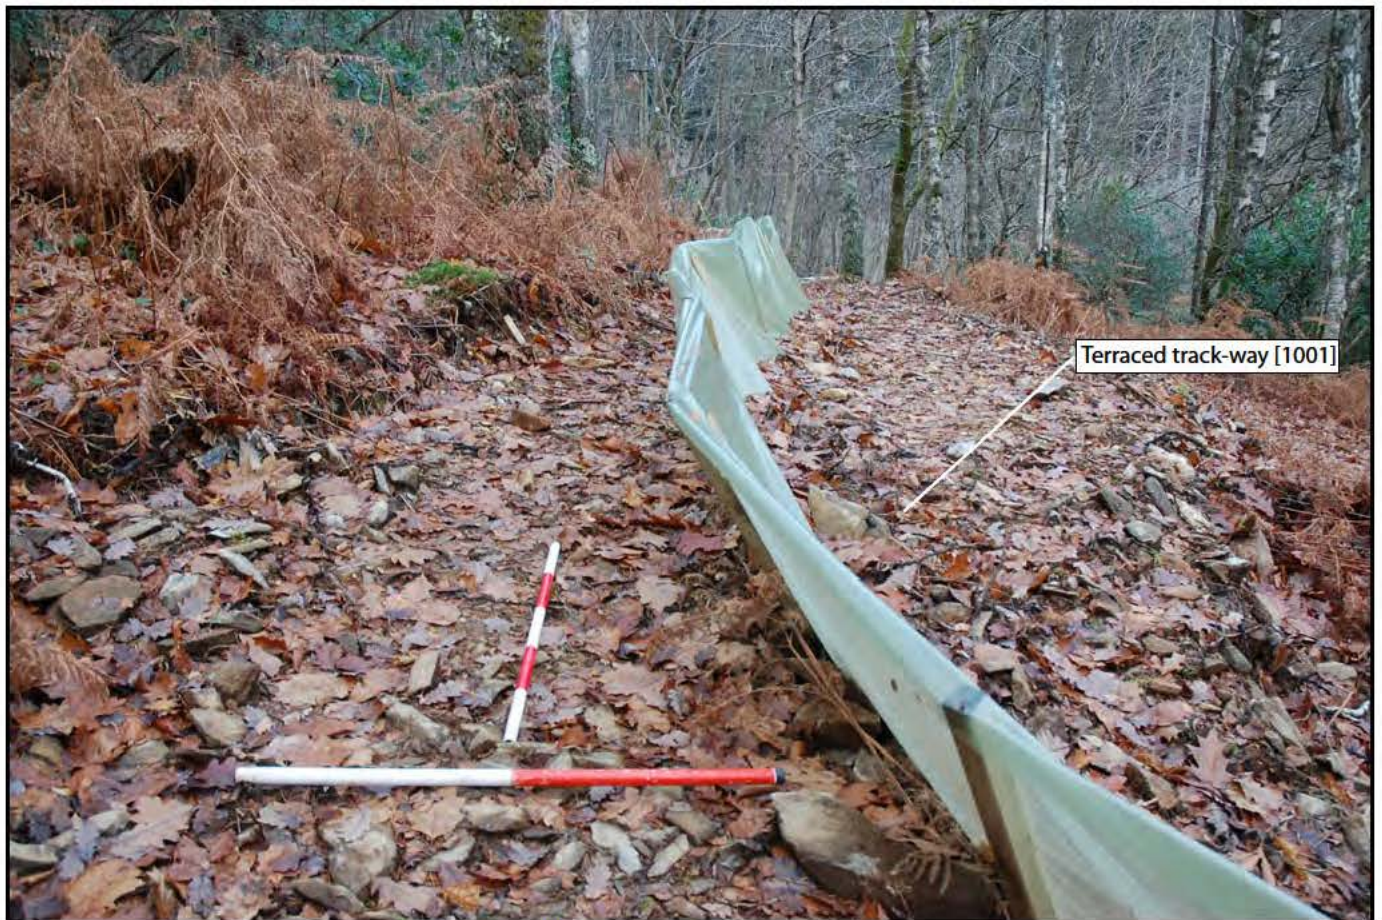
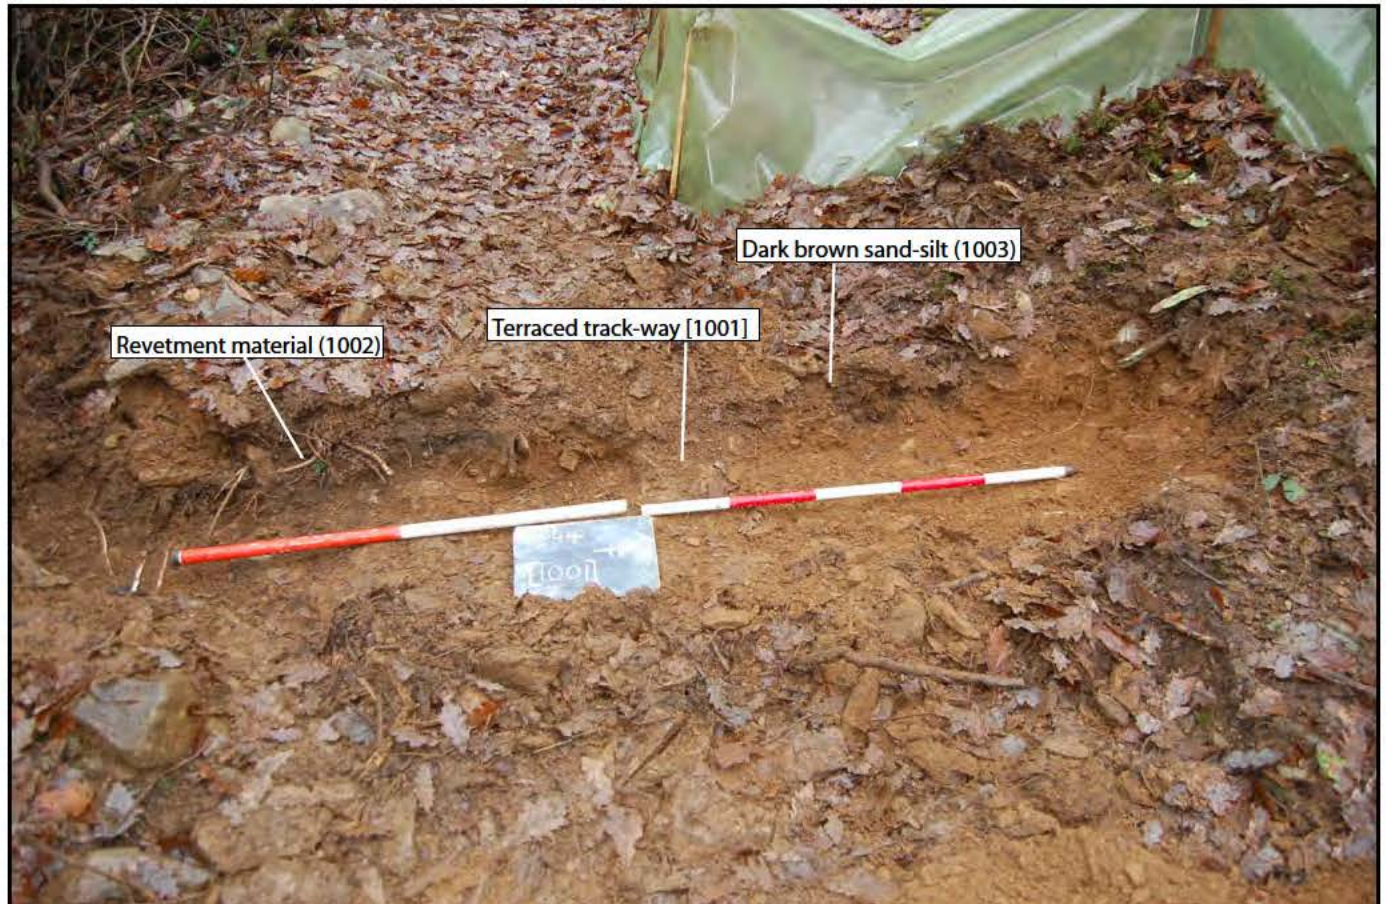
This track averaged approximately 1.5m in width and was terraced into the western hillside, zigzagging up the slope away from the current road. An excavated section (figure 4) across the track showed it to be well constructed, with a fairly regular terrace cut (1001) being concaved with a mildly undulating base. The cut was filled by a mid ginger-brown sand-silt with approximately 70% medium-sized, angular cobbles on its southerly edge (1002). This undoubtedly formed a revetment structure which prevented erosion on the outward edge. Despite the track having silted up naturally over time with a dark brown sand-silt (1003), its characteristics were still obvious, although no dating evidence could be found.

The track is depicted on the OS 6 inch and 25 inch maps from the 1880s onwards, and is believed to have been a link between the main roadway in the valley and the farms further up the slope. However, the dominance of rhododendrons on the upper parts of the slope has rendered this feature untraceable higher up. Indeed, since the initial assessment phase by GAT in 2000 (report No.711), a substantial portion of this feature has become lost.

Plate 12: View east of Feature 16.

Plate 13: View south of Feature 16, track-way.

Plate 14: View east of section through Feature 16, track-way.

The archaeological value of the track is deemed medium (GAT report No.711), however no recommendations are made for further mitigation. The effect of the scheme after mitigation is rated moderate, as despite only the eastern part of the track being destroyed by the scheme, it is undoubtedly the most well preserved and constructed section.

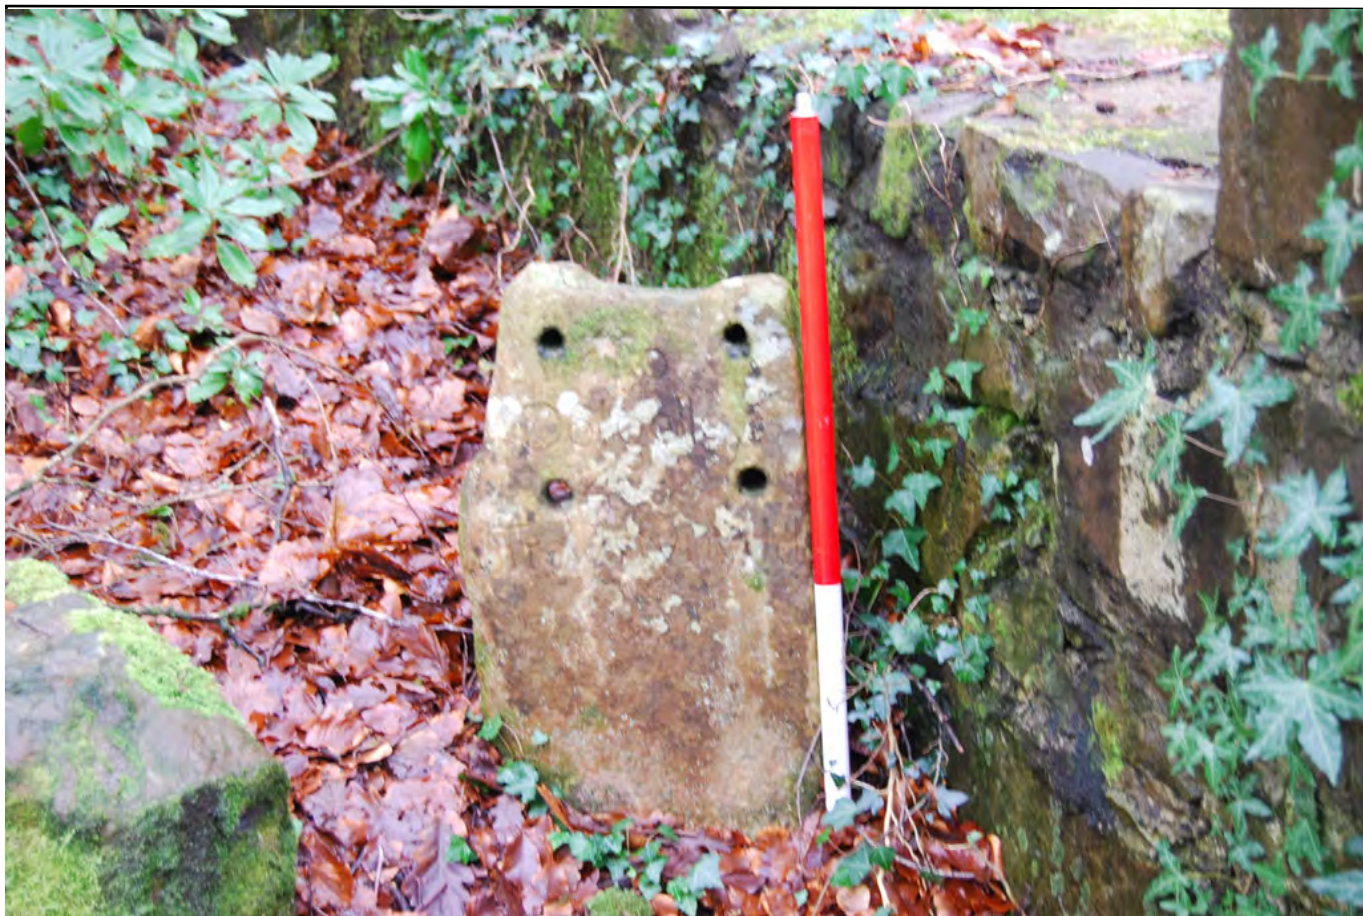
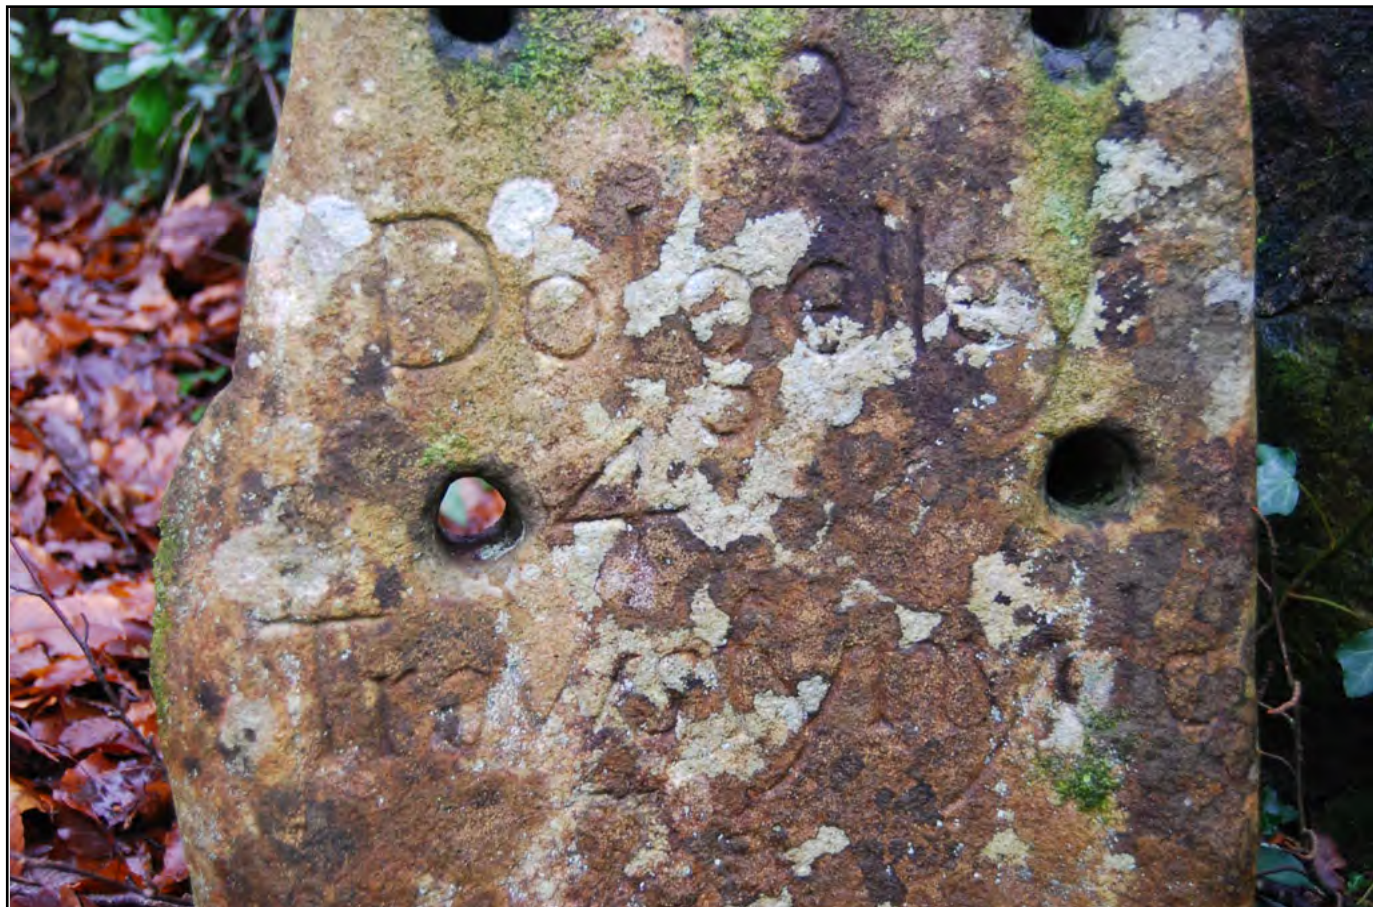
A single slab of dimensions 0.66m x 0.4m x 0.16m stands just within the grounds of the Gelligemlyn estate, immediately to the south of the most southerly entrance wall. The stone appears to be worn sandstone and is inscribed with 'To Dolgelley 4 Trewsfynydd ?'.

The mileage to Trawsfynydd (Trewsfynydd) is not clear due to weathering, however the mileage to Dolgellau (Dolgellay) is correct suggesting the stone is either in-situ or has originated in close proximity to its current location. The inscription is orientated to the east and subsequently away from the current A470 (T), suggesting that if the stone is in-situ then it predates the road and perhaps belongs with an earlier route through the valley which was at least 4.0m to the east. However, it seems more likely that the stone has been relocated from nearby and erected as a feature of interest, most probably by the residents of Gelligemlyn.

Four holes have been drilled into the upper portion of the stone, spaced 0.2m width and 0.17m height apart. These appear to be of a later event than the stone and are most probably for the purpose of fixing a sign of some sort, of which there is now no trace.

Plate 15: View east of Feature 23.

Plate 16: View east of inscription on Feature 23.

The feature is currently located within the path of the proposed alterations to be implemented during the scheme, and thus will be directly affected. However, discussions with the residents of the Gelligemlyn estate have shown a desire to relocate the stone further to the east, and to orientate the inscription towards the entranceway to the west before the commencement of works. Considering the likelihood that the stone is not in-situ and has already been relocated to its current position, this proposal is a recommended mitigation.

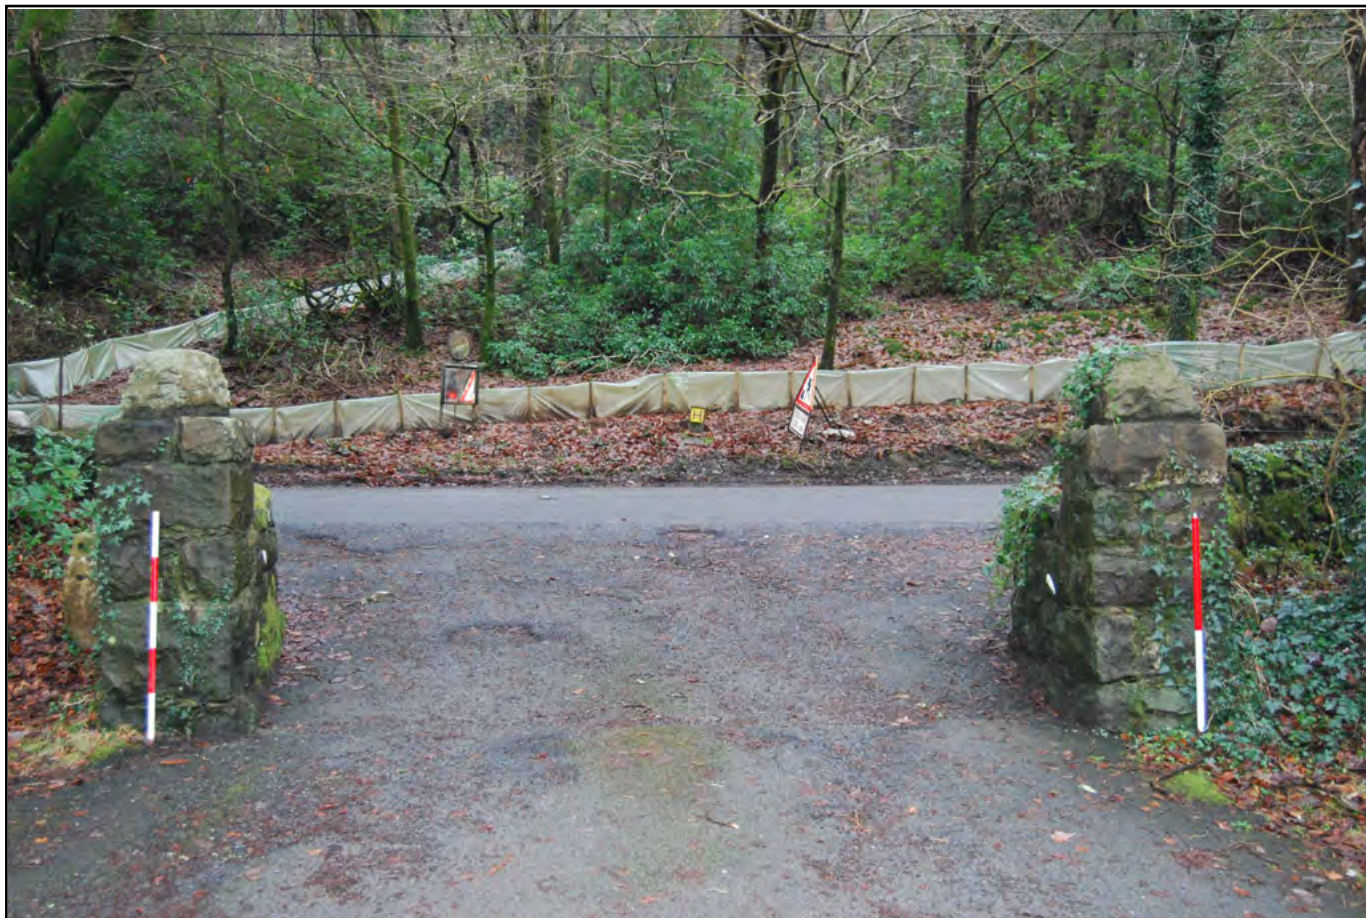
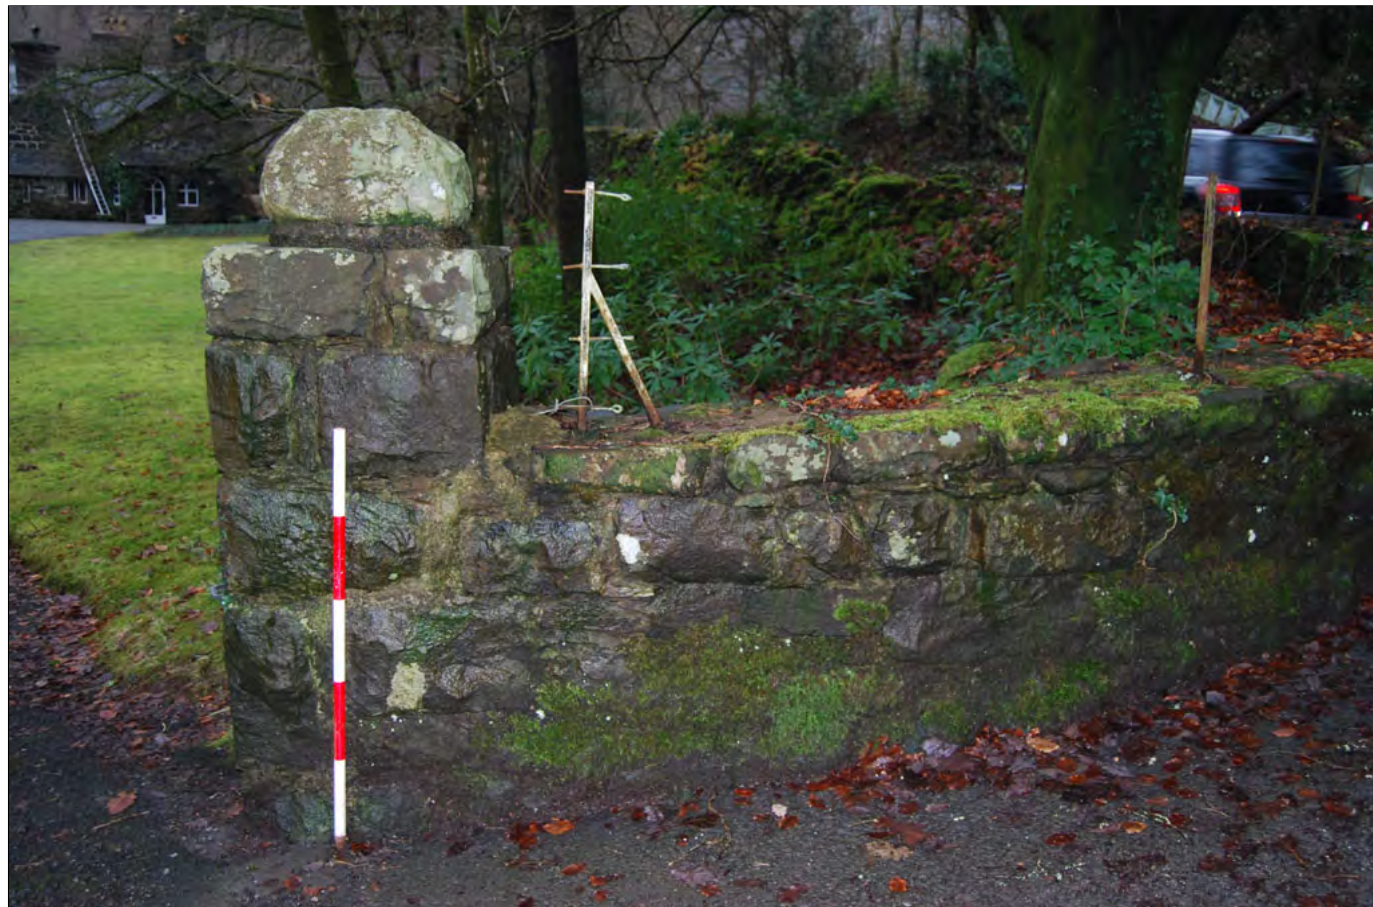
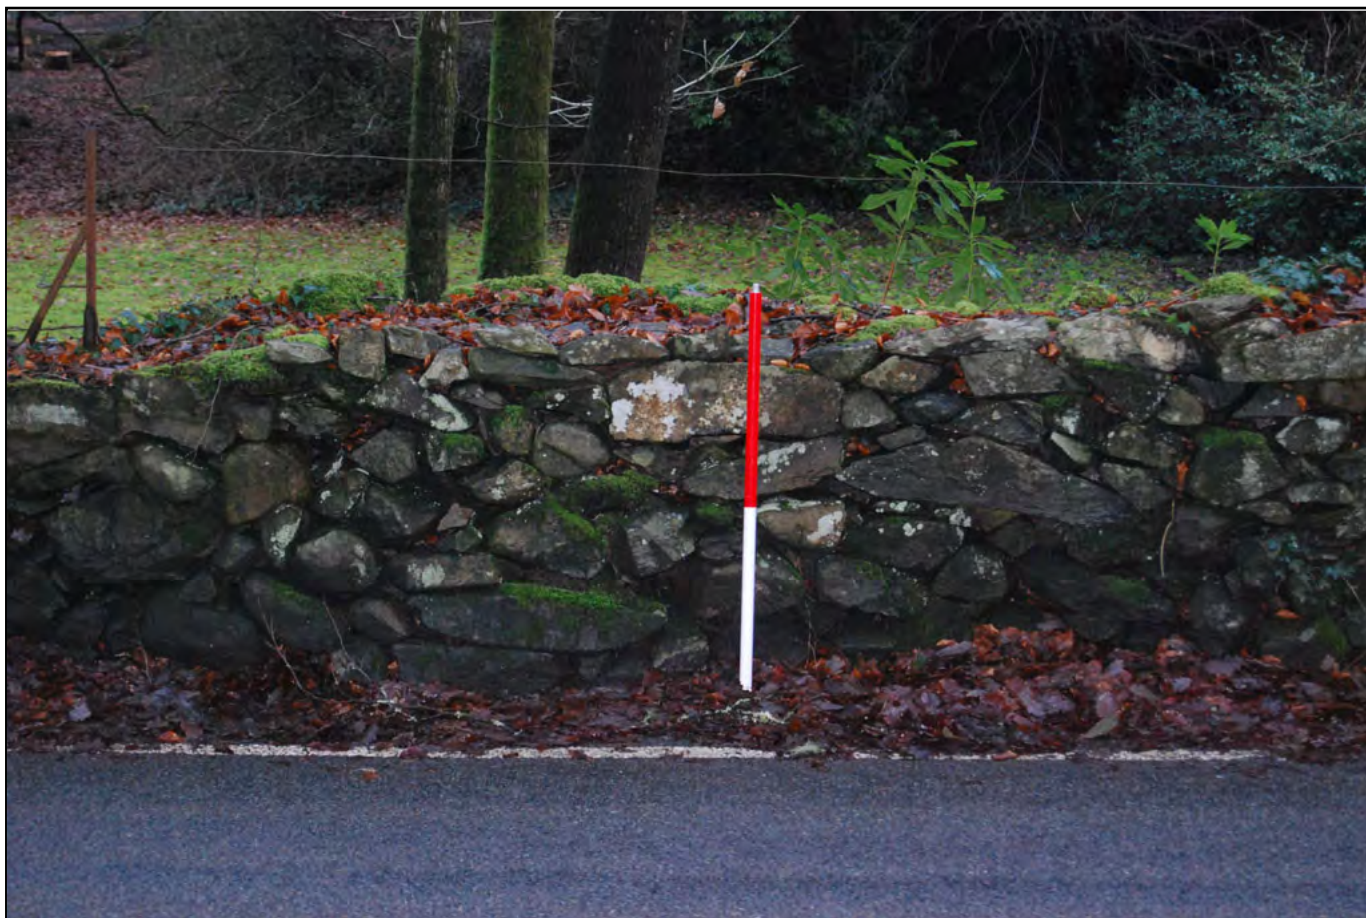
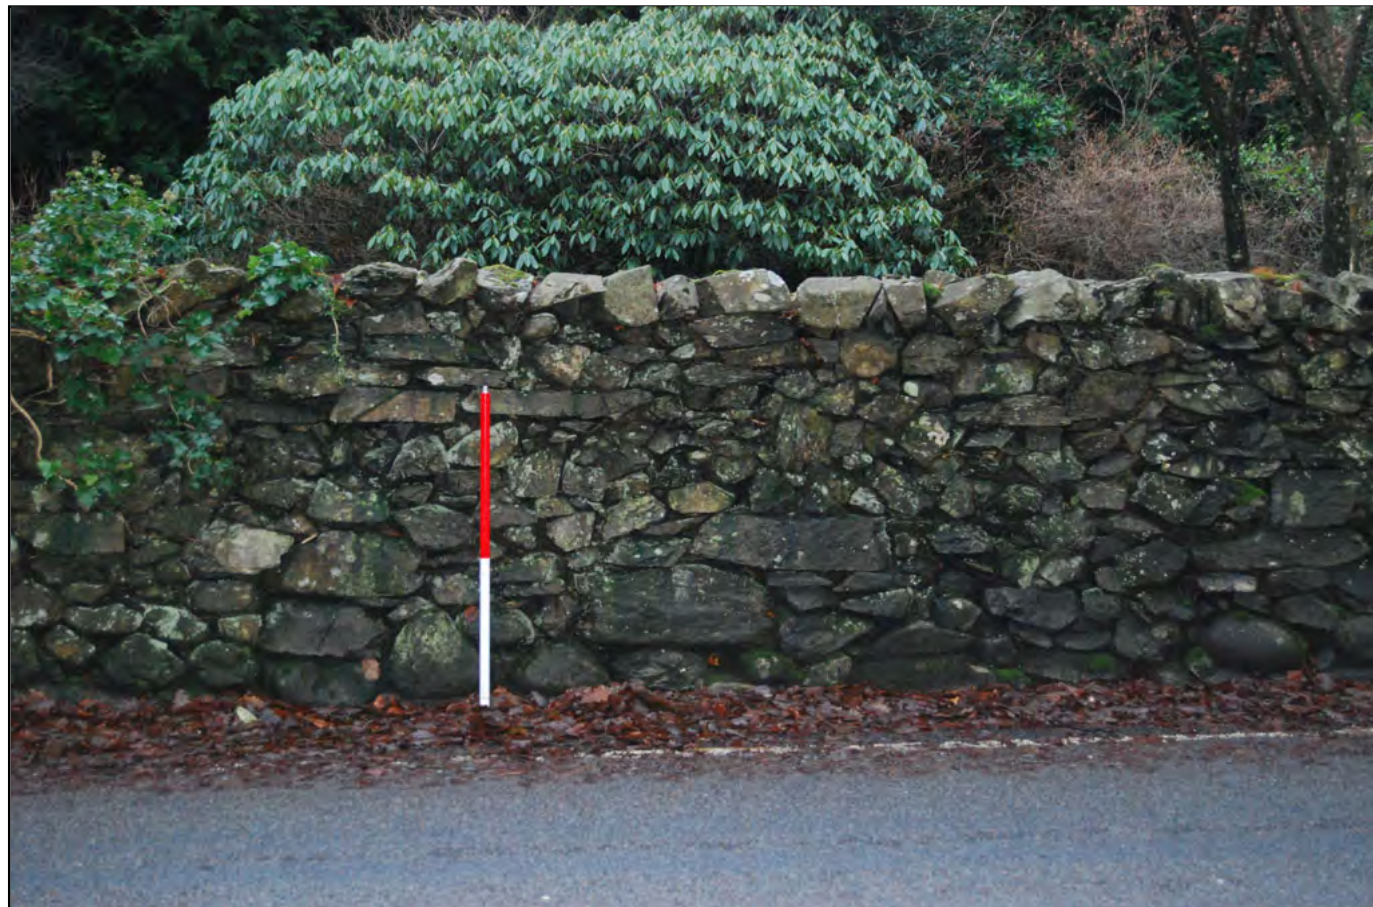
The stone built entranceway to the Gelligemlyn estate is 0.95m in height and is constructed of large and medium sized cut granite blocks averaging 0.6m long and 0.23m deep, bonded by mortar. The two stone entrance piers stand 1.43m in height with a roughly chiselled granite block 0.27m in diameter adorning the top. The wall is mostly four courses high and appears to be a more recent addition to an earlier dry-stone wall, constructed of medium rounded and sub-rounded river cobbles located 10.0m to the south. This earlier wall is 0.7m high and 1.0m wide, and projects 0.45m further to the east than the later entrance wall. This suggests that the Gelligemlyn entrance wall originally ran closer to the estate than the current alignment.

The earlier wall is only present for approximately 4.0 to 5.0m before again being superseded by another later wall to the south. This later wall is of dry-stone construction measuring 1.3m high and 0.6m wide, but of cut blocks as opposed to river cobbles.

Plate 17: View east of Feature 24.

Plate 18: View northwest of Feature 24.

Plate 19: View west of Feature 24 original dry-stone wall.

Plate 20: View west of Feature 24 later dry-stone wall .

This wall will be demolished as a result of the impending interim improvements to the A470(T), but rebuilt utilising the existing stone to blend it into the landscape. This fact combined with the basic recording already carried out on the wall, means that no further mitigation will be necessary.
