Mynydd Llandegai Raw Water Main Replacement Works

MYNYDD LLANDEGAI RAW WATER MAIN REPLACEMENT WORKS

AN ARCHAEOLOGICAL ASSESSMENT

GAT Report No. 776

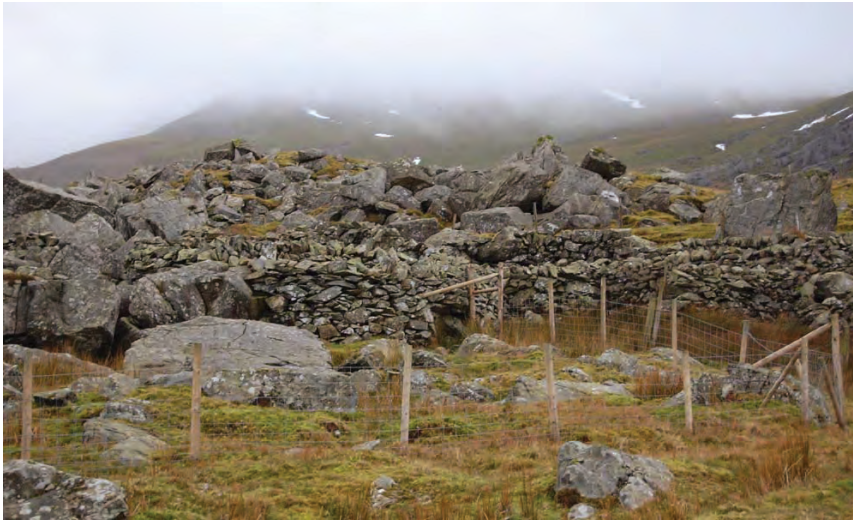
Plate 1: Feature 1, sheepfold
from north-west

Recommendations for further assessment: None

Recommendations for mitigatory measures: None

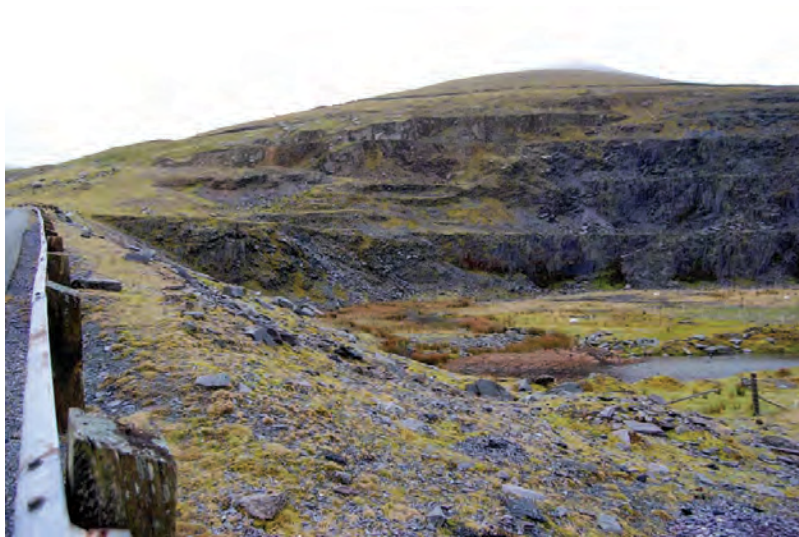
Plate 2: Feature 2, Marchlyn Quarry
from north

Recommendations for further assessment: None

Recommendations for mitigatory measures: None

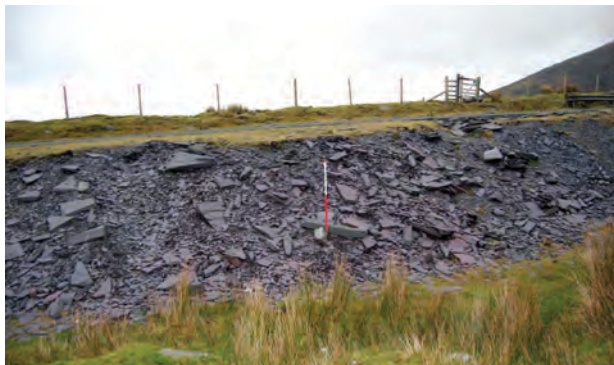
This section of road was built in 1975 to provide access to Marchlyn Mawr reservoir (Roberts 2006). It is generally built on a bed of slate waste, in some places built up to 2m in height. The road surface is tarmaced. No significant archaeological features were seen close to this road and it is unlikely that any archaeology would be found beneath it. The impact on the road itself will be significant but this feature is of very little archaeological importance. The chance of impact on important buried archaeology is unlikely.

Plate 3: Feature 3, road near Marchlyn Quarry
built up on slate waste, from south-east

Recommendations for further assessment: None

Recommendations for mitigatory measures: None

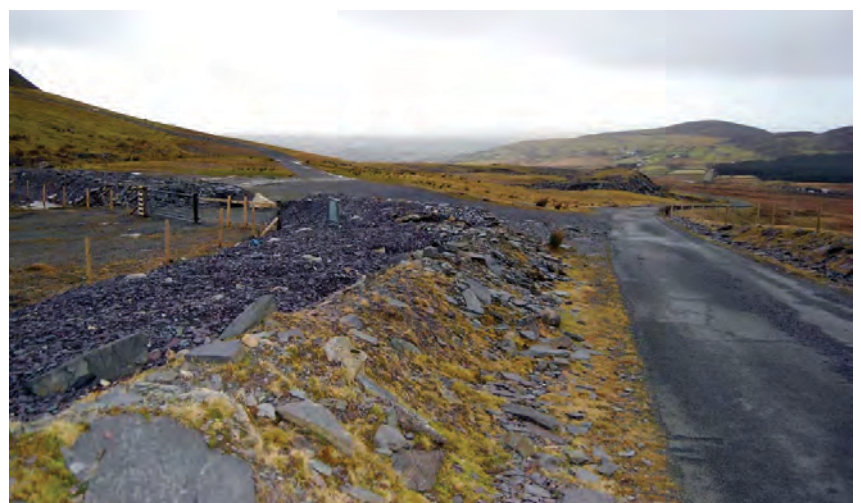
Plate 4: Feature 3, road near Marchlyn Quarry,
looking down road from south-east

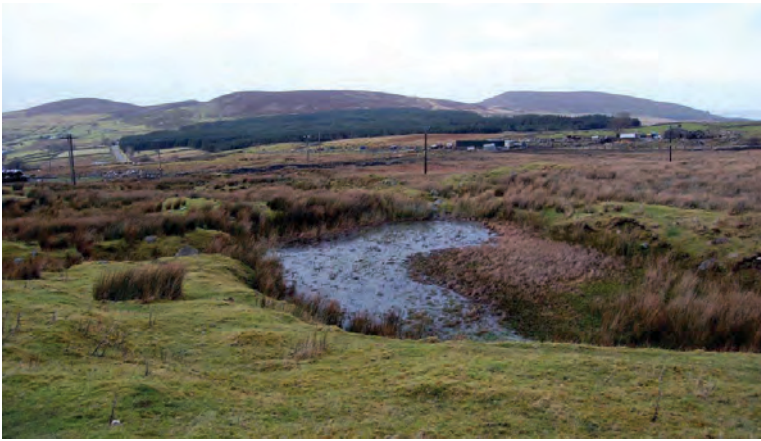
Plate 5: Feature 4, hollows and disturbed ground from south-east

Recommendations for further assessment: None

Recommendations for mitigatory measures: None

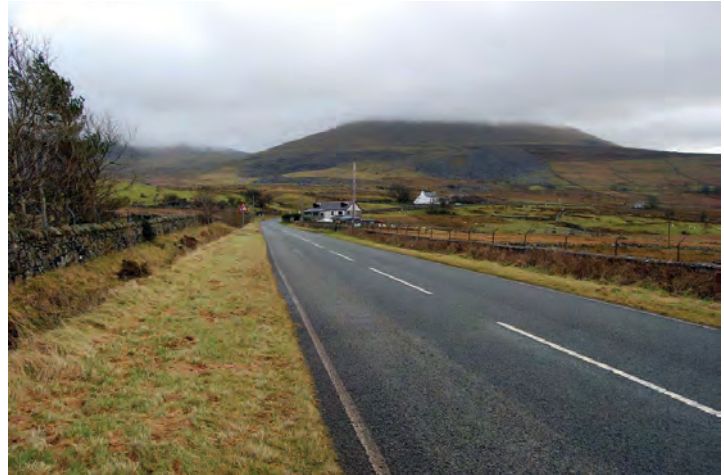
Plate 6: Feature 5, road along north-east edge of Deiniolen, from north-west

Recommendations for further assessment: None

Recommendations for mitigatory measures: None

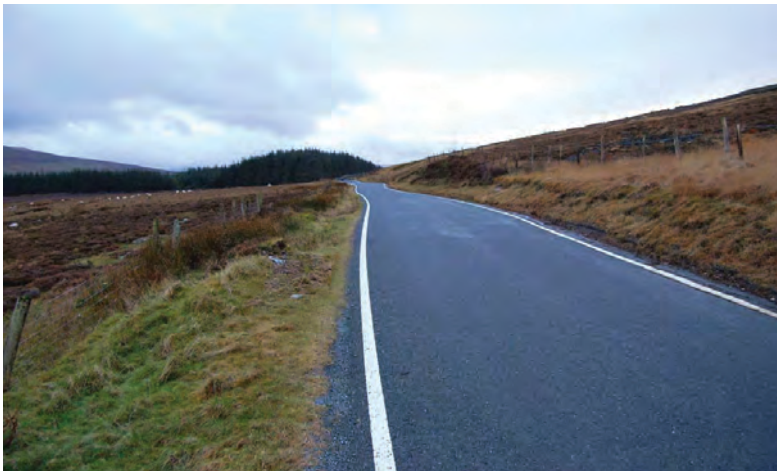
Plate 7: Feature 5, road along edge of Gwaen Gyfni, from north

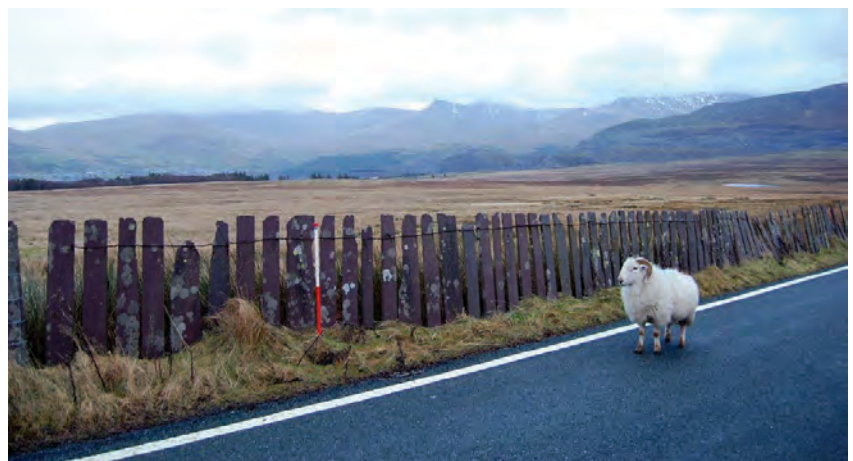
Parts of the field boundary along this stretch of road, mainly on the eastern side, are composed of slate fencing typical of the Penrhyn Estate. Damage to this should be avoided, but if it needs to be disturbed it should be reinstated in the same style.

Plate 8: Feature 8, slate fencing, from south-west

Recommendations for further assessment: *None*

Recommendations for mitigatory measures: *Reinstatement*
