# Proposed Pumping Station, Rhiwgoch, Harlech

**PROPOSED PUMPING STATION, RHIWGOCH, HARLECH  
AN ARCHAEOLOGICAL ASSESSMENT**

**GAT Project no. G2064**

**Prepared for Egniol Consulting  
on behalf of Dŵr Cymru/Welsh Water**

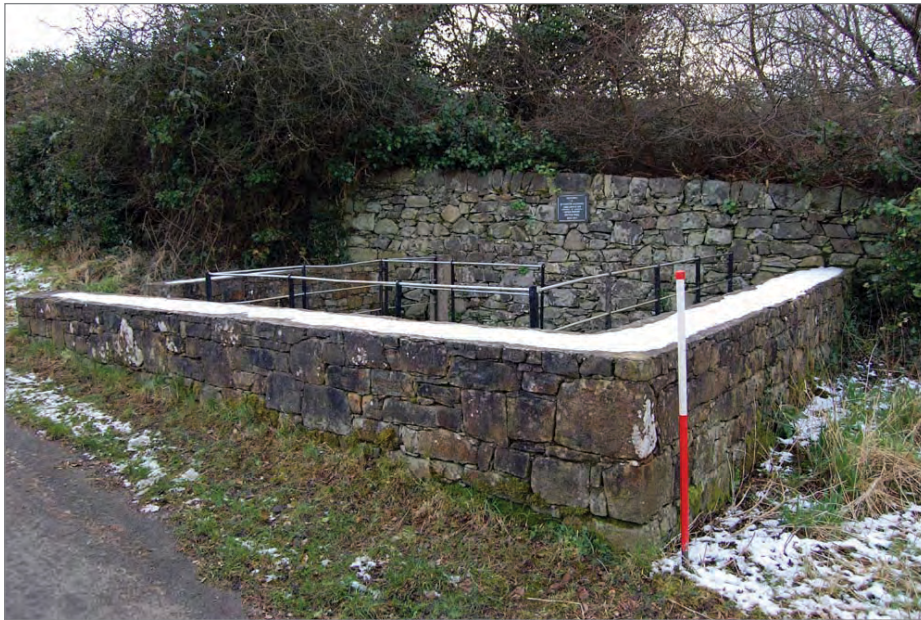
Plate 1. Feature 01, baptismal well,  
from NW

A rectangular concrete pool with steps down into it and railings around, all surrounded by a low stone wall. To the south of the well is a higher stone wall, on which is a slate plaque bearing the inscription ‘Scotch Baptist, baptismal well, built 1841’ in Welsh and English.

***Recommendations for further assessment: None***

***Recommendations for mitigatory measures: Avoid***

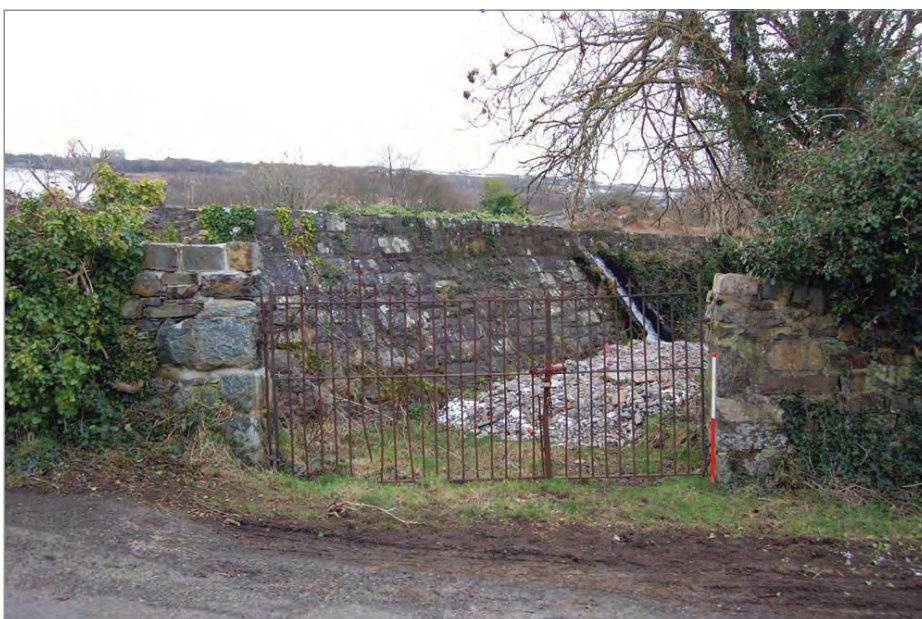
Plate 3. Feature 02, dam and entrance  
to reservoir, from NW

A small reservoir constructed in the 20<sup>th</sup> century, certainly by 1951 but possibly in the 1920s or 30s. This reservoir seems to have been a late phase of a complex of water works supplying some buildings on the east side of the town. The tithe map marks a small round pond just east of the site of the reservoir and this was in use in 1889. The pond was fed by a stream originating on the site of the later reservoir and passing through the Baptismal Well. The water was then carried down hill by a series of regular leats and an aqueduct, apparently heading for a row of buildings immediately to the south-east of the parish church. The leat system, pond and the buildings were still in use in 1901 and there is a local memory of the buildings being a bottling plant (Davidson pers com). The 1953 map shows the reservoir having been constructed at the top end of this water supply system and it was probably constructed to improve the water supply to the buildings below, although it may also have been a general source of drinking water. The reservoir, therefore, appears to be part of the industrial history of this part of Harlech and the system as a whole is of considerable interest.

***Recommendations for further assessment: None***

***Recommendations for mitigatory measures: Avoid***

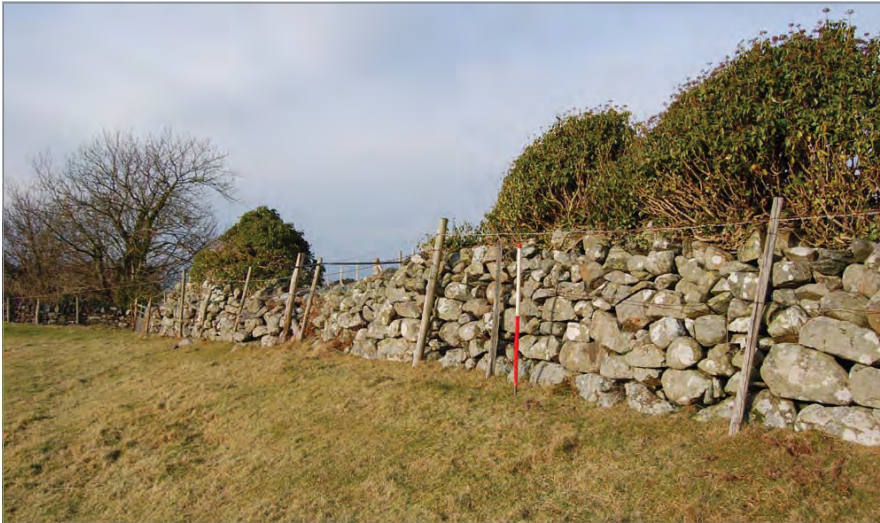
Plate 4. Feature 04c, wall near road,  
from E

The field in which the development area is located is enclosed by drystone walls. Very little of this represents the actual boundary shown on the 1841 tithe map. The wall next to the reservoir (04a) is of recent character and is probably contemporary with the reservoir. The southern boundary walls (04b) date from the late nineteenth century according to map evidence, but the wall by the road (04c) could be older and is of a different character to the southern walls, having more rounded stones. The gateway through this wall next to the development area has substantial gateposts but has recently been damaged.

The earlier sections of the field boundary should be avoided. Boundary 04f will have to be fenced off to ensure no accidental damage by plant. It is unlikely that other parts of the field boundary will be damaged but if this is unavoidable they should be reinstated in the same style to maintain the character of the area.

***Recommendations for mitigatory measures:*** *Avoid or reinstate*

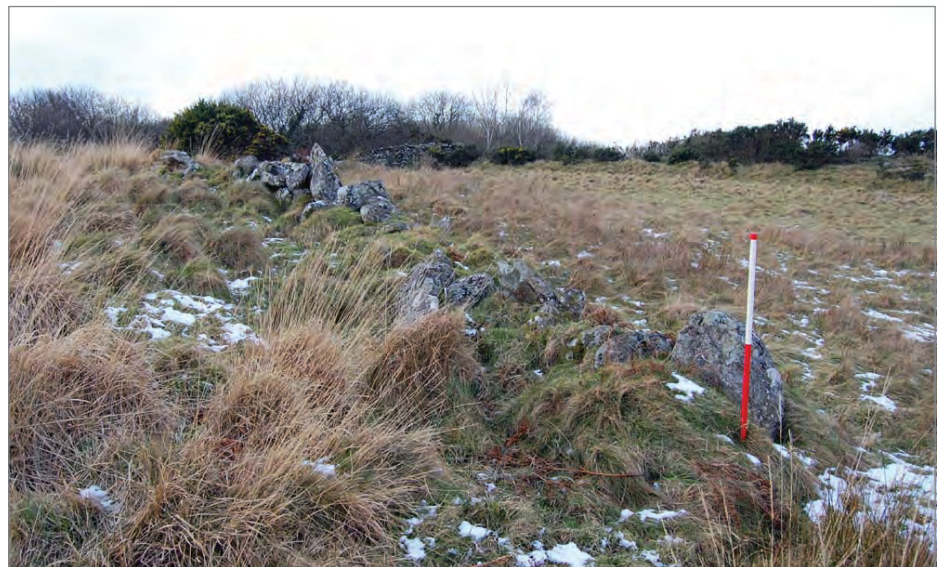
Plate 5. Feature 04d, denuded wall  
from N

The irregular indented south-western corner of the field boundary (04d) could date from the 18<sup>th</sup> century or earlier. It no longer functions as a wall but the reduced foundations, containing some large boulders, are still visible. Similarly part of the eastern boundary (04e) is largely denuded but some very large stones from its foundations remain. The northern section (04f) of this eastern boundary is visible only as a slight linear scatter of stones.

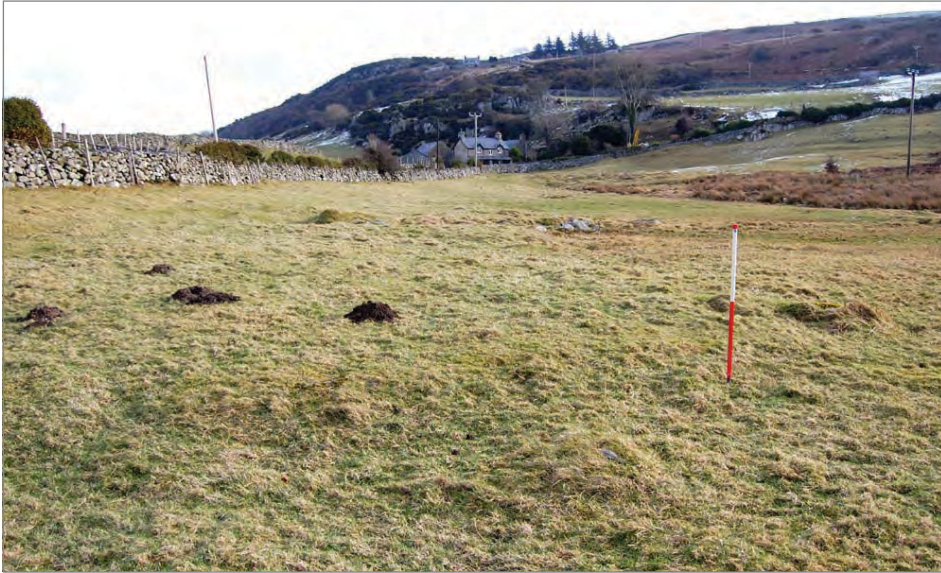
Plate 7. Feature 05, possible hut platform from W

A low roughly rectangular earthwork platform measuring about 7m by 4m and up to 0.3m in height. This is grass covered but occasional stones protrude along the edges. The top of the platform is fairly level. The regularity of this feature suggests that it may be a platform for a rectangular hut, possibly medieval in date. However, there are no clear diagnostic features and it could be a natural feature based on a bedrock outcrop. Although outside the development area this feature is very close and could easily be damaged by plant movement during construction. It is recommended that this feature is fenced off to avoid accidental damage.

***Recommendations for further assessment:*** *None*

***Recommendations for mitigatory measures:*** *Avoid*

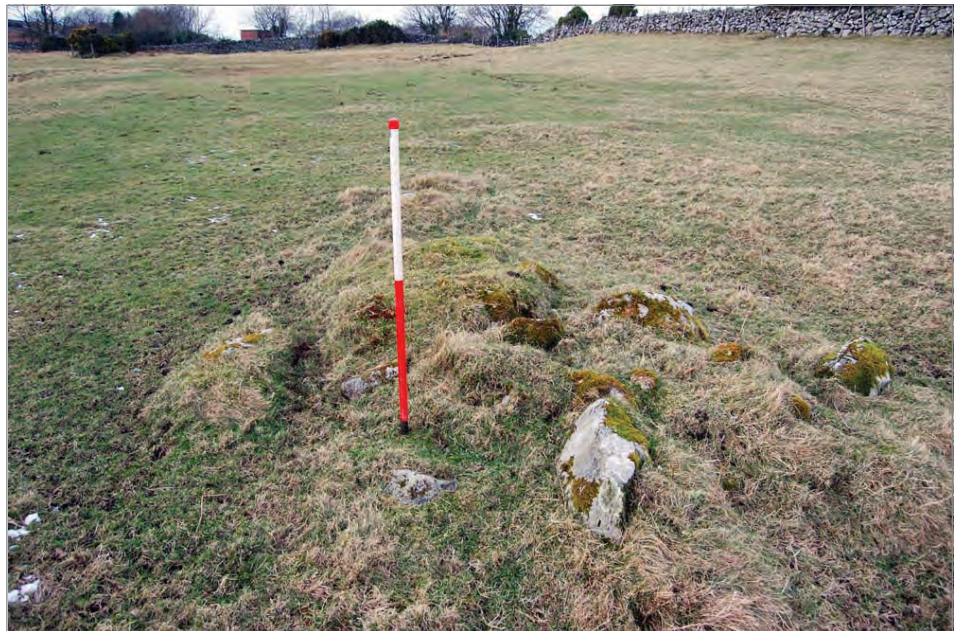
Plate 8. Feature 06, clearance cairn, from E

A small field clearance cairn about 4m by 2m and 0.2m high. It is composed of stones dumped around a large boulder, probably natural outcropping bedrock. It is a rather rough and disordered heap of stones but well overgrown with grass and could be of some antiquity. A low (0.1m high) very straight bank near the cairn, running perpendicular to the open ditch, is probably caused by buried drainage as no maps indicate a field boundary at this location. This area should be avoided during construction.

***Recommendations for further assessment:*** *None*

***Recommendations for mitigatory measures:*** *Avoid*

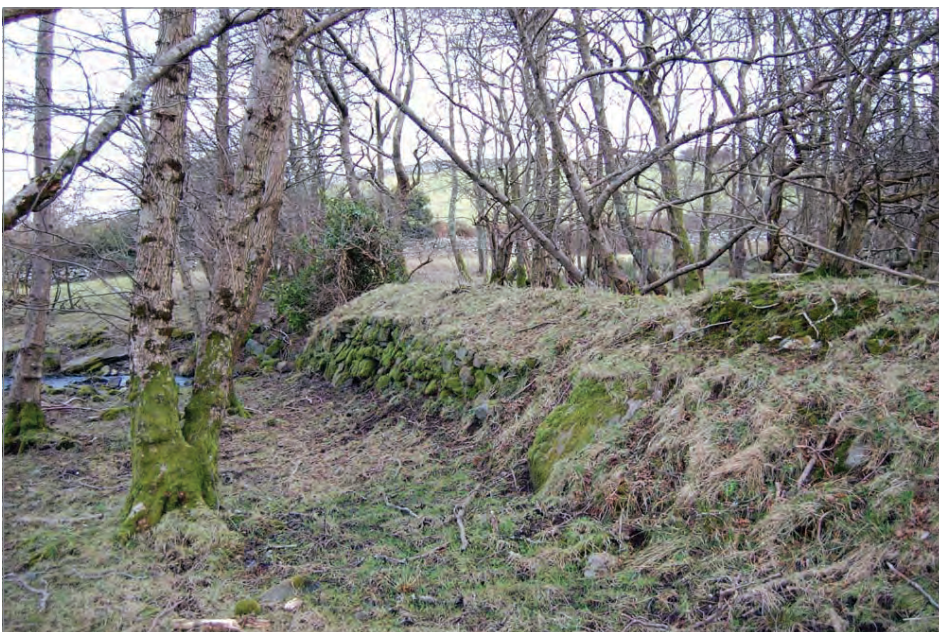
Plate 9. Feature 07, possible dam, from SW

To the west of the reservoir is a straight section of a thick stone-faced bank or wall about 1m high and at least 2m wide. This is 40m long and much of the middle section is collapsed. This is shown on the 1889 map, when it lay just west of a small round pond, although not forming one side of the pond. The bank remained in 1901 when the pond had gone. The bank does not join on to other walls and is not just a boundary feature. It's character suggests a dam, so it may have been a safety feature to prevent flooding down stream, and was probably part of the water supply system discussed under feature 02.

***Recommendations for further assessment:*** *None*

***Recommendations for mitigatory measures:*** *Avoid*
