Report number : 779

March 2009

# **G1632 ROMAN MILITARY SITES 2008**

## **THE ROMAN ROAD BETWEEN SEGONTIUM AND ABER**

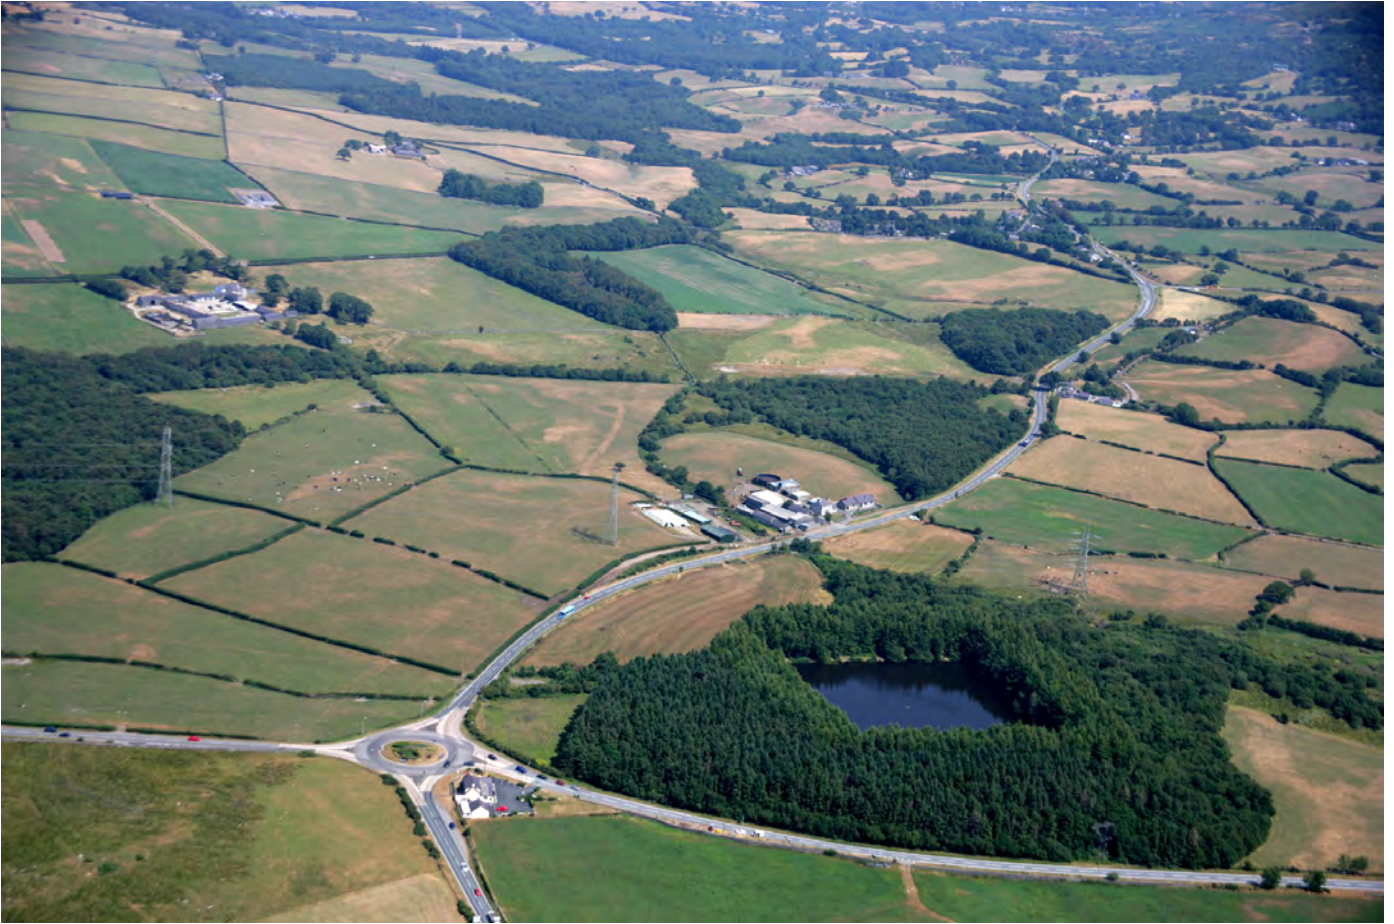
Plate 4 RCAHMW AP2006/3450

A linear parchmark extending top the east from the Groeslon roundabout was shown to be a result of a gas pipeline.

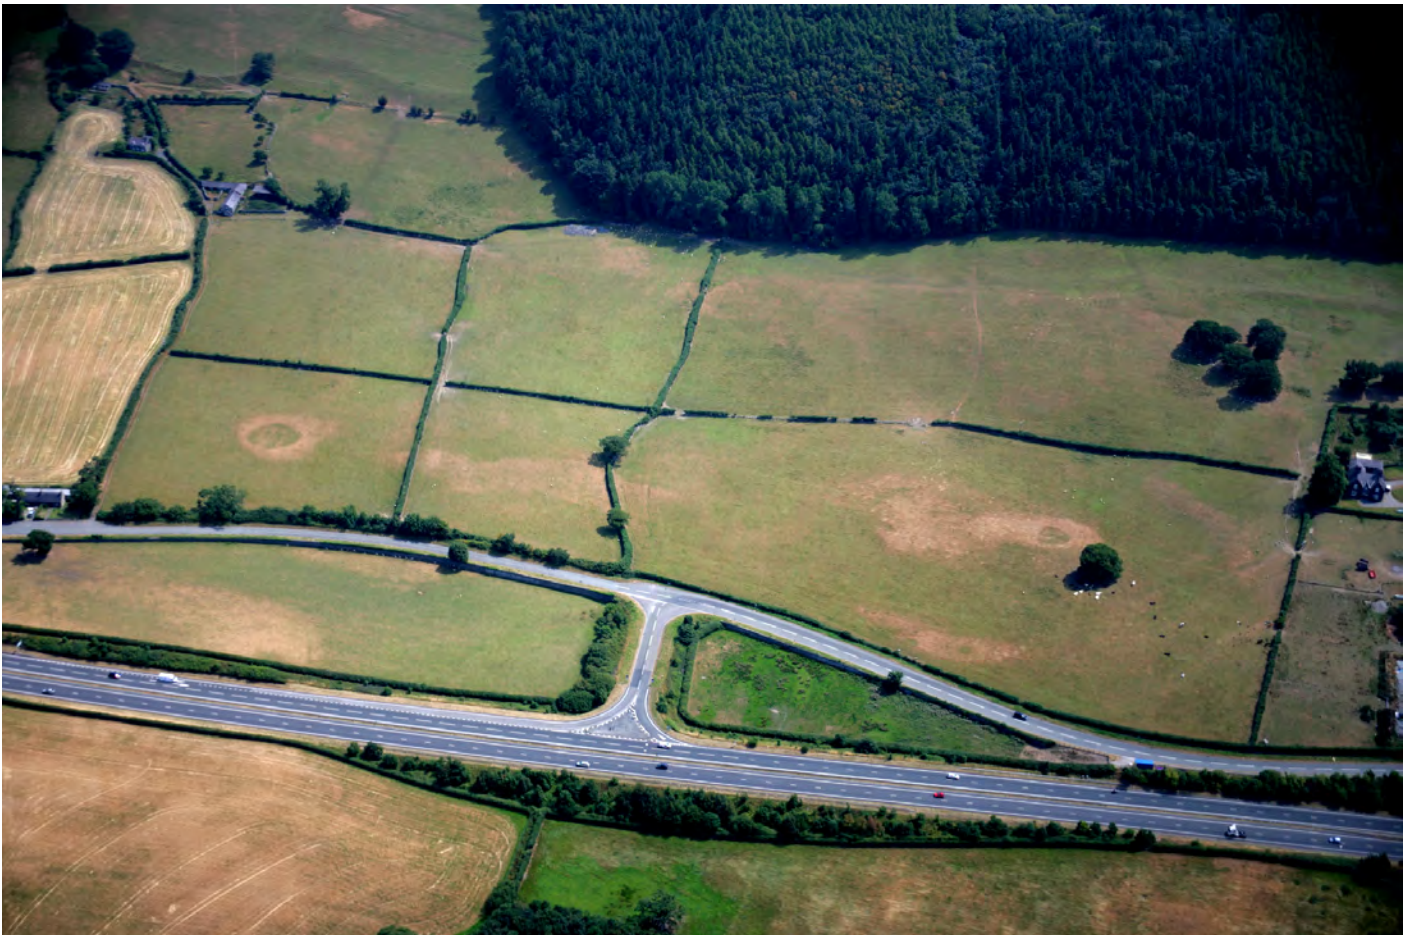
Plate 7 RCAHMW AP2006/3421

An alignment of hedgerows and parchmarks that could be quarry pits at Ty'n y Hendre and Tai'r Meibion. There is no sign of a surviving agger but the parchmarks correspond to hollows. These could be quarry pits but could also be features unrelated to the Roman road. The line through the fields by Ty'n y Hendre is not entirely convincing because the lie of the land is quite uneven and cuttings or terracing would have been necessary. Several hundred years of intensive agriculture could however have removed all signs of the road. This length would merit further aerial monitoring but remains unproven

An earthwork and a parchmark form a linear alignment from Ty'n Hendre to Capel Gilfach. Examination on the ground showed the earthwork to the south-east of Ty'n-y-hendre to be a pronounced roughly linear scarp curving sharply to the south-west at the north-east. This appears to be a lynchet, probably part of the extensive multiperiod field systems that run from the uplands down to the coastal plain in this area. A parchmark beyond this is not visible as an earthwork and could either be a road or a gas pipeline. The pipeline appears to cross the road near Ty'n-y-hendre just below the line of the lynchet and crosses the road near Capel Gilfach so the pipeline is the most likely interpretation.

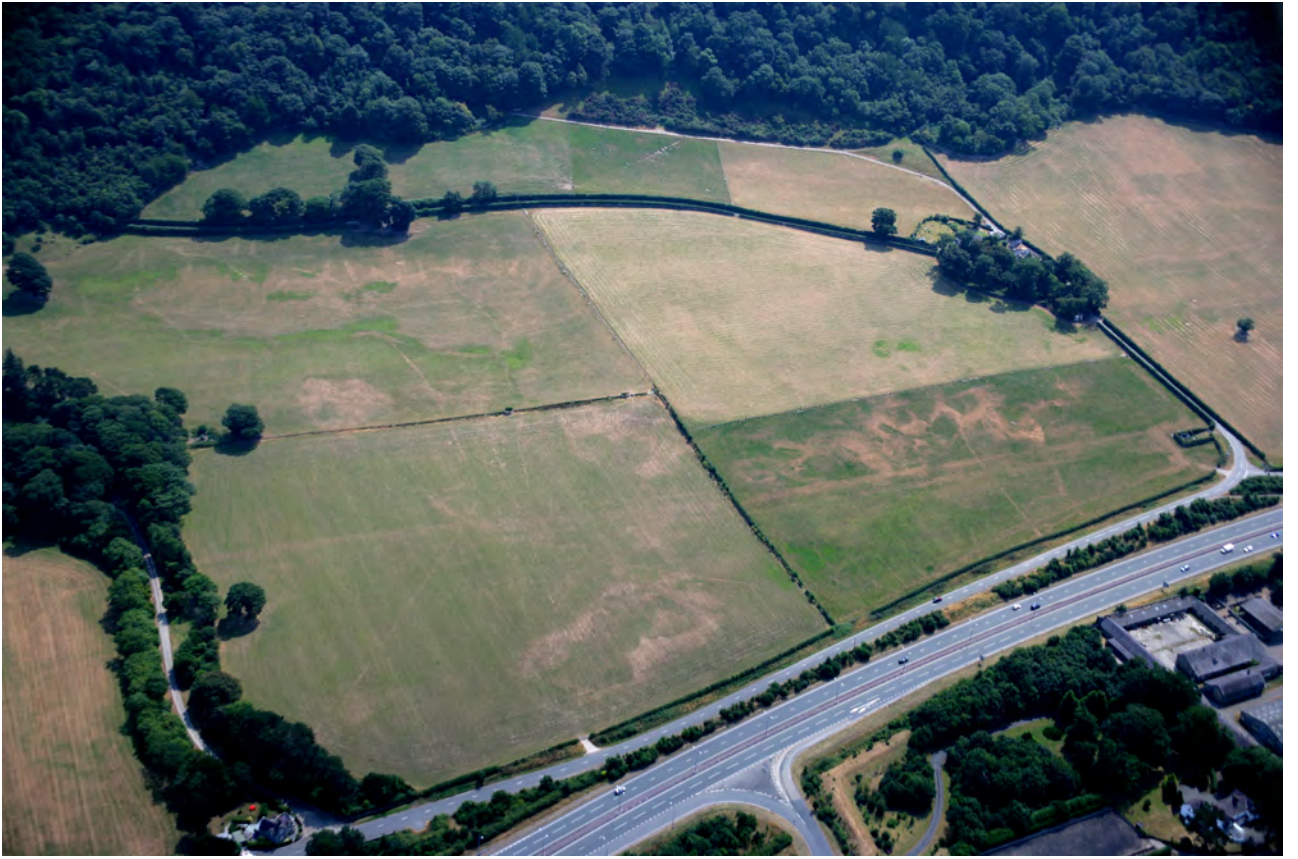
Plate 8 RCAHMW AP2006/3416

This linear cropmark corresponds to the gas pipeline. An alternative line below the minor road between Tan-y-clogwyn cottages and Gorddinog is visible as a slight break in slope but is not of obviously Roman construction.
