# Degannwy Castle, Degannwy, Conwy

## Report on an archaeological assessment

GAT Project No.2068

**DEGANNWY CASTLE, DEGANNWY**  
**ARCHAEOLOGICAL ASSESSMENT**

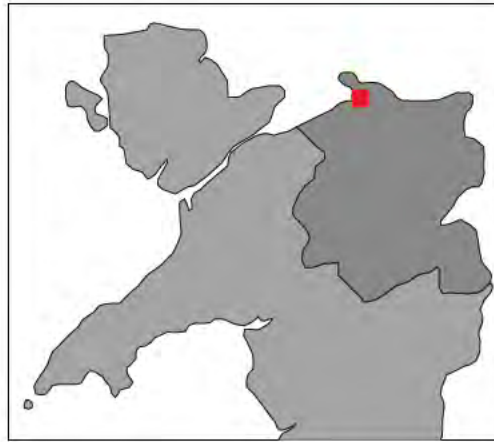
Figure 1. Location of Degannwy Castle and sites in the area  
(Degannwy Castle SAM in red, other HER sites are green circles, the numbers are PRNs)

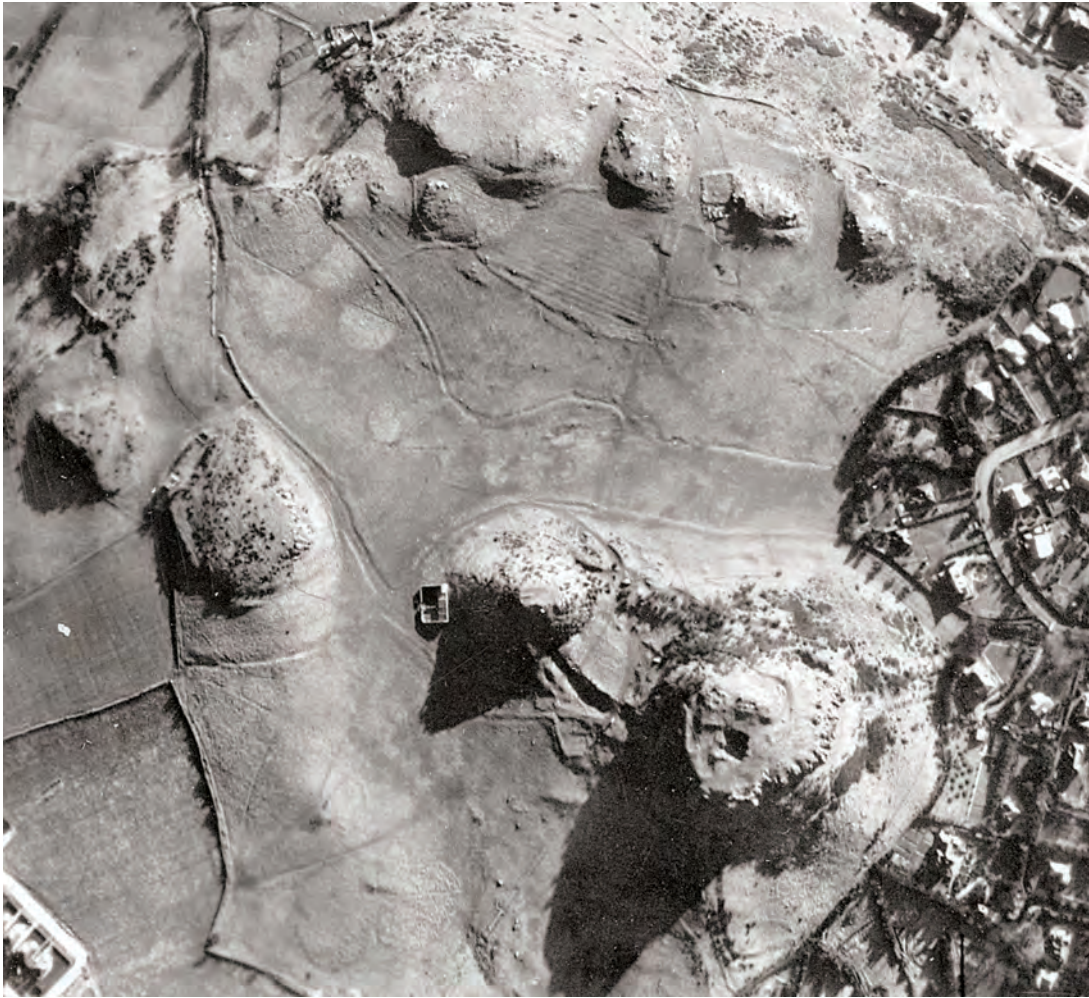
Plate 1. Part of air photograph showing field system (CPE UK 1939, frame 4222, date 20/01/1947)

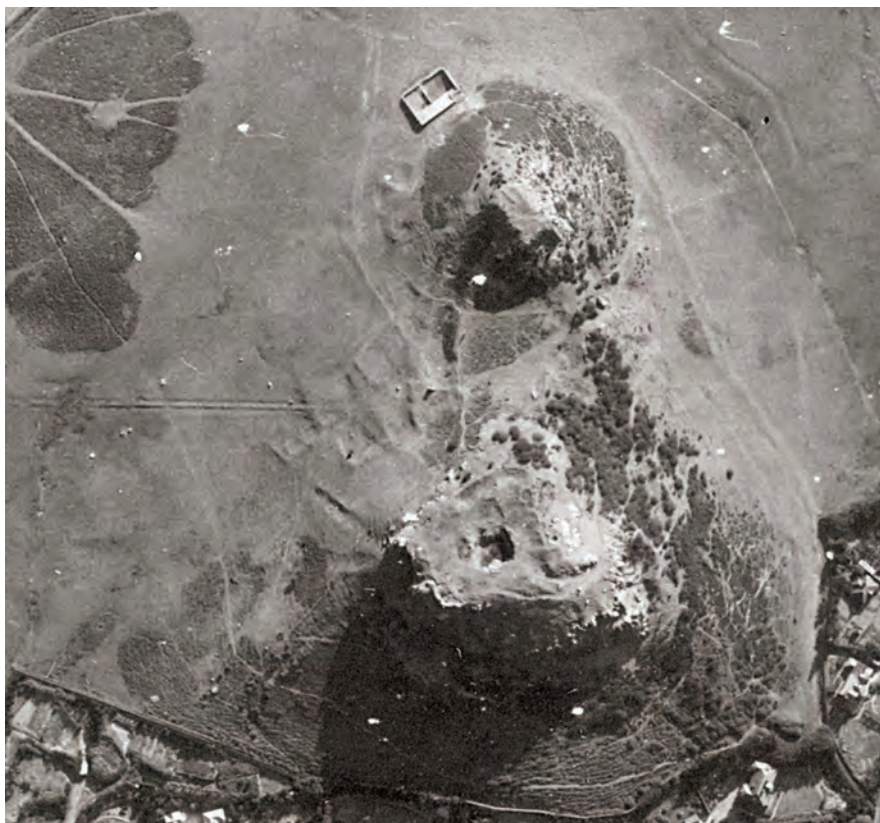
Plate 2. Part of air photograph showing settlement to the north of the castle (106G UK 735, frame 4013, date 27/08/1945)

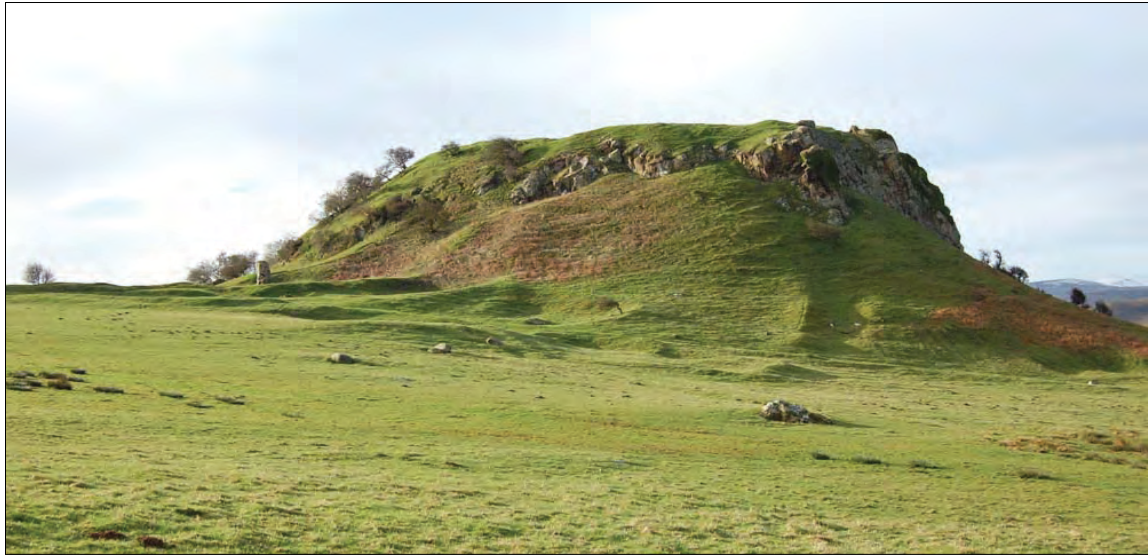
Plate 3. West hill of Degannwy Castle with donjon (PRN 30301) on top, building platforms (PRN 30305) in front and construction incline (PRN 30313a) running up the slope

At the foot of the crags on which the south-west corner of the donjon is built there is a quarry. This consists of two hollows containing loose, broken stone with rounded heaps of quarry waste on their southern sides. On the southern side of the quarry, towards the eastern end, is a chunk of mortared masonry. This has probably fallen from the gatehouse on top of the crags above, though it seems surprisingly intact to have survived such a fall. However it may indicate a stone structure closer to its present location. The crag above can be seen to have been extensively quarried with quarried faces visible to a considerable height. The date of the quarry is not known, though it might well have supplied the stone for the construction of the donjon and related features.

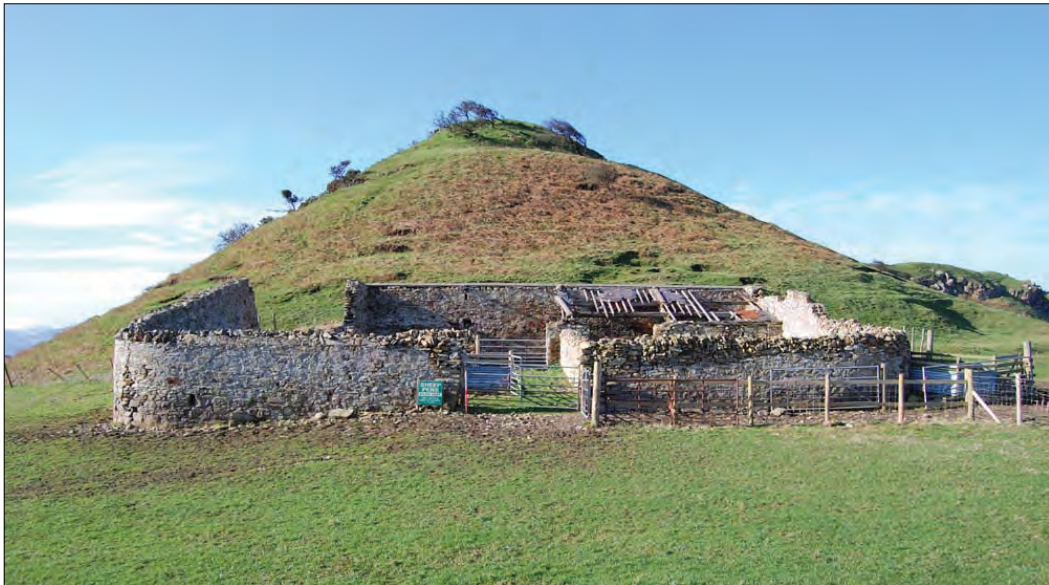
Plate 4. East hill of Degannwy Castle with Mansel's Tower (PRN 30302) on top, possible ditch/platform (PRN 30312) just below the summit, and 19th century farm buildings (PRN 30317) at the foot of the hill

Mansel's Tower, named after John Mansel, Henry III's chief clerk and counsellor, was built by 1249, when its height was ordered to be raised. It was further raised and roofed in 1250 (Brown et al 1963, 625; Alcock 1967, 193). Its foundations can be seen on the eastern hill as low stony banks, no more than 0.4m high, forming a D-shape in plan with a central division. Alcock's excavations found no evidence for a closing wall on the west side of the 'D' (Alcock 1967, 193), and little can be seen on the ground at this side. Just below the tower, where the bailey wall would have joined on it are the traces of a small turret (RCAHMW 1956, 154).

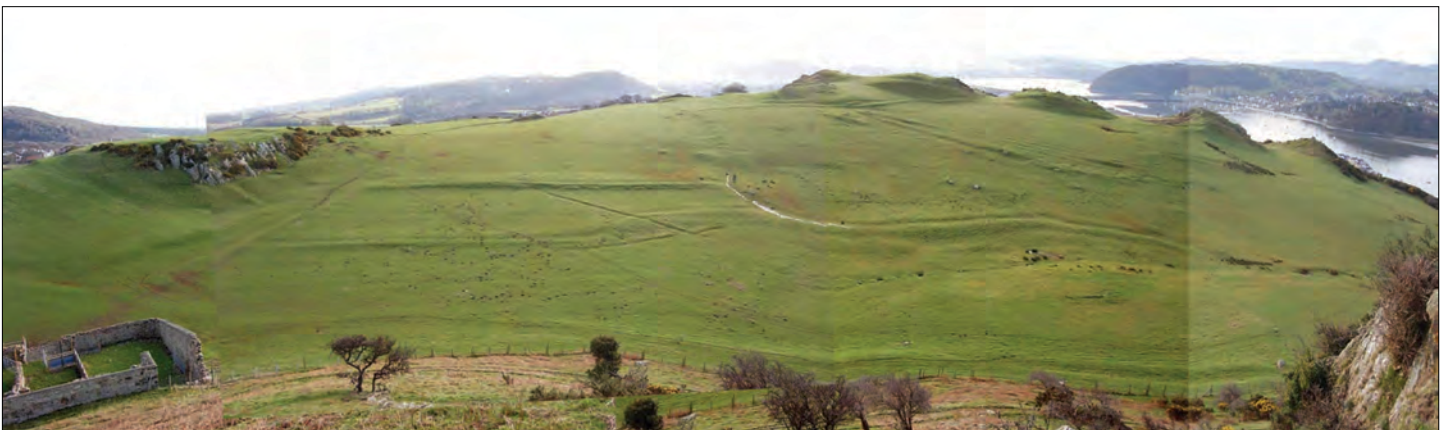
Plate 5. Composite photograph of field system (PRN 30309) to the south of the castle. View from the east hill.

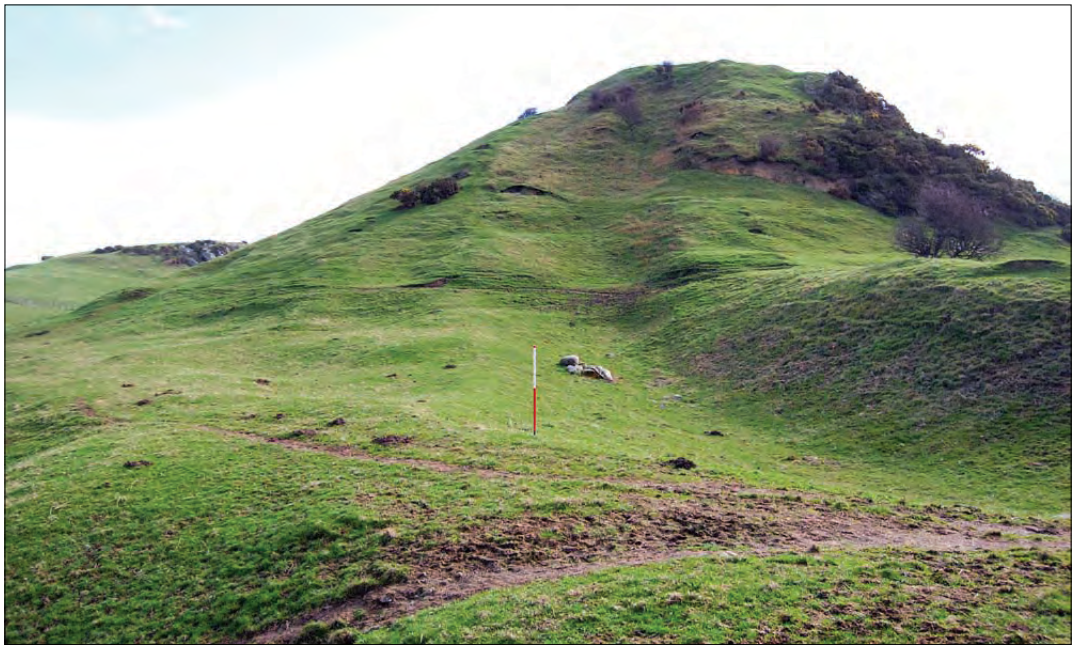
Plate 6. Main north ditch with possible construction incline (PRN 30313d) on the outside, running down east hill

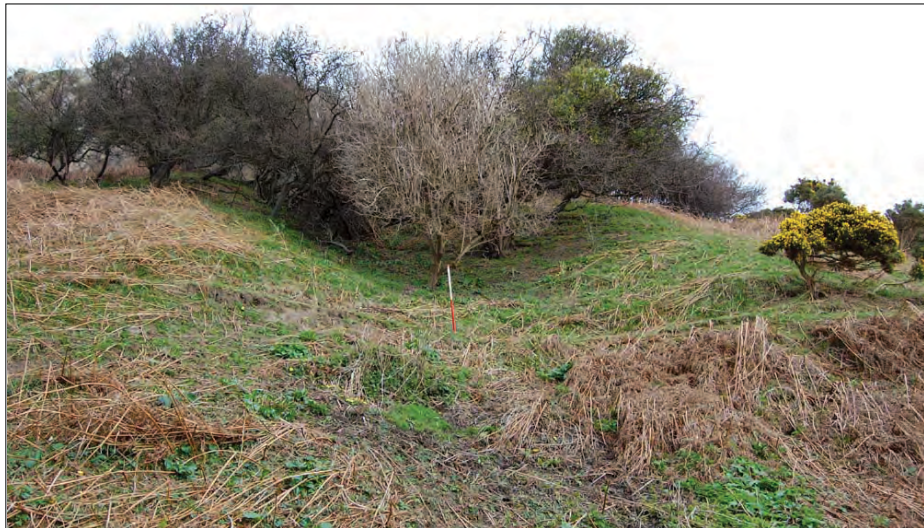
Plate 7. One of the possible construction inclines (PRN 30313c) seen at the foot of the west hill
