Conwy Valley Flood Alleviation Scheme Trefriw Borrow Pit

Report on an archaeological evaluation

GAT Project No. G1877
Report No. 784
March 2009

Prepared for The Environment Agency

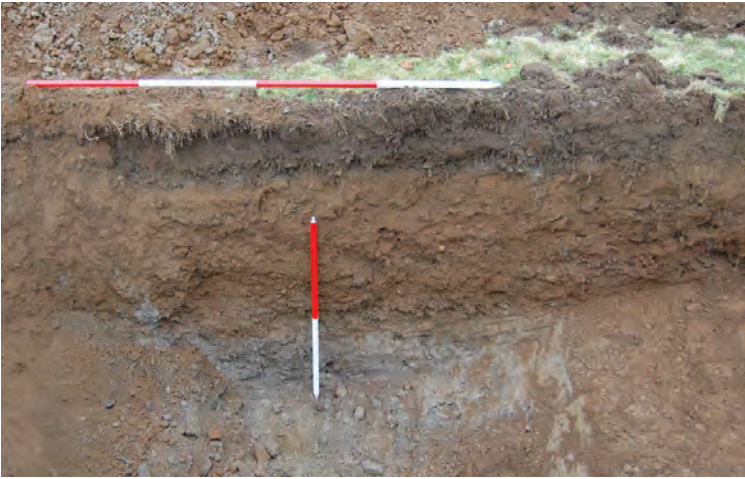
Plate 1. South-west end of trench 1, from south-east

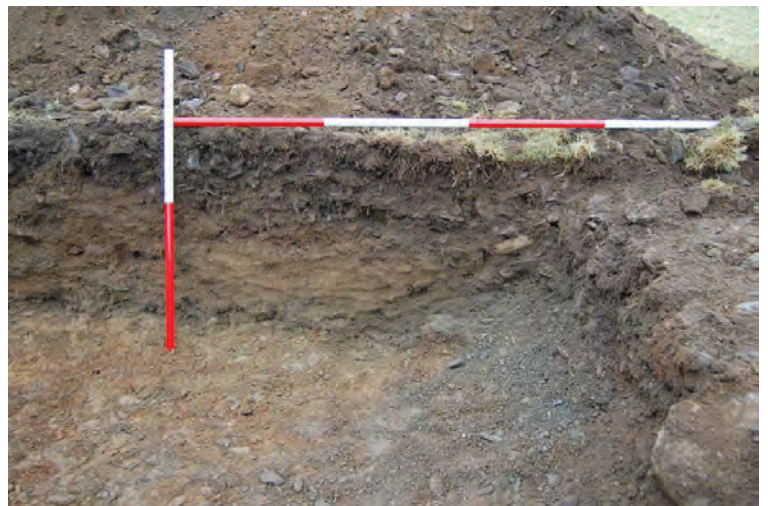
Trench 1 showed that the two linear hollows (114 and 116) had originally been a single feature filled with typical alluvial silts and gravels. The causeway was shown to be artificial and caused by dumping stone over the largely infilled channel. The rectangular platform (115) could be seen to be composed of ploughsoil (106), but the trench alone did not allow full interpretation of the deposits. In particular the fills of the channel appeared to be natural flood deposits and it was initially assumed that the channel was entirely natural.

Plate 2. Fill of hollow way 113 sealed by
causeway 103, from south-east

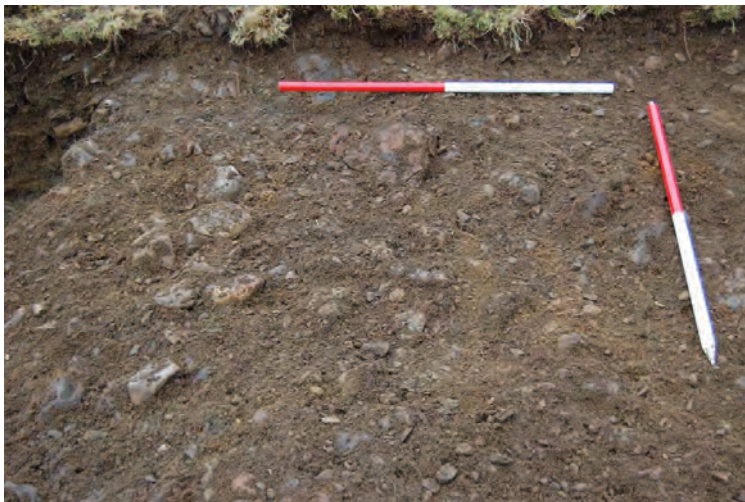
- 103 Very loose, dark grey silt with up to 50% stone and also lenses of gravel, forming a layer up to 0.24m thick. The stones are up to a maximum of 300mm in length and are fairly randomly laid.
This seems to be a deliberate dump of stones and gravel to create a rough causeway across the channel. Occasional post medieval pot and iron objects were recovered from just below the topsoil but no stratified objects were found.

Plate 3. Detail of causeway deposit 103 in plan
from south-east

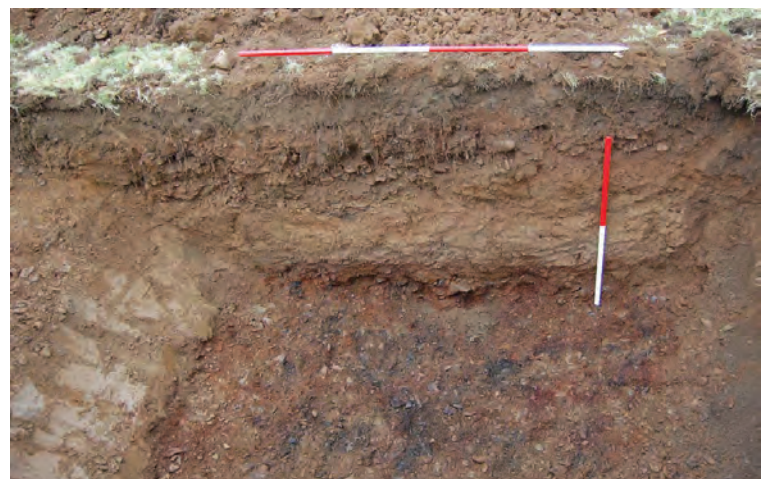
Plate 4. North-east end of trench 1, from south-east

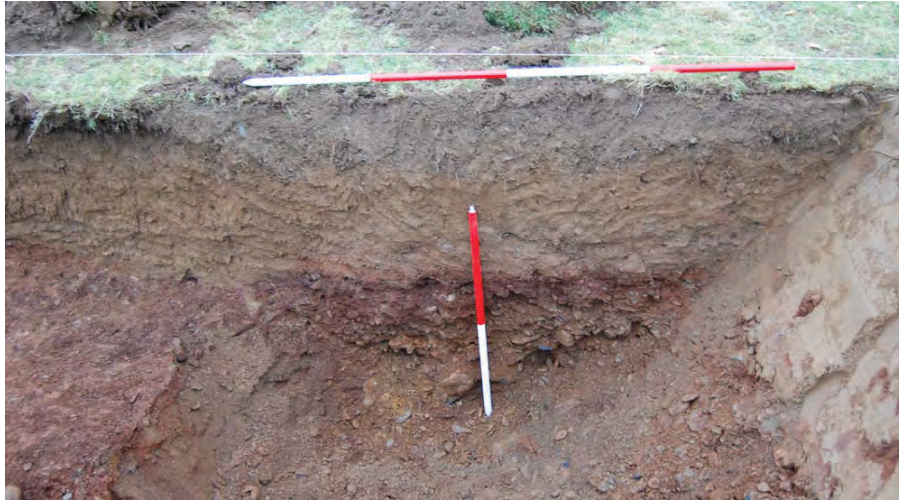
Plate 5. Northern end of trench 2,
from east

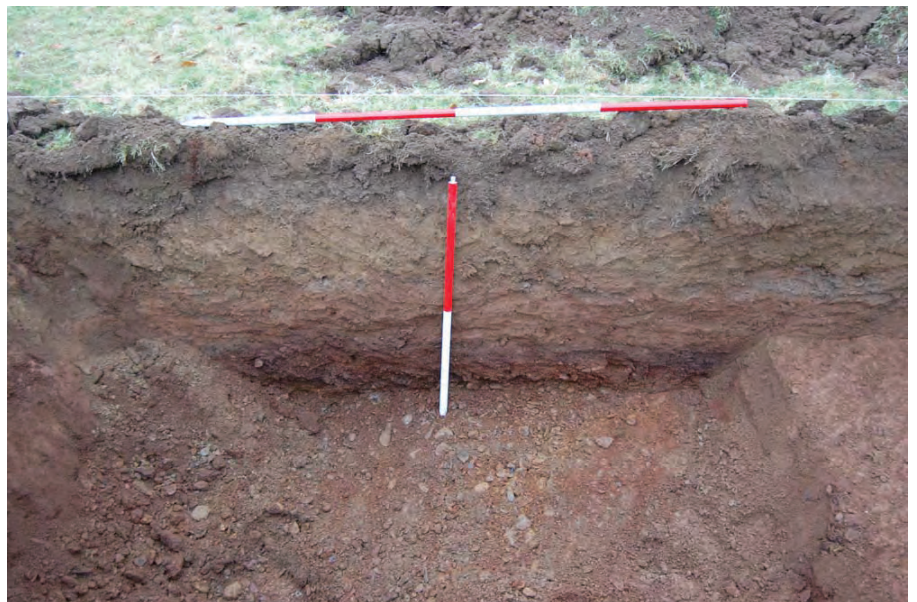
Plate 6. Southern end of trench 2,
from east

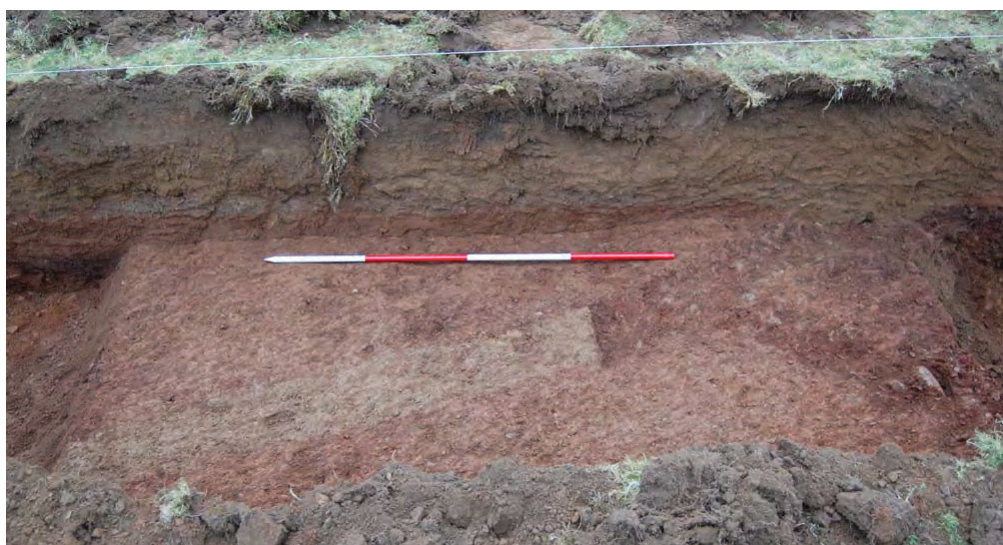
Running north-west to south-east across the middle of the trench was a straight ditch (207) with parallel sides and a flat base. Its fill (206) was indistinguishable from layer 202. The ditch was only visible where it cut layer 204, at which point it was about 0.4m wide and 0.2m deep. Its north-western end was concealed under the western baulk but it never reached the eastern side of the trench and seems to have petered out within trench 2. In section the sides can be seen to be gently sloping and it is probable that this ditch was cut from quite high within layer 202 but subsequent ploughing, alluvial silting and bioturbation has obscured the sides higher up. The apparent ending of the ditch within the trench is also probably due to the fact that it could not be seen within 202 and where its base did not cut layer 204 it could not be followed. The ditch ran for about 4m within the trench.

The ditch (207) running across trench 2 is probably an open drain dug at some point during this long history of flooding. Its straightness suggests a date no earlier than the medieval period, and probably later, but no dating evidence was available. The upper parts of the ditch have been lost due to ploughing mixing its fill with surrounding deposits, making its full depth and the level from which it was cut difficult to determine. However to work effectively it must have been about 0.4-0.5m deep and could have been cut from just below the present topsoil.

Plate 7. Ditch 207 with fill 206, cutting layer 204, from east

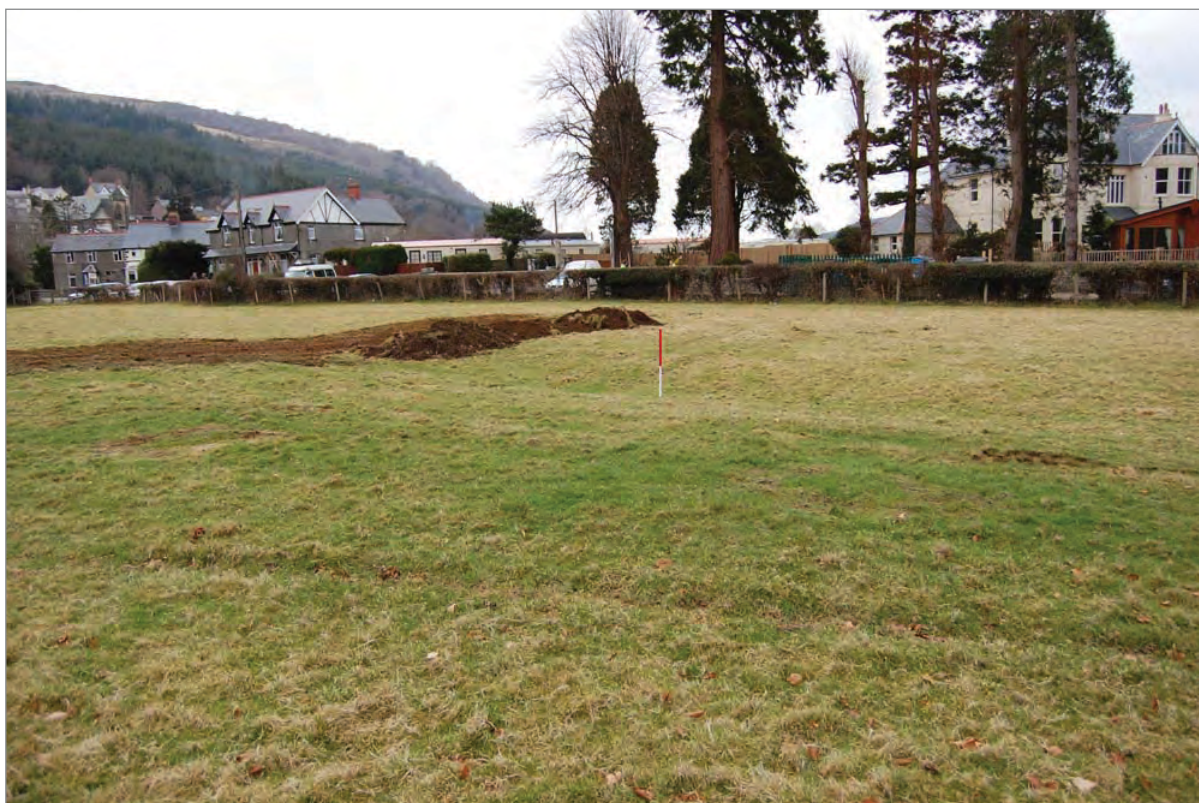
- 114 This is a linear hollow seen as an earthwork. It is up to 5.5m wide and c.77m long. In places the sides are well defined and up to 0.75m high but elsewhere, especially on the southern side towards the fence, the sides are very slight. The channel curves slightly and is lost at the eastern end in the hedge. The western end rounded and there is a slight causeway between this part of the channel and 116. The evaluation trench showed that the channel continued through and that the causeway is largely artificial.

Plate 8. View of hollow way 114, from south (trench 1 has been backfilled)

There is a reasonable possibility that the track has a medieval origin, and the evaluation excavations have revealed it to be well preserved beneath the visible earthworks. It is therefore recommended that the earthworks, including the track, are preserved *in situ* by moving the borrow pit away from this part of the site. If direct impact upon this area cannot be avoided, then it is recommended that two trenches (each 10m by 2m) are excavated across the line of the track to record it. Further recommendations may be made following this work.

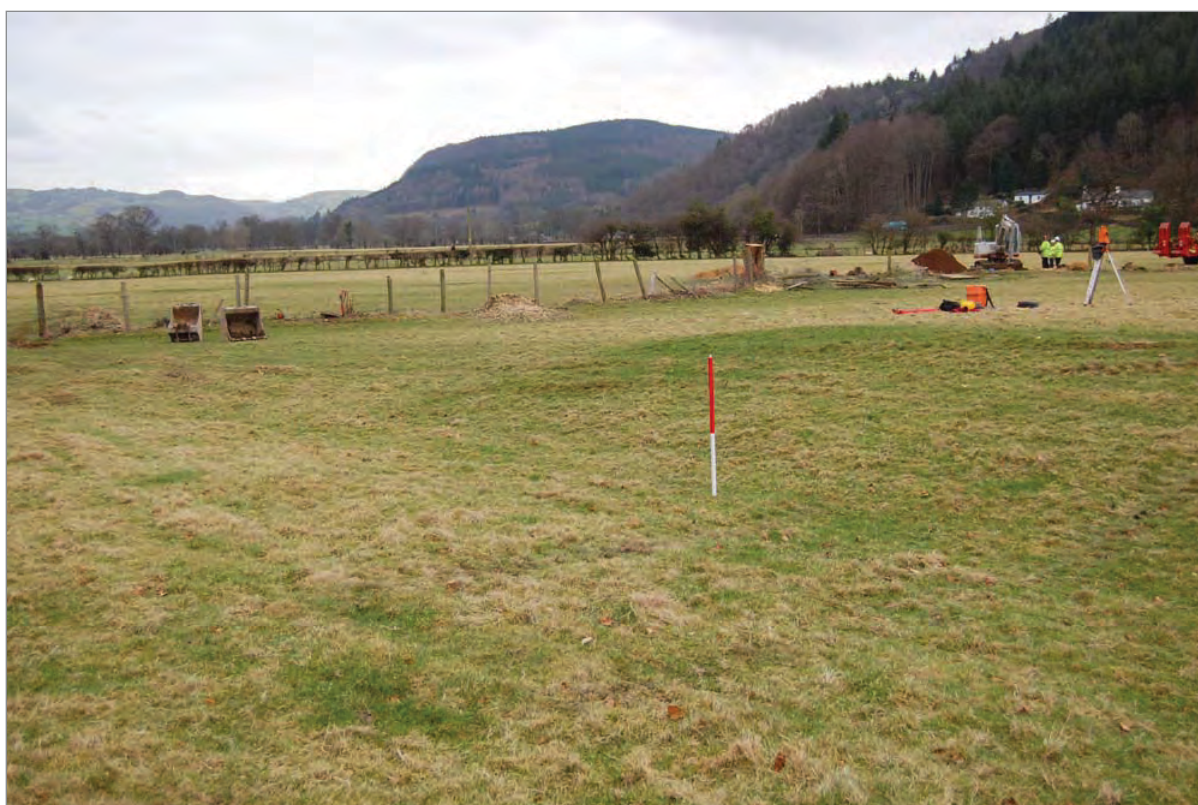
- 115 This earthwork appears as a roughly rectangular platform with a well defined eastern corner and a slighter north-western corner. It measures about 24m NW to SE and about 11m across, although there is no defined SW side. The long side runs parallel to the channel 114 and is up to 0.5m high at the E corner, although much slighter elsewhere. The evaluation trench suggests that this platform is built up largely of ploughsoil (106) and the well defined eastern corner may be the result of ploughing depositing soil against a field boundary.

Plate 9. View of hollow way 114 and south-eastern corner of platform 115, from north-west
