GAT Project No. 2027

Report No. 795

**AN ARCHAEOLOGICAL WATCHING BRIEF AT THE CORNER OF
DEAN STREET AND GARTH ROAD, BANGOR, GWYNEDD**

Prepared for Watkin Jones and Son Ltd

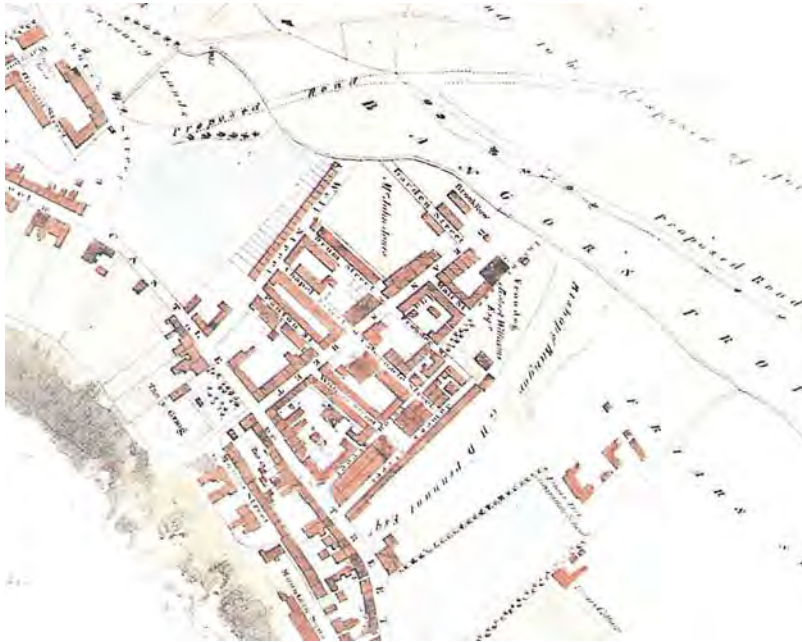
Fig.2 Detail of Wood's Map of 1834 showing site undeveloped between the proposed road and the Afon Adda

The development area is an irregular shaped plot at the junction of Garth Road and Dean Street, comprising the former location of an electricity works and various other post-medieval structures. The northwestern end of the plot existed as undeveloped meadowland until the early twentieth century. This is evident on Wood's Map of Bangor of 1834 (Fig. 2) and the evidence from the tithe map of 1841 (Gwynedd Archives).

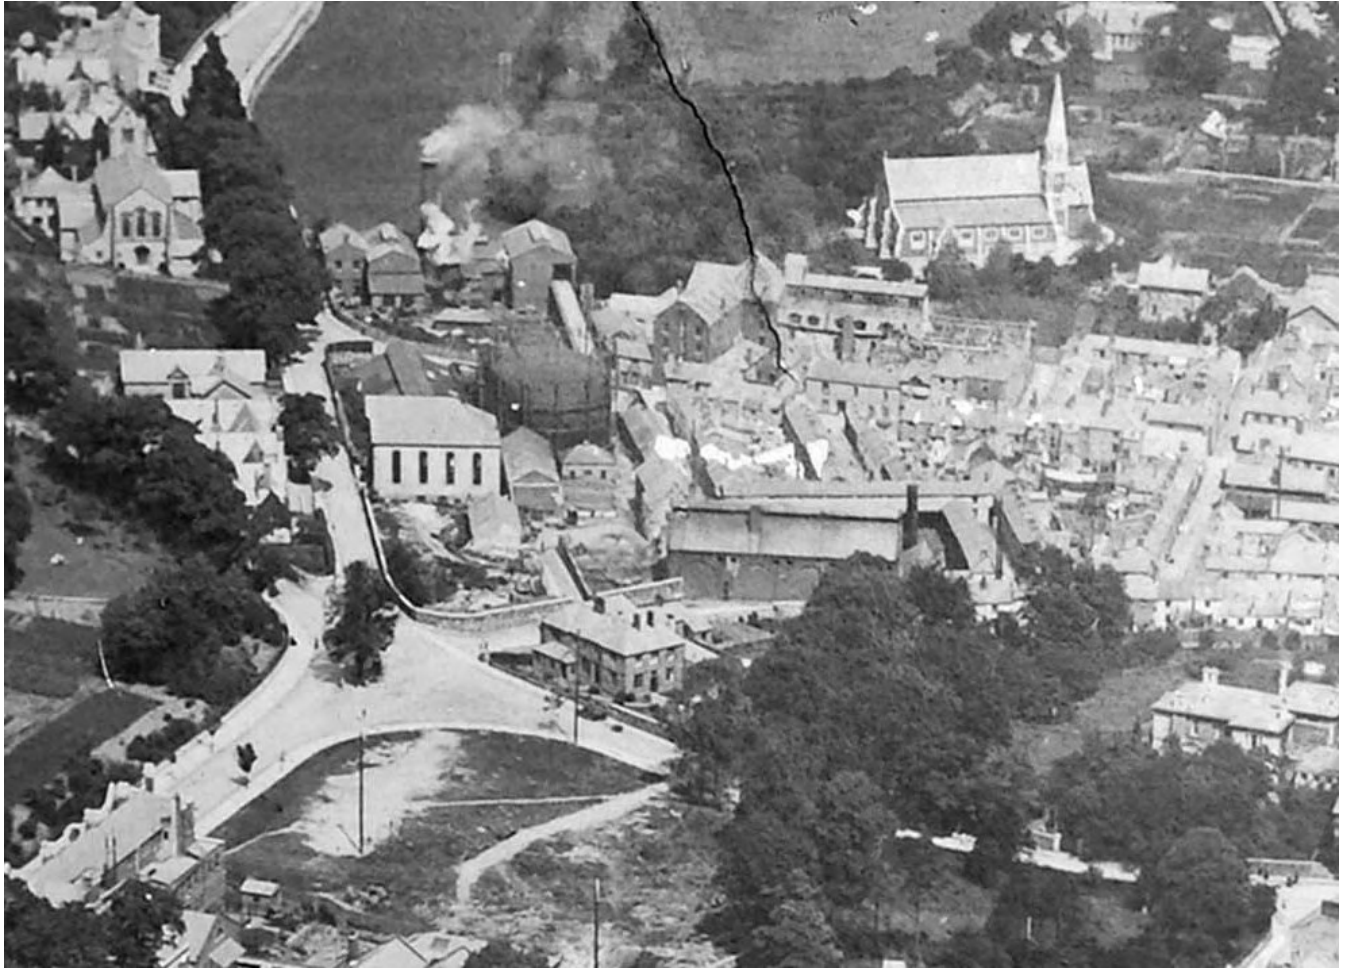
Fig. 4 Detail from c.1910 aerial photograph of Bangor (Gwynedd Archives XS 3910/2) showing electrical works beyond the gasometer

The electricity works were established during the early twentieth century and are extant on a 1914 Ordnance Survey Map of the area (reproduced in Cowell, 1994: 54), and are shown on an aerial photograph of 1910 (Gwynedd Archives XS 3910/2; Fig. 3). The buildings demolished in 2006, were all extant by at least the mid twentieth century and are visible on a 1966 Ordnance Survey map of the area, covering the majority of the development plot (1:1250; SH5771NE).

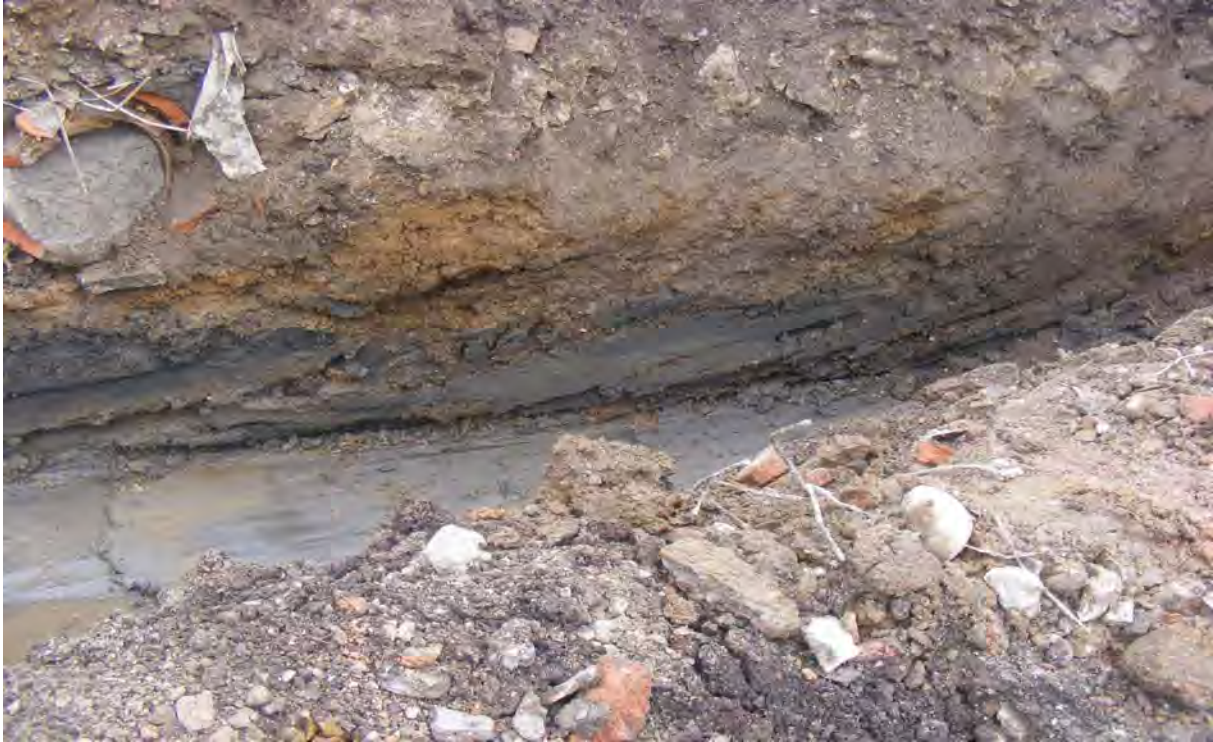
Fig. 5 Alluvial Silting (8) below old field soil (7) and mixed rubble (6)

A diversionary trench for the Afon Adda was excavated to the north of old culvert to a depth of between 2.5m and 3m in order to channel the flow of the Adda during the construction of the replacement culvert. A brick structure at the eastern end of the route (8) was identified as a waste tank connected with the electricity works that formerly stood on the site 20.7m east of Dean Street. It had a depth greater than the depth of the diversionary trench and consequently this was not observed (Fig. 7). This cut the basic stratigraphy observed in the trench which consisted of 2.2m of deposits (Fig. 5). Below 0.3m of compacted and cemented surface was 0.9m of made ground of mixed rubble brick and tile (6), which overlay 0.7m of a mid orange brown silty clay (7). This is interpreted as a relict field surface, which much of this area was until the early years of the 20th century. This overlay a mid blueish brown silty clay, which is probably evidence of silting early river channel prior to any canalisation (8).

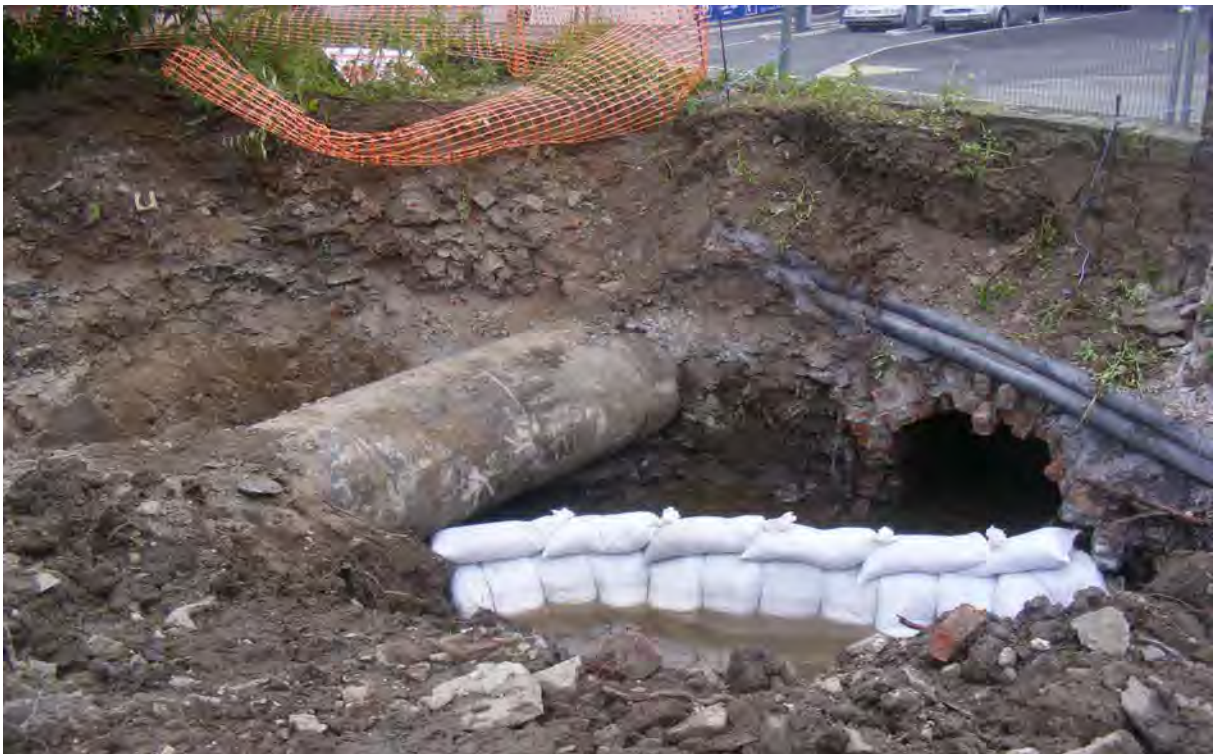
Fig. 6 The breached brick arched culvert (14) with concrete overflow pipe to the south. Facing South-West

On the Dean Street frontage a section through the culvert (14), at this point 0.8m deep and 1.4m wide, brick arched and with a slate base was observed (Fig. 6), along with a concrete capped overflow pipe to the south of it. The backfill of the cut of the trench for the culvert [16] was backfilled with slate chippings of Penrhyn slate (15). This appears to be a 19th century section of culvert, which is in turn cut by the concrete overflow pipe cut on the southern side. 10.55m from the Dean Street frontage the culvert changes to a concrete lined one at an inspection chamber.

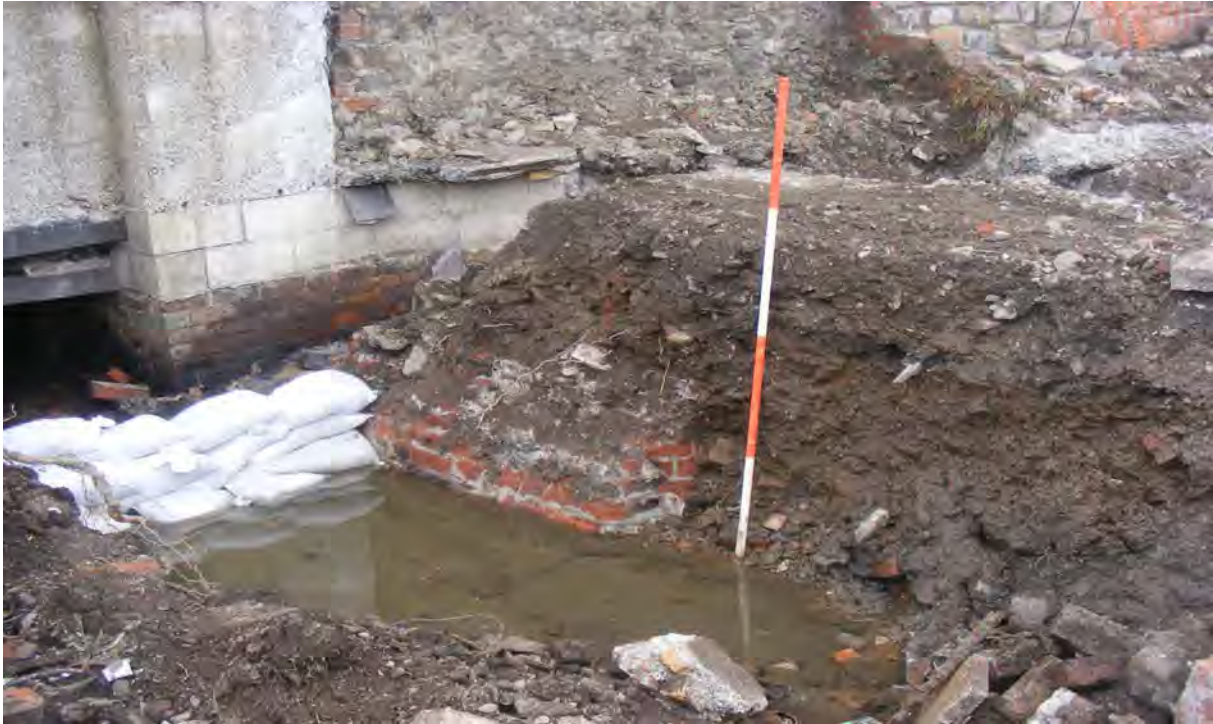
Fig. 7 Remnant of Brick waste tank at eastern end of culvert
