GAT Project No. 2081
Report No. 800
April 2009

Field to the rear of Capel En-gedi, Rhiwgoch, near Harlech
An Archaeological Assessment

Prepared for Egniol Consulting
on behalf of Dŵr Cymru/Welsh Water

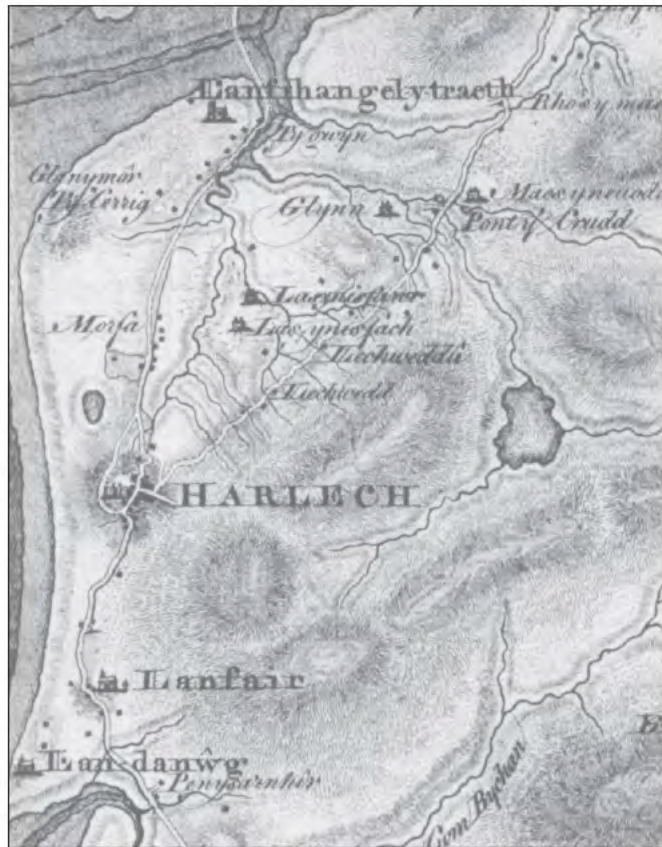
Figure 3. Part of John Evans' Map of Wales (1795)

John Evans' 1795 map of Wales shows a short track heading east from Harlech, that may suggest the road leading from Harlech to the study area had an 18th century origin, although most of it must have been a footpath rather than a road (figure 3). In 1849 and 1856 Lord Mostyn bought much land in and around Harlech from the Cors y Gedol Estate. With the purchases came some earlier maps and one dated 1801 shows that this road did indeed lead to other tracks and to the road to Cwm Nantcol (figure 4). However, map ends just before the cross roads so it does not show whether the other roads were in use at this date, nor does it give an indication of who owned the study area in the early 19th century.

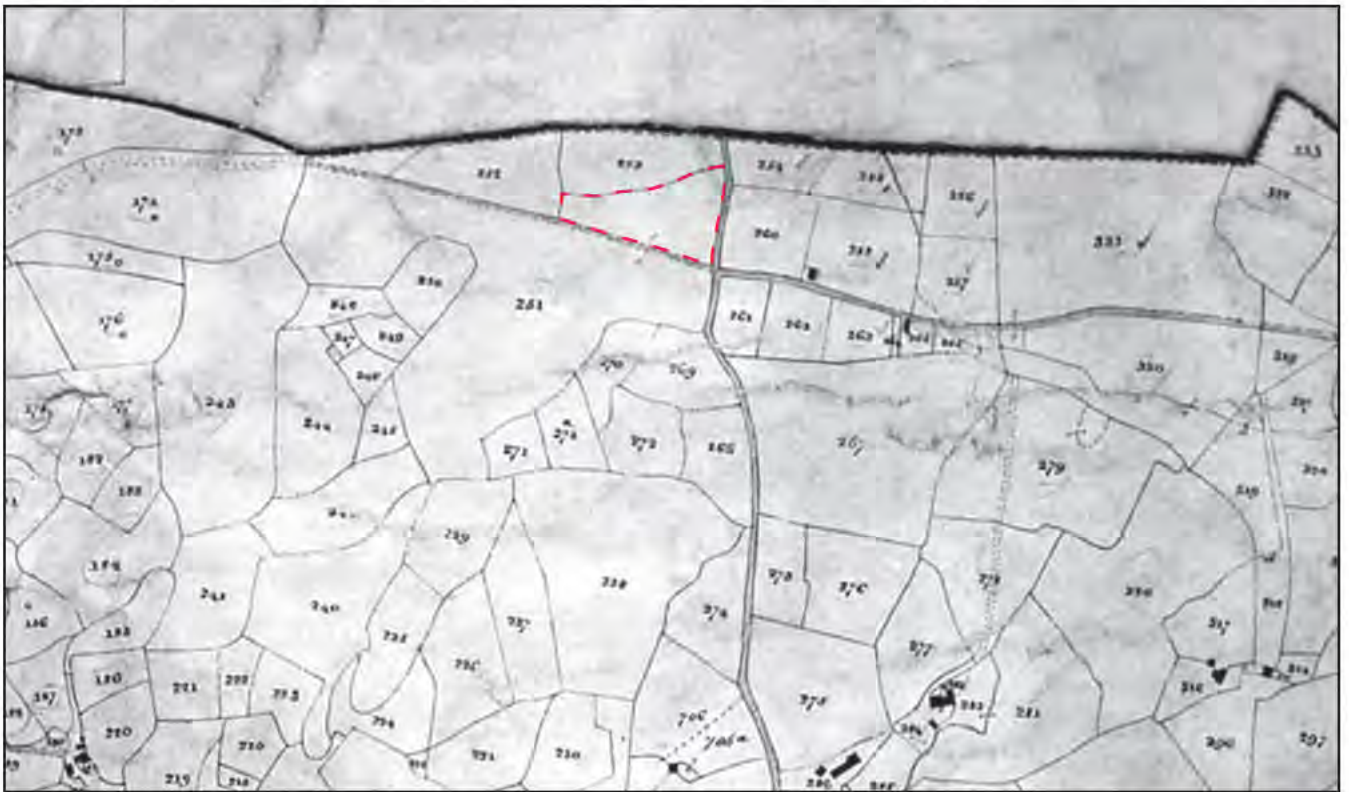
Figure 5. part of tithe map for Llanfair parish (1840). Study area marked by red dashed line

The field is shown on the tithe map (figure 5) just as it appears today, except that the chapel in the eastern corner of the field had not yet been built. The road on the south-east side of the study area is shown on the tithe map as an unenclosed track, and it remained unenclosed until at least 1953 (figure 8). The present boundaries at each side of the road at this point are fences and this section has never been walled. Symbols on both the tithe map and the County Series maps (figures 6 and 7) show that the study area was considered to be part of land parcel 248, which continued to the south of the road and the rough grazing symbols suggest a very different agricultural regime to parcel 244 just the other side of the wandering wall to the north. The triangle of the study area was originally part of a rectangular field cut in half by the track and partially enclosed by paddocks associated with the house of Pen-rhiw-goch. It is likely that its original south-eastern boundary was formed by the ancient trackway (PRN 2901) and that its north-western boundary probably also dates back to the Iron Age. The tithe map shows that it was part of a pasture field called Tir Goed. Possibly this and the other rough fields in the area, including that containing Muriau Gwyddelod had been covered by woodland, so helping to protect the archaeological remains from agricultural damage.

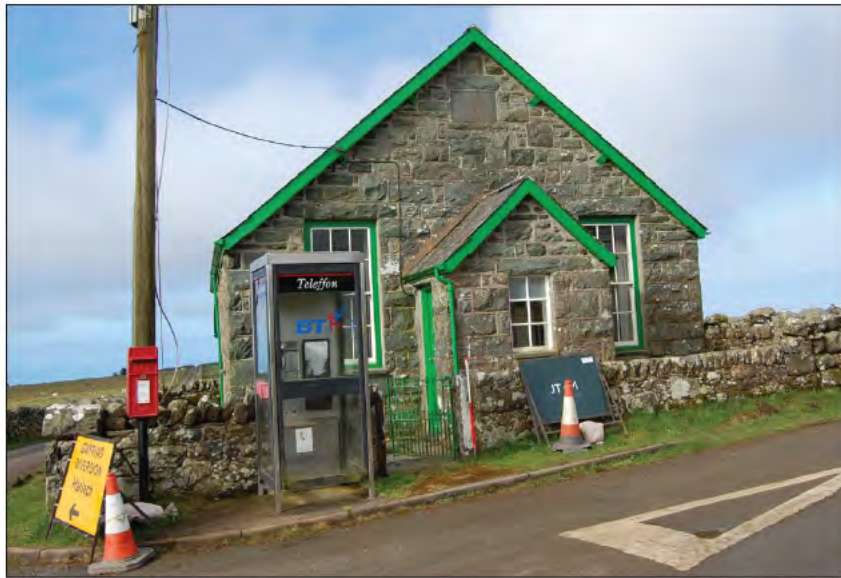
Plate 1. Capel En-gedi (PRN 28919)
from north-east

Stone built chapel, still in use. Built, according to the plaque on the wall in 1894, in what RCAHMW (NPRN 8479) describes as vernacular style of gable entry type. The plaque located high on the gable end reads:

Recommendations for further assessment: None

Recommendations for mitigatory measures: Avoid

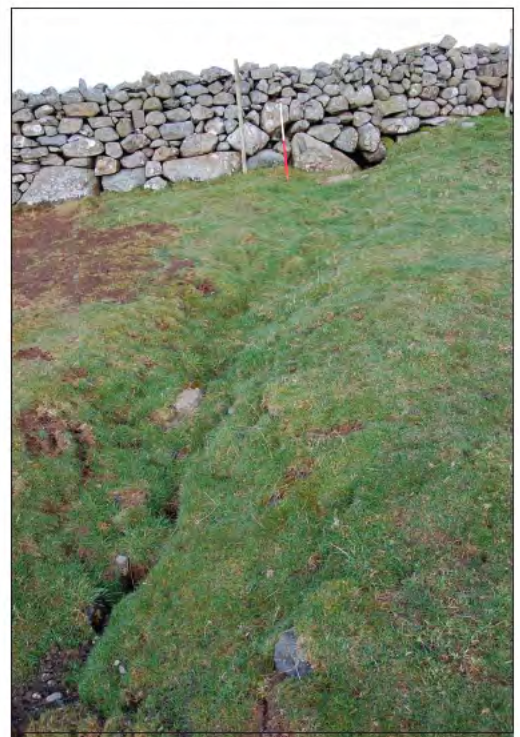
Plate 2. Culvert/drain (PRN 30324)
from south-east

A stream runs across the northern corner of the field in a dug channel. Low gaps have been constructed in the walls to allow it to pass under them. The stream is shown on the 1889 map and was presumably canalised when the present walls were built or rebuilt in the late 18th or early 19th century. Just to the south-west is an 18m section of what appears to be a stone-lined culvert. This has partially collapsed leaving a linear hollow in the field surface. It is shown on the modern map as a drain and seems to run into the stream. To avoid the risks of flooding it is recommended that this corner of the field is avoided.

Recommendations for further assessment: *None*

Recommendations for mitigatory measures: *Fence and avoid*

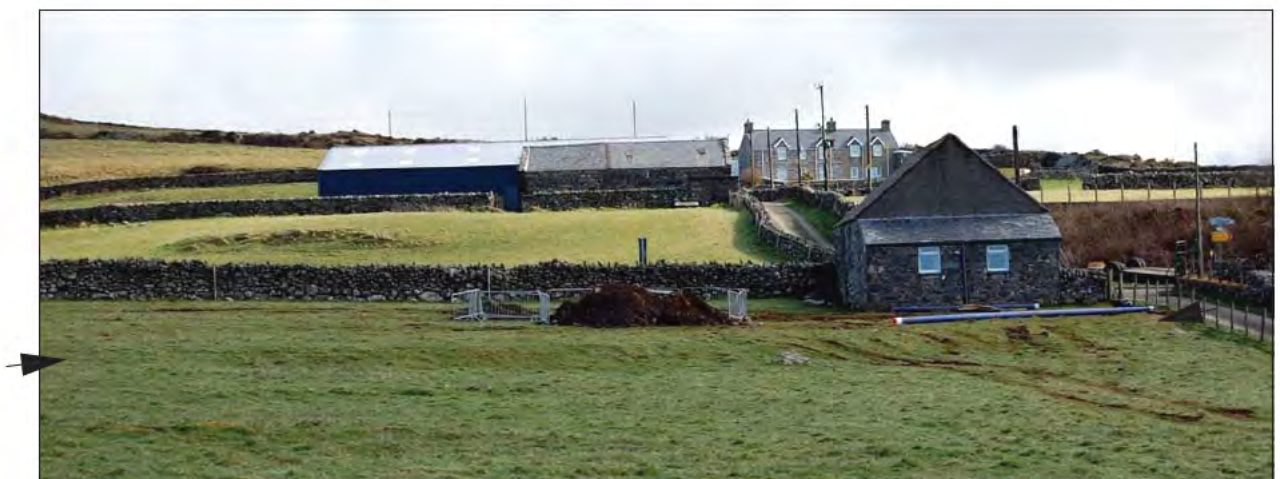
Plate 3. Terraced ancient field boundary (PRN 30325) from south-west (arrows point to ends of scarp)

Running south-east to north-west across the eastern end of the field is a prominent scarp. This faces south-west and is up to 0.8m high. Its south-eastern end is quite straight and is most clearly defined, it then becomes slighter and more wandering but still continuous. Numerous small stones can be seen in the face of the scarp. This feature was not recognised on the aerial photographs, although knowing its location does allow the more prominent south-eastern end to be recognised on the 1971 photograph. As the sun generally will light this feature from the south-west it is rarely in shadow and this explains the difficulty of seeing it on APs.

The north-western wall of the field bulges out to meet this boundary and it is likely that they formed part of the same field system. The scarp may be largely a lynched created by ploughing but the stones in its face suggest it was either reverted with stone or there was a wall along its top. This almost certainly forms part of the Iron Age/Romano British field system associated with Muriau Gwyddelod. The stones on its face are just below the topsoil and topsoil stripping here is likely to disturb this feature. Vehicles running over the stripped boundary would certainly cause significant damage. It is recommended that the area along and near the boundary is not stripped but is fenced off to prevent access.

Recommendations for further assessment: *None*

Recommendations for mitigatory measures: *Fence and avoid*

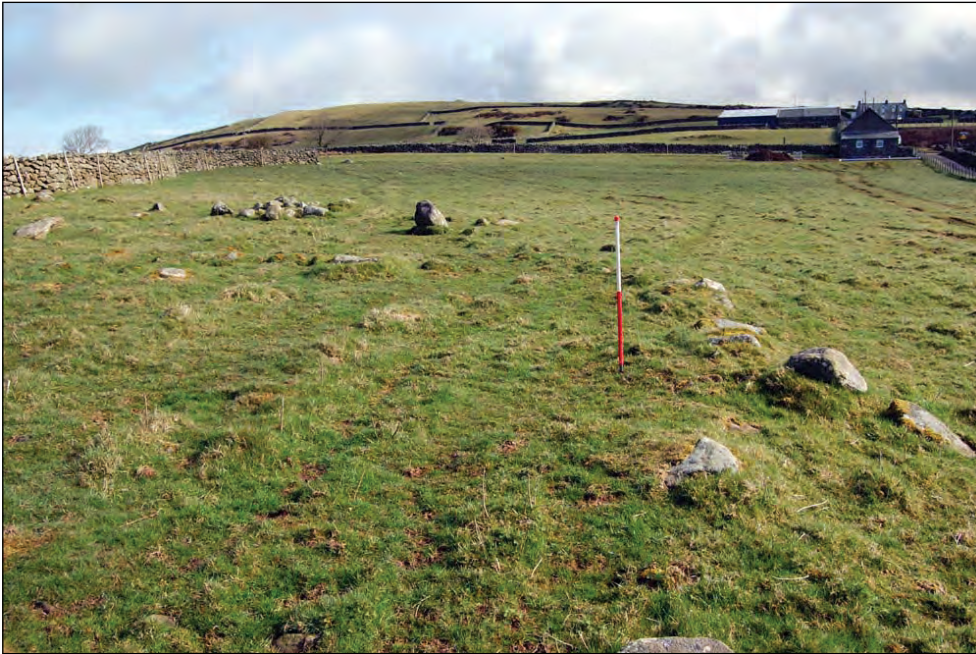
Plate 4. Ancient field boundary (PRN 30326) from south-west

A slight and wandering line of stones forms a low bank running across the south-western end of the field, running approximately north to south. Most of the stones are grass covered but some protrude. The stony bank is 1.5m wide and generally only about 0.2m high. Towards the northern end is a heap of stones partially overlying the bank. These stones are less overgrown than the bank and probably represent a later clearance cairn. To the south-west of the bank are numerous stones scattered on the field surface. Many of these are natural but some seem to form short lines.

This feature was just visible on the 1971 aerial photograph and could be seen quite clearly on that to be a continuation of the much better preserved ancient wall to the south-east of the road. On the ground this was confirmed and this stony bank is the denuded remains of a wall of the Iron Age/Romano-British field system. All the south-western end of the field should be avoided and excluded from the compound.

Recommendations for further assessment: *None*

Recommendations for mitigatory measures: *Fence and avoid*

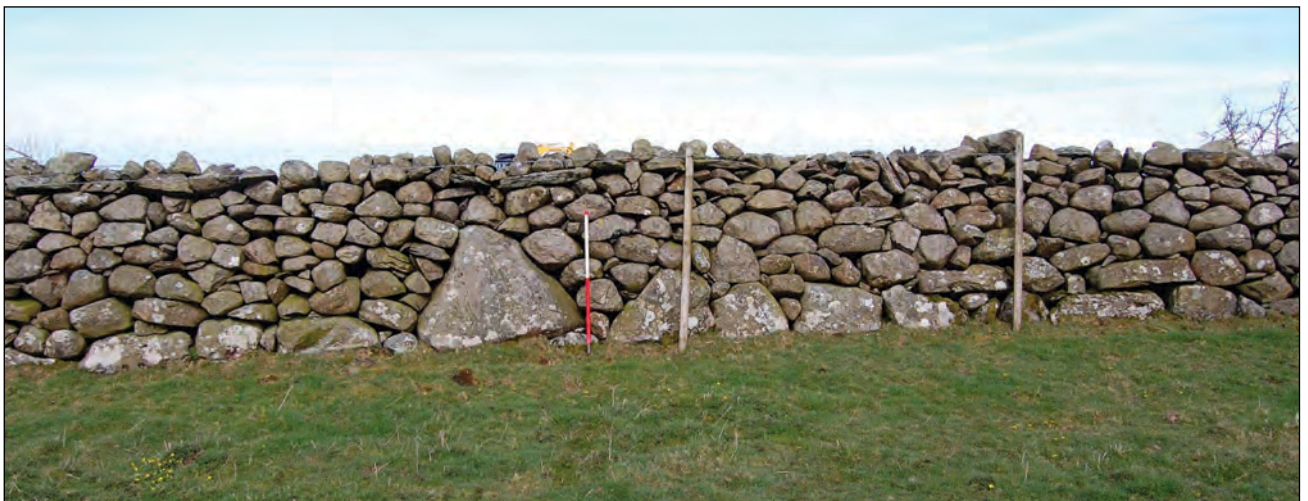
Plate 6. Post medieval field wall with probable ancient foundations (PRN 30327)

The existing north-western boundary of the field appears on the ground to be similar to the other walls in the area. It is about 1.5m high and constructed of rounded glacial boulders. Its difference is evident from the air or from maps as its irregular line contrasts with the regular rectangular fields surrounding it. Other fields also have these irregular boundaries, particularly the boundary to the north of Muriau Gwyddelod, which continues to the south of the road. The way in which the boundary encircles the settlement and relates to the radiating walls running from the settlement strongly suggests that it is in origin contemporary with the settlement. Similarly the north-western wall of the study area relates well to the Ffordd Wyddelod and related field boundaries including the two identified within the study area. Both these tie into the standing wall at points where the wall seems to bulge to meet the ancient boundaries.

This wall should not be impacted on by the compound but should not be broken through or otherwise disturbed without archaeological investigation.

Recommendations for further assessment: None

Recommendations for mitigatory measures: Avoid
