**Track to the south of Moel Goedog, near Harlech**  
**An Archaeological Assessment**

**GAT Project no. G2082**

**GAT Report No. 804**

**Prepared for Egniol Consulting**  
**on behalf of Dŵr Cymru/Welsh Water**

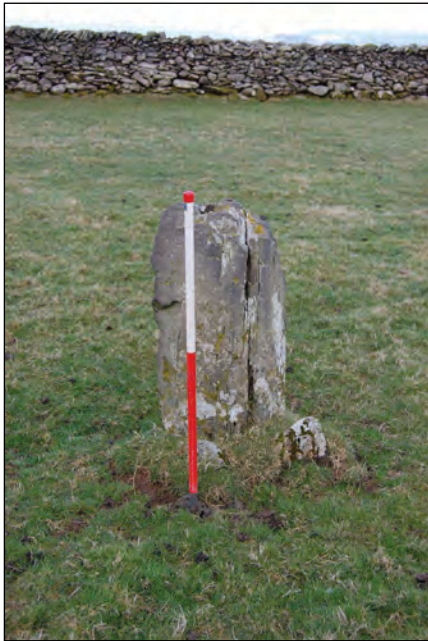
Plate 1. Standing stone (PRN 1040), from east

This small standing stone stands to the west of the tarmaced road and is easily identified. Boulders have been placed along this stretch of road to prevent parking so there should be no risk of accidental damage while turning vehicles.

***Recommendations for mitigatory measures: Avoid***

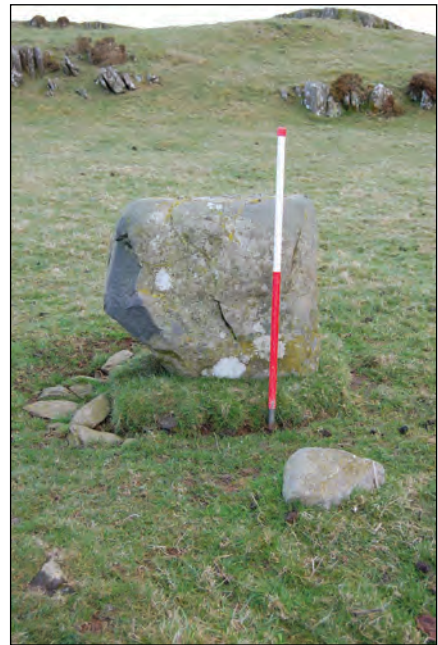
Plate 2. Standing stone (PRN 1041), from south-west

This small stone of slightly unusual shape is close to the edge of the track on its western side. It is less obvious than the previous stone because of other boulders in the area including a heap of boulders at the start of the track and a natural erratic to the east of the track. There should be no risk of damage but it is recommended that the stone be fenced off as it is a scheduled ancient monument.

***Recommendations for mitigatory measures: Fence off and avoid***

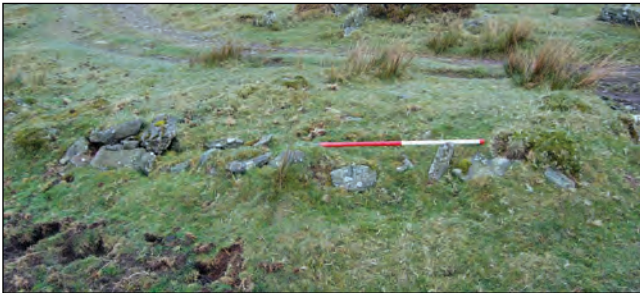
Plate 3. Revetment wall (PRN 30425), from south

This is a short section of rough revetment wall no more than 10m long, about 0.5m wide and 0.2m high. Only 1 or 2 courses survive and it is very disturbed. It runs at a slight angle to the track and does not seem to revet the current track but may be related to a previous track joining from the south-west. It is probably of a late date but with the presence of early field boundaries in the area it is not impossible that it is related to these. This feature should be fenced off to avoid damage.

***Recommendations for mitigatory measures: Fence off and avoid***

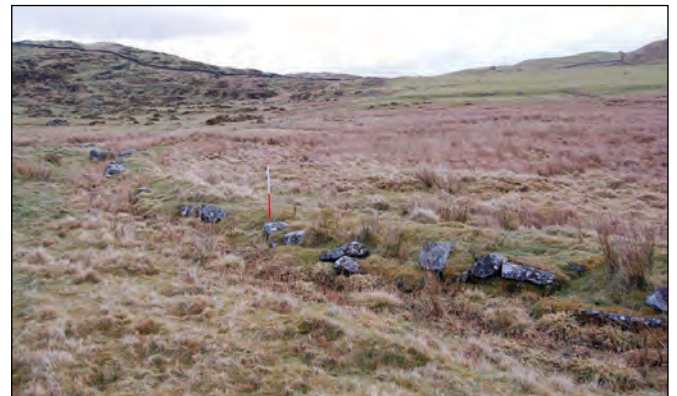
Plate 4. Field boundary (PRN 30426), from west

This is far enough from the track that there should be no risk of accidental damage.

***Recommendations for mitigatory measures: Avoid***

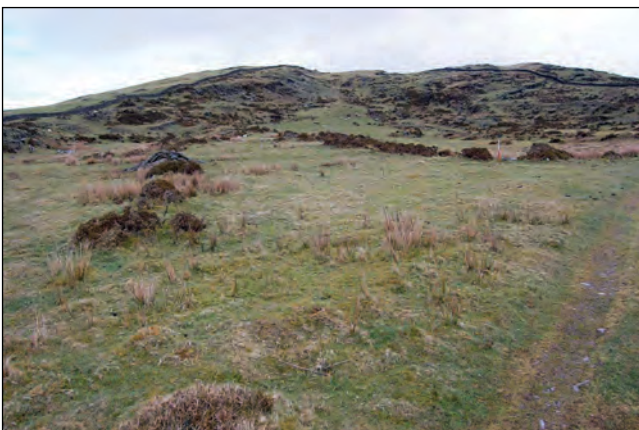
Plate 5. Ancient fields (PRN 30427), from south-west

As long as vehicles stay on the track there is no reason why these features should be damaged, although they are very close to the track and very difficult to identify. The track should be fenced where it passes through this area to ensure no vehicles leave the track here.

**Recommendations for mitigatory measures:** *Fence and avoid*

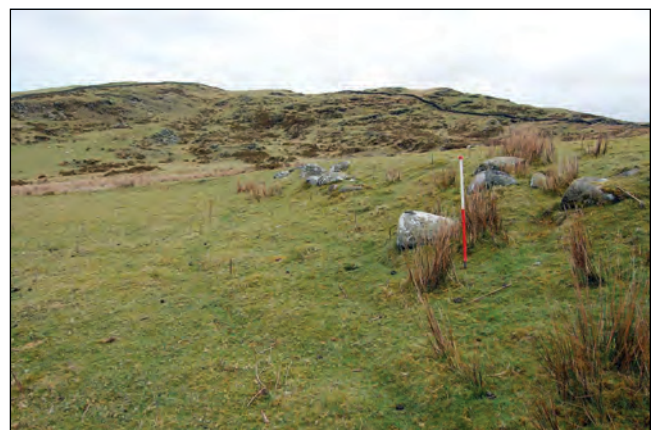
Plate 6. Terraced boundary (PRN 30428), from south

As long as vehicles stay on the track there is no reason why this feature should be damaged.

**Recommendations for mitigatory measures:** *Avoid*

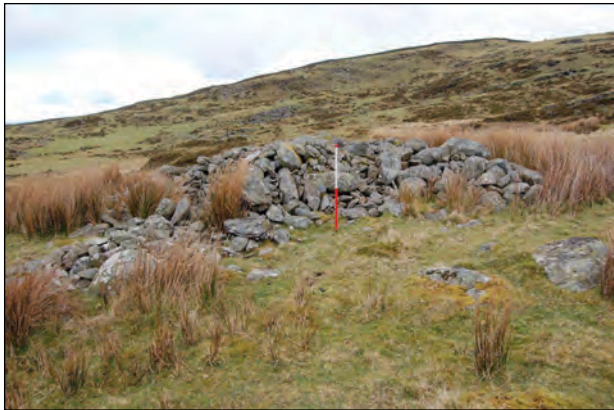
Plate 7. Cairn (PRN 30429), from south-east

This is a heap of stones about 6m in diameter and 1m high. The stones are generally loose and unconsolidated and it is likely that this is a 19<sup>th</sup> century field clearance cairn built up on an outcrop of rock. However there is the possibility that an earlier cairn or a structure might be preserved beneath it. This must be close to the location of a cottage on the Llanfair tithe map, although its precise position is difficult to determine. The cottage seems to have been known as Tyddyn y Cefn and belonged to the farm of Rhydyreirin (figure 4).

**Recommendations for mitigatory measures:** *Avoid*

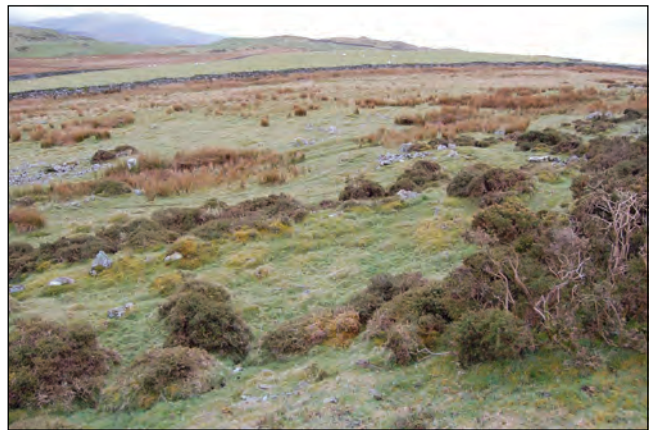
Plate 8. Settlement (PRN 1002), from north-west

As long as vehicles stay on the track there is no reason why these features should be damaged, but the field is quite open here and drivers should be prevented from leaving the track to turn or park.

**Recommendations for mitigatory measures:** *Avoid*

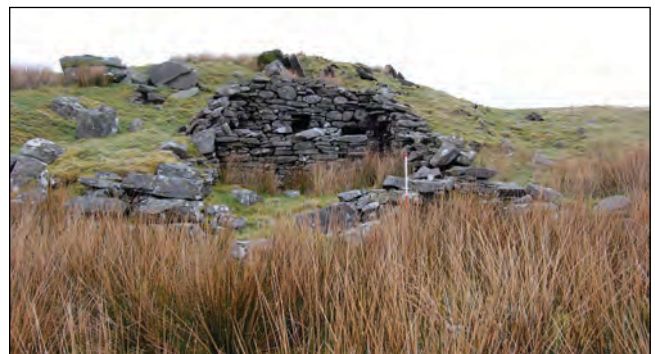
Plate 10. Sheepfold/shelter (PRN 28907), from south

The building is some distance from the track, easily recognized and unlikely to be damaged.

**Recommendations for mitigatory measures:** *Avoid.*

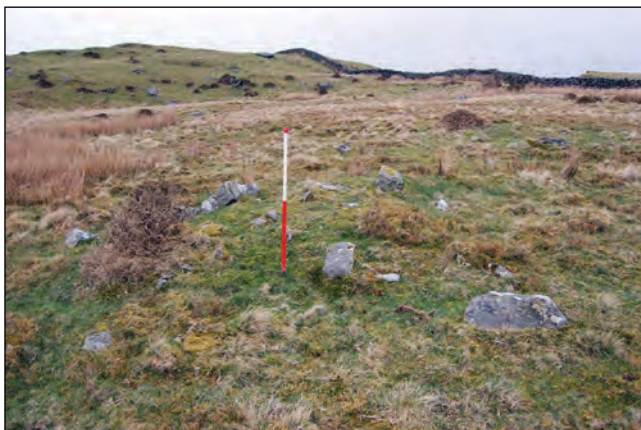
Plate 11. Cairn (PRN 30430), from south

This cairn is on the very edge of the track. If vehicles repeatedly tracked over it the stones could be disturbed and the appearance of the cairn confused. It is difficult to recognise and would need to be clearly fenced off to avoid damage.

**Recommendations for mitigatory measures:** *Fence and avoid*

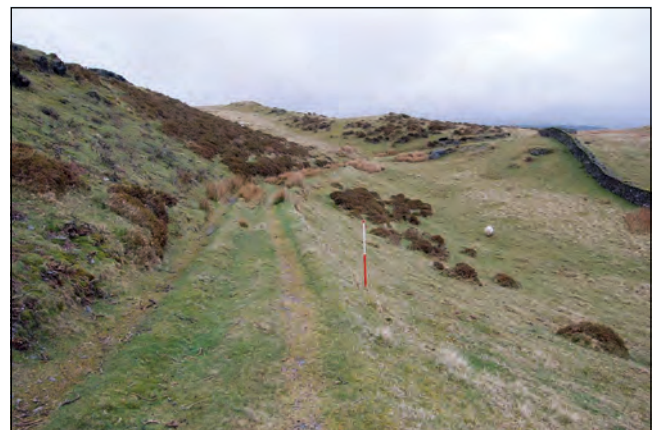
Plate 12. Section of track (PRN 30431) terraced into hill slope, from west

The track will have to be up-graded by the deposition of hardcore to create a more robust surface, but as long as it is not widened or re-terraced there will be no loss of the existing route or features of the track. No other specific mitigatory measures are therefore recommended.

**Recommendations for mitigatory measures:** *Upgrade to prevent erosion*
