**PROPOSED PUMPING STATION, RHIWGOCH, HARLECH
REPORT ON AN ARCHAEOLOGICAL WATCHING BRIEF**

GAT Project no. G2064

GAT Report No. 809

**Prepared for Egniol Consulting
on behalf of Dŵr Cymru/Welsh Water**

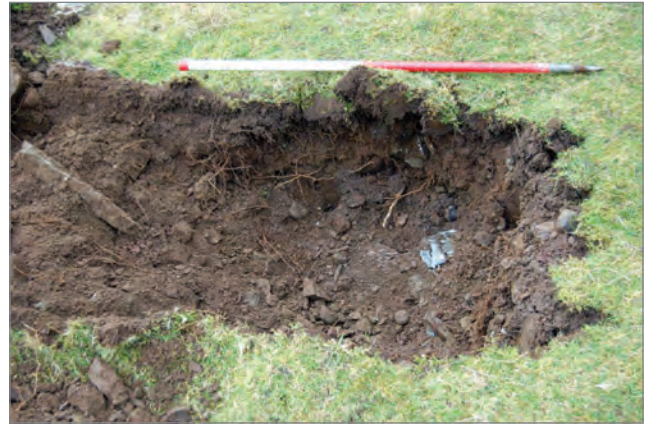
Plate 1. Test pit 1 from E

Size: 1.1m by 0.7m, 0.4m deep max.

0-0.1m: Layer 101. Dark grey loam with occasional stones. Topsoil.

0.1-0.4m: Layer 102. Friable dark brown loam with c.50% angular and sub-rounded stones up to 300mm in length. Main soil horizon developed on the boulder clay. No traces of mixing due to ploughing.

0.4m: Bedrock. Broken up surface of the shale bedrock, breaks into angular slabs.

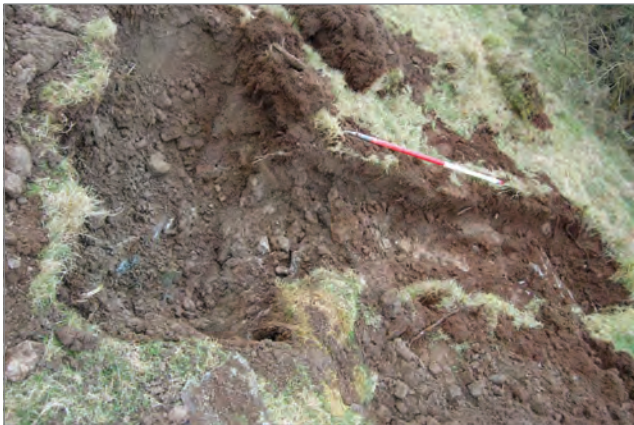
Plate 2. Test pit 2 from NW

Size: 2.8m by 0.7m, with an extra width of 1.6m at the eastern end, 0.6m deep max.

0-0.1m: Layer 201. Dark grey loam with occasional stones. Topsoil.

0.1-0.2m: Layer 202. Friable dark brown silty loam with c.10% sub-rounded stones up to 150mm in length. This was thickest at the western end and petered out towards the east. Main soil horizon developed on the boulder clay. No traces of mixing due to ploughing.

0.2-0.6m: Layer 203: Mid grey, clayey loam, lighter towards the base of the layer, with numerous stones up to 500mm in length, mainly angular and sub-angular. Altered boulder clay.

0.6m: Bedrock. Broken up surface of the shale bedrock, slopes down fairly steeply from west to east.

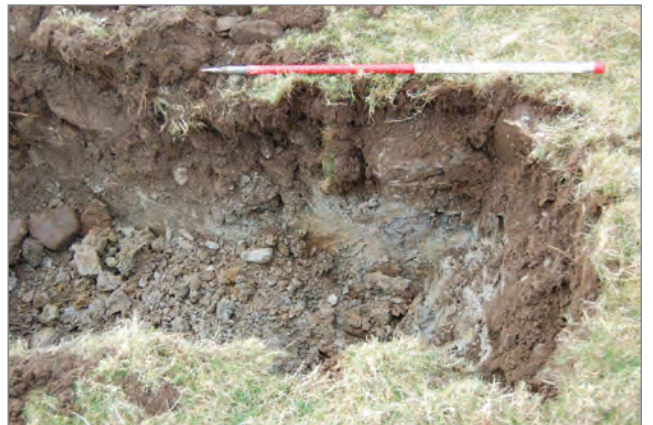
Plate 3. Test pit 3 from E

Size: 2.0m by 0.7m, 0.8m deep max.

0-0.1m: Layer 301. Dark grey loam with occasional stones. Topsoil. It has a thin layer of pea gravel at its base indicating where the gravel was stored during the laying of one of the water pipes running across the site.

0.1-0.4m: Layer 302. Friable dark brown clayey silt with some grit and c.50% sub-angular stones up to 300mm in length. Main soil horizon developed on the boulder clay. No traces of mixing due to ploughing.

0.4-0.8m: Layer 303: Friable light grey, silty clay, with numerous stones up to 500mm in length, mainly sub-angular but some rounded. Boulder clay.

0.8m: Bedrock. Broken up surface of the shale bedrock.

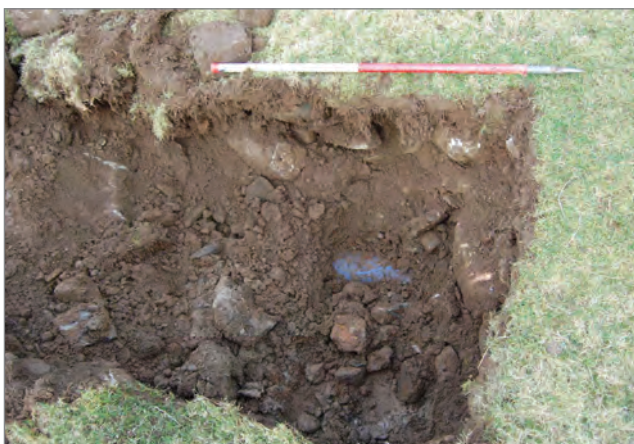
Plate 4. Test pit 4 from S

Size: 1.6m by 0.7m, 0.7m deep max.

0-0.1m: Layer 401. Dark grey loam with occasional stones. Topsoil.

0.1-0.7m: Layer 402. Friable dark brown silty loam with numerous stones up to 600mm in length. Quite loose. Fill of pipe trench.

0.7m: Plastic water pipe found, excavation stopped.

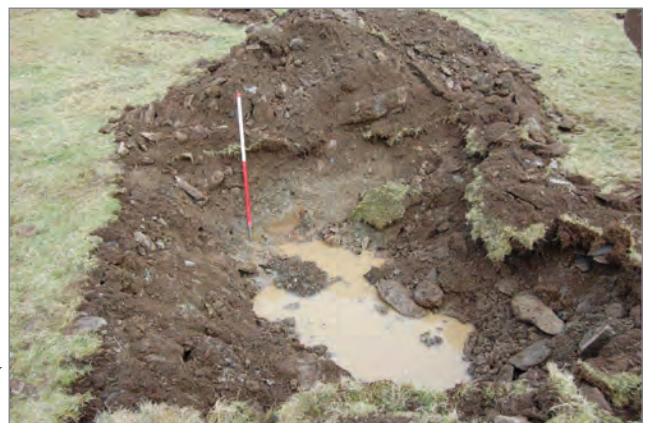
Plate 5. Test pit 5 from SW

Size: 2.7m by 2.3m, 1.1m deep max.

0-0.1m: Layer 501. Dark grey loam with occasional stones. Topsoil.

0.1-1.1m: Layer 502. Loose dark brown loam mixed with lenses of mid grey clay and numerous stones up to 500mm in length. Fill of pipe trench. Pipe trench occupies western half of the test pit but is broader at the top and the fill covered most of the test pit near the surface.

0.1-0.4m: Layer 503. Friable dark brown silty loam with numerous sub-angular stones up to 300mm in length. Main soil horizon developed on the boulder clay. No traces of mixing due to ploughing.

0.4-0.8m: Layer 504: Friable light grey, silty clay, with numerous stones up to 500mm in length, mainly sub-angular but some rounded. Boulder clay.

0.8m: Bedrock. Broken up surface of the shale bedrock.

1.1m: Mains water pipe located under concrete cover.
