# CONWY QUAY REDEVELOPMENT PROGRAMME

## ARCHAEOLOGICAL RECORD & WATCHING BRIEF

### Photographic survey and watching brief

GAT Project No. 2070

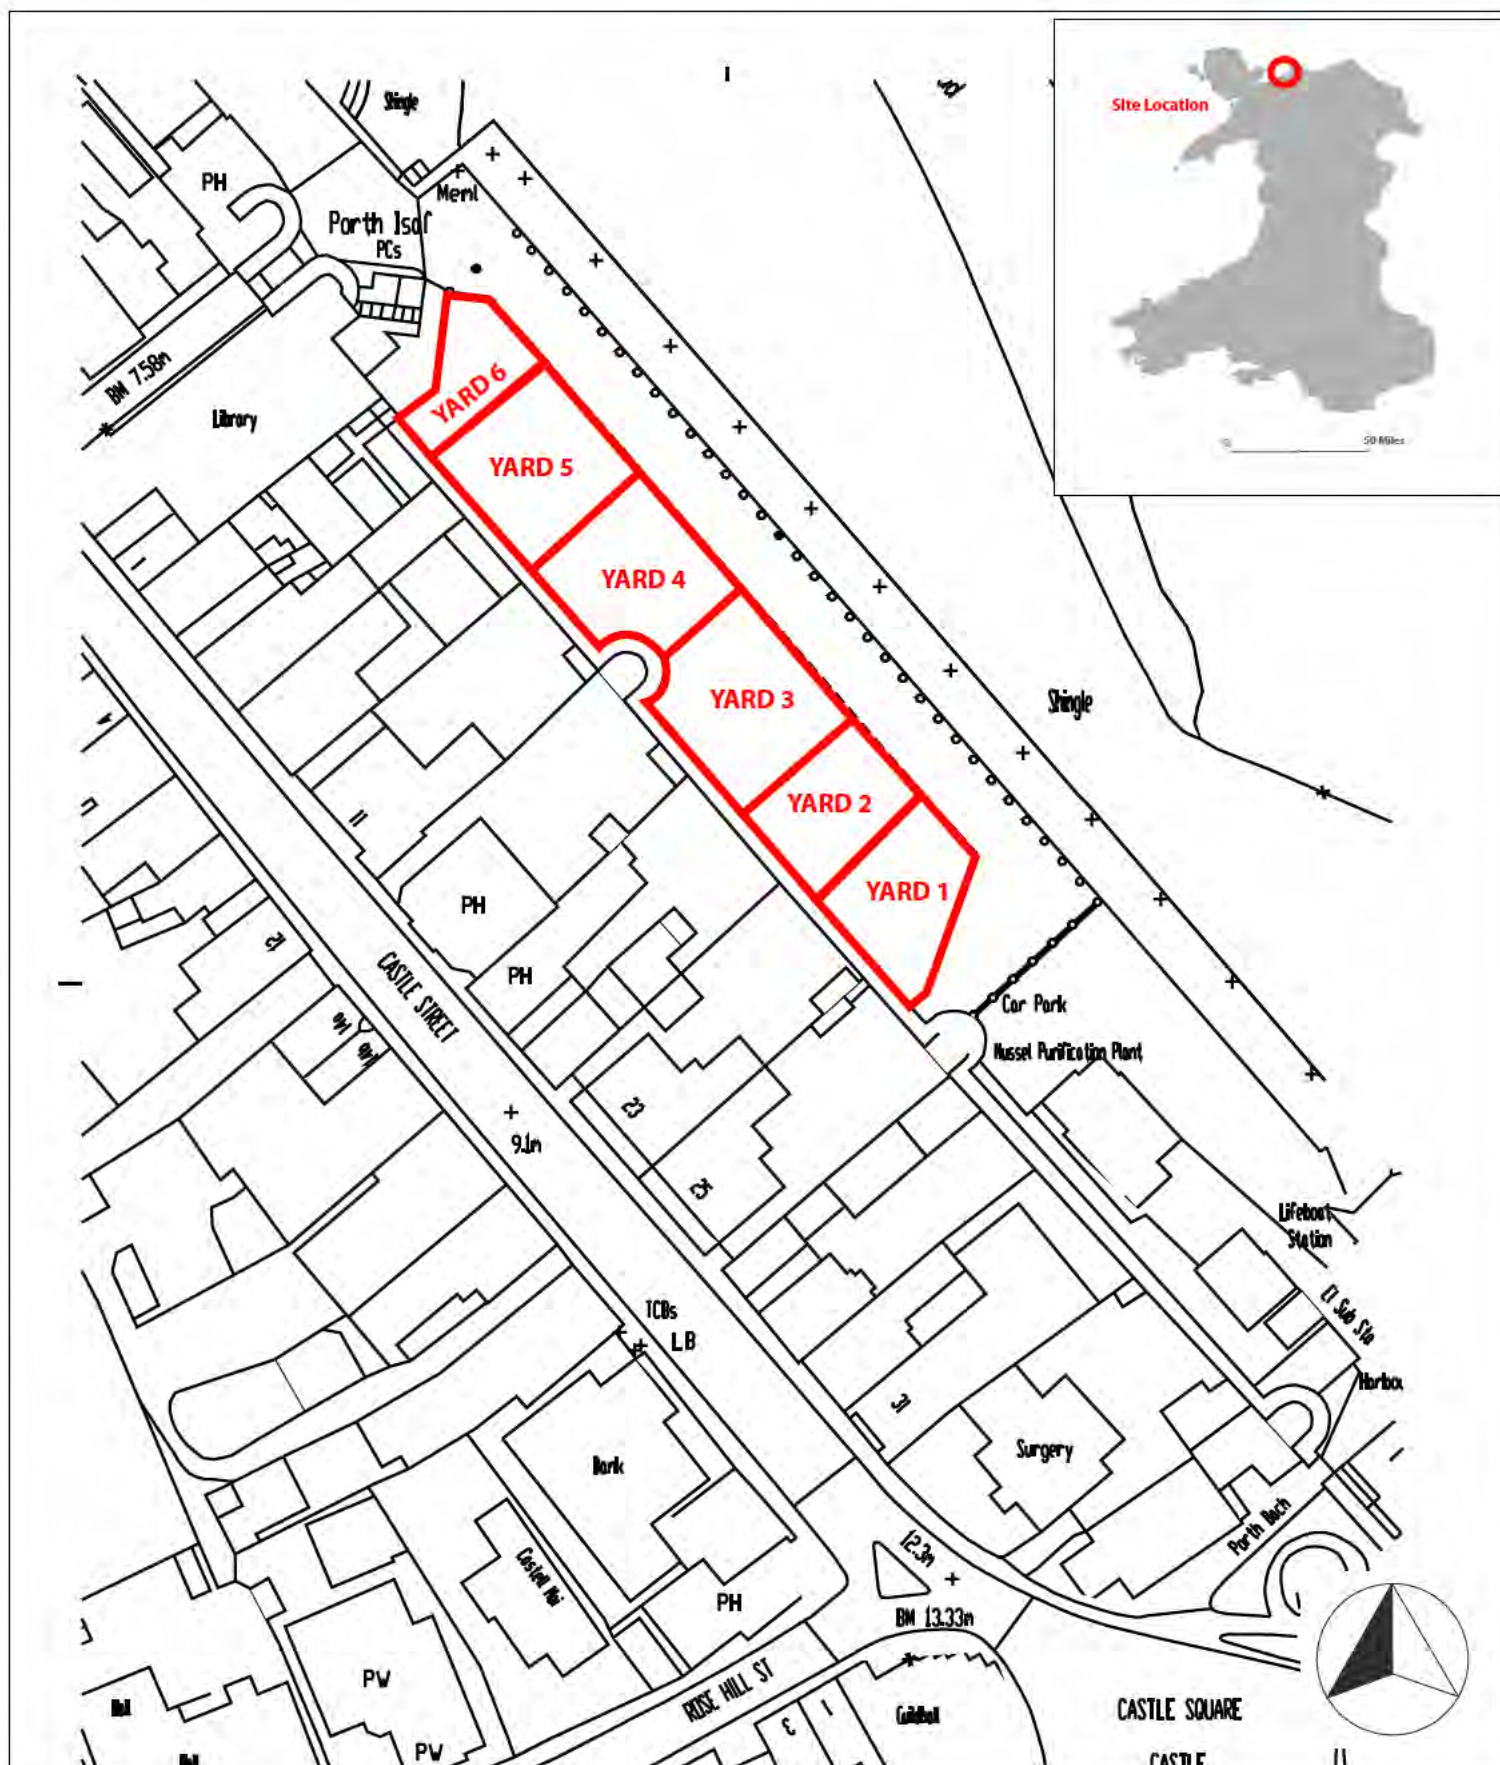
**Figure 02: Location of the designated YARDS (See Appendix I for PRN numbers) discussed in the report and located within the quay redevelopment area (Map based on Conwy County Borough Council Property Block and Key Plan CEU901.09/01#02) NOT TO SCALE**

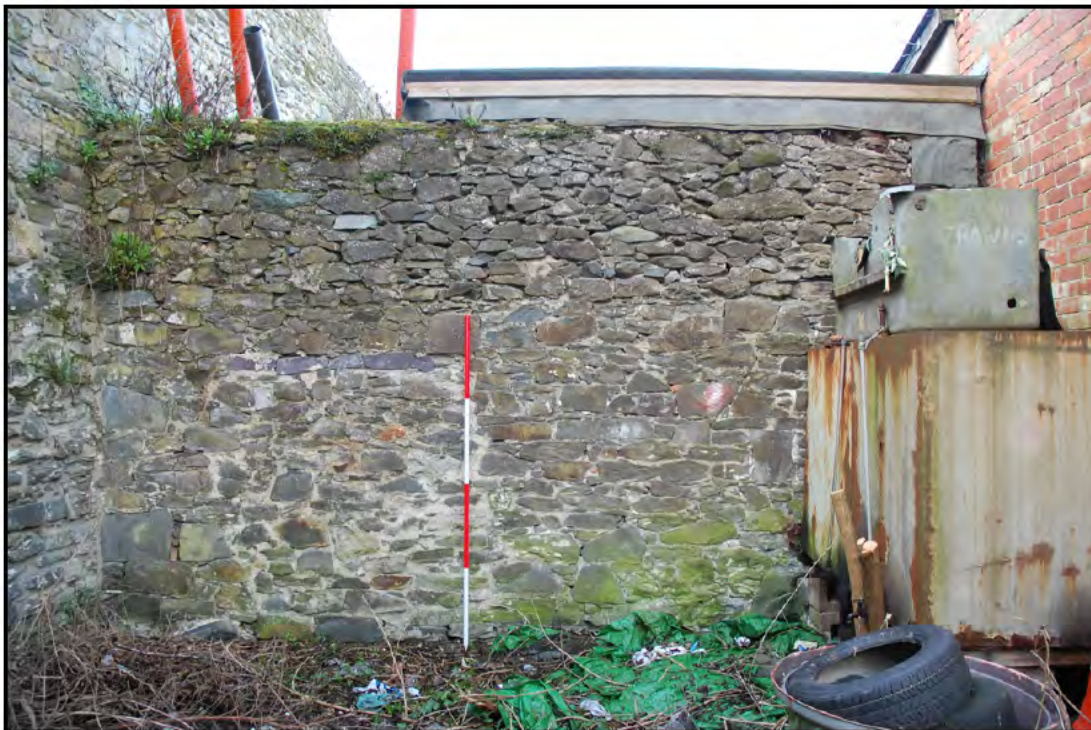
**Plate 1: YARD 1 (PRN 30452): Cross Wall A: south-facing elevation of rubble-built mortared stone wall 3.0m high that defined the northern boundary of Yard 1; the topmost metre is a later addition. A blocked entrance is visible to the left of the ranging pole. (Ranging pole: 2.0m)**

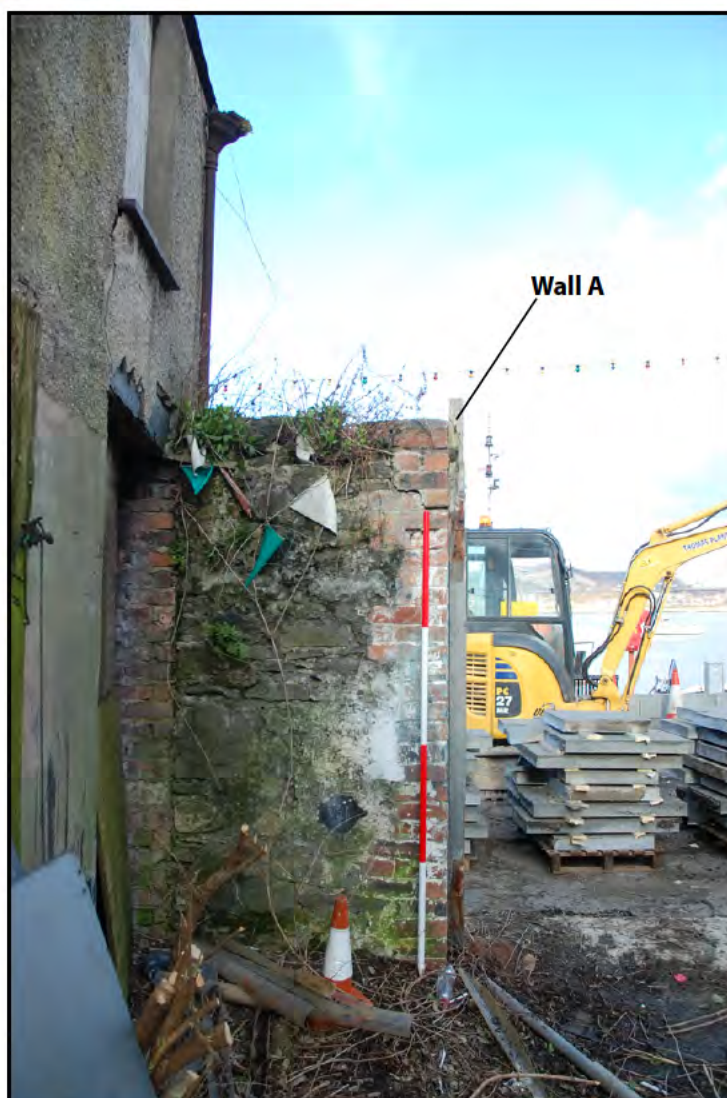
**Plate 2: YARD 1 (PRN 30452): Wall A: view east of enclosure wall (Wall A) that initially surrounded the entire quay but was subsequently altered to accommodate new entrances/structures. Entrance through Wall A into Yard 1 visible in this example (Ranging pole: 2.0m)**

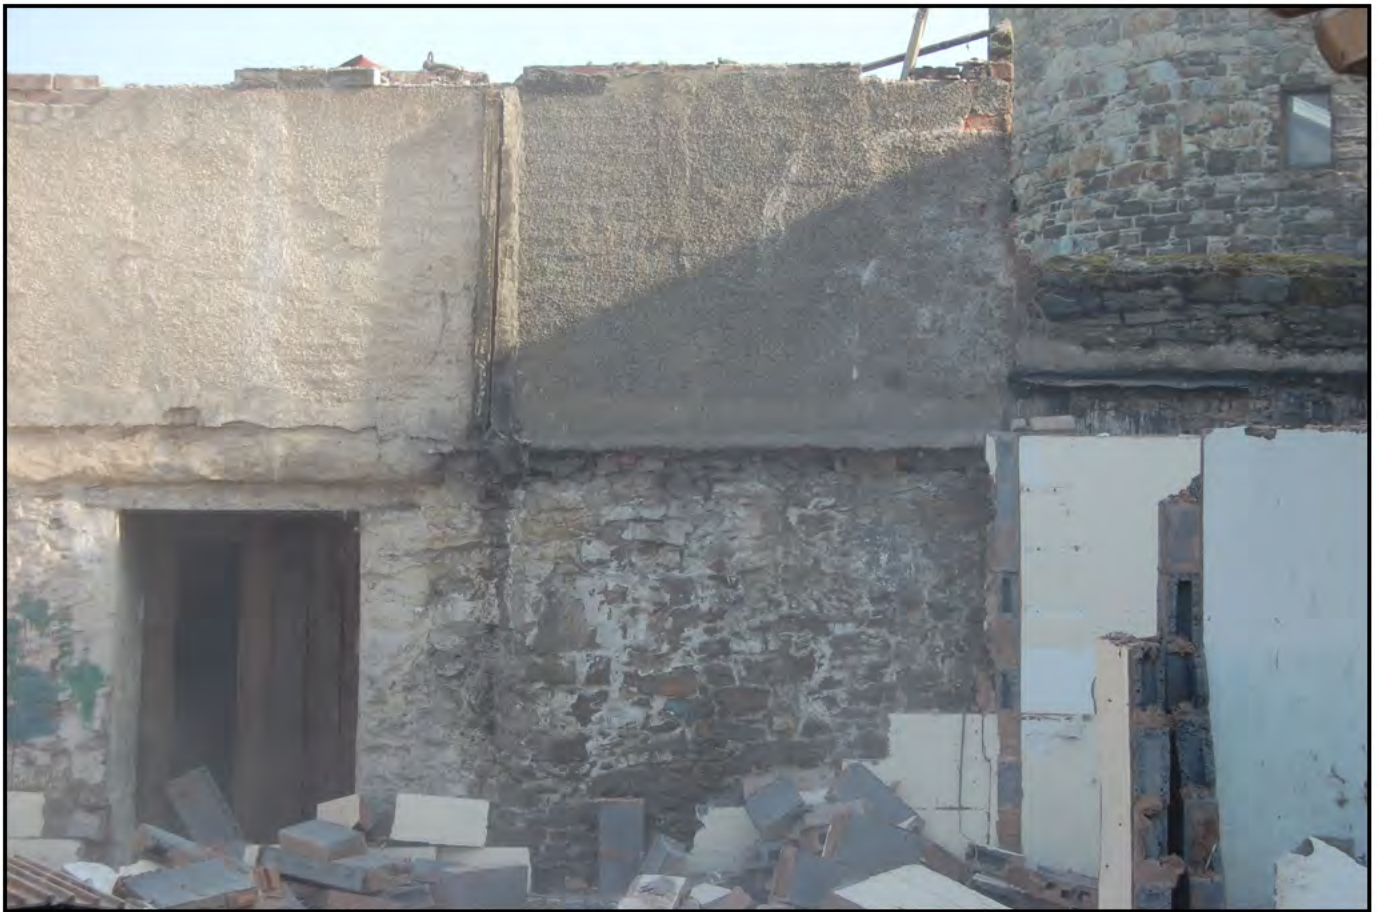
**Plate 03: YARD 1/2 (30454): Building 01(PRN 30452): doorway identified in the north elevation of Building 01 during the watching brief phase. The doorway linked Buildings 01 and 02 (PRN 30455) and was constructed through Building 01/Cross Wall A and both buildings functioned as a single business.**

A blocked up doorway was found in the north elevation of **Building 01** linking both buildings and yards (plate 03). The north exterior wall of **Building 01**, covered by **Building 02**, was rendered, which suggests it was originally constructed to stand alone, and **Building 02** added later (plate 04).

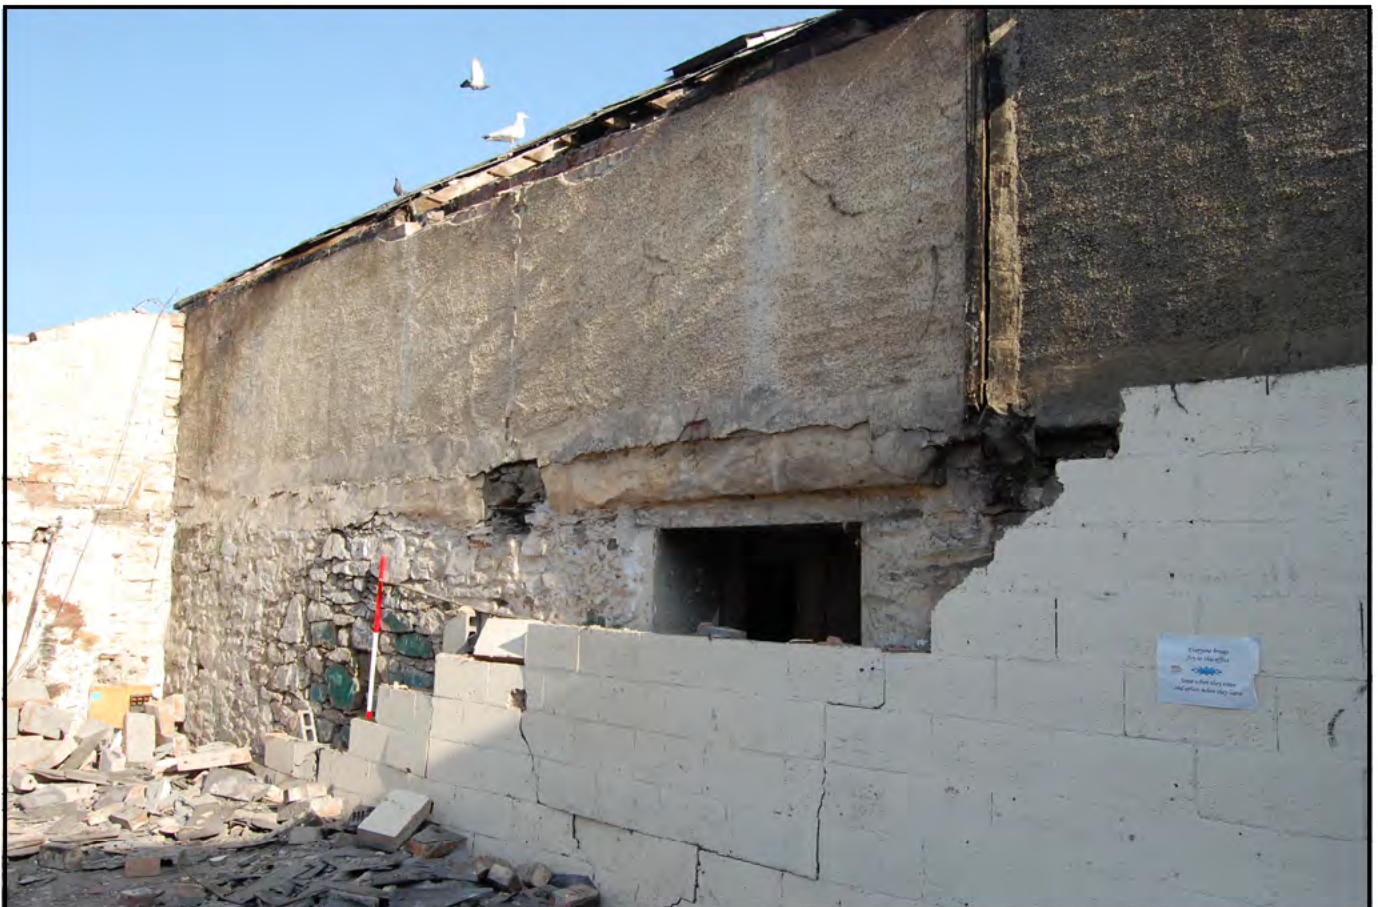
**Plate 04: YARD 1/2 (PRN 30451/PRN 30454: Buildings 01 (PRN 30452) and 02 (PRN 30455) : doorway identified in the north elevation of Building 01 during the watching brief phase. The doorway linked Buildings 01 and 02 and was constructed through Cross Wall A. Building 02 was built from thermal blockwork whereas the exterior wall of Building 01 (facing north), covered by Building 02, was rendered, suggesting it was originally constructed to stand alone with Building 02 added later (Ranging pole: 2.0m)**

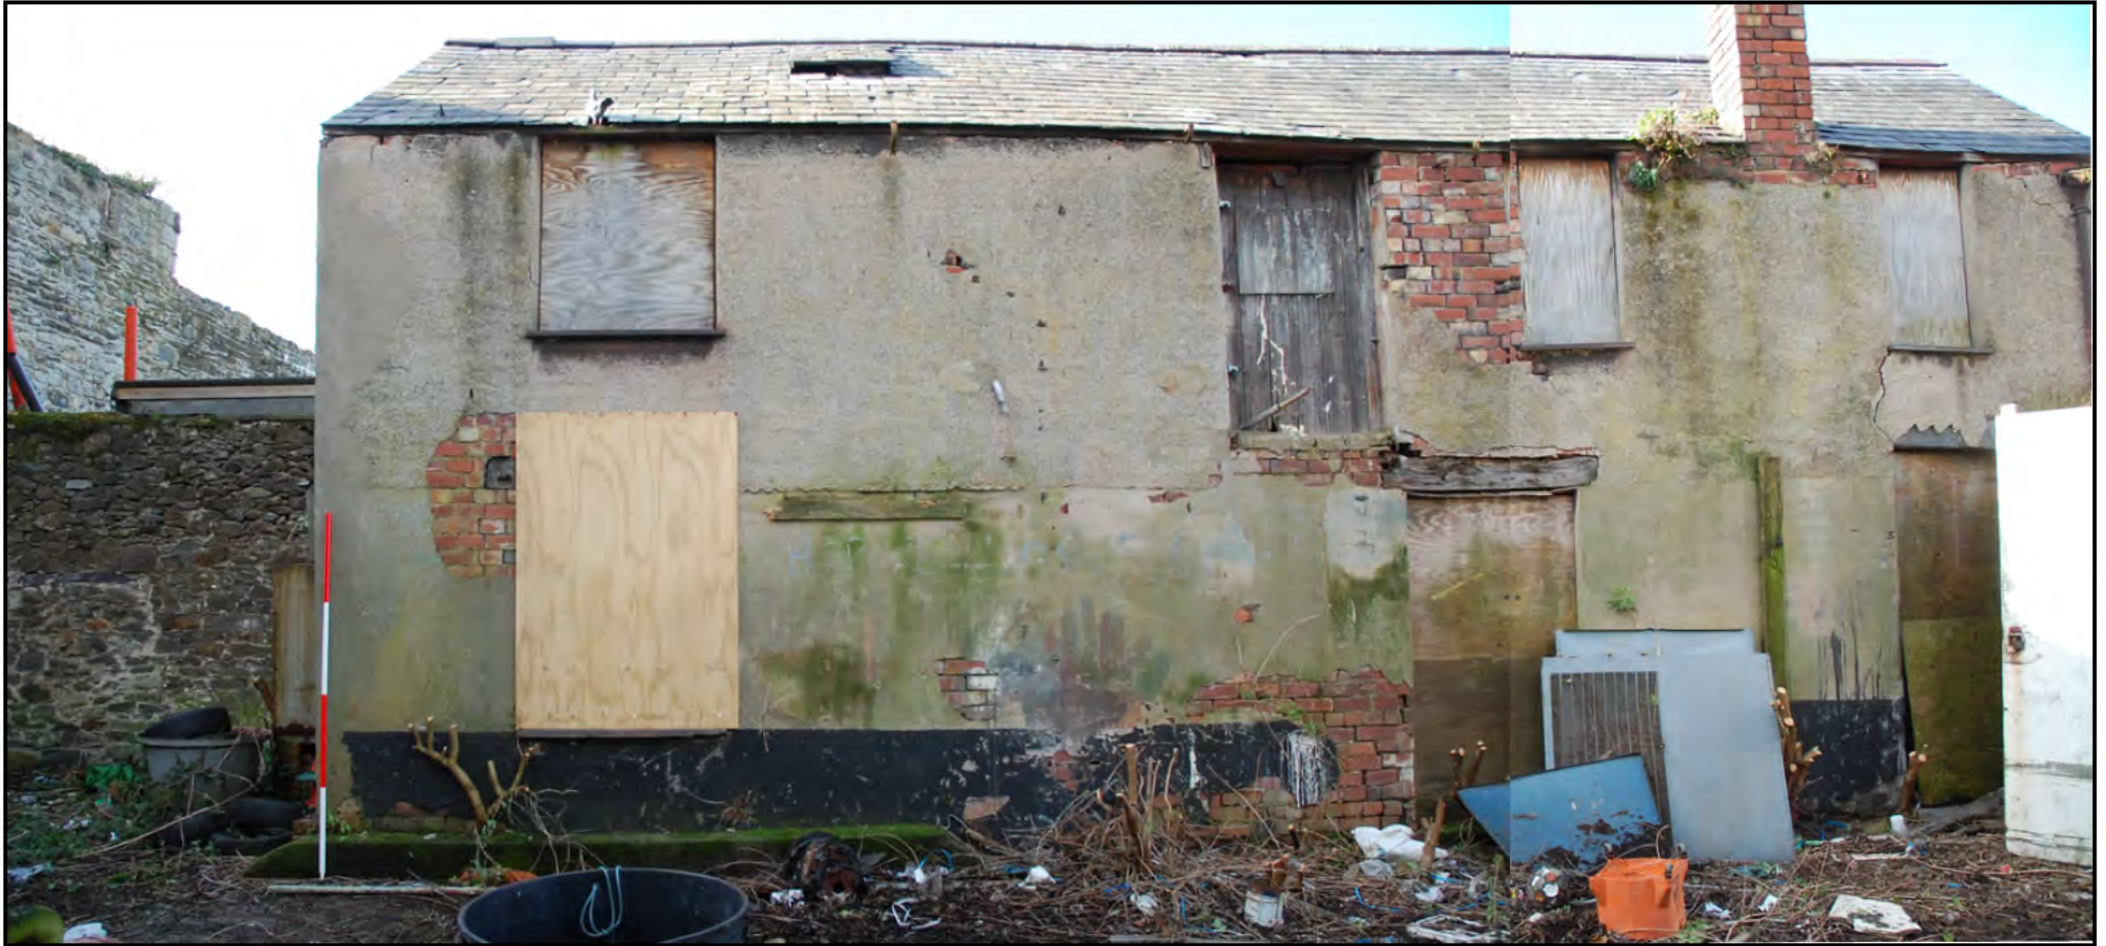
**Plate 05: YARD 1 (PRN 30451): Building 01 (PRN 30452): south elevation: measured 10.84m in length and 3.95m in height. This elevation was in red brick (stretcher bond) partly covered by roughcast render. On the ground floor were two doors and one window, whilst on the first floor were three windows and a door. A single stack brick-built chimney rises from this wall, between the two windows, surmounted by a bishop-style chimney pot. Cross Wall A is visible to left of Building 01 (cf. plate 01) (Ranging pole: 2.0m)**

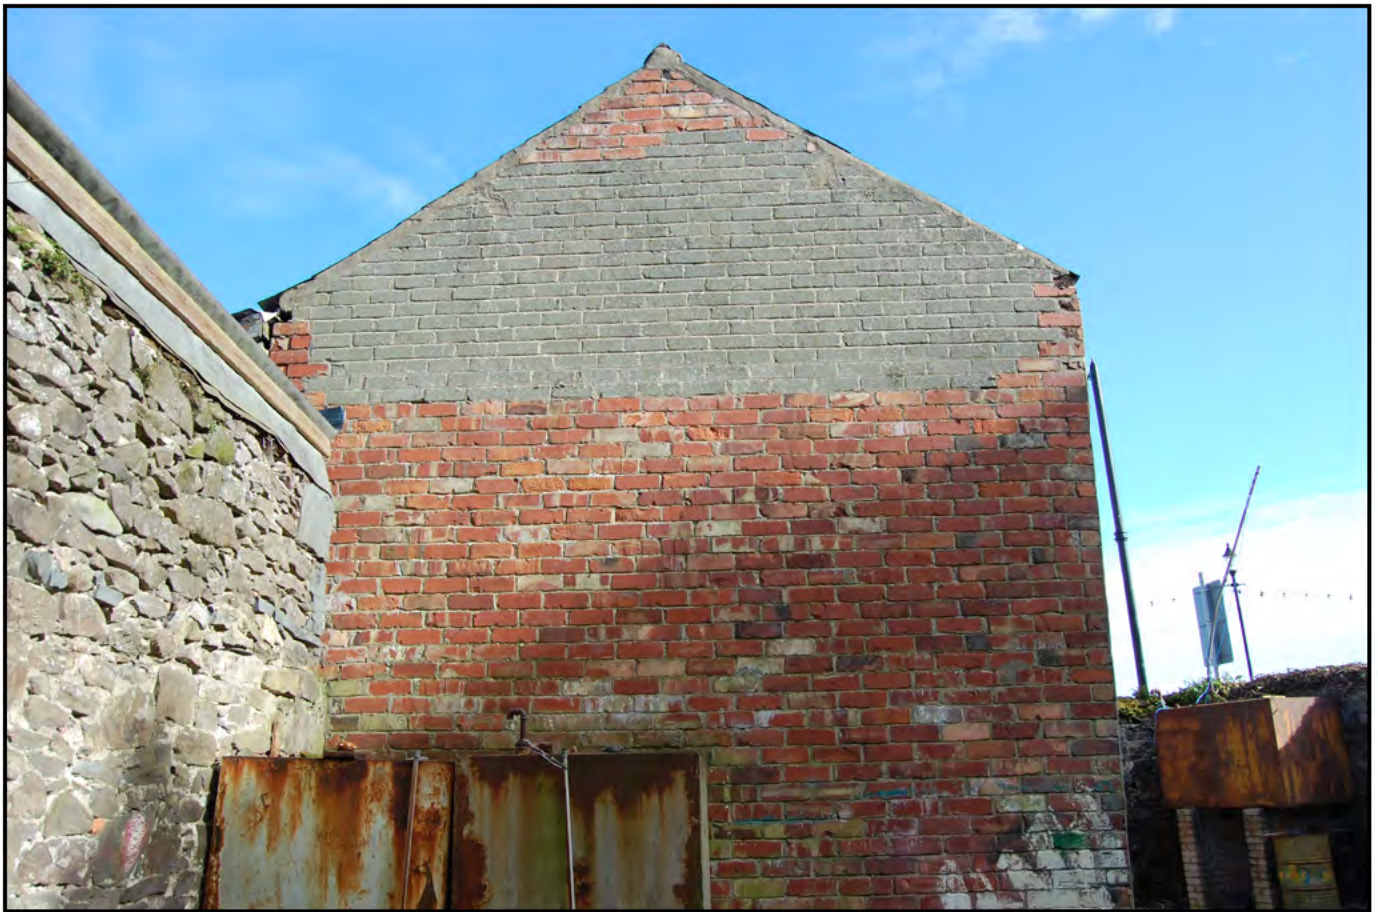
**Plate 06: YARD 1 (30451): Building 01 (30452): west elevation, built largely of red brick using a stretcher bond with first floor grey brick repair. Note Cross Wall A at left of image.**

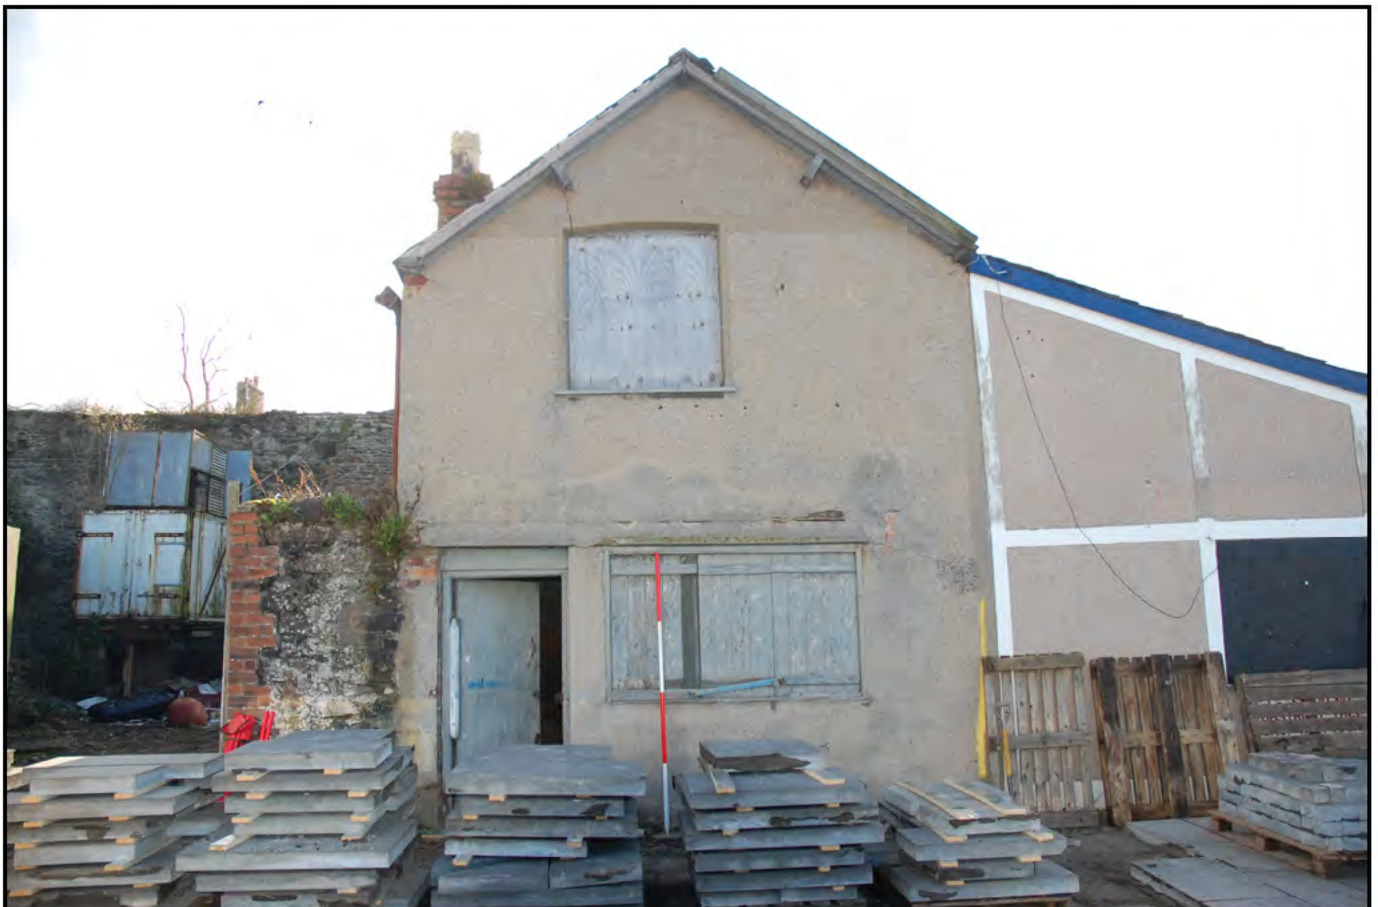
**Plate 07: Building 01 (PRN 30452) & Building 02 (PRN 30455): facing the quaysie (east elevation). Main entrance to Building 01 is visible along with ground floor window and first floor window. Pebbledash render throughout. Chimney also visible. Remnant of Wall A visible at left of image (enclosure wall). (cf. plate 16 for Building 02 east elevation)(Ranging pole 2.0m)**

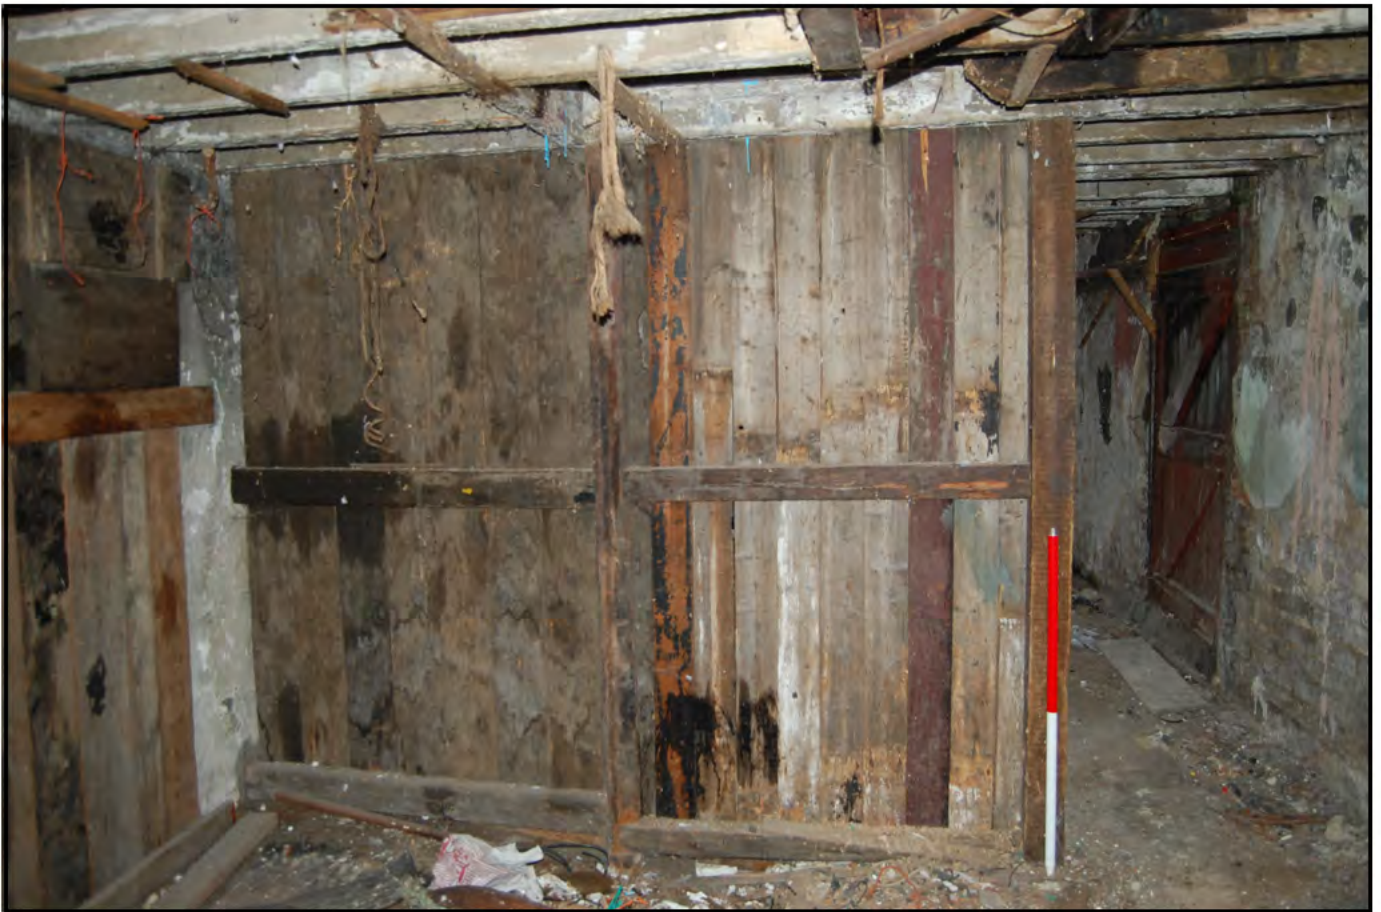
**Plate 08: Yard 01 (PRN 30451)/Building 01 (PRN 30452): internal view detailing ground floor. Comprised two rooms divided by a timber partition. Internal walls were rendered, the floor was concrete and the first floor supported on wooden ceiling joists. (Ranging pole: 1.0m)**

The ground floor partition consisted of an upright wooden panel, 2.20m high and 2.70m wide, attached to a wooden frame (plate 08). The floor of the building was sunken in the middle and it was first thought this might reflect some specialist function, but after demolition it was seen that the original floor had subsided, and that the concrete skim was merely a poor repair covering, but not levelling, the floor. The first floor, also divided into two rooms, was plastered and decorated for use as an office, with skirting board and plaster ceiling (plate 11). In the south wall a fireplace (removed) connected to the brick chimney. Either side were two narrow eight pane sash windows (4+4) with moulded architrave.

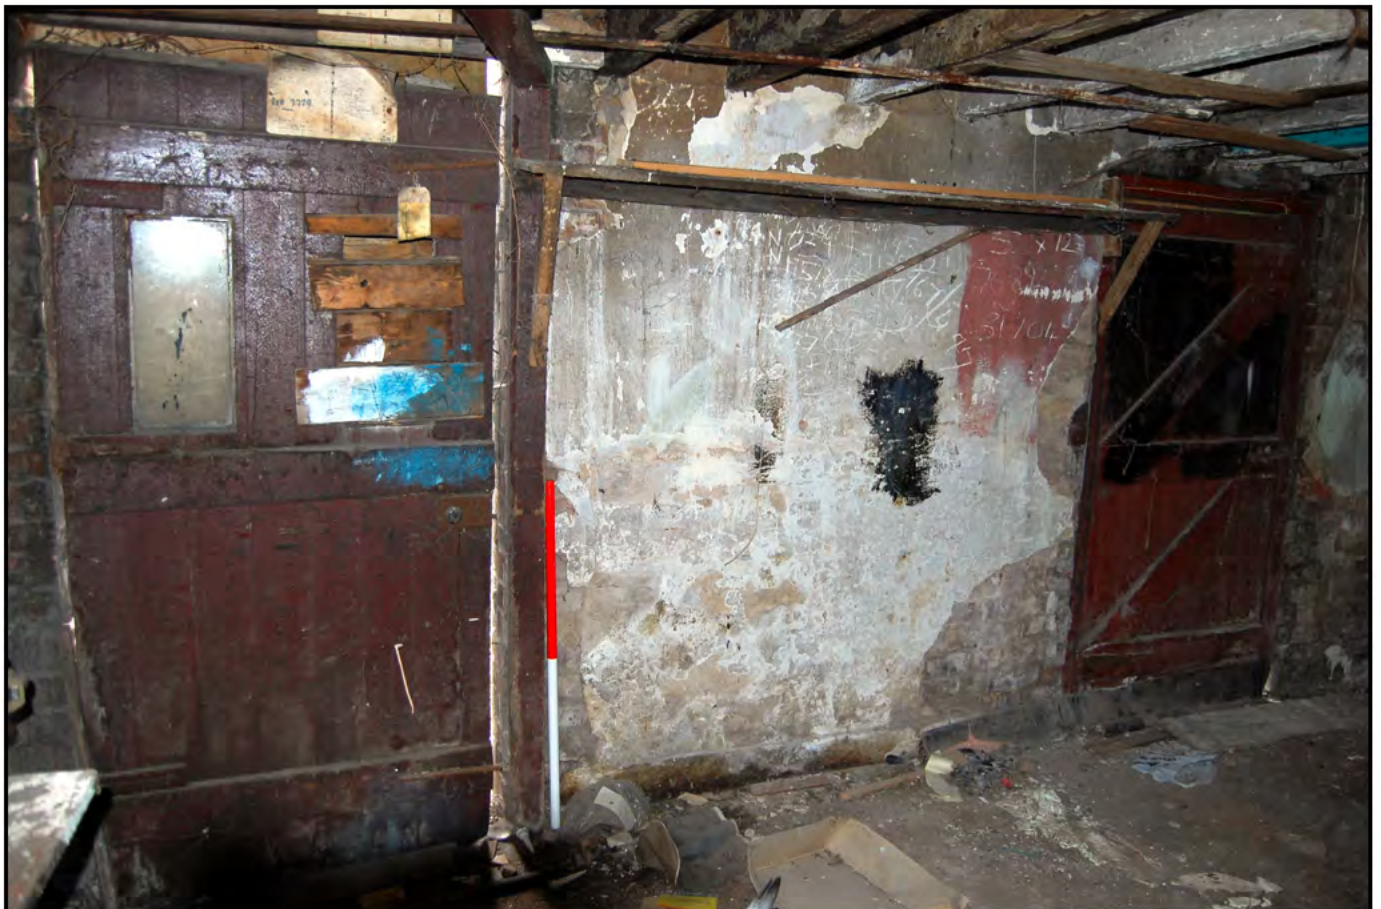
**Plate 09: Yard 01 (PRN 30451)/Building 01 (PRN 30452): internal view detailing ground floor (south wall). one ledged and braced door and one ledged door surviving in the south wall. (Ranging pole: 1.0m)**

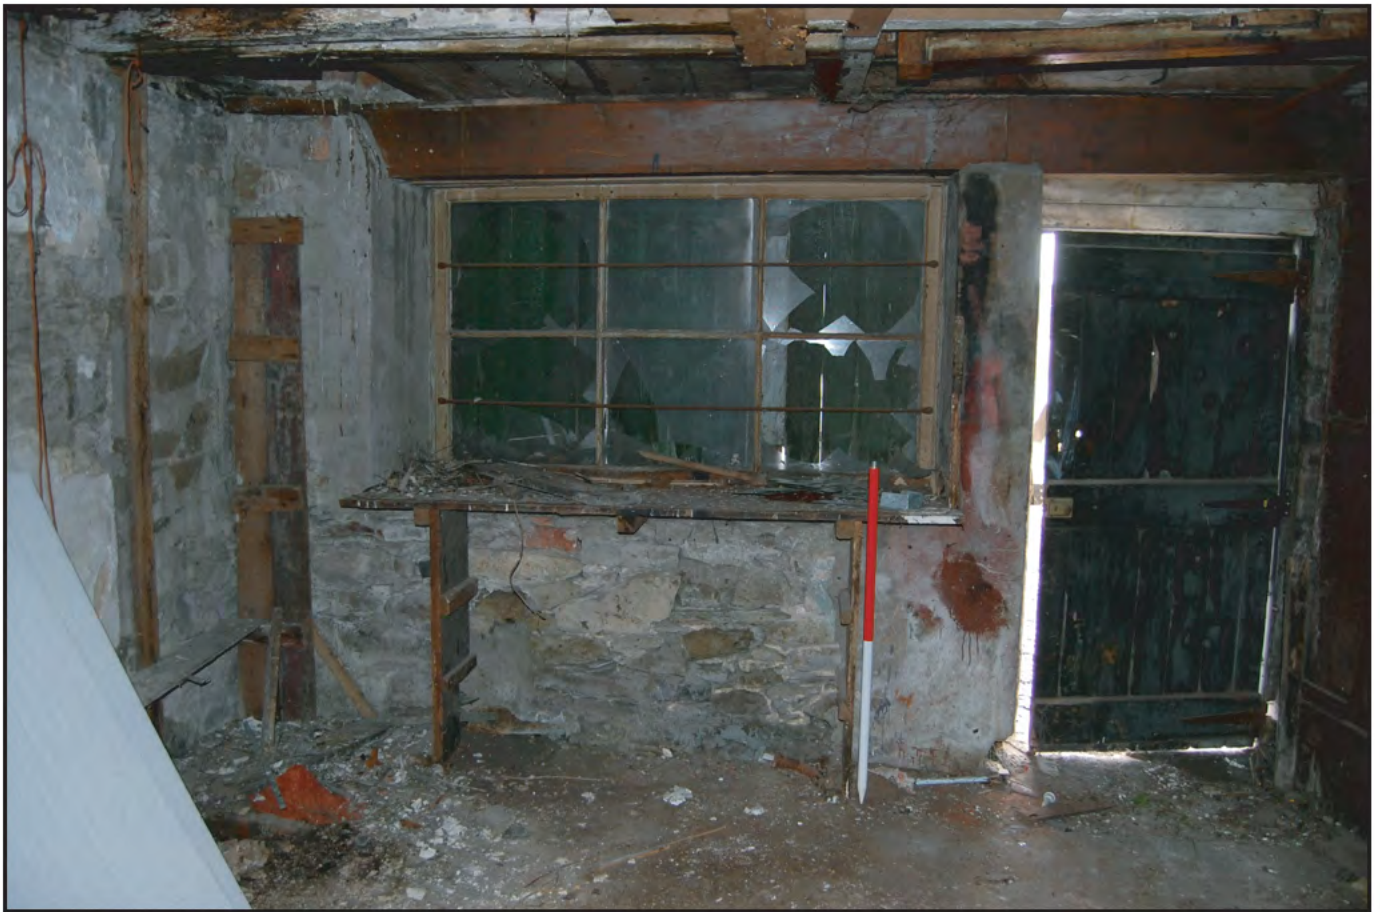
**Plate 10: Yard 01 (PRN 30451)/Building 01 (PRN 30452): internal view of east wall: ledged door and window. (Ranging pole: 1.0m)**

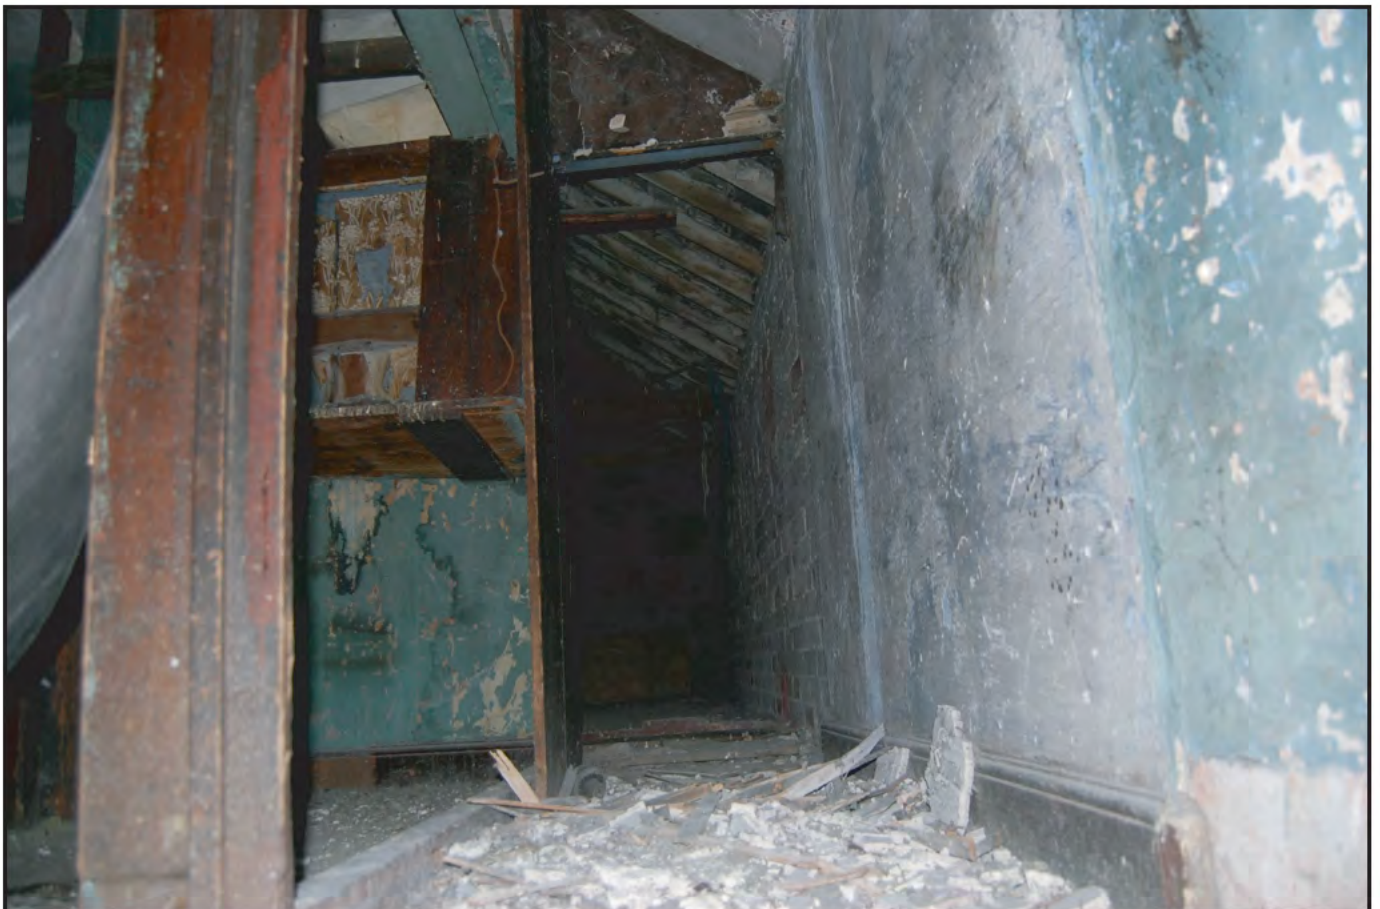
**Plate 11: Yard 01 (PRN 30451)/Building 01 (PRN 30452): internal view of the first floor; divided into two rooms, both plastered and decorated for use as an office, with skirting board and plaster ceiling**

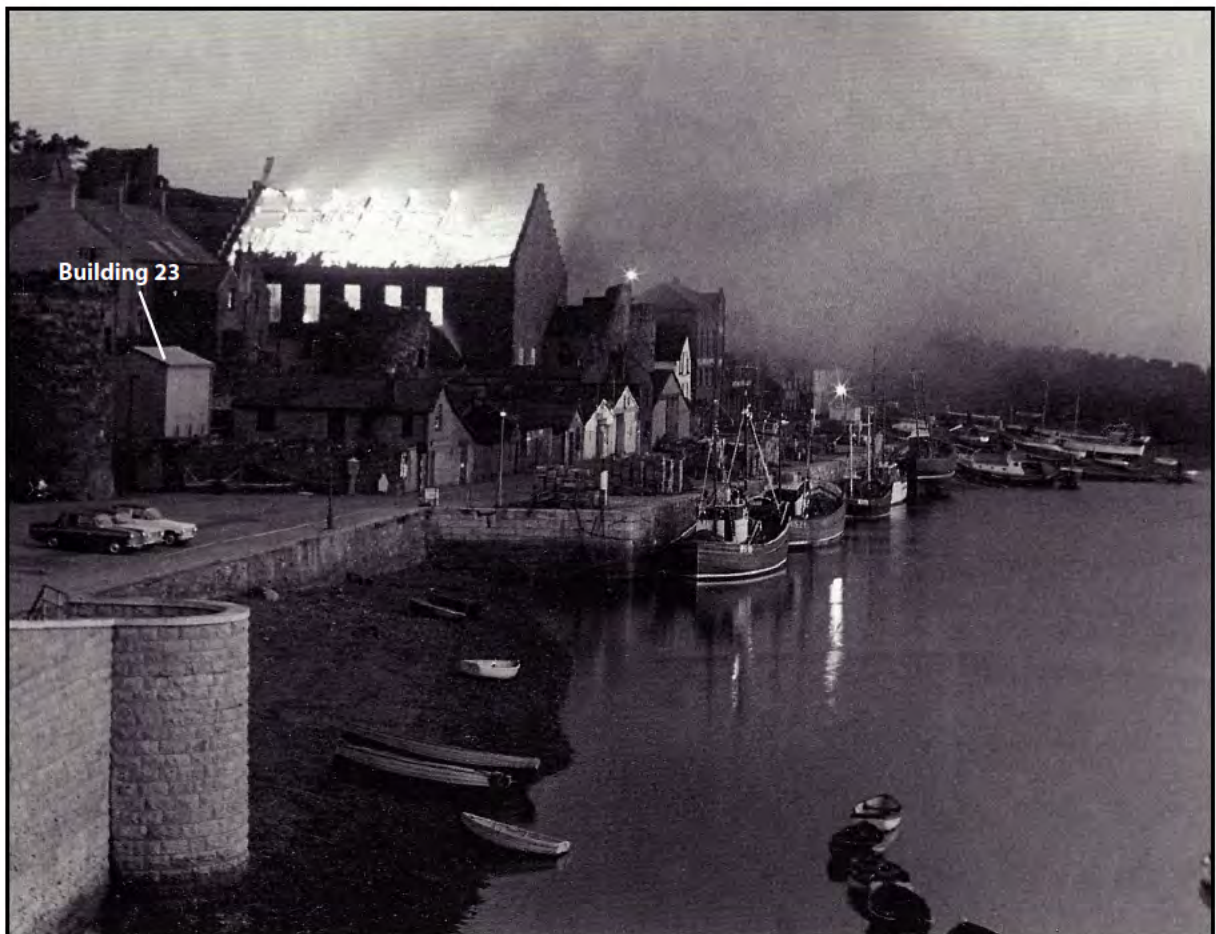
**Plate 13: THE QUAY: reproduction from E.M. Pattinson, vol. 2, of the Civic Hall ablaze in the 1960s. Building 23 (PRN 19749) is visible at the rear of Yard 01 (PRN 30451).**

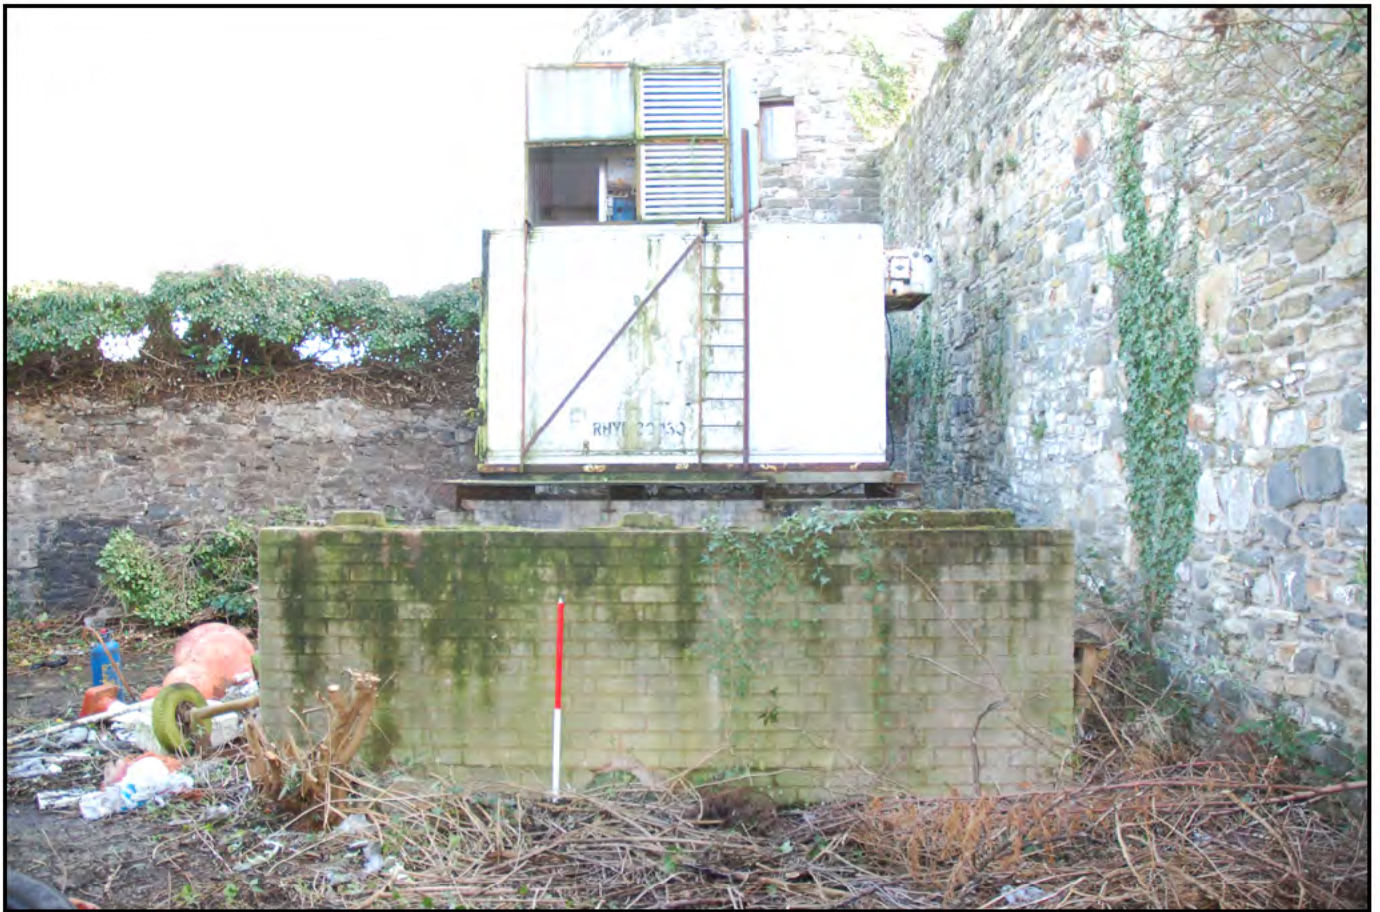
**Plate 14: YARD 1 (PRN 30451): Ice plant built in 1993 to replace Building 23 (PRN 19749) (cf. plate 13). Located at the rear of Yard 1. This unit produced ice on demand but did not have the capacity to store surplus ice. (Ranging pole: 1.0m)**

The final use of this building was as a fisherman's store and the yard was the location of the ice production and storage plant but this function was unconnected with the building. The first ice plant was erected in 1963 (pers. comm. various) and produced and stored shaved ice for the icing of boxed fish after landing. Previously the ice had been bought in blocks from a supplier in Llandudno (pers. comm. Mr Meddings). The ice plant which was in situ at the time of demolition was a 1993 replacement (plate 14).

**Building 23** was the ice plant within **Yard 1**. It was first built in 1963 to provide and store shaved ice for the icing of fish as they were unloaded on the Quay. Ice was not taken to sea. Before this, ice was brought in block form from Llandudno (pers. comm. Mr. Meddings, Martin Hughes, et. al.). A good view of this building can be seen on page 128 (E.M. Pattinson, vol. 2), in the view showing the Civic Hall ablaze (plate 13). It is the tall grey structure between tower 2, and **Building 01**. This was replaced in 1993 by the smaller unit which existed at the time of demolition, which was supported on parallel brick walls. This unit produced ice on demand but did not have the capacity to store surplus ice (plate 14).

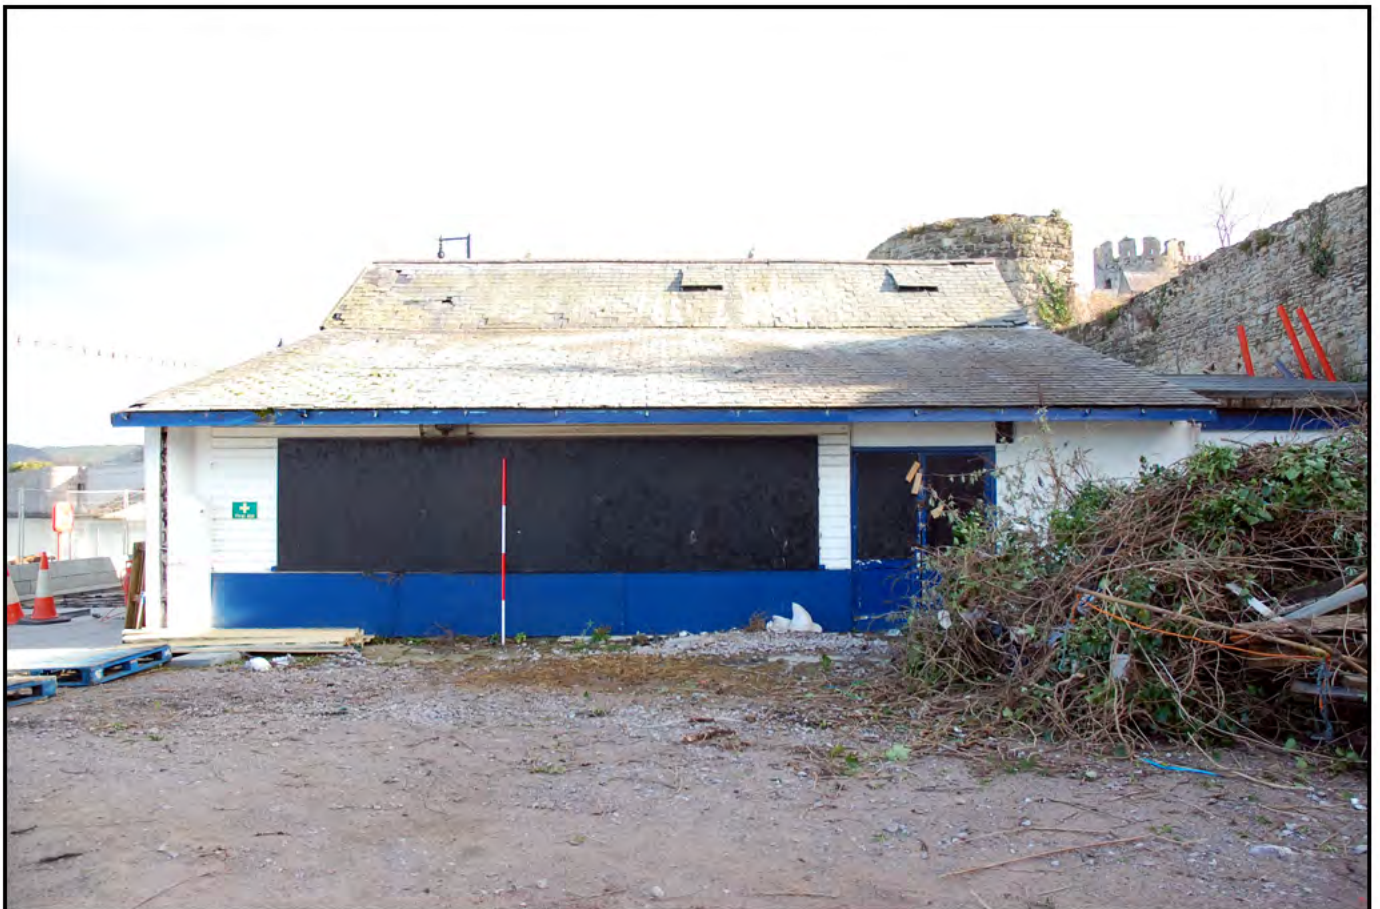
**Plate 15: Yard 2 (PRN 30454): Building 02 (PRN 30455): a single storey lean-to located against the south wall of Yard 2, opposite Building 01 (PRN 30452), with which it shared a common wall (Cross Wall A). A modern extension had been constructed onto the western end of the building. (Ranging pole: 1.0m)**

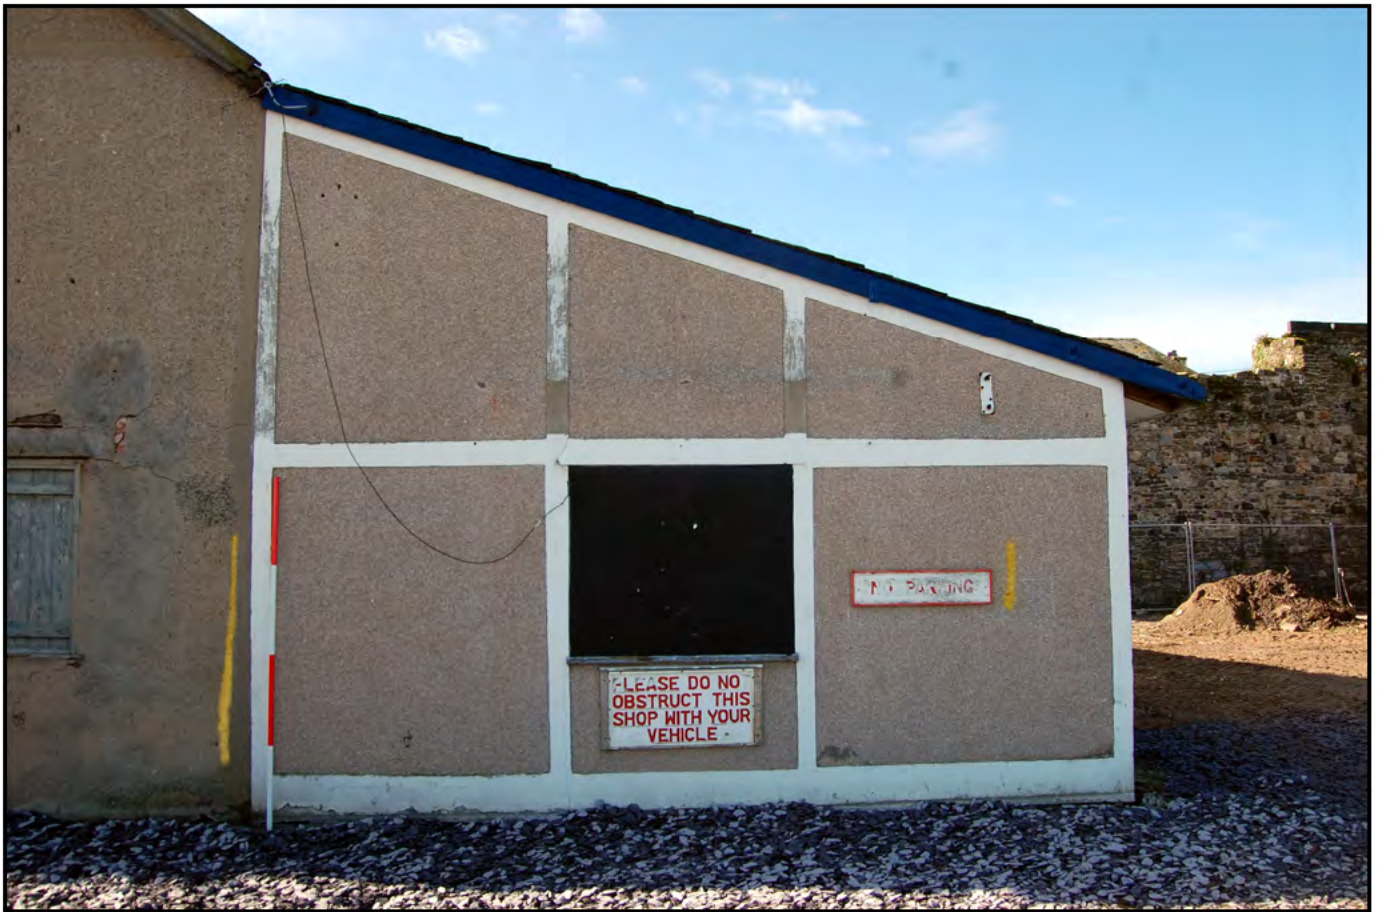
**Plate 16: YARD 02 (PRN 30454): Building 02 (PRN 30455): east elevation (quay side) prior to demolition.** The east elevation measured 5.30m in width and 3.95m in height, with pebbledash render. A blocked window was extant towards the centre of the elevation, c.1.00m above ground level (window measurements: 1.00m in height and width). (Ranging pole: 2.0m)
